# Anvil Range Mine Complex

## 2004 to 2008 Water Licence Renewal Application Report

Anvil Range Mining Corporation  
(Interim Receivership)

May 2003

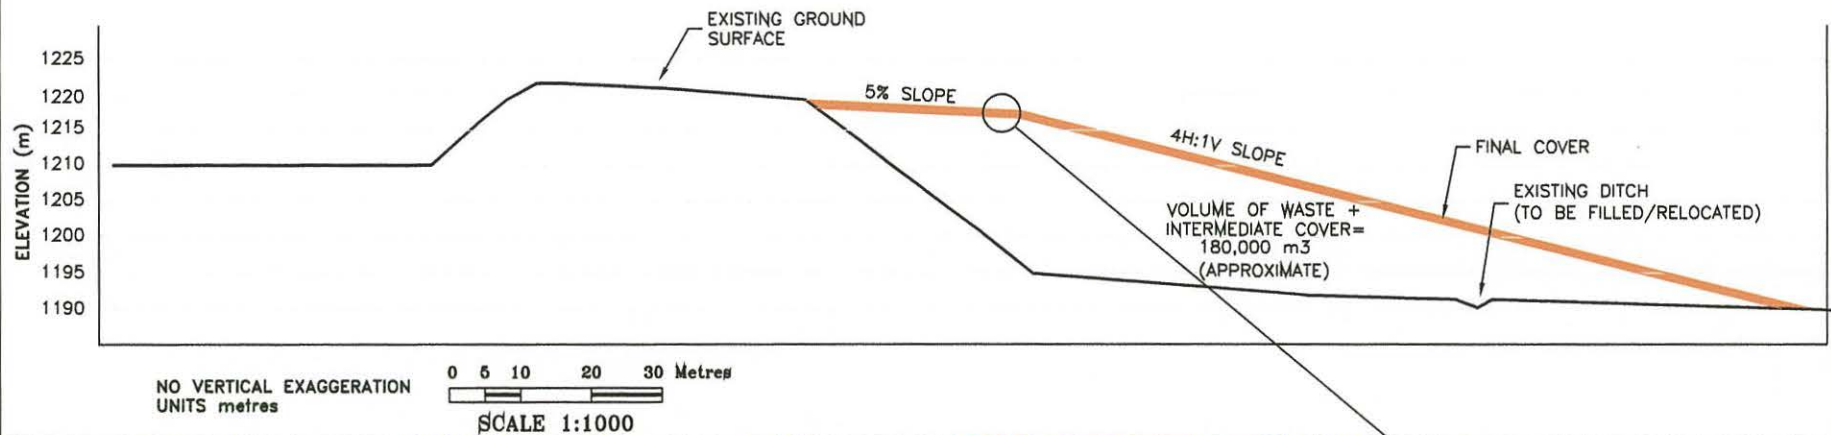
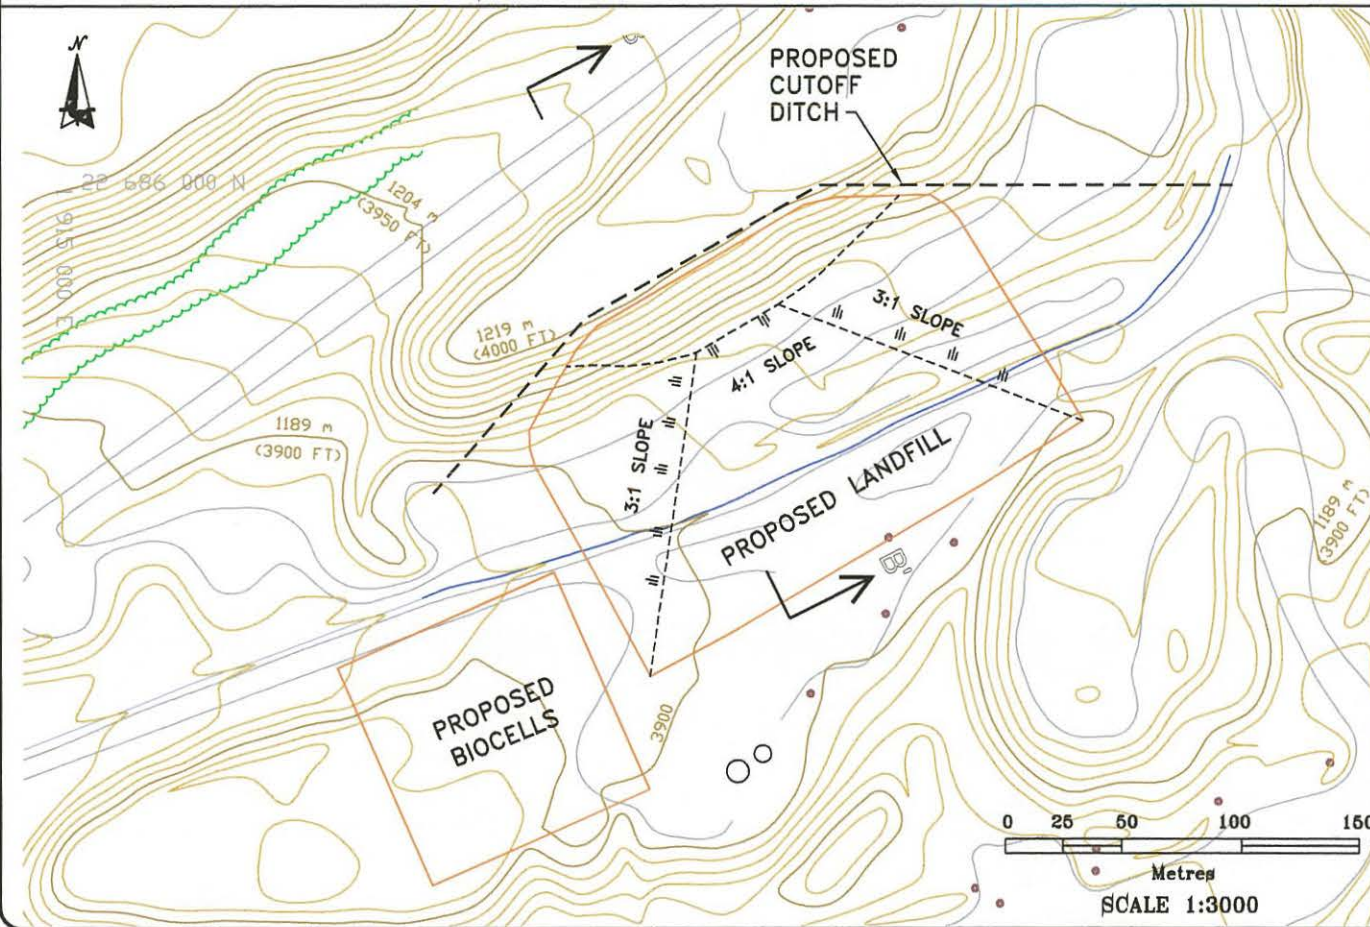
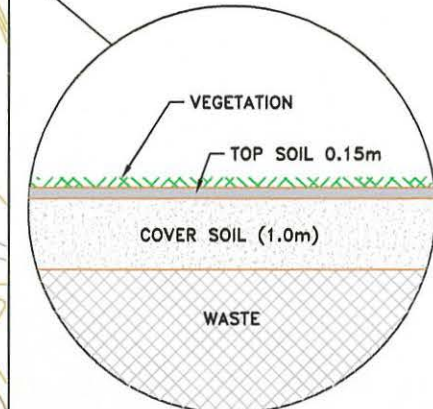
22

**PROPOSED LANDFILL AREA  
PROFILE - FARO SITE**

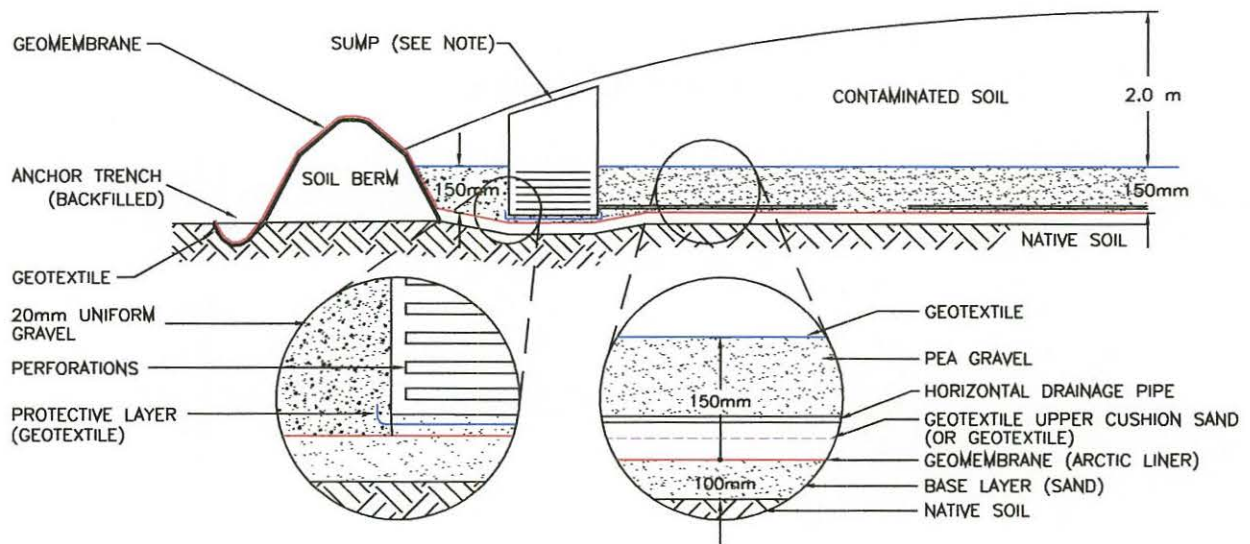
NOTE: BASE LAYER SAND LOWERED AT SUMP LOCATION

SECTION VIEW OF TYPICAL SOIL BIOTREATMENT CELL  
NOT TO SCALE

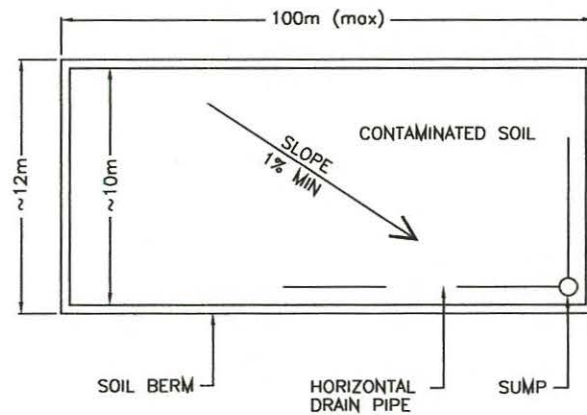
PLAN VIEW OF TYPICAL SOIL BIOTREATMENT CELL  
NOT TO SCALE
