## Anvil Range Mining Complex Bedrock Data and Groundwater Review for the Lower Rose Creek Valley

**2007/08 Task 21 – Final**

**Anvil Range Mining Complex  
Bedrock Data and Groundwater Review  
for the Lower Rose Creek Valley**

**2007/08 Task 21 – FINAL**

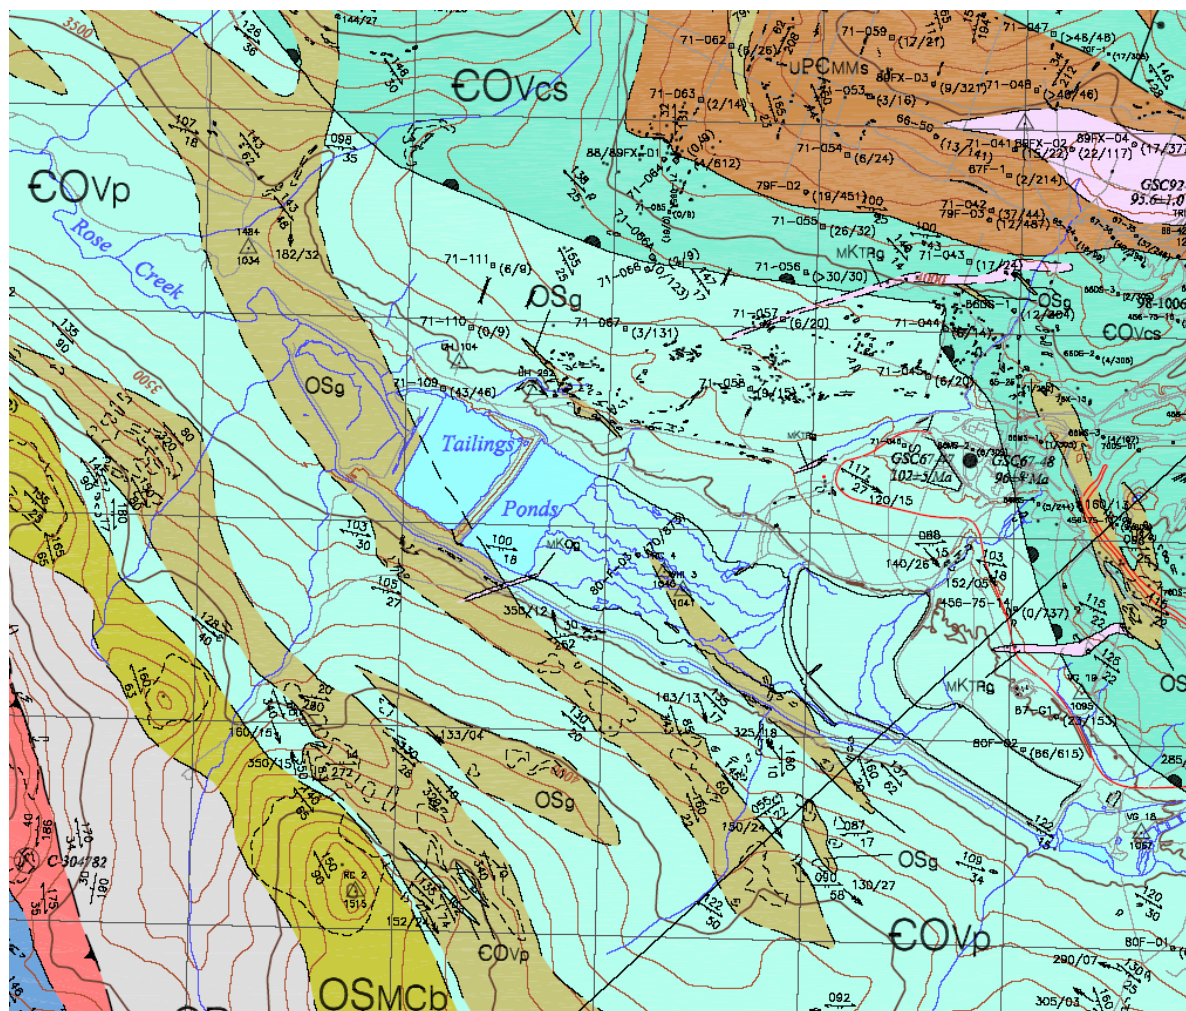
**Figure 2**

General strike and dip in region of the Cross Valley Dam and Intermediate Dam

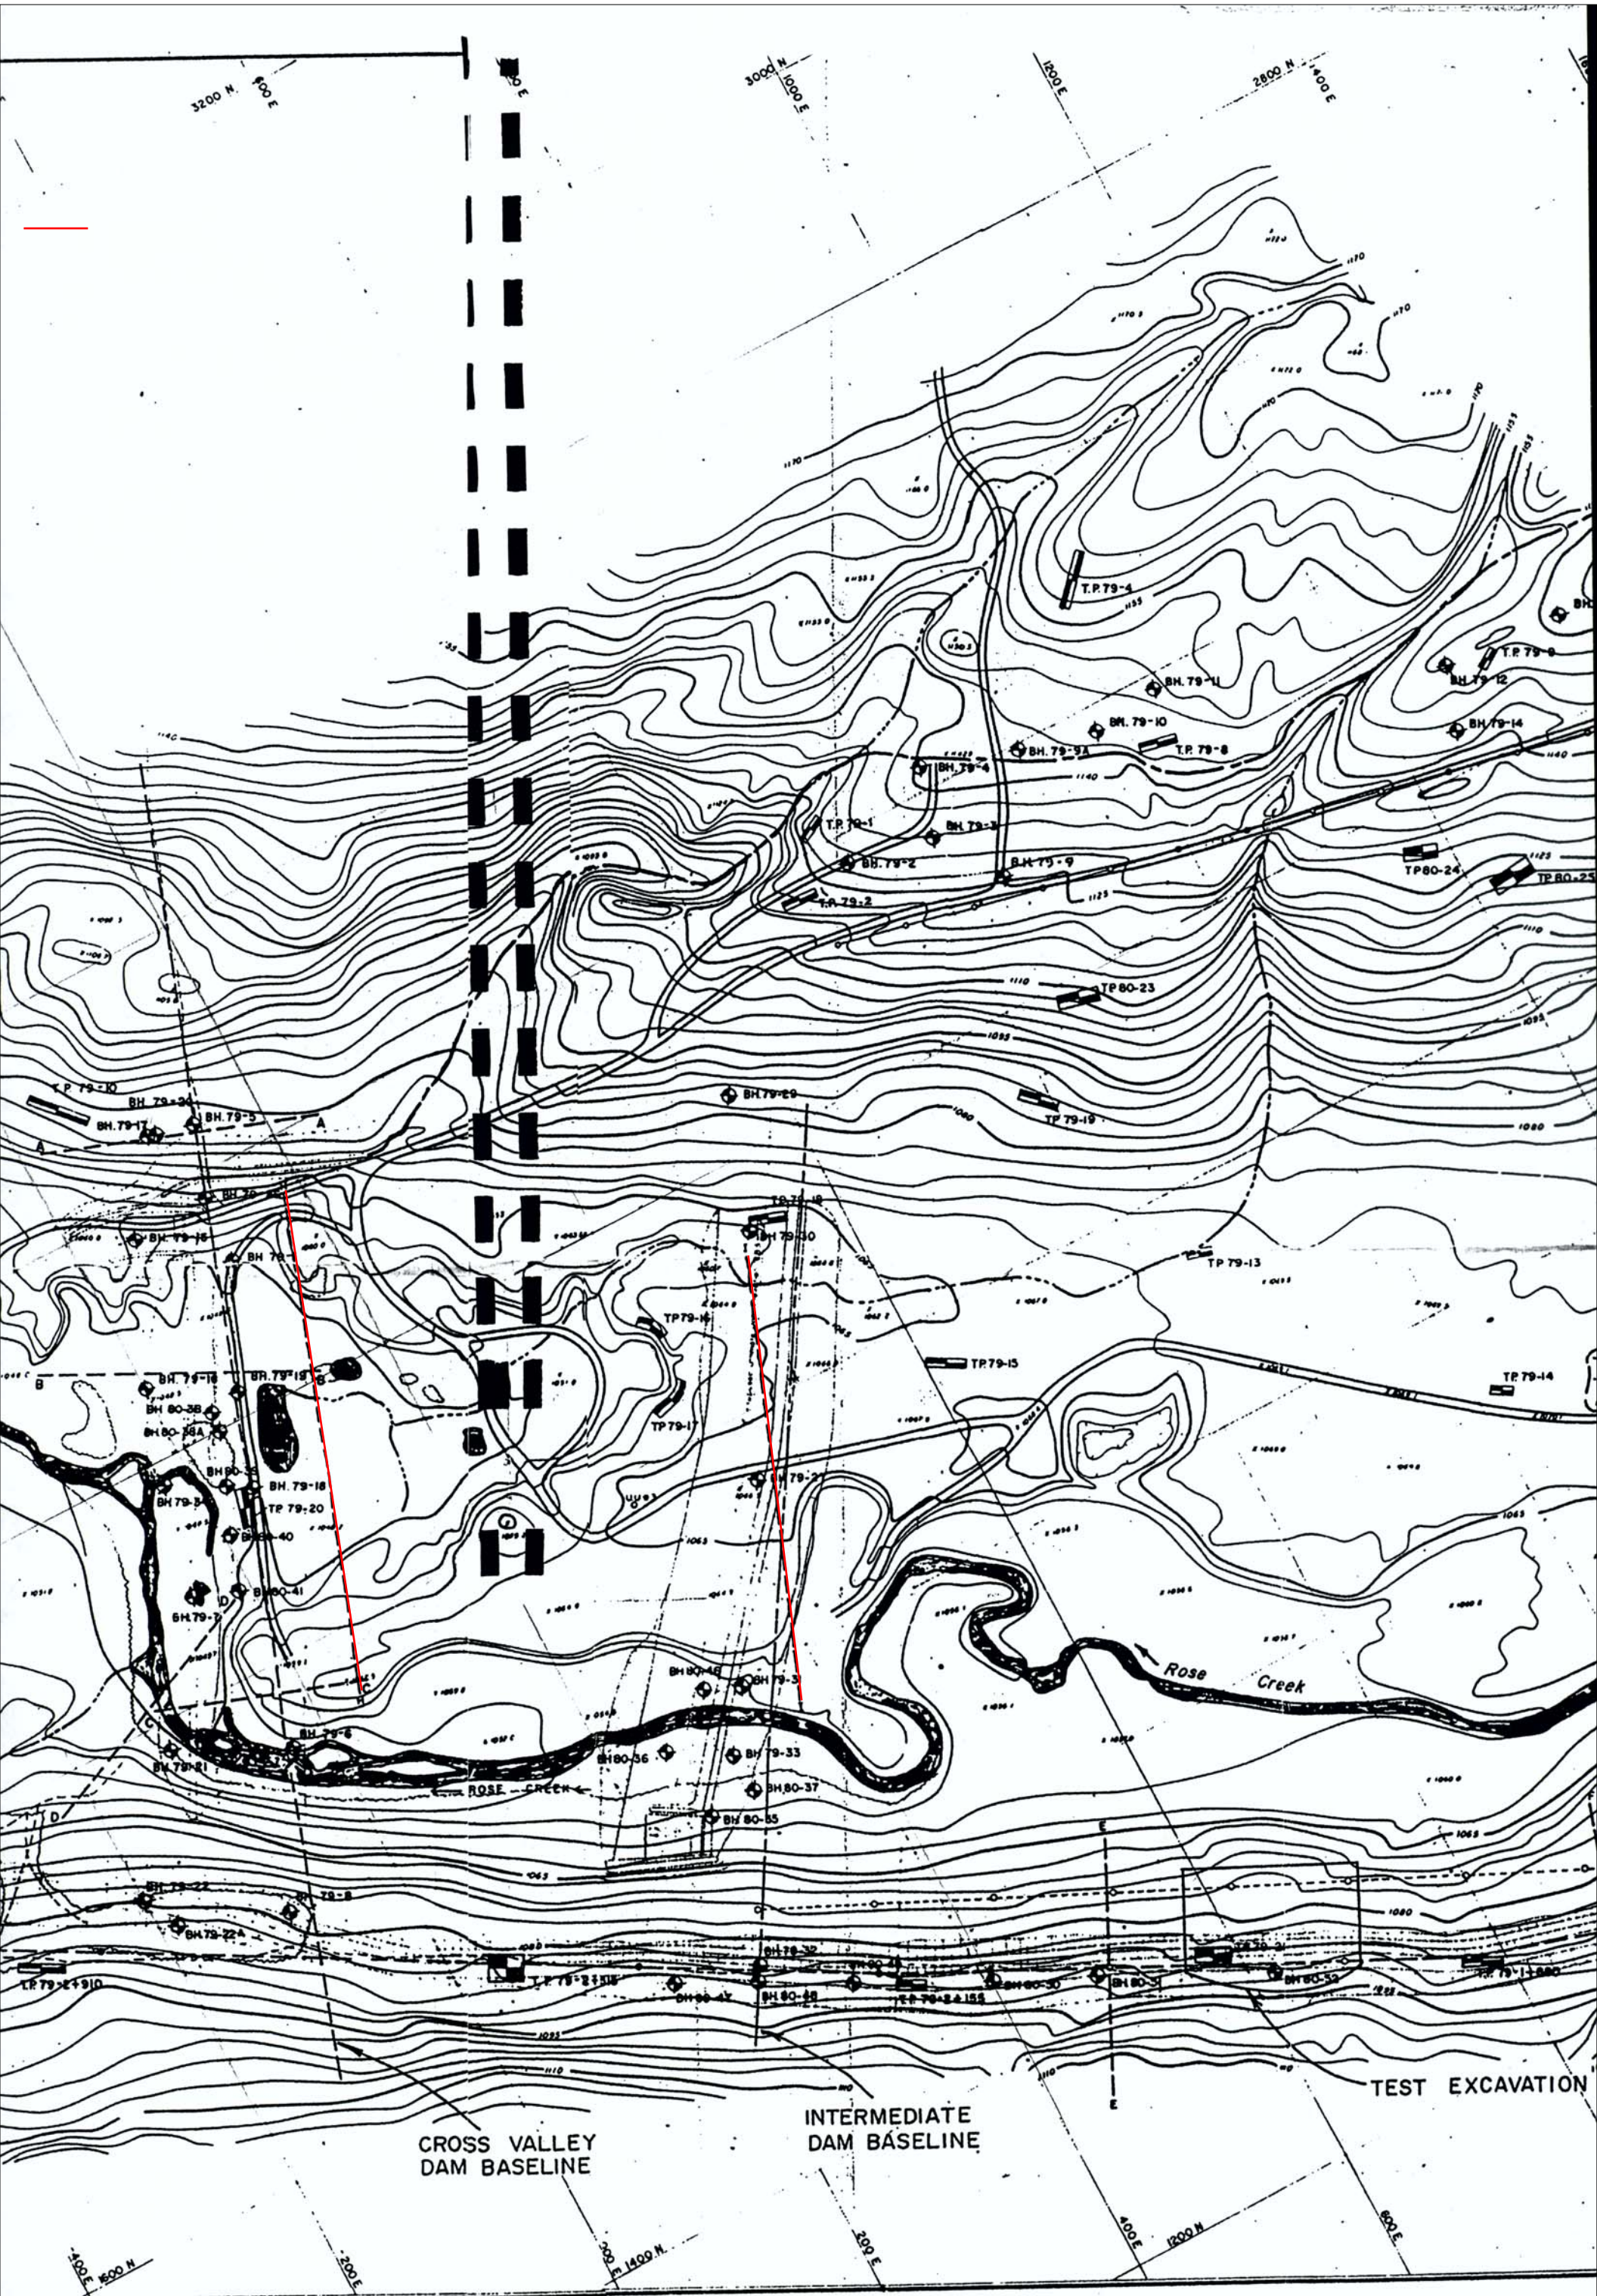
FIGURE 6-7

# CROSS VALLEY DAM BASELINE

Approximately 50 boreholes were drilled in three separate field investigations spanning 1979-1980. Most holes were drilled with a Failing 1000 rotary rig and several were logged with downhole geophysics (downhole seismic, nuclear (gamma-gamma) and resistivity). The boreholes that intersected bedrock are summarized in Table 2 and shown in Figure 1. Only seven holes were drilled more than 5 meters into bedrock (highlighted in Table 2). Overall, the bedrock descriptions contained in the logs are very generic - the lithology is described as “schist bedrock” that varies in color from greenish grey to black (79-1). Weathering is noted in boreholes 79-11 and 79-31 while other descriptions mention harder and softer drilling (79-4, 79-19). There is specific mentioning of fractures in the upper 1 m of 79-18 (middle of Cross-Valley Dam). Silt infilling joints or layers in the bedrock is noted in boreholes 79-32 and 80-47 (located at the diversion channel near the Intermediate Dam toe). Perhaps the strongest evidence of bedrock fracturing is recorded in 79-33 (south side of Intermediate Dam), where the pumping rate increased by 20-50 gpm while drilling into bedrock. The log of borehole 79-33 is included in Appendix B. The text of the document suggests that ‘bedrock disturbance may exist at this location’ and that the permeability could be as high as  $10^{-4}$  cm/s. The location of this disturbed bedrock is in line with low seismic velocities observed in the vicinity of the historic Rose Creek channel downstream at the Cross-Valley Dam (Figure 6-7, Appendix C).

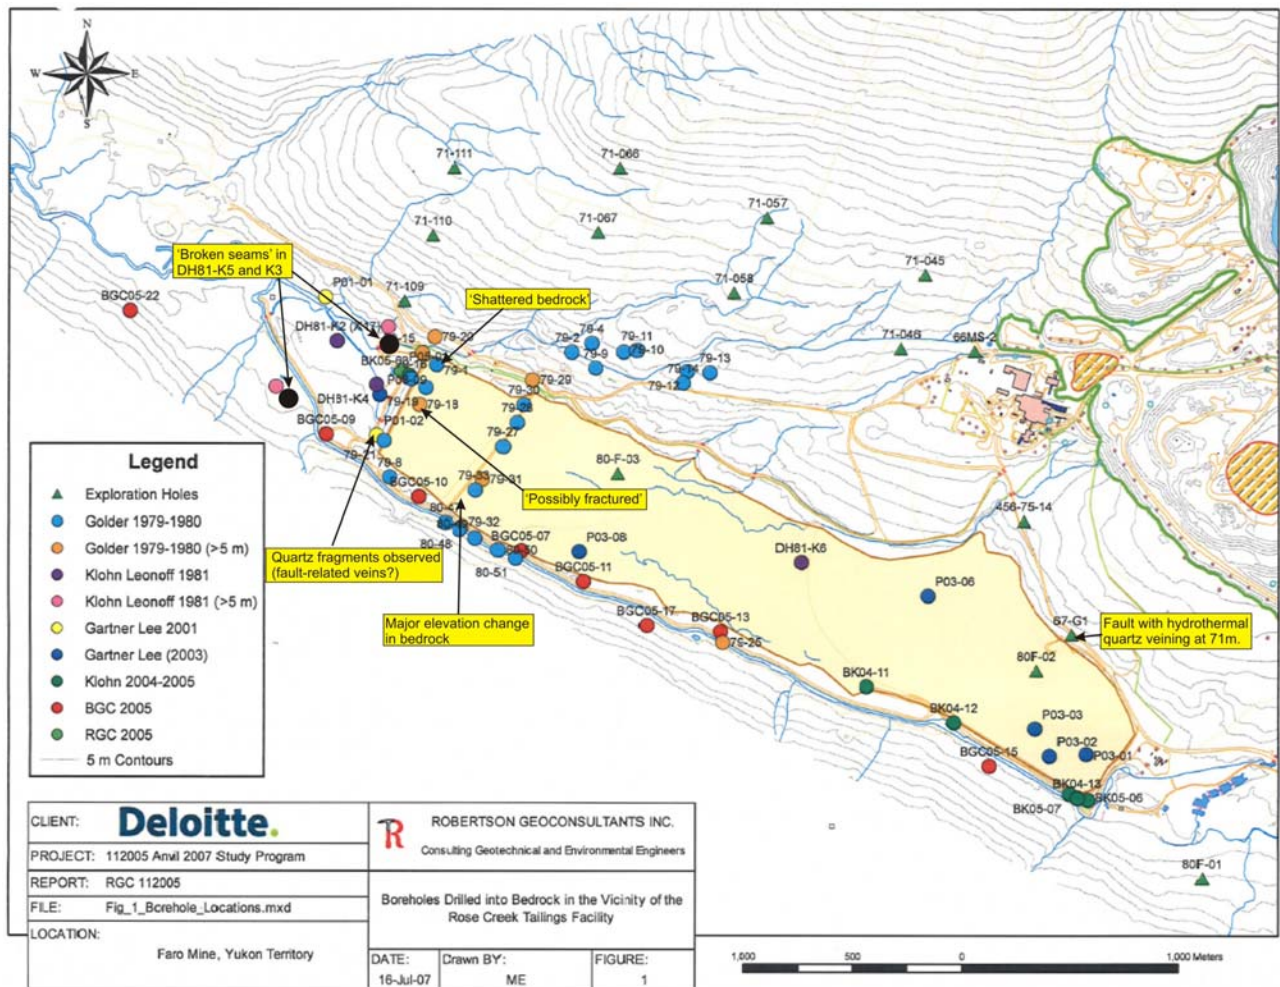
Figure 1. Drillhole observations

Several drillhole descriptions within the vicinity of the westernmost tailings dam mention the presence of broken seams of rock or the possibility of fracturing. No information is given on the orientation of these fractures. It is very possible that the rock is jointed. Unfortunately, all of the drillholes are vertical and therefore do not sample vertical joints.

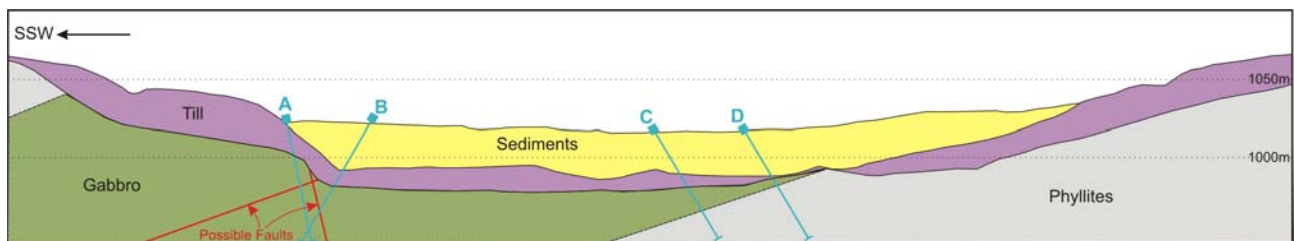
Figure 2. Schematic representation of recommended drillholes. Drillholes A and B are targeted to intercept a possible fault; drillholes B and C are targeted to test the contact of the gabbroic intrusive.

Two drill-holes are recommended to test the presence of the potential fault in the bedrock below the southern valley side, illustrated in Figure 2 (Drillholes A and B). The first should be inclined towards the south-southwestern valley side and be designed to intercept the bedrock below the area of the recessive erosion (Drillhole B). This drillhole may intercept a fault if the fault dips into the valley and will yield some information on joints, if present. If no fault is intercepted in this inclined hole, a vertical hole, or hole steeply-inclined hole should be positioned over the area of bedrock elevation change (Drillhole A).

The lower contact of the gabbroic intrusive should be tested using inclined drillholes oriented to the NNE (Figure 2; drillholes C and D). The contact should be tested both at depth (Drillhole C) and close to the non-solid geology (Drillhole D) to investigate the original and potentially weathered state of the contact.

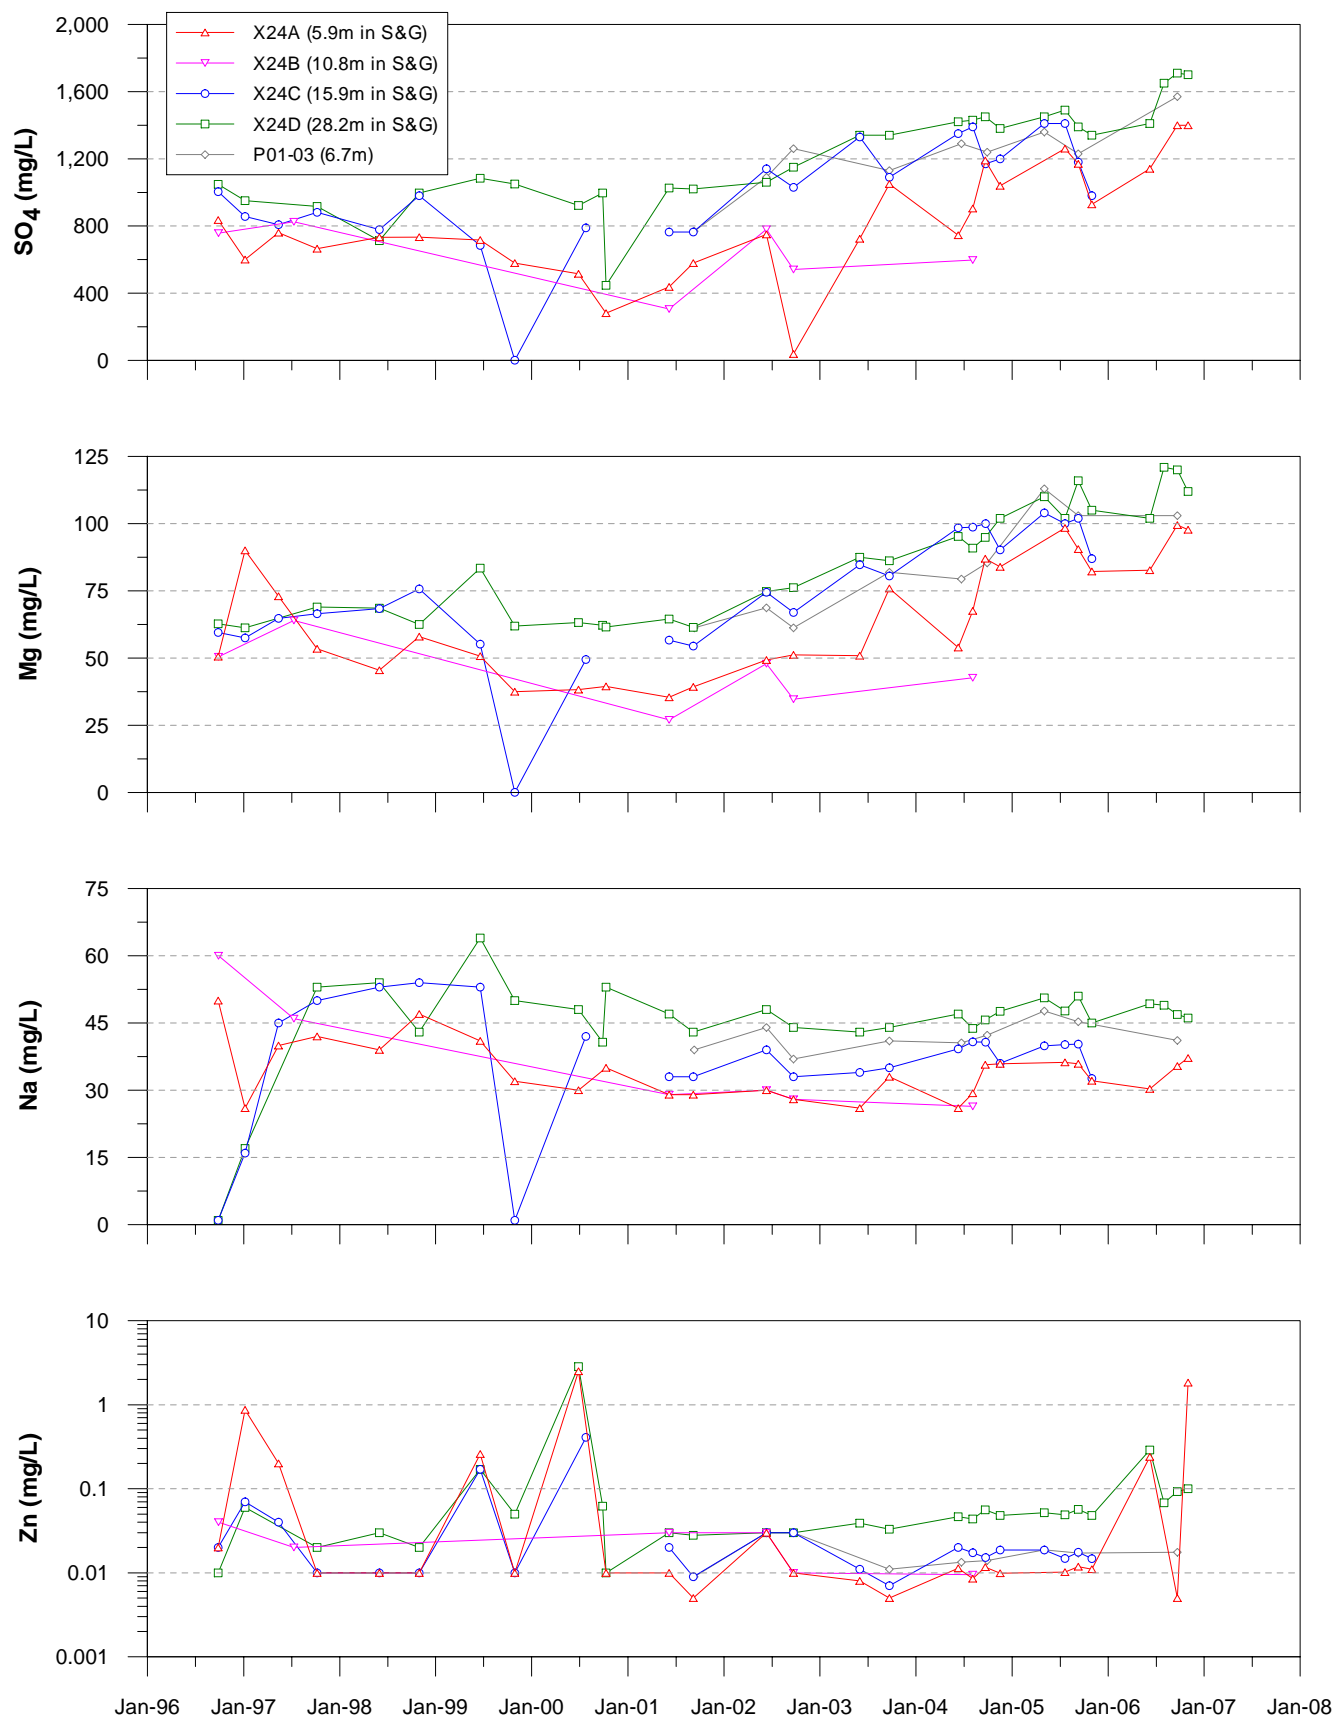
Figure 2a. Water quality (SO<sub>4</sub>, Mg, Na and Zn) in X24(96) and P01-03 (north side of Intermediate Dam).

Figures 2a/b and 3a/b show the water quality time trends in wells screened in the northern section and southern section of the Intermediate Dam, respectively. The following observations can be made:

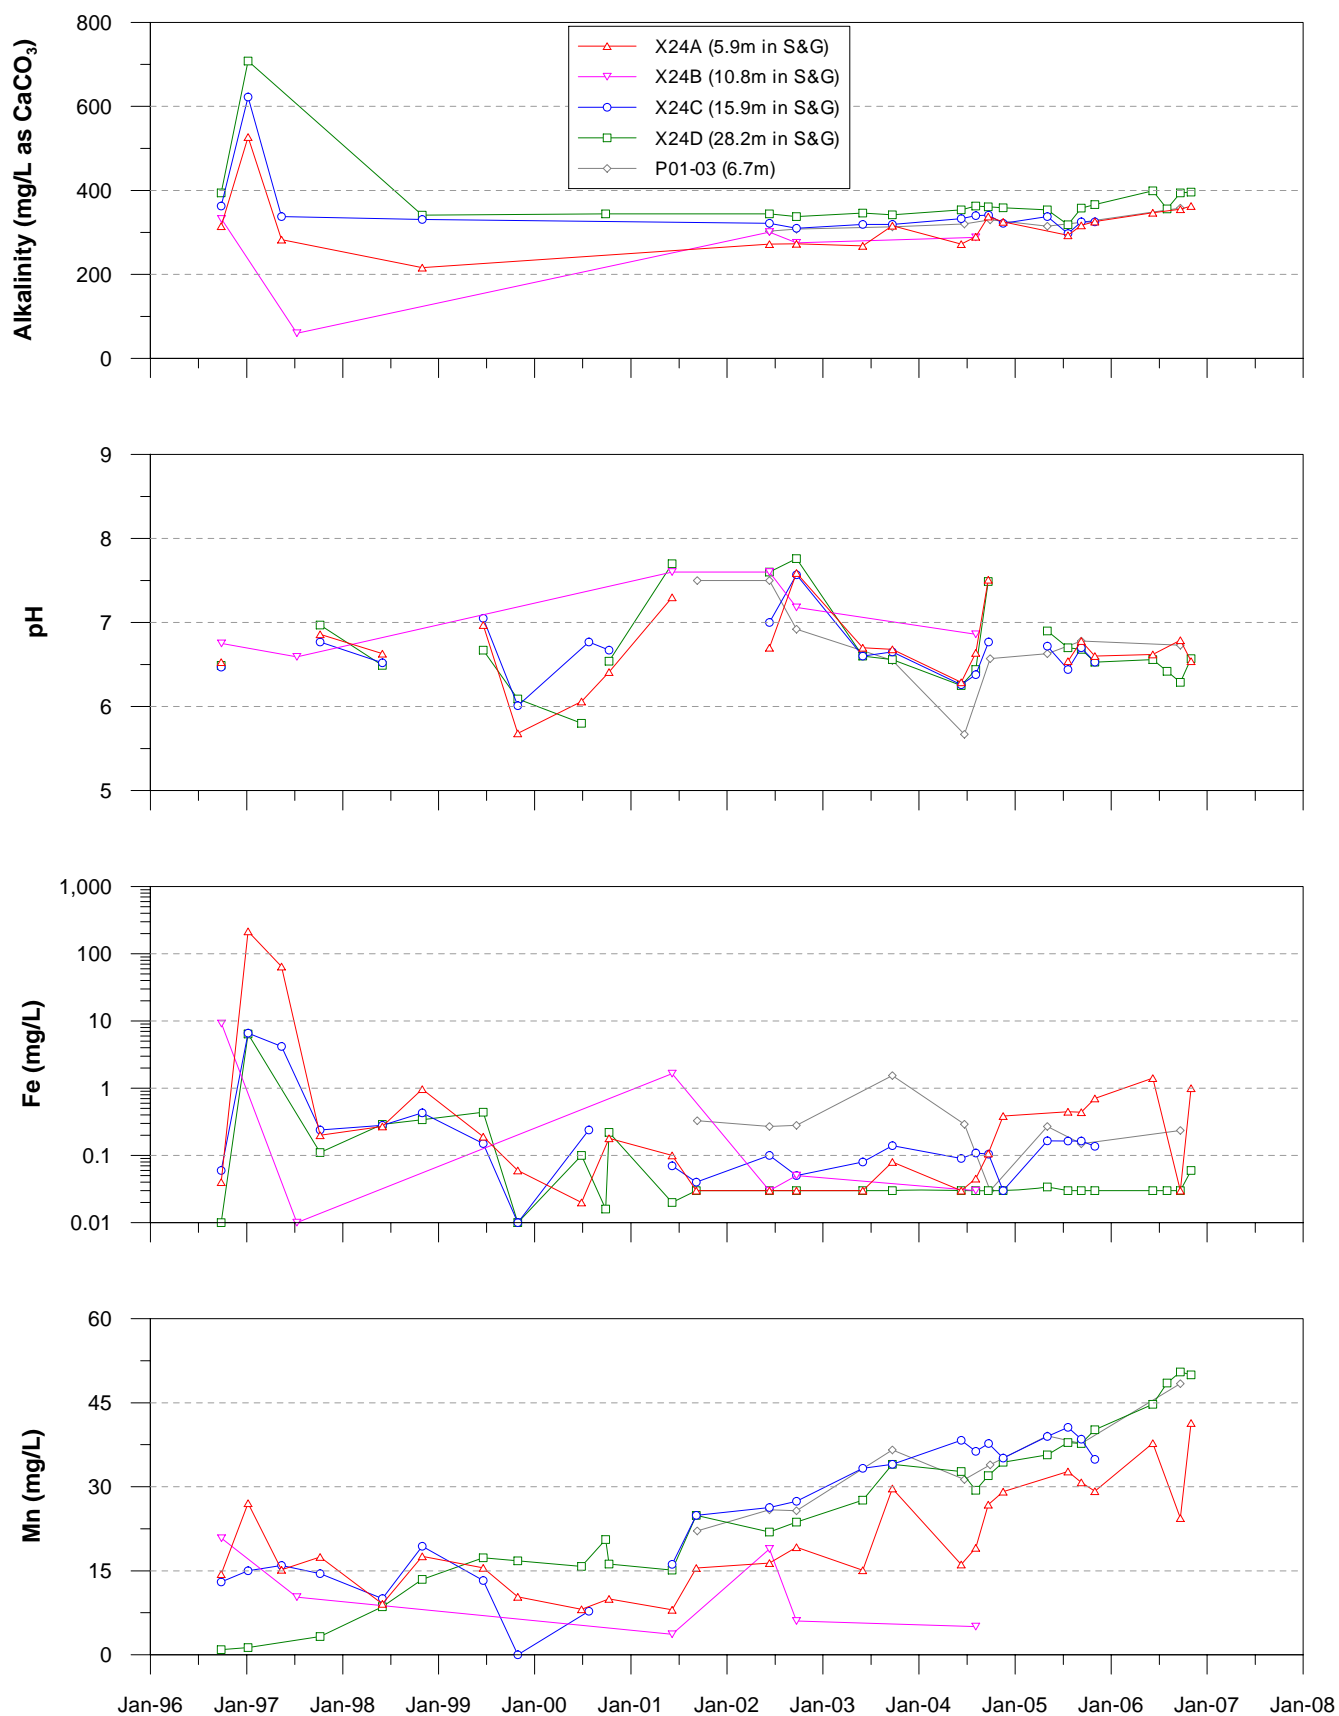
Figure 2b. Water quality (alkalinity, pH, Fe and Mn) in X24(96) and P01-03 (north side of Intermediate Dam).

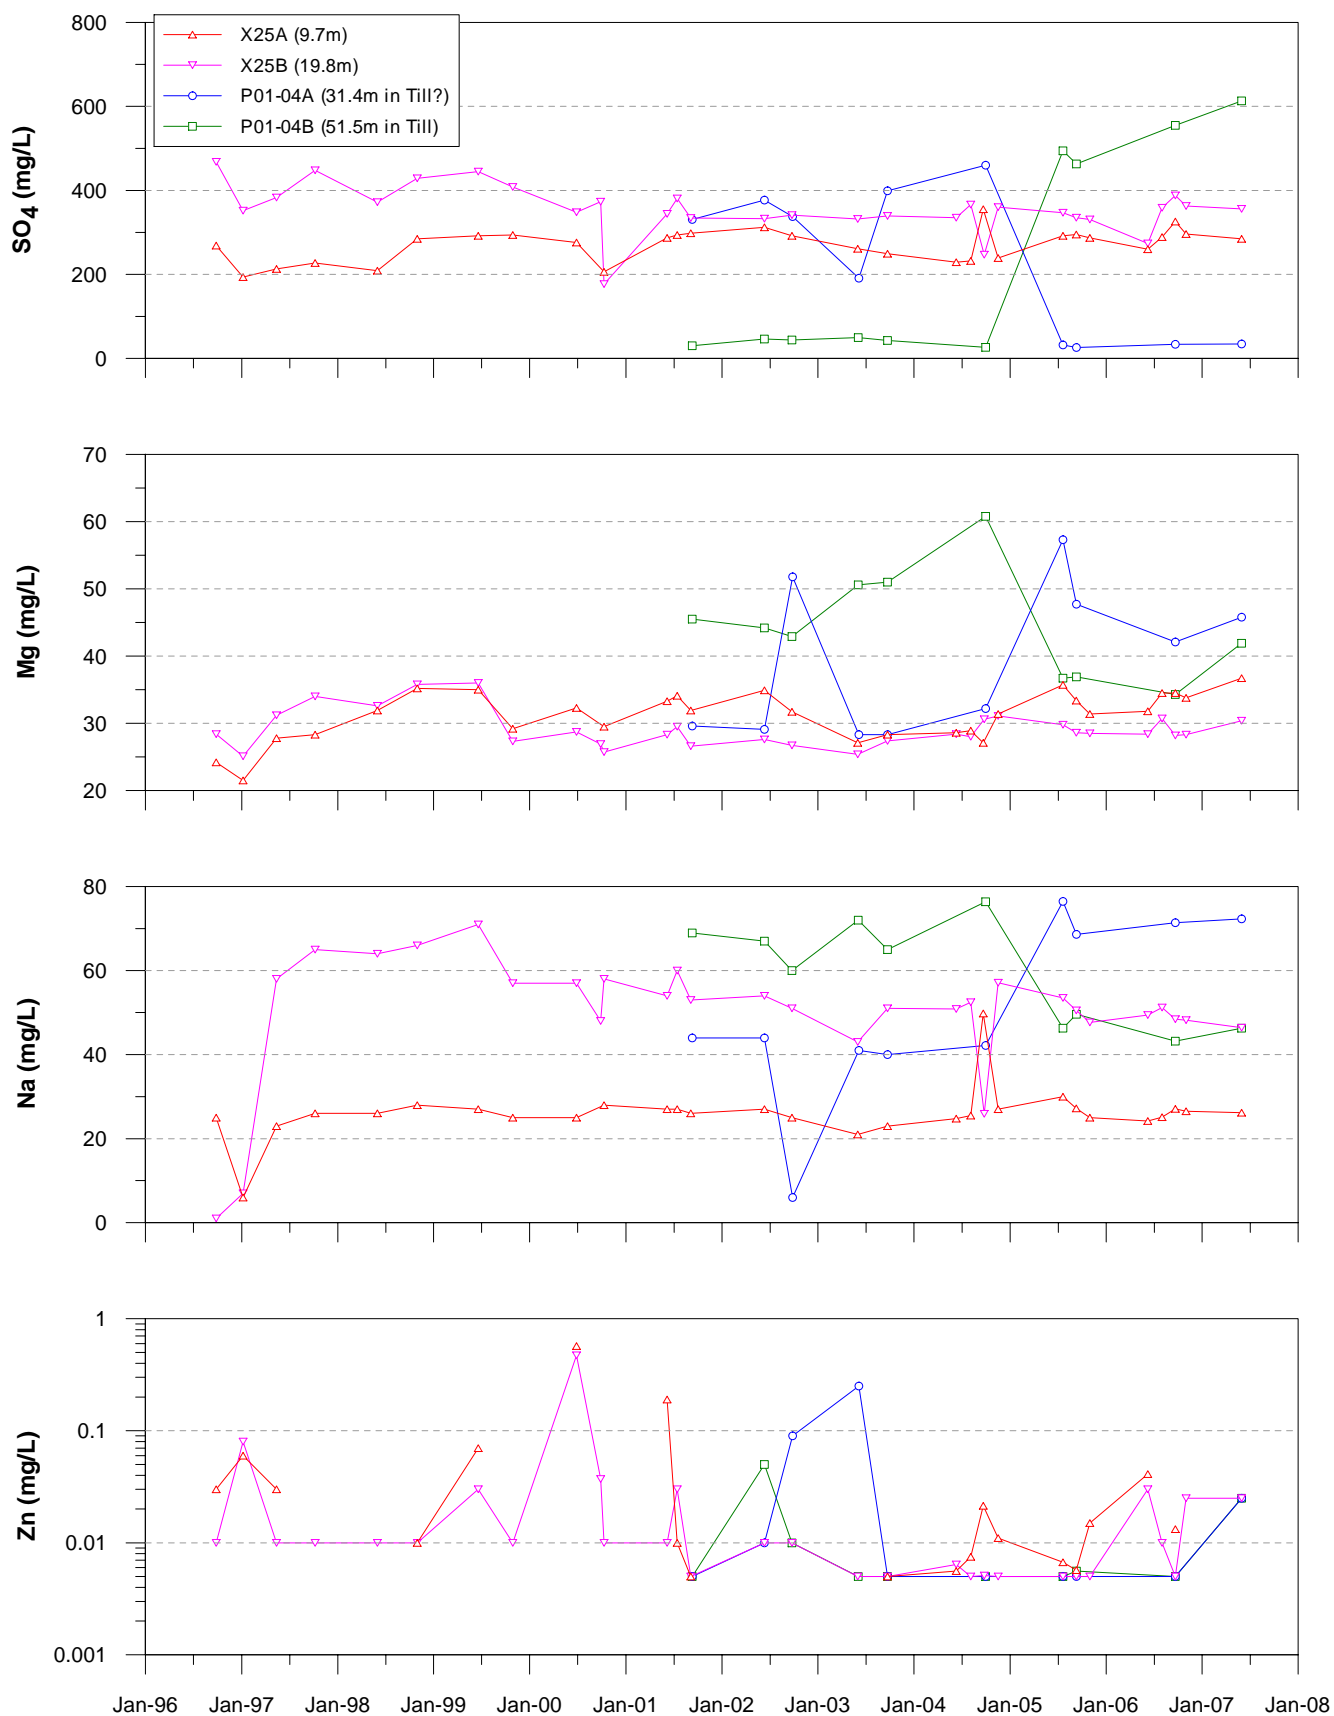
Figure 3a. Water quality (SO<sub>4</sub>, Mg, Na and Zn) in X25(96) and P01-04 (south side of Intermediate Dam).

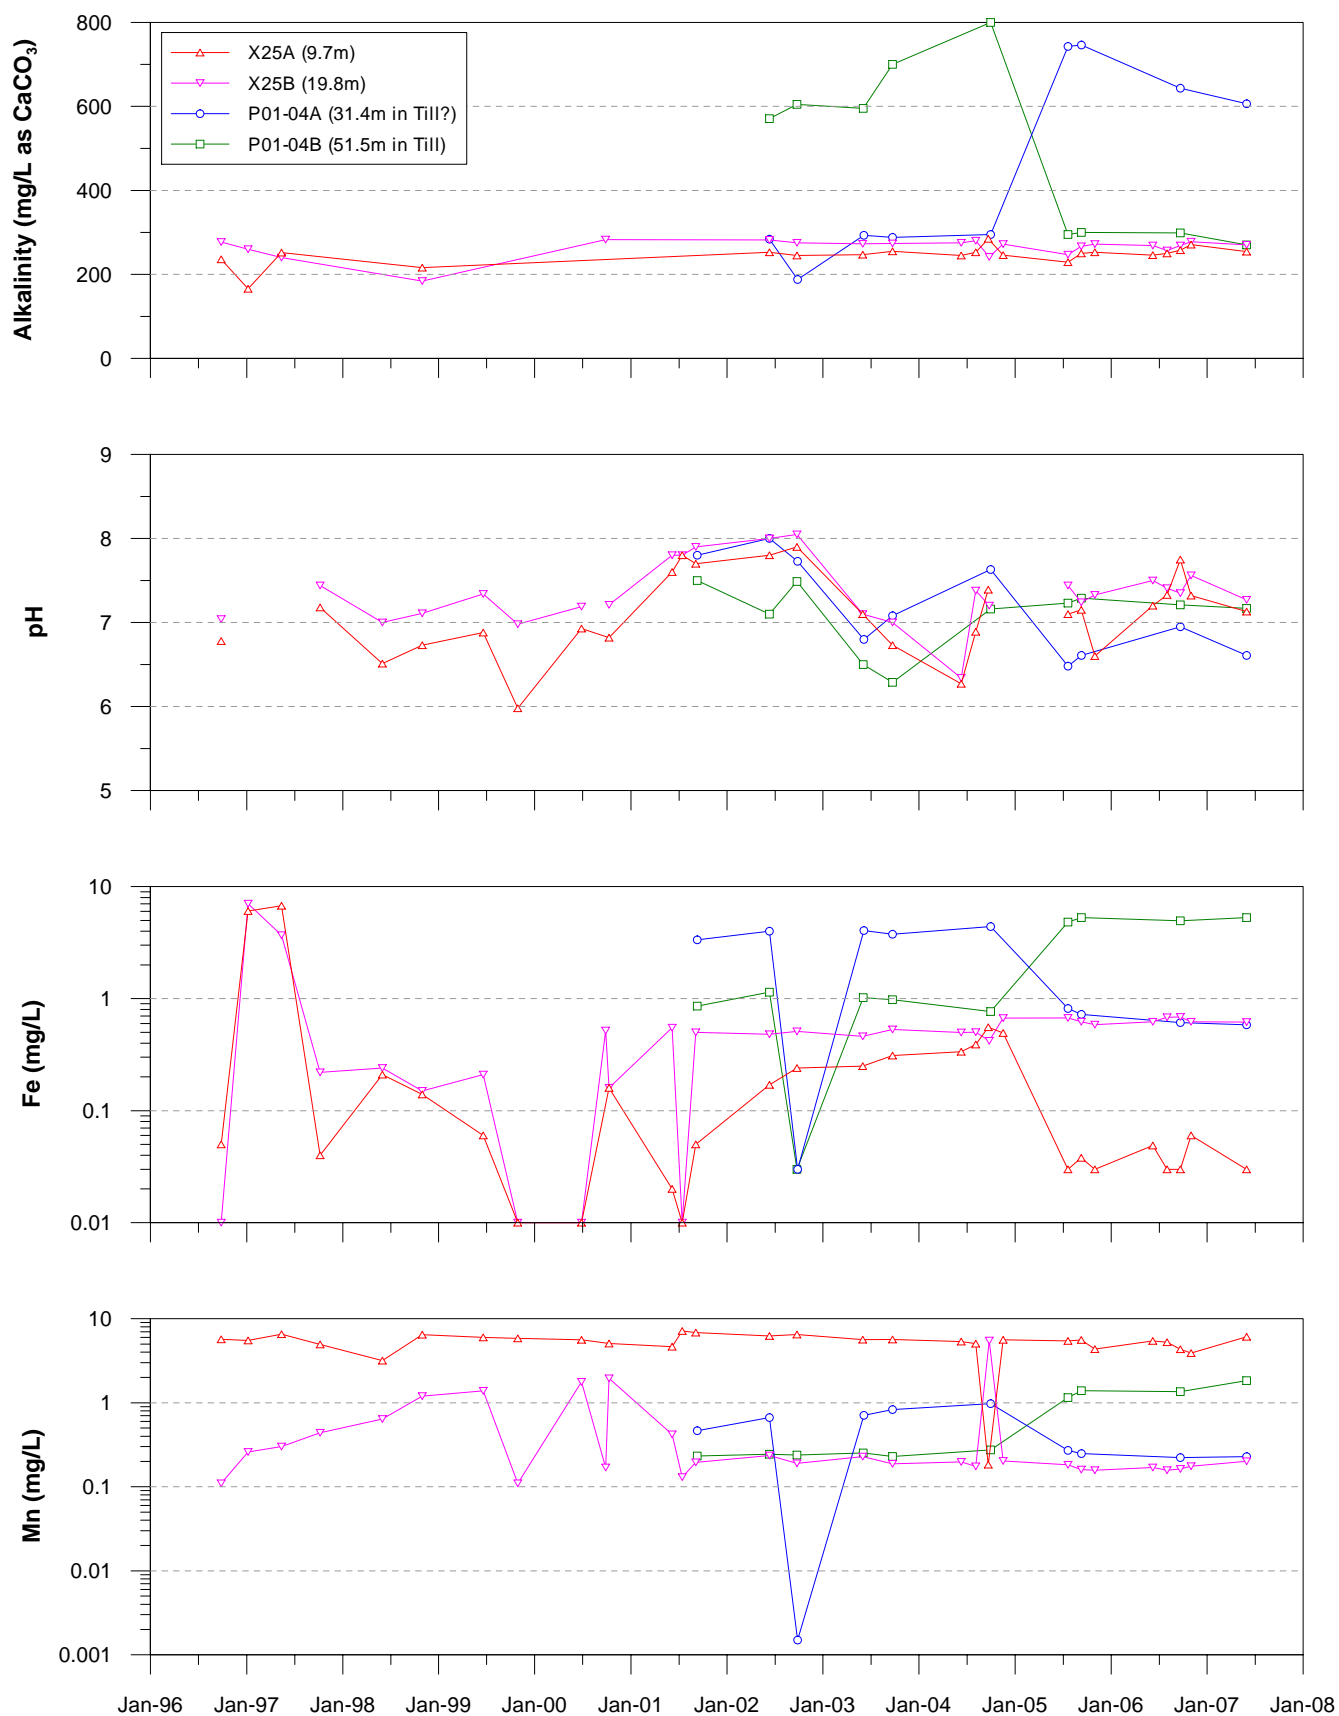
Figure 3b. Water quality (alkalinity, pH, Fe and Mn) in X25(96) and P01-04 (south side of Intermediate Dam).

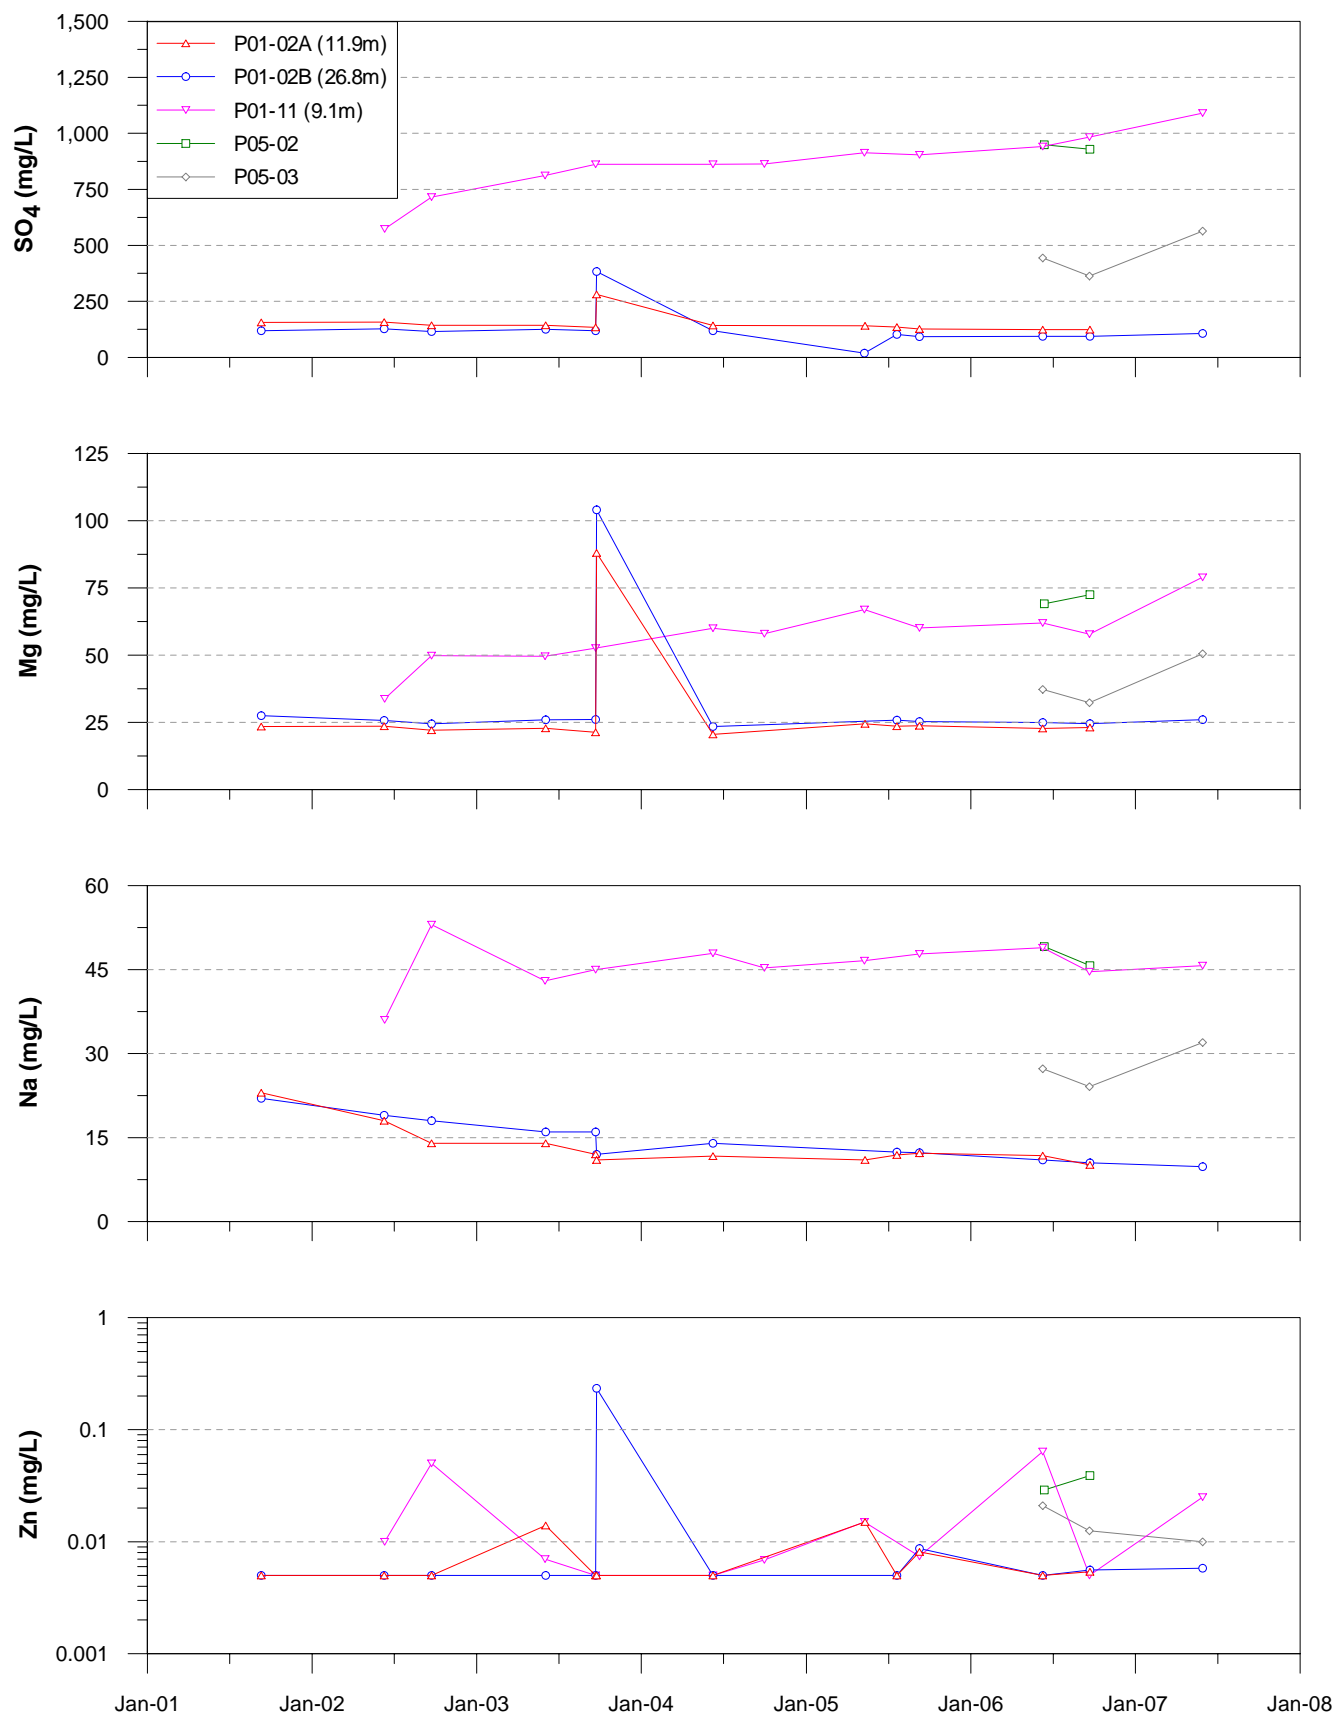
Figure 4a. Water quality (SO<sub>4</sub>, Mg, Na and Zn) in wells along toe of Cross Valley Dam.

Figures 4a/b show the water quality time trends in all wells screened near the toe of the Cross Valley Dam. Figures 5a/b and 6a/b show water quality depth profiles for selected dates in the multilevel wells P03-09 and P05-01, respectively. The groundwater quality in vicinity of the Cross Valley Dam shows significant transverse variations (from north to south) suggesting

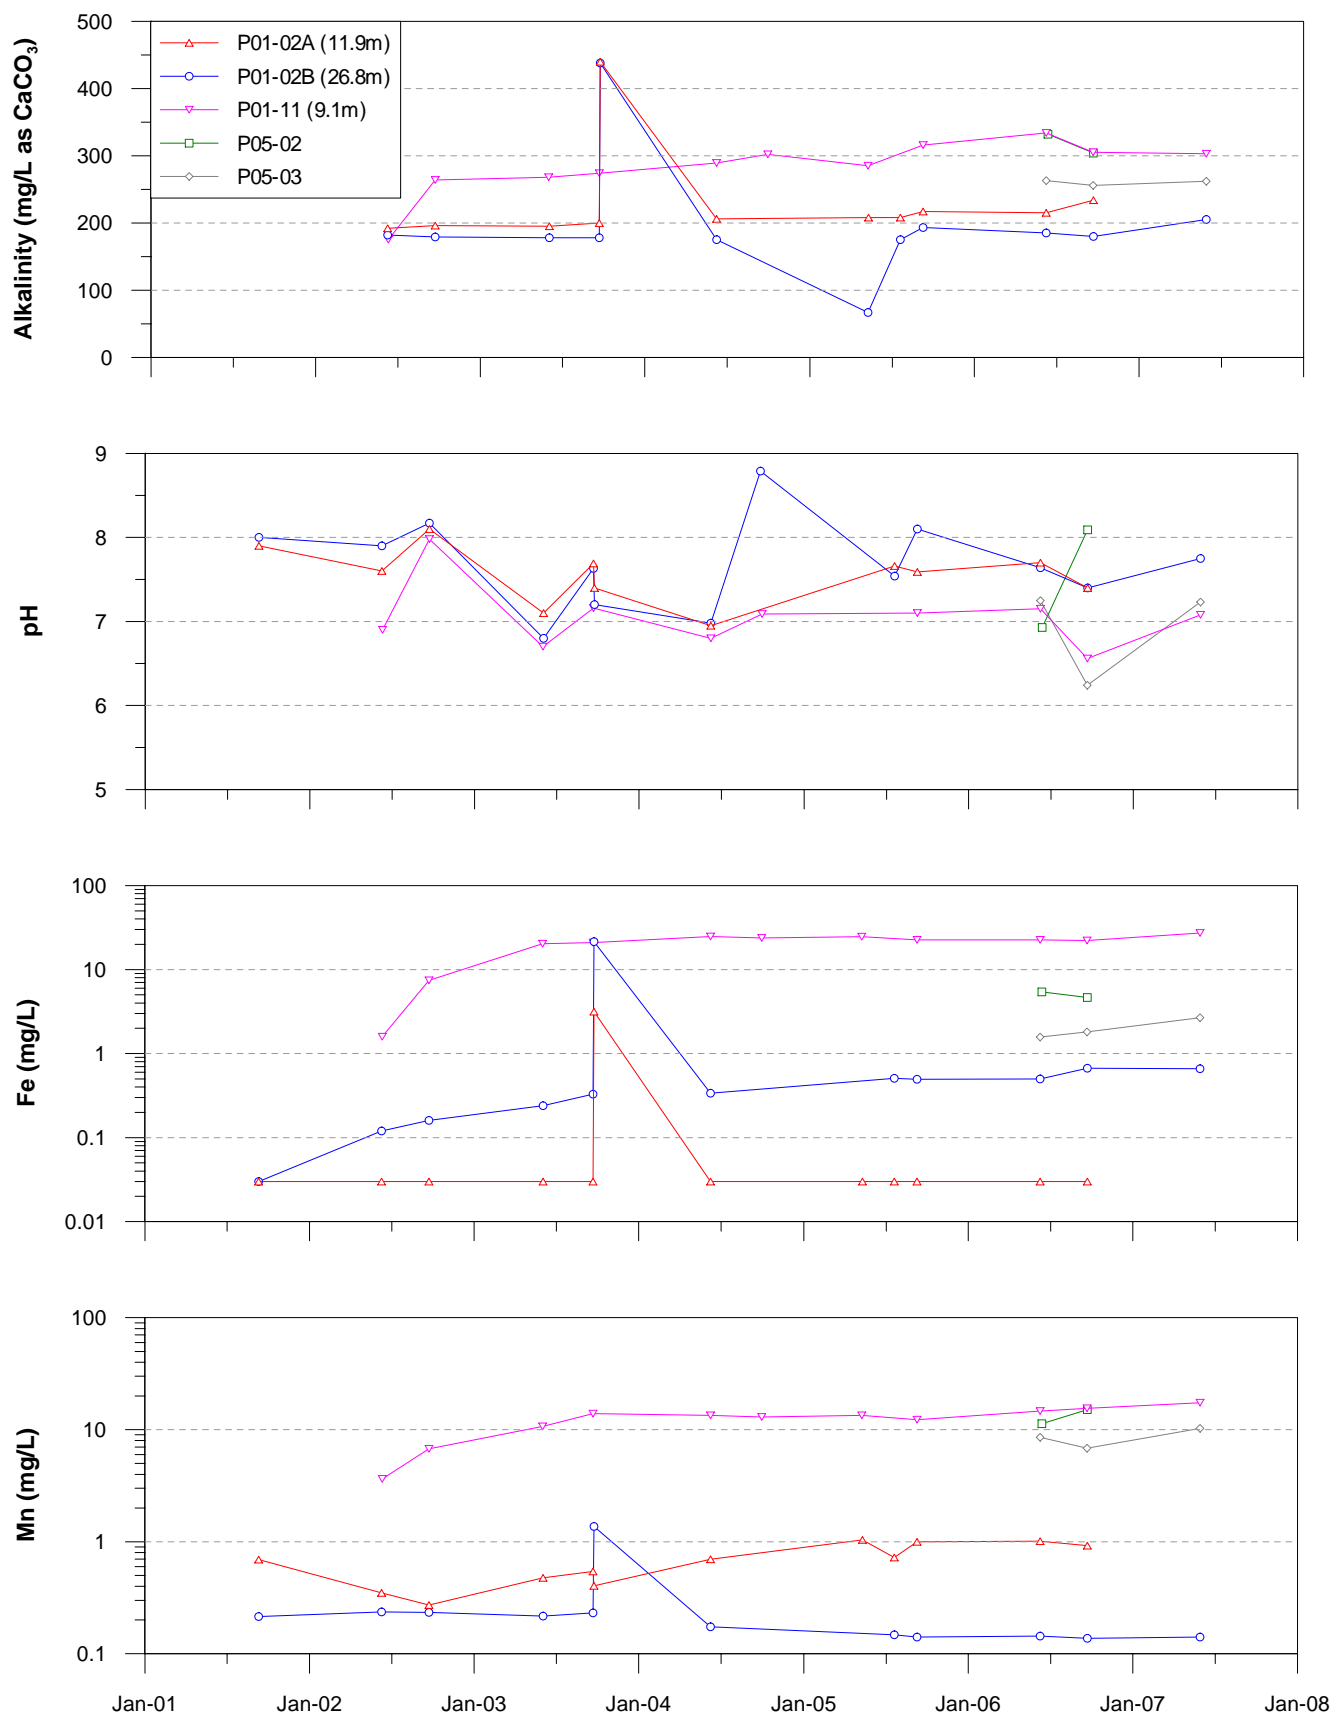
Figure 4b. Water quality (alkalinity, pH, Fe and Mn) in wells along toe of Cross Valley Dam.
