## Anvil Range Mining Complex Bedrock Data and Groundwater Review for the Lower Rose Creek Valley

**2007/08 Task 21 – Final**

**Anvil Range Mining Complex  
Bedrock Data and Groundwater Review  
for the Lower Rose Creek Valley**

**2007/08 Task 21 – FINAL**

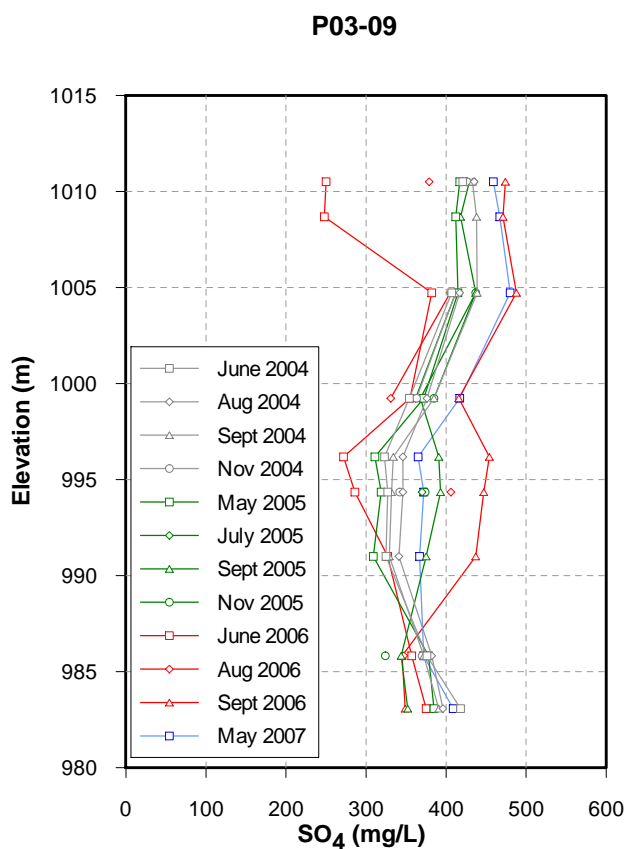
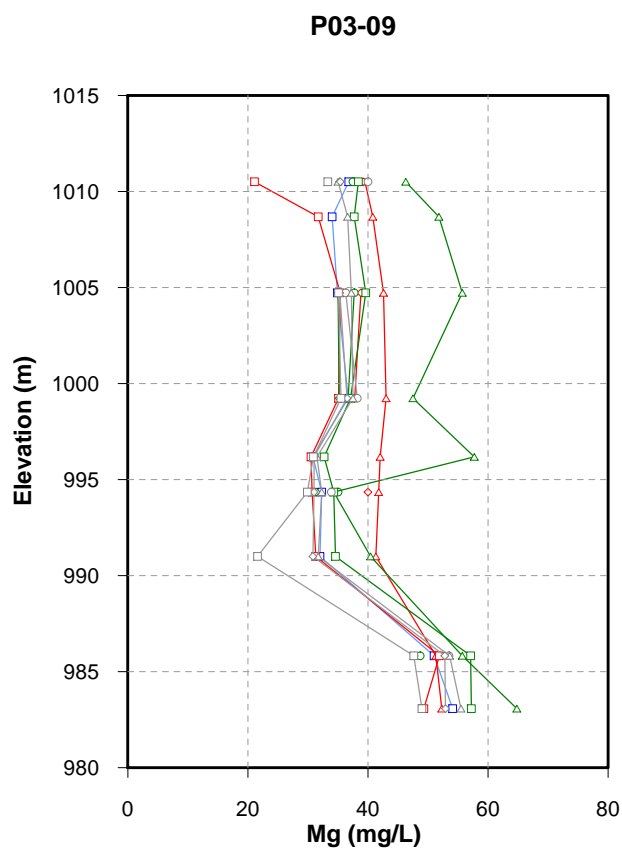
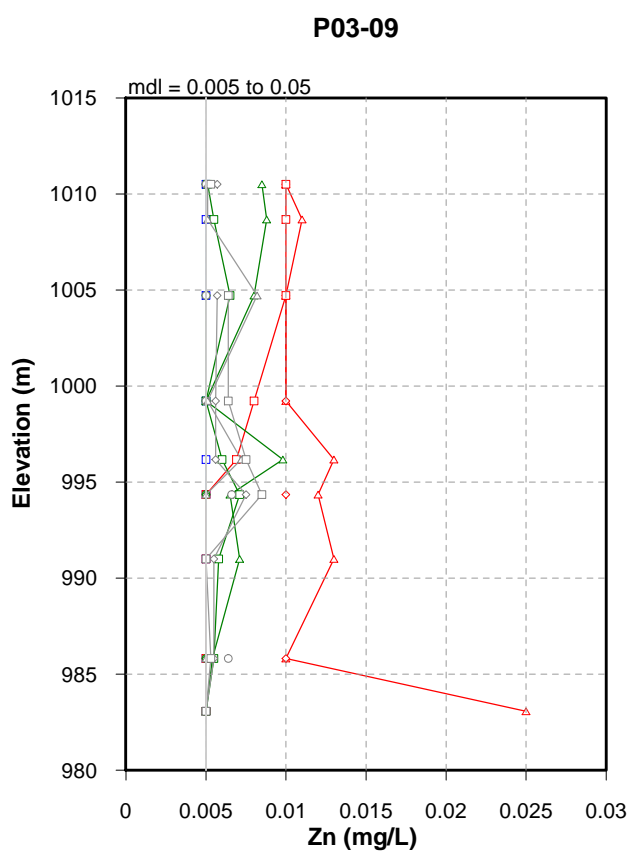
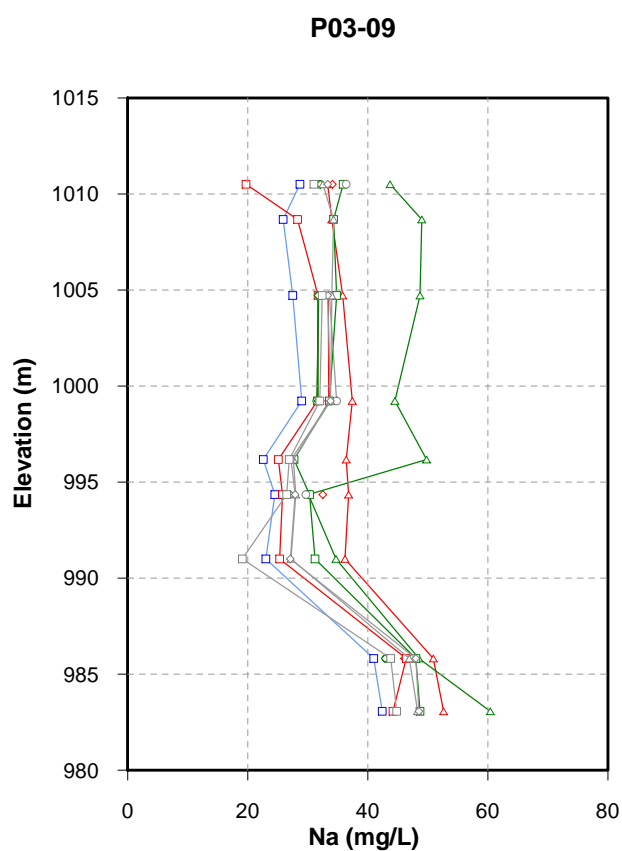
Figure 5a. Water quality depth profiles of SO<sub>4</sub>, Mg, Zn and Na in P03-09 (at Cross Valley Dam).

Figures 4a/b show the water quality time trends in all wells screened near the toe of the Cross Valley Dam. Figures 5a/b and 6a/b show water quality depth profiles for selected dates in the multilevel wells P03-09 and P05-01, respectively. The groundwater quality in vicinity of the Cross Valley Dam shows significant transverse variations (from north to south) suggesting

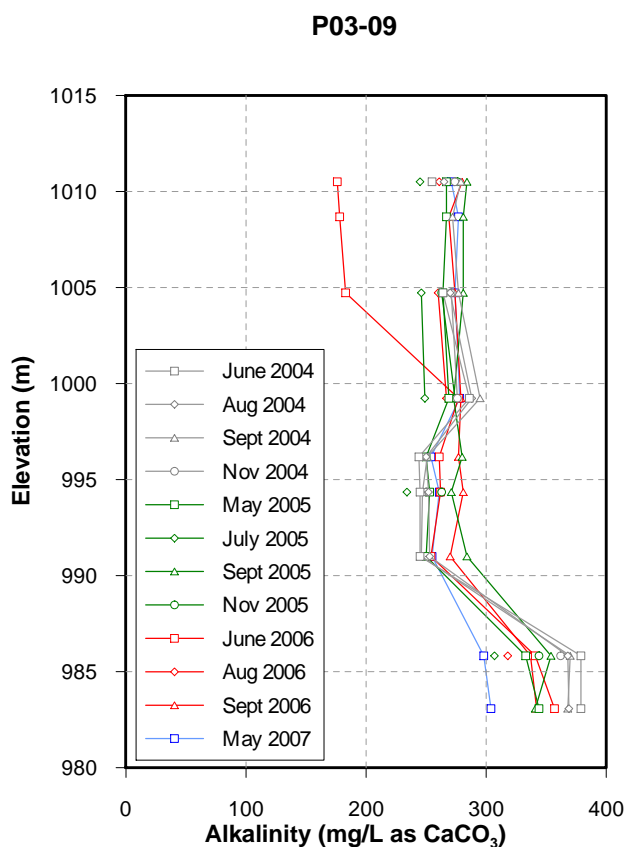
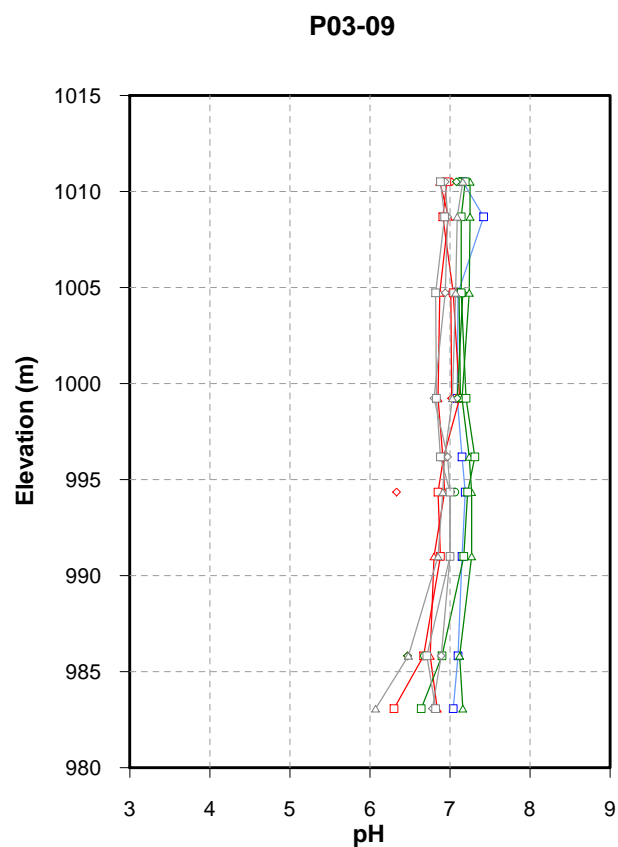
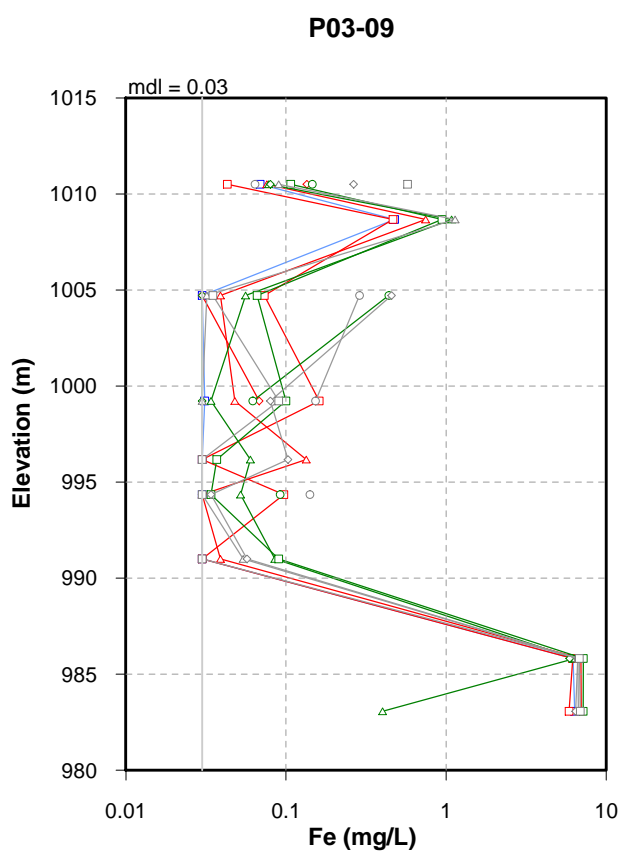
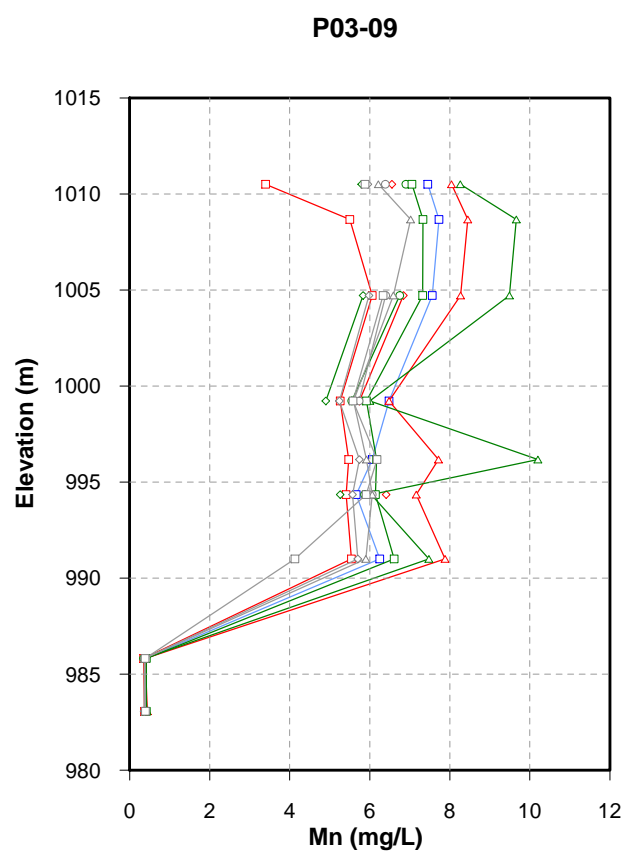
Figure 5b. Water quality depth profiles of alkalinity, pH, Fe and Mn in P03-09 (at Cross Valley Dam).

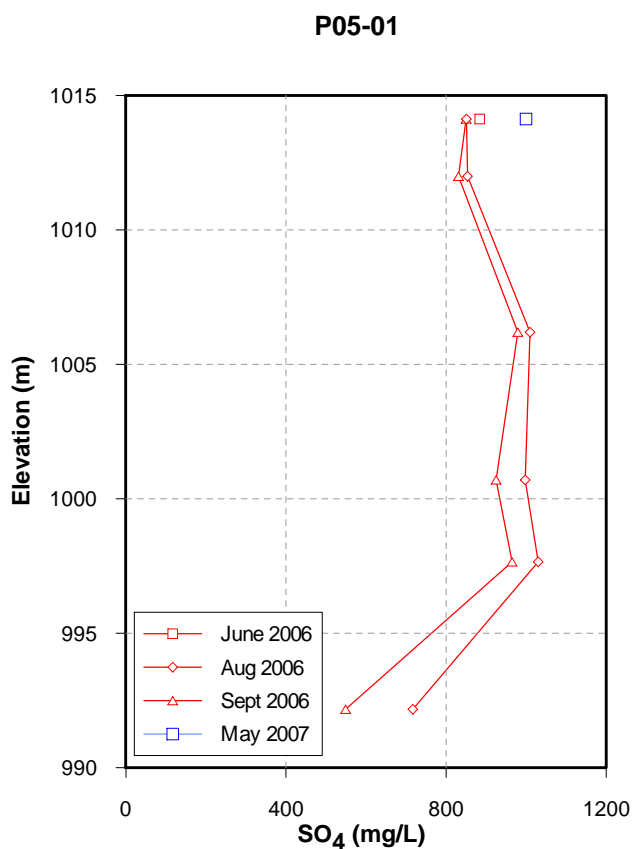
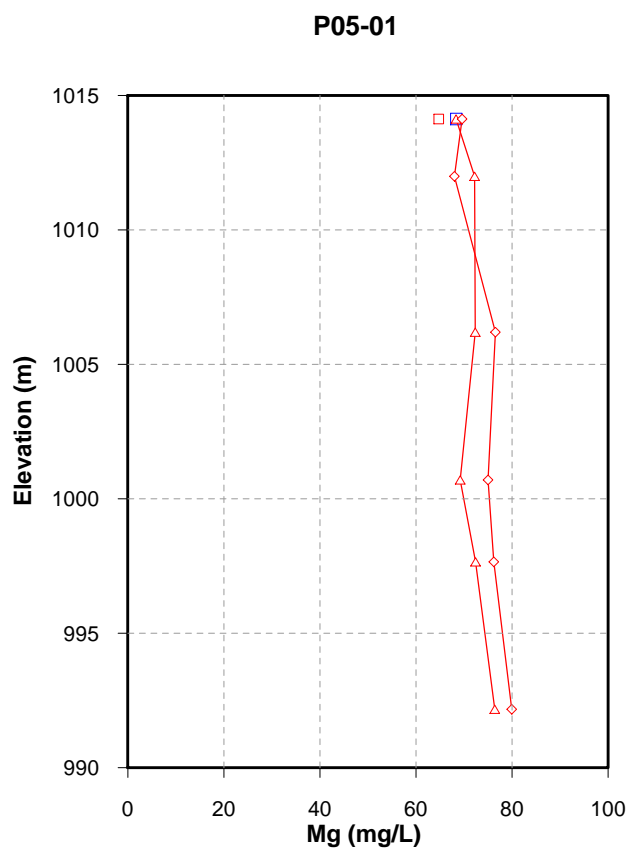
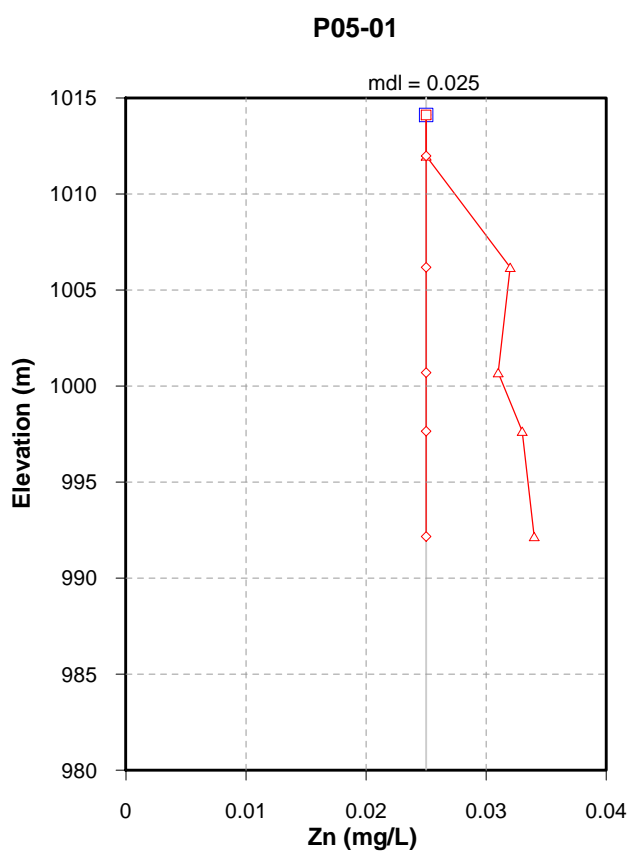
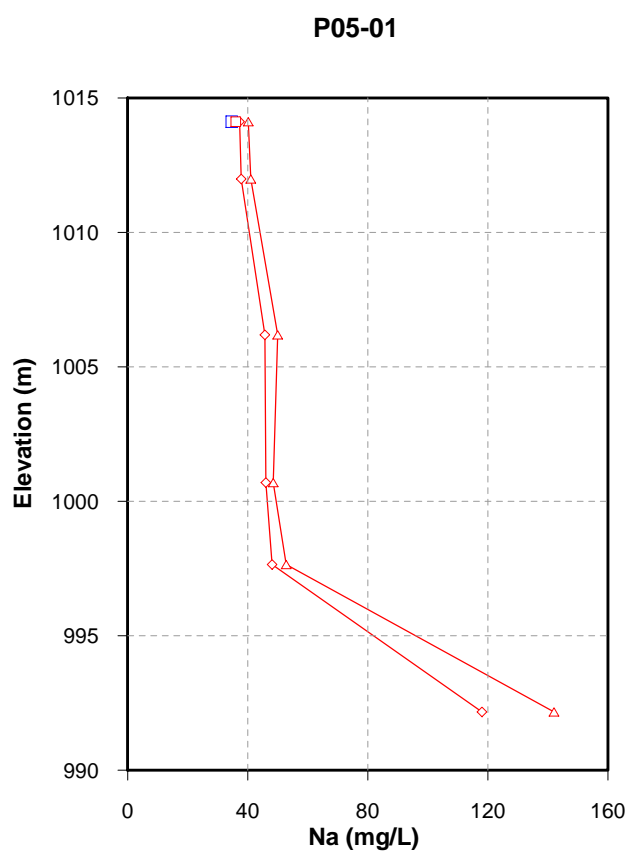
Figure 6a. Water quality depth profiles of SO<sub>4</sub>, Mg, Zn and Na in P05-01 (at Cross Valley Dam).

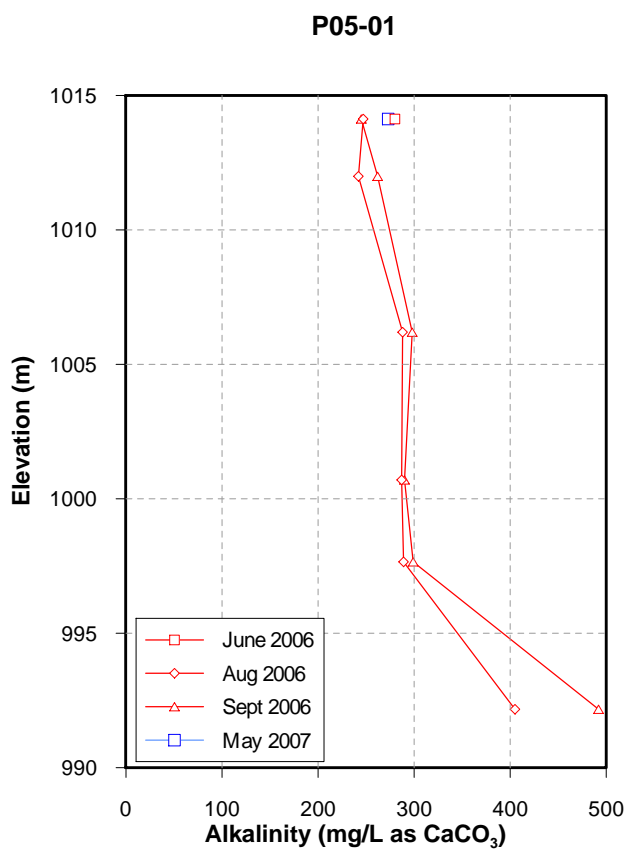
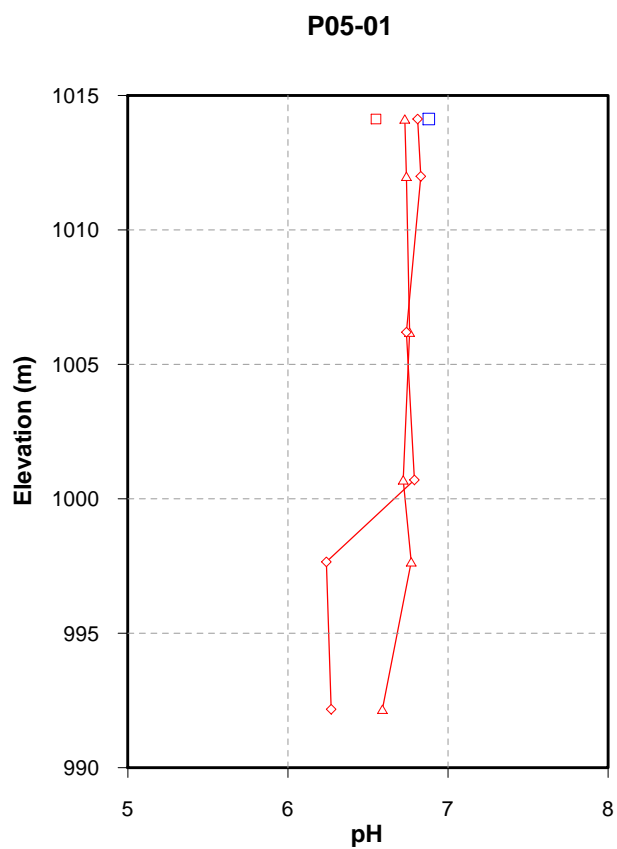
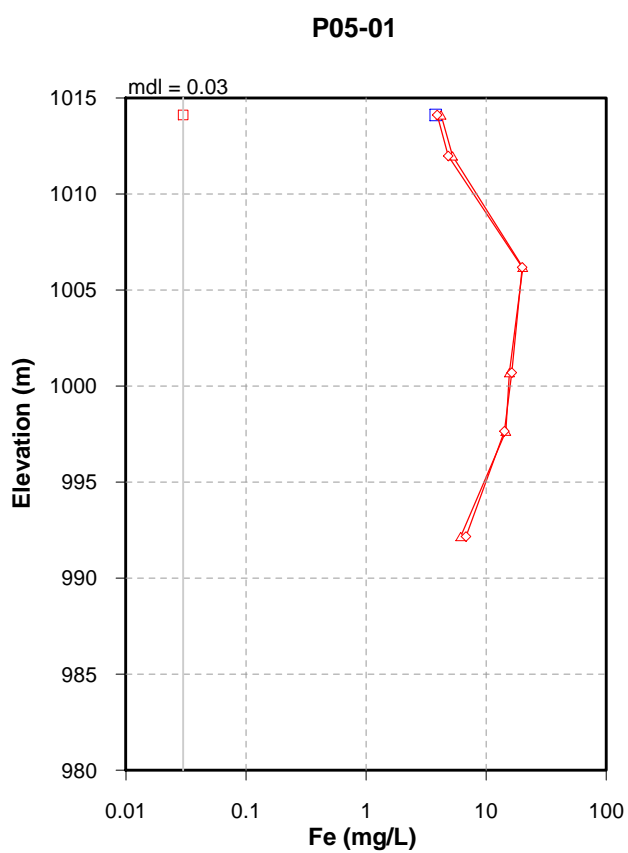
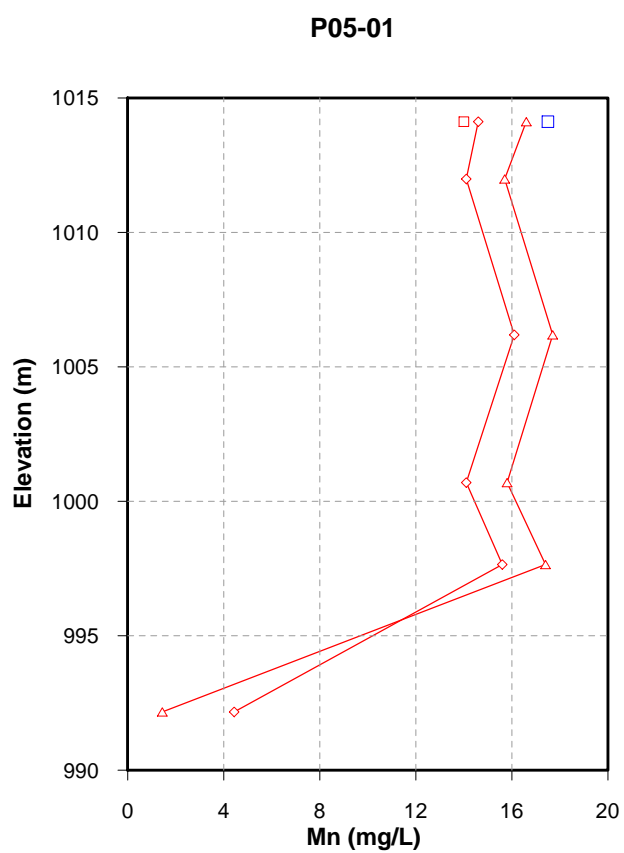
Figure 6b. Water quality depth profiles of alkalinity, pH, Fe and Mn in P05-01 (at Cross Valley Dam).

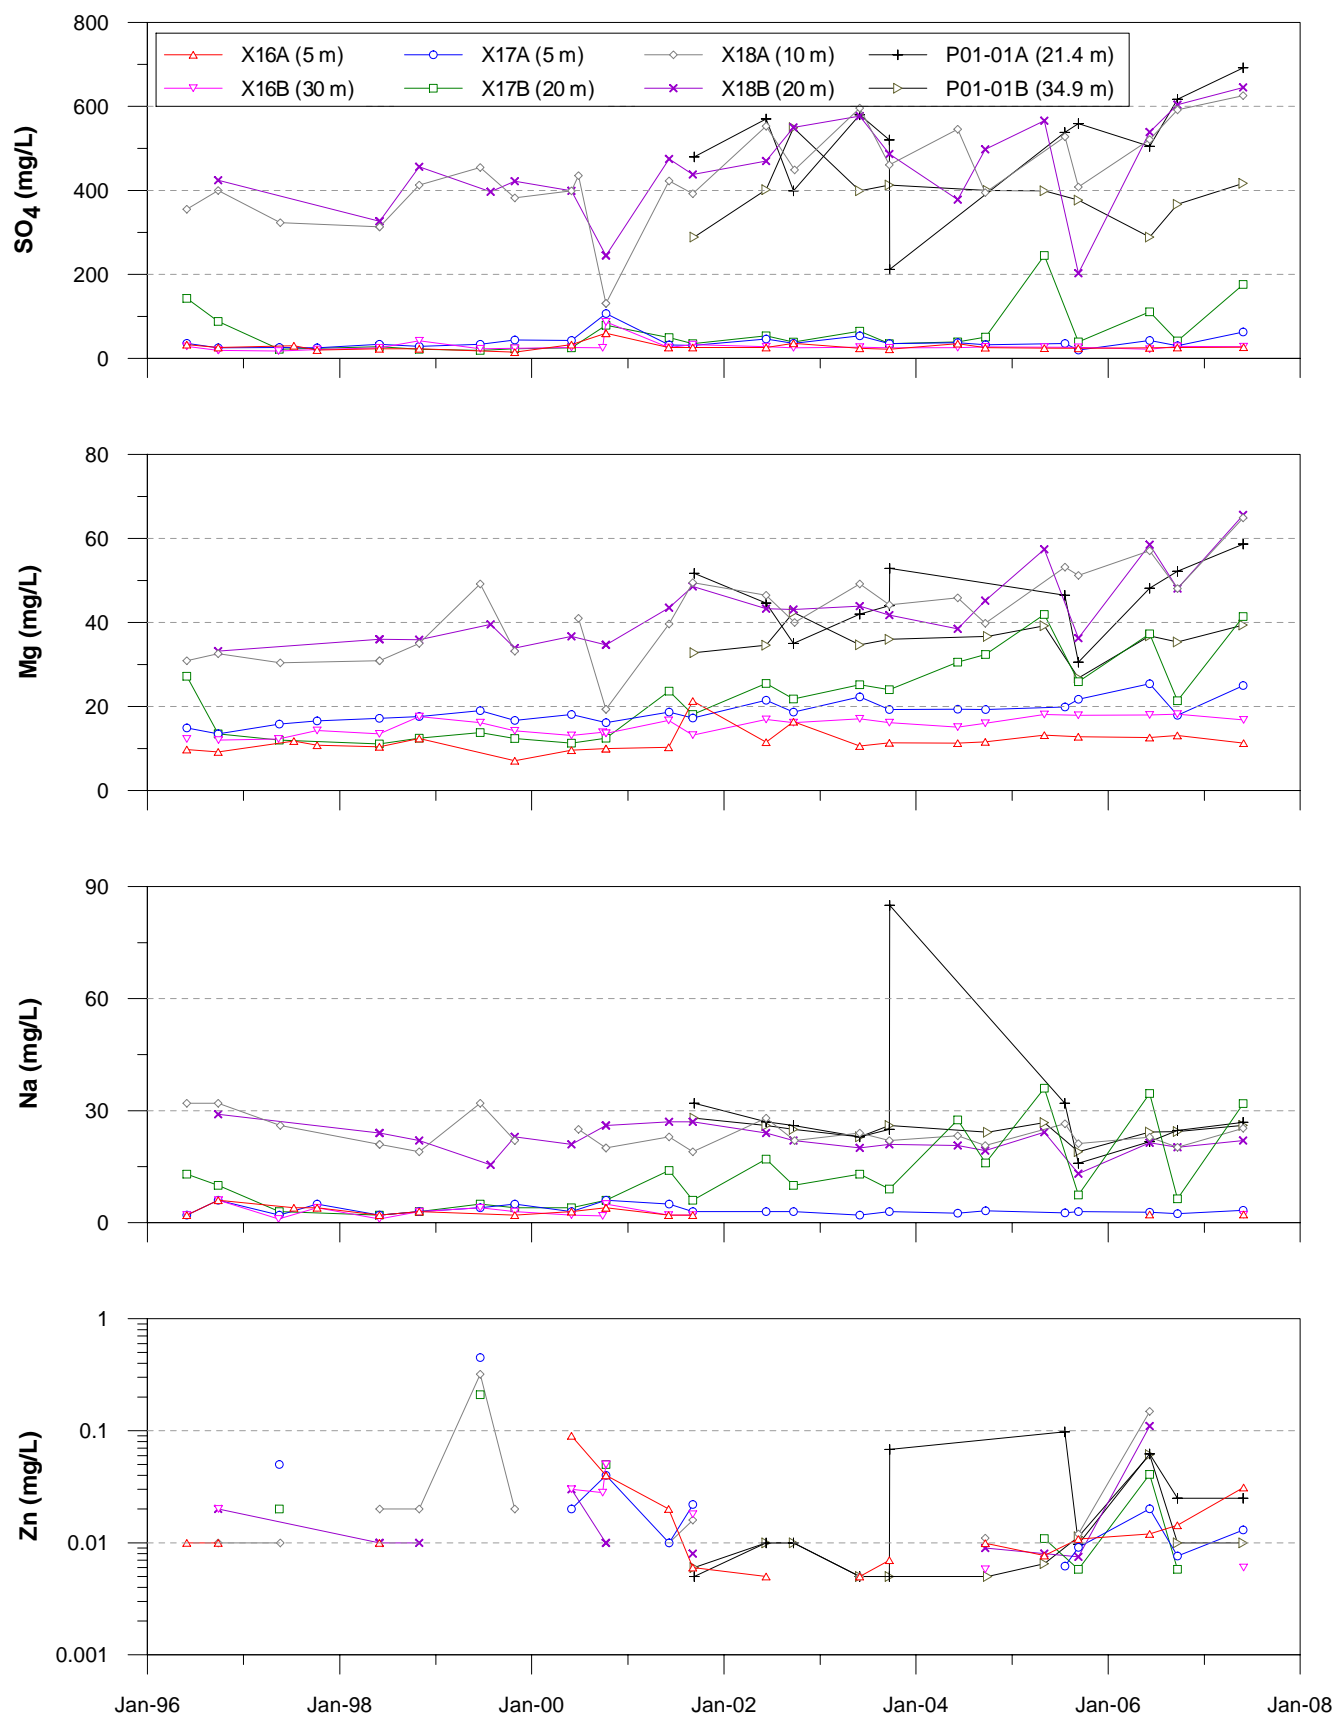
Figure 7a. Water quality (SO<sub>4</sub>, Mg, Na and Zn) in wells downgradient of Cross Valley Dam.

Figures 7a/b show the water quality time trends in all wells screened downgradient of the Cross Valley Dam. The recent time trends can be summarized as follows:

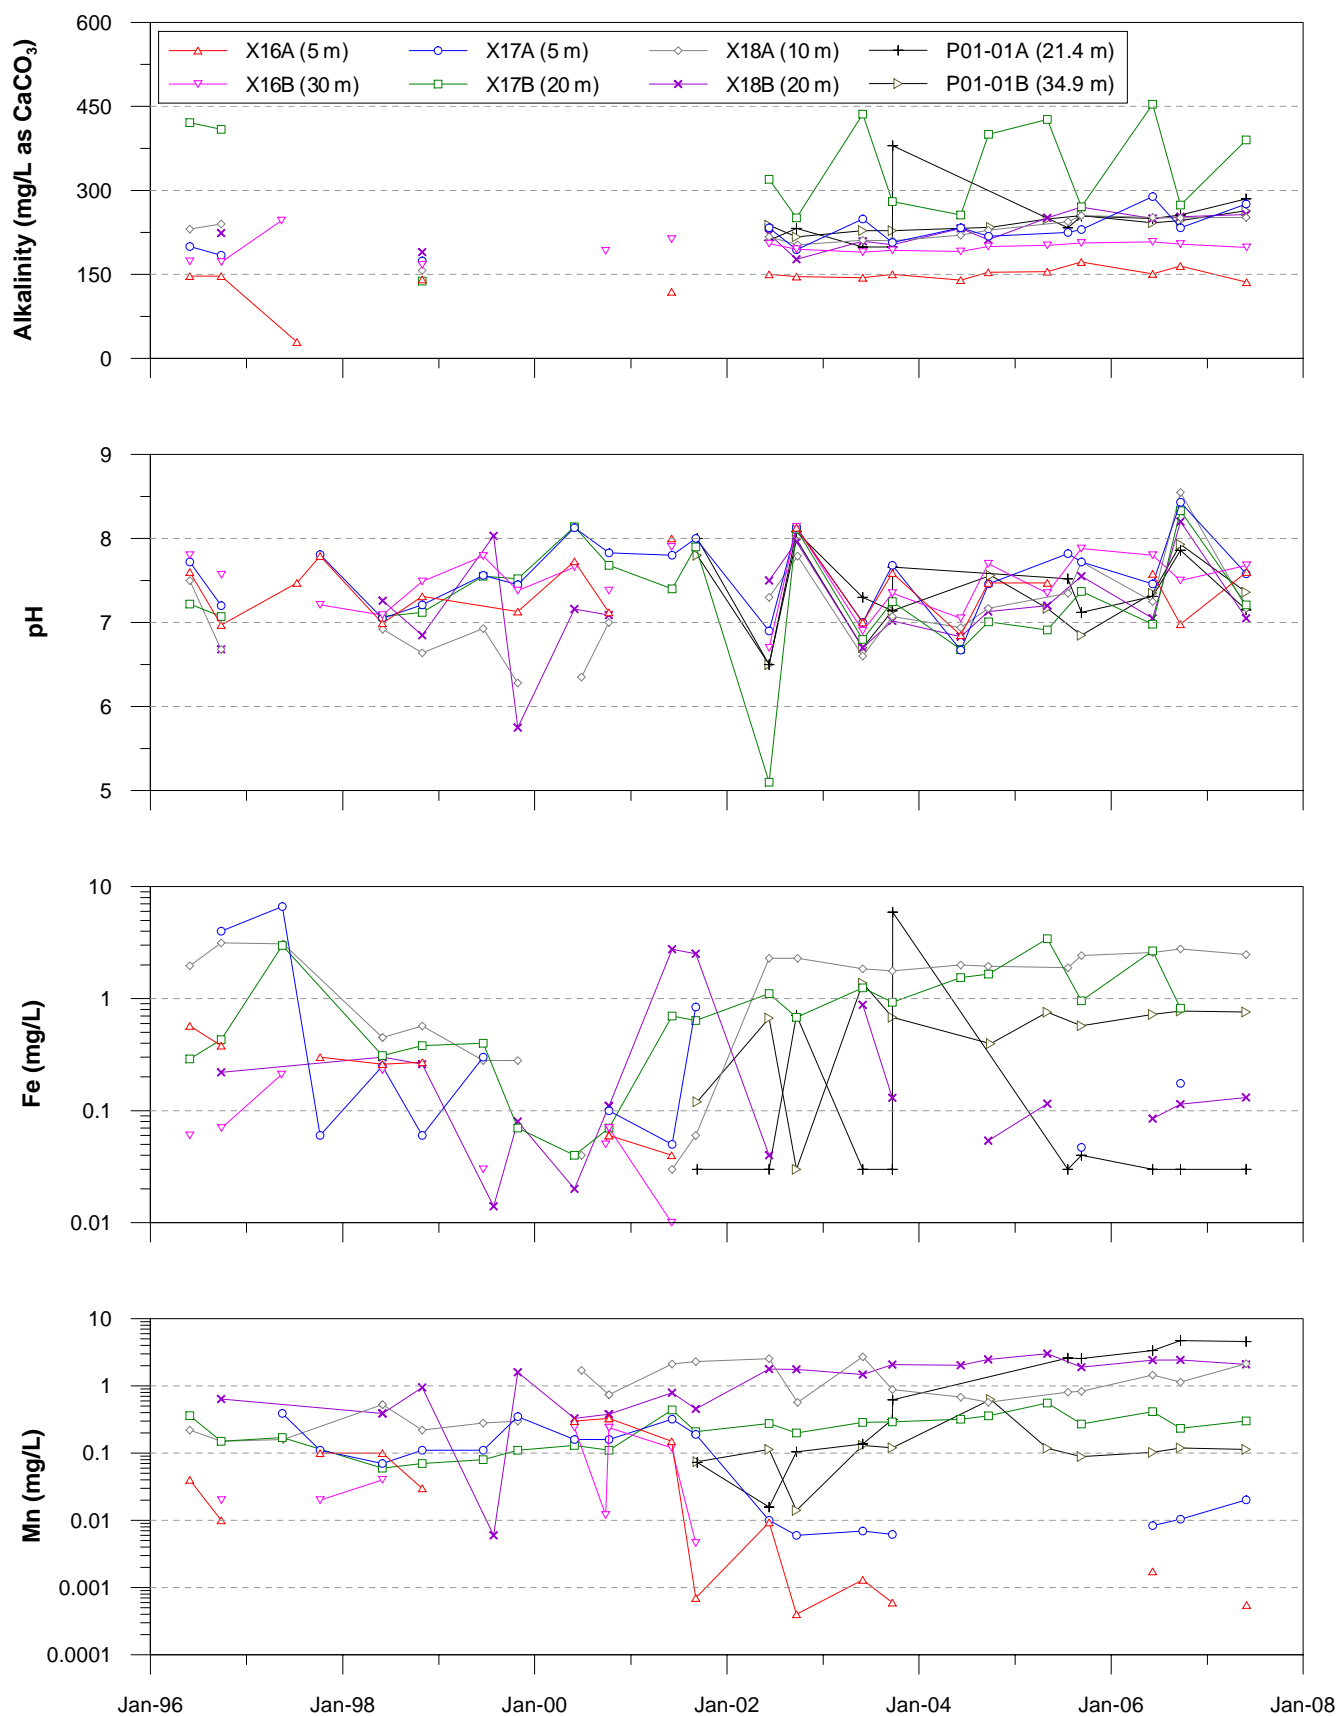
Figure 7b. Water quality (alkalinity, pH, Fe and Mn) in wells downgradient of Cross Valley Dam.
