# Conclusions from Rose Creek Tailings Area Alternatives Evaluation

Prepared for  
Government of Canada  
as represented by Aboriginal Affairs and  
Northern Development Canada and the Government of Yukon

November 2012

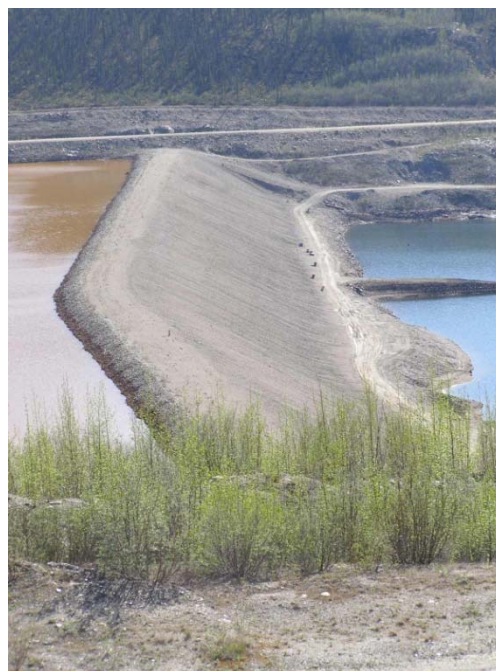
- NOTES :
1. Embankment geometry and internal zoning as shown in Golder Associates Drawing 912-2402-3, Int. Dam Raising & C.V. Dam Toe Drain, Cross Section and Detailed Plan, Rev. 1, Aug. 8, 1991.
  2. All elevations are referenced to Down Valley Project Datum, Subtract 32.3m from elevations shown to convert to mean sea level (NAD27) datum.
  3. Refer to Golder Associates as built reports for detailed descriptions of material classes. General descriptions as follows :

CLASS VI	Dam Core (glacial till)
CLASS VII	Upstream Shell (silty sand and gravel)
CLASS VIIA	Downstream Shell (sand and gravel)
CLASS VIIA	Drainage Filter (sand and gravel)
CLASS IX	Upstream Filter (silty sand)
CLASS X	Downstream Filter (sand and gravel)
CLASS XI	Tailings Sand (fine to medium sand)
CLASS XII	Drainage Zone (gravel)

FIGURE 1-2  
As-Built Cross-Sections and Photographs of the Secondary Dam  
Faro Mine Remediation Project

The Secondary Dam was designed by Golder Associates and its construction started in 1974. The West Limb of the Secondary Dam is defined as the curved portion of the dam that crosses the Rose Creek Valley in a roughly north to south direction. The East Limb is the portion of the Secondary Dam that is parallel to the south Rose Creek Valley wall. The West Limb of the Secondary Dam was raised using centerline construction and compacted fill to a maximum height of 27 m. The East Limb is a low retention dyke that was constructed of compacted fill. Tailings were deposited behind this dam from 1975 until 1982 and then for approximately 5 months in 1986. Rose Creek was diverted to a channel that ran parallel to the south Rose Creek Valley wall and emptied into its original channel downstream from the Secondary Dam. Cross-sections and photos of the Secondary Dam are shown on Figure 1-2.

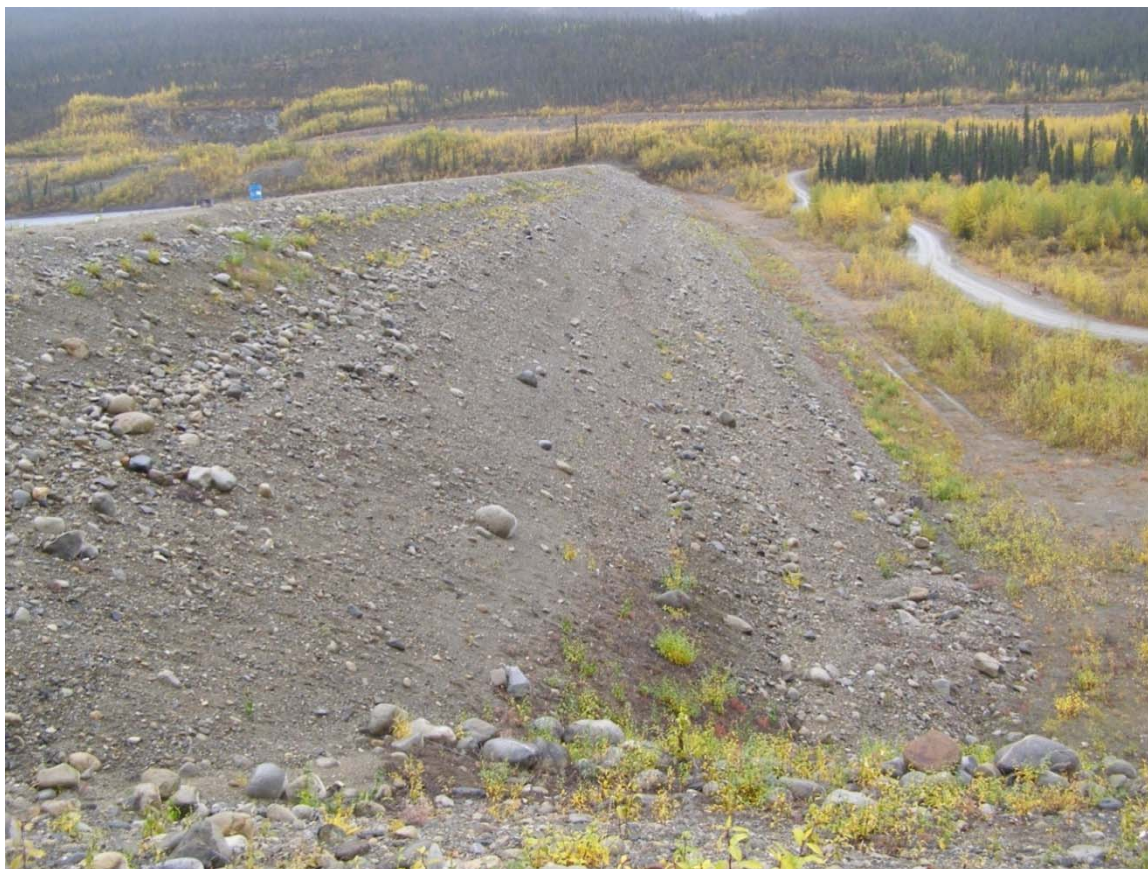
FIGURE 1-4  
**As-Built Cross-Section and Photograph of the Cross Valley Dam**  
 Faro Mine Remediation Project

The CVD was constructed as part of the Down Valley Project in the early 1980s to expand the tailings disposal capacity in the Rose Creek Valley. The CVD retains a polishing pond downstream from the ID. The embankment is a zoned dam with core and filters constructed as a conventional water retaining dam with no retained tailings. Figure 1-3 shows the design section of the CVD without the seepage berm at the downstream toe. The seepage berm was constructed at a later date (after the original construction was completed) to control seepage that appeared near the toe of the dam.

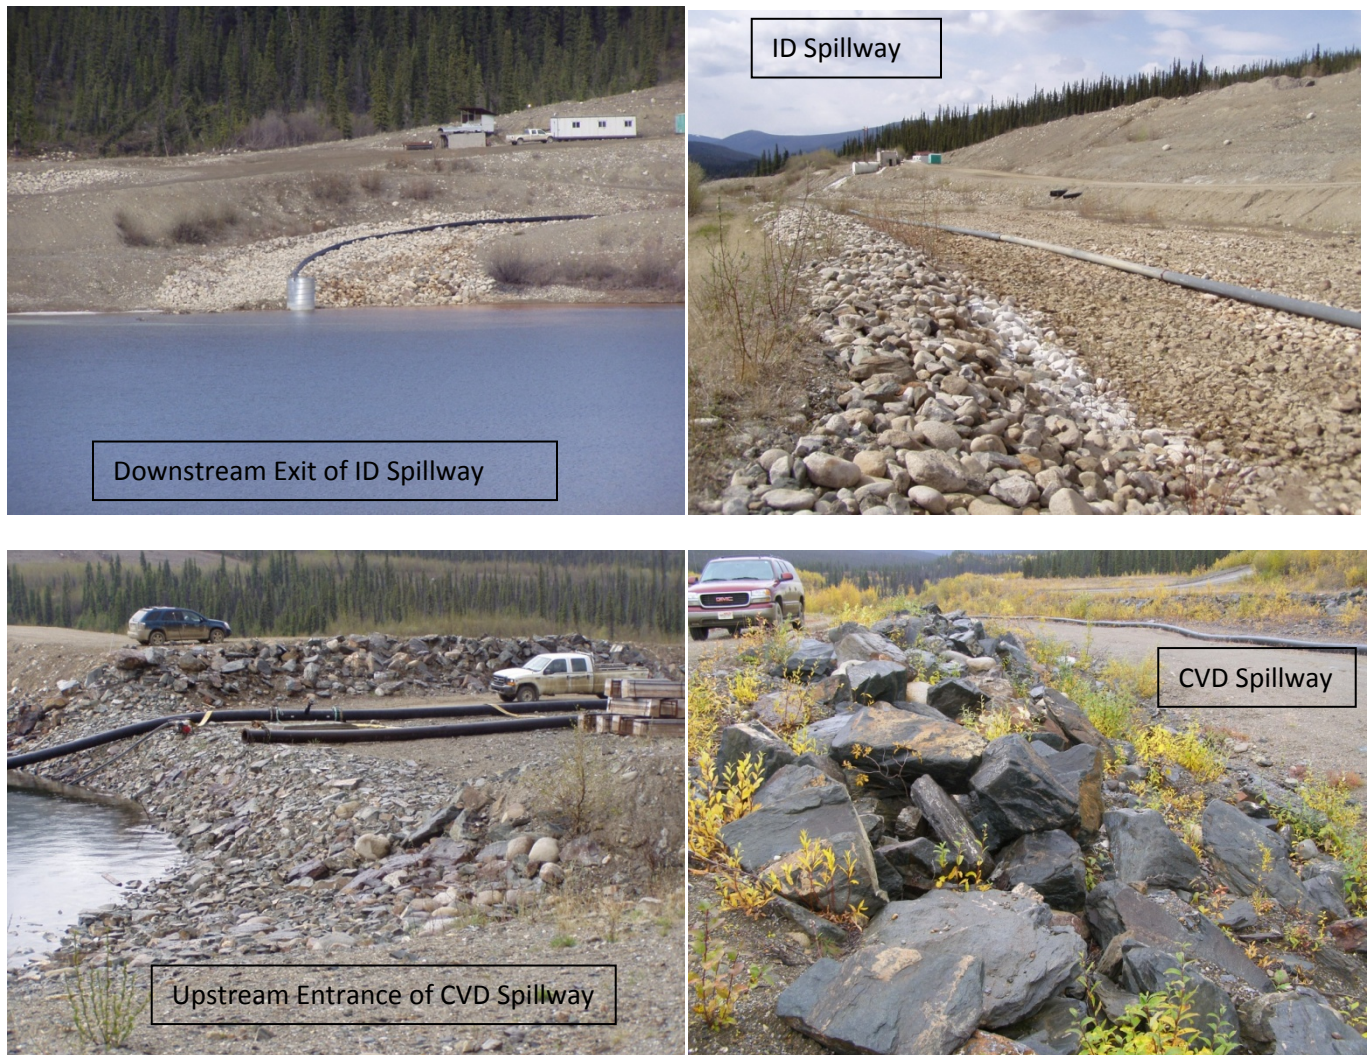
FIGURE 1-5  
**Photographs of the Intermediate Dam and Cross Valley Dam Spillways**  
*Faro Mine Remediation Project*

The current spillways at the right abutments of the ID and the CVD are not sized to pass large floods. They have capacities of about 30 to 40 cubic metres per second ( $\text{m}^3/\text{sec}$ ), and pass the snowmelt and stormwater generated from precipitation on the tailings area only.

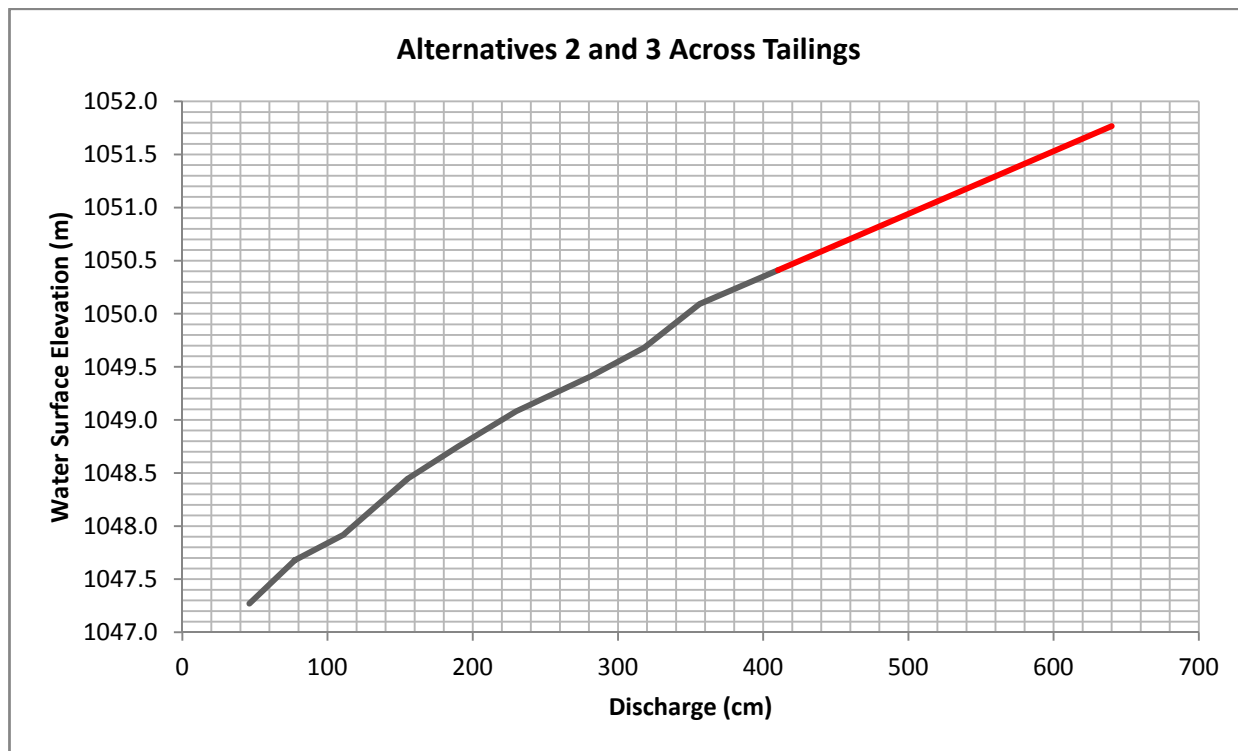
FIGURE 2-6

**Peak Reservoir Stage versus AEP Relationships for ID for Alternative 2 and Alternative 3**  
*Faro Mine Remediation Project*

Similarly, the peak reservoir stage vs. AEP relationship for the intermediate dam was derived from the stage-discharge curve shown in Figure 2-6.

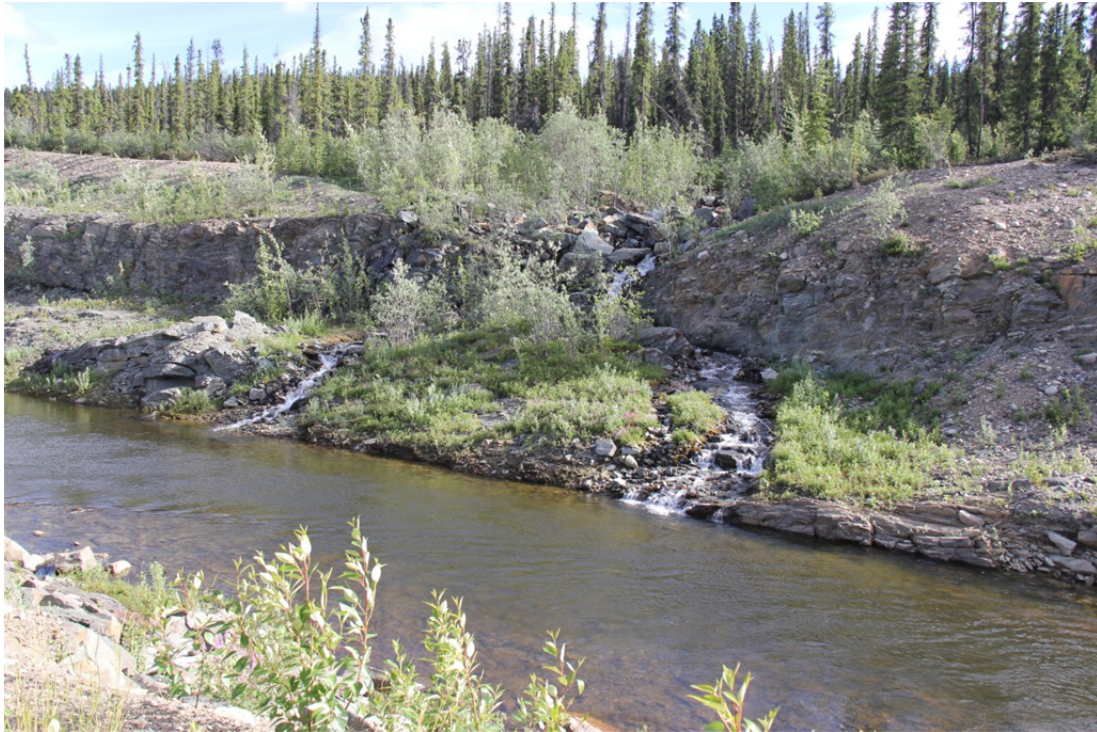
Photo 1: (0900, WMV, June 26-27, 2012)  
Local inflow into RCDC opposite the Secondary Containment Dyke (approx. Station \_\_\_\_)

- The local tributary drainage area and thus local inflow into the RCDC (Figures 1 - 2) will not be affected by an expanded RCDC.

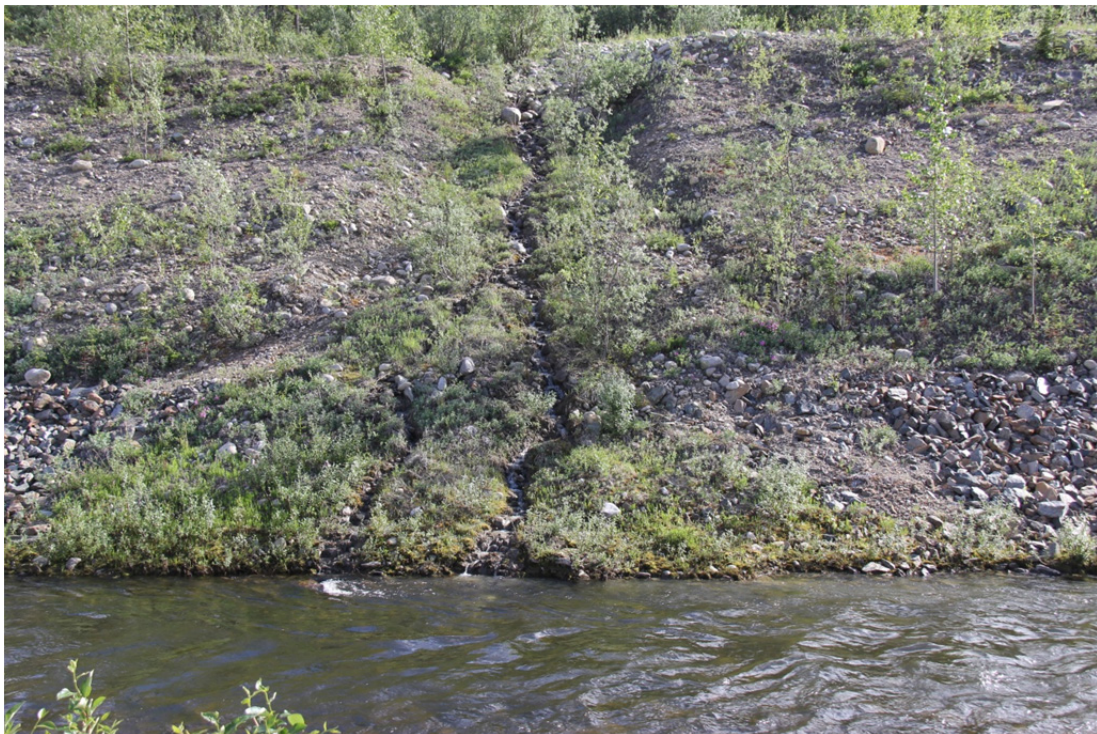
Photo 2: (0898, WMV, June 26-27, 2012)  
Local inflow @ BCB 05-05 monitoring site (approx. Station \_\_\_\_)

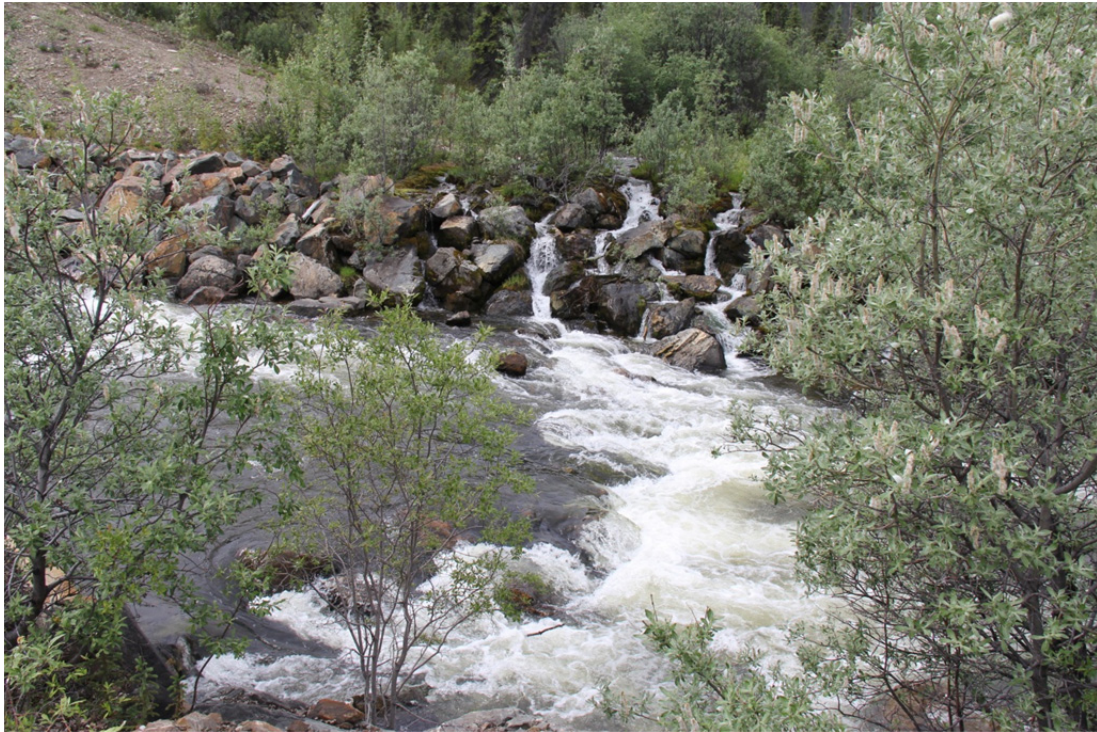
Photo 3: (0922, WMV, June 26-27, 2012)  
Significant inflow into the steep drop section (approx. Station \_\_\_\_)
