Klohn Crippen Berger

Faro Mine Remediation Project

Dam Breach and Inundation Study

February 28, 2014

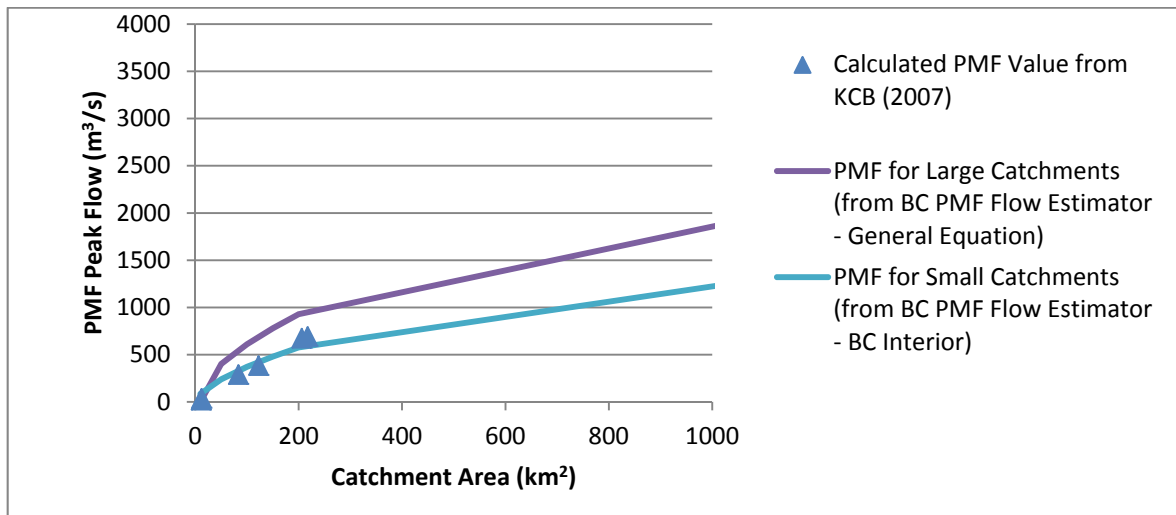
Figure 3.2 PMF Values from KCB 2007 and from PMF Estimator for BC

The catchments used in these calculations are relatively small. When extrapolated to the larger catchments of Pelly River, the resulting flows are considered to be unrealistically large. Instead, these flows were compared to those generated using the equations from the Probable Maximum Flood Estimator for British Columbia (Abrahamson 2010). For catchments with drainage areas greater than 8,320 km², the general equation is used. For smaller catchments, the “BC Interior” zone appears to correlate best with the previously calculated data from KCB (2007), as shown in Figure 3.2, and is used for small catchment areas.

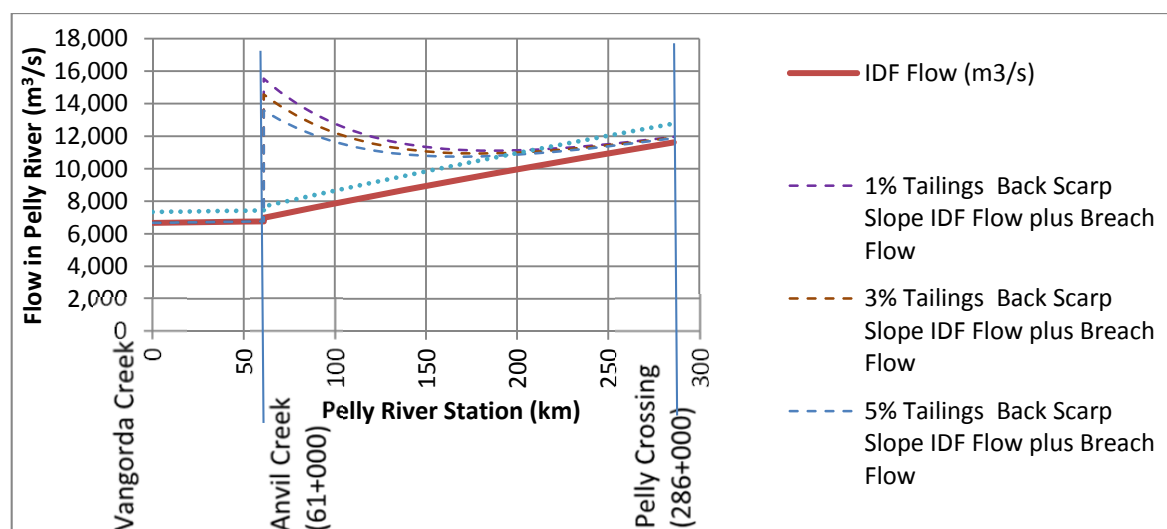
Figure 3.7 Breach Flood Attenuation for Intermediate and Cross Valley Dams Rainy-day Cascading Failure

The high Q_2/Q_1 , Q_3/Q_1 and Q_4/Q_1 ratios in Table 3.7 indicate that the incremental impact of a cascading rainy-day breach of the Intermediate and Cross Valley Dams is significant over the entire length of Rose and Anvil Creeks, and extends past the confluence with Pelly River. As shown in Figure 3.7, in all tailings runout cases, the breach flow is substantially attenuated, (i.e., to 110% of the IDF) approximately 139 km downstream of the confluence of Anvil Creek and Pelly River (140 km straight distance downstream of the Town of Faro).

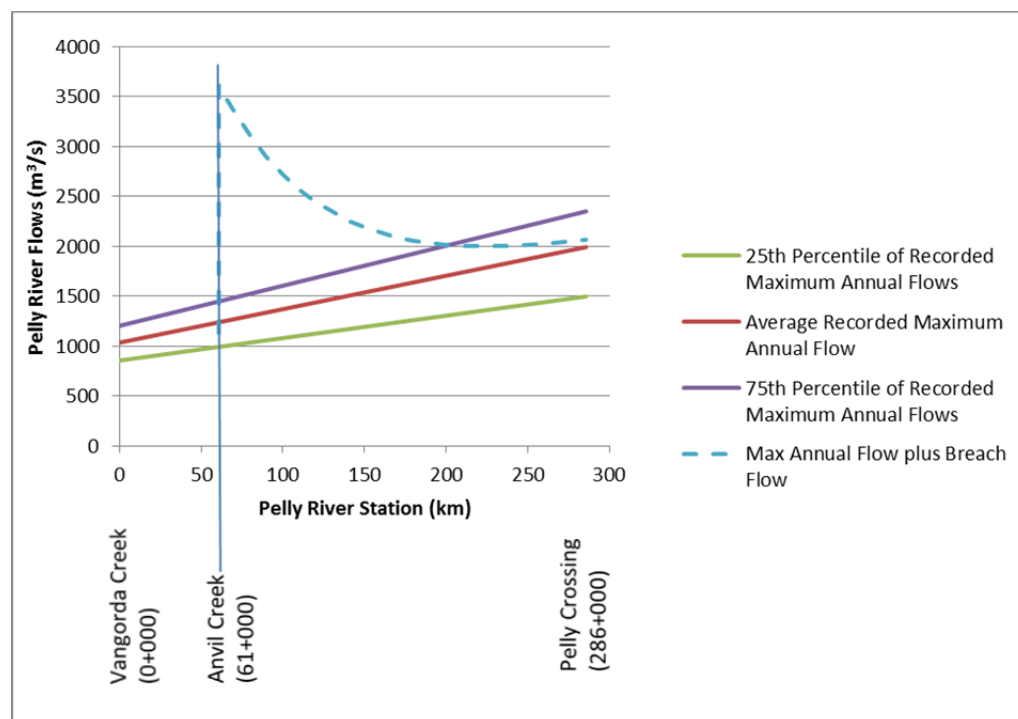
Figure 3.8 Breach Flood Attenuation for Cross Valley Dam Sunny-day Failure

The high Q_2/Q_1 ratios in the above table indicate that the incremental impact of a sunny-day breach of the Cross Valley Dam is significant over the entire extent of Rose and Anvil Creeks, and past the confluence with Pelly River. As shown in Figure 3.8, the breach flow is attenuated to the 75th percentile of the recorded average maximum annual flow in the Pelly River approximately 139 km downstream of the confluence of Anvil Creek and Pelly River (140 km straight distance downstream of the Town of Faro).

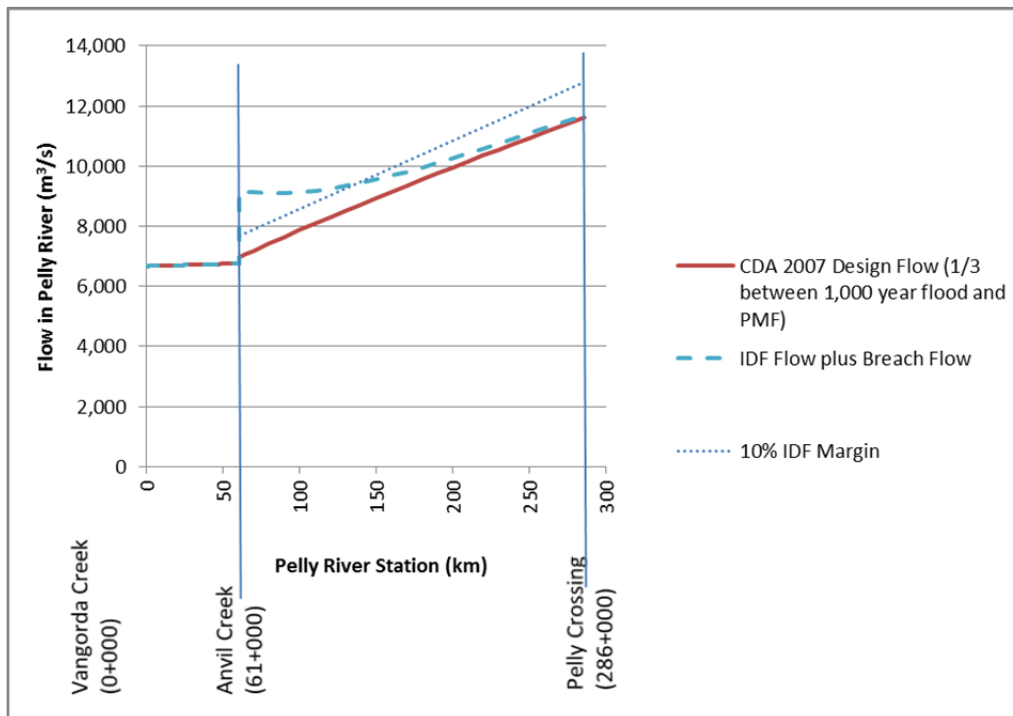
Figure 3.9 Breach Flood Attenuation for Cross Valley Dam Rainy-day Failure

As with the previously seen cases, the incremental impact of a rainy-day breach of the Cross Valley Dam is significant over the entire length of Rose and Anvil Creeks, and extends past the confluence with Pelly River. As shown in Figure 3.9, the breach flow is attenuated to within 10% of the IDF flow in the Pelly River approximately 64 km downstream of the confluence of Anvil Creek and Pelly River (105 km straight distance downstream of the Town of Faro).

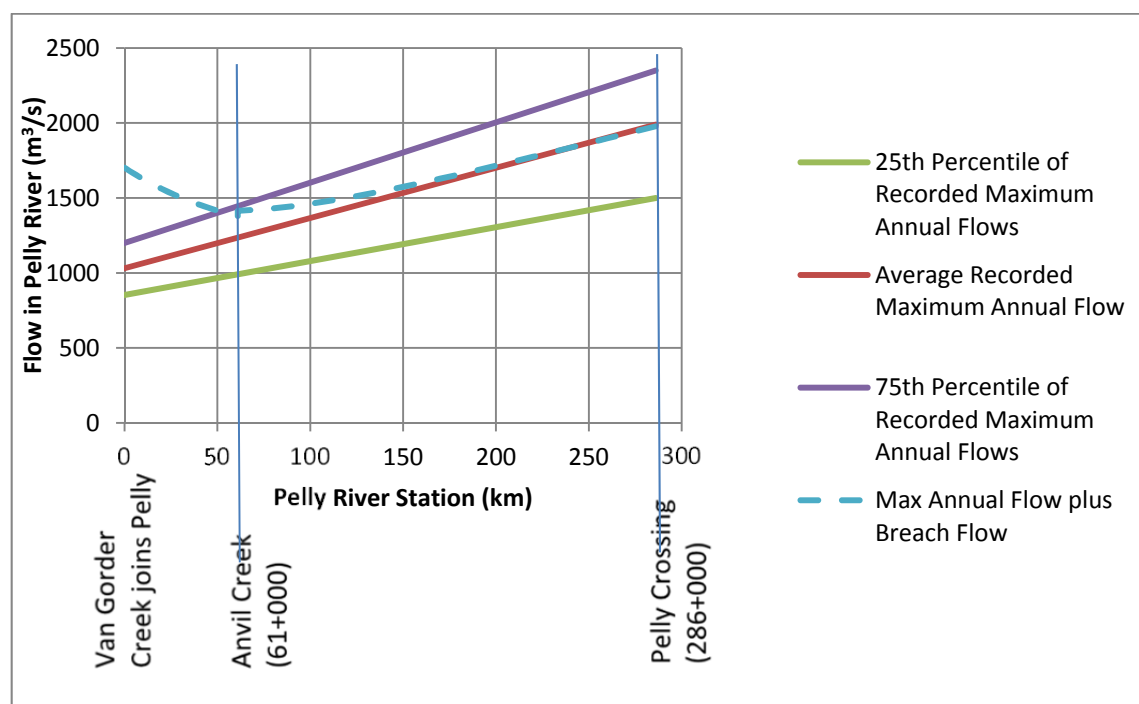
Figure 3.10 Breach Flood Attenuation for Little Creek Dam Sunny-day Failure

It can be seen from the above table that the incremental impact of a sunny-day breach of the Little Creek Dam is significant over the entire extent of Vangorda Creek, and past the confluence with Pelly River. As shown in Figure 3.10, the breach flow is attenuated to the 75th percentile of the recorded average maximum annual flow in the Pelly River approximately 45 km (straight distance) downstream of the Town of Faro.

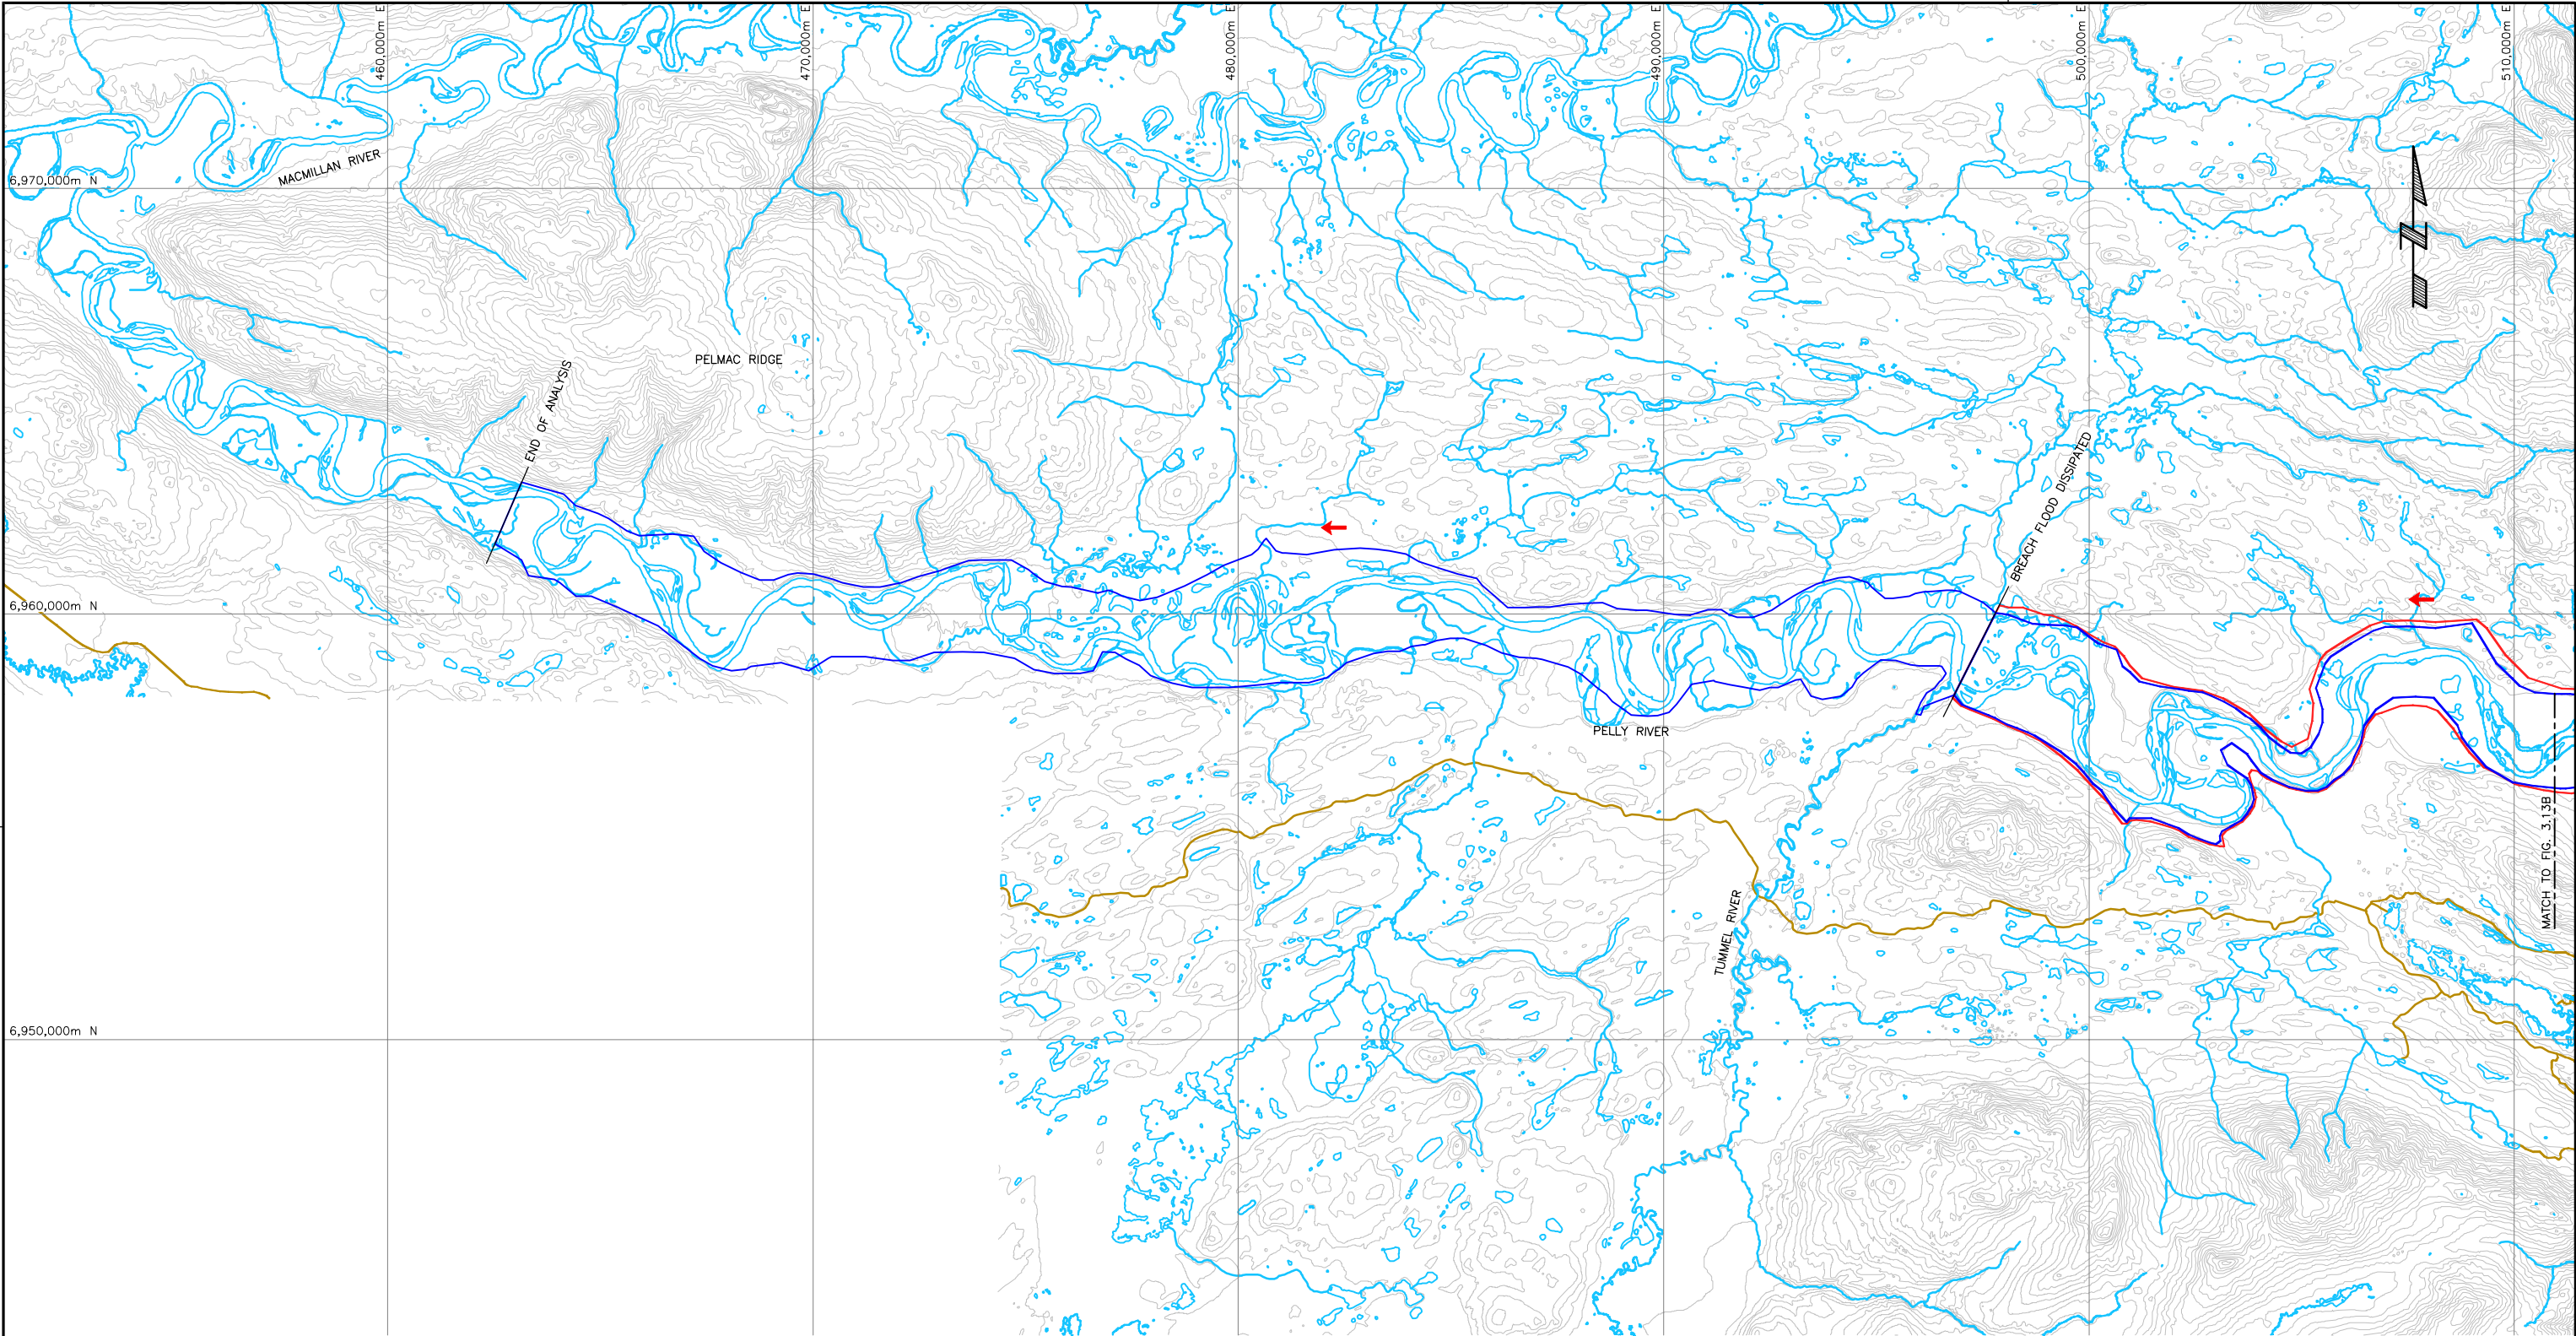
PROJECT No. M09770A02	FIG. No. 3.13B

AS A MUTUAL PROTECTION TO OUR CLIENT, THE PUBLIC AND OURSELVES, ALL REPORTS AND DRAWINGS ARE SUBMITTED FOR THE CONFIDENTIAL INFORMATION OF OUR CLIENT FOR A SPECIFIC PROJECT AND AUTHORIZATION FOR USE AND/OR PUBLICATION OF DATA, STATEMENTS, CONCLUSIONS OR ABSTRACTS FROM OR REGARDING OUR REPORTS AND DRAWINGS IS RESERVED PENDING OUR WRITTEN APPROVAL.	CLIENT	PROJECT FARO MINE REMEDIATION PROJECT DAM BREACH AND INUNDATION STUDY	
	YUKON GOVERNMENT	TITLE CROSS VALLEY DAM RAINY DAY FAILURE INUNDATION EXTENTS SHEET 2 OF 3

- NATURAL CREEK
- NATURAL FLOOD EXTENTS (½ BETWEEN 1000 YR FLOOD AND PMF)
- "RAINY DAY" FAILURE PLUS NATURAL FLOOD FLOW INUNDATION EXTENTS
- ROAD

The incremental flow depths shown in Table 3.17 for the Cross Valley Dam rainy-day failure are much lower than those for the sunny-day failure, due to the magnitude of the flows already present in the creeks and river during the natural IDF event. The flood wave is considered to be dissipated approximately 105 km (straight distance) downstream of the Town of Faro, and no infrastructure has been identified in the flooded area. The estimated flood limits for the Cross Valley Dam rainy-day failure are shown along with the extents of the natural IDF flood in Figure 3.13A, Figure 3.13B and Figure 3.13C.
