DEVELOPMENT OF THE ZONE 2 WASTE DUMP

Submitted to the Yukon Territory Water Board

December, 1987

CURRAGH RESOURCES, INC.
117 Industrial Road
Whitehorse, Yukon

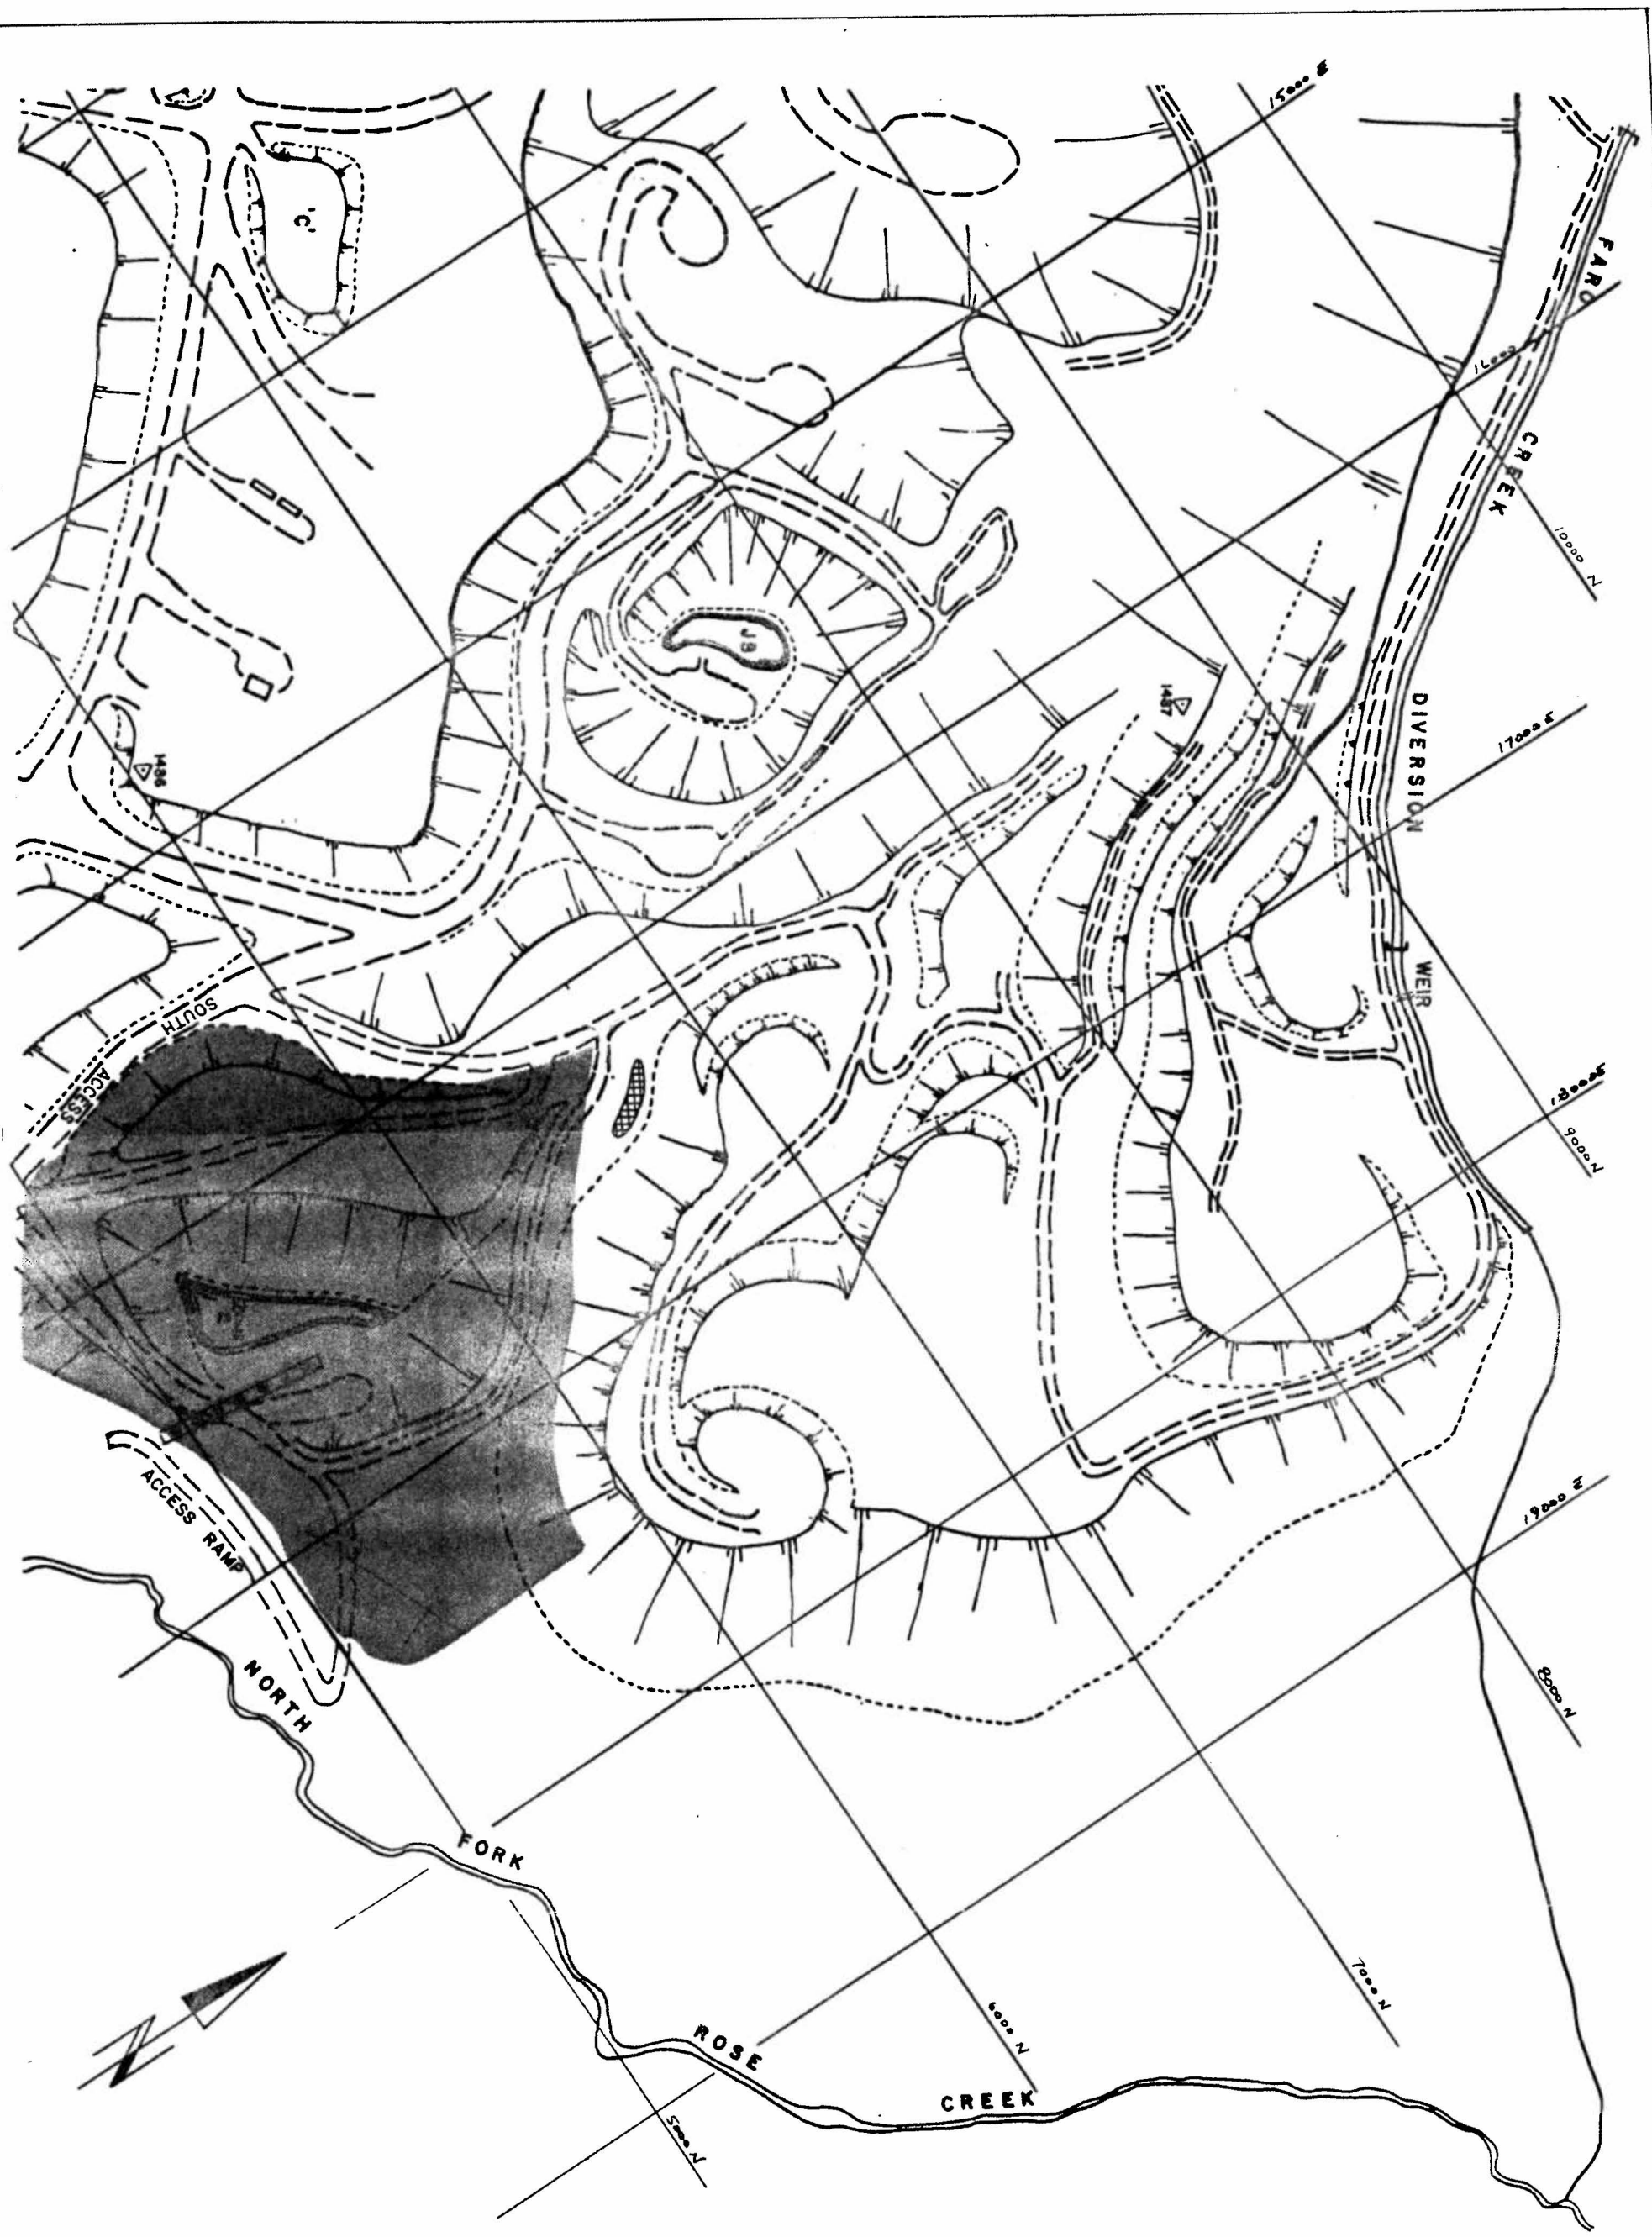
- LEGEND**
- FARO DIVERSION LINER
 - INTERNAL ROCK DRAIN
 - SEEP AREA
 - AREA TO BE COVERED BY ZONE 2 WASTE DUMP
 - CURRENT DUMPS
 - CREST
 - TOE

Construction of an access ramp to the 3710 foot elevation (Figure 2) requires approximately 34,000 loose m³ of material cut from the existing crest of the Zone 2 waste dump as well as approximately 23,000 loose m³ of additional fill. This material is non sulphide-bearing rock, calc-silicate transitional to phyllite. Ramp design is constrained by the dump limit on the west to a 21 m width. With berm allowance, this restricts the ramp to single truck hauling. The ramp grade is -10% and follows on top of the old perimeter access into the Zone 2 pit. The ramp will provide access to the discharge point of the internal drain as well as accessing a source of gravel for the pit operation.
