EDI Job Number: 09-YC-0030

Re: Dome Creek Fish and Fish Habitat Assessment

Figure 1. Investigation of Fish and Fish Habitat in Dome Creek

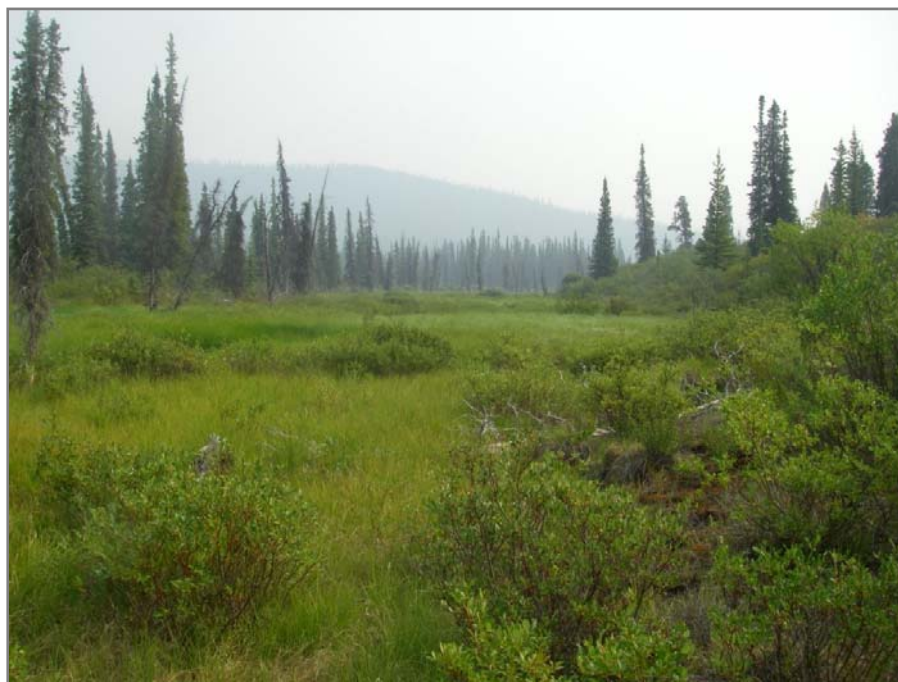
Photo 1. View of Dome Creek valley, showing a section of the watercourse with no distinct channel.

Downstream of the road Dome Creek is a small channel that runs through a grassy wetland area. While it is mostly channelized the water periodically disperses to flow unconfined through the grass (Photo 1). In channelized areas the wetted width and channel were equivalent, and ranged from 0.30 to 0.65 m. Average water depth of the creek was 0.46 to 0.68 m. Pools were few and shallow with residual depths ranging from 0.05 to 0.21 m. The gradient of the stream bed was very shallow, only 1 to 2%.

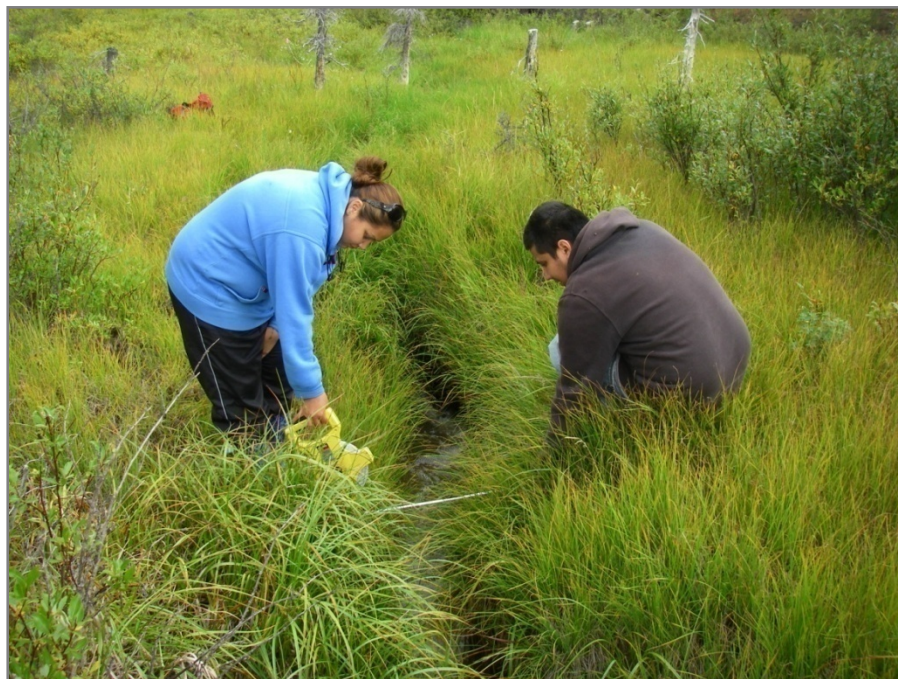
Photo 2. View of Dome Creek showing general stream attributes and surroundings.

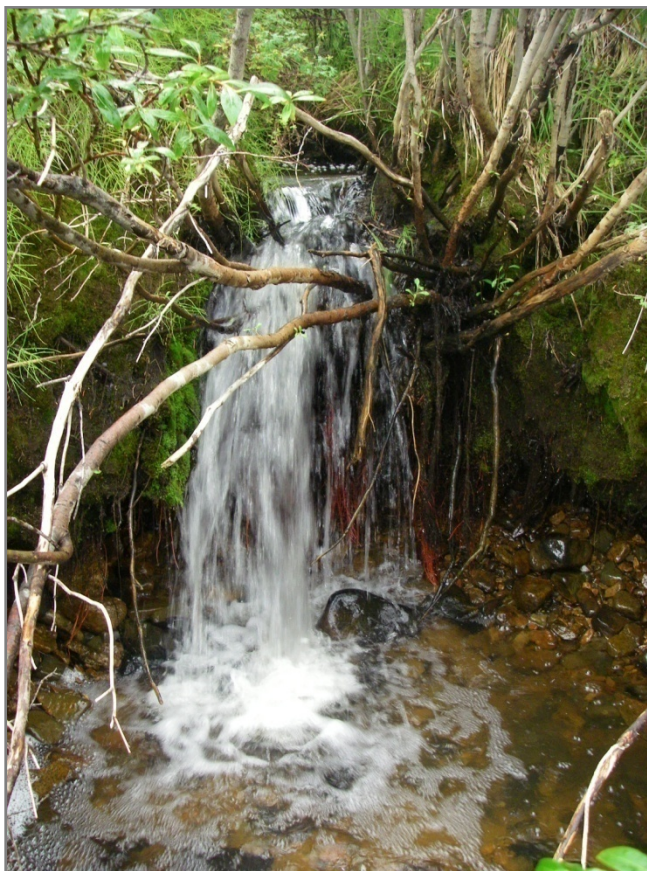
Photo 3. View of waterfall at the mouth of Dome Creek, as it flows into Victoria Creek.

In most areas there was very little cover present for the use of fish, generally taking the form of overhanging and instream grasses combined with some small woody debris. Both banks were vertical in shape, and were composed of grasses. Riparian vegetation was composed of grasses with some shrubs and willows. The stream substrate was composed entirely of organic fines. The stream followed a sinuous pattern and no islands or bars were noted within the reach investigated. Dome Creek was decoupled from surrounding terrain and unconfined (Photo 2). Finally a significant waterfall was noted where Dome Creek flows into Victoria Creek (Photo 3)¹. This fall had a height of 0.94 m, with a relatively shallow plunge pool of 0.09 m depth. A waterfall of this height without a plunge pool of significant depth likely does not permit fish passage for species found in this area. Parker (2000) indicates that adult grayling have the ability to jump heights of 1.0 m if there is a minimum pool size of 1.25 m. The waterfall's location at the mouth of Dome Creek likely precludes entry to Dome Creek by any fish in Victoria Creek.

¹ Note that the falls were not bedrock and thus could change over time. During a high water event in 2005, Dome Creek was observed to flow into Victoria Creek at more than one location; however, all locations had notable falls associated with them due to a high bank height on Victoria Creek. It is not expected that these falls will cease to exist in the near future due to the current height combined with the low volume of water flowing in Dome Creek.
