Faro Mine Complex, Yukon

Emergency Response Plan for:

***Intermediate Dam, Cross Valley Dam,
Little Creek Dam, Faro Creek Diversion Channel,
Rose Creek Diversion Channel and
Vangorda Creek Diversion Flume***

March 31, 2014

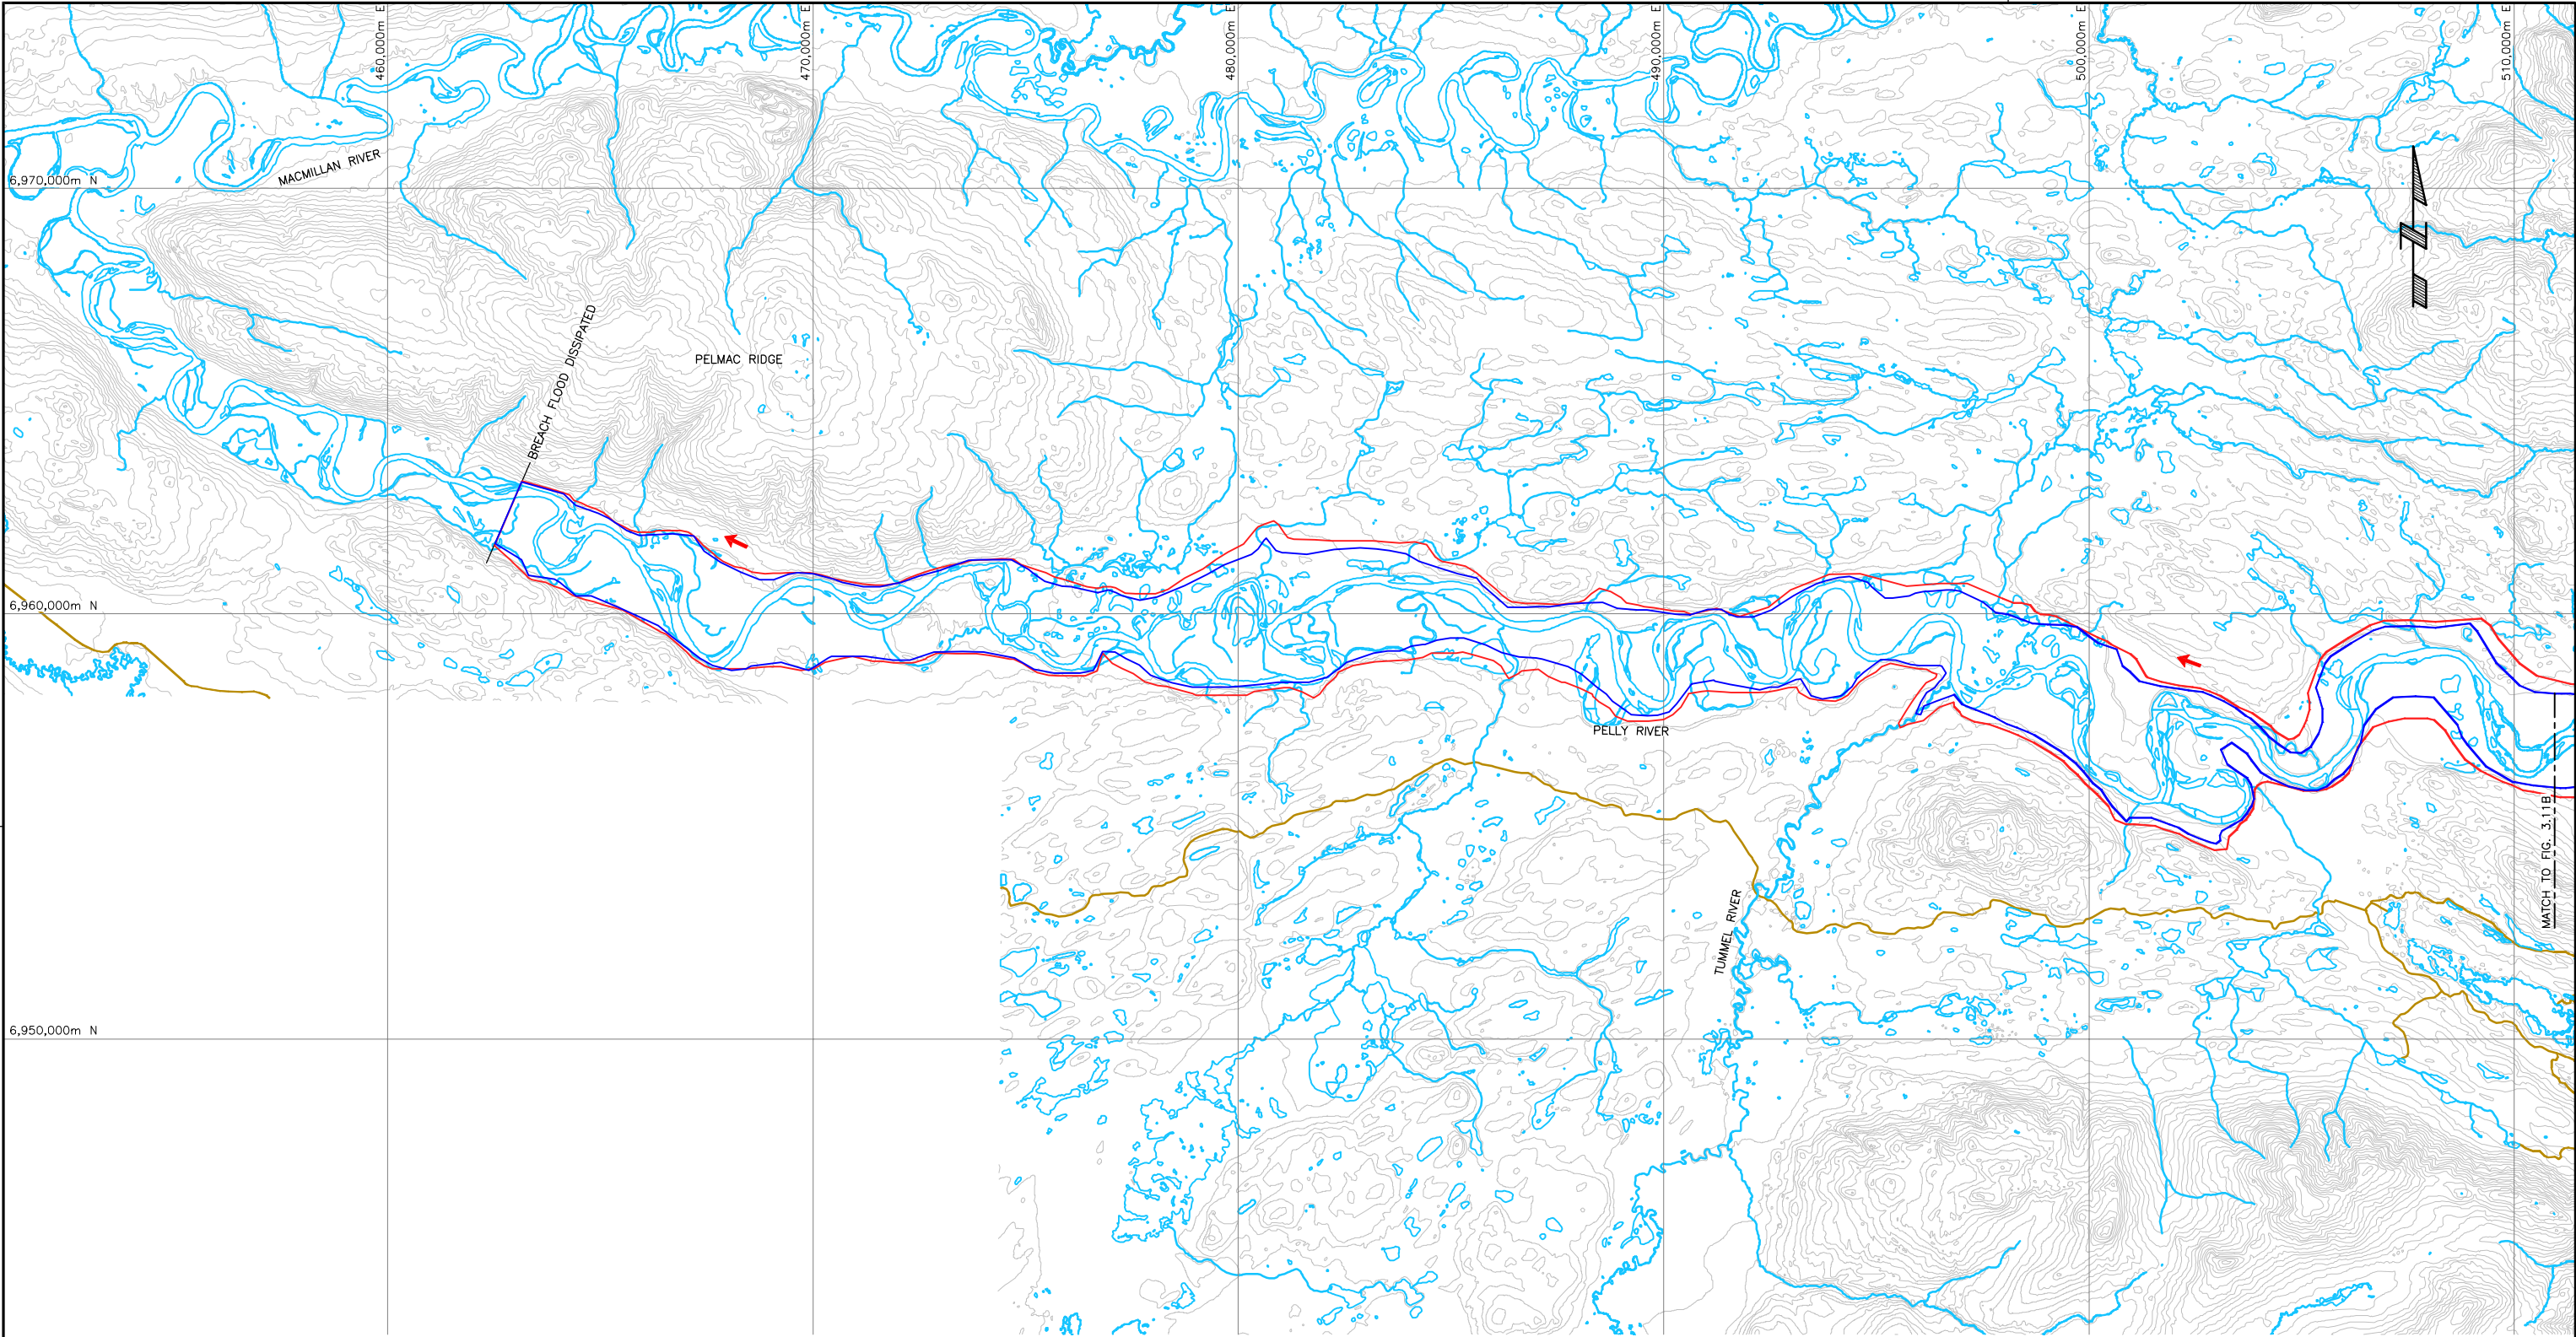
- Figure 3.11C Intermediate and Cross Valley Dam Rainy-day Cascading Failure Inundation Extents (Sheet 3 of 3)
- Figure 3.12A Cross Valley Dam Sunny-day Failure Inundation Extents (Sheet 1 of 3)
