# **Anvil Range Mining Corporation Interim Receivership**

**Environmental Assessment of the Lowering of the FWSD Project**

**September 3, 2002**

Environmental Assessment  
of the  
Lowering of the Fresh Water Supply Dam Project

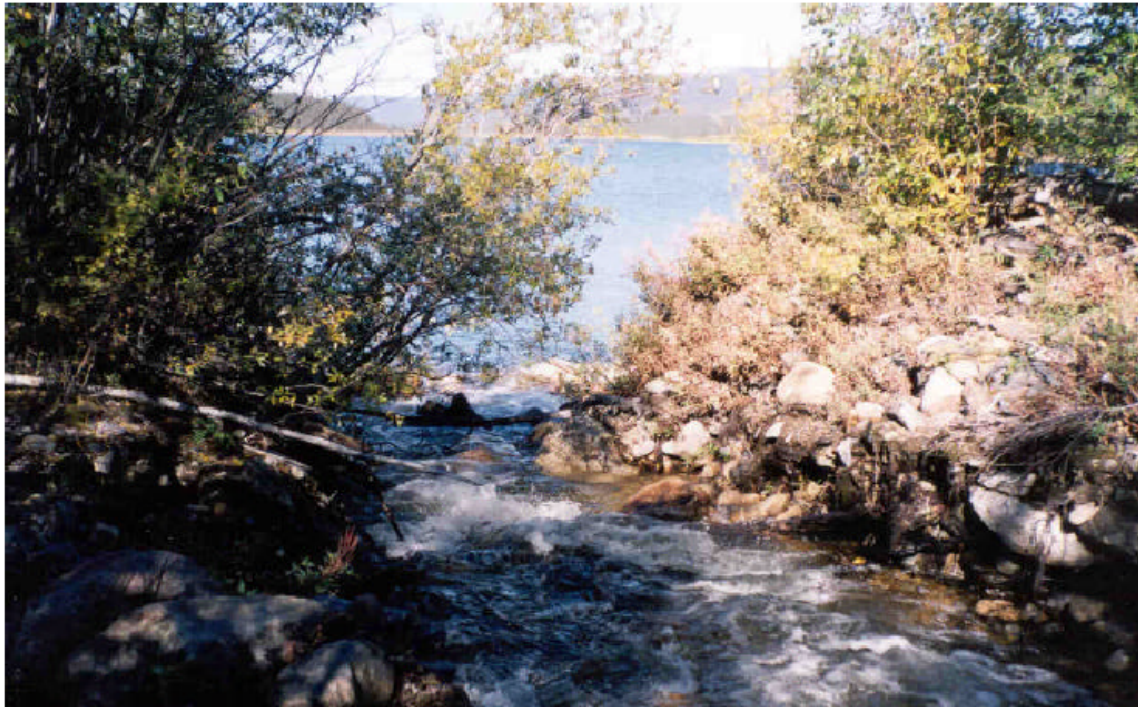
**PHOTOGRAPH 1**

Tributary entering FWS Reservoir from north during high flow conditions (Aug 29 /00)

The unnamed tributary that flows into the Reservoir from the north is a relatively steep gradient from the current Reservoir shore to the mine access road 40 m upstream with cobble substrate (Photo 1). This channel section provides moderate rearing and summer habitat and low spawning and winter habitat. The unnamed tributary that flows to the Reservoir from the southeast is an unconfined low-flow channel through the willow-sedge-spruce valley with a substrate of fines (Photo 2). The channel at the mouth is defined with boulder substrate. This channel offers moderate rearing and low value spawning, winter and summer habitat. Reach 4 of the South Fork, is predominantly riffle channel over boulder and cobble (Photo 3) with some beaver dams in the upper end. Habitat is considered moderate for all grayling life stages. Reach 5 contains three barriers at the lower end: a culvert under the mine access road, the rock drain under the haul road and a steep gradient section (>20%). Fish cannot move in either direction across this section. There is moderate summer habitat and low habitat for all other life stages. Reach 6 is predominantly riffle over boulders at a 5% slope, with habitat considered moderate for spawning (grayling have been observed spawning at the upper end) and low for all other life stages. Dixon Lake is a shallow basin in reach 7, which offers low spawning habitat but high value habitat for rearing, and moderate value summer and winter habitat.

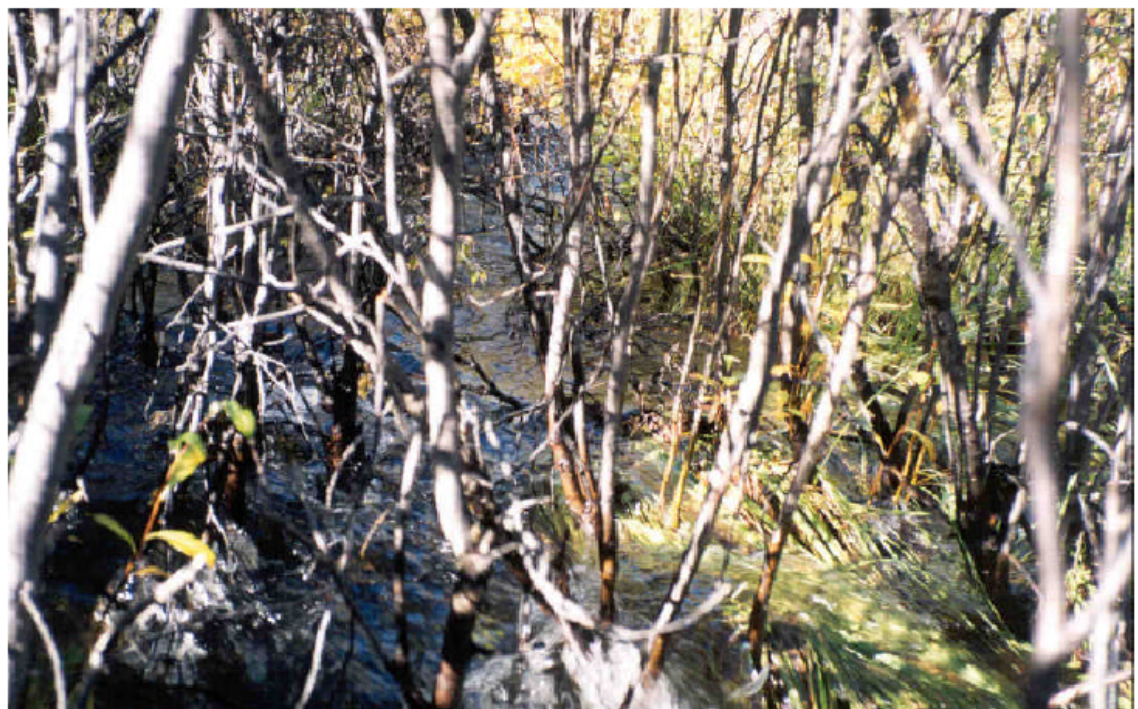
**PHOTOGRAPH 2**

Tributary entering FWS Reservoir from southeast during high flow conditions (Aug 29 /00)

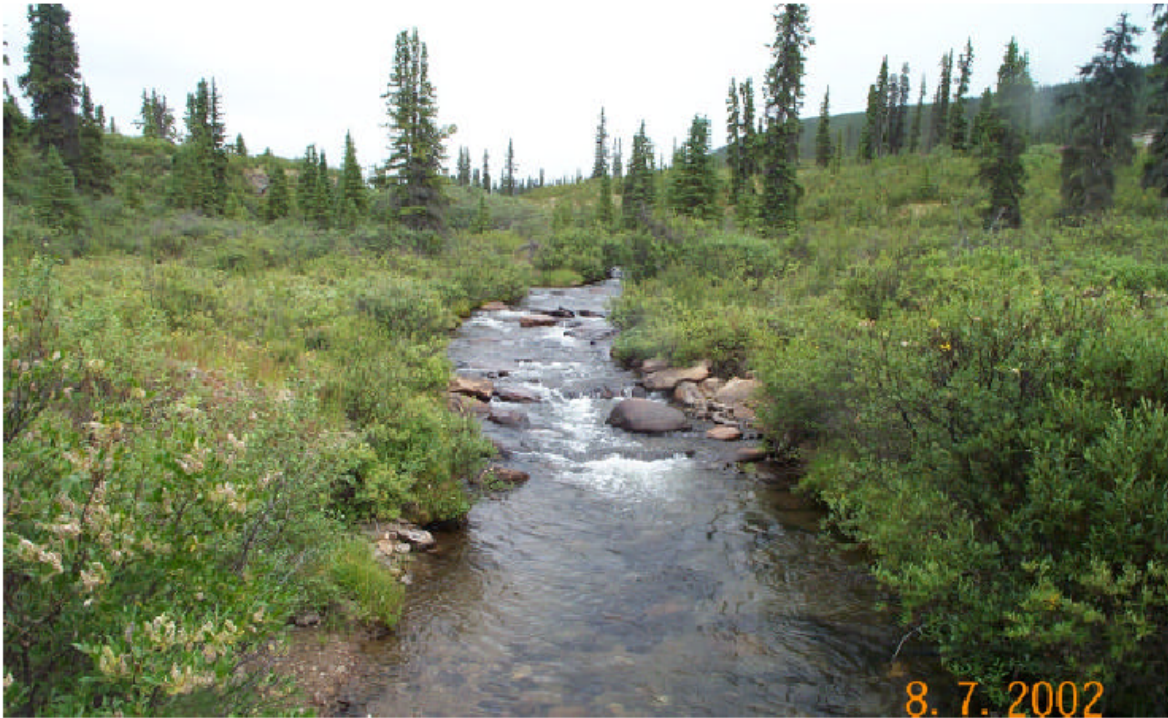
**PHOTOGRAPH 3**

Lower section of Reach 4 South Fork Rose Creek

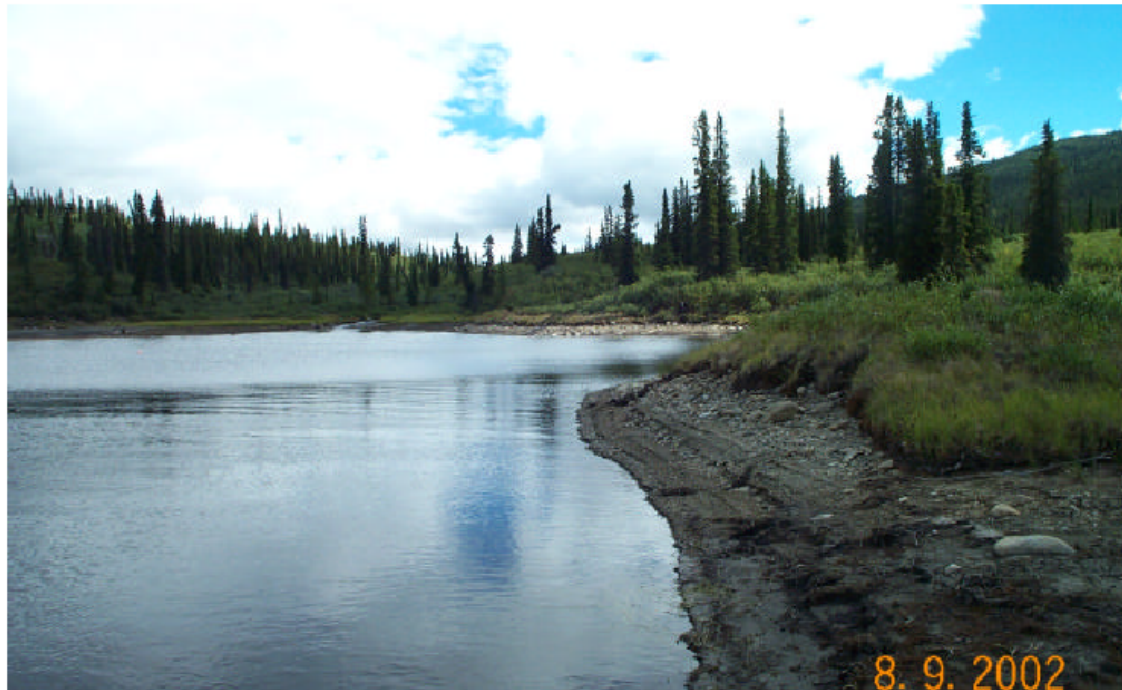
**PHOTOGRAPH 5**

Shoreline at Polygon F

As a general rule the near shore area of a lake to a depth of 6 m is defined as the littoral zone (RIC 1999) and is the most productive area of the lake as light penetrates to the bottom sediments and aquatic plants can grow. Descriptions of each habitat polygon are outlined in Table 7 and include slope, substrate and aquatic vegetation. In addition, shoreline substrate exposed by wave action and vegetation was noted for the shoreline perimeter polygons. In general, the north side of the Reservoir is more gradually sloped than the south side and has a greater abundance of aquatic vegetation. At the east side, two shallow bays are present. Aquatic vegetation identified within the Reservoir includes milfoil (*Myriophyllum sibiricum*), bur-reed (*Sparganium angustifolium*), pondweed (*Potamogeton alpinus*) and mare's tail (*Hippuris vulgaris*). The near shore substrate is predominantly fines with boulders, with cobble and gravel visible in some areas. Angular material is located along the south side of the Reservoir at the shale bedrock bluffs. Boulders are visible lining the upstream end (to 4 m depth) of the flooded South Fork Rose Creek channel (polygon G). Branches from flooded vegetation (willow) are located throughout the Reservoir, generally denser at the 6 to 12m water depth. In addition, stumps from cut trees (white spruce) are present throughout the Reservoir. Photo documentation of the Reservoir is provided in Photos 4 to 8.

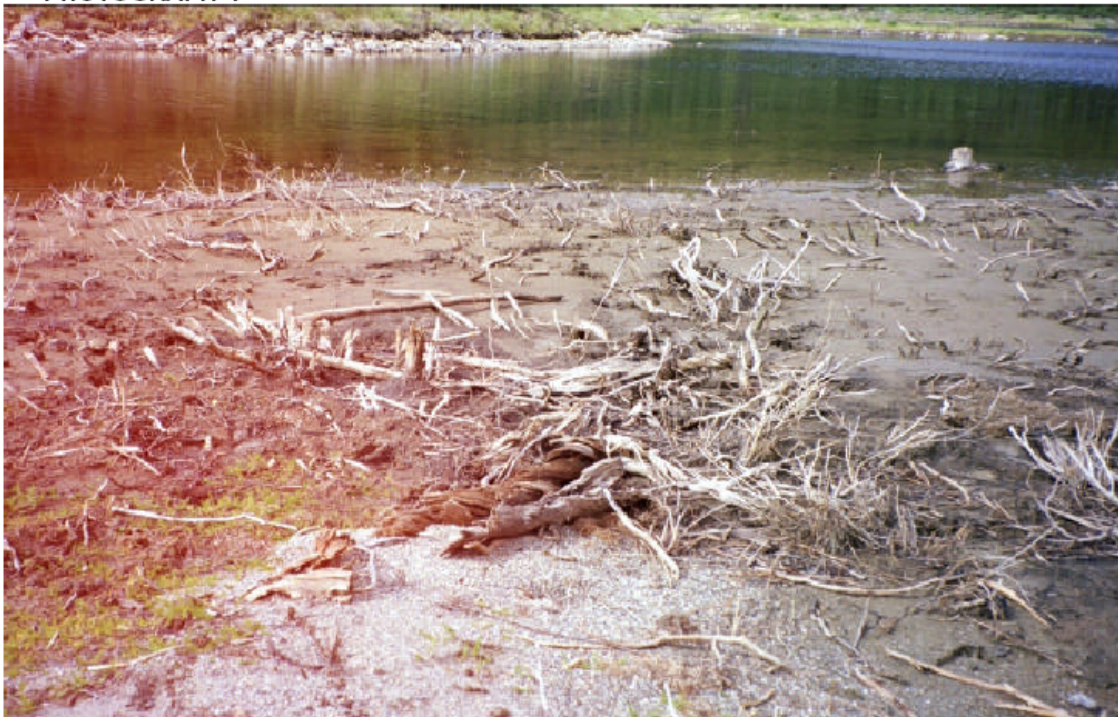
**PHOTOGRAPH 7**

Exposed Substrate at Polygon G (July 26 / 02)

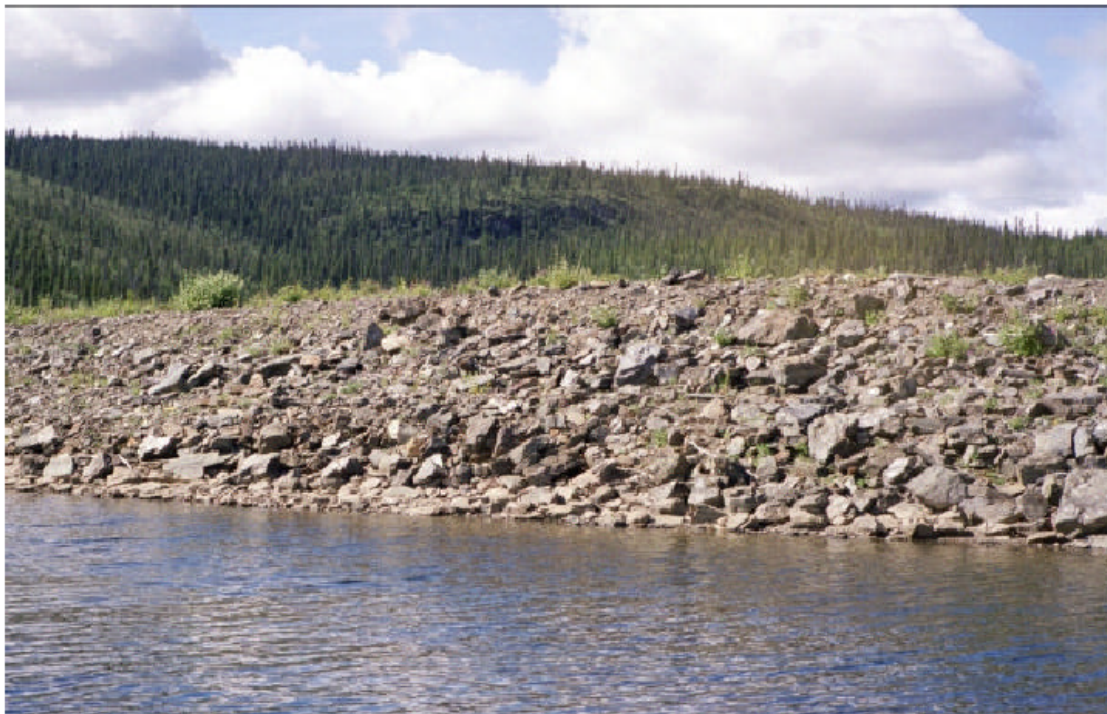
**PHOTOGRAPH 8**

Substrate at Polygon M - dam ((July 26 / 02)
