Faro Mine Closure
Fermeture de la mine Faro

Faro Mine Complex Vangorda Creek Diversion Design Report- Draft

*Project Reference Number
SRK 1CY001.031*

April 2010

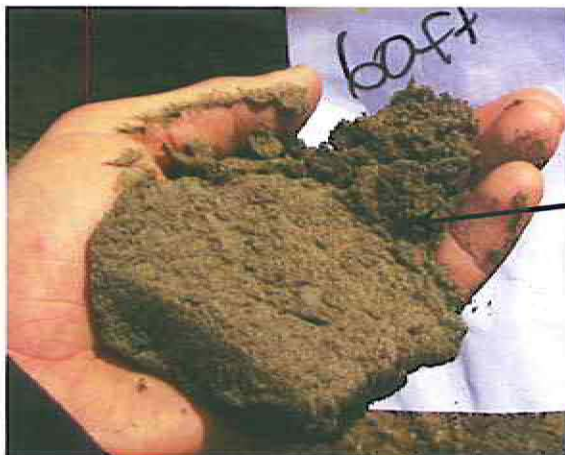
Sand cutting observed
at ~18.29 m depth.

Igneous cutting
observed at ~20 m
depth.

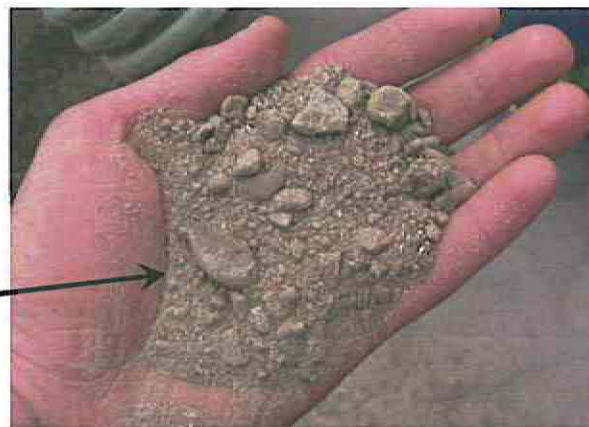
Phyllite cutting
observed at ~21m
depth.

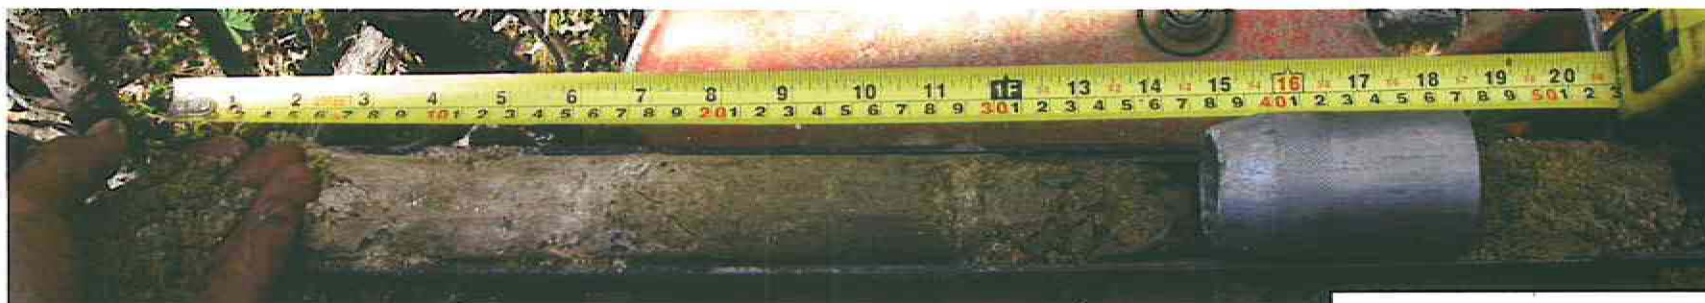
Split Spoon 1

~4.27 m depth

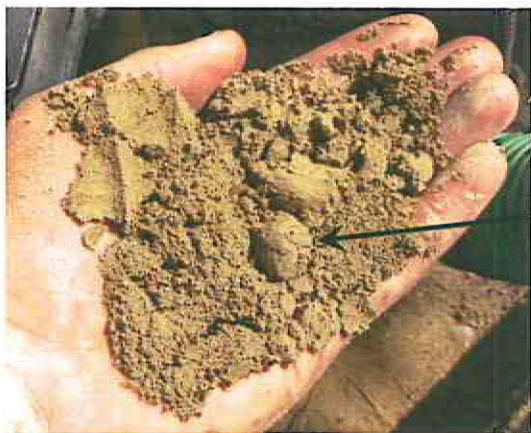
Light brown silty sand,
cutting observed at
~10.4m depth

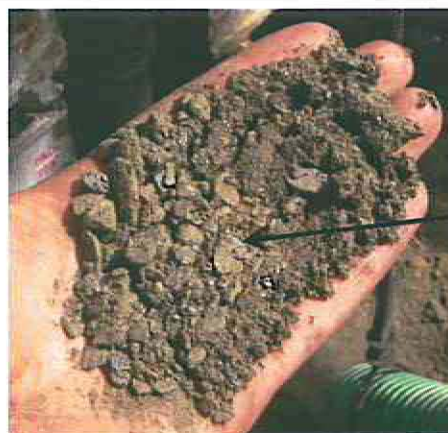
Weathered phyllite (a
silty dark grey with
rock fragments)
encountered at
~13.41m depth

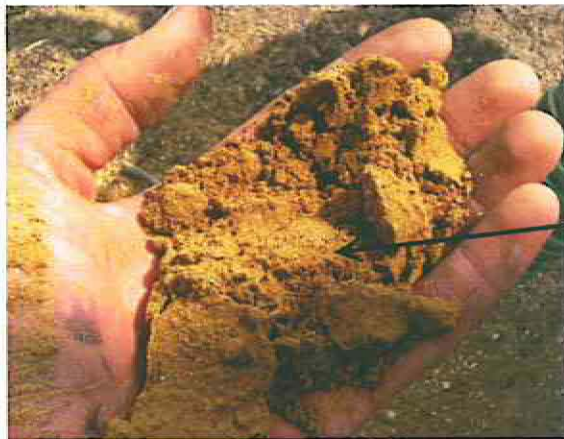
Sandy silty till cutting
observed at ~3.96 m
depth.

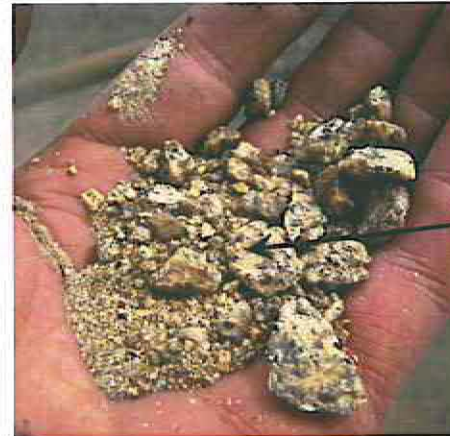
Igneous (granodiorite
like) boulder encountered
at ~4.27m depth.

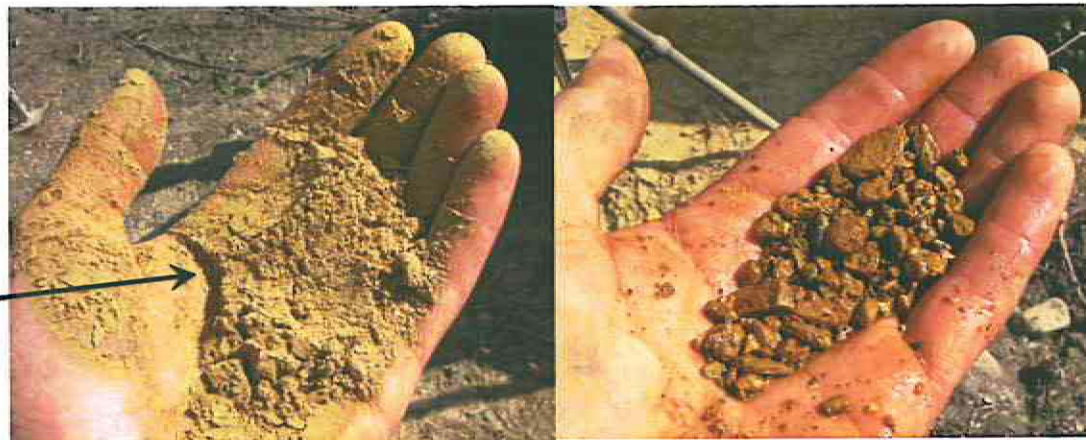
Sandy silty rocky
(cobble and boulder
rich) till cutting
observed at ~6.40 m
depth.

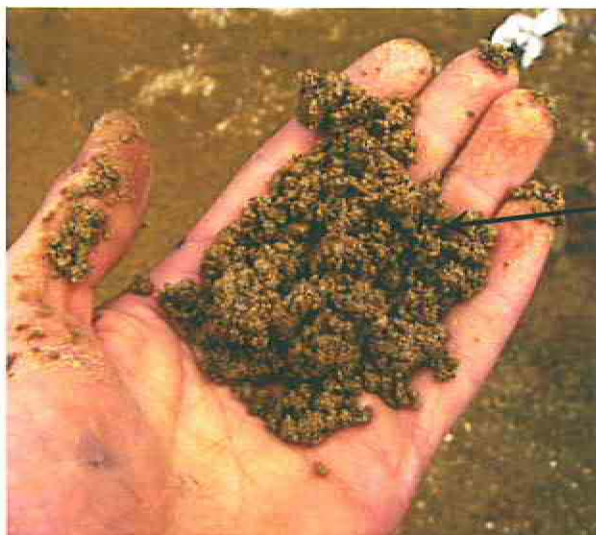
Wet till, cuttings comprised of sand and gravel with some silt at ~12.19 m depth.

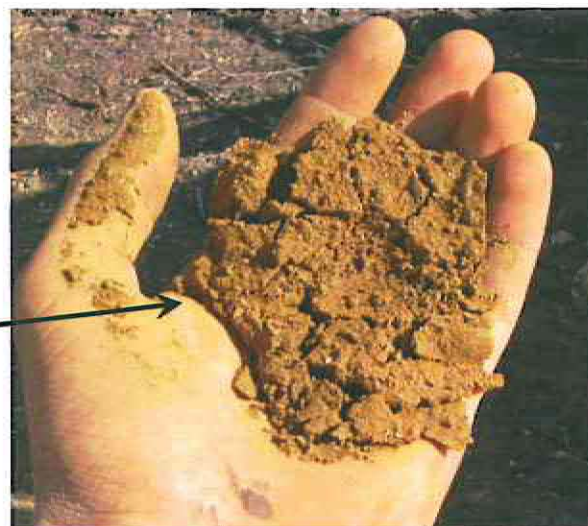
Sandy silty till with gravel, cutting observed at ~16.76 m depth

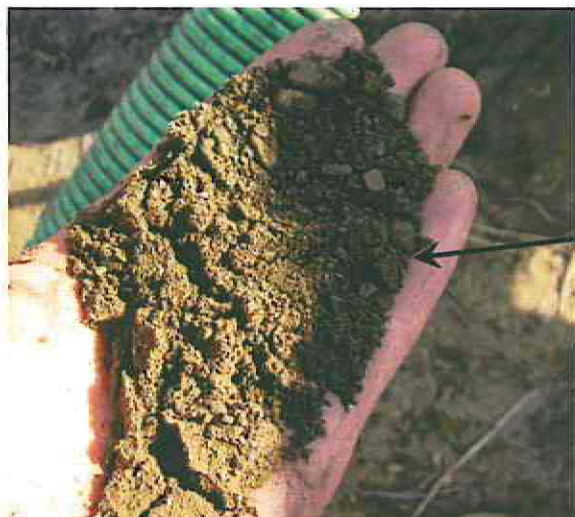
Weathered phyllite (a silty dark grey with rock fragments) encountered at ~17.37m depth.

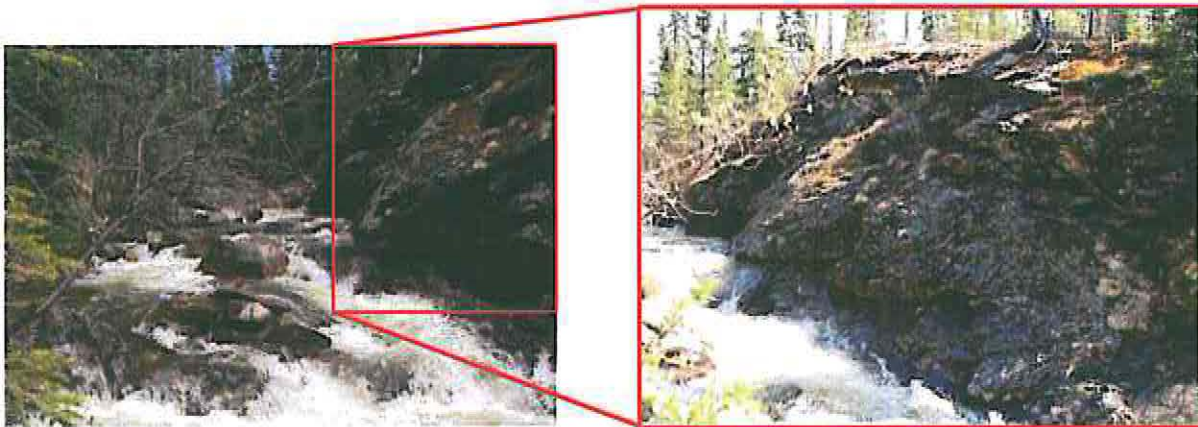
Photo 1 & 2: NE end of Alignment - at Vangorda Creek edge. Close-up view of phyllitic bedrock observed on Diversion opposing (more N) side of Vangorda Creek.

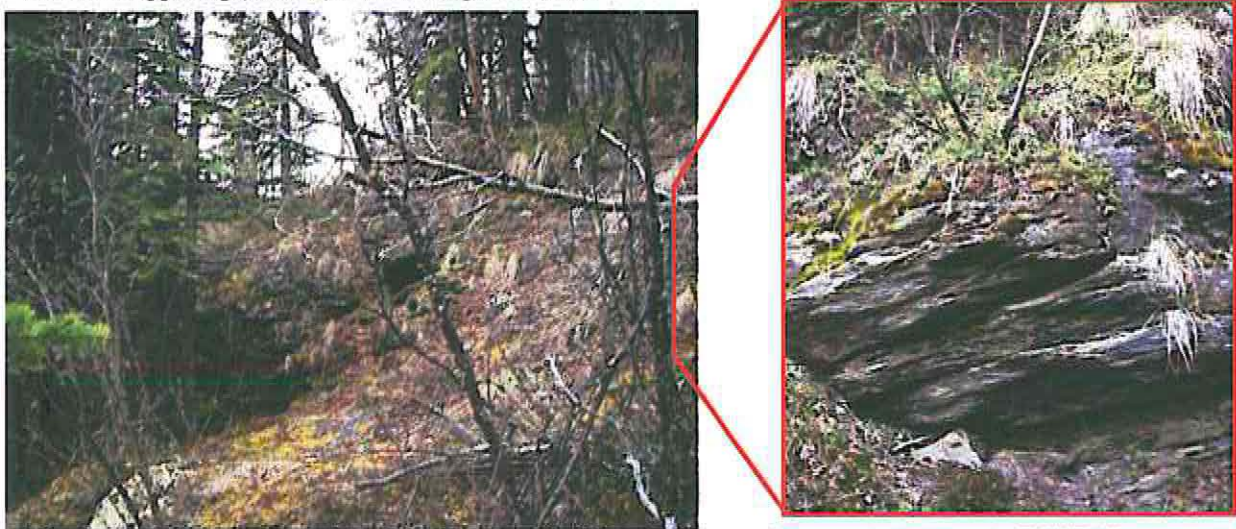
Photo 3 & 4: NE end of diversion alignment - looking ~SW down alignment back towards DHVDO1 (the red outline shows close up of bedrock observed near the W limits of photo 13).

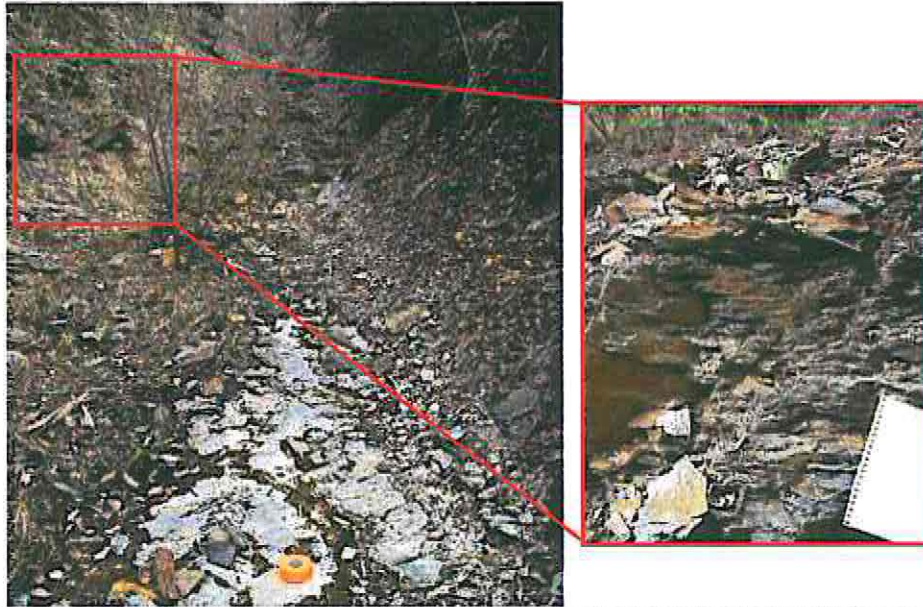
Photo 6 & 7: ESE of DHVC06/ down slope from Test Pit #10 – Phyllitic bedrock noted in existing drainage ditch; note that the slope shown is at ~25° to the horizontal.

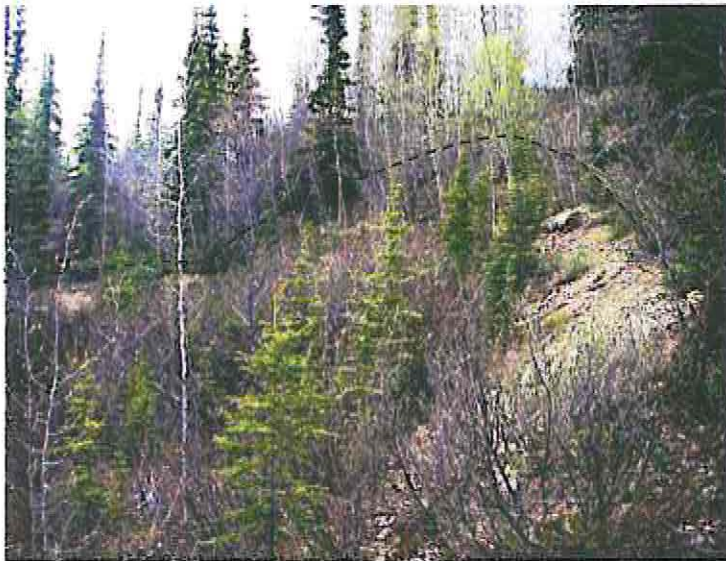
Photo 8: In Between TP#1 and TP#2- Evidence of Minor mass movement. Note head scarp, ~25m SW of DHVD01.

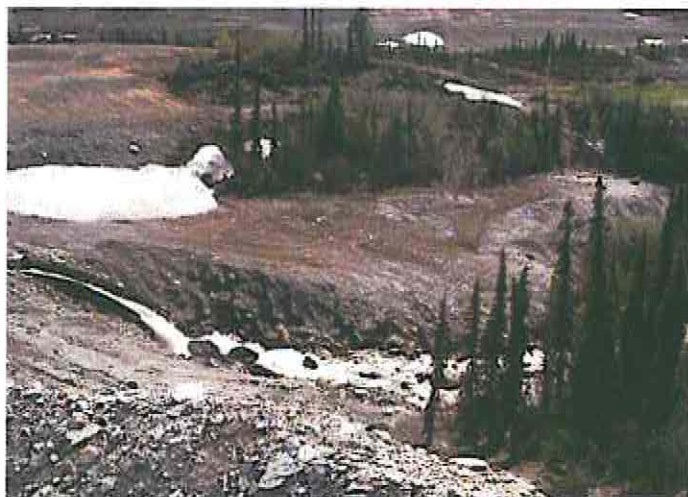
Photo 12: SE view, over bank adjacent to main haul access road. Note the flow through the existing culvert re-entering the original flow path of Vangorda Creek .

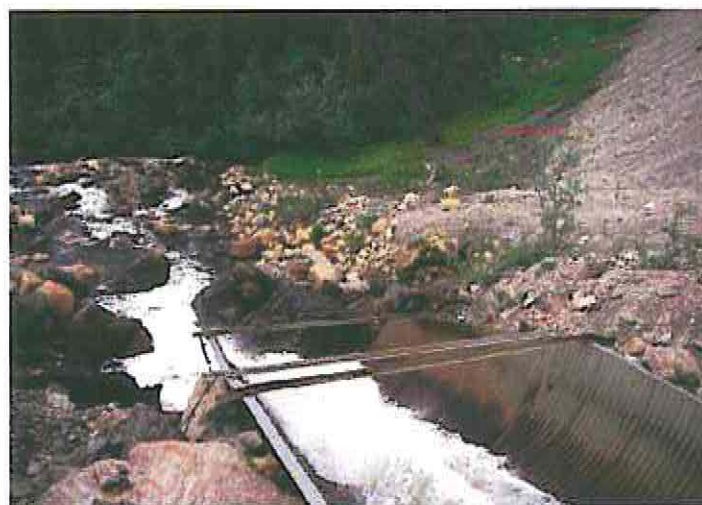
Photo 14: SSW view, of culvert flow entering Vangorda Creek, as well as the toe of bank adjacent to main haul access road.

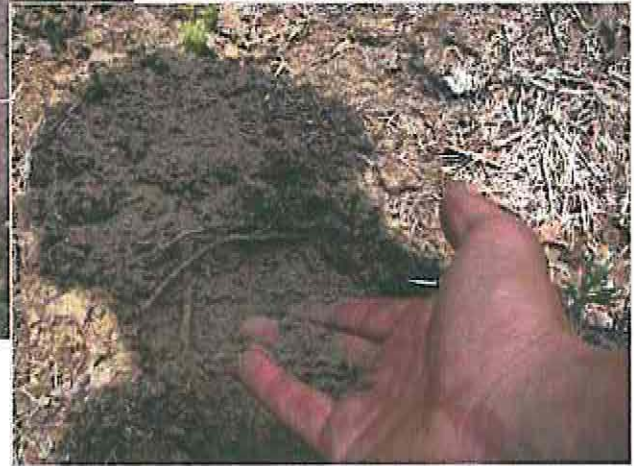
Photo 16: Close up of silty glacial till overburden observed under a thin layer of organic rich topsoil. W of Vangorda Creek and S of the toe of the main haul road.

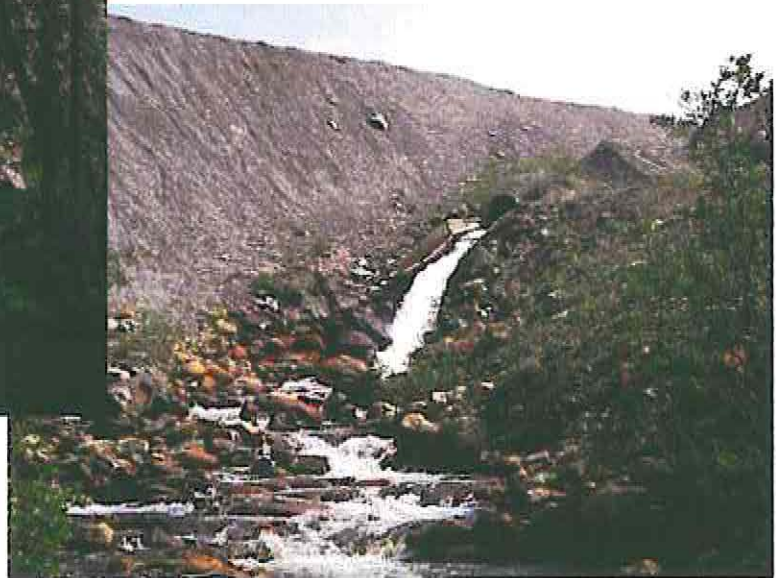
Photo 18: NNE view, of culvert flow entering Vangorda Creek, as well as the toe of bank adjacent to main haul access road.
