**Faro Mine Site - Phase I
Environmental Site Assessment
FINAL REPORT**

Prepared For:
DIAND – Waste Management Program

Prepared By:
**Gartner Lee Limited
Mehling Environmental Management Inc.
BGC Engineering Inc.
Sheila C. Greer**

GLL 99-913

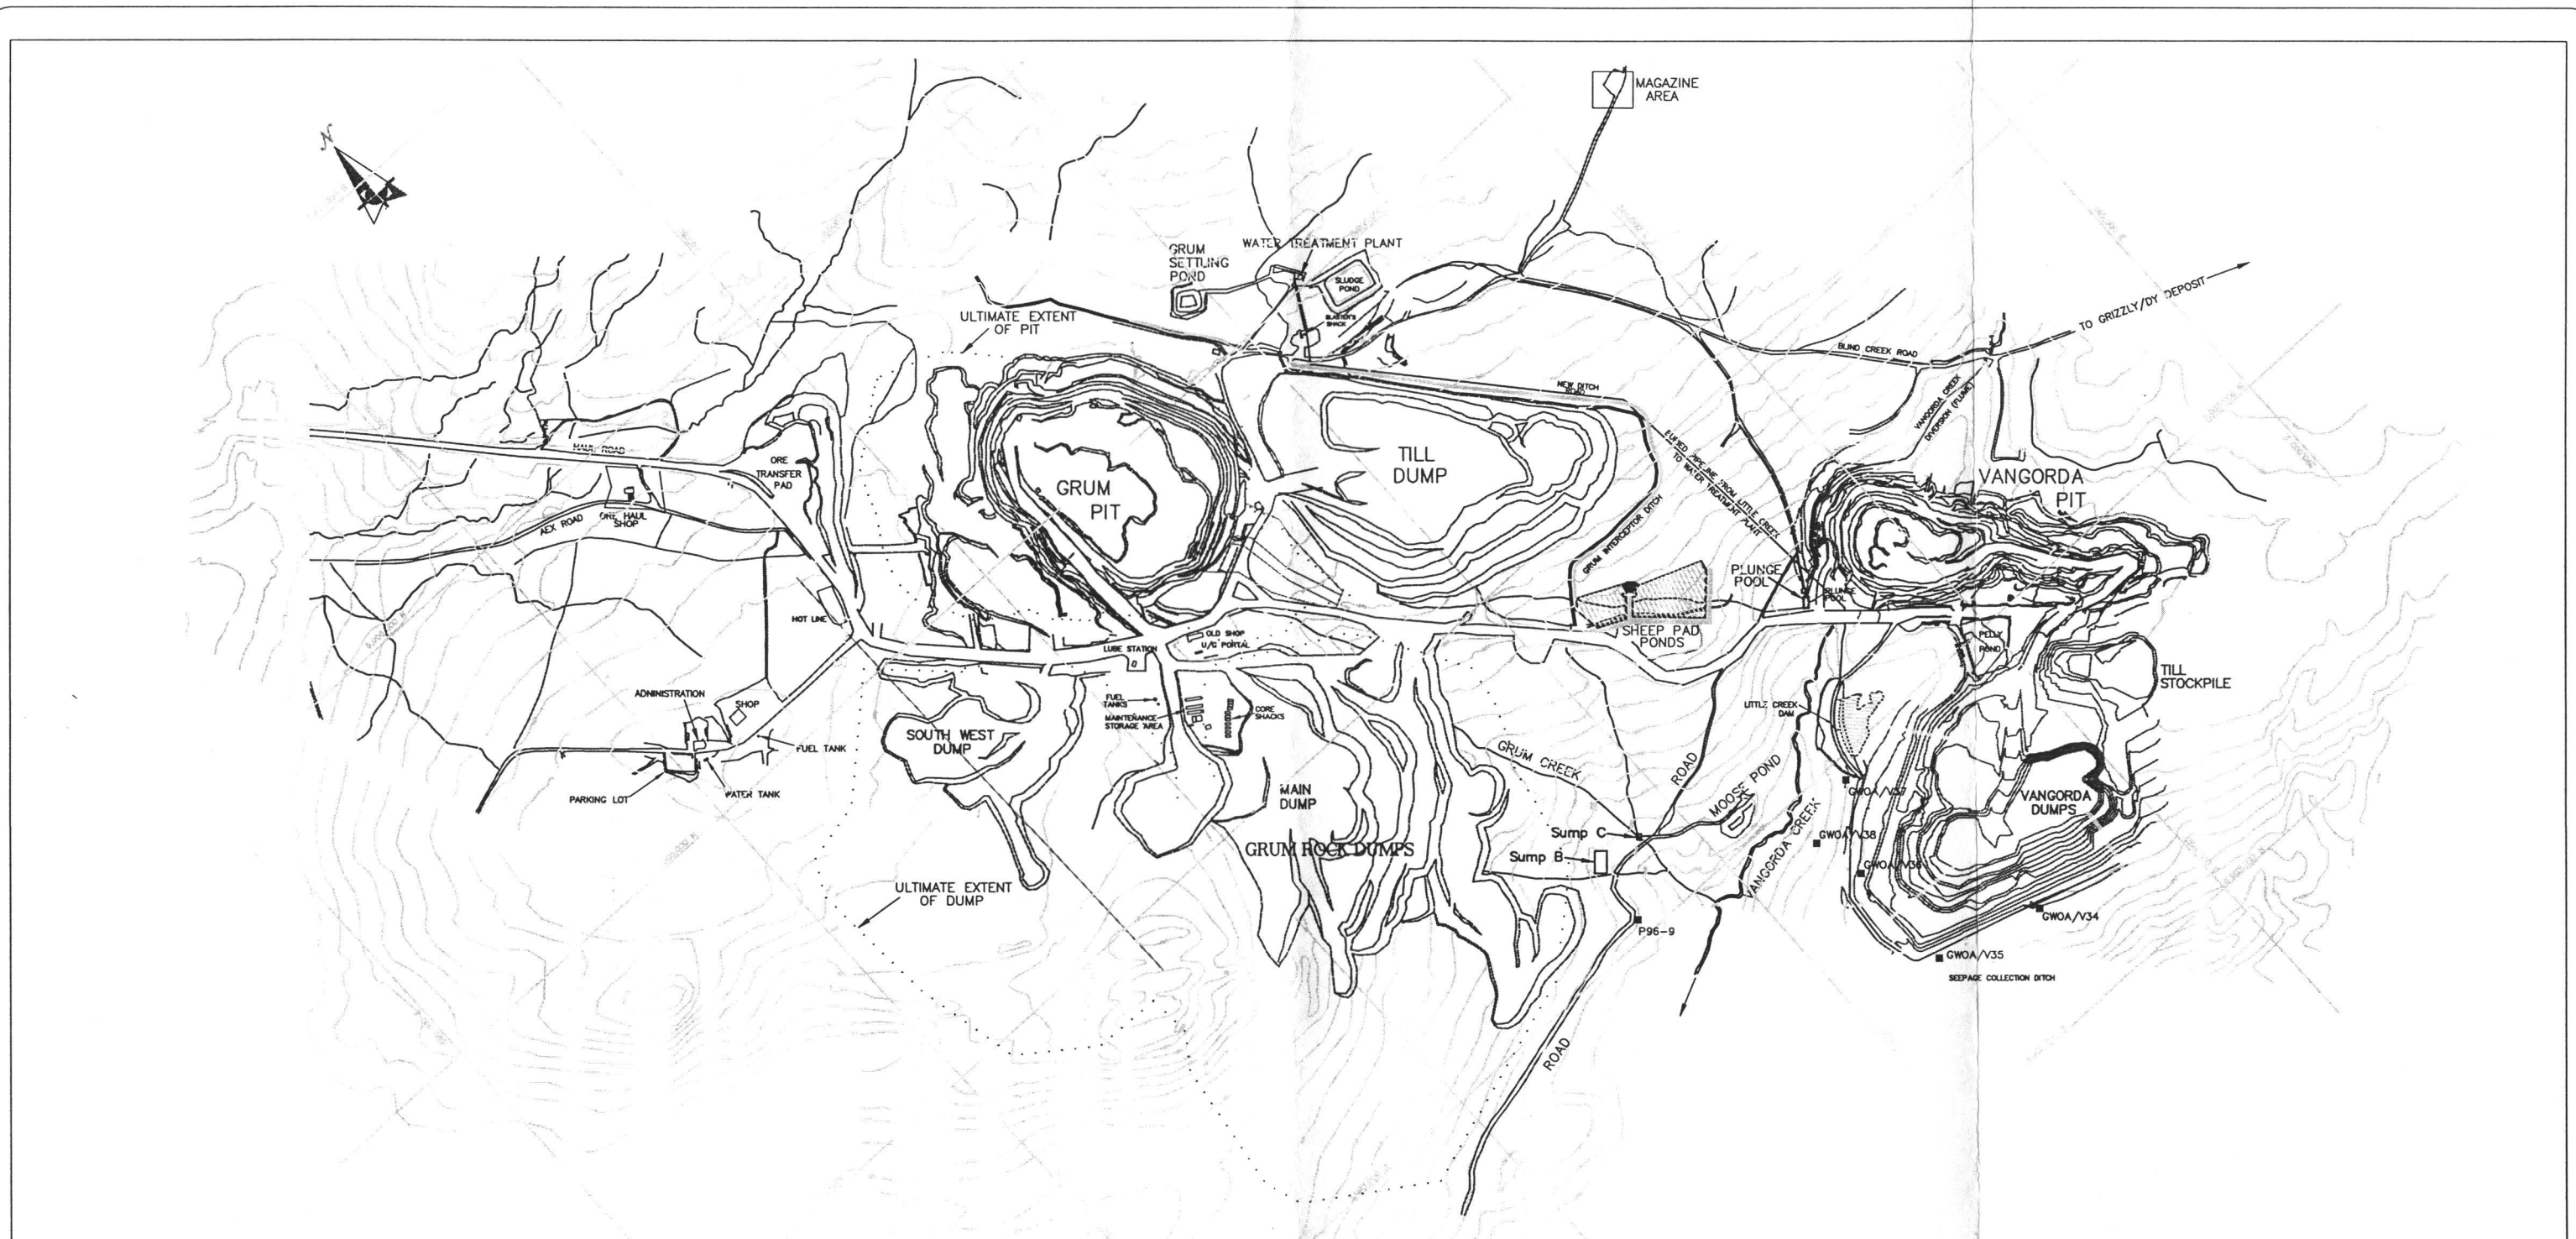
The results of the chemical analysis of groundwater sampled by the Receiver from monitoring wells at Vangorda Plateau during June and October 1999 are shown in Table 6.2. The locations of these monitoring wells are plotted on Figure 6.2. The pH levels of the water sampled are near neutral. Zinc concentrations exceeding all of the surface water guidelines occur in the Little Creek Dam water and in the Vangorda Pit ramp ditch seepage. However, zinc concentrations were found to be below the detection limit in all of the monitoring wells sampled. Copper concentrations in the monitoring wells exceeded the CCME Guidelines for the Protections of Aquatic Life. Cadmium and aluminum were also found to exceed at least one of the criteria in more than one of the wells. Since this groundwater would be greatly diluted when discharging to a surface water body, it is unlikely that this groundwater would impact aquatic life.

■ Groundwater monitoring well site

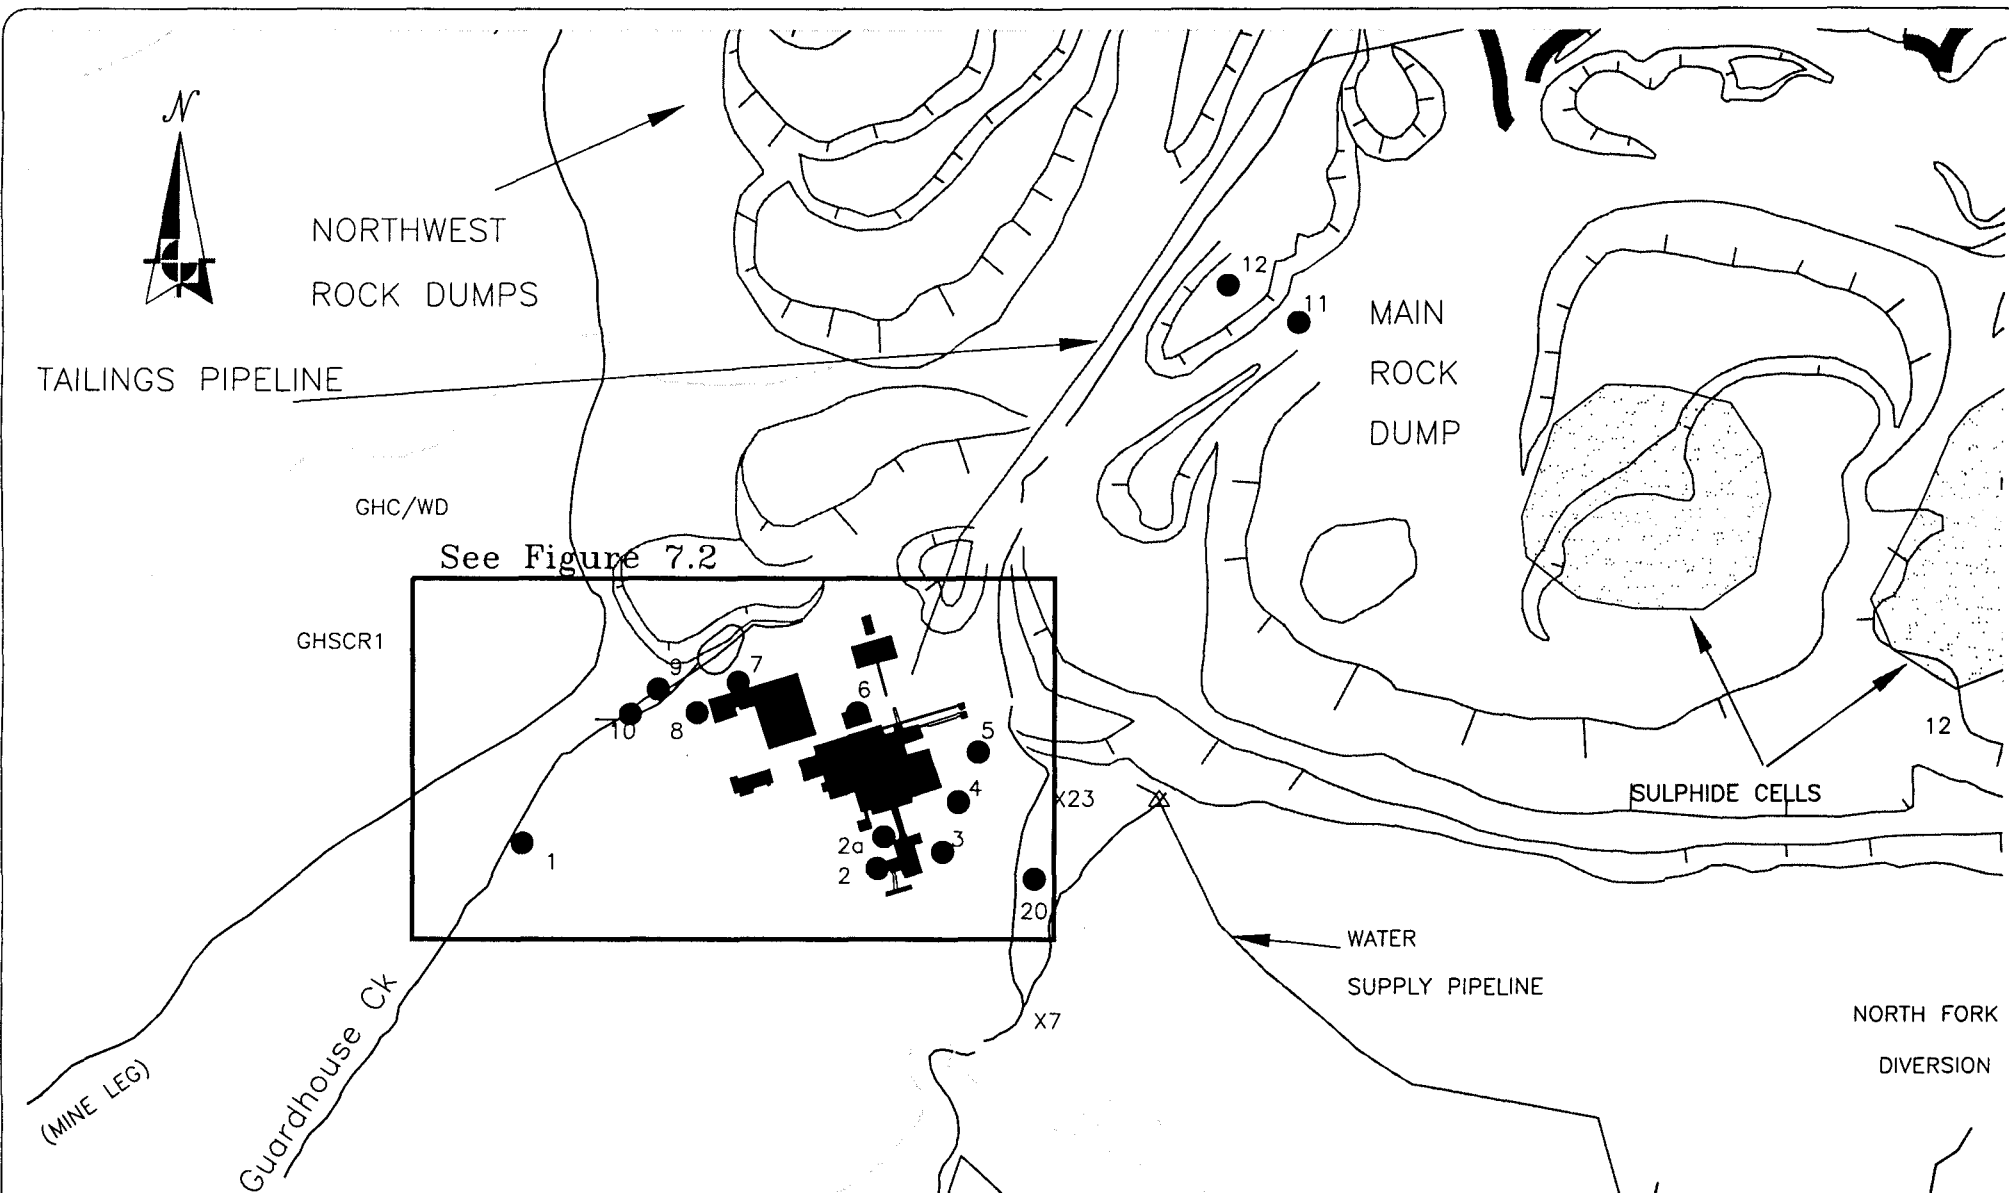
Figure No.
7.1

- Soil sample sites

The results of chemical analysis of soil samples are summarized in Tables 7.1 through 7.3. The applicable regulatory standards are included with the analytical data in each table. The sampling locations are shown in Figure 7.1 through 7.3. The laboratory reports and quality assurance/quality control data are provided in Appendix B.

- Emergency Tailings Disposal Area located just below the Concentrate Loadout (Figure 7.1)
- Old Tailings Spill Area downstream of the Rose Creek Tailings Facility.
