FARO PIT PLUG DAM

**CONCEPTUAL DESIGN
REPORT NO. 2**

PROJECT NO.: 0257-027-02
DATE: NOVEMBER 2004

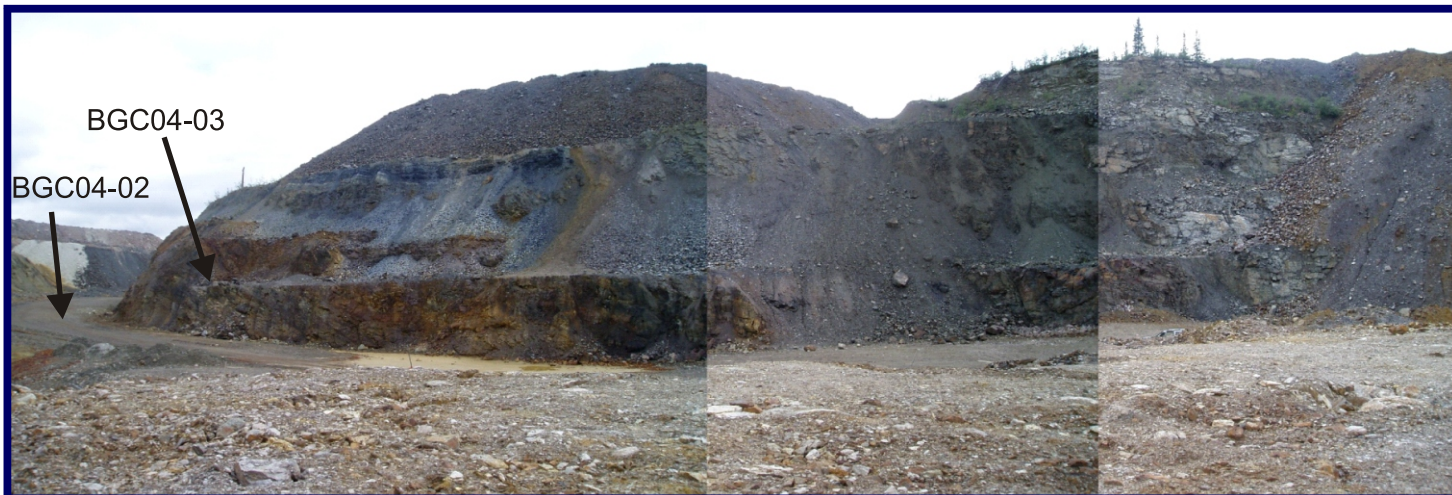
Photo 2a overview of the right abutment and “pillar” area between Faro Main Pit and Zone II Pit.

The right abutment is a critical element of the design due to the proximity of the Zone II Pit. The pillar of rock between the Faro Pit and the Zone II Pit is traversed by several fault zones, which were mapped in the open pit. The rock mass is expected to be of poor quality due to the presence of these faults and the fact that the pit walls on both sides of the pillar are affected by blast damage.

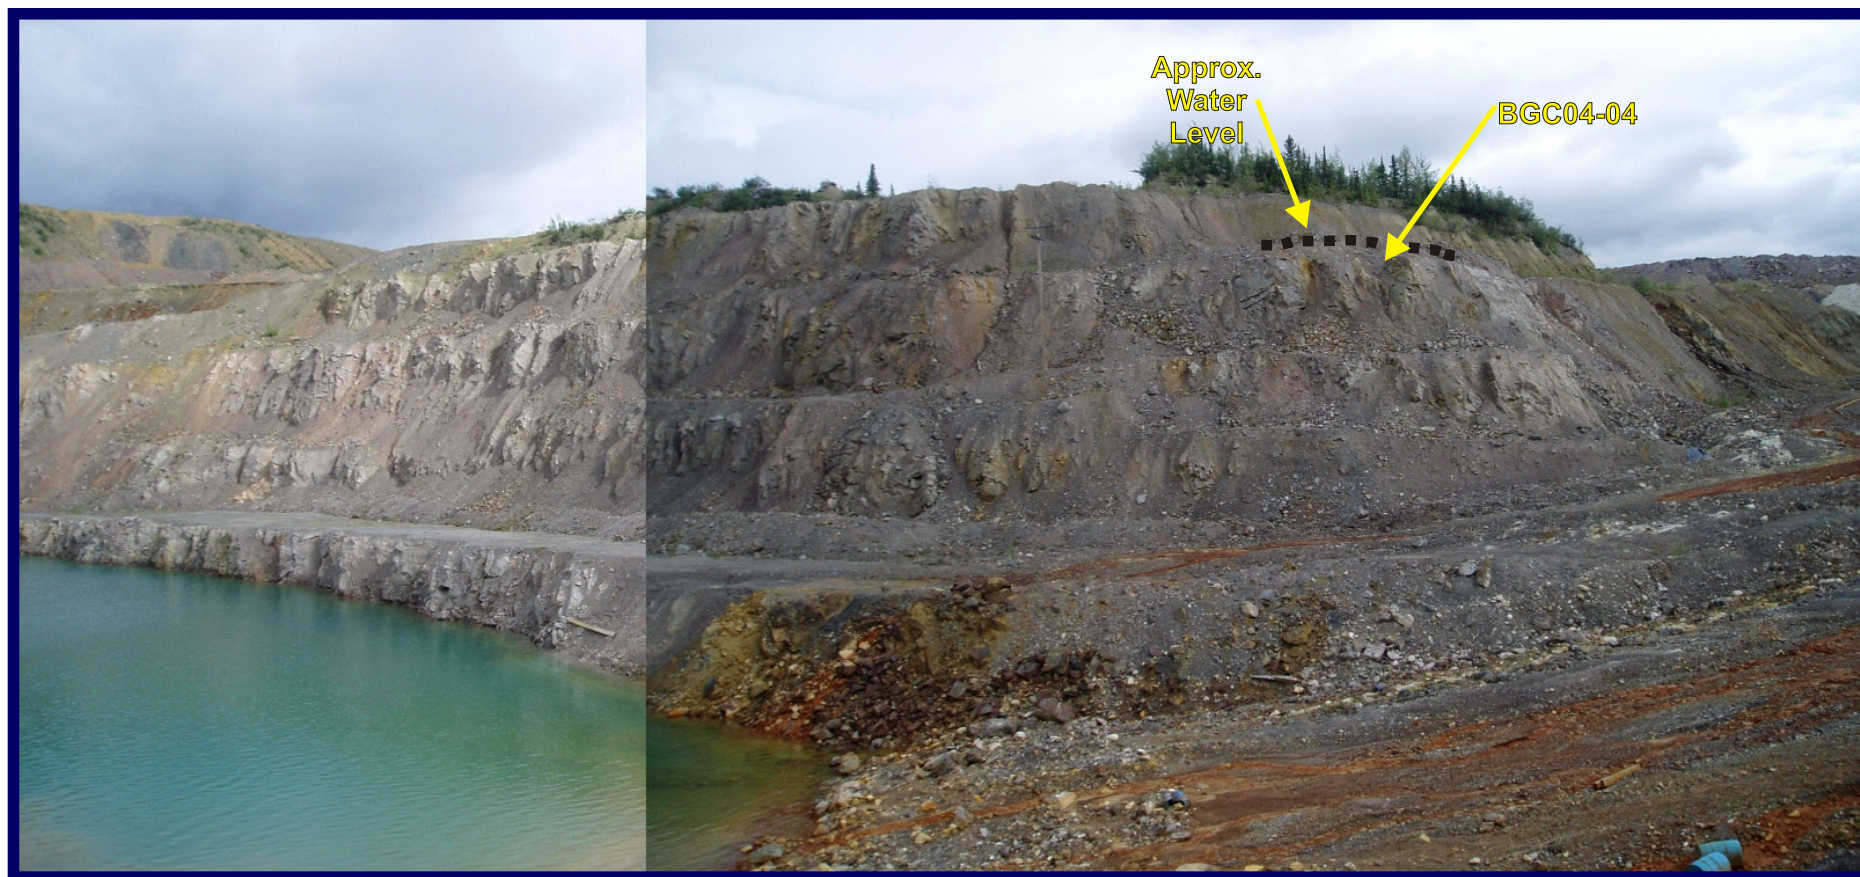
Photo 3 overview of left abutment.

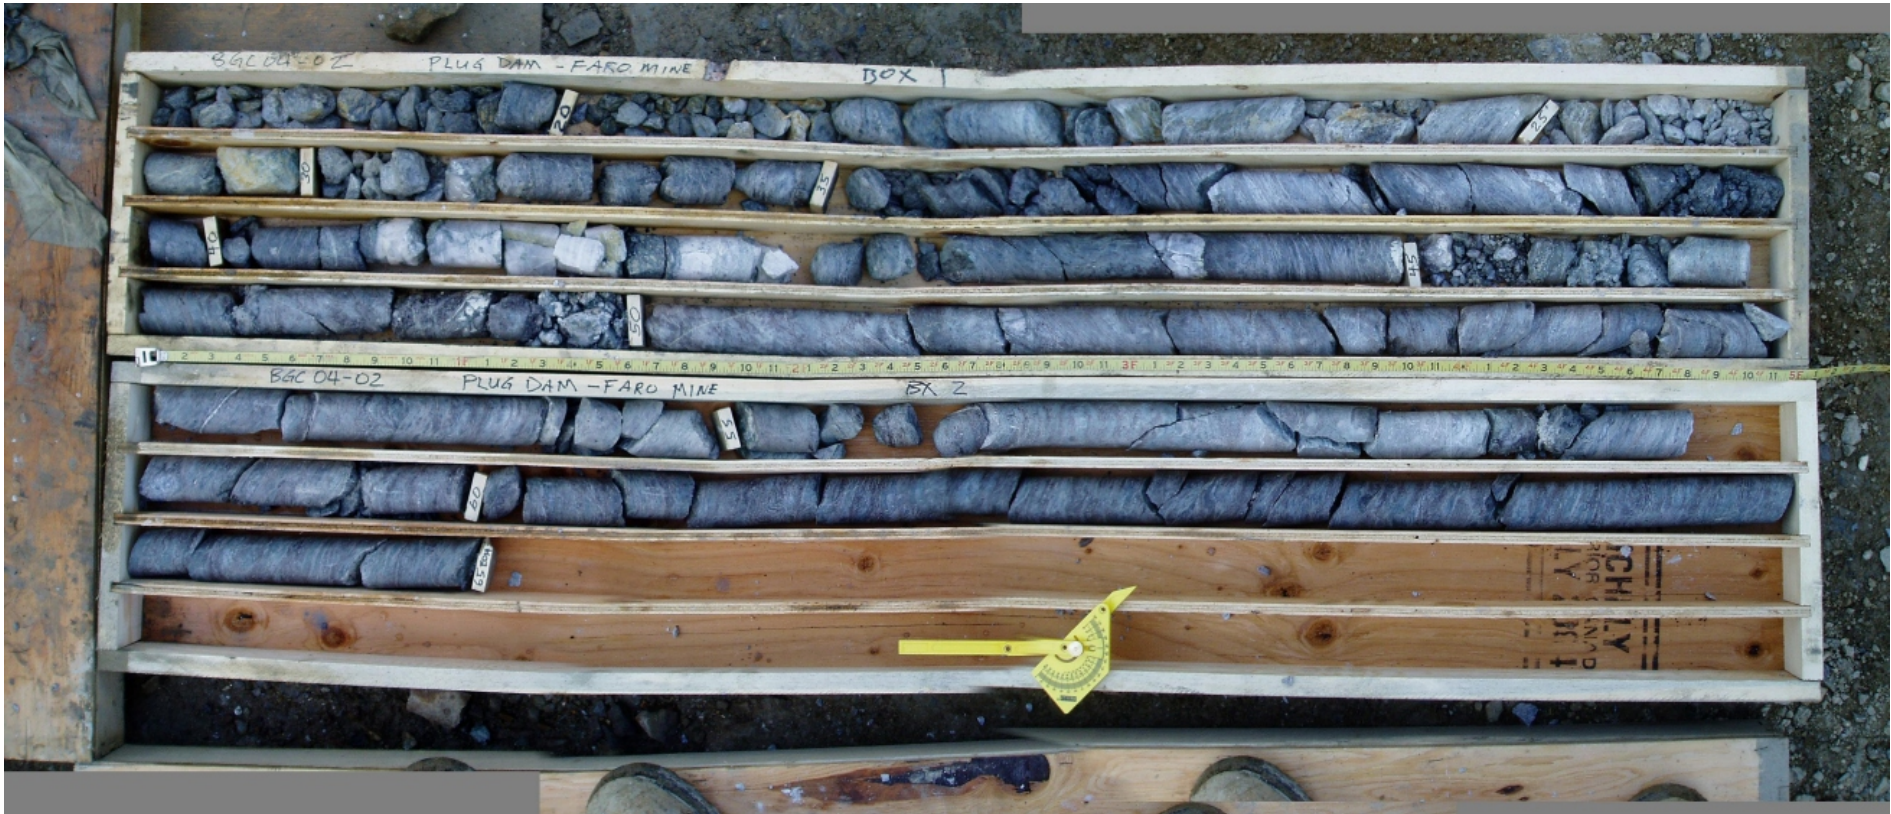
Photo 4 core collected from BGC04-02.

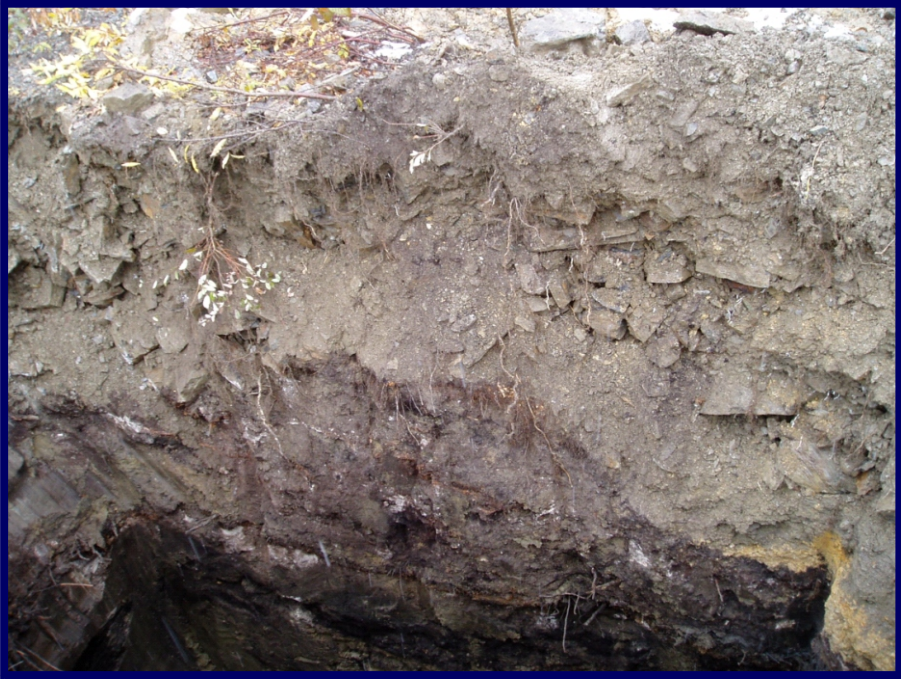
Photo 7a waste rock and upper part of organics.

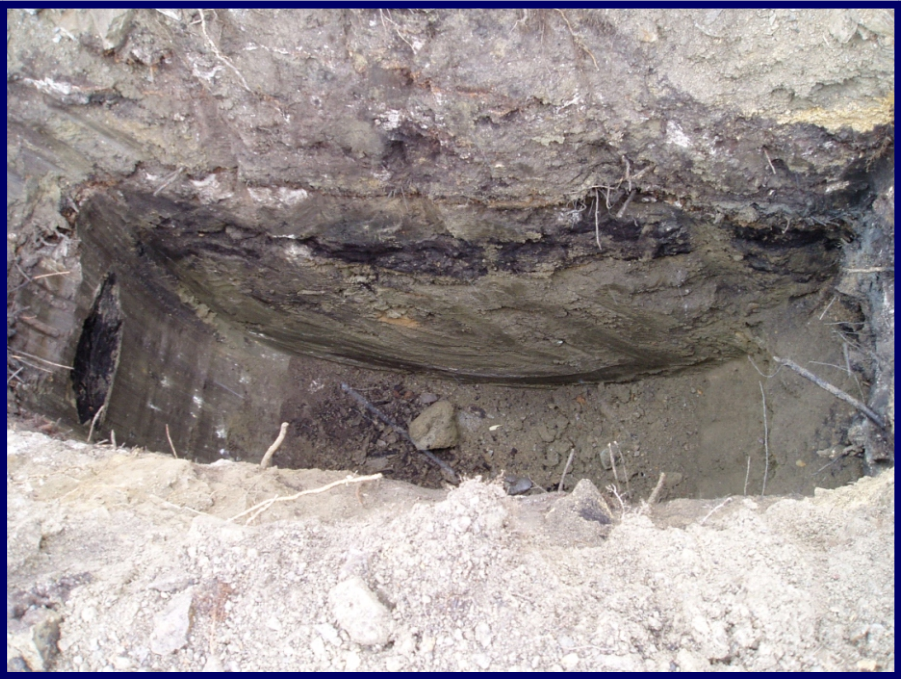
Photo 7b view of wall of test pit, showing waste rock, organics and the lower silty sand.

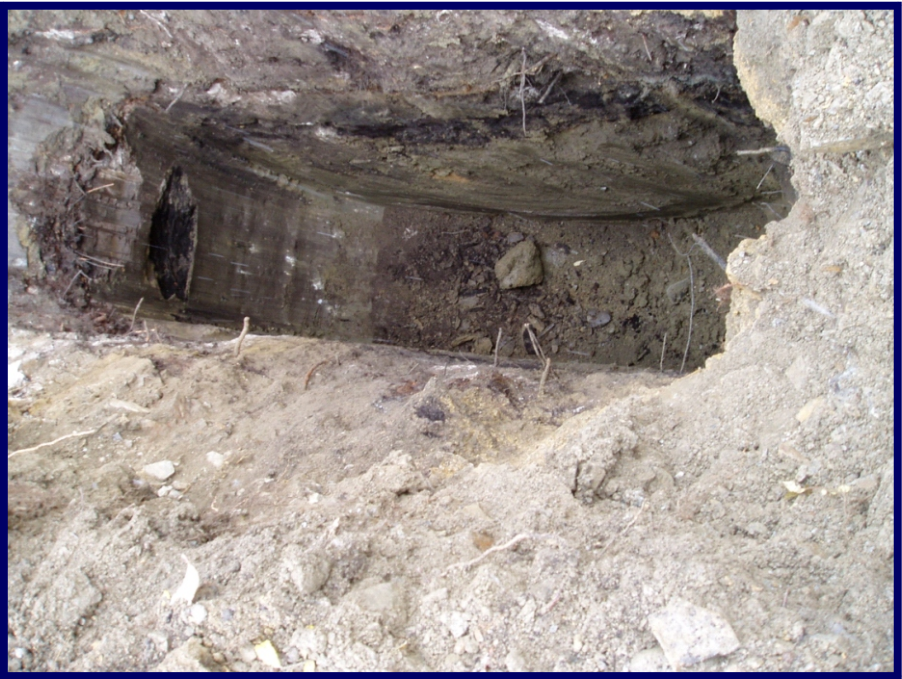
Photo 7c base of test pit.

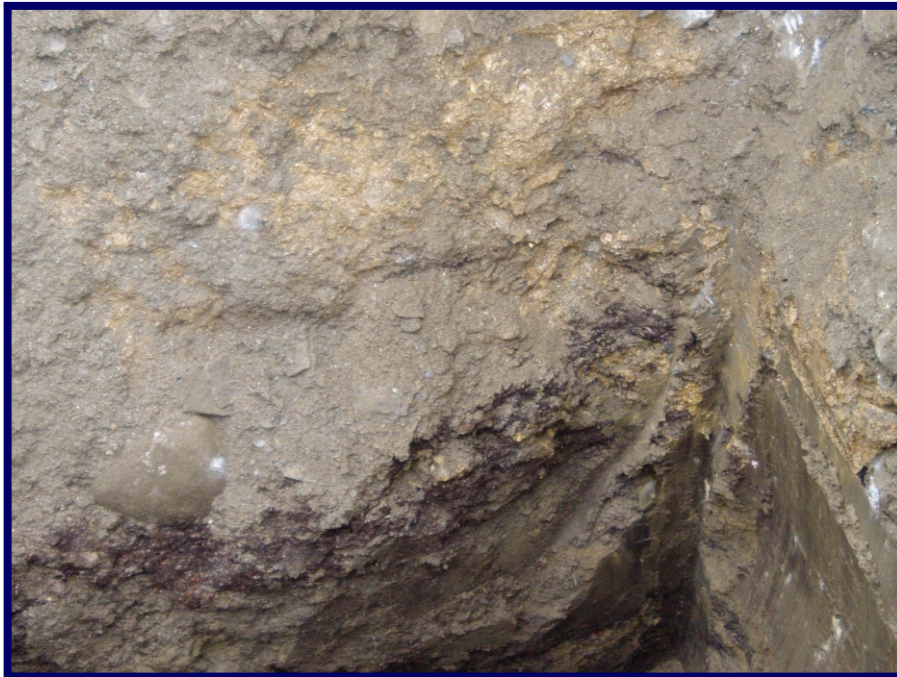
Photo 8a transition from waste rock, organics to silty sand.

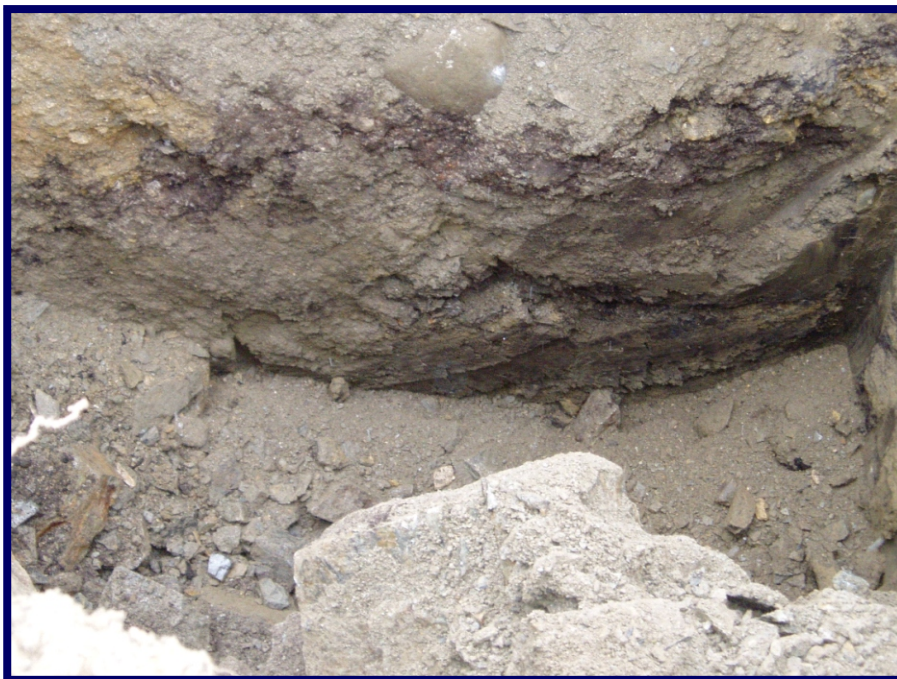
Photo 8b view of base of pit, note sloughing of waste rock.

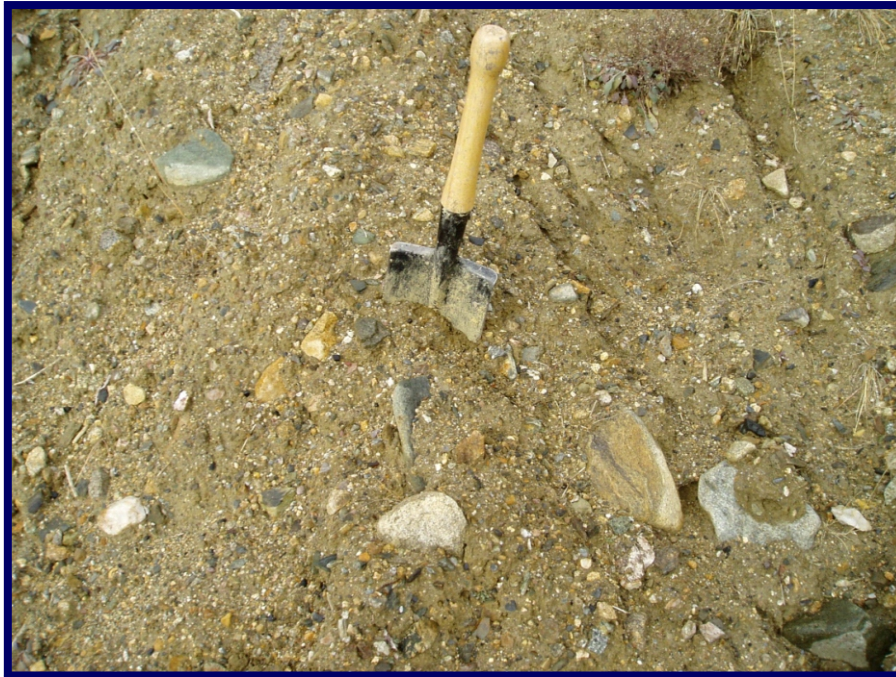
Photo 13, till dump sample location. Soil sample GWF 22 collected from here.

Surface samples GWF22 through GWF27 were collected at the base of "till dumps" as shown in Figure 7. The soil encountered at these locations varied from sandy gravel with some cobbles to gravely sand with some cobbles. Moisture contents of these samples were measured and the results are included in Appendix III. Given the test pit program performed and visual inspection of the crest of the dumps it was concluded, that none to little Zone I core material would be available from these locations. Based on this review, the material exposed in this area may be more suitable, after processing as Zone 2 filter material. It is considered unlikely however, that this area represents a significant resource in terms of volume of material available.

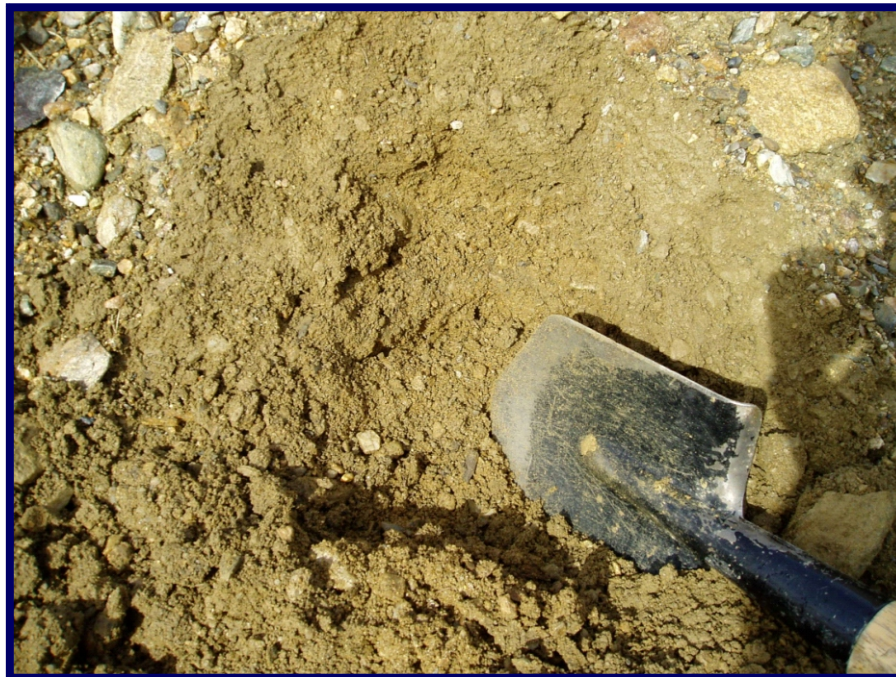
Photo 14b, sample GWP 23 collected.

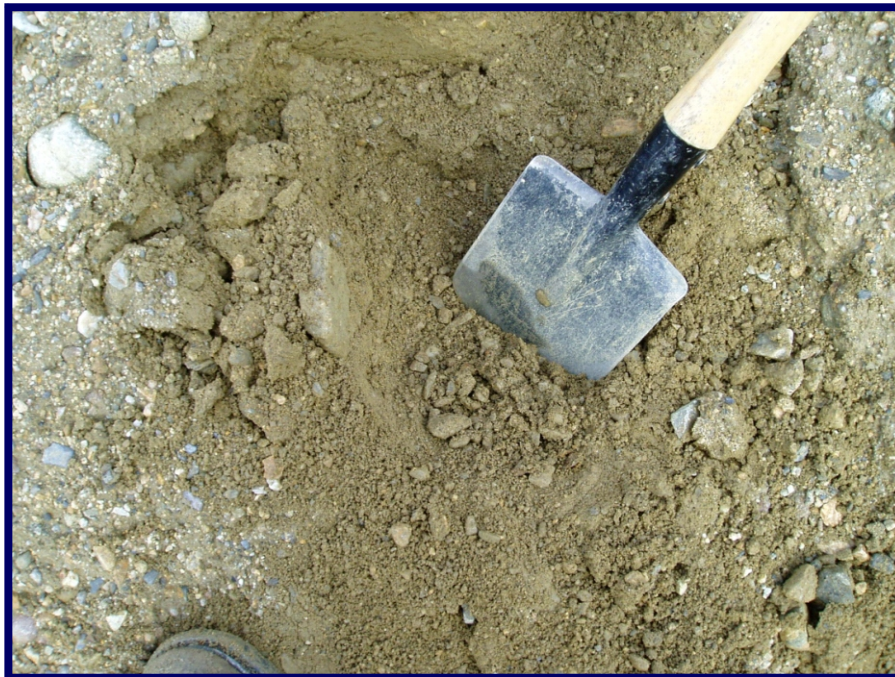
Photo 15b, Soil sample GWF24 collected

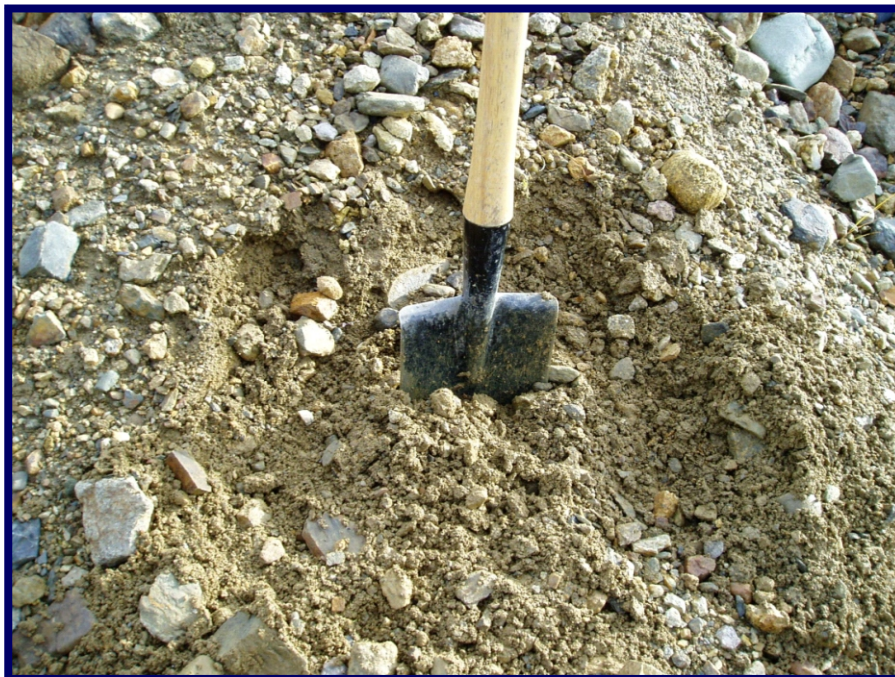
Photo 19b, following collection of sample GWF 28.

Surface samples GWF28 and GWF29 were collected from a sand and gravel dump located on the crest of the Northeast waste dump, as shown in Figure 8. The soil encountered at these two surface sampling locations consisted of sandy gravel with some cobble to gravely sand with some cobble. A summary of the laboratory testing results for these samples are attached in Appendix III. This material potentially could be used, following processing as Zone 2 filter material.

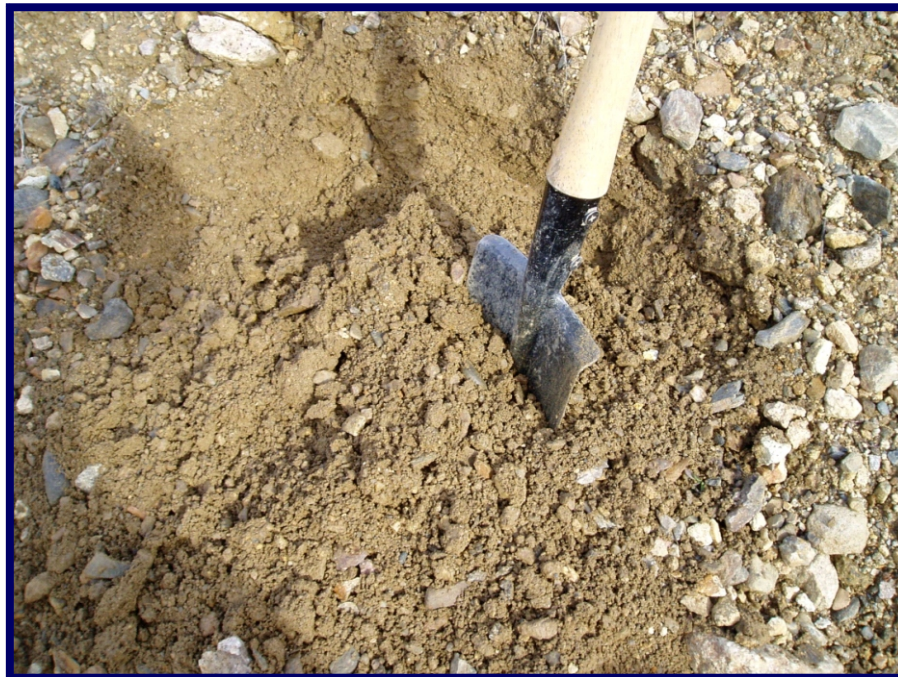
Photo 20b, collection of sample GWF 29.

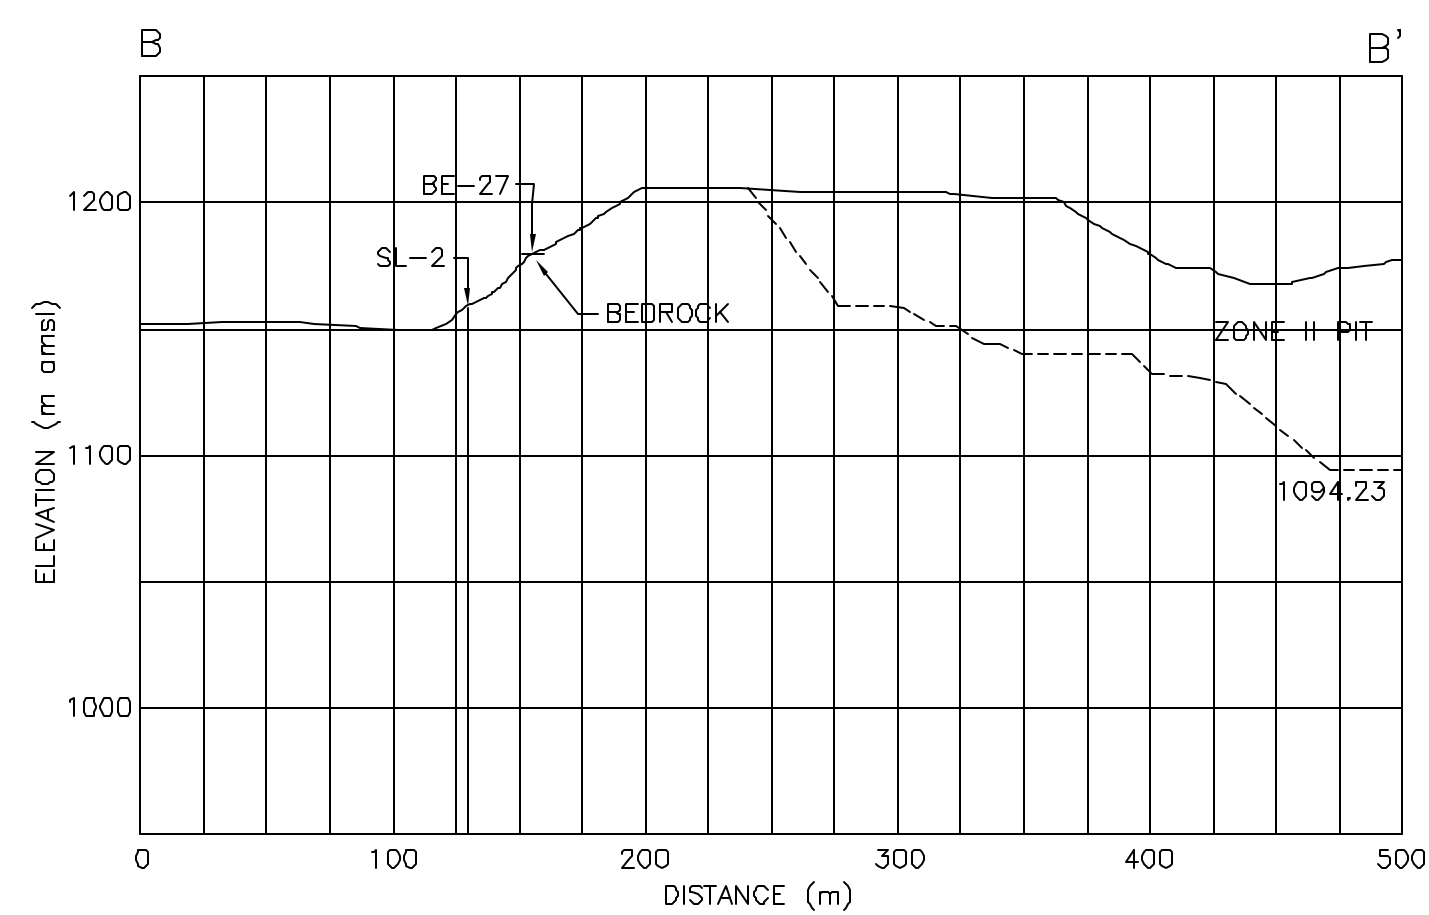
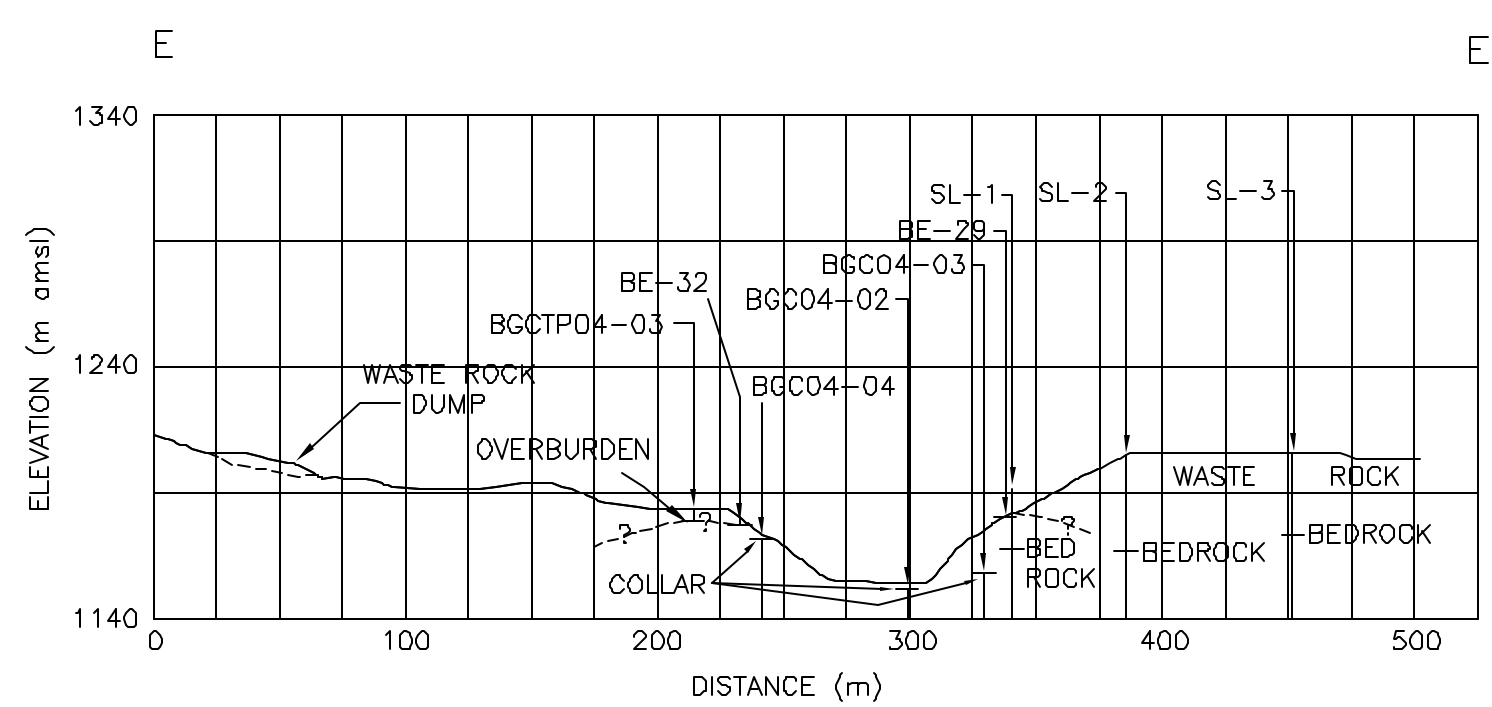
PROJECT: PLUG DAM CONCEPTUAL DESIGN NO. 2
 TITLE: REPRESENTATIVE CROSS SECTIONS
 PROJECT NO.: 0297-027-02 FIGURE NO.: 9 REV.: 0

SOURCES:
 1. ZONE II PIT OUTLINE FROM SRK REPORT 81703
 2. TAILINGS DISPOSAL IN FARO PIT, MAY 1991, FIGURE 4.2.
 3. 2M CONTOUR TOPOGRAPHY BASED ON 1:20,000 SCALE PHOTOGRAPHY DATED JULY 25, 2003. COMPILED BY ORTHOSHOP, CALGARY, SEPTEMBER 2003.
 4. SURVEY CONTROL BASED ON UTM PROJECTION, NAD27.
