MT. NANSEN GOLD PROJECT

TAILINGS DAM PRELIMINARY DESIGN REPORT

PROJECT: MOUNT NANSEN GOLD PROJECT

LOCATION: DAWSON RANGE
YUKON TERRITORY

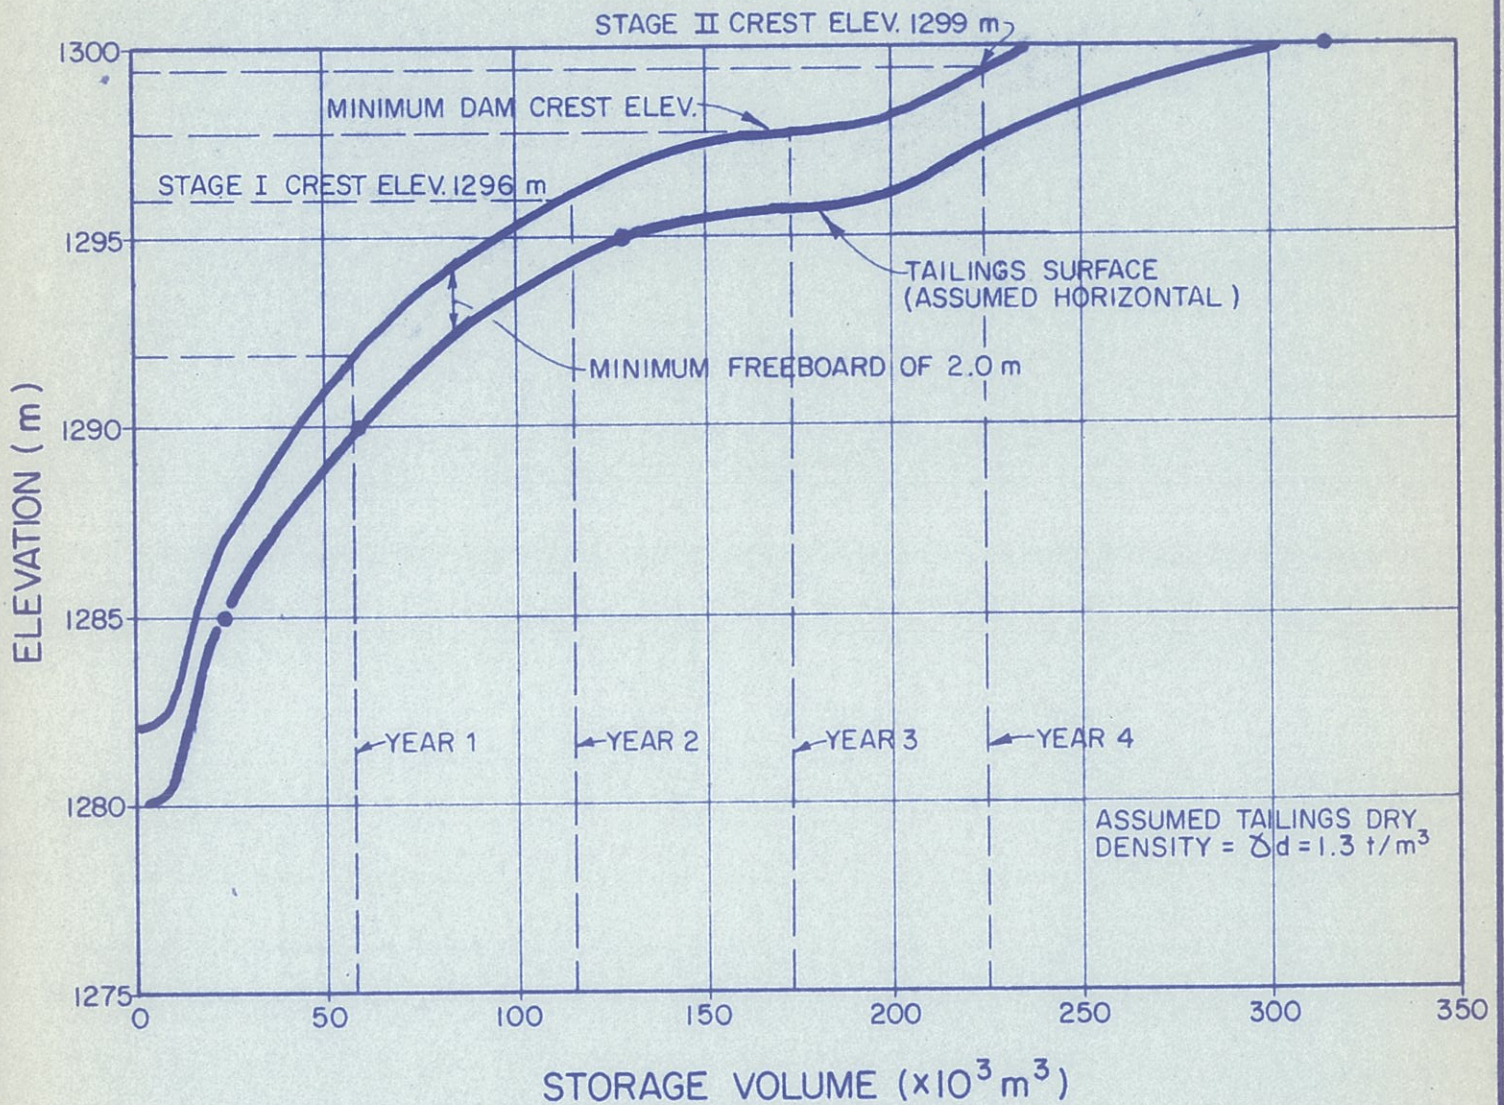
CREST ELEVATIONS SHOWN ASSUME THAT ROCK FILL OBTAINED FOR THE DYKE COMES FROM WITHIN THE POND AREA.
