Re: Mt. Nansen Gold Project  
Tailings Facility  
Preliminary Design Report

TAILINGS FACILITY  
PRELIMINARY DESIGN REPORT

PROJECT: MT. NANSEN GOLD PROJECT  
LOCATION: DAWSON RANGE, YUKON TERRITORY  
CLIENT: B.Y.G NATURAL RESOURCES INC.

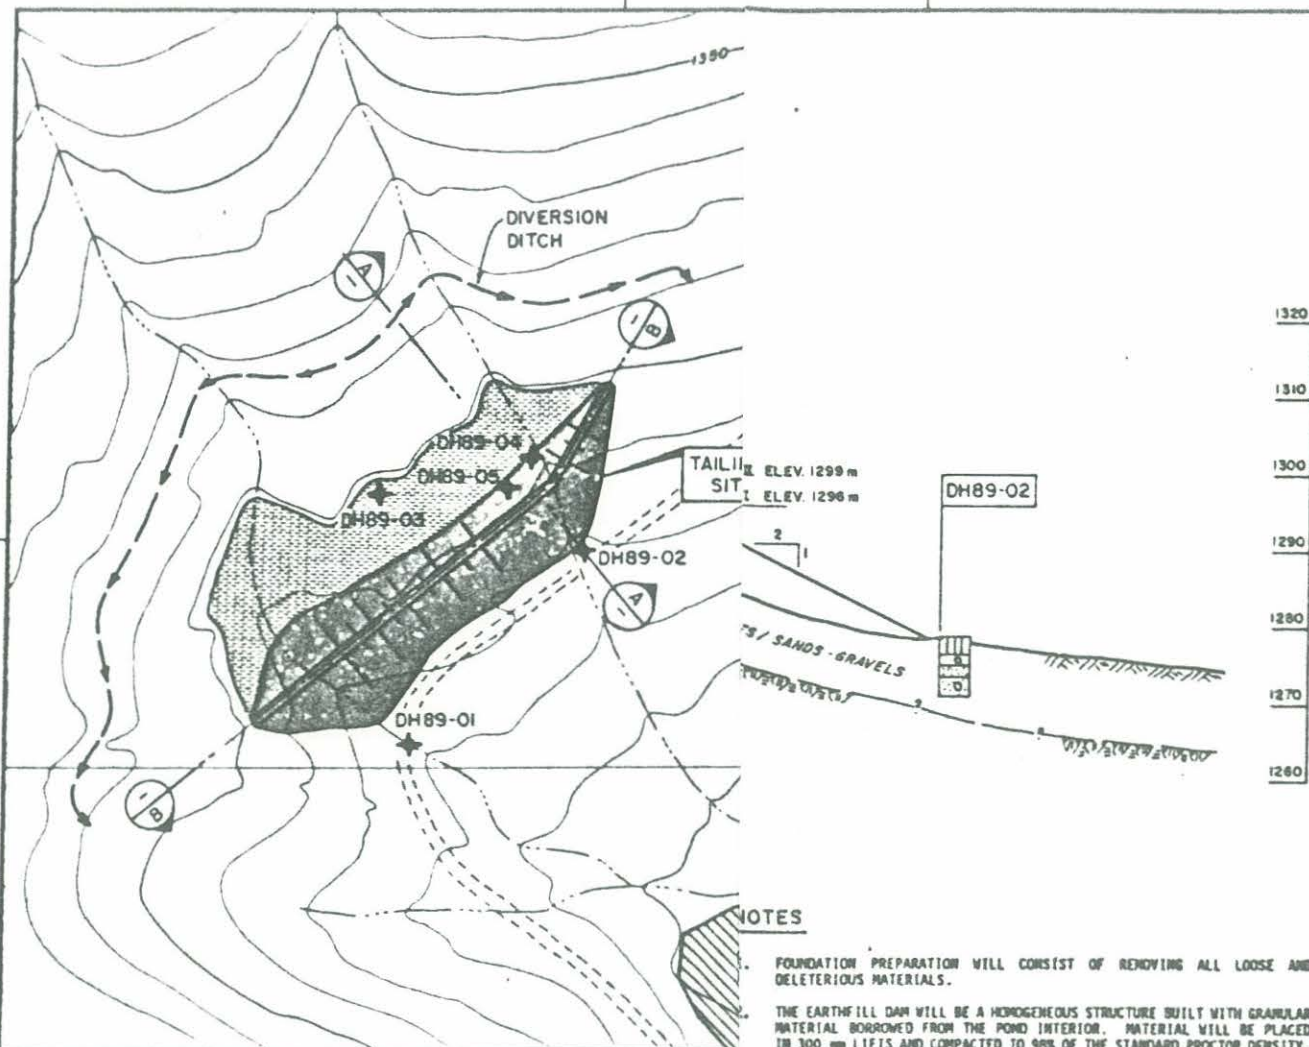
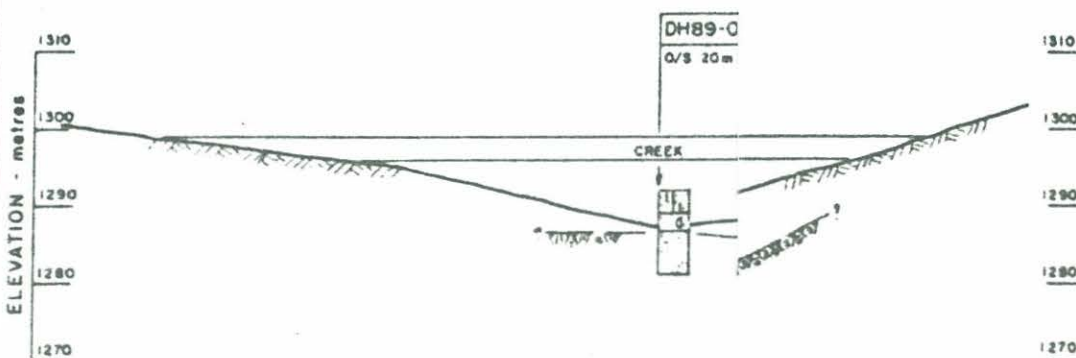
### PLAN

1. FOUNDATION PREPARATION WILL CONSIST OF REMOVING ALL LOOSE AND DELETERIOUS MATERIALS.
2. THE EARTHFILL DAM WILL BE A HOMOGENEOUS STRUCTURE BUILT WITH GRANULAR MATERIAL BORROWED FROM THE POND INTERIOR. MATERIAL WILL BE PLACED IN 300 mm LIFTS AND COMPACTED TO 98% OF THE STANDARD PROCTOR DENSITY.
3. THE POND AND DAM WILL BE LINED TO PREVENT SEEPAGE. THE LINER SYSTEM COULD CONSIST OF ONE OF THE FOLLOWING OPTIONS:
  - CLAYMAX (BENTONITE FABRIC REINFORCED LINER SYSTEM) WITH 300 mm OF PROTECTIVE SAND AND GRAVEL PLACED OVER IT; OR
  - FIELD MIXED 300 mm TO 1200 mm THICK LIFT OF BENTONITE/SAND-GRAVEL. FILTERS MAY BE REQUIRED TO PREVENT PIPING.
4. THE POND WILL BE OPERATED AS A CLOSED SYSTEM. SURFACE WATER WILL BE DIVERTED AROUND THE POND. A PUMP BARGE OR SIPHON SYSTEM WILL BE USED FOR WATER RECLAIM.

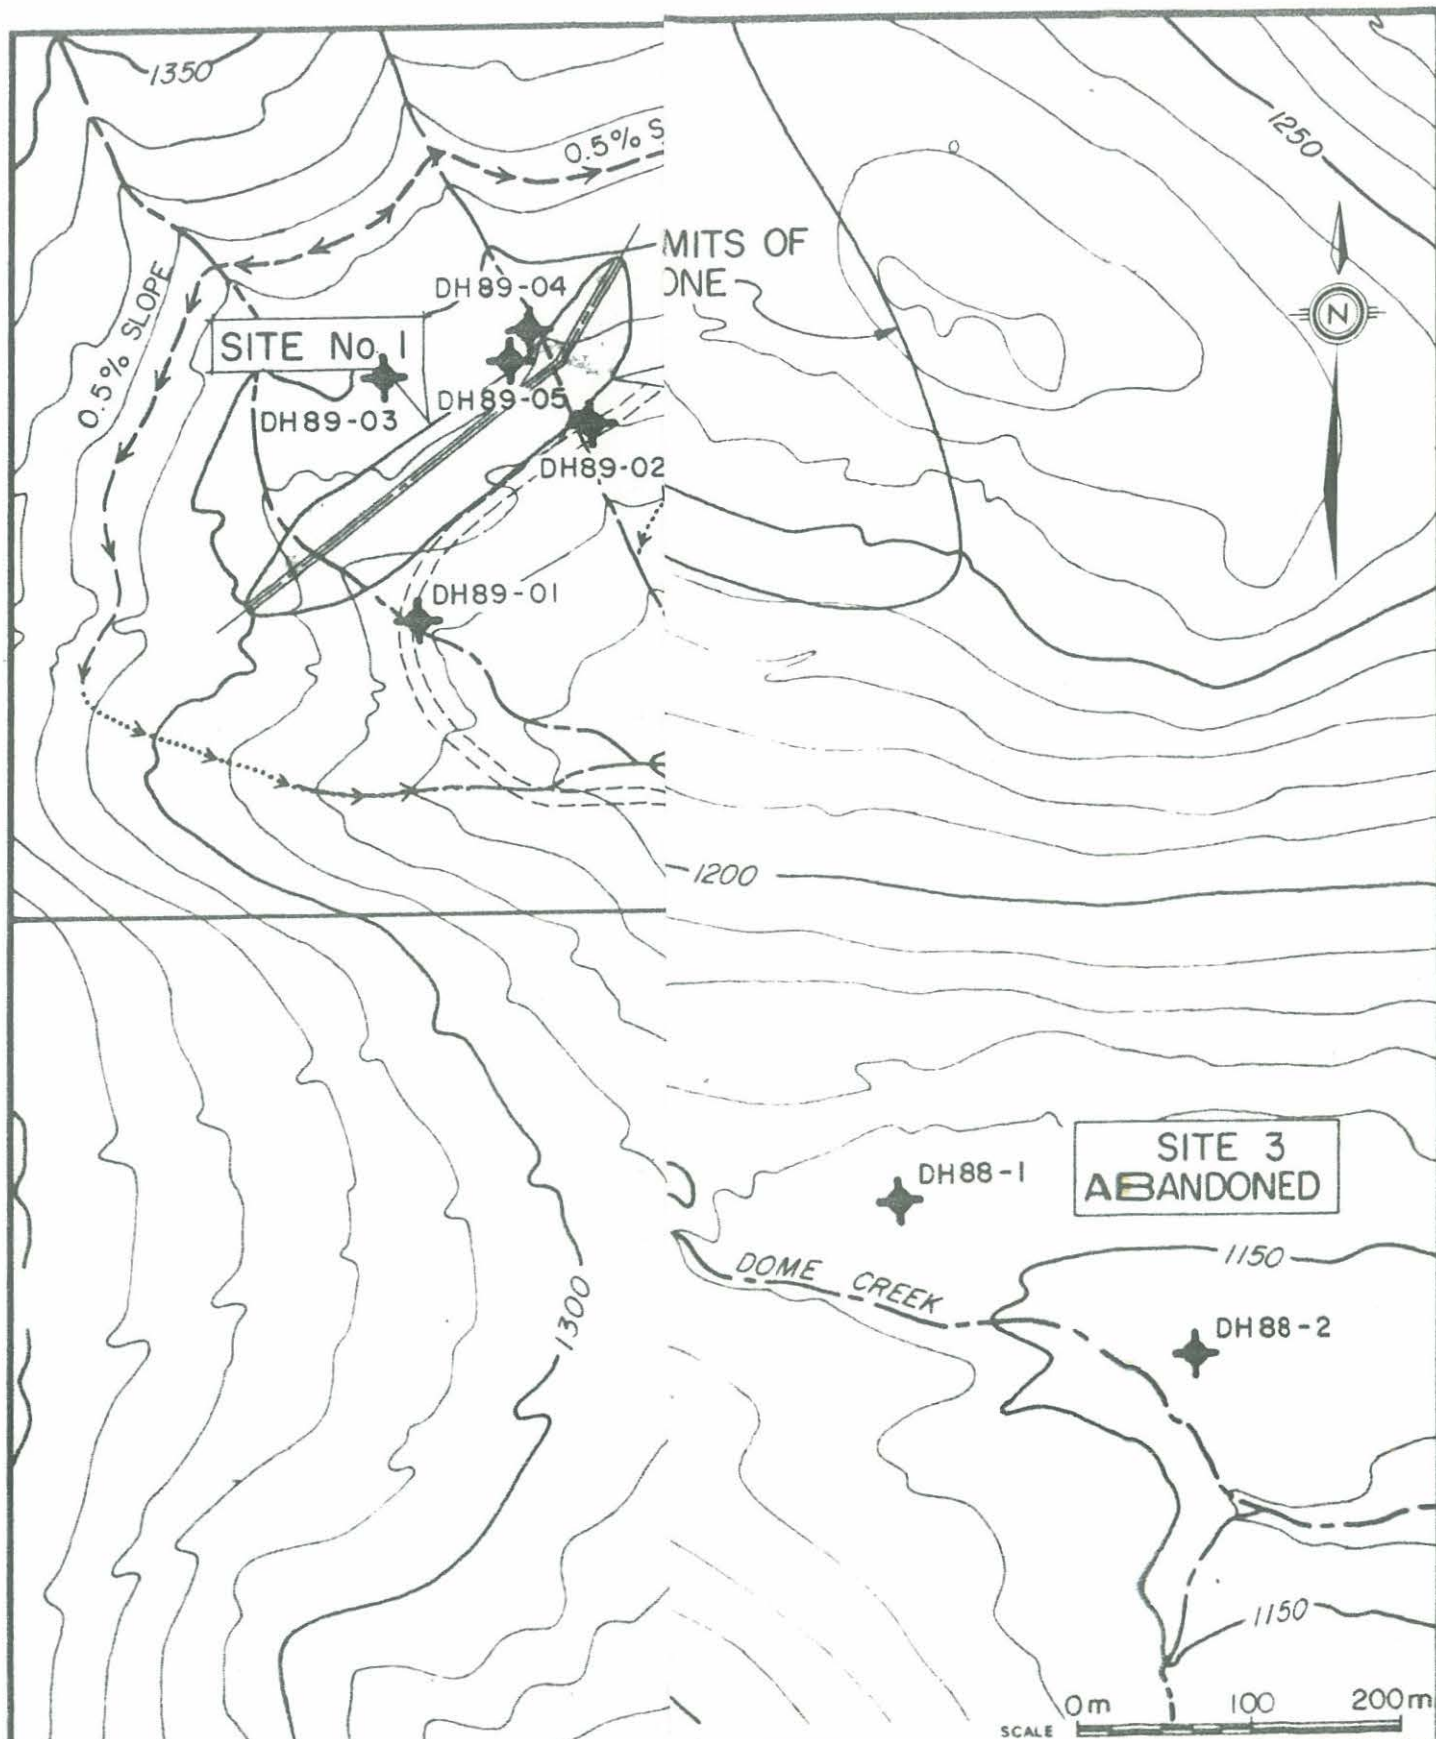
PROJECT MOUNT NANSEN GOLD PROJECT			
TITLE LOCATION OF BORE HOLES AND DAM OUTLINES			
2 DATE OF ISSUE MAY 4, 1990	PROJECT No PB 5314 02	DWG No B-2002	REV.
APPROVED <i>[Signature]</i>

- > DIVERSION DITCH
- .....> LINED DIVERSION DITCH (TO BE DESIGNED LATER)
- ✦ DRILL HOLE LOCATION (NOT SURVEYED)

**SITE No. I**  
**MILLSITE TAILINGS DAM**

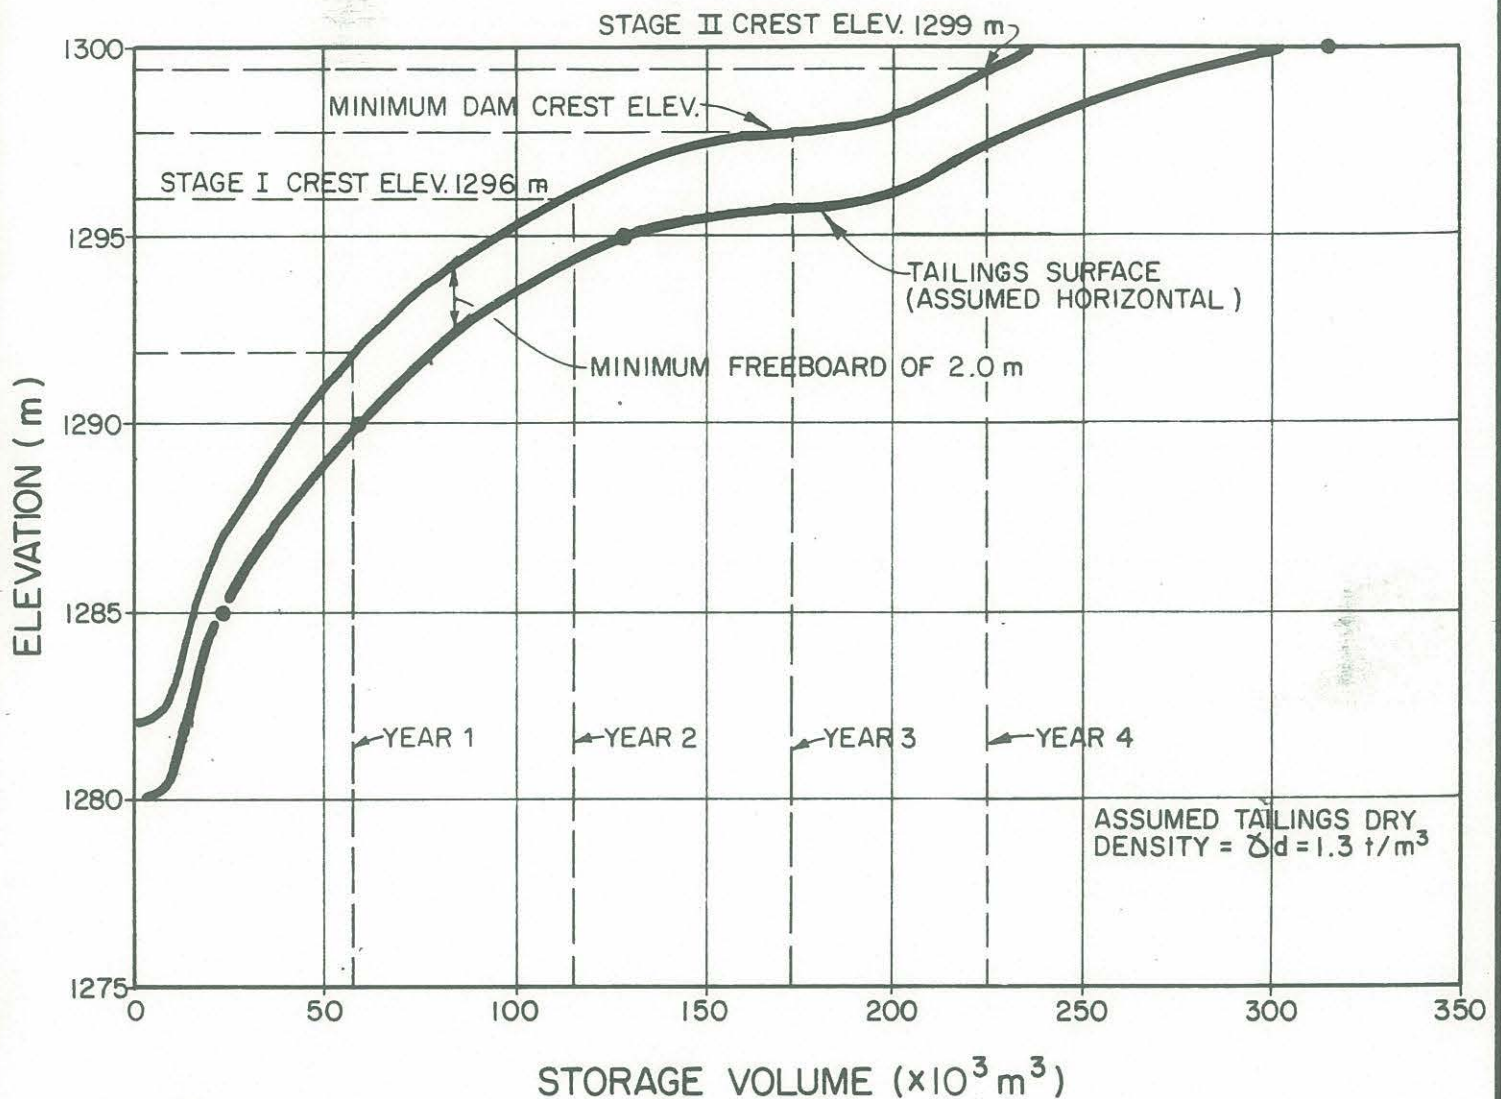
1. CREST ELEVATIONS SHOWN ASSUME THAT ROCK FILL OBTAINED FOR THE DYKE COMES FROM WITHIN THE POND AREA.
2. THIS CURVE IS BASED ON LIMITED TOPOGRAPHY AND WILL REQUIRE REVISION UPON RECEIPT OF DETAILED GROUND SURVEY AND DAM ALIGNMENT DETAILS.
3. STORAGE VOLUME IS BASED ON PRODUCTION RATE OF 200 tpd.

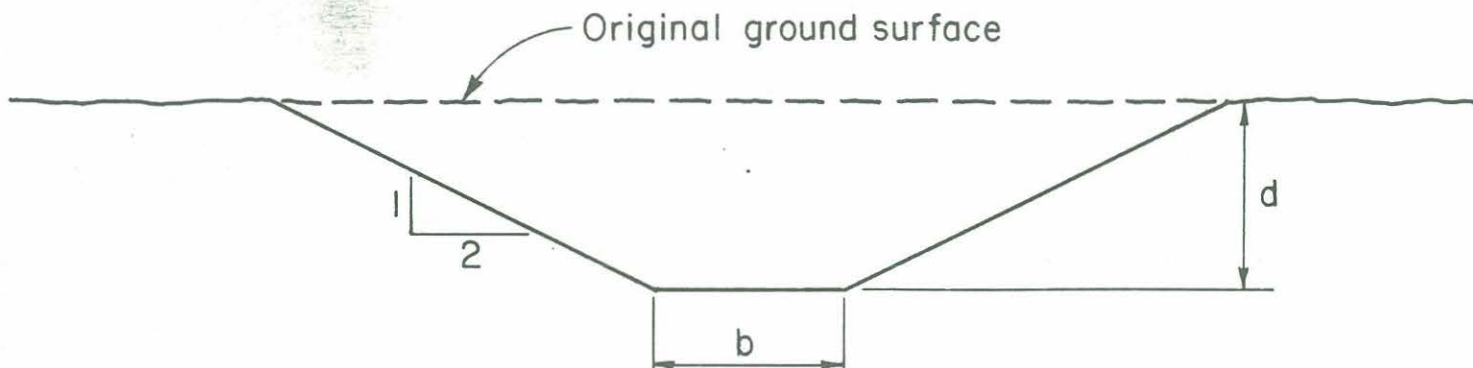
TYPICAL DIVERSION DITCH SECTION

MINIMUM DIVERSION DITCH DIMENSIONS			
	b (m)	d (m)	slope (%)
SITE No.1	1.0	1.0	0.50
SITE No. 2	3.0	1.6	0.25

Water may infiltrate into ditches excavated in the fractured bedrock. Lining of the ditches may be required to ensure that runoff is diverted away from the pond.

In the spring, when snowmelt begins or when infrequent rainstorms may occur, excessive snow and snow drifts must be cleared from the ditches to allow for the safe diversion of surface runoff. Every spring and fall, the ditch must be checked for vegetation build-up and subsidence due to frost action. Both of these may render the ditches useless for runoff control.
