MT. NANSEN GOLD PROJECT

Tailings Storage Study

FEASIBILITY DESIGN

SEPTEMBER 1994

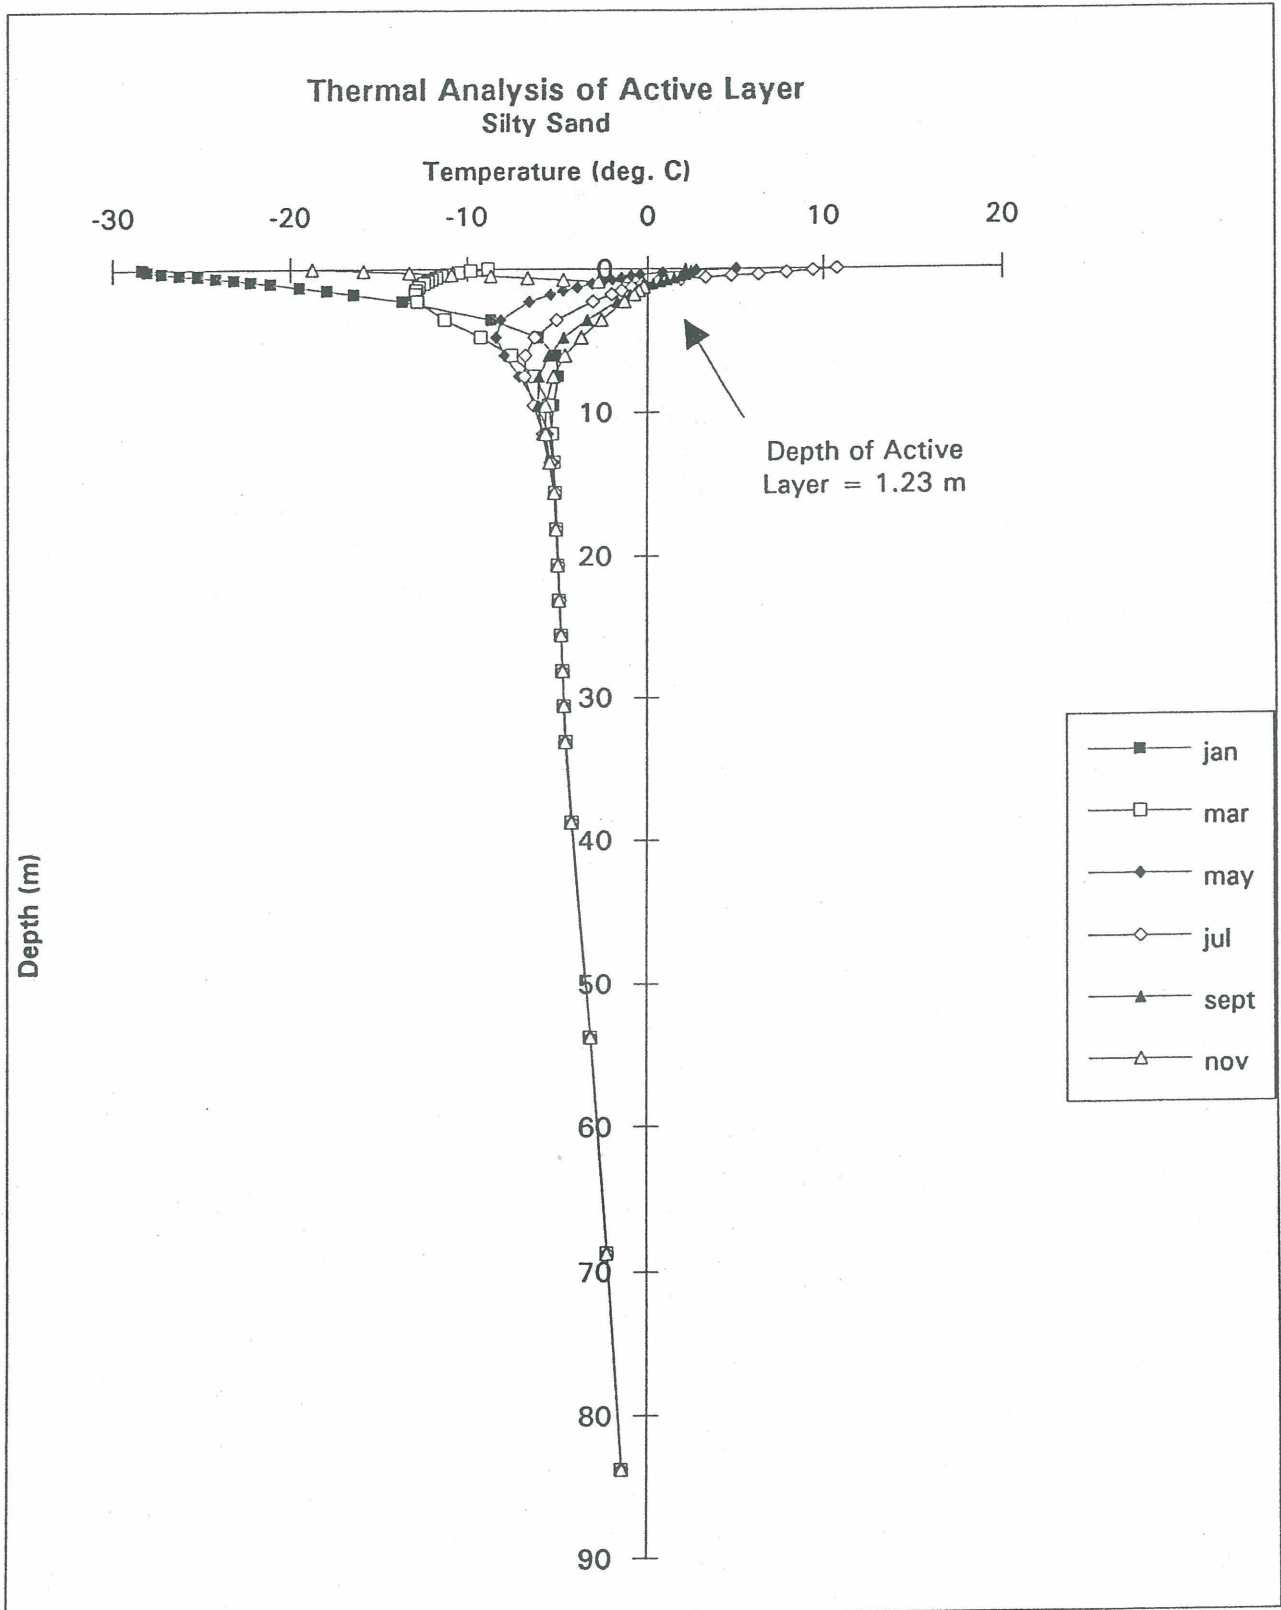
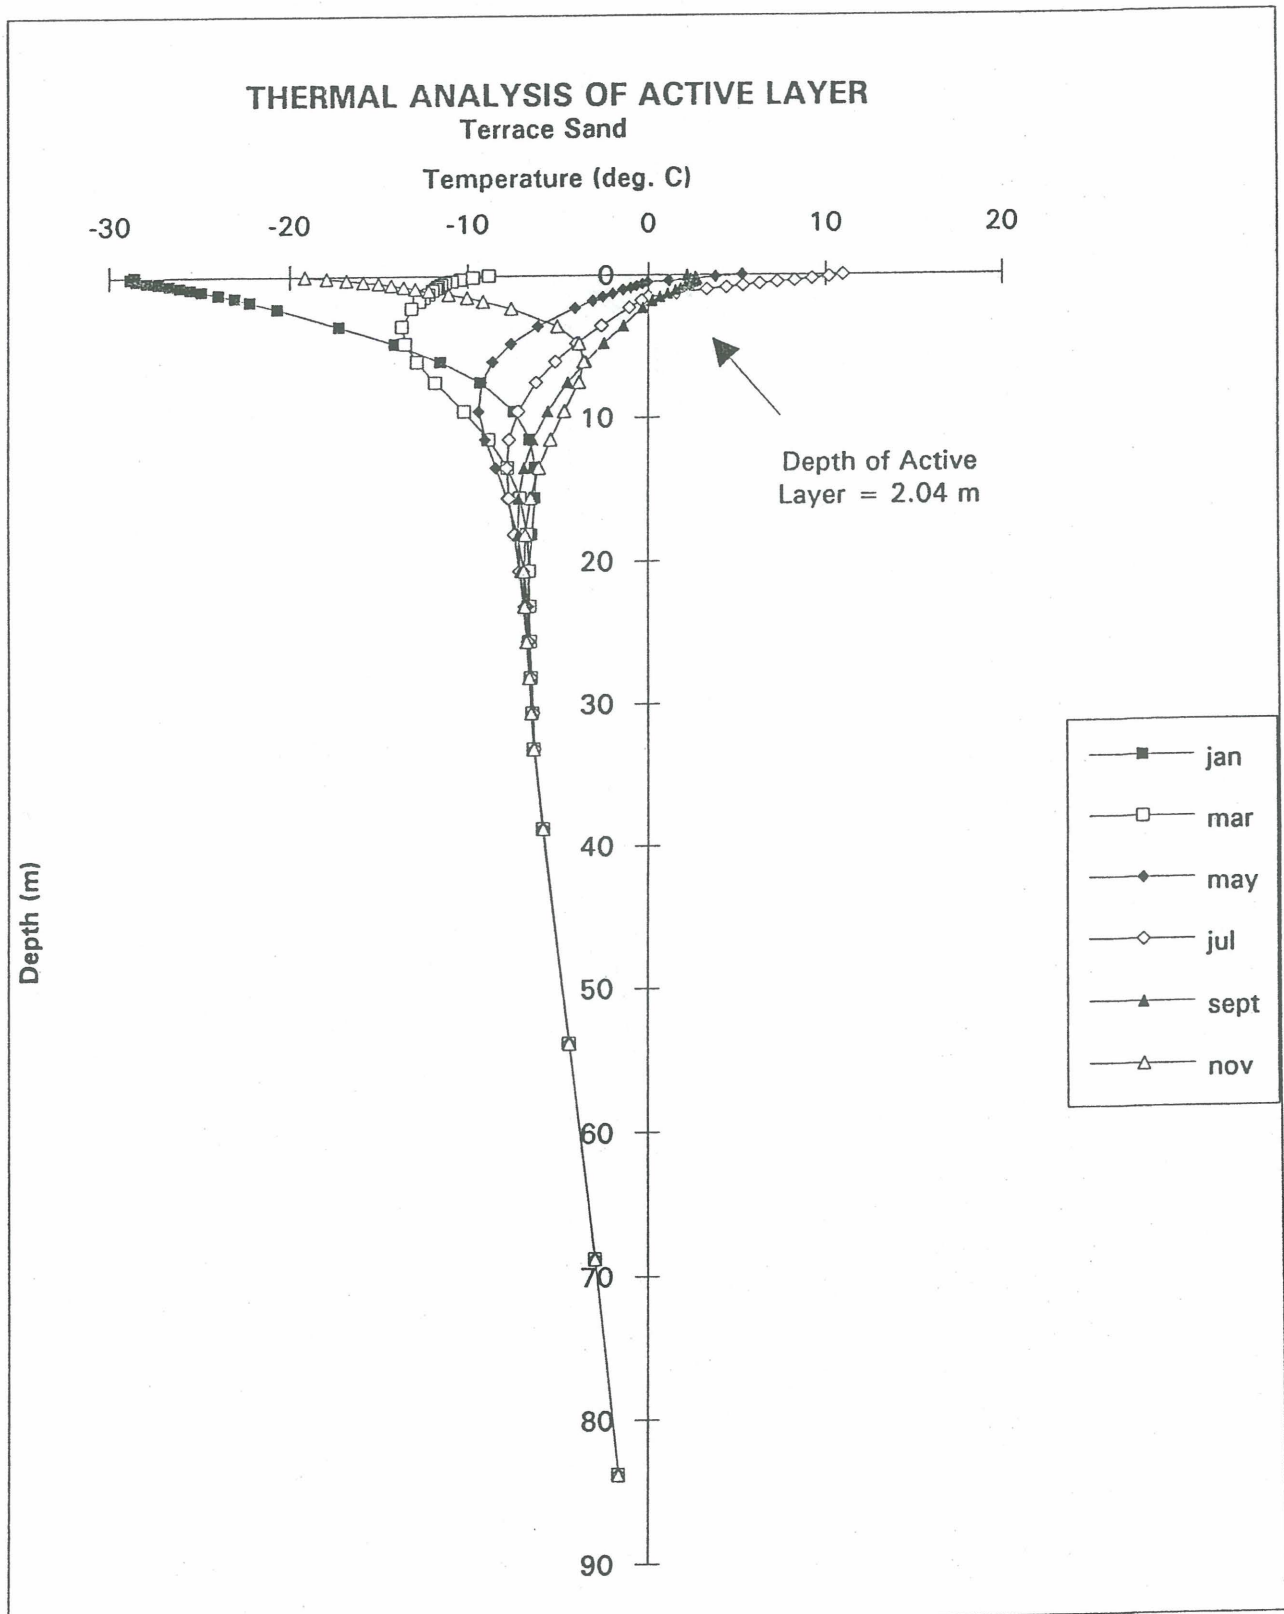
Thermal analyses were carried out to determine the depth of the active layer. Two plots are shown (terrace sand and silty sand) representing the two main soil types on site. The terrace sand will probably be used for low construction.

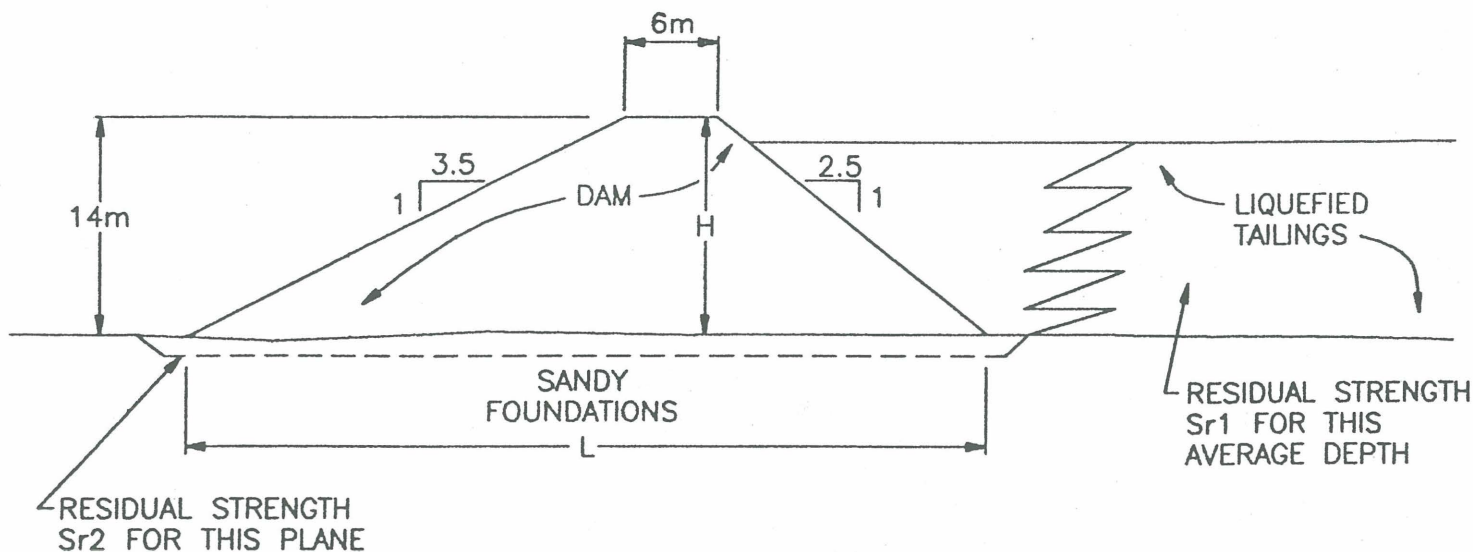
LIQUEFACTION FAILURE MODEL

For the overall stability of the embankment, a simple two-dimensional model is used to calculate a factor of safety (see Figure IV.2). It is assumed that the entire saturated mass of tailings behind the embankment will liquefy. It is also assumed that a layer of saturated sand in the foundations will also liquefy, producing a potential horizontal failure path underneath the dam. The dry density of the tailings is assumed to be about 1.25 tonnes/m³ (12.26 kN/m³). The dry density of the compacted sand embankment is assumed to be about 1.75 tonnes/m³ (17 kN/m³). The residual strength following liquefaction (S_{r1}) of the tailings is calculated according to the average depth of tailings, or about 6 m:

$Sr1$ = RESIDUAL STRENGTH OF LIQUEFIED TAILINGS

$Sr2$ = RESIDUAL STRENGTH OF LIQUEFIED SANDS ALONG THE HORIZONTAL FAILURE SURFACE.

H = AVERAGE DEPTH OF THE FAILURE SURFACE.

The driving force (P_d) is generated by the hydrostatic head of the liquefied tailings (behaving as a dense slurry) behind the embankment, less a small strength component calculated from the residual strength (S_{r1}). The driving force is calculated according to the following equation:

If we assume that the average depth of embankment dam above the foundation failure surface is about 8 m, then the residual strength (S_{r2}) along the basal failure plane is:

The length (L) of the failure surface times the residual strength (S_{r2}) gives the force resisting failure (P_r). Assuming a foundation length of 100 m, the resisting force is calculated according to the following equation:

So the factor of safety against failure is equal to the ratio of the resisting force over the driving force:

From this it can be seen that the factor of safety is proportional to the length of the failure surface, or the width of the dam. For this situation, a factor of safety of 1.1 is considered appropriate for design. A factor of safety of 1.1 is achieved when the dam base width is about 80 m.

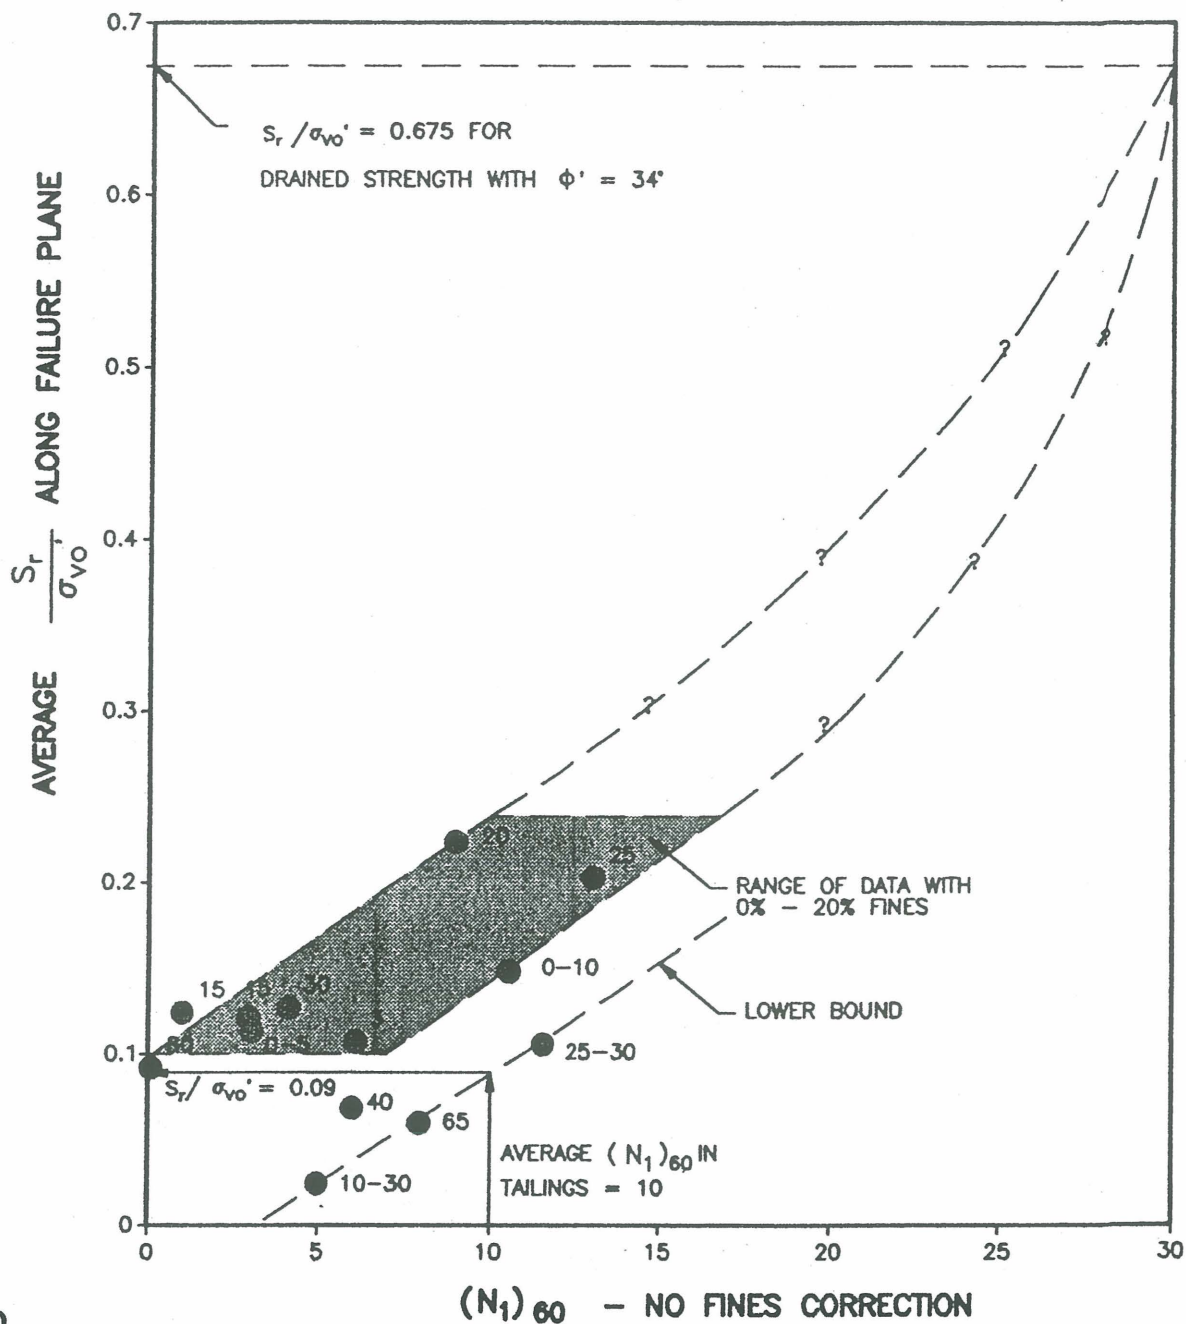
AFTER STARK
AND MESRI (1992)

S_r = AVERAGE RESIDUAL SHEAR STRENGTH BACKCALCULATED ALONG
FAILURE PLANE IN LIQUEFIED SOIL MASS USING POST-FAILURE GEOMETRY

$\sigma_{vo'}$ = AVERAGE INITIAL VERTICAL STRESS IN LIQUEFIED SOIL MASS PRIOR TO FAILURE.

There is a small potential for thawing of the foundations, particularly at the beginning of operations. This could result in loose sands which may be subject to liquefaction under seismic conditions. The residual strength of the tailings following liquefaction (S_{r1}) has been assessed using relationships developed from case histories (see Figure IV.1). Using these relationships, the residual strength can be estimated as a fraction of the initial vertical stress (σ_{v0}') related to the $(N_1)_{60}$ value. The $(N_1)_{60}$ value is normally derived from cone penetration tests. However, this is impossible in frozen ground. Based on previous experience, $(N_1)_{60}$ values in the range of 8 to 10 are conservatively assumed for the thawed foundation sands and for the tailings. From the lower bound of the plot of $(N_1)_{60}$ vs. S_r/σ_{v0}' (see Figure IV.1 after Stark and Mesri, 1992), a value of 0.09 is implied for S_r/σ_{v0}' . Consequently, a residual strength for liquefied tailings and foundation sands of 0.09 times the vertical stress is assumed for design.
