# PHASE I GEOTECHNICAL INVESTIGATION PROGRAM ADJACENT TO THE FWS DAM

# **FARO MINE, YT**

# **FINAL REPORT**

PROJECT NO.: 0257-009-02 DISTRIBUTION LIST:

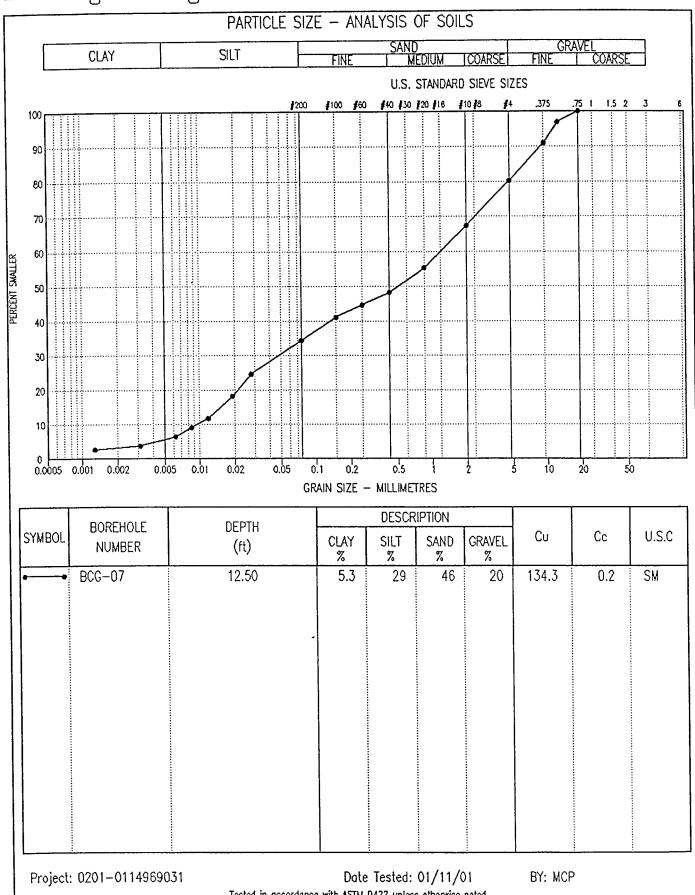
Tested in accordance with ASTM D422 unless otherwise noted.

Selected samples were submitted for moisture content, grain size analyses and Atterberg Limits testing. The results of the testing are shown on the borehole logs included in Appendix I, and separately on the laboratory summary sheets in Appendix II.
