DATE 9 January 2017**REFERENCE No.** 1410944-012-TM-Rev1-2016**TO** Ms. Carrie Gillis
Faro Mine Remediation Project**FROM** Ryan Preston and Al Chance**EMAIL** Ryan_Preston@golder.com;
Al_Chance@golder.com**PIT SLOPE PHOTOGRAMMETRY MONITORING NETWORK TRAINING MANUAL**

1.0 INTRODUCTION

2.0 ABOUT THE NETWORK

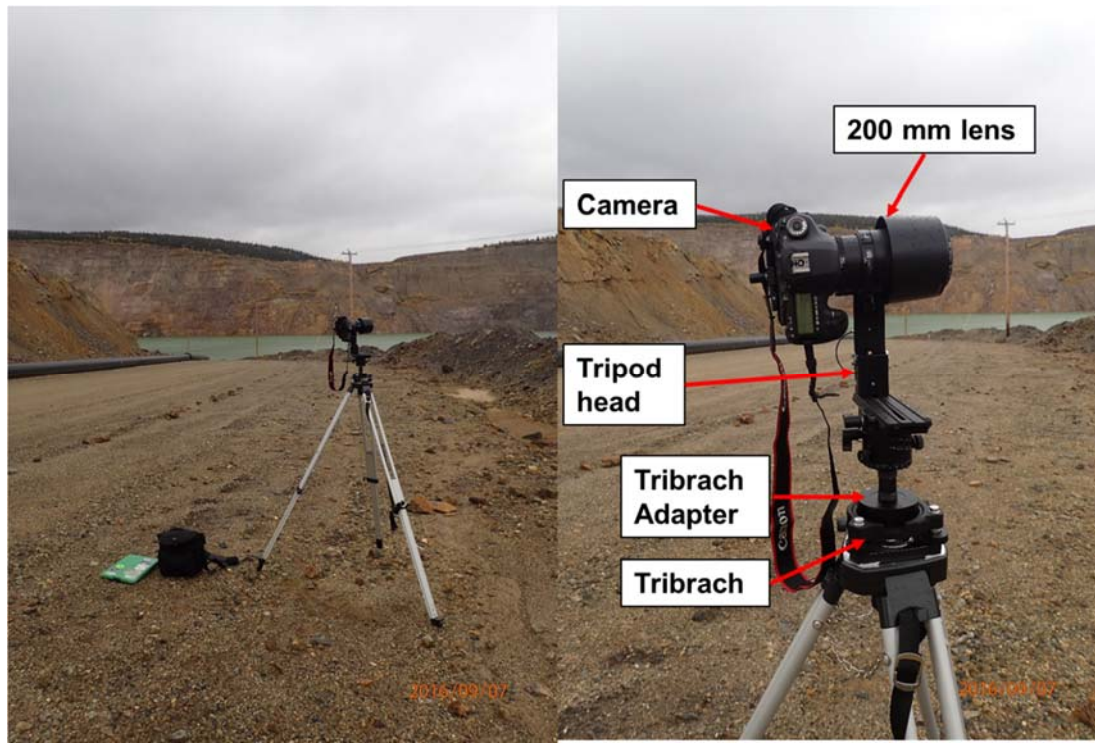
Figure 2: Camera and Tripod Assembly

- 2) Assemble equipment – Camera (Canon 5D Mark III), lenses (200 mm and 85 mm), tribrach, tribrach adapter, and tripod head. Check camera for dust and smudges on lens and clean as necessary with soft, lint free cloth.

- 4) Attach tribrach to monitoring station and level.
- 5) Attach tribrach adapter and tripod head (Figure 2).
- 6) Assemble camera and check settings. Table 1 lists the important camera settings which should be used during photo collection and Figures 3, 4, and 5 show how to setup the tripod head, adjust camera settings and change the camera's lens, respectively:

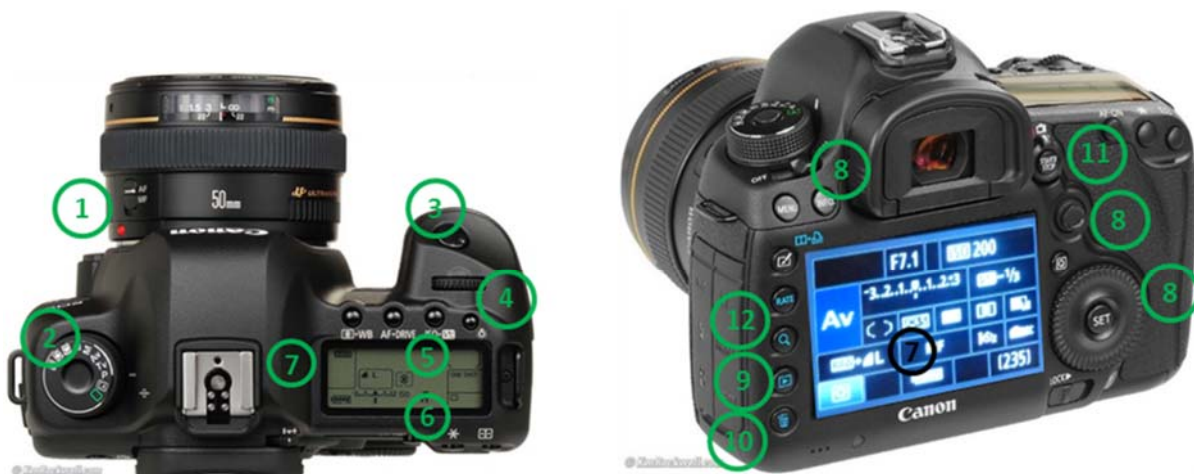
Camera Parts

1. Switch from Autofocus (AF) to Manual focus (MF)
2. Leave on Av (Aperture priority)
3. Press half way to focus during AF
4. Adjust Aperture (Leave at 8.0)
5. Shows Aperture value
6. Shows ISO (Leave on auto)

7. Leave on L
8. Press "INFO" until this screen appears, press Q and use joystick to select value to adjust, adjust with scroll wheel and button
9. Review photos
10. Delete photos
11. Use LCD screen as viewfinder
12. Zoom in and out of reviewed photos

Figure 4: Camera Settings and User Guide

Table 1: Camera Settings

Setting	Value
Aperture	F8.0
ISO	Auto
Image Quality	JPEG L
Drive Mode	2 Second Timer

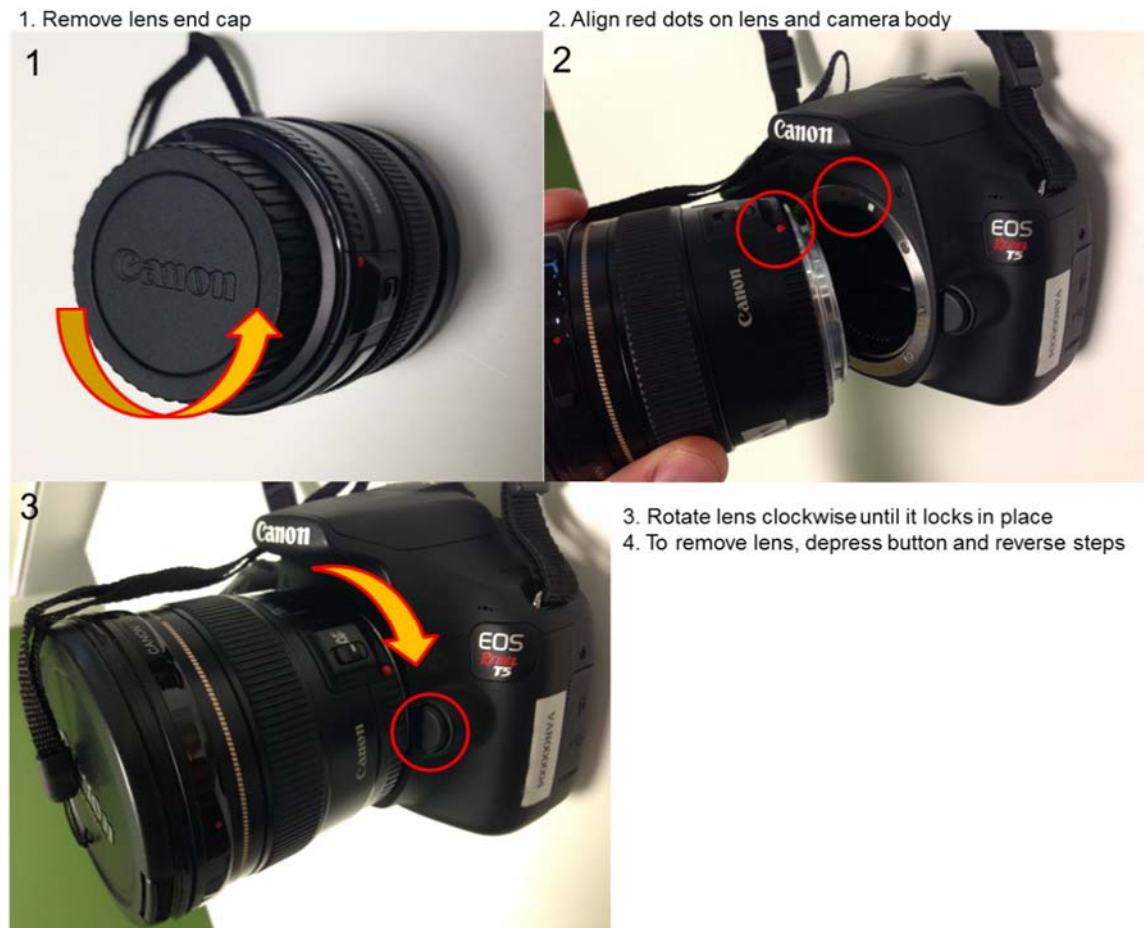
Figure 5: Changing Lenses

- a) The 200 mm lens should be used for Faro and Grum pit photos.
 - b) The 85 mm lens should be used for Vangorda Pit photos.

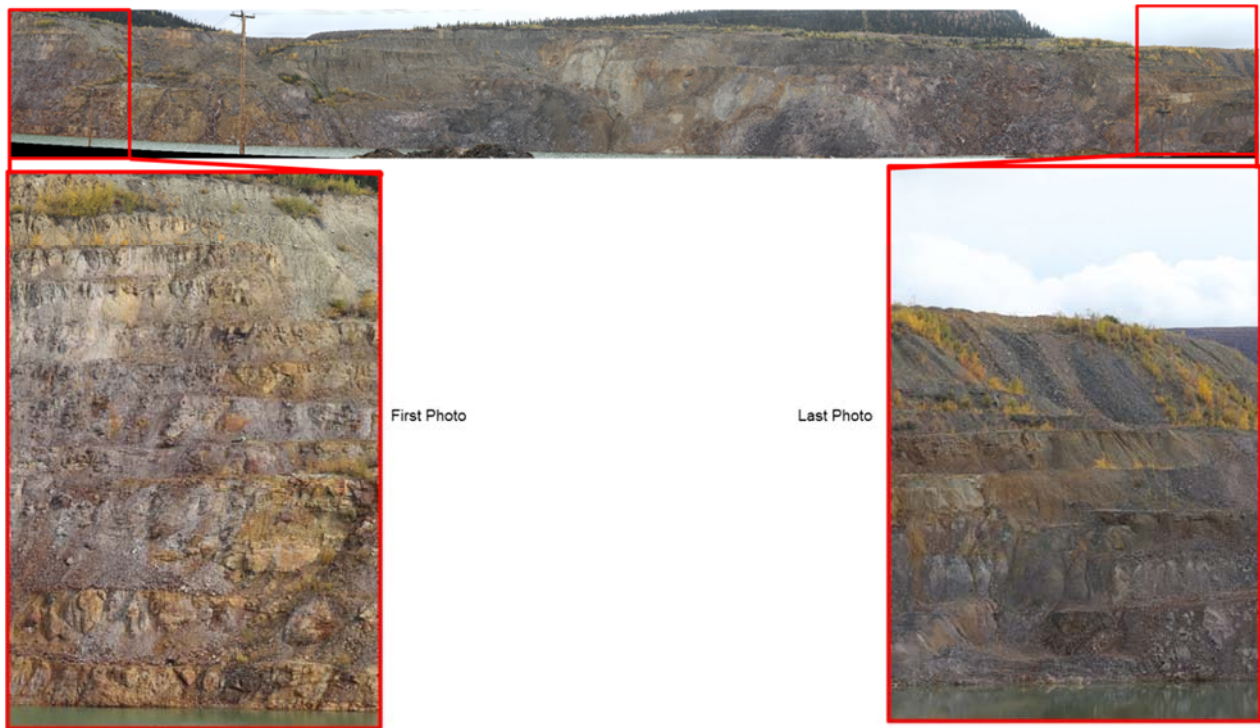
Figure 6: Area of Interest – Faro Pit

- 7) Adjust tilt on tripod head so entire pit slope is visible and pan camera to far left extent of zone of interest (see Figures 5 to 7 for zones of interest for each pit).

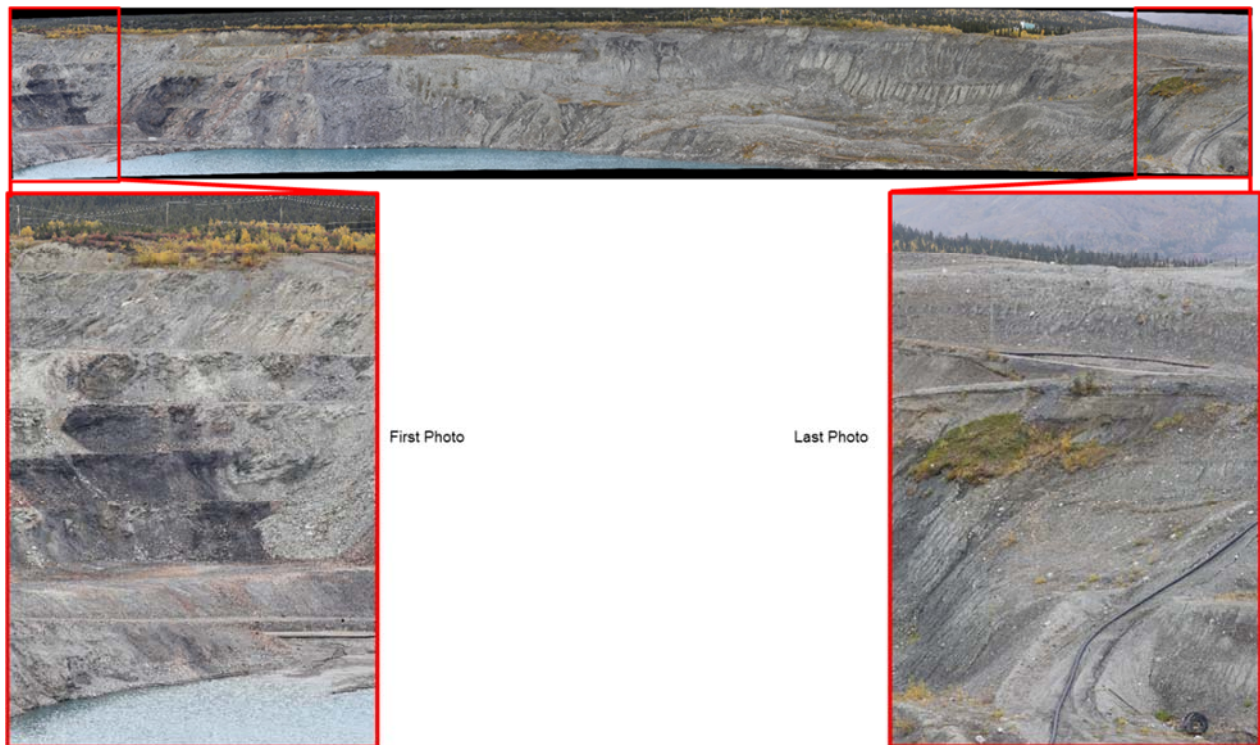
Figure 7: Area of Interest – Grum Pit

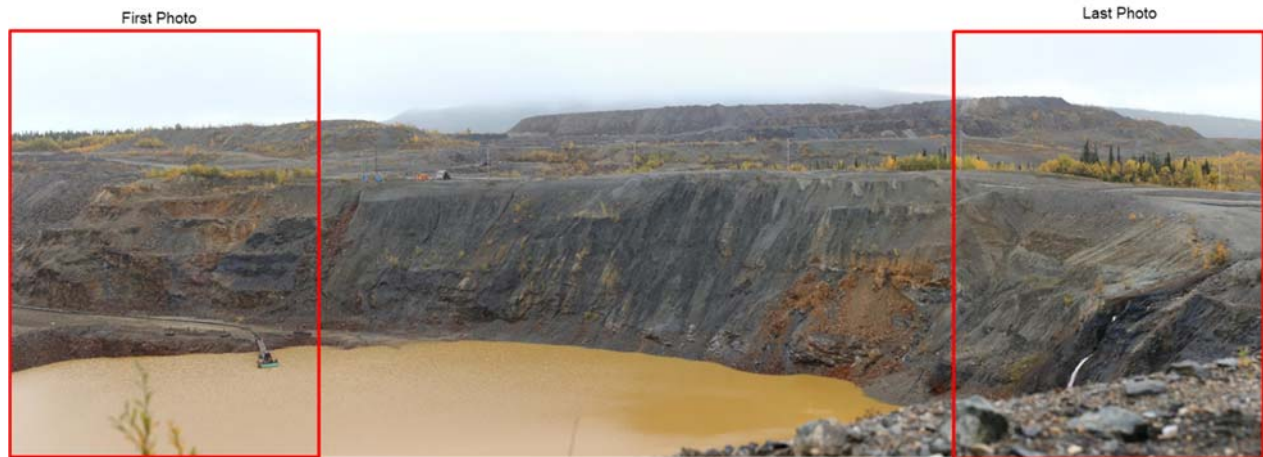
Figure 8: Area of Interest – Vangorda Pit

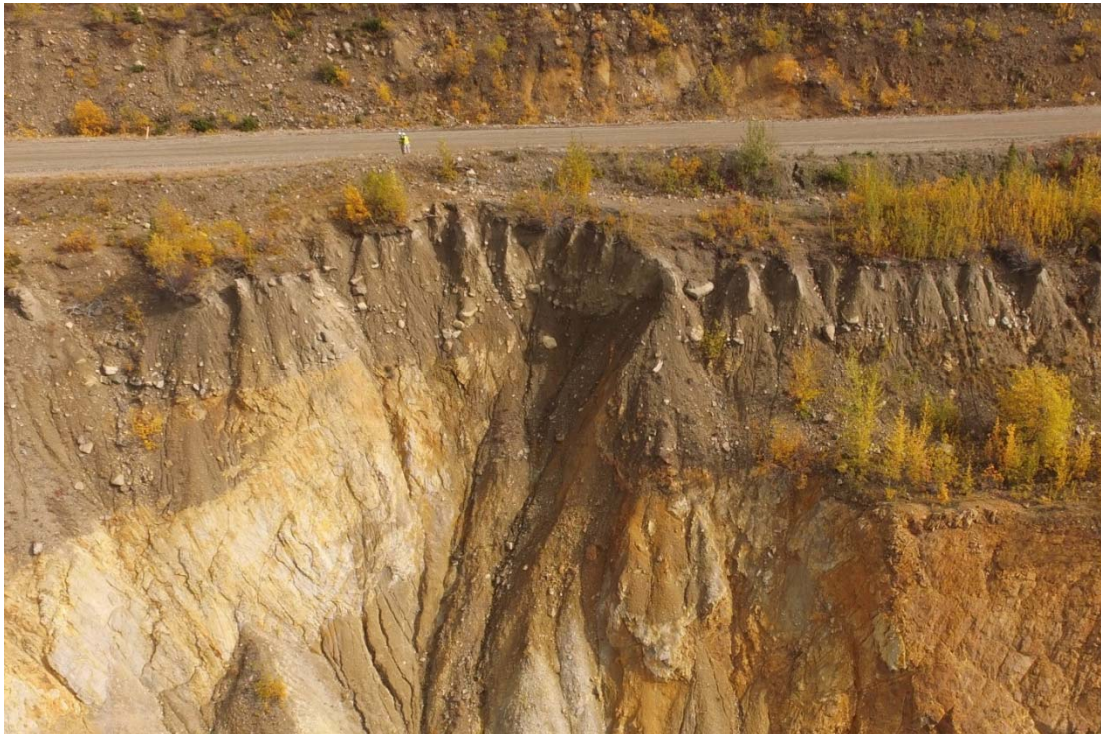
Figure 9: Critical Crest Regression Area in Faro Pit

- Any crest regression in the critical area of the Faro Pit crest observed from photo comparison or crest tours (Figure 9).

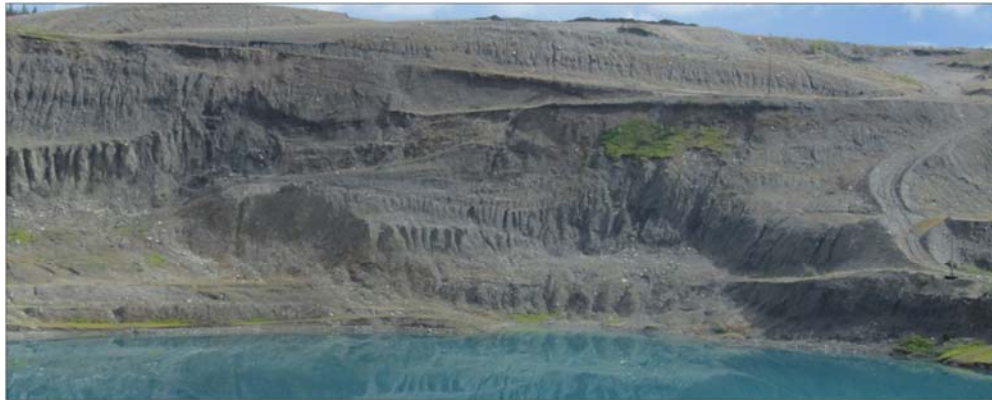
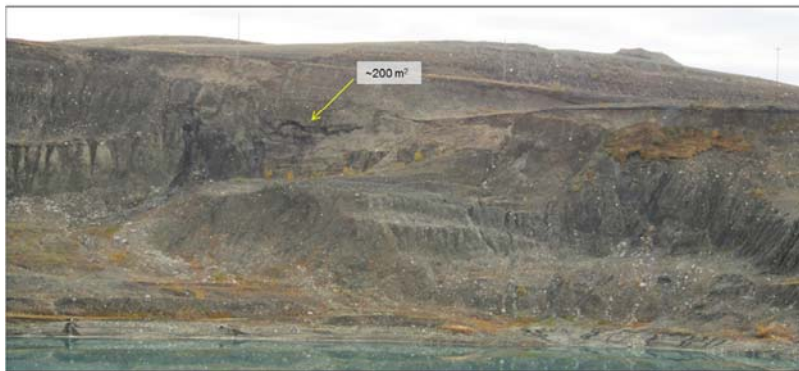
2014 PHOTOGRAPH OF INSTABILITY ZONE, VIEW LOOKING EAST

2015 PHOTOGRAPH OF INSTABILITY ZONE, VIEW LOOKING EAST

Figure 10: Example of Sloughing – Grum Pit

- Any regression or sloughing affecting an area of 5×5 m or greater in any of the pits (Figures 10 to 13). The 3D PDF models provided in Golder's site visit report (Golder 2016b) can be used to measure affected areas (Figure 14).

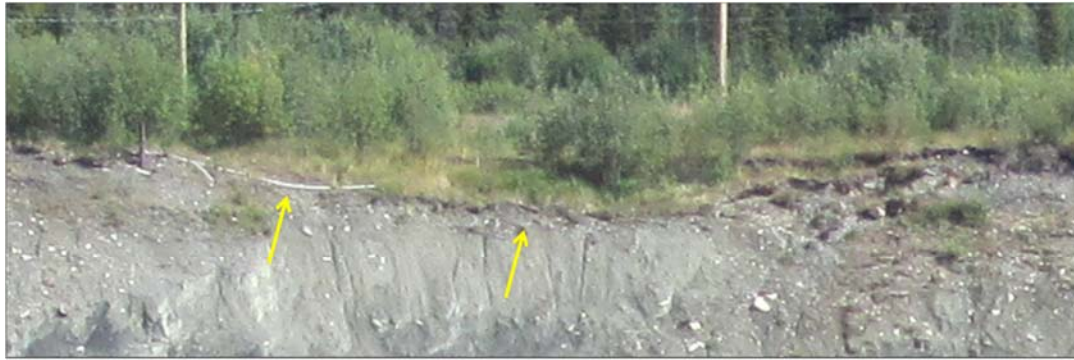
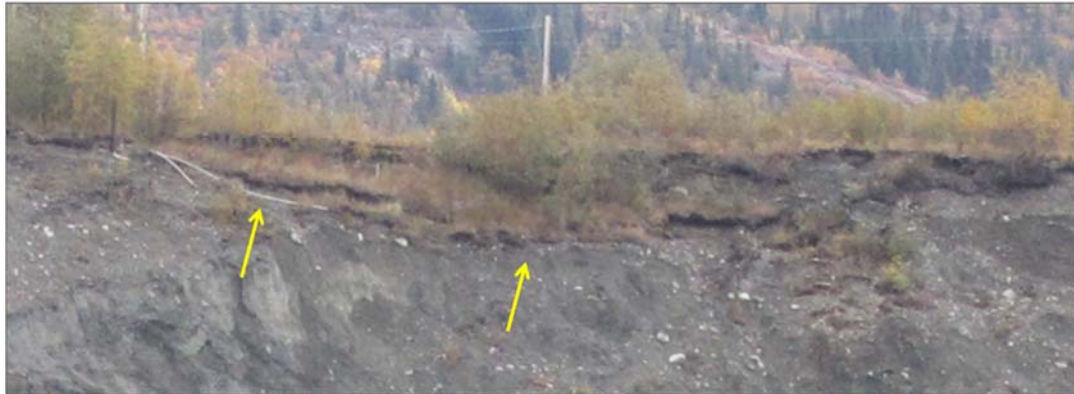
2014 PHOTOGRAPH OF
CREST OF EAST WALL,
BACKSCARP OF
INSTABILITY ZONE,
VIEW LOOKING EAST

2015 PHOTOGRAPH
OF CREST OF EAST
WALL, BACKSCARP
OF INSTABILITY ZONE,
VIEW LOOKING EAST

Figure 11: Example of Slumping – Grum Pit

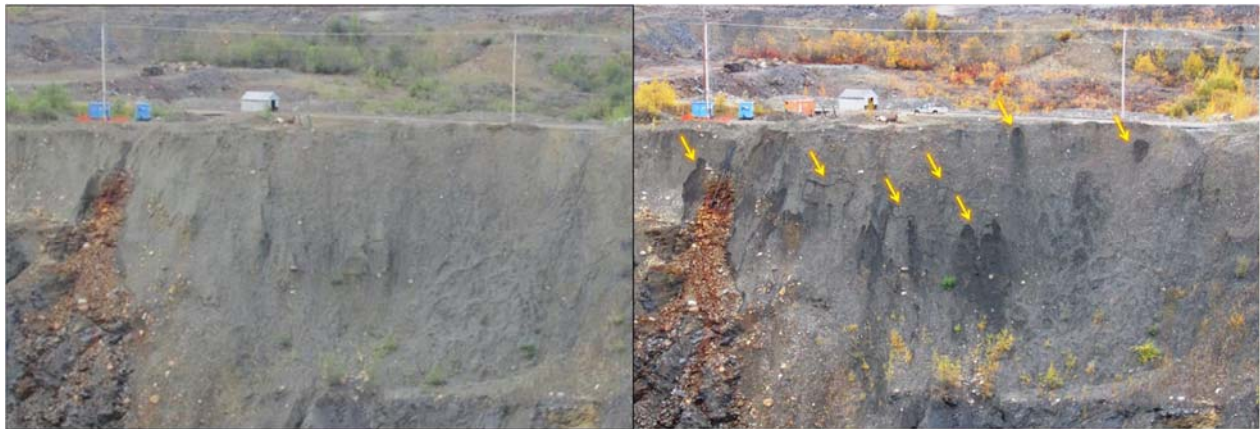
2014 - SOUTH SIDE OF UPPER WEST WALL, VIEW LOOKING WEST

2015 - SOUTH SIDE OF UPPER WEST WALL, VIEW LOOKING WEST
YELLOW ARROWS SLUMPED AREAS

Figure 12: Seepage Induced Sloughing in Upper Part of Vangorda West Wall

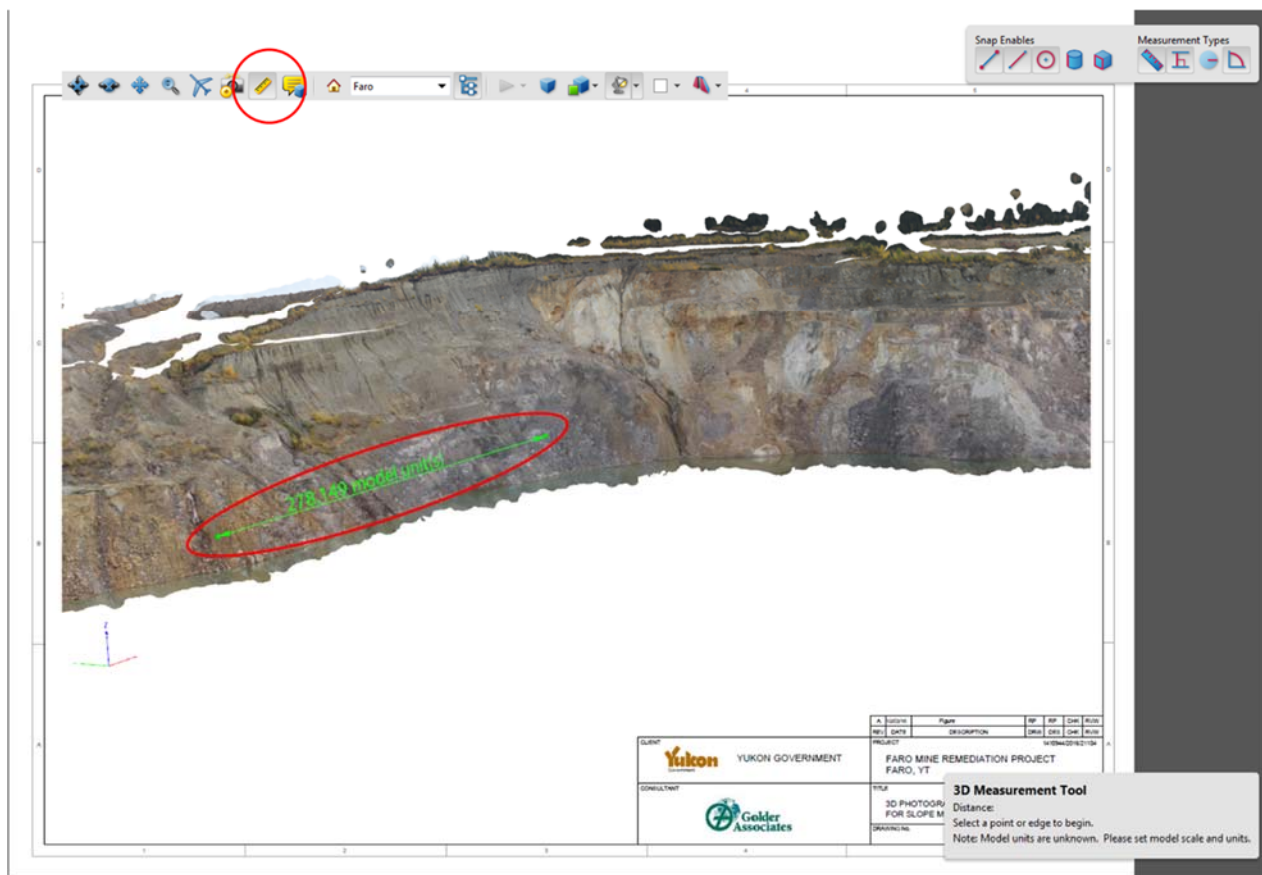
Figure 14: Measuring Dimensions from 3D PDF of Models

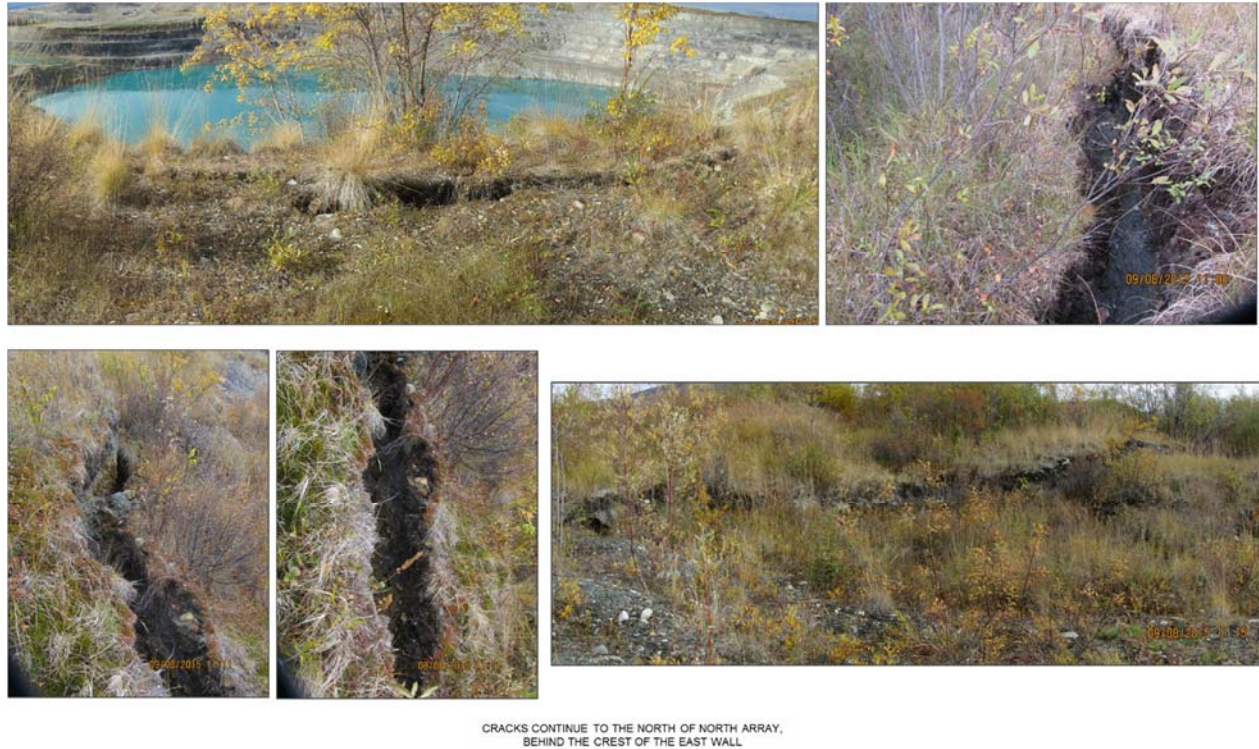
Figure 15: Cracks behind Crest of East Wall – Grum Pit

- Increases in pit wall seepage above those normally experienced for the time of year (Figure 13). Photo data from the preceding year and site personnel experience can be utilized to determine if observed seepage is unseasonal.
- New or growing cracks are observed in the pit crest (Figure 15).
