Preliminary Breach Design Fresh Water Supply Dam, Faro Mine

**PRELIMINARY BREACH DESIGN
FRESH WATER SUPPLY DAM, FARO MINE**

STEFFEN ROBERTSON AND KIRSTEN (CANADA) INC.

FEBRUARY 2003

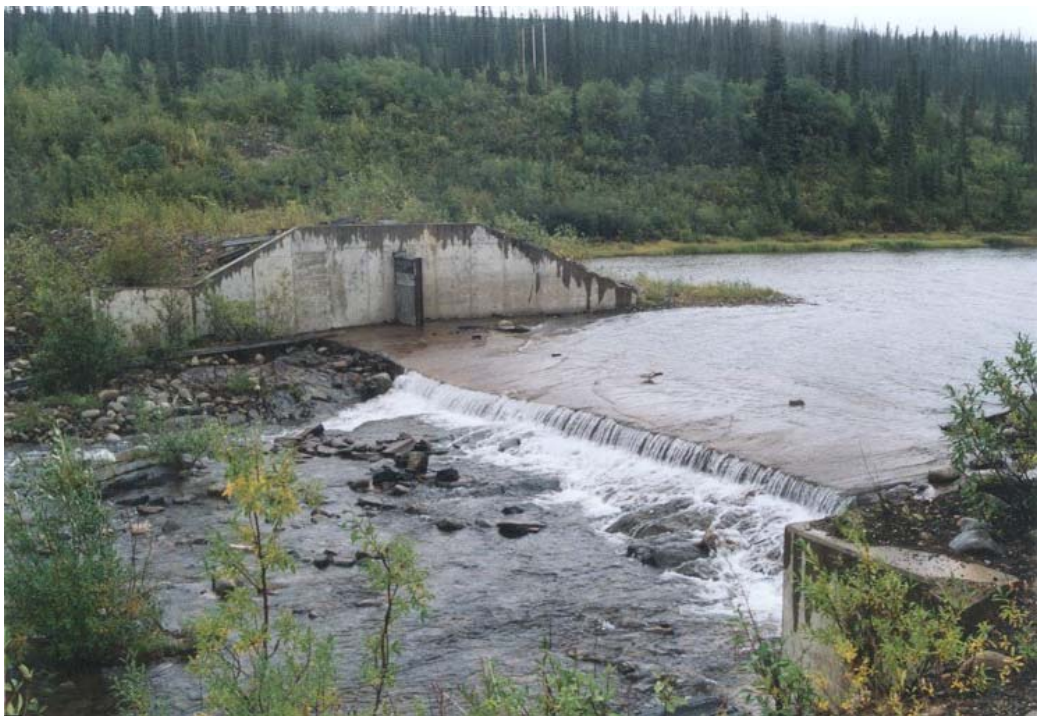
Photo 2: Spillway near North Abutment of FWSD

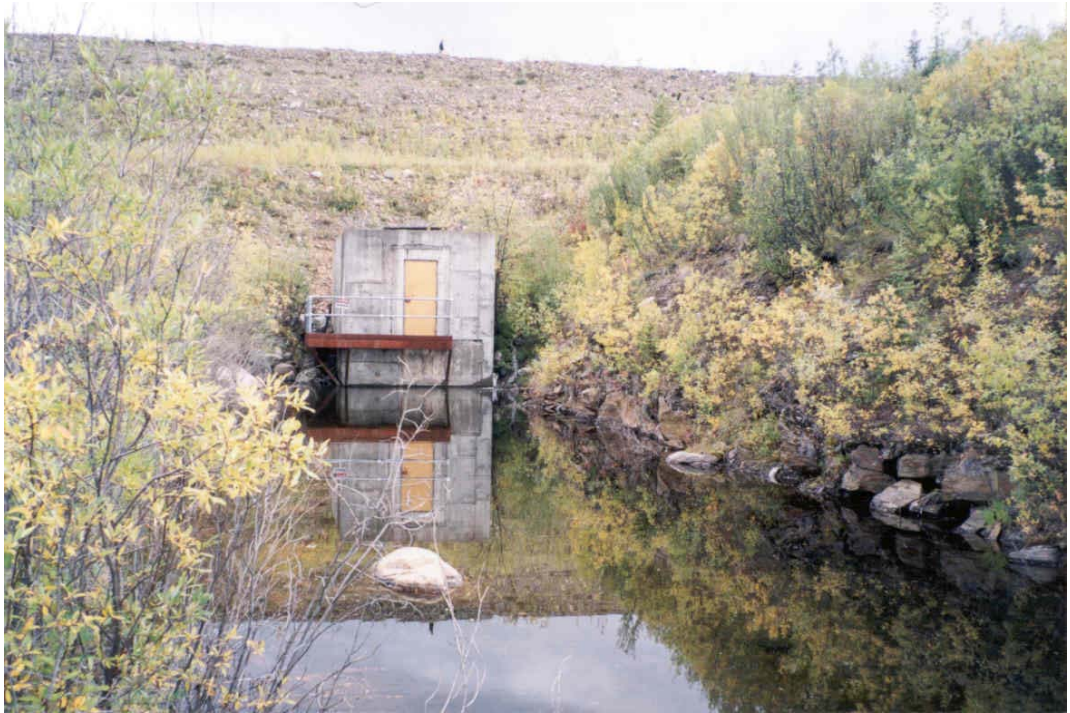
Photo 3: Valve House and portion of Fresh Water Channel

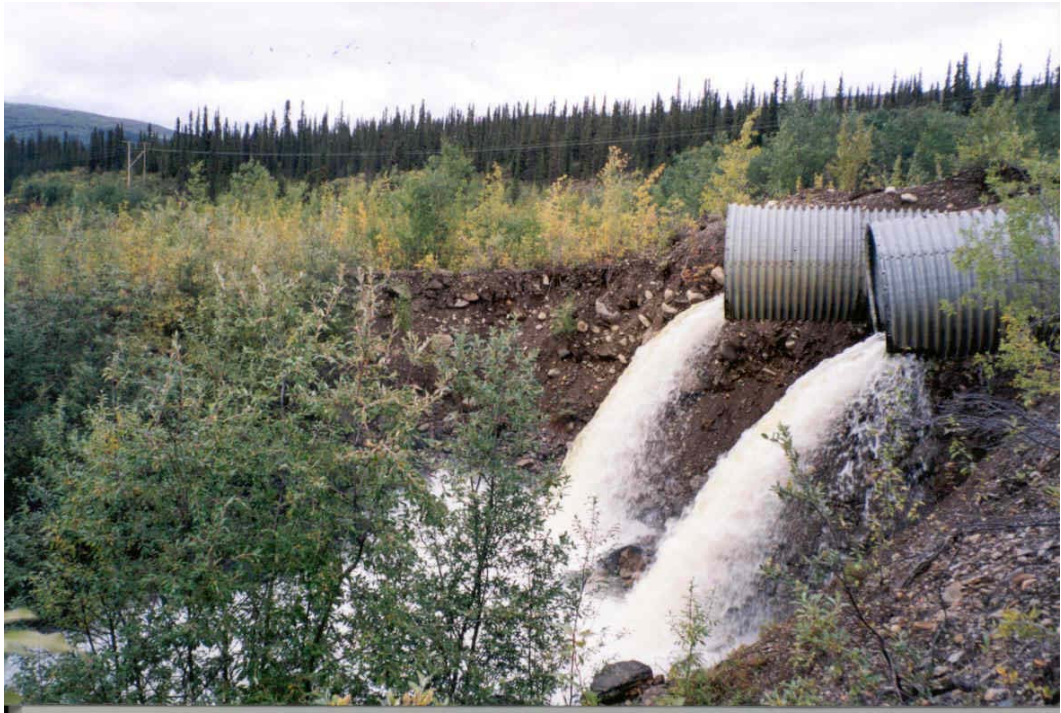
Photo 5: Culvert Discharge at downstream end of spillway

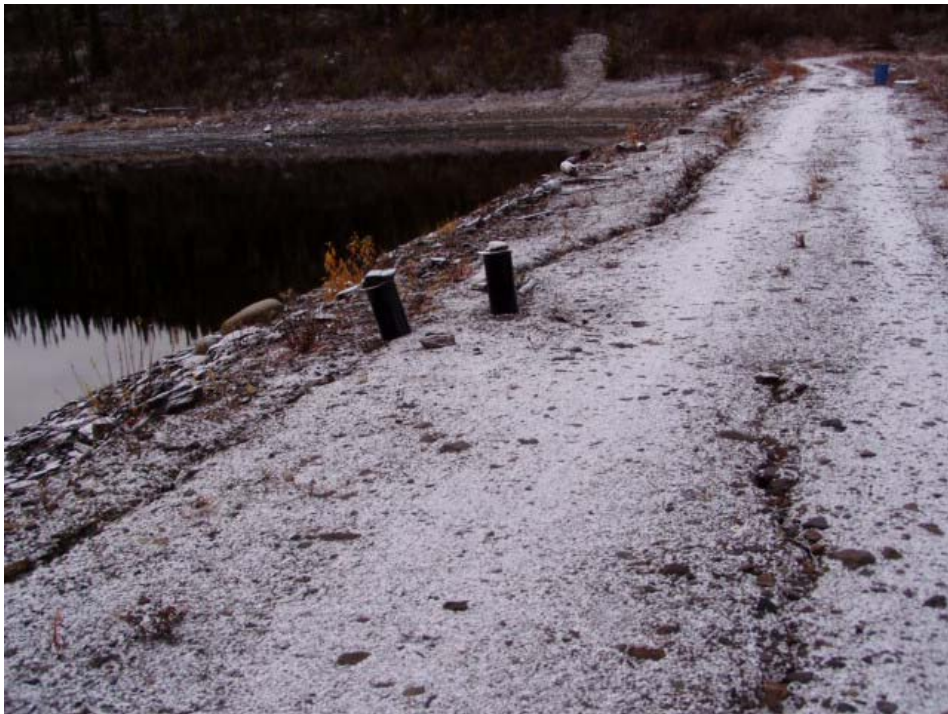
Photo 6: Cracking on the crest of the FWSD

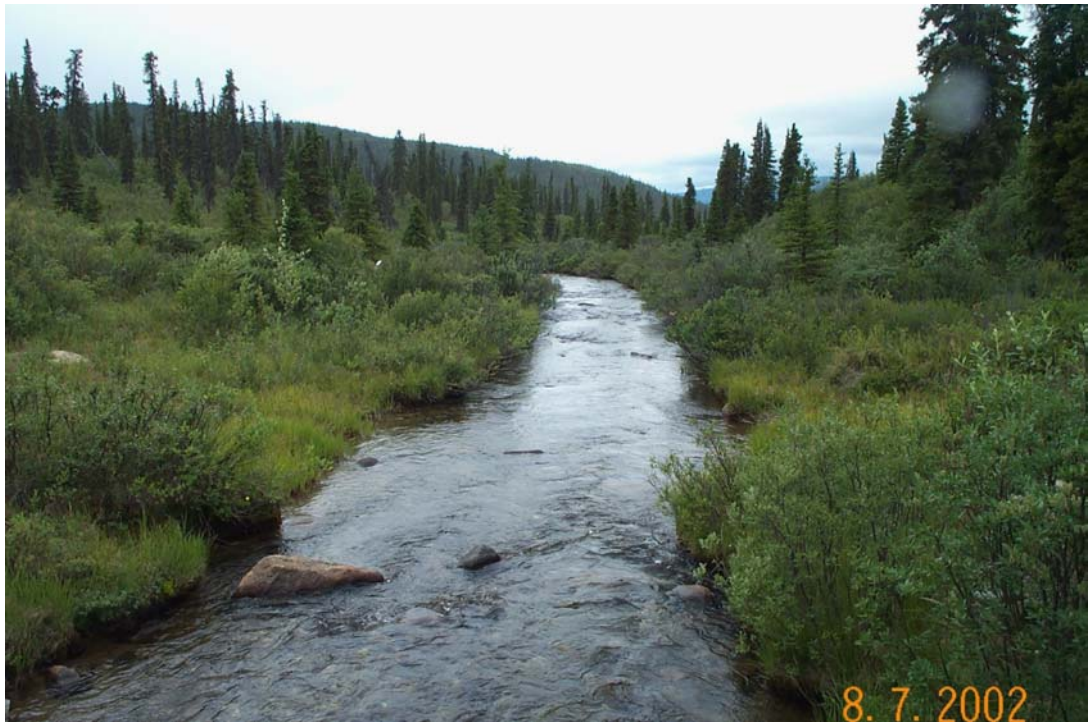
Photo 7: South Fork of Rose Creek – upstream from the FWSD reservoir

The South Fork of Rose Creek above the reservoir has a gradient ranging from 2% near the reservoir increasing to 5% above the haul road. The dominant substrate in this section is boulder with cobbles and gravels, as shown in Photo 7. The north tributary to the reservoir is somewhat incised and has a dominant substrate of cobble and boulders, Photo 8. The southeast tributary has a somewhat different character with a substrate dominated by fine material interspersed with boulders, Photo 9. The South Fork of Rose Creek, downstream of reservoir (Figure 2.9), is a low gradient, sinuous channel altered by beaver activity, Photo 10. The substrate in this area is primarily fine sediment. The current position of the South Fork of Rose Creek is shown in Figure 2.9 as being slightly different than the original position.

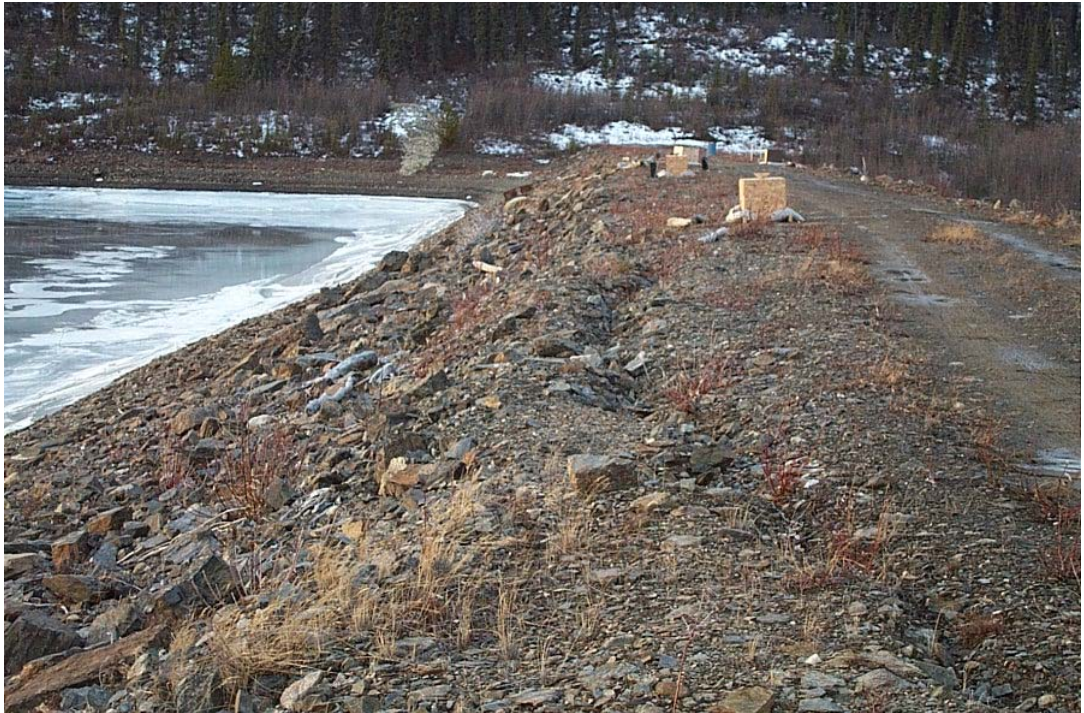
Photo 11: View of the exposed reservoir base near the south abutment of the FWSD

Two samples, from near the location of the LLO inlet, were collected during the recent diving inspection, the samples were tested to determine their grain size and metals content. Two photos of the exposed surface of the reservoir base, Photos 11 and 12, show that the soils consist of mostly coarse grained soil. The results of the grain size testing (Figure 2.10) indicated that the samples were sand with some silt. A copy of the results of the metal testing is included in Table 2.10. Note that based on its angularity, the gravel component is thought to be the result of contamination from the gravel cover overlying the upstream seepage blanket, and not part of the natural sediment. During the summer of 2002 the reservoir was temporary drawn down by approximately one metre and Photos 13 and 14 were taken near the inlet to the FWSD reservoir. These photos indicate that the sediment at this location is finer grained than the samples that were collected at the FWSD. During the planned testing program for sediment thickness additional samples will be collected and their grain size determined.

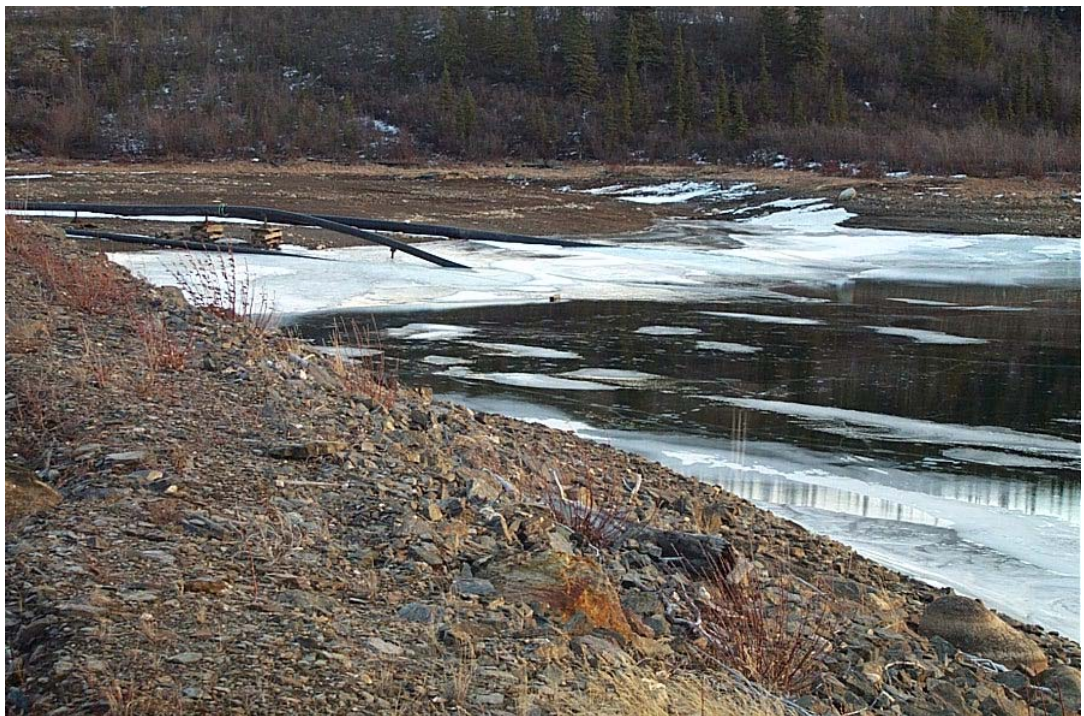
Photo 12: View of the exposed reservoir base, near the spillway
