Anvil Range Mine Complex 2006 Annual Environmental Report Water Licence QZ03-059

Prepared for
Deloitte & Touche Inc.
(acting as Court Appointed Interim Receiver for
Anvil Range Mining Corporation)

Submitted by
Gartner Lee Limited

February 2007

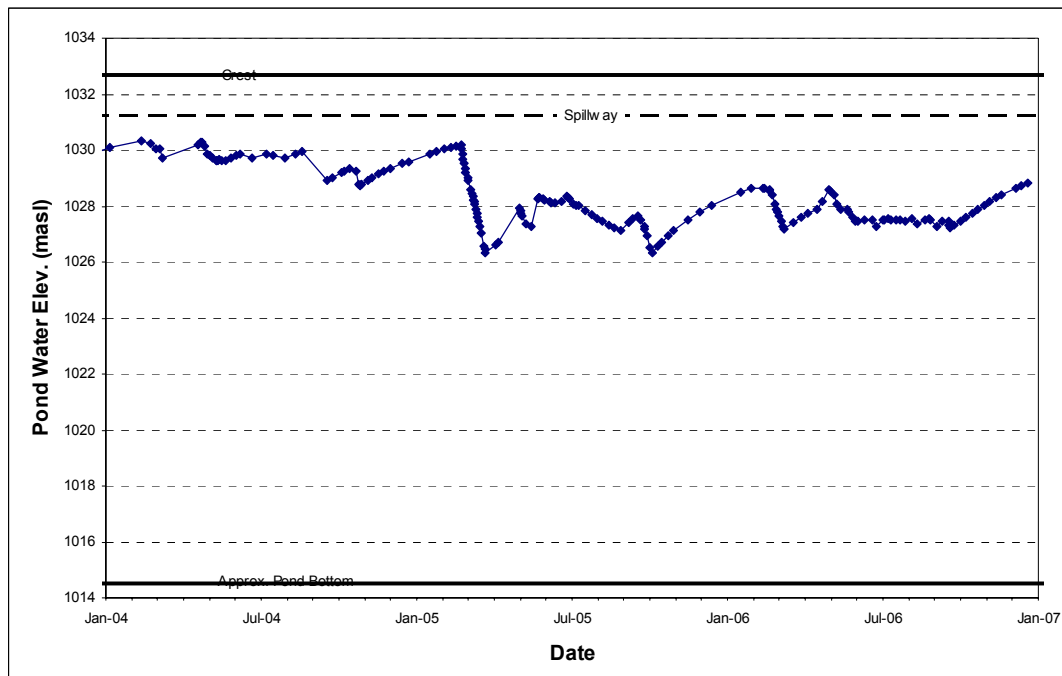
Figure 2-5. Cross Valley Pond Water Level, 2004-2005

Figure 2-5 illustrates the water level measurements in the Cross Valley Pond from 2004 to 2006. The pond level was 0.54 m higher at year end (2006) than at the beginning of the year.

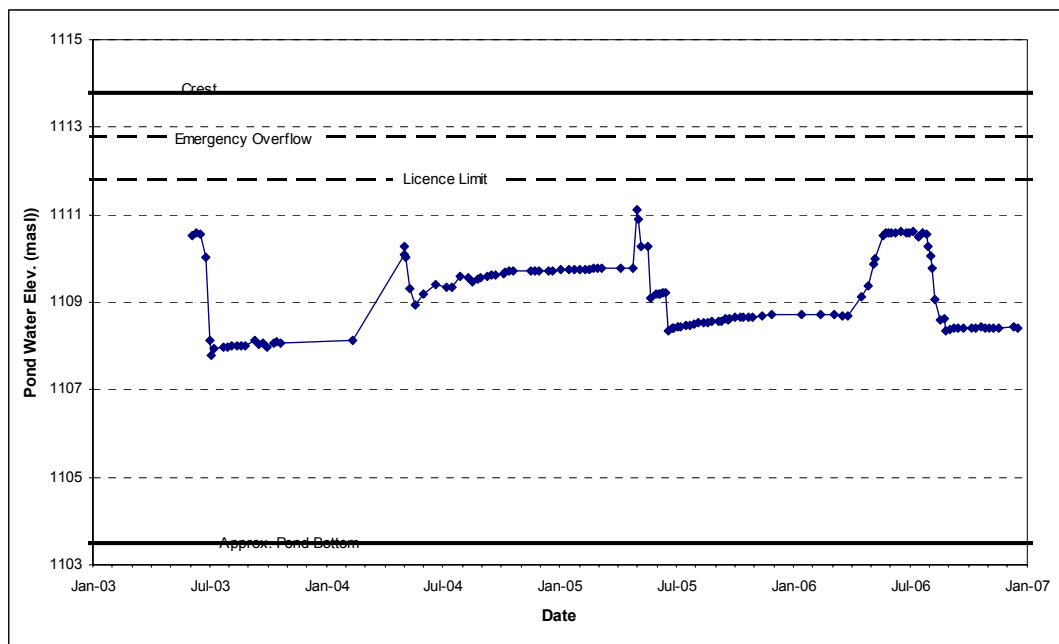
Figure 2-8. Little Creek Dam Pond Water Levels, 2003 to 2006

Figure 2-8 illustrates the water level measurements in Little Creek Dam Pond from 2003 to 2006. The pond level was approximately 0.3 m lower at year end than at the beginning of the year. The Water Licence requires that the water level in Little Creek Dam Pond be maintained no less than 1 m below the overflow structure (Part B, Item 26). This was achieved through 2006.

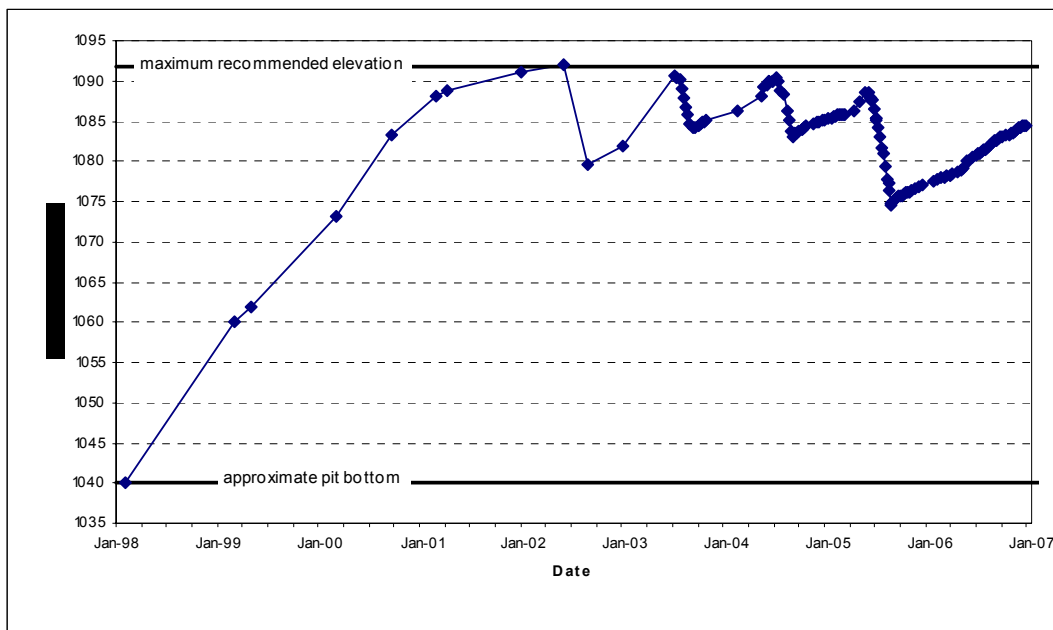
Figure 2-9. Filling Curve for Vangorda Pit, 1998 to 2006

The filling curve for the Vangorda pit through 2006 is illustrated on Figure 2-9. The Water Licence requires that the water level in the Vangorda pit be maintained below 1092.0 m asl (Part B, Item 25). This was achieved through 2006.

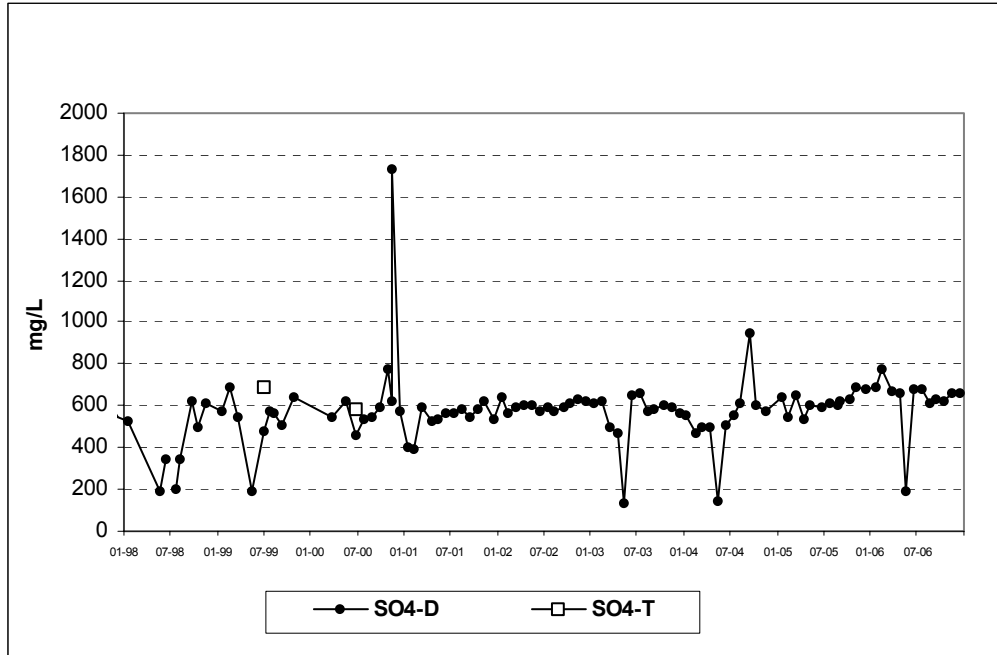
Figure 3-1. Sulphate at X22B

Sulphate (SO₄) concentrations ranged from 191 mg/L to 774 mg/L at station X22B during 2006, with an average concentration of 627 mg/L. The concentrations of total and dissolved zinc (Zn) at location X22B in 2006 ranged from 6.72 mg/L to 16.4 mg/L and from 6.14 mg/L and 14.8 mg/L, respectively, with average concentrations of 13.5 mg/L and 12.3 mg/L, respectively. Concentrations of SO₄ and Zn observed in 2006 are within ranges typically observed at this site in recent years (Figures 3-1 and 3-2).

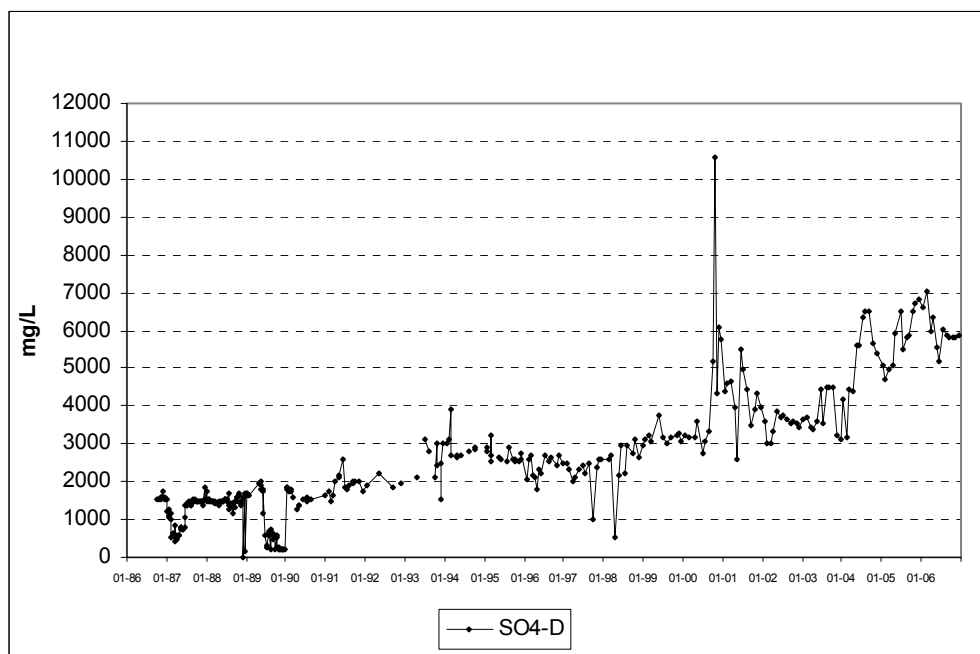
Figure 3-6. Sulphate at X23

Twelve monthly samples were collected at location X23 in 2006. Sulphate concentrations were generally higher than the previous year, averaging 5,799 mg/L, continuing a generally increasing trend observed at this location since 1998 (Figure 3-6).

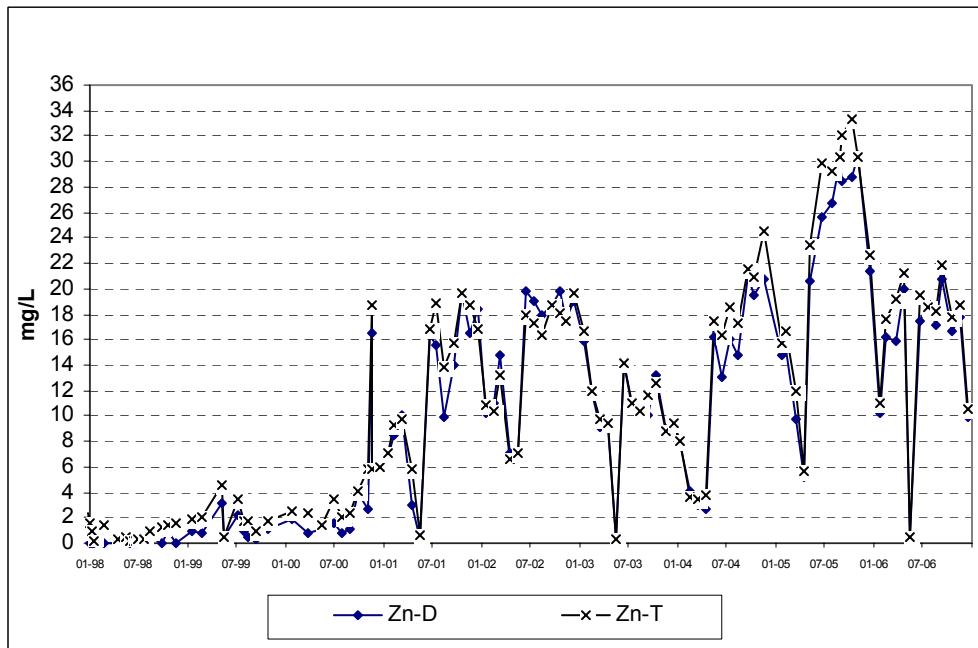
Figure 3-13. Zinc at X4

The concentrations of total and dissolved Zn at location X4 ranged from 0.54 mg/L to 21.8 mg/L and from 0.49 mg/L to 20.8 mg/L, respectively, with average concentrations of 16.2 mg/L and 15.1 mg/L, respectively. Zinc concentrations within the Intermediate Pond in 2006 were less than the previous year (Figure 3-13).

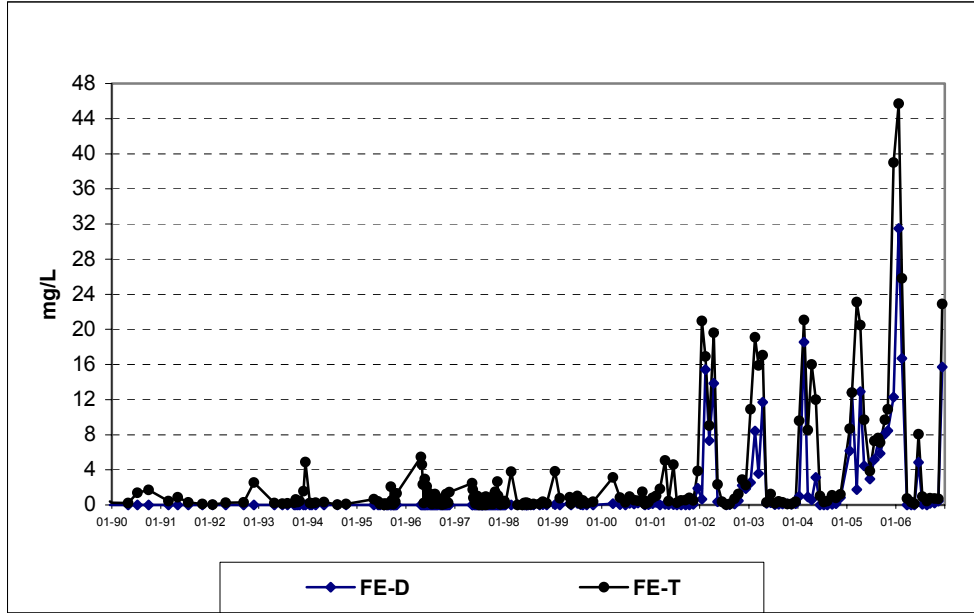
Figure 3-14. Iron at X4

Since 2002, iron (Fe) concentrations in the Intermediate Pond have followed a seasonal trend with maximum concentrations observed during the winter months and minimum concentrations observed during the summer months. Prior to 2002, Fe concentrations at X4 ranged from <0.01mg/L to 5.48 mg/L. Total and dissolved iron concentrations in 2006 are consistent with those typically observed at this site over the last four years, ranging from 0.15 mg/L to 45.7 mg/L and 0.05 mg/L to 31.5 mg/L, respectively (Figure 3-15).

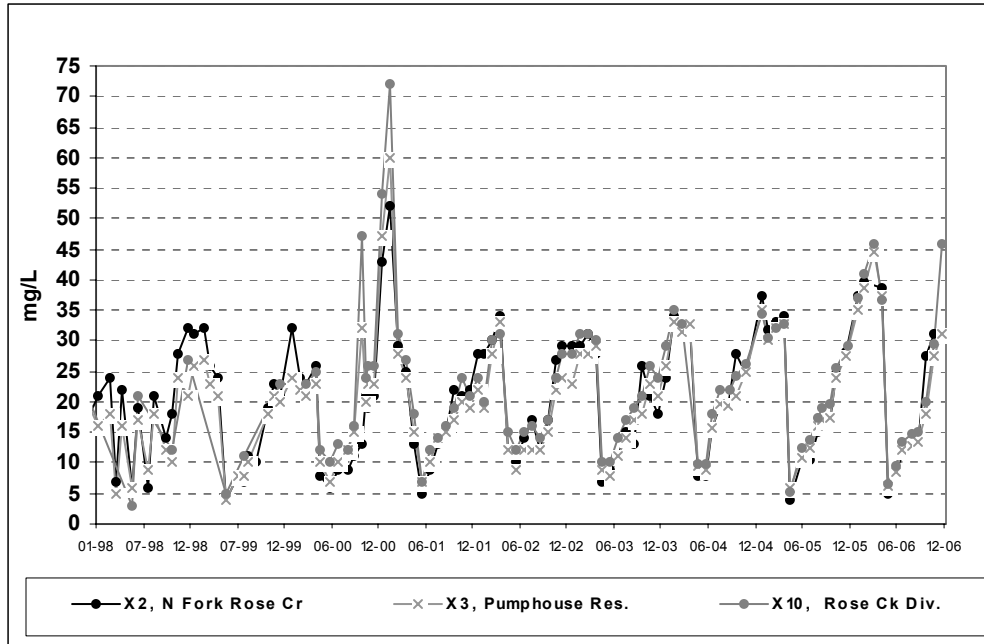
Figure 3-23. Sulphate at X2, X3, X10

Trends in Zn and SO₄ concentrations at location X2, X3, and X10 generally mirror one another, with seasonal fluctuations of both constituents represented by higher concentrations observed during winter months (Figures 3-23 and 3-24). Iron and Pb peaked in concentration at all three stations during the month of May.

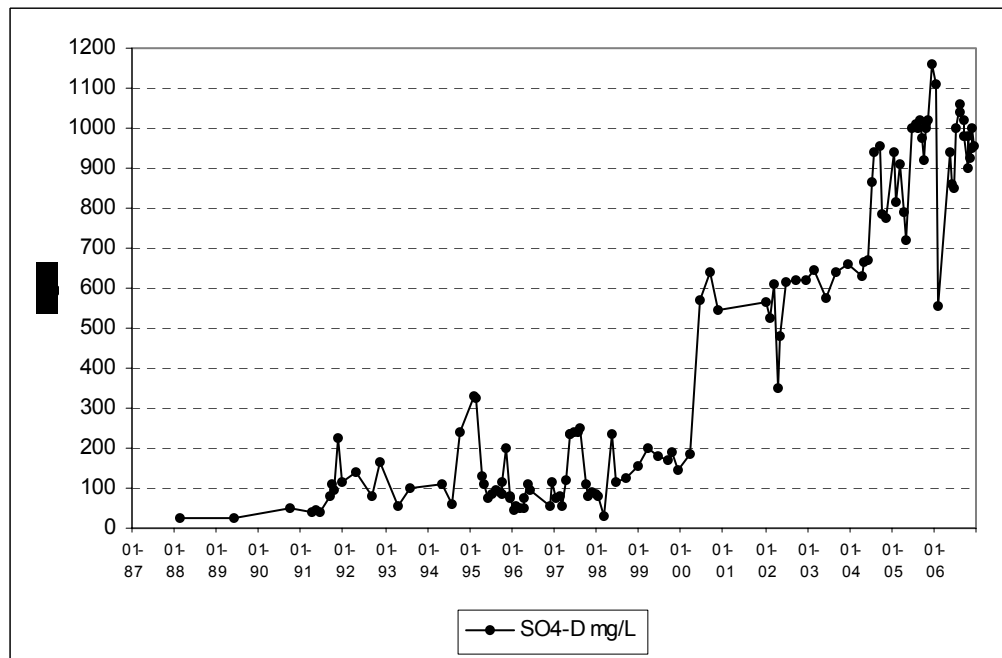
Figure 4-7. Grum Creek (V2) Sulphate

The concentrations of SO₄ at location V2 in 2006 ranged from 554 mg/L to 1,110 mg/L (Figure 4-7). An increasing trend in the concentration of SO₄ at V2 is evident from 1989 (beginning of sample record) through 2006, with a sharp increase observed in 2000. There has not been a corresponding increase in the concentrations of total or dissolved Zn. This trend in SO₄ is consistent with upstream location V15 (Section 4.2.2). The SO₄ concentrations are higher at location V15, which is reasonable given that it is a smaller flow closer to the suspected source, the Grum rock dump.
