**2010 ANNUAL ENVIRONMENTAL MONITORING AND ACTIVITY
REPORT
FARO MINE COMPLEX – FARO, YT**

Denison Environmental Services
Faro Care and Maintenance Project
4109 4th Avenue
Suite 207
Whitehorse, YT
Y1A 1H6

Annual Environmental Monitoring and Activity Report – 2010

Faro Mine Complex – Faro, YT

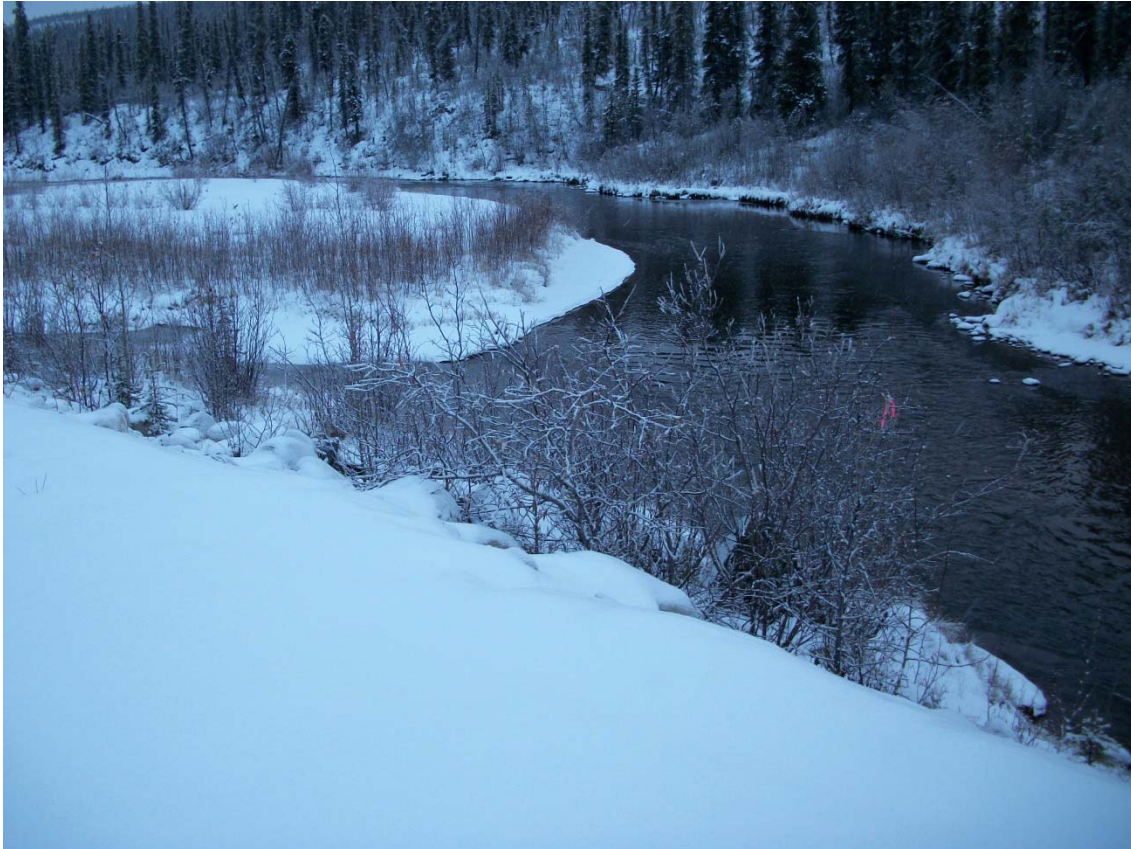
Cover photo of monitoring station X3A.
Photo taken by Jay Cherian, DES Environmental Coordinator
