## **Anvil Range Mine Adaptive Management Plan**

**AECOM Canada Ltd.**

February, 2009

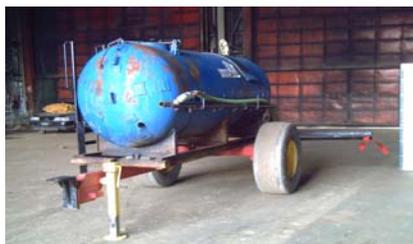
Tank on Chassis

A 1000 U.S. gallon tank was available on site and was mounted onto a chassis with a hitch and axel to provide mobility for the tank when spraying, and when moving to and from site. Two spray arms with several nozzles that can be opened and closed individually as required were mounted to a valve at the back end of the tank. These bars, when not in use, can be detached and placed on the side of the tank along with any hoses. A pump sits on the back end of the chassis where the spray bars connect to the tank.

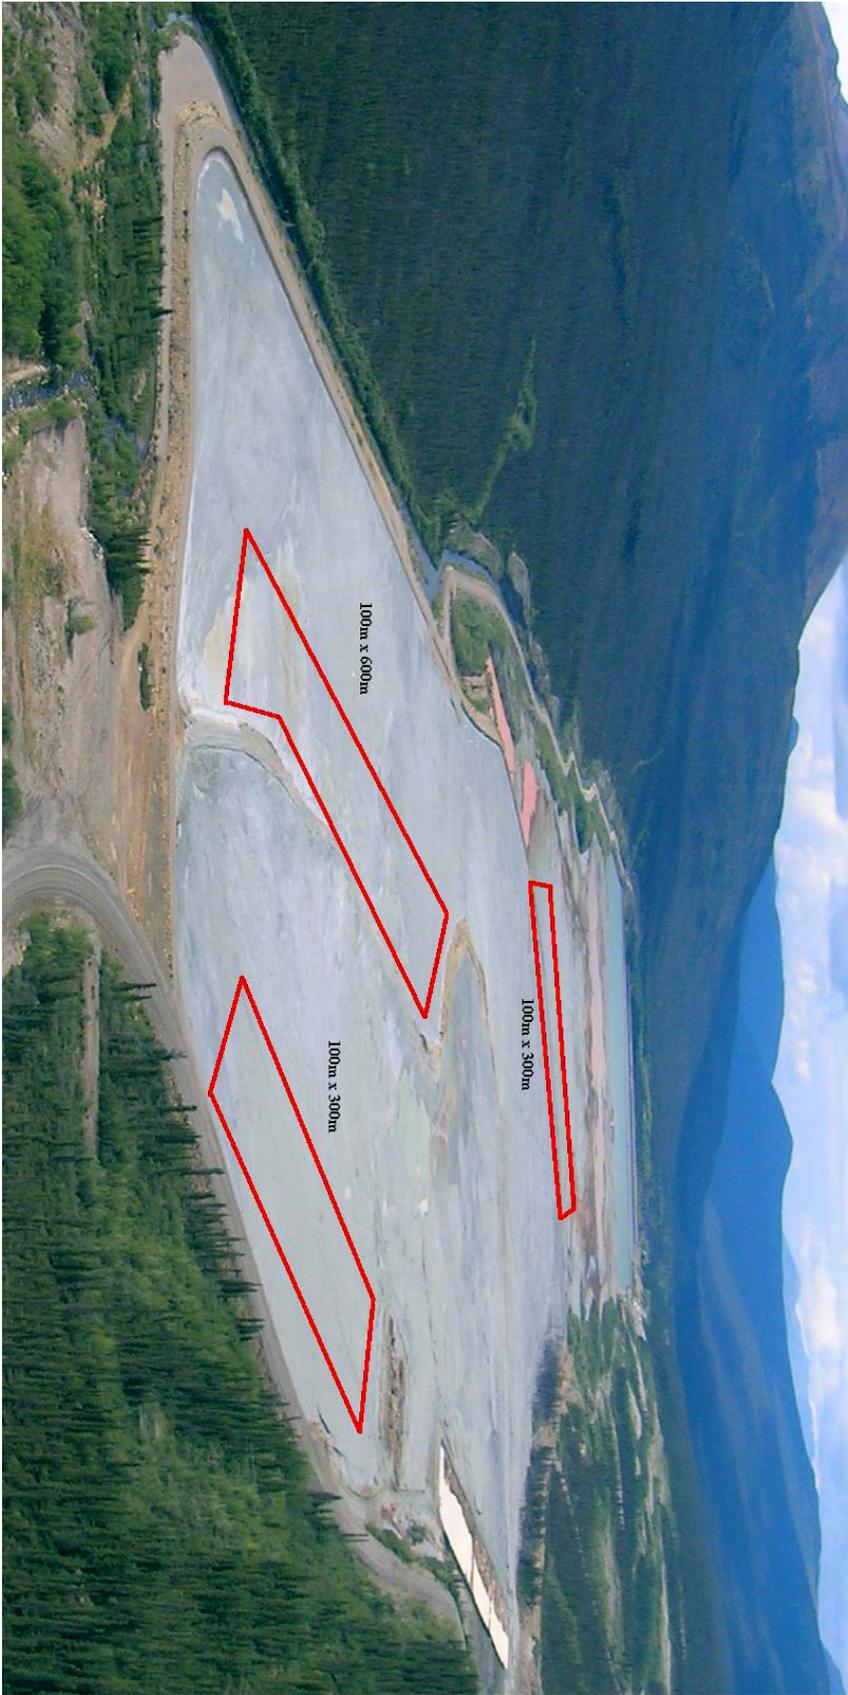
APPENDIX B:  
TAILINGS PERIMETERS

ANVIL RANGE MINE SITE  
TAILINGS DUST CONTROL  
TEST PROJECT

The three selected areas of the tailings impoundments, which can be seen in Appendix B, were staked out for testing. At all three of the areas identified the stakes were placed in rows spaced at intervals of 6.5m marking the path that should be followed when spraying to ensure the best coverage. Rows of stakes were placed every 25m along the bottoms of the different impoundment dams.
