MEMO

Date 24 July 2013
Subject **Mount Nansen Remediation Project**
Data Gap Analysis

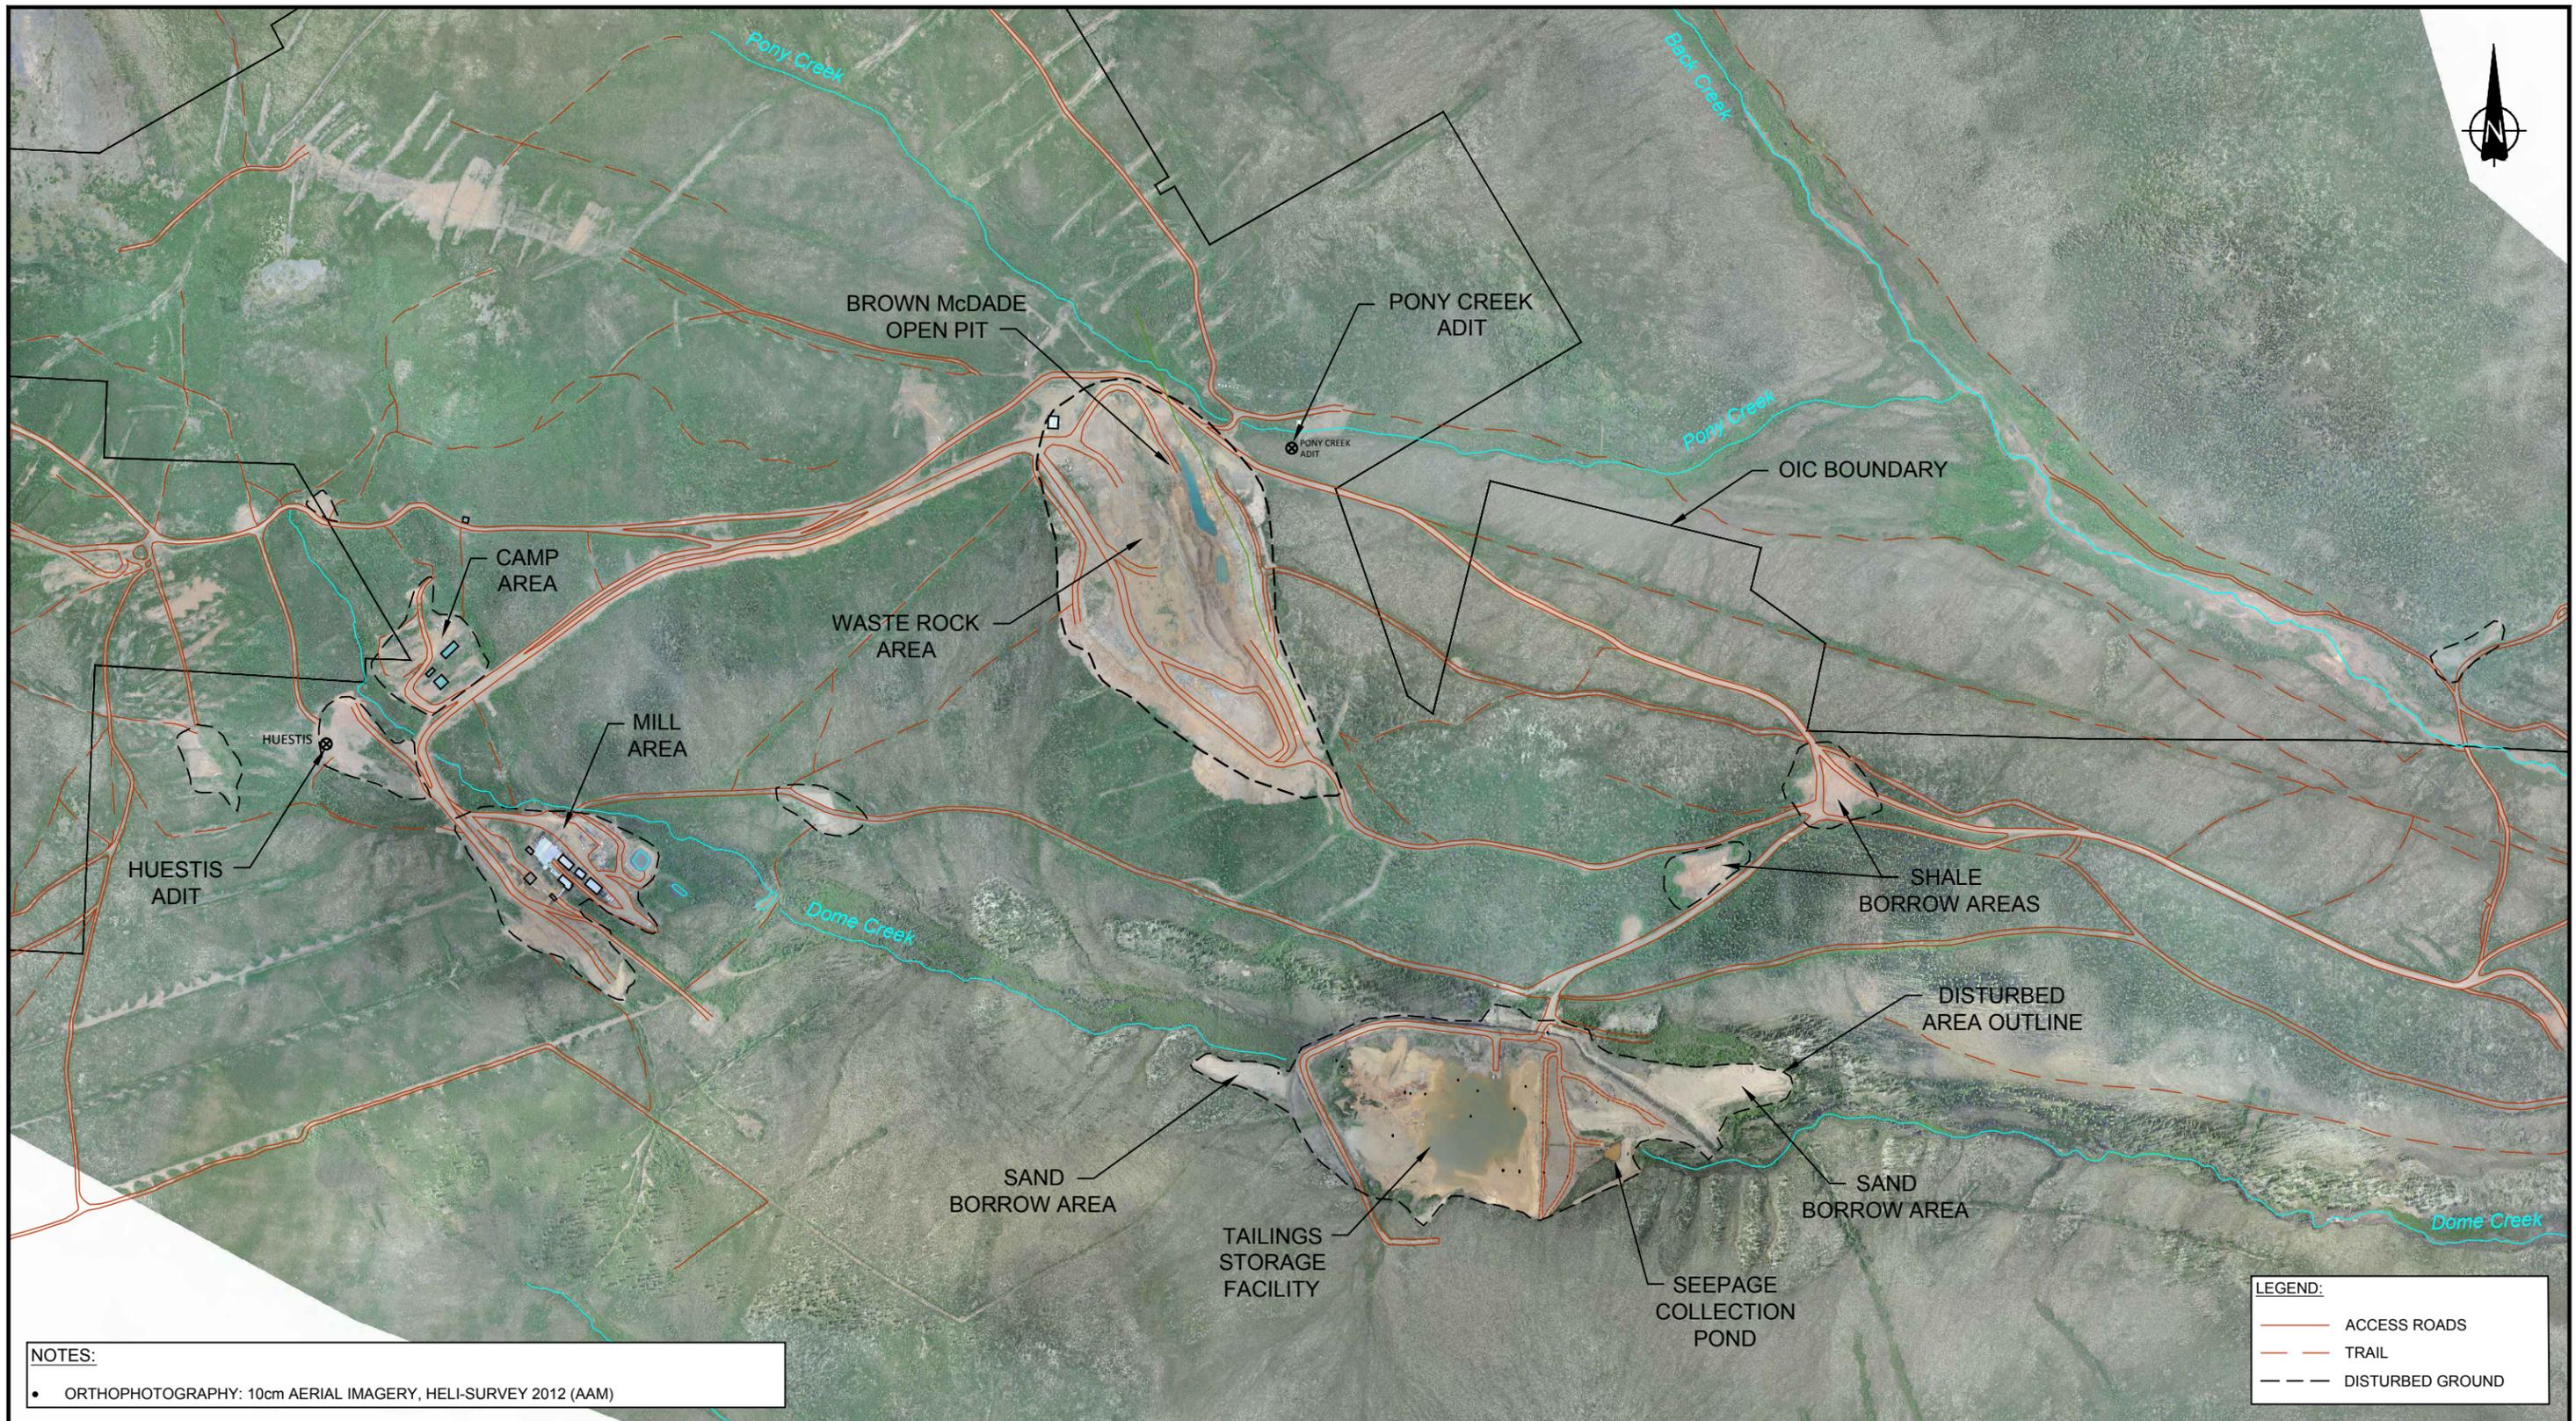
DATE: JULY 2013
 PROJECT NO: VM00605
 REV. NO: A
 FIGURE NO: 1

TITLE: **GENERAL SITE PLAN**

A site plan showing the current condition at the Mount Nansen site is included in Figure 1. The selected remediation plan involves the following key features:

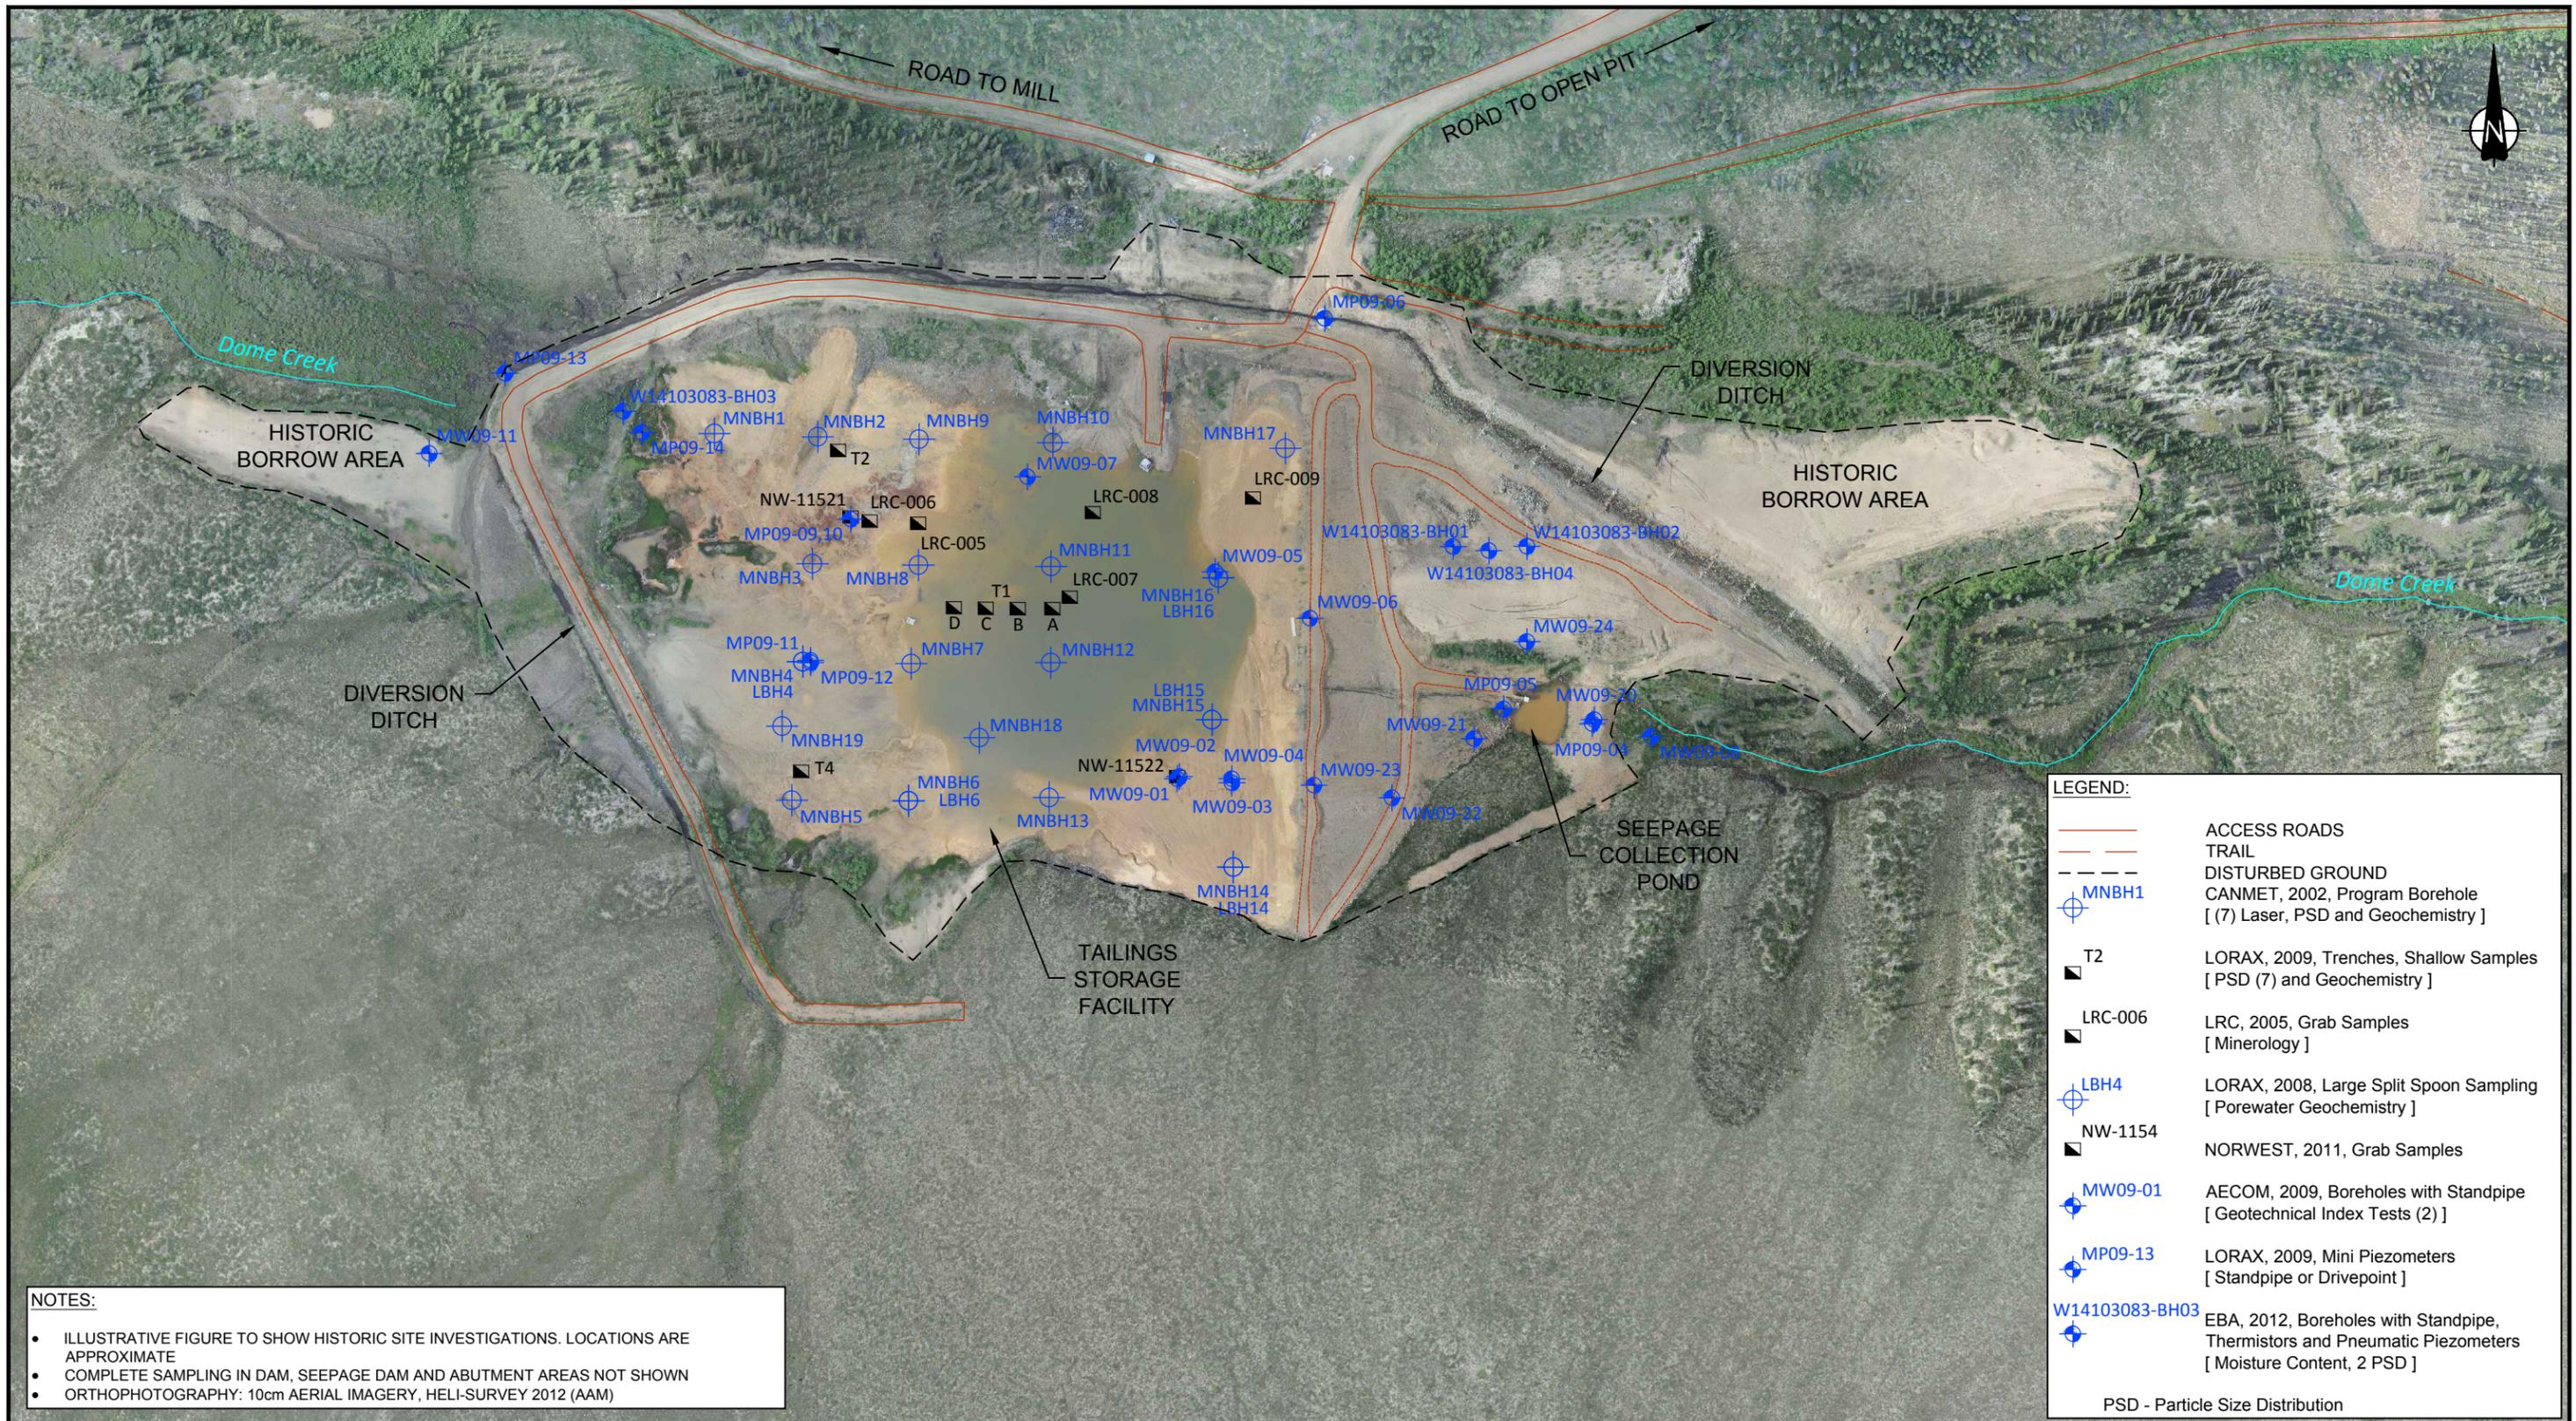
- ILLUSTRATIVE FIGURE TO SHOW HISTORIC SITE INVESTIGATIONS. LOCATIONS ARE APPROXIMATE
- COMPLETE SAMPLING IN DAM, SEEPAGE DAM AND ABUTMENT AREAS NOT SHOWN
- ORTHOGRAPHY: 10cm AERIAL IMAGERY, HELI-SURVEY 2012 (AAM)

ACCESS ROADS
	TRAIL
	DISTURBED GROUND
	MNBH1 CANMET, 2002, Program Borehole [(7) Laser, PSD and Geochemistry]
	T2 LORAX, 2009, Trenches, Shallow Samples [PSD (7) and Geochemistry]
	LRC-006 LRC, 2005, Grab Samples [Mineralogy]
	LBH4 LORAX, 2008, Large Split Spoon Sampling [Porewater Geochemistry]
	NW-1154 NORWEST, 2011, Grab Samples
	MW09-01 AECOM, 2009, Boreholes with Standpipe [Geotechnical Index Tests (2)]
	MP09-13 LORAX, 2009, Mini Piezometers [Standpipe or Drivepoint]
	W14103083-BH03 EBA, 2012, Boreholes with Standpipe, Thermistors and Pneumatic Piezometers [Moisture Content, 2 PSD]

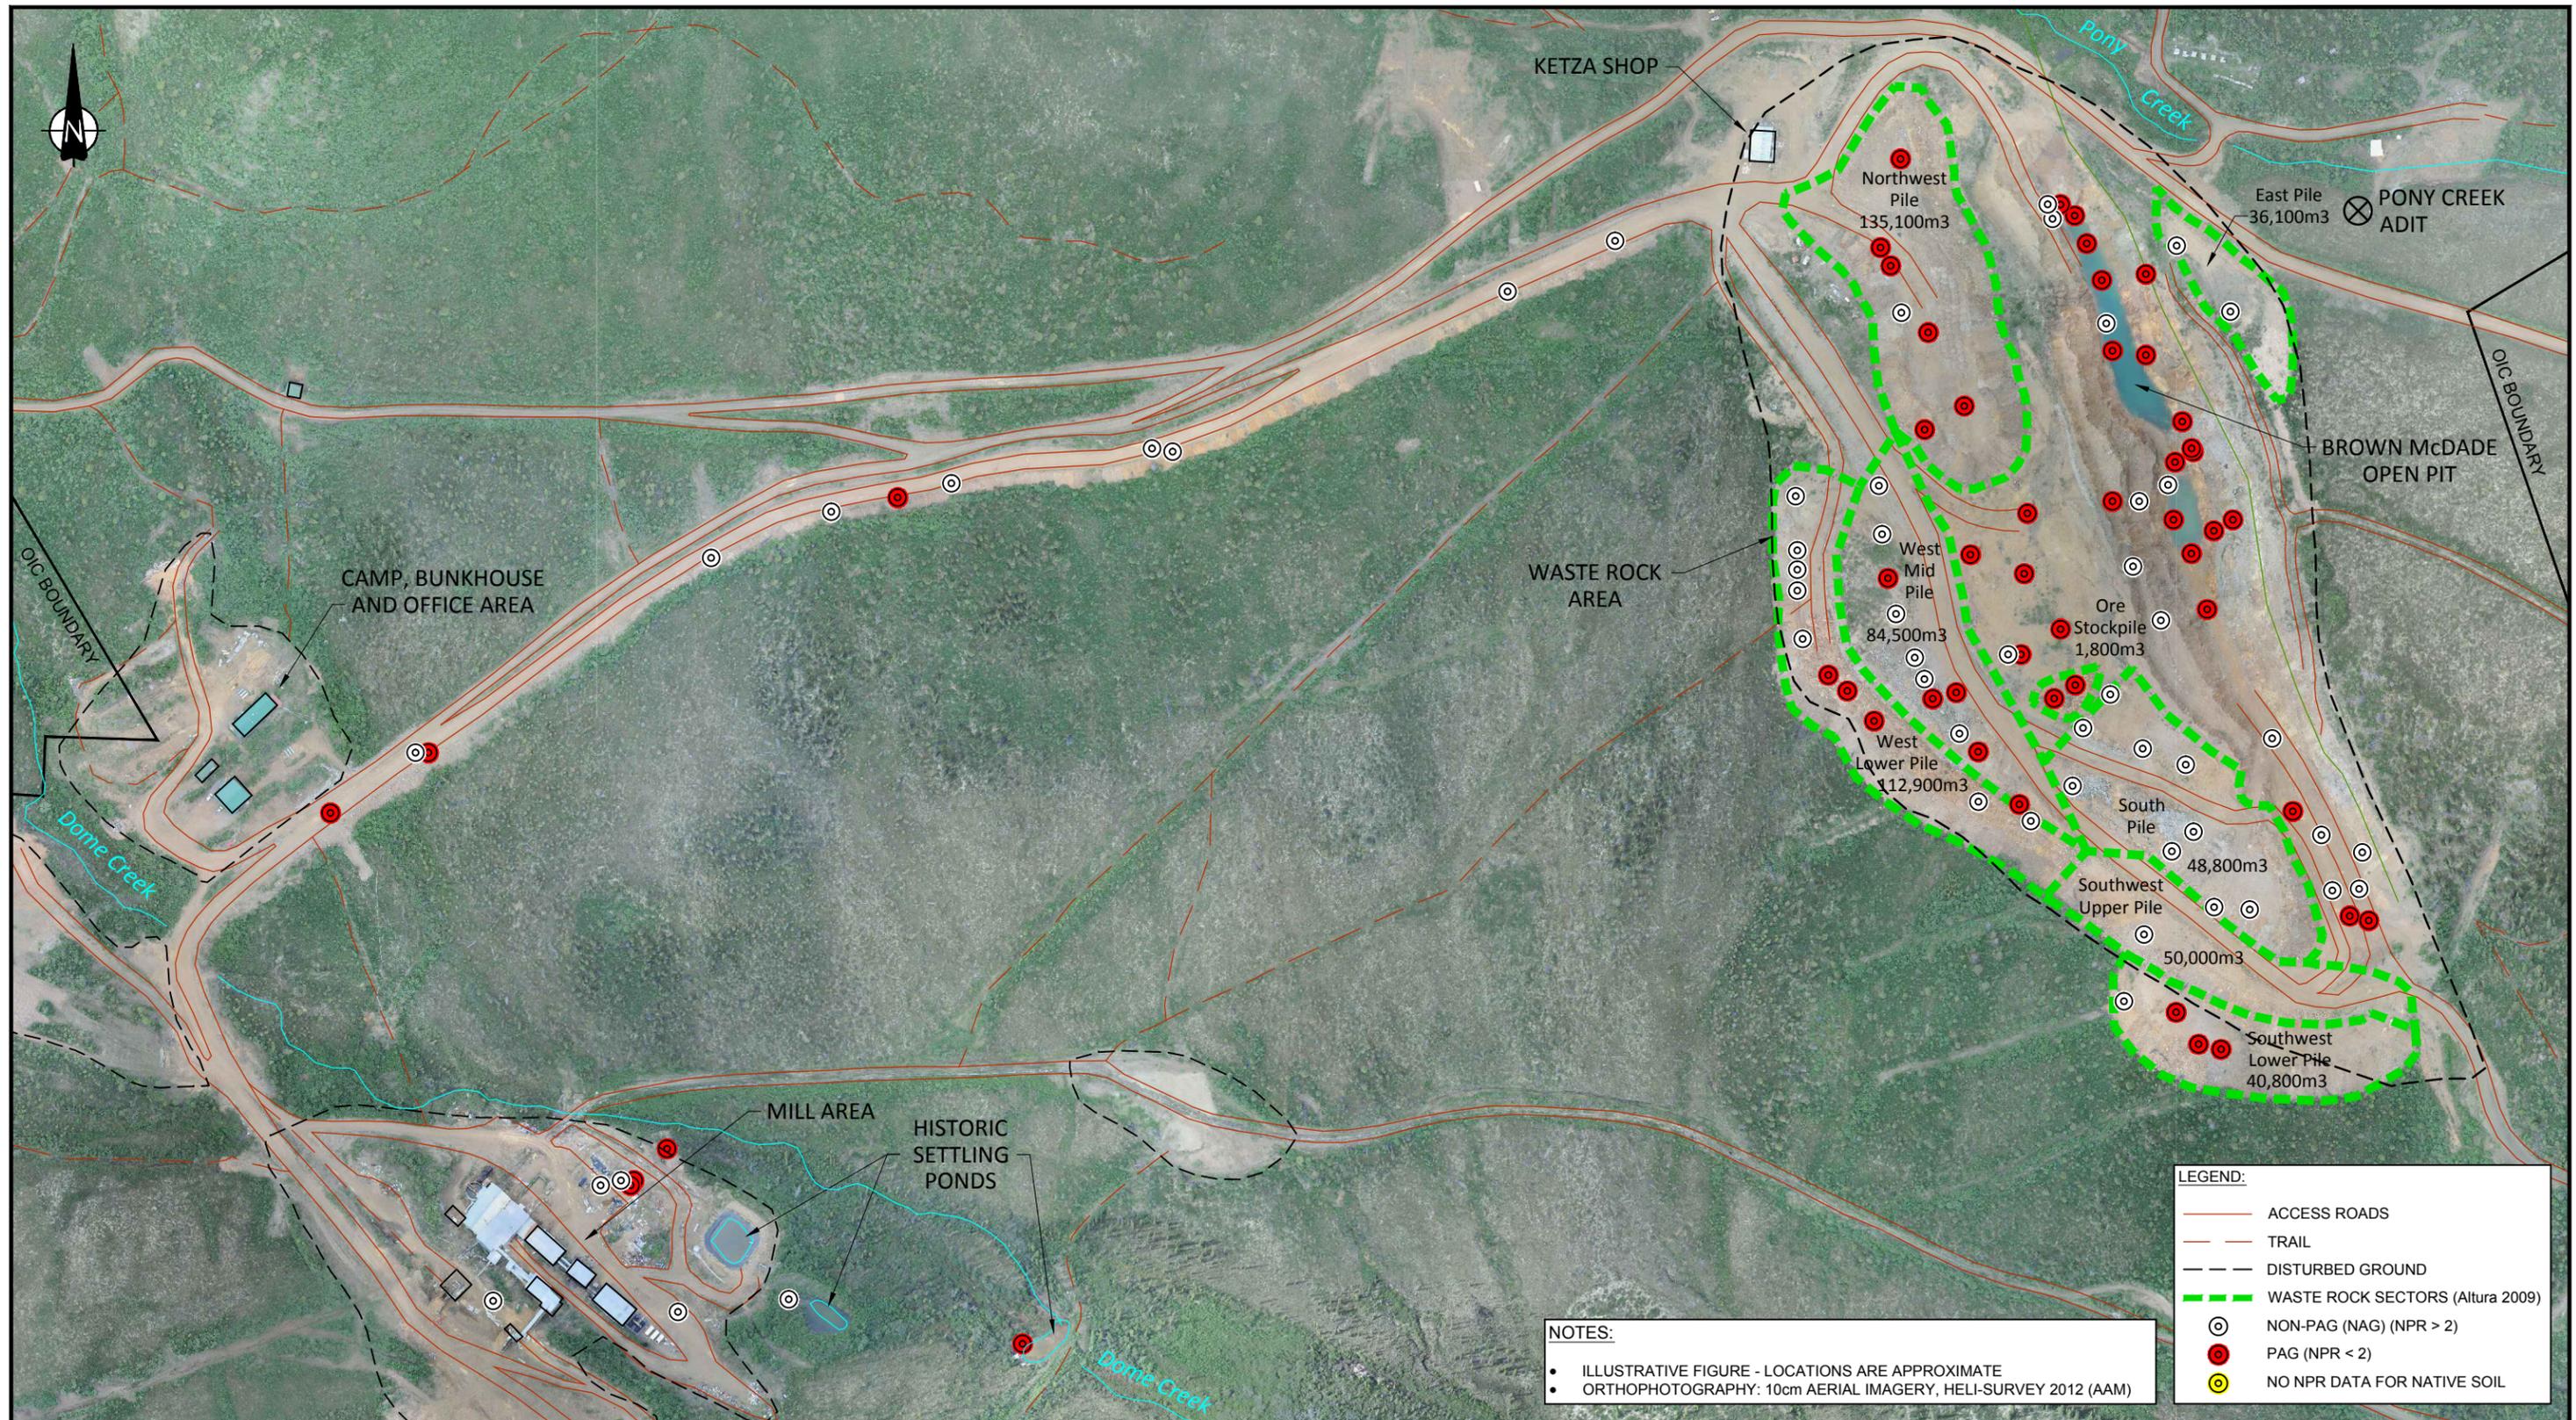
DATE: JULY 2013
PROJECT NO: VM00605
REV. NO: A
FIGURE NO: 3

PROJECT: **MOUNT NANSEN REMEDIATION PROJECT
GAP ANALYSIS**
TITLE: **HISTORIC GEOCHEMICAL TESTING
AT WASTE ROCK DUMP, PIT AND MILL SITES**

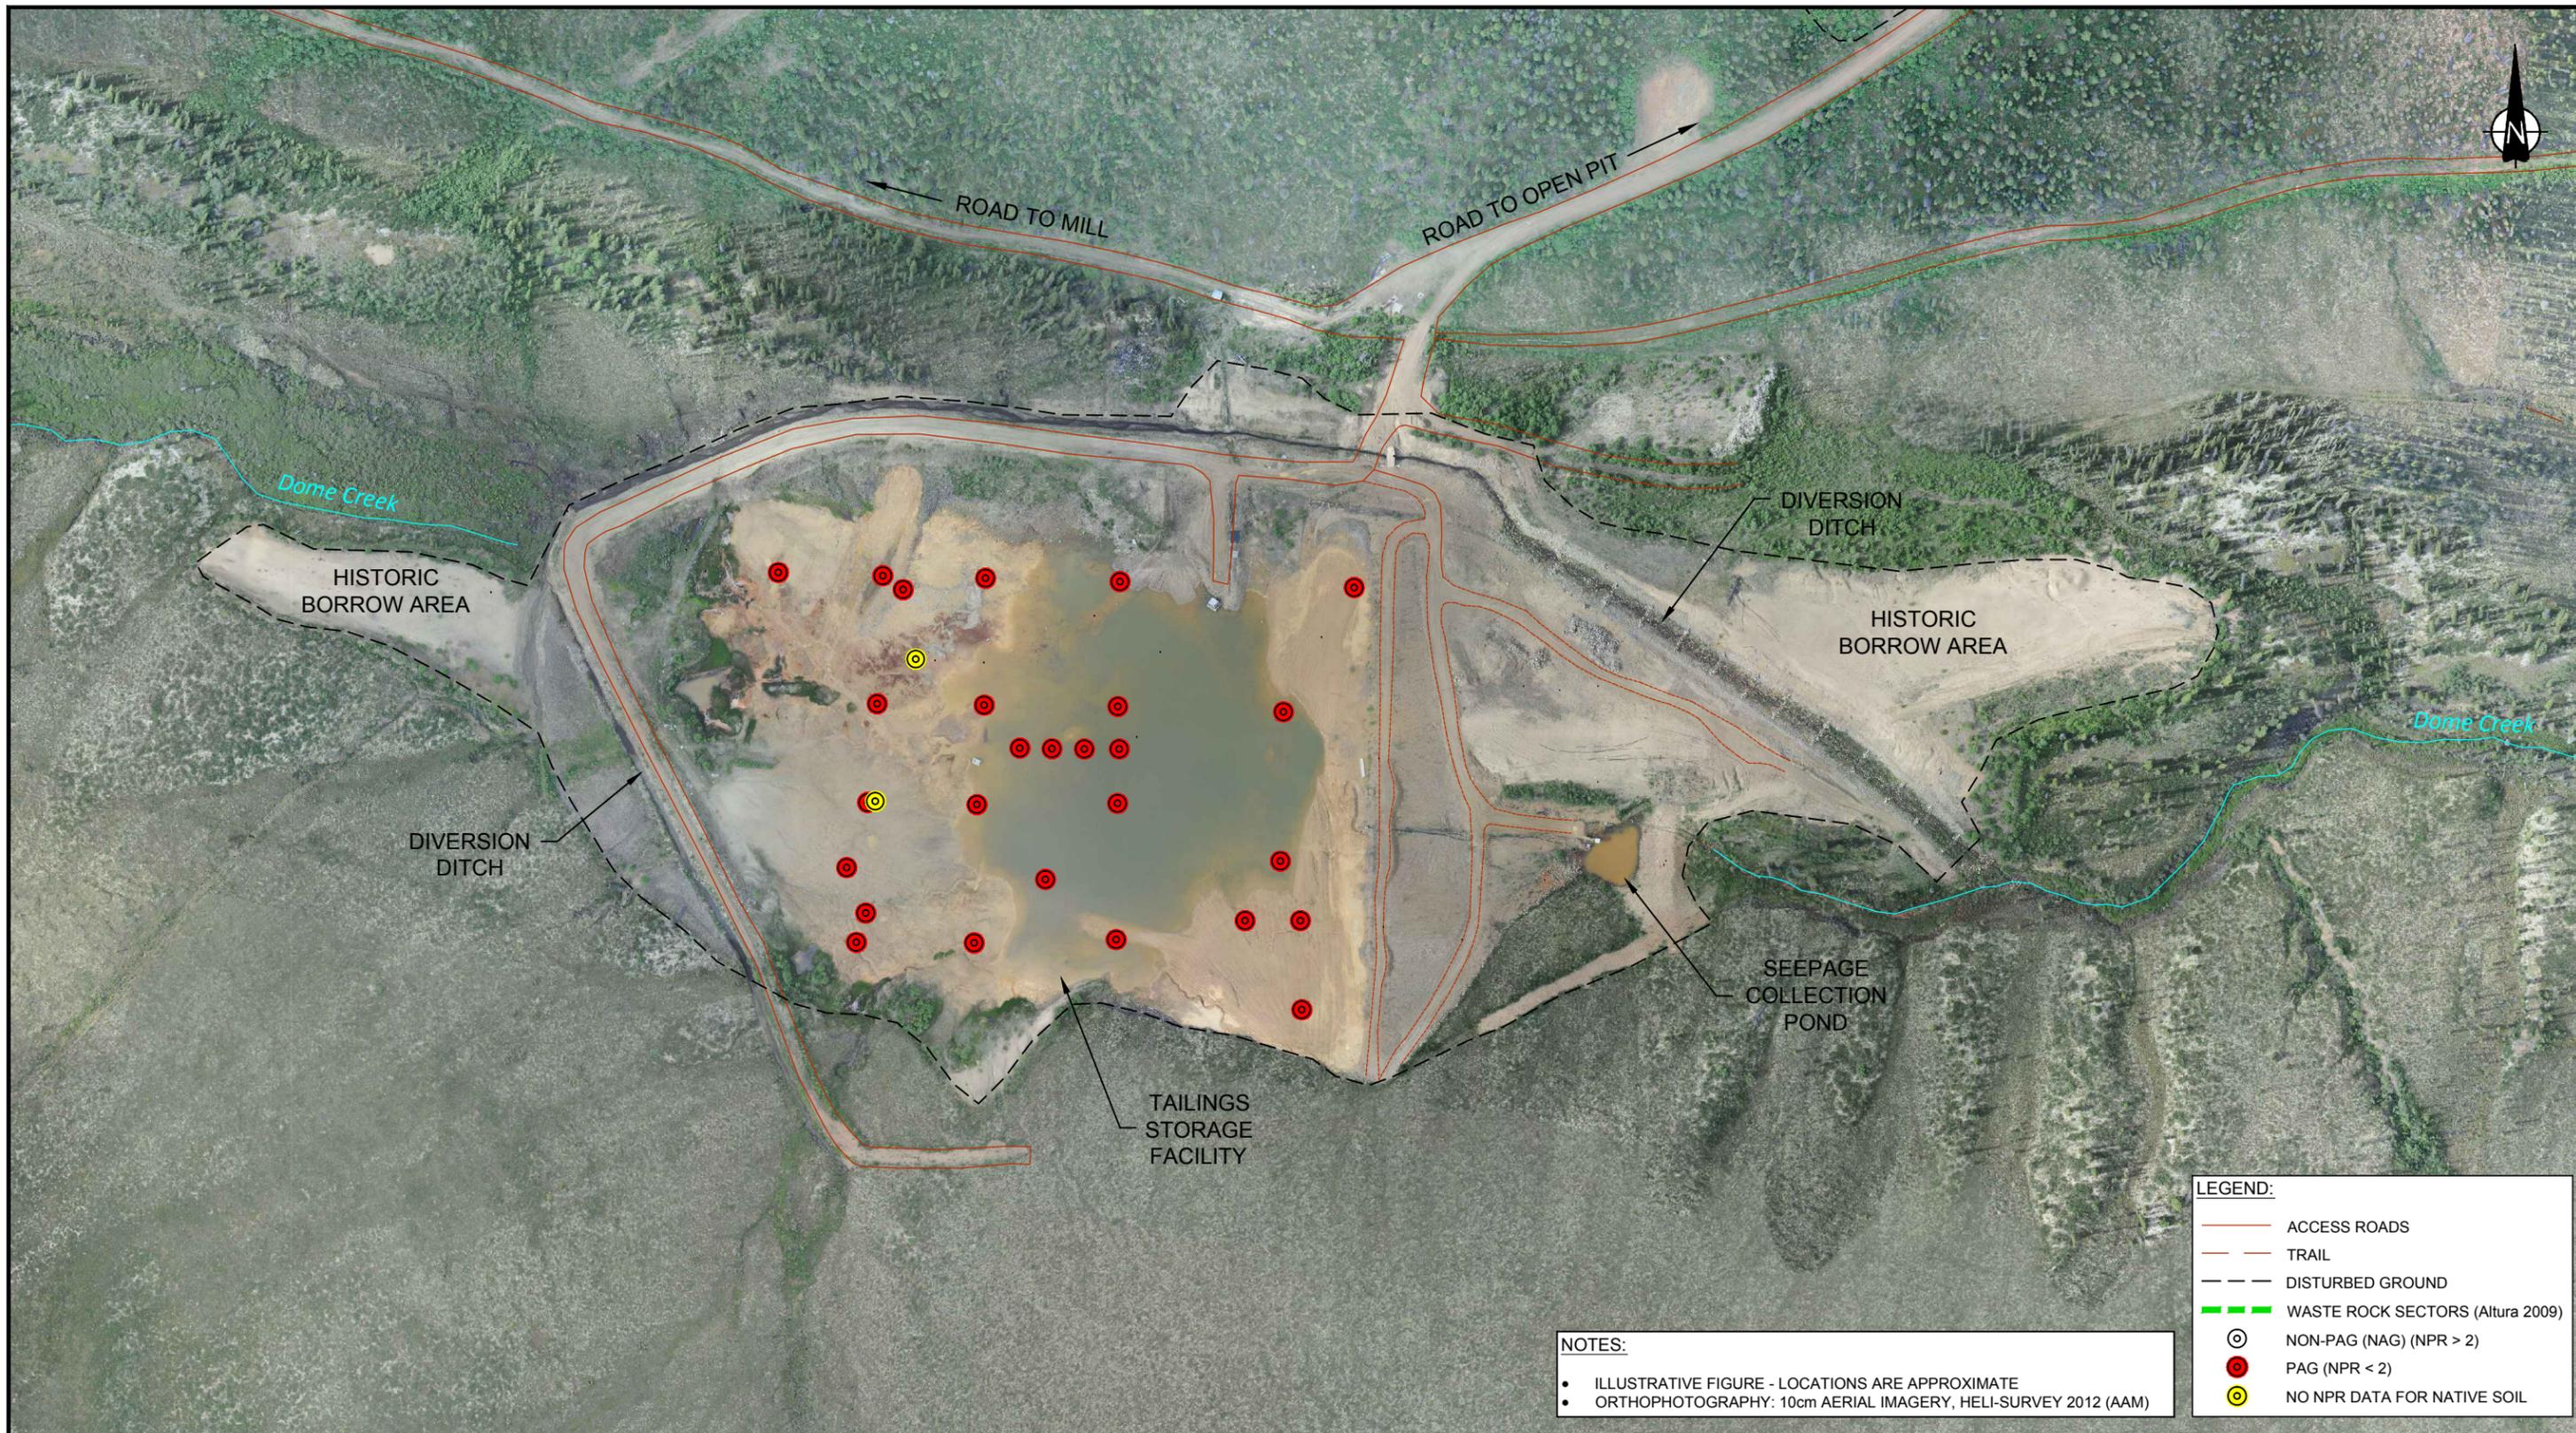
ACCESS ROADS
	TRAIL
	DISTURBED GROUND
	WASTE ROCK SECTORS (Altura 2009)
	NON-PAG (NAG) (NPR > 2)
	PAG (NPR < 2)
	NO NPR DATA FOR NATIVE SOIL
