# Mount Nansen Site

## **Tailings Facility and Associated Structures**

### **Operation Maintenance and Surveillance Manual**

*April 16, 2014*

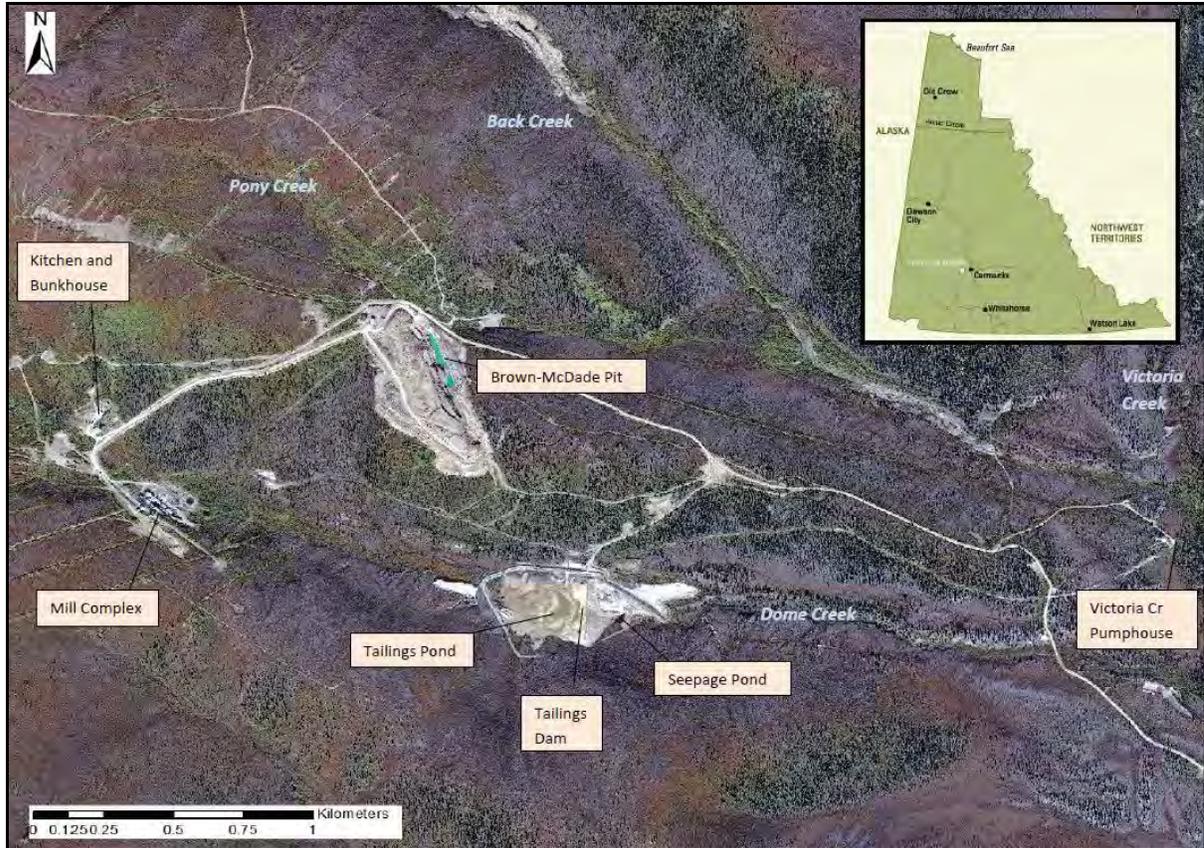
Figure 1 – Mount Nansen Site Layout

There are three major structures associated with the tailings facility at the Mount Nansen Site: the tailings dam, the seepage pond dam and the diversion channel berm/ditch. All of the structures are of prime importance where failure of any of the structures constitutes an emergency that must be addressed through the procedures and processes within the Emergency Response and Preparedness Plan (ERPP).
