# Mount Nansen Site

## **Tailings Facility and Associated Structures**

### **Emergency Response and Preparedness Plan**

*April 16, 2014*

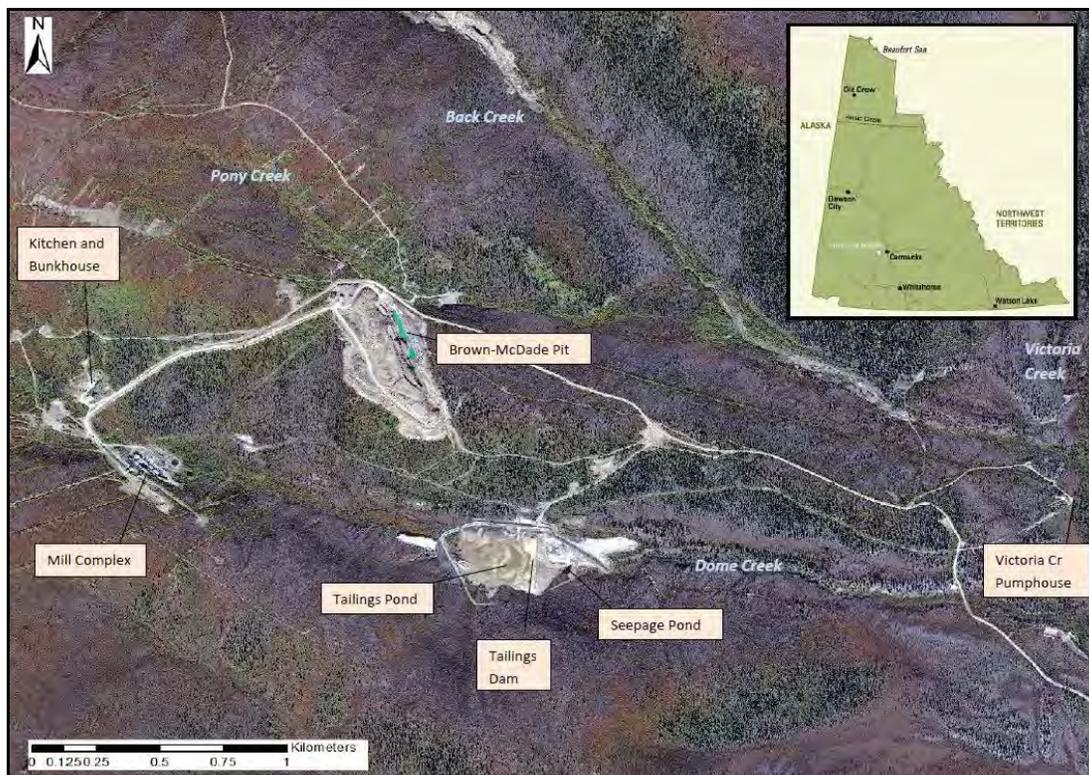
Figure 1 – Mount Nansen Site Layout

There are three structures associated with the Tailings facility at the Mount Nansen Site: the tailings dam, the seepage pond dam, and the diversion channel berm/ditch. All of the structures are of prime importance where failure of any of the structures constitutes an emergency which must be addressed through the procedures and processes within this document.
