Yukon Government,
Assessment and Abandoned Mines Branch

Mt. Nansen Surface Water Quality Baseline Characterization

AECOM
2251 2nd Avenue
Whitehorse, YT, Canada Y1A 5W1
www.aecom.com

November 2009

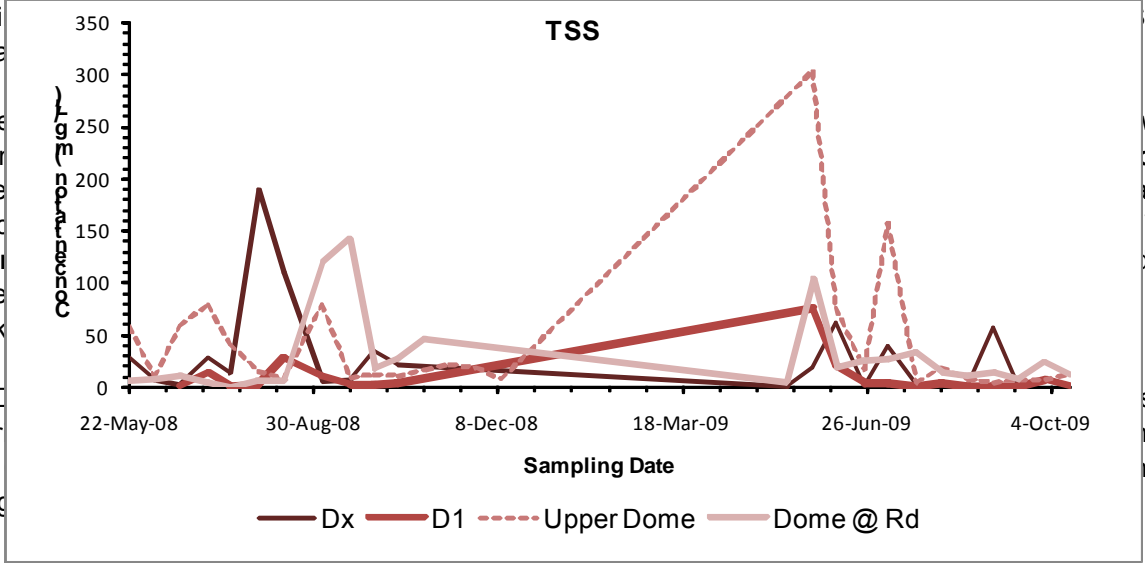
Figure 5. Concentrations of TSS, Total Aluminium and Total Iron in Dome Creek

The seasonal variability in total suspended solids concentrations (TSS) for the Mt. Nansen surface water quality data is shown in Figure 5 and

Figure 6 for Dome Creek and Victoria Creek, respectively. To identify a correlation between TSS and total metals concentrations, concentrations of total aluminum and total iron were compared with concentrations of TSS.

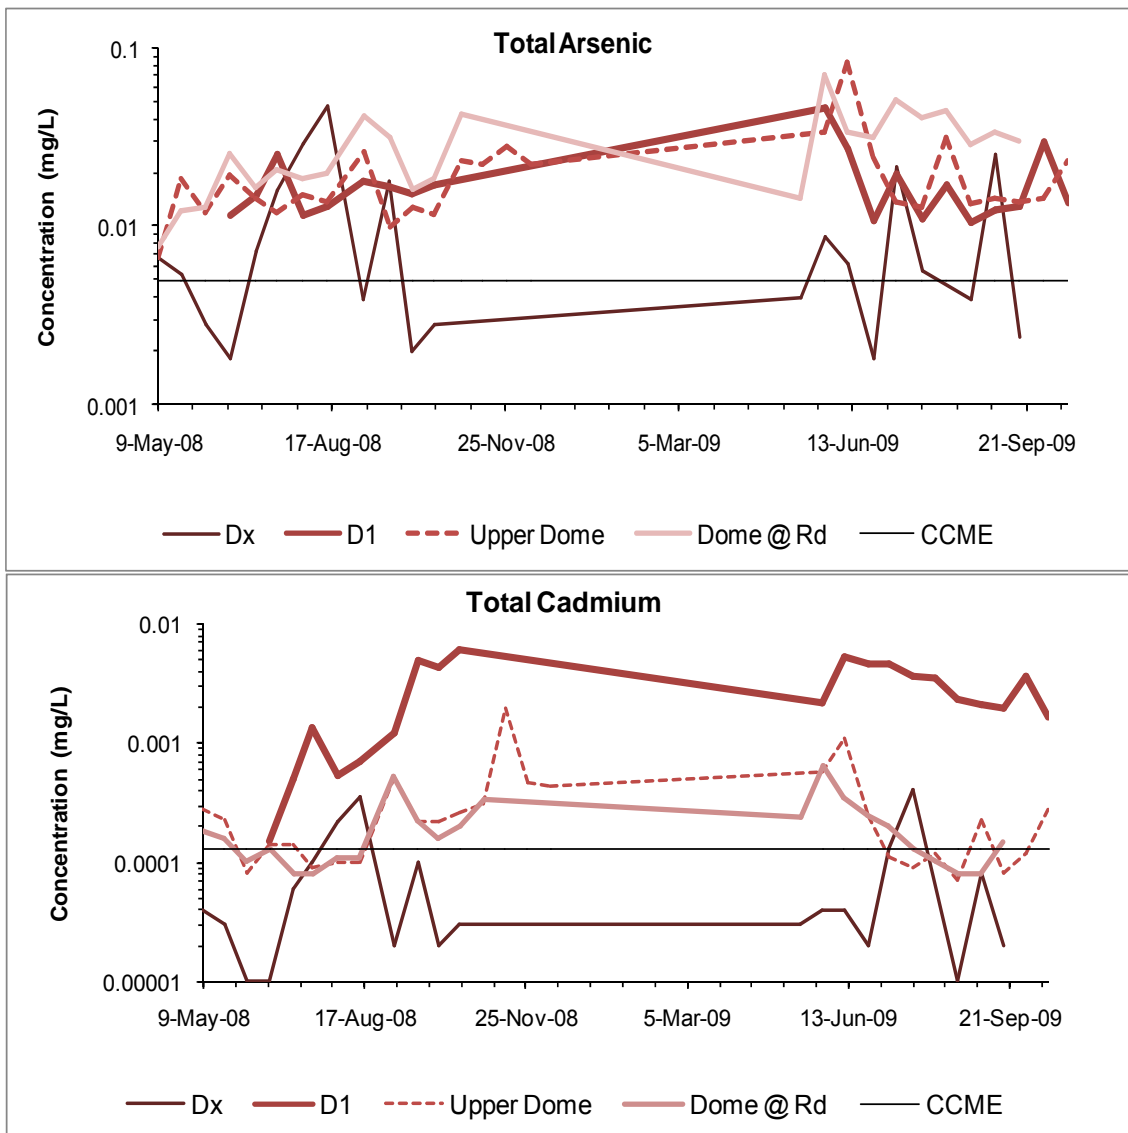
Figure 7. Concentrations of Total Arsenic and Total Cadmium in Dome Creek

The water quality on Dome Creek can be influenced by the mill site, Brown-McDade Pit, waste rock piles, tailings pond or seepage discharge pond. It appears that the uppermost site on Dome Creek, DX, exhibits lower concentrations of total metals than the sites further downstream. Some metals, such as arsenic, steadily increase in concentration in a downstream trend, while other metals, such as cadmium, spike in concentration immediately downstream of the mill site (D1) and then gradually attenuate downstream by Dome @ Rd (Figure 7). Generally, mine impacts on Dome Creek is varied depending on inputs from the mill site, tailings pond or seepage pond.

As D1 and Upper Dome are located just downstream of mill and tailings pond, they are considered to be part of the mine impacted area. The same set of parameters that exceeded CCME guidelines for D1 exceeded CCME guidelines for DX (although the magnitude of exceedance differs as shown in Section 4, Figure 7). CCME guidelines

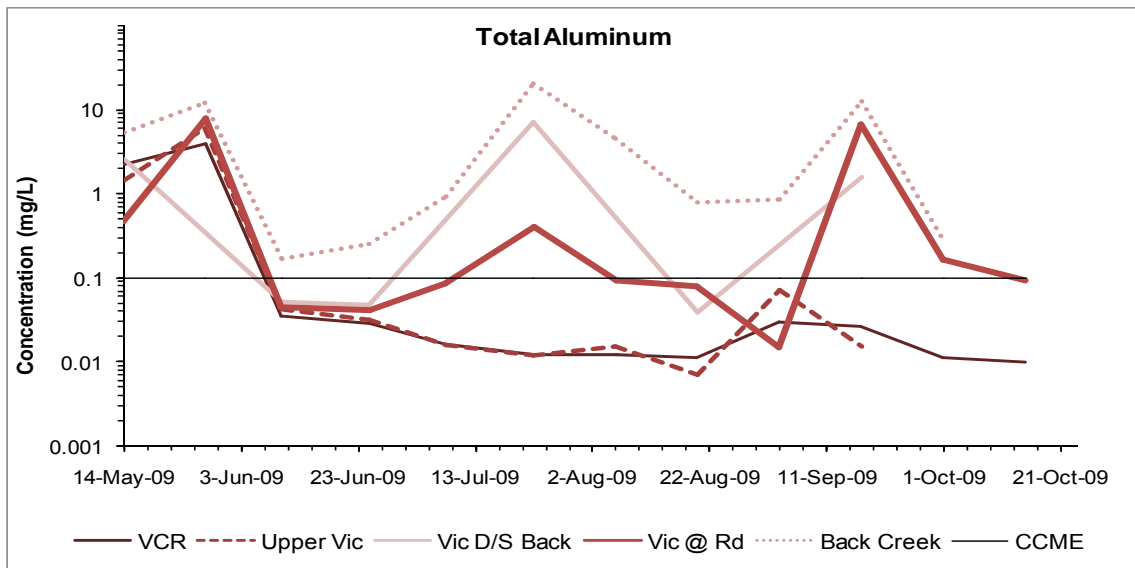
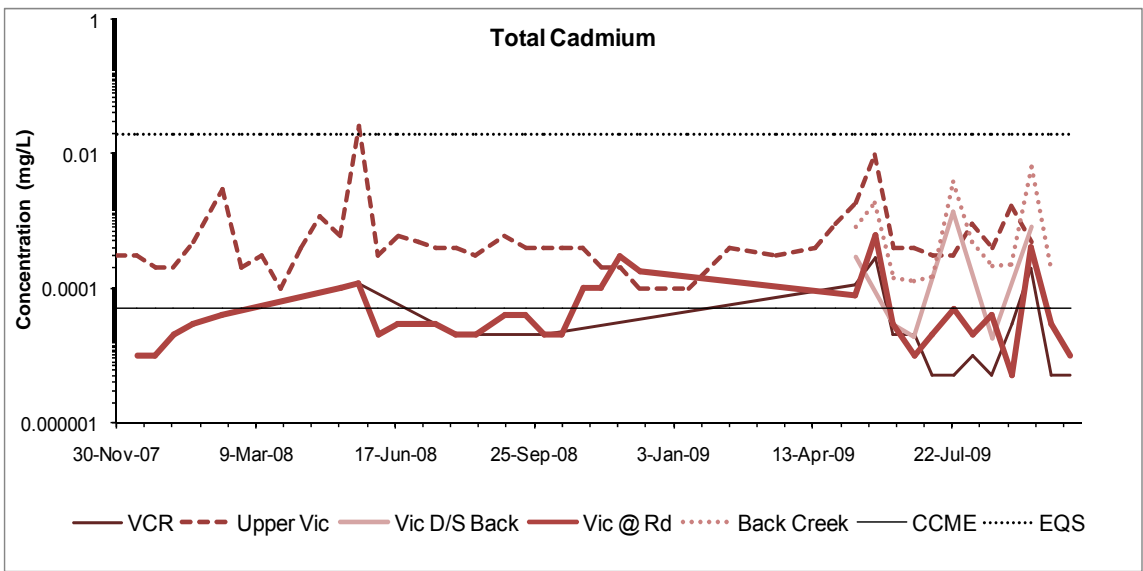
Figure 10. Concentrations of Total Aluminum and Cadmium in Victoria Creek and Back Creek

For the most part, concentrations of metals are similar between Victoria Creek reference stations VCR and Upper Vic, although there is evidence that the close vicinity of Upper Vic to Back Creek may have resulted in some backwater effects of Back Creek on the Upper Vic site. Figure 10 shows the concentrations of total aluminum and total cadmium in Victoria Creek and Back Creek. Although Pony Creek discharges into Back Creek, it appears that concentrations of some total metals in Back Creek are predominately affected by active placer mining operations on Back Creek. The high concentrations of TSS and metals associated with the active placer mine on Back Creek appear to be impacting Victoria Creek.

As there is strong evidence that Back Creek influences the water quality of Victoria Creek, the water quality downstream of Back Creek, but upstream of Dome Creek is considered the most representative of background water quality. This water quality was back-calculated from water quality concentrations and flows on the Upper Victoria Creek site and the Back Creek site and is shown in Appendix E. This background site is represented on Figure 10 and Figure 11 by "Vic D/S Back".
