Yukon Government,  
Assessment and Abandoned Mines Branch

## **Overview of Mt. Nansen Closure Alternatives Characterization**

**Project Number:**  
60119144 (112359)

**Date:**  
May 2010

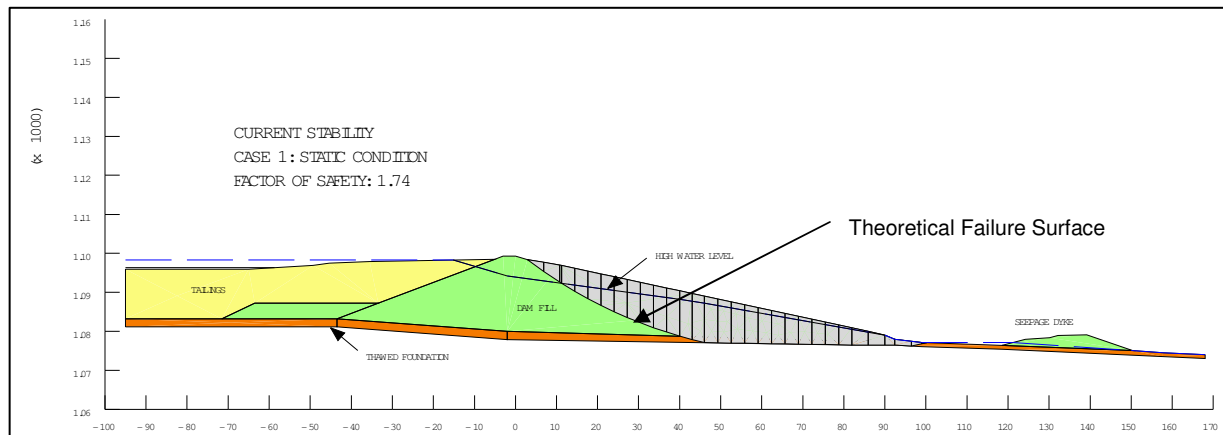
**Figure 4-1. Cross Section for Slope Stability Analysis**

A typical stratigraphic profile was developed using the depth to permafrost and the thickness of the thawed foundation zone based on borehole and monitoring data from previous geotechnical investigations and information obtained in AECOM's 2009 investigation. The cross section chosen for the slope stability analysis (Section A) is shown in plan view on Drawing B-02. A typical output from the slope stability model showing the cross section is illustrated on Figure 4-1. The results of the stability analysis for the three loading cases for existing and upgraded dam configurations are summarized on Drawings B-05 and B-06.
