Appendix A

Figures

FIGURE 1-1
Faro Mine Complex Location
 Faro Mine Remediation Project

FIGURE 1-2
Faro Mine Complex Overview
 Faro Mine Remediation Project

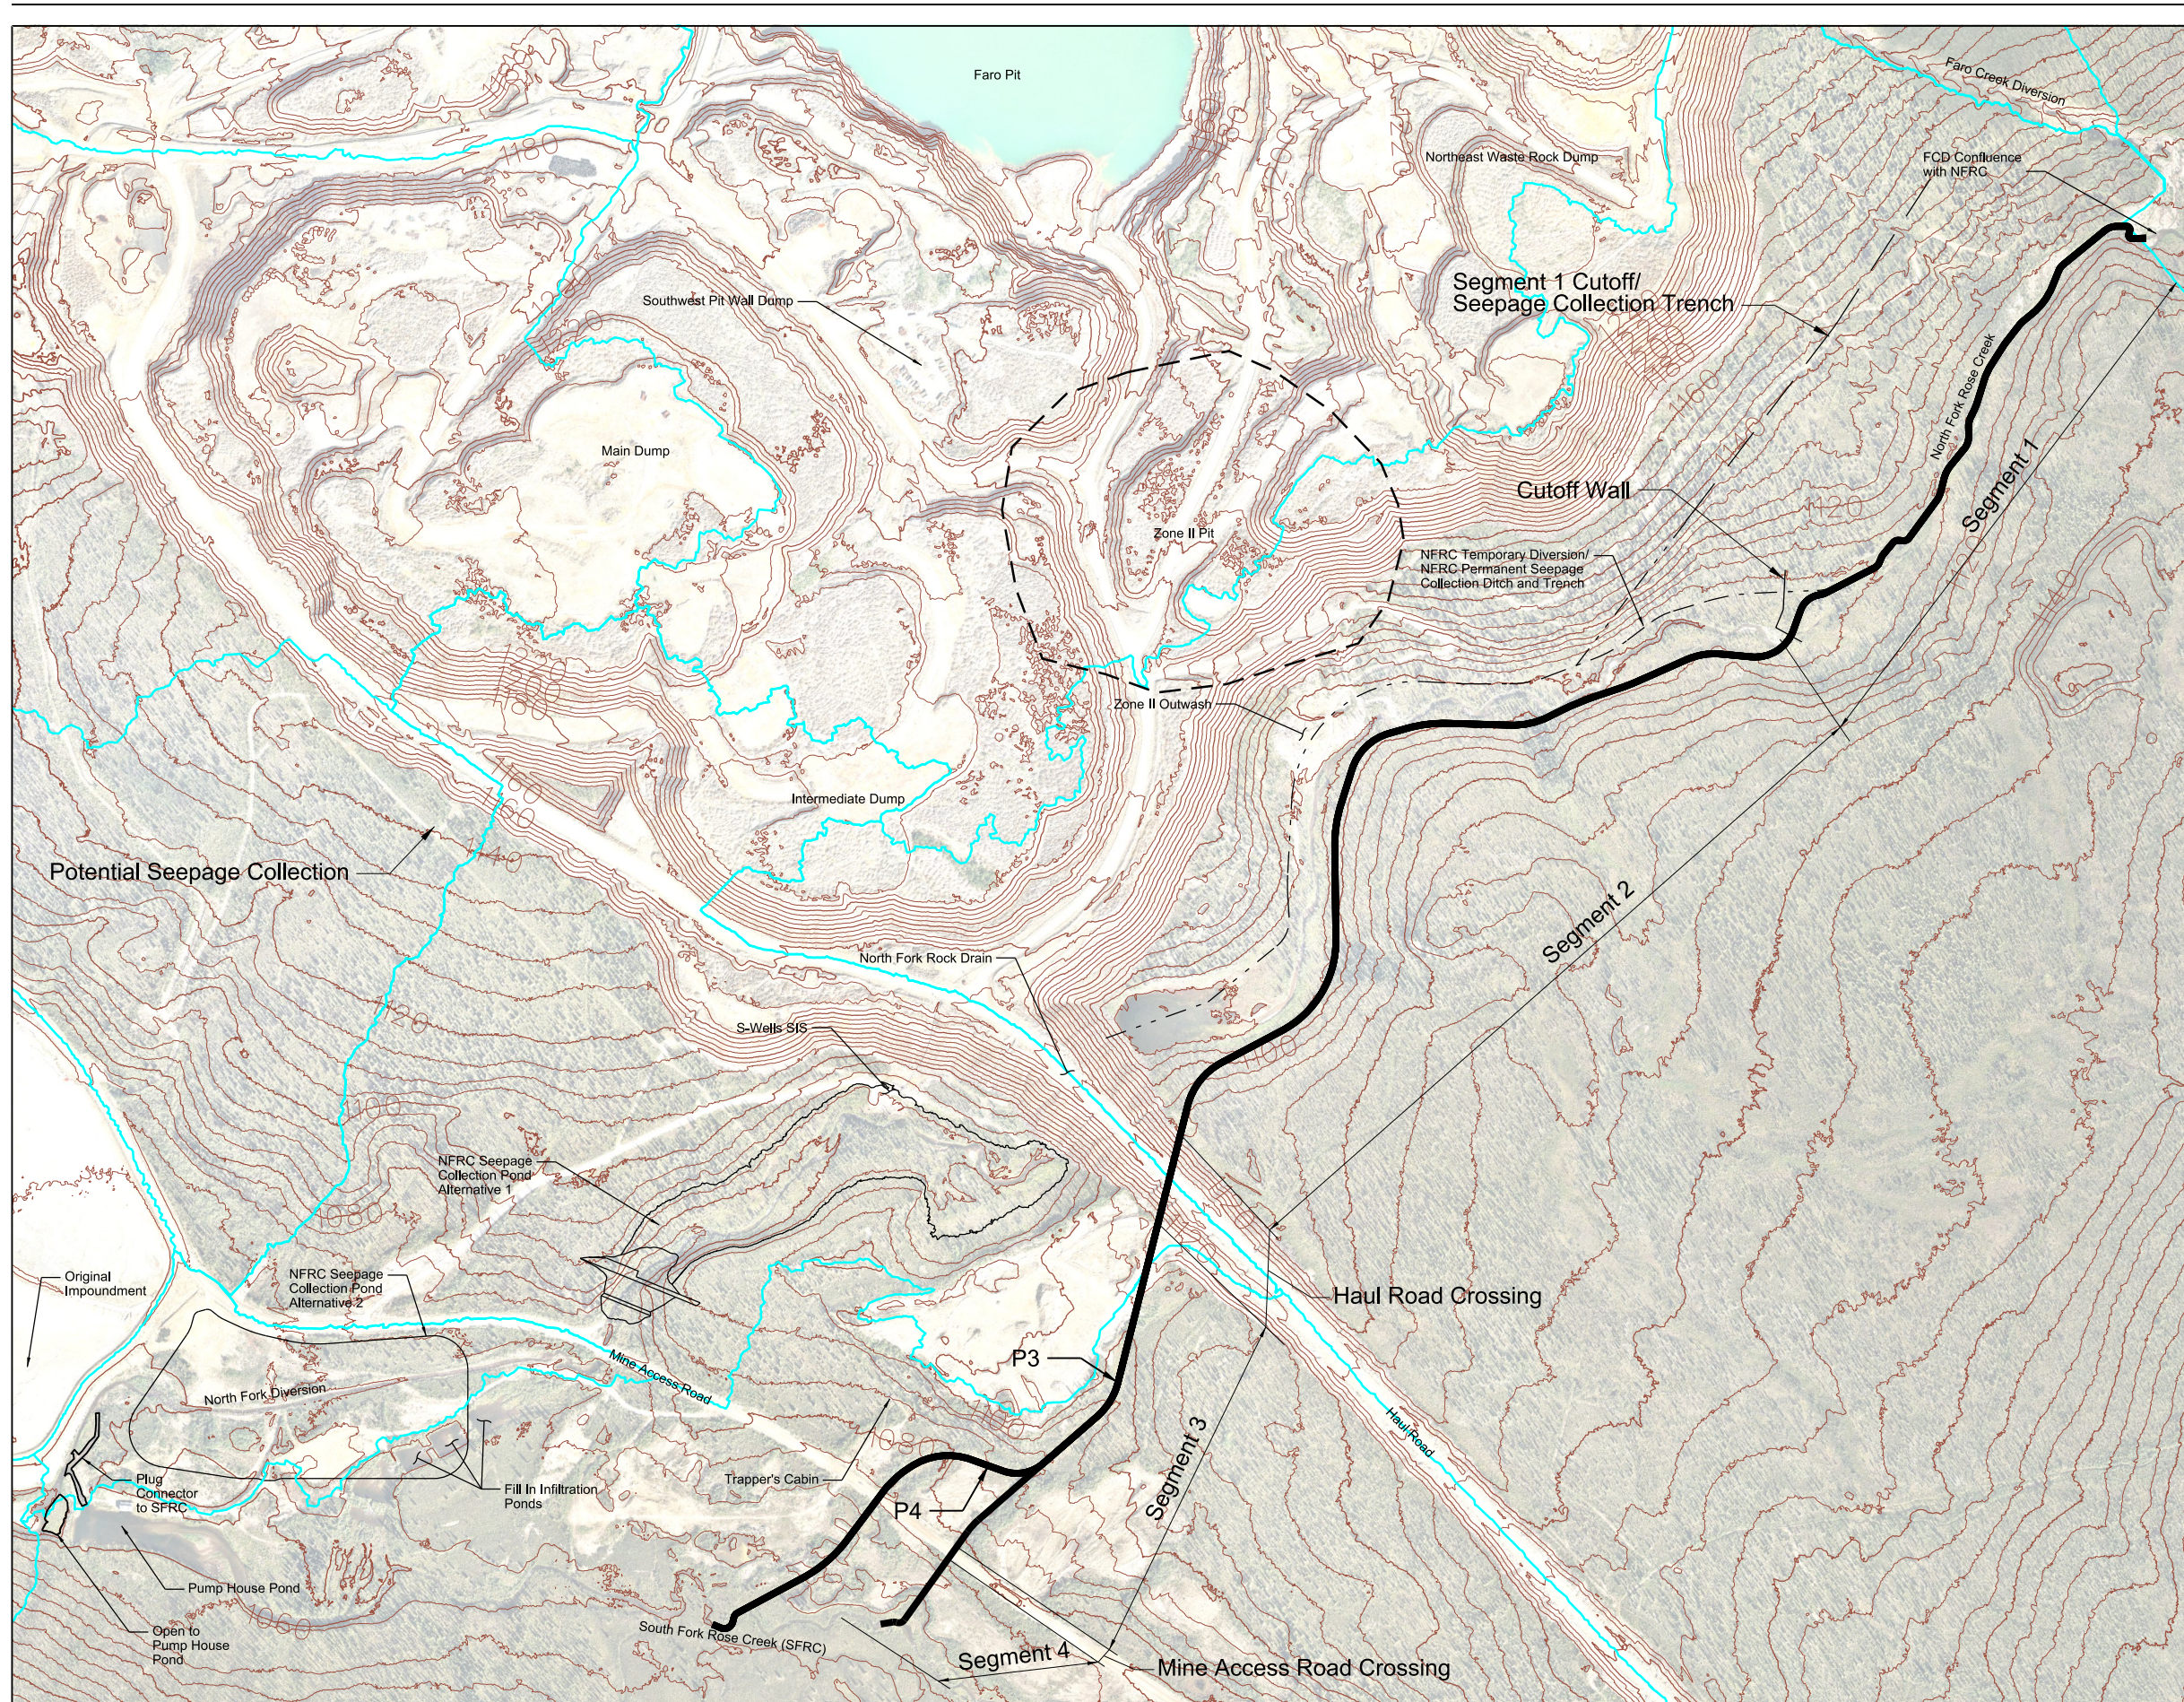
Figure 3-1
**NFRC Project Planning Areas/
 Realigned Channel Alternatives**
 Faro Mine Remediation Project

- LEGEND
- Surface Water Catchment Boundaries
 - NFRC Realigned Channel Alternatives

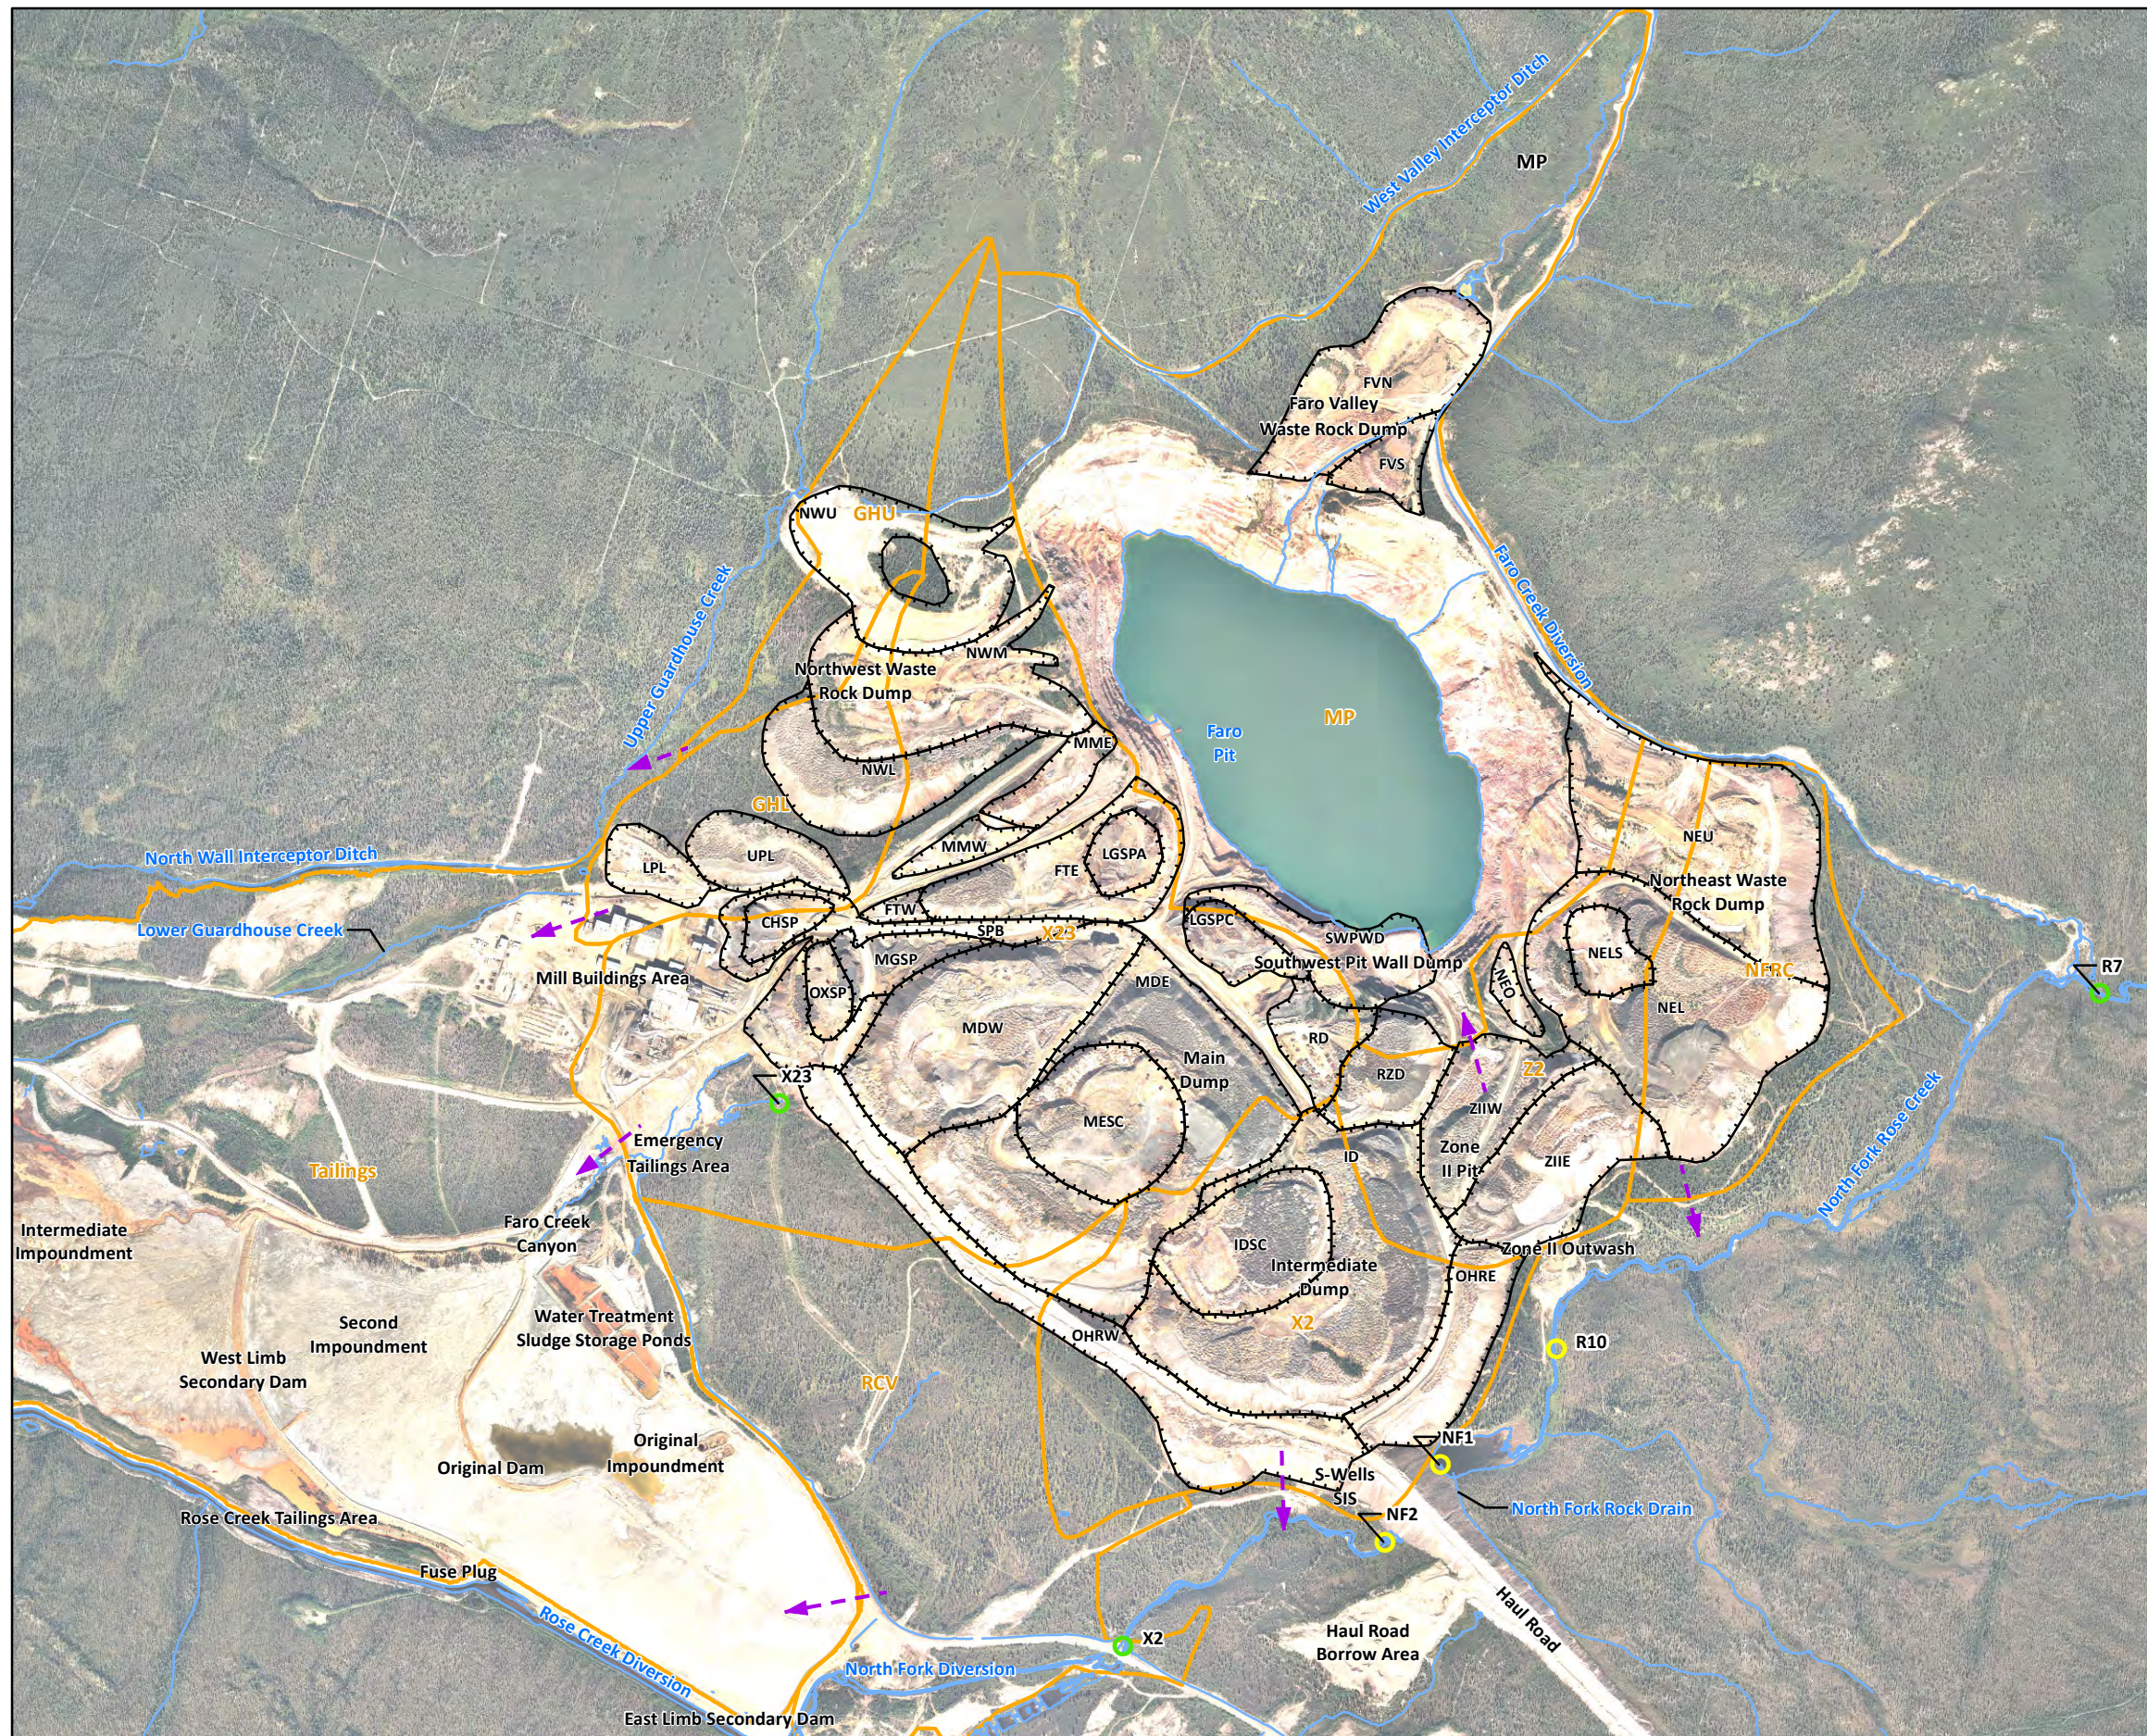
FIGURE 3-4
Faro Mine Waste Dump Footprints
and Catchment Boundaries
 Faro Mine Remediation Project

- Continuous Flow Monitoring Location
- Spot Flow Monitoring Location
- ▲ Catchment Pour Point
- Catchment Area
- Waste Dump

- Notes:**
- Aerial photography acquired by Peregrine Aerial Surveyors Inc. and Eagle Mapping in August 2012.
 - Orthophotography prepared by Critigen Canada Corp.
 - Rose Creek Tailings Area is also called Down Valley Tailings Area, and is where the Rose Creek Alluvial Aquifer is located.
 - Waste Dump Definitions:

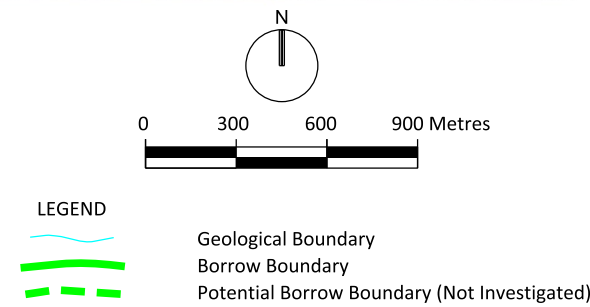
FIGURE 3-5
Faro Mine Borrow Areas
 Faro Mine Remediation Project

MINE DISTURBANCE
 MD - mine disturbance; consisting of an open-pit and stripped till and bedrock accumulations. Bedrock and surficial sediments exposed in open-pit.

MINE TAILINGS
 MT - mine tailings; consisting of sand, silt and some clay.

ALLUVIAL DEPOSITS
 Ap - alluvial plain; silt, sand and pebbles with reworked cobbles and boulders occurring as bars, overbank floodplain deposits, 0 - 10 m thick; floodplain subject to periodic floods. Small valley alluvial plains may not be mapped at this scale.
 Ap (active) - alluvial plain; area of Pelly River floodplain that has been recently active.
 At - alluvial terrace; silt, sand, and pebbles with reworked cobbles and boulders occurring as low terrace deposits, 0 - 10 m thick.
 Af - alluvial fan; coarse sand, pebbles, cobbles and mudflow deposits, up to or >10 m thick. Appear as vegetated, often peat covered, landforms developed during post-glacial sedimentation.
 Ax - complexes of Ap and Af undivided. Common when a stream is unconfined and also in narrow valleys where side-entry alluvial fans cannot be differentiated from an alluvial plain.

COLLUVIAL DEPOSITS
 Cv - colluvium veneer; conforms to bedrock topography, <1 m thick.
 Ca - colluvium apron; coalescing colluvial fans at the base of a slope, >1 m thick.
 Cz - mass wasting; includes slumping, debris slides and rockfalls. Slumping and rockfalls are common on Mt. Mye.

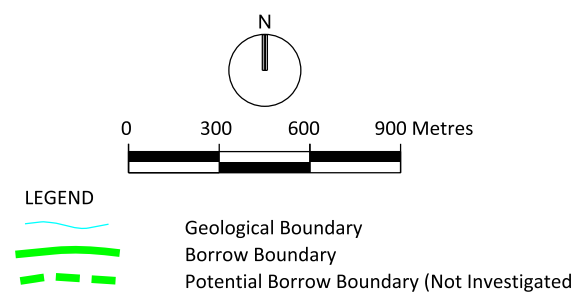
FIGURE 3-6
Haul Road Borrow Areas
 Faro Mine Remediation Project

MINE DISTURBANCE
 MD- mine disturbance; consisting of an open-pit and stripped till and bedrock accumulations. Bedrock and surficial sediments exposed in open-pit.

MINE TAILINGS
 MT - mine tailings; consisting of sand, silt and some clay.

ALLUVIAL DEPOSITS
 Ap - alluvial plain; silt, sand and pebbles with reworked cobbles and boulders occurring as bars, overbank floodplain deposits, 0 - 10 m thick; floodplain subject to periodic floods. Small valley alluvial plains may not be mapped at this scale.
 Ap (active) - alluvial plain; area of Pelly River floodplain that has been recently active.
 At - alluvial terrace; silt, sand, and pebbles with reworked cobbles and boulders occurring as low terrace deposits, 0 - 10 m thick.
 Af - alluvial fan; coarse sand, pebbles, cobbles and mudflow deposits, up to or >10 m thick. Appear as vegetated, often peat covered, landforms developed during post-glacial sedimentation.
 Ax - complexes of Ap and Af undivided. Common when a stream is unconfined and also in narrow valleys where side-entry alluvial fans cannot be differentiated from an alluvial plain.

COLLUVIAL DEPOSITS
 Cv - colluvium veneer; conforms to bedrock topography, <1 m thick.
 Ca - colluvium apron; coalescing colluvial fans at the base of a slope, >1 m thick.
 Cz - mass wasting; includes slumping, debris slides and rockfalls. Slumping and rockfalls are common on Mt. Mye.

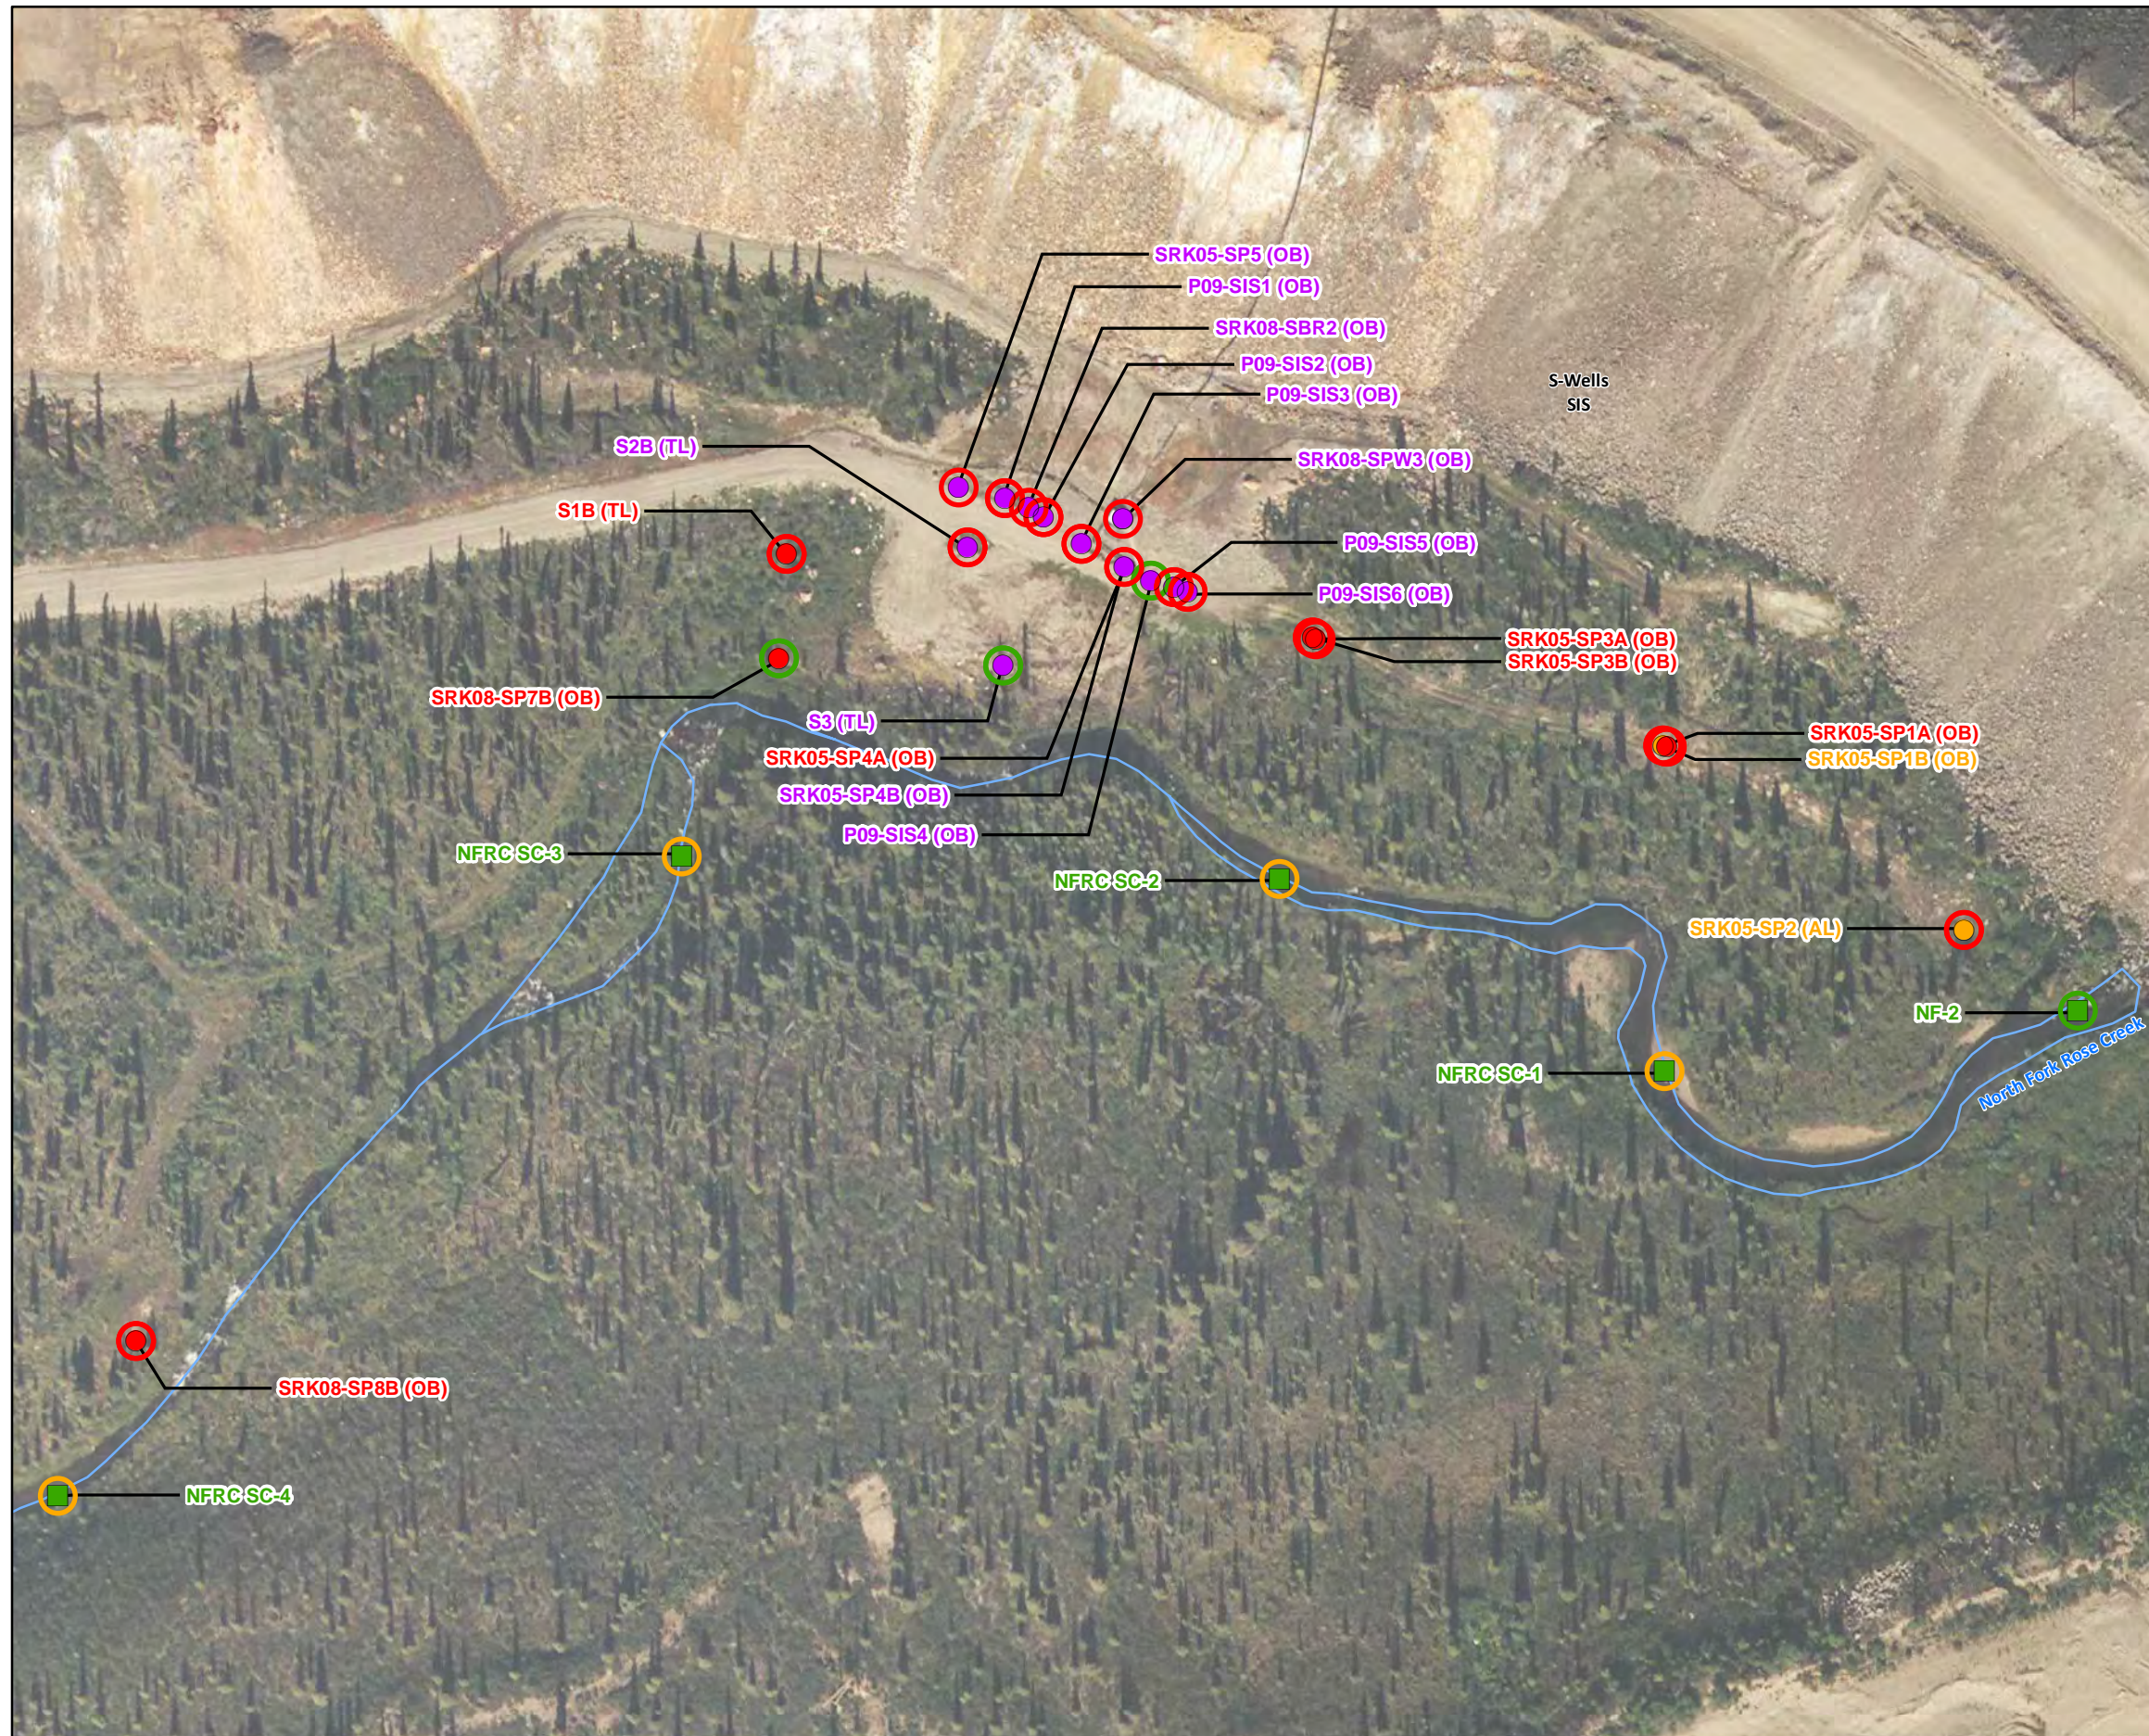
FIGURE 5-2
S-Wells Groundwater Monitoring Locations
Faro Mine Remediation Project

- Groundwater Monitoring Well Location
- Surface Water Sampling Location
- △ Seep Sampling Location

- Highly Impacted (SO₄ ≥ 4,000 mg/L or Zn ≥ 5 mg/L)
- Moderately Impacted (SO₄ ≥ 400 and < 4,000 mg/L or Zn ≥ 0.5 and > 5 mg/L)
- Slightly Impacted (SO₄ ≥ 40 and < 400 mg/L or Zn ≥ 0.05 and > 0.5 mg/L)
- Not Impacted to Mildly Impacted (SO₄ < 40 mg/L and Zn < 0.05 mg/L)
- No Data

- High (pH ≥ 7.5)
- Neutral (pH ≥ 6.5 and < 7.5)
- Low (pH ≥ 5 and < 6.5)
- Very Low (pH < 5)

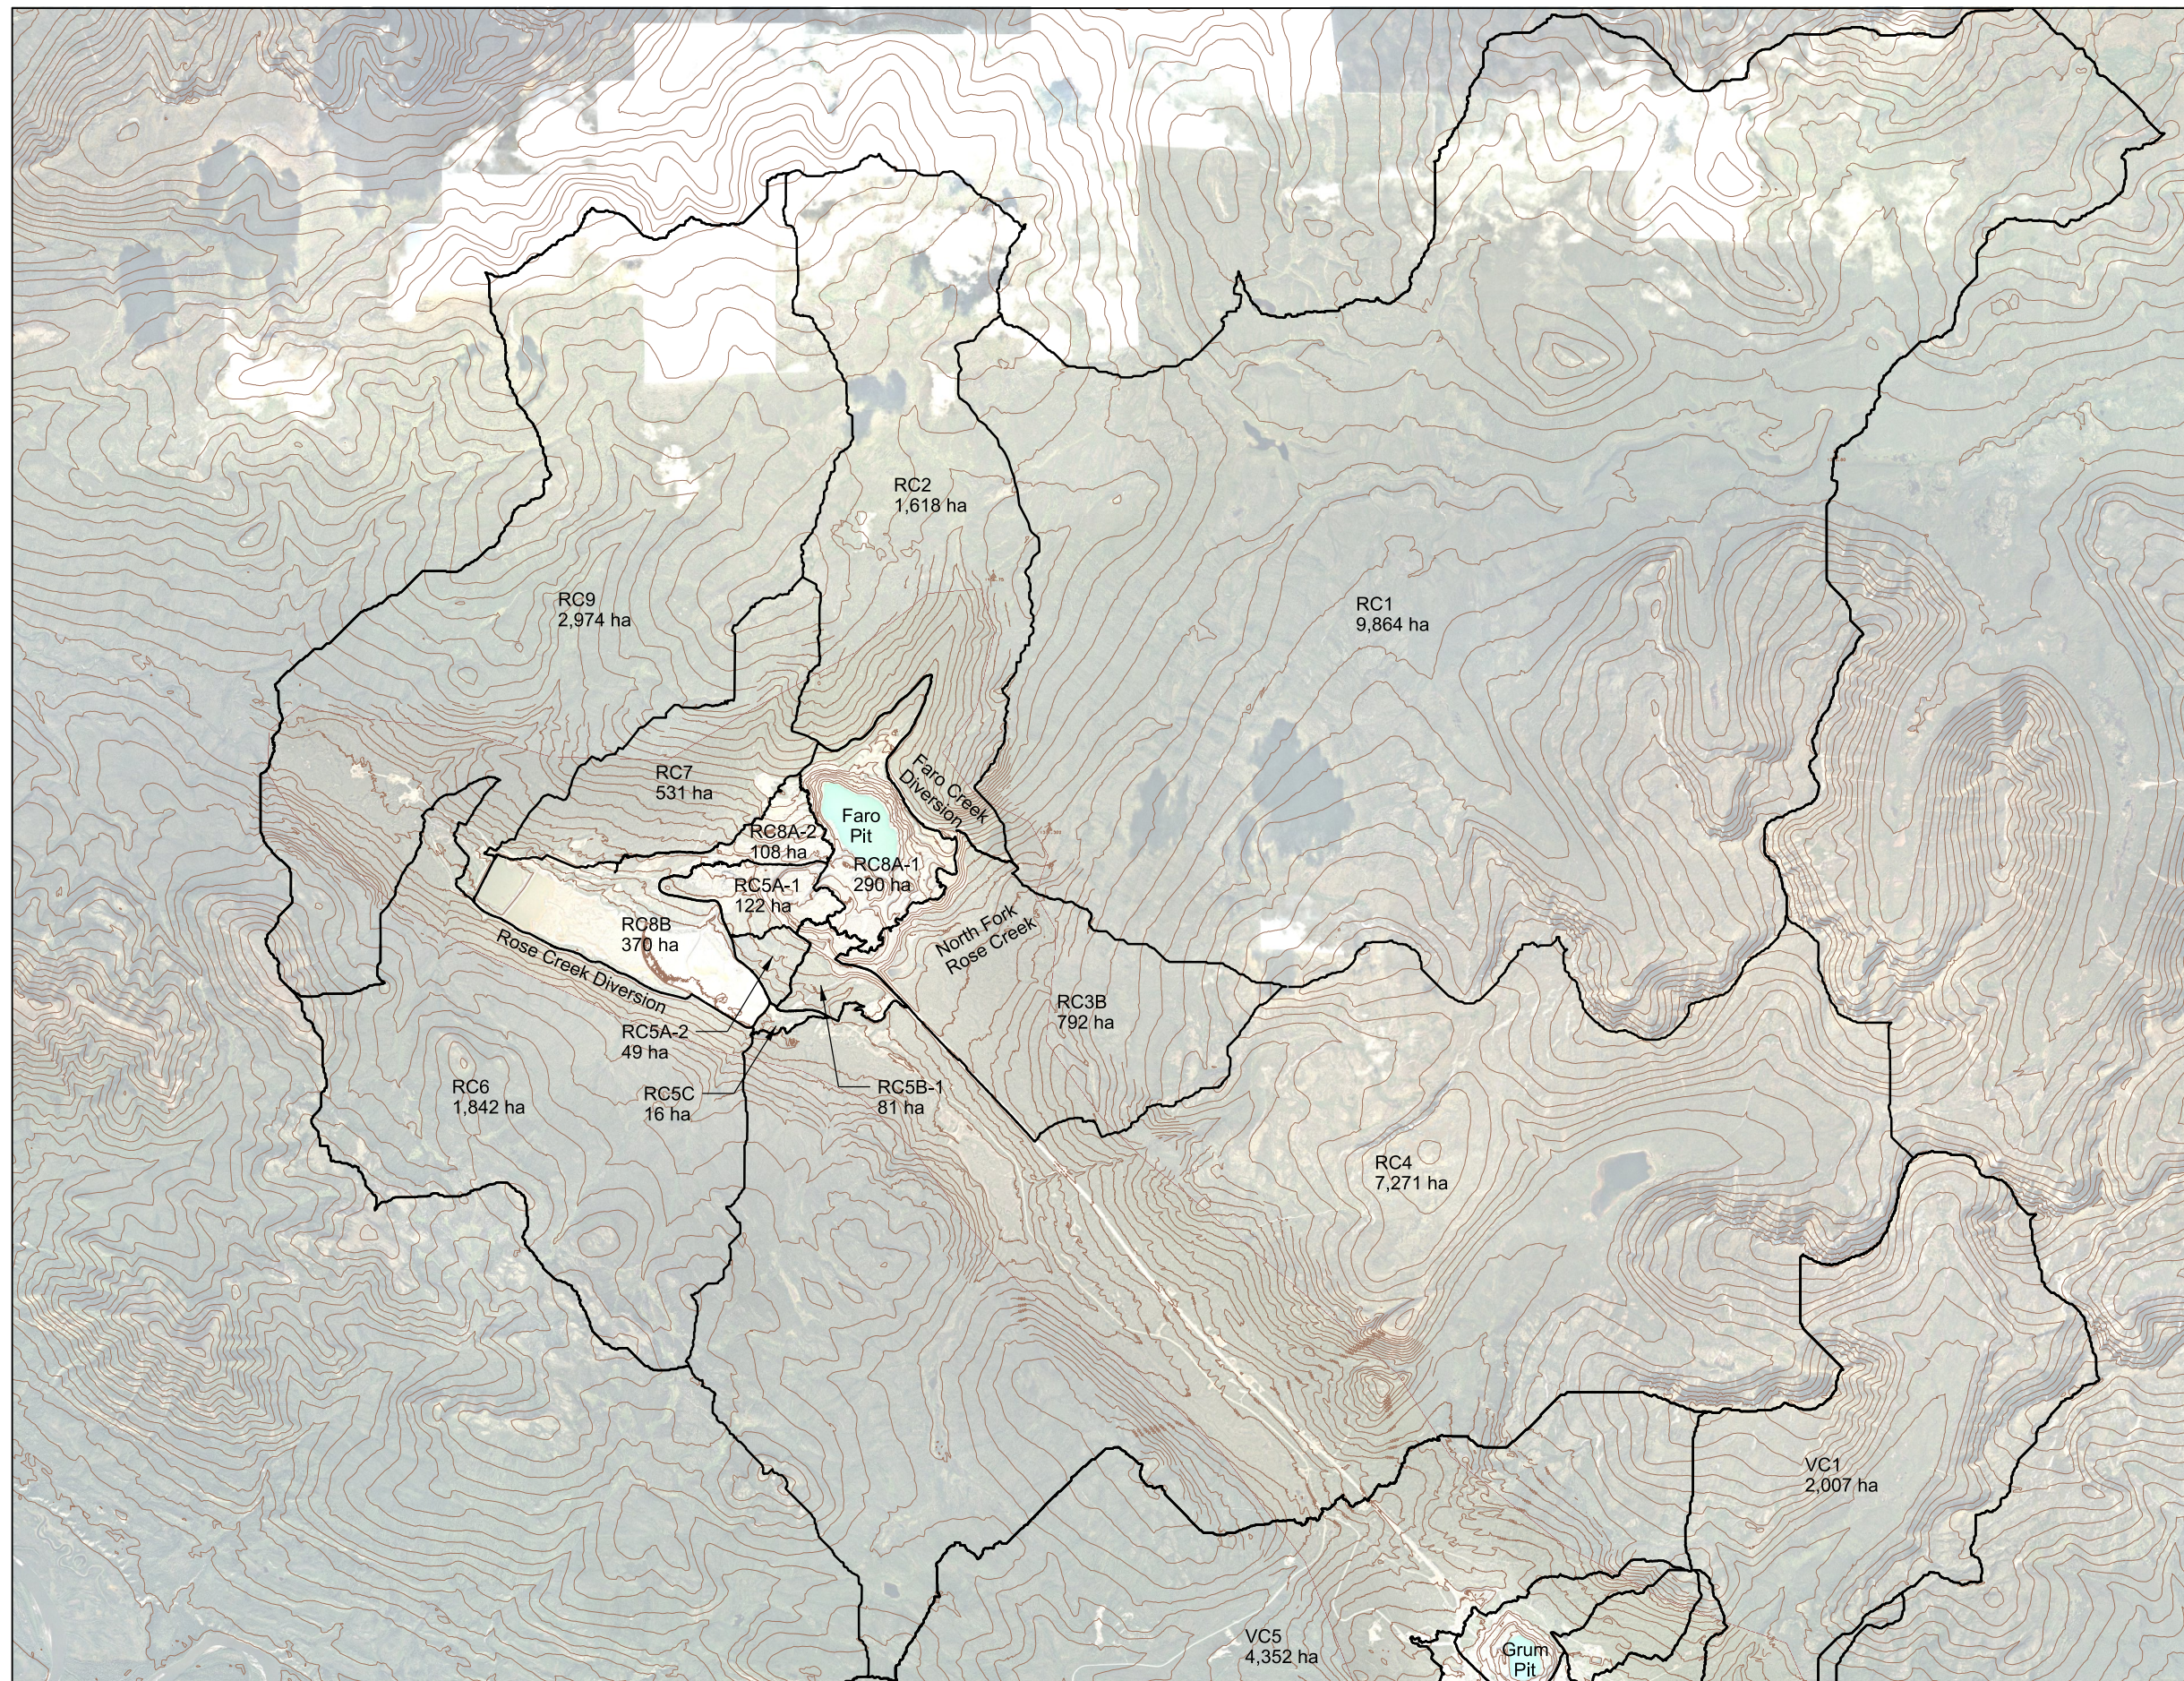
Figure 5-7
NFRC Regional Surface Water Catchment Boundaries
 Faro Mine Remediation Project

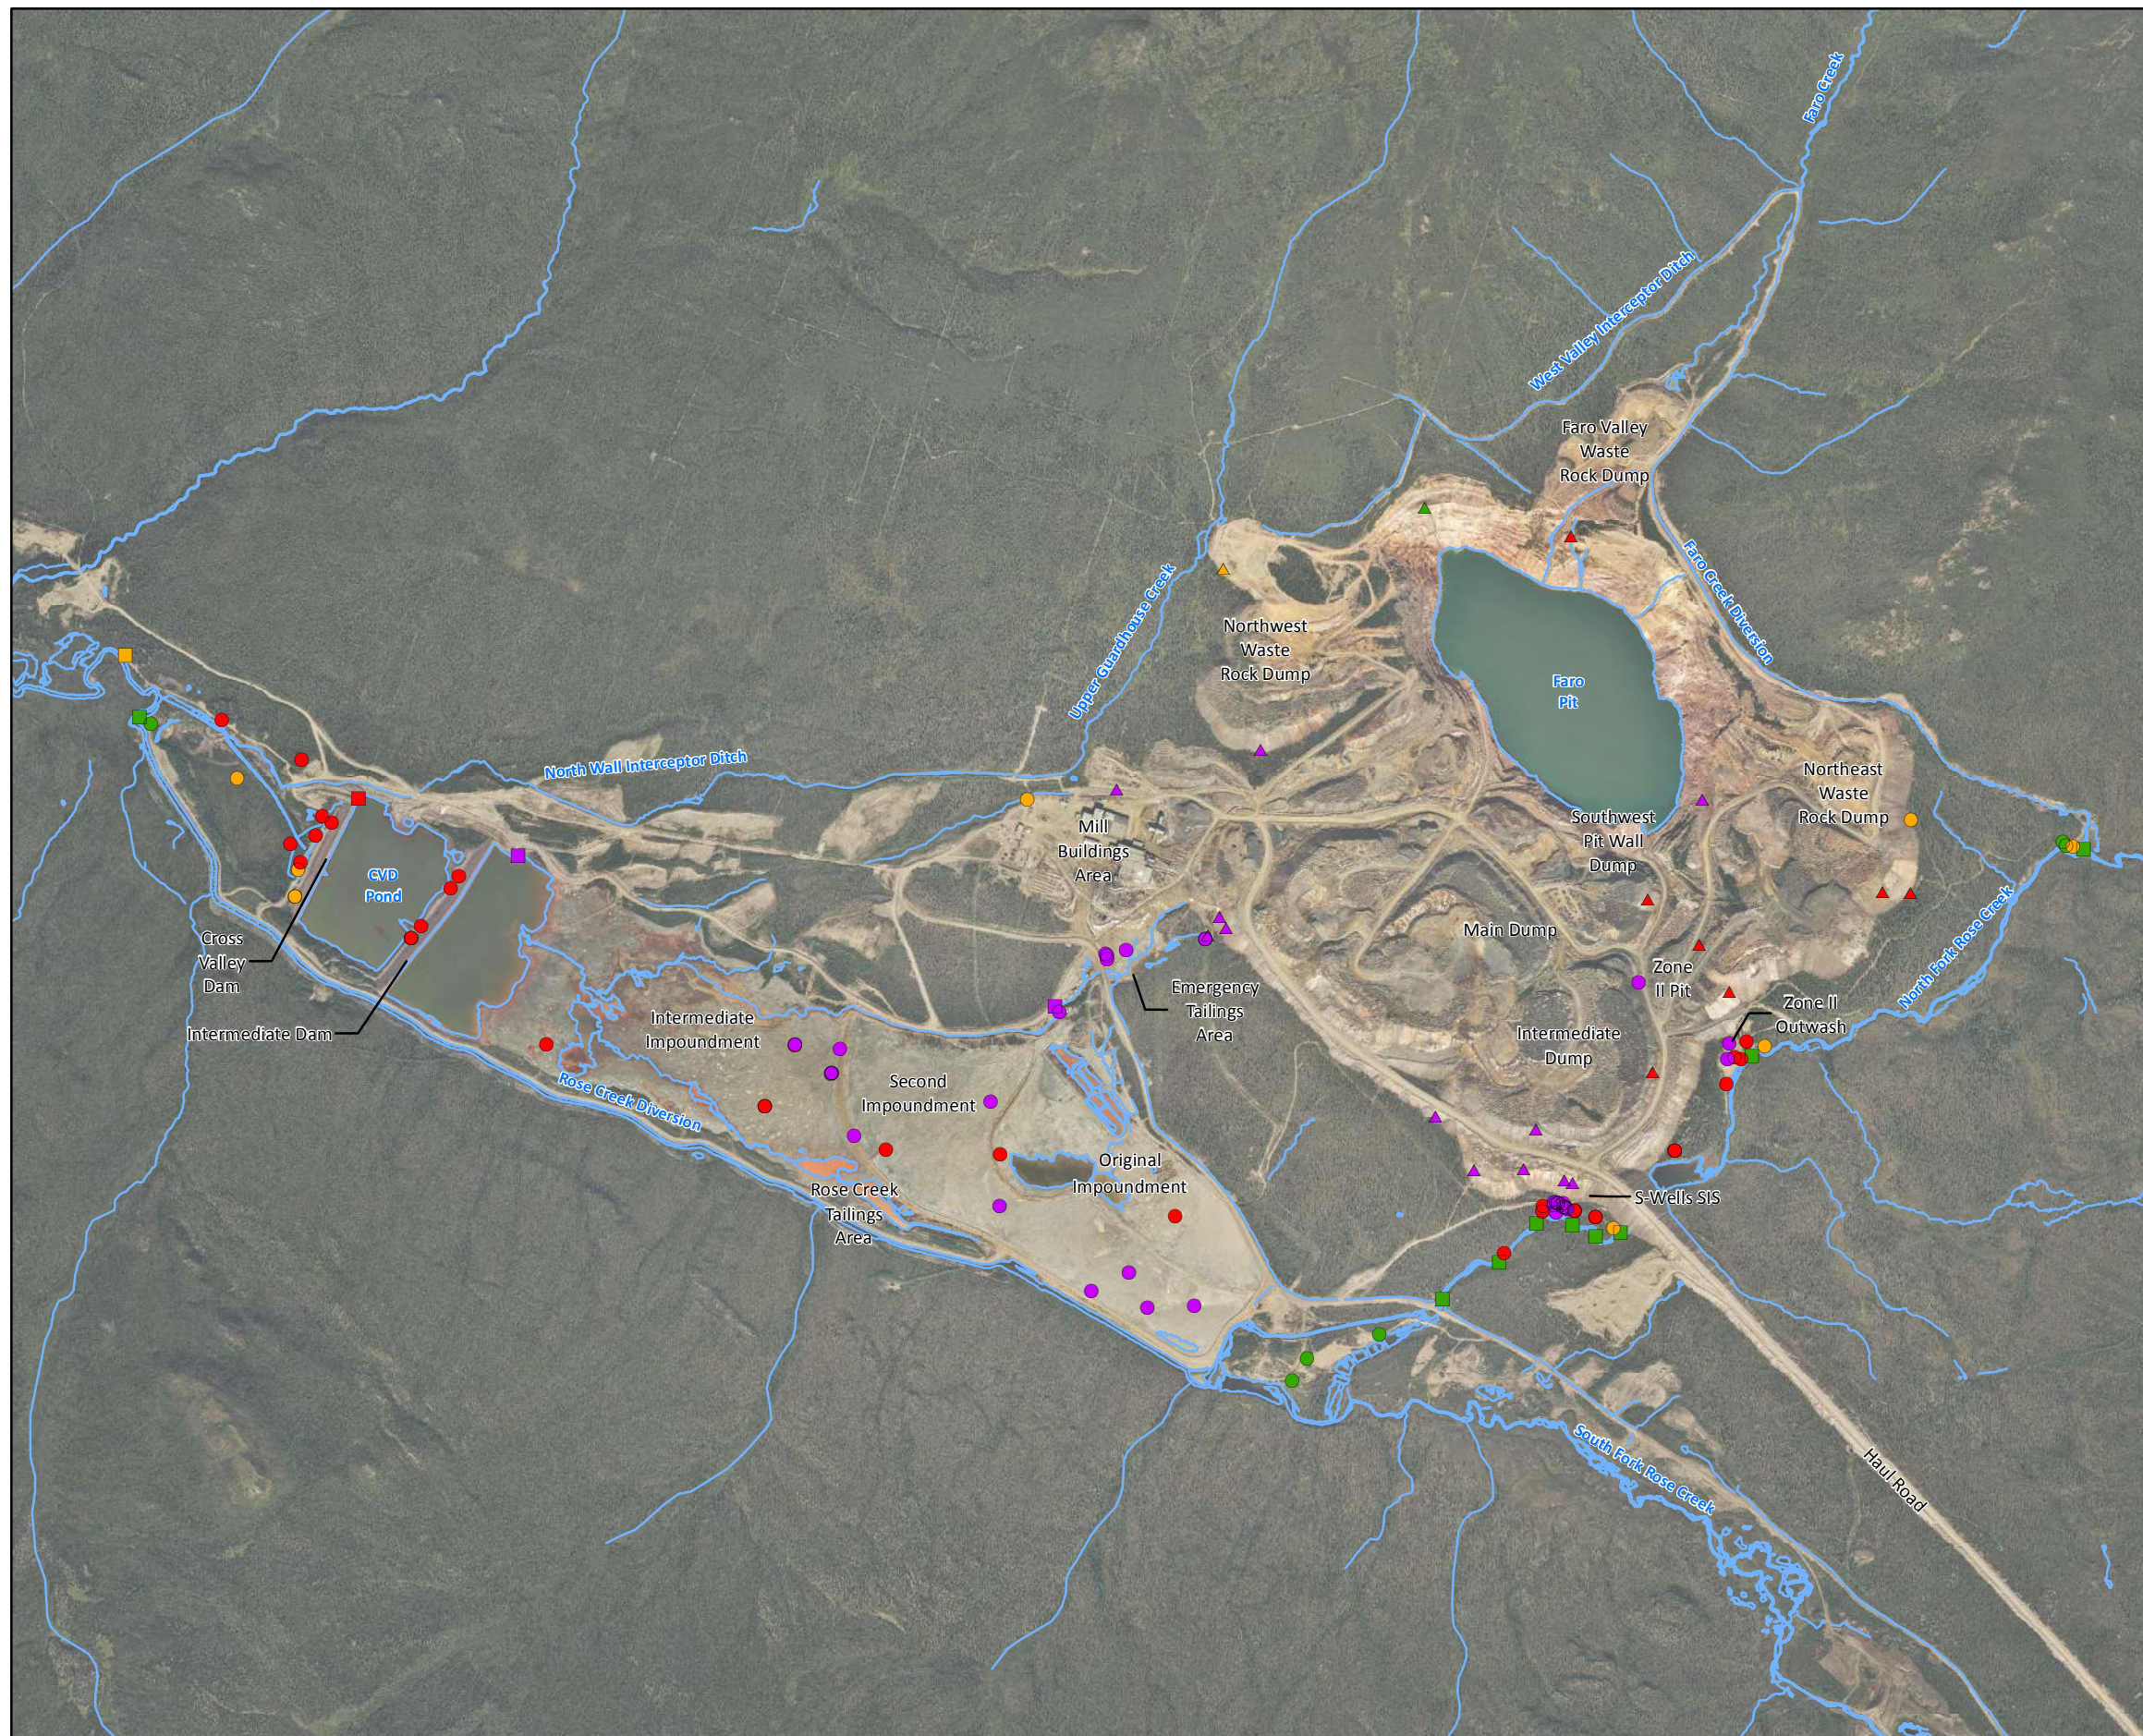
- Highly Impacted
(SO₄ ≥ 4,000 mg/L or Zn ≥ 5 mg/L)
- Moderately Impacted
(SO₄ ≥ 400 and < 4,000 mg/L or Zn ≥ 0.5 and > 5 mg/L)
- Slightly Impacted
(SO₄ ≥ 40 and < 400 mg/L or Zn ≥ 0.05 and > 0.5 mg/L)
- Not Impacted to Mildly Impacted
(SO₄ < 40 mg/L and Zn < 0.05 mg/L)

1. All locations are approximate pending results of the 2012 field survey.
2. Symbol colour shows the highest impact at each well pair or cluster location.

FIGURE 5-8
Water Quality at Seeps and in the Alluvial Aquifer of the Faro Mine Area
Faro Mine Remediation Project
