Appendix A

Figures

FIGURE 1-1
Faro Mine Complex Location
 Faro Mine Remediation Project

FIGURE 1-2
Faro Mine Complex Overview
 Faro Mine Remediation Project

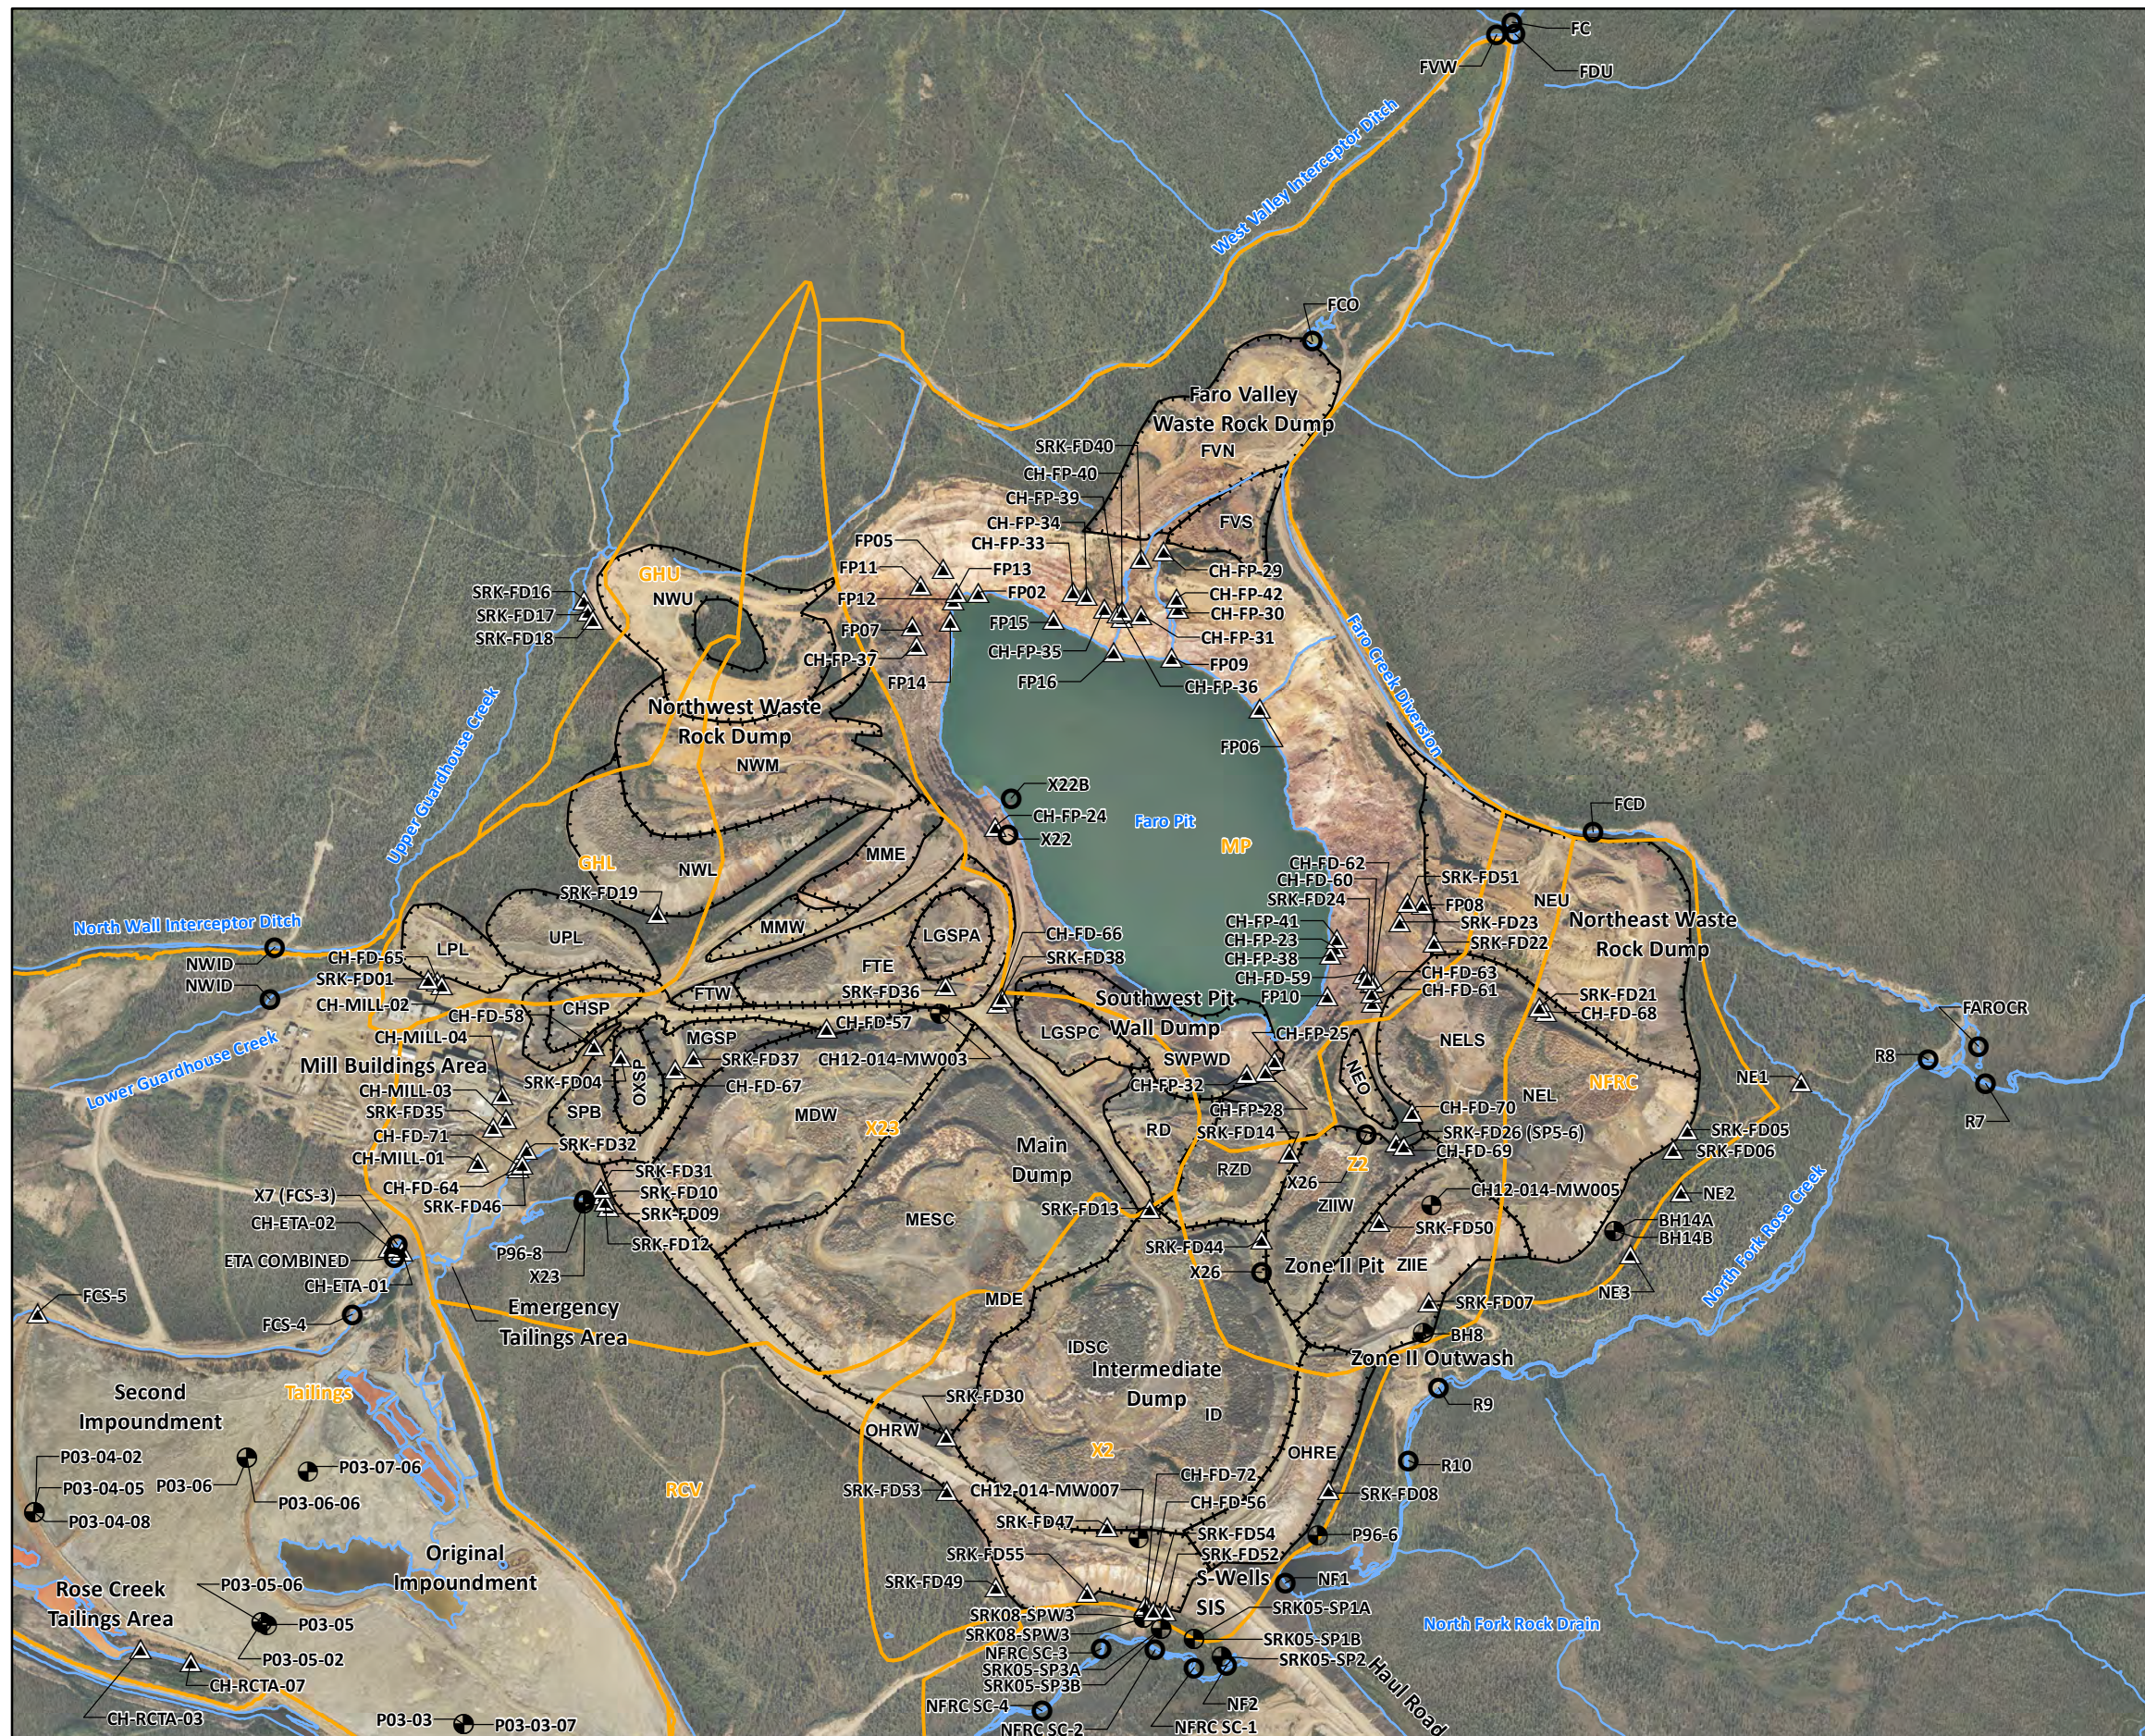
1. Aerial photography acquired by Peregrine Aerial Surveyors Inc. and Eagle Mapping in August 2012.
2. Orthophotography prepared by Critigen Canada Corp.
3. Rose Creek Tailings Area is also called Down Valley Tailings Area, and is where the Rose Creek Alluvial Aquifer is located.
4. Waste Rock Dump Definitions:

FIGURE 5-9
Seep and Surface Water Monitoring Stations,
Waste Dump Boundaries, and Catchment
Boundaries in the Faro Pit Area
 Faro Mine Remediation Project

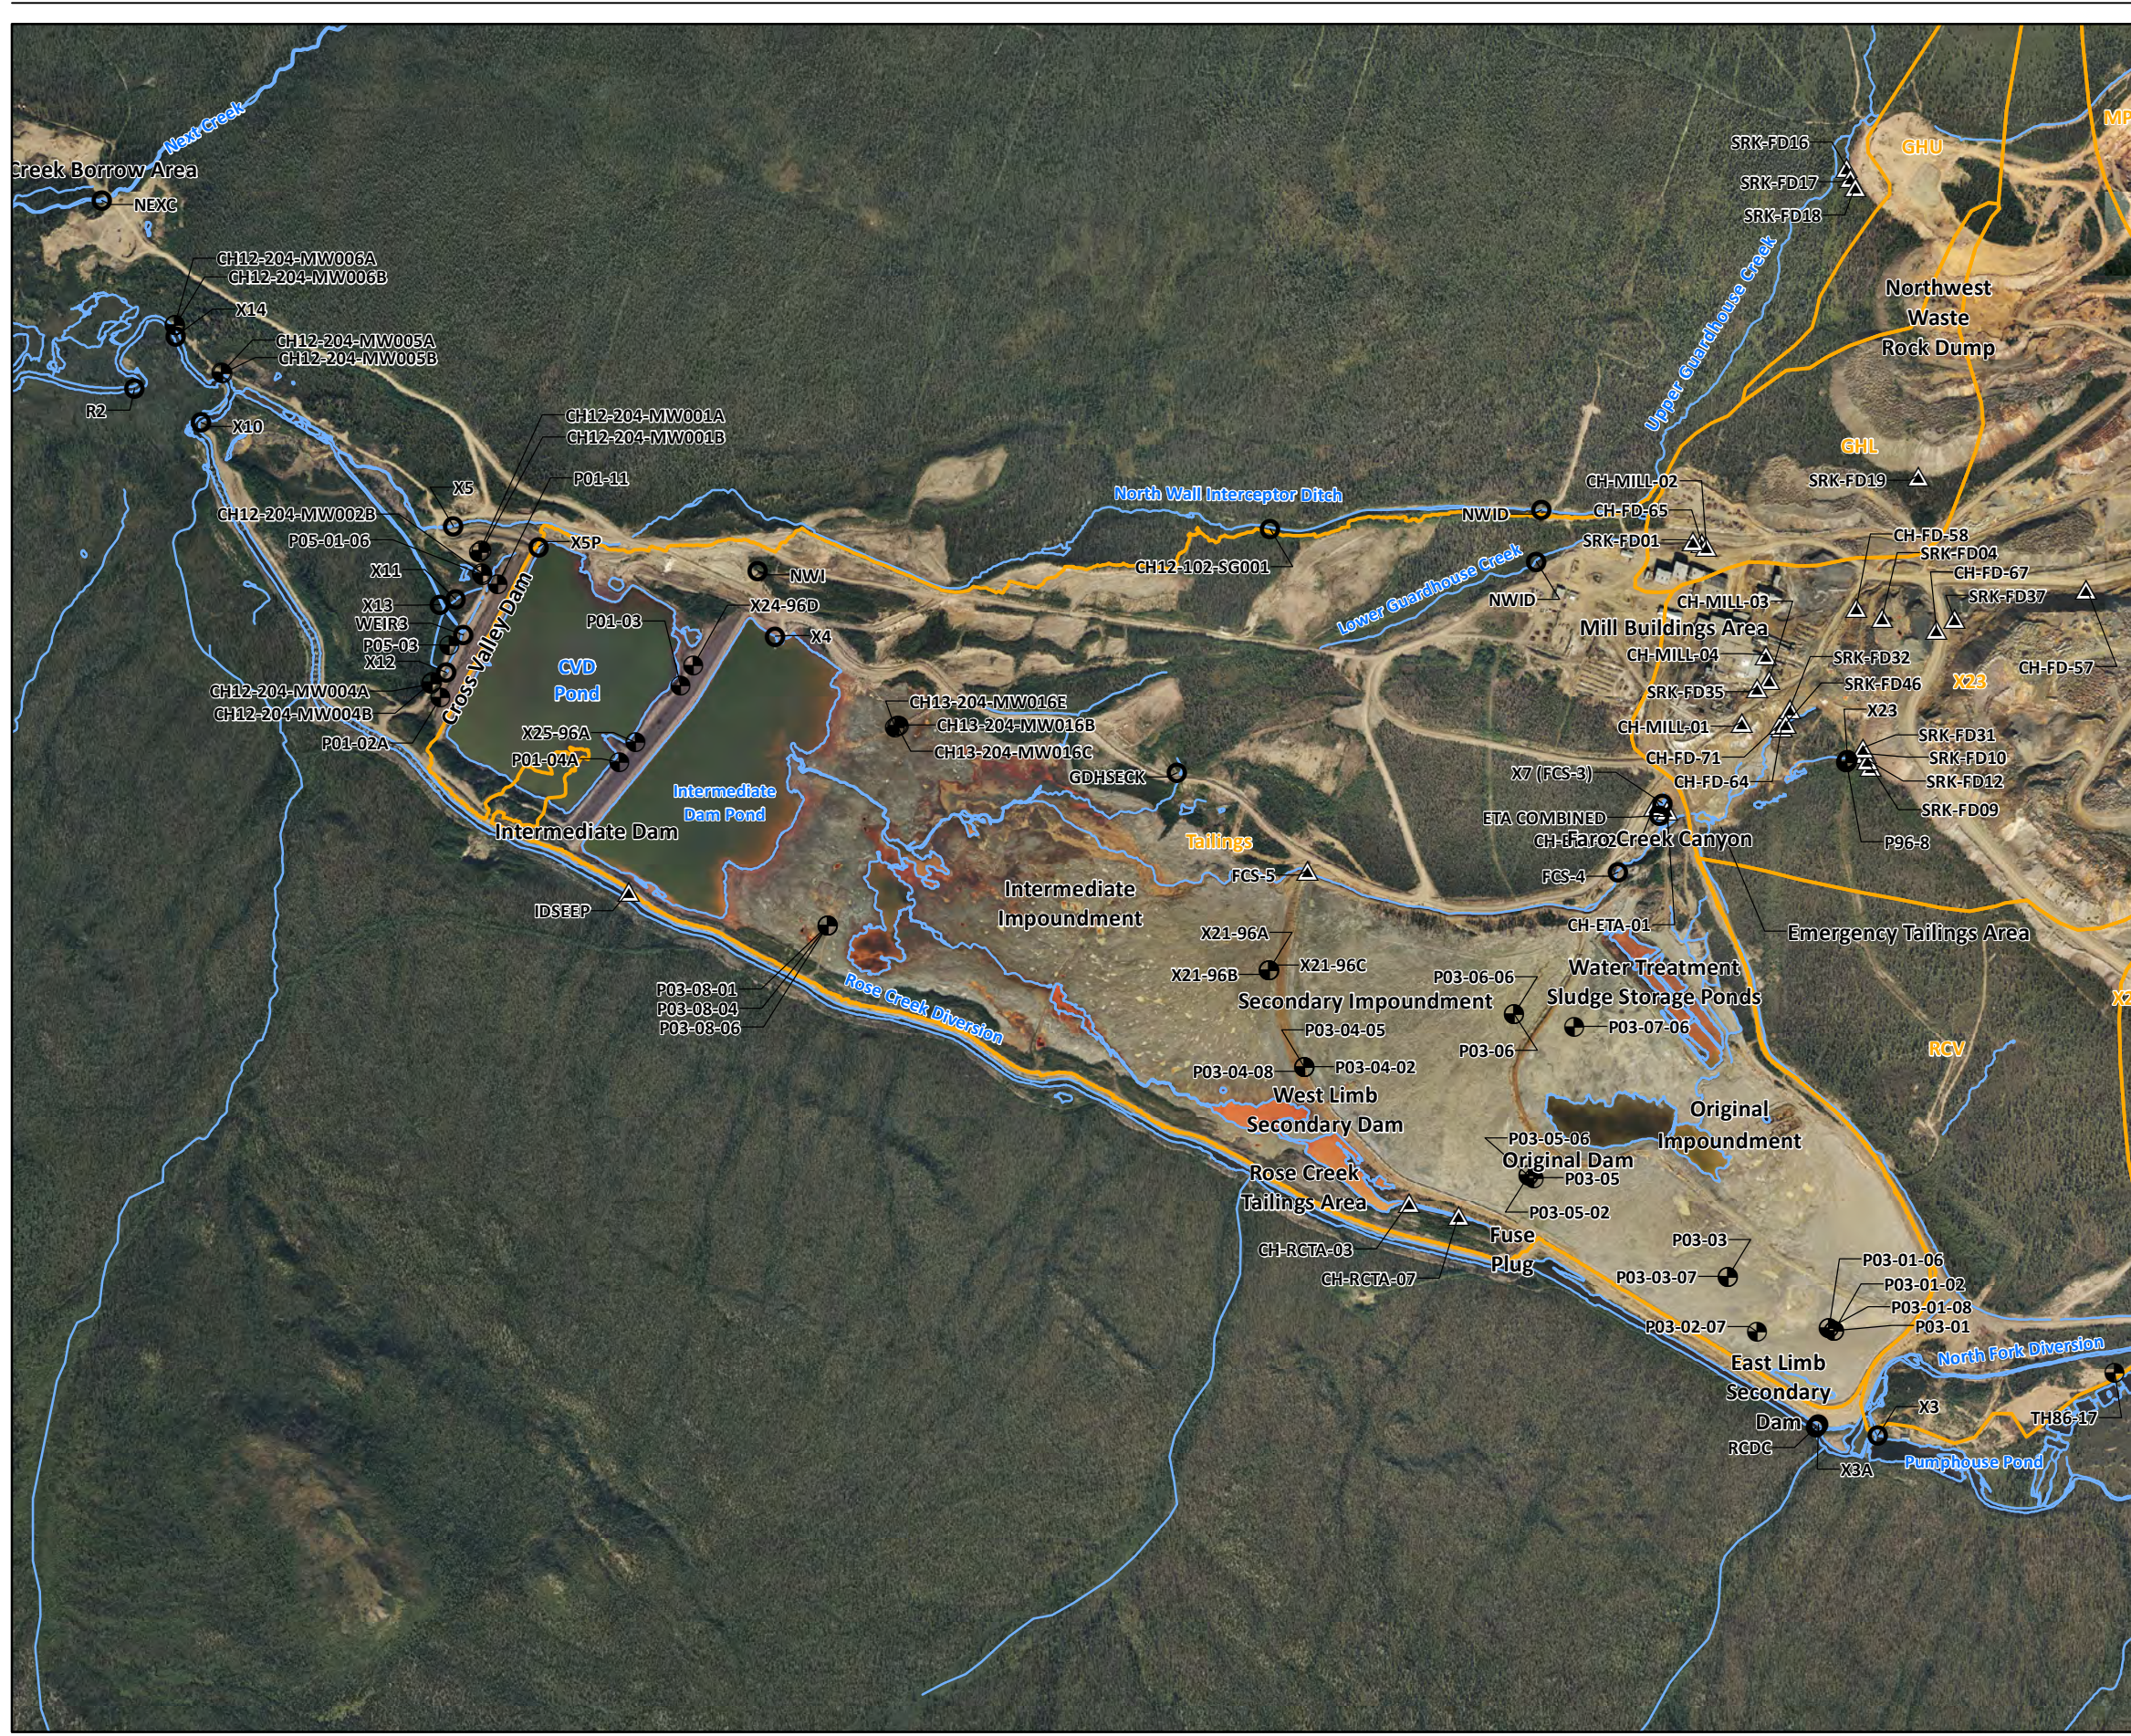
FIGURE 5-11
Seep and Surface Water Monitoring Stations in the Rose Creek Tailings Area
 Faro Mine Remediation Project

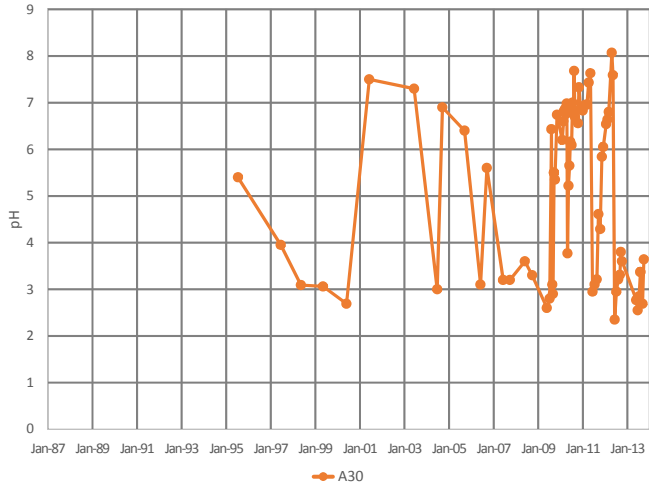
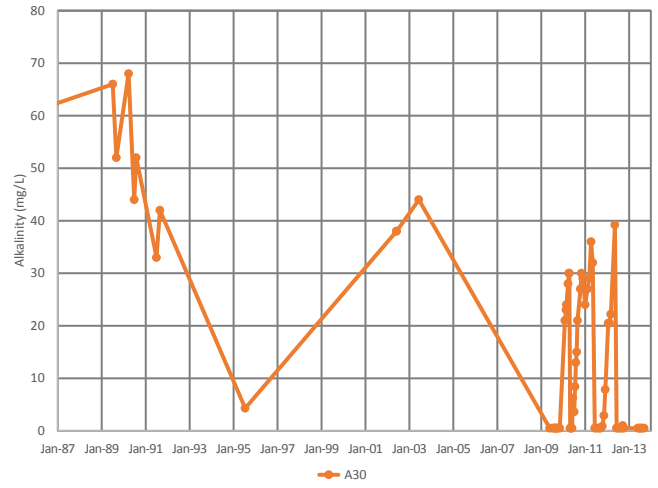
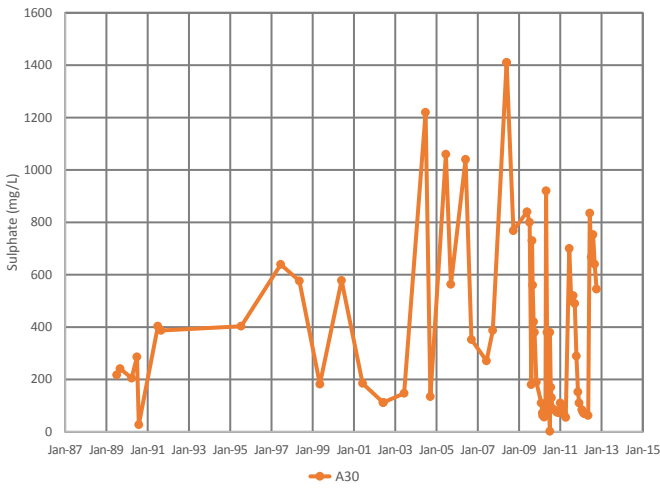
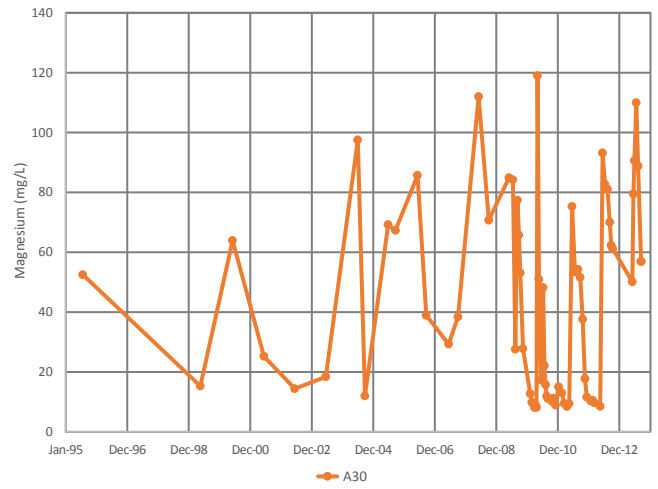
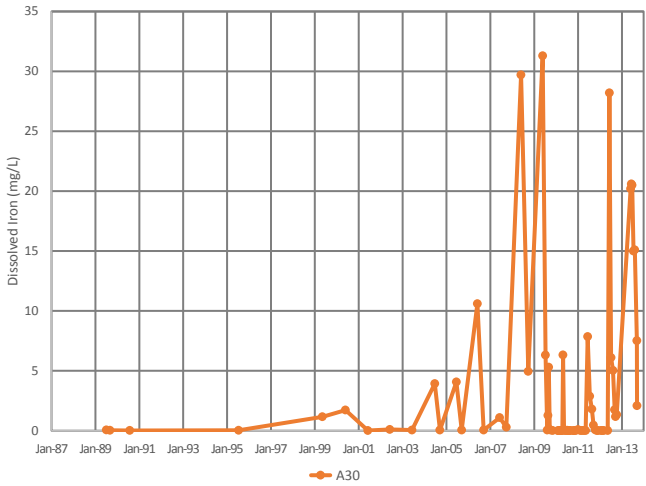
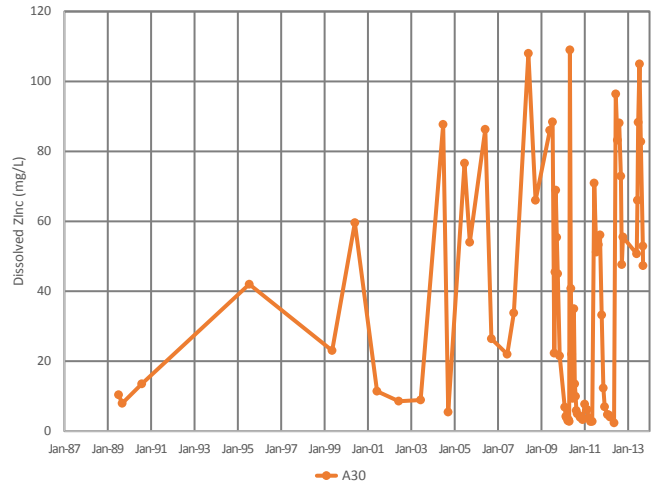
FIGURE 5-12
Trends in Selected Water Quality Parameters
of Seepage from the North Faro Pit Area
Faro Mine Remediation Project

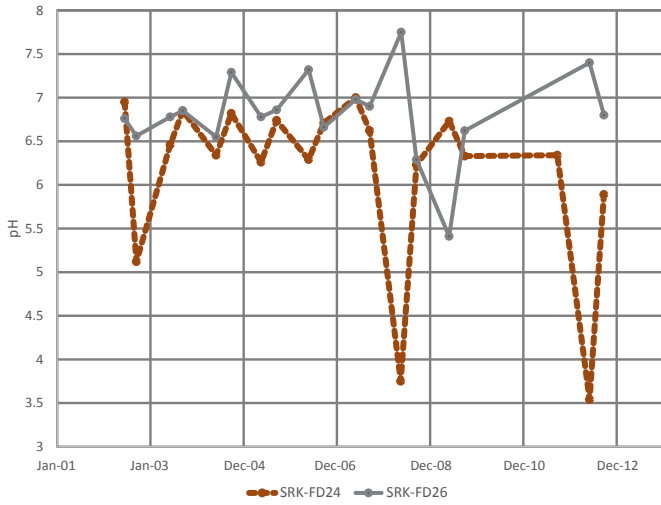
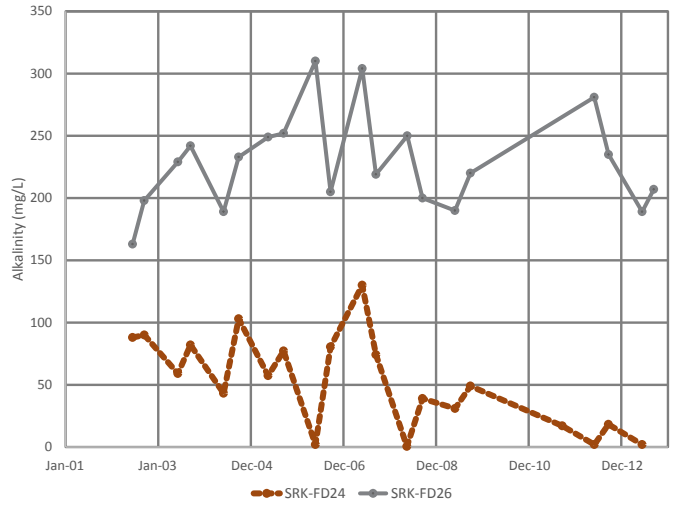
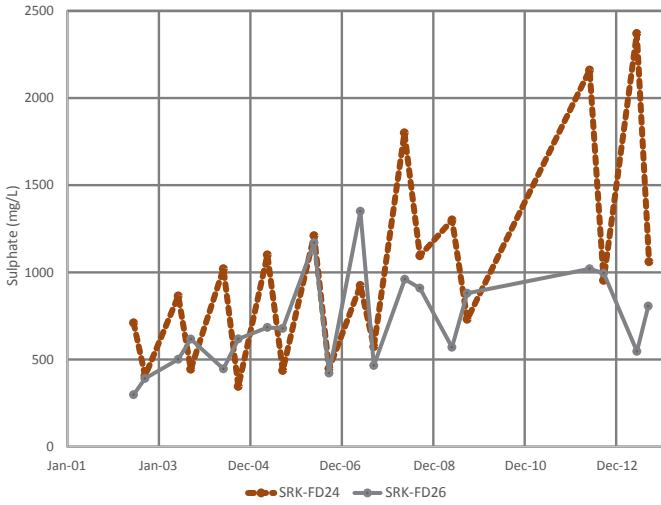
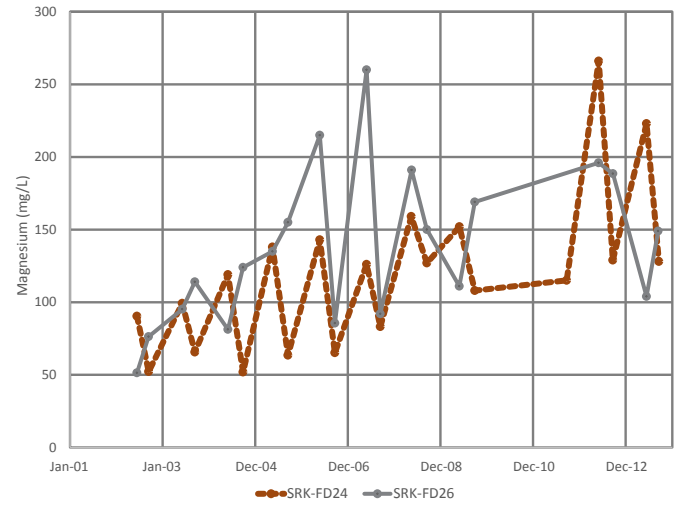
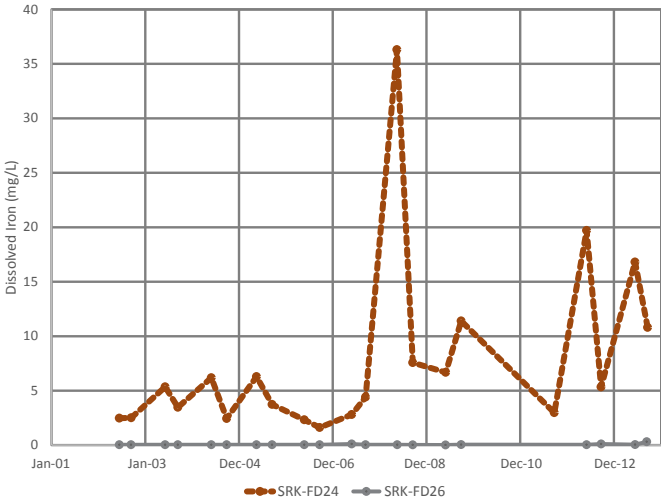
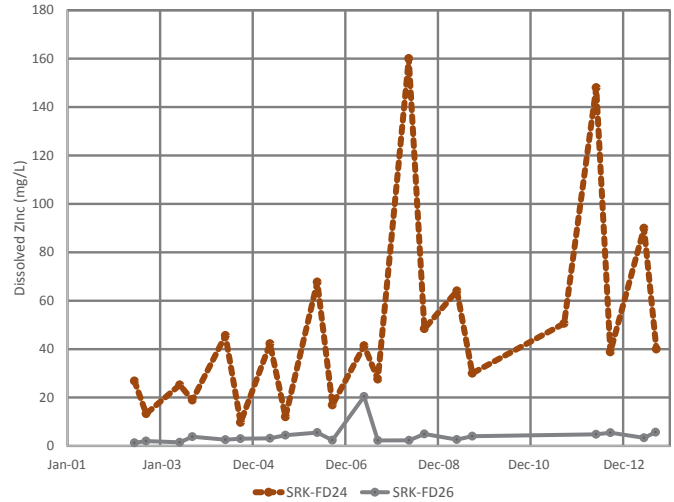
FIGURE 5-13
Trends in Selected Water Quality Parameters
of Seepage from the Northeast Faro Pit Area
Faro Mine Remediation Project

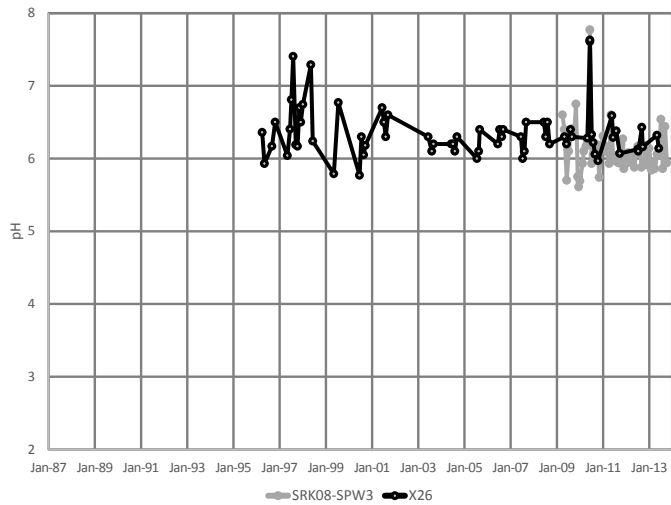
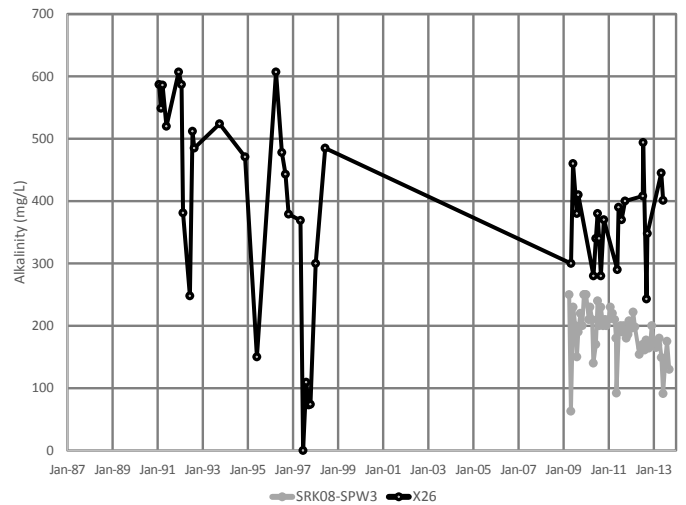
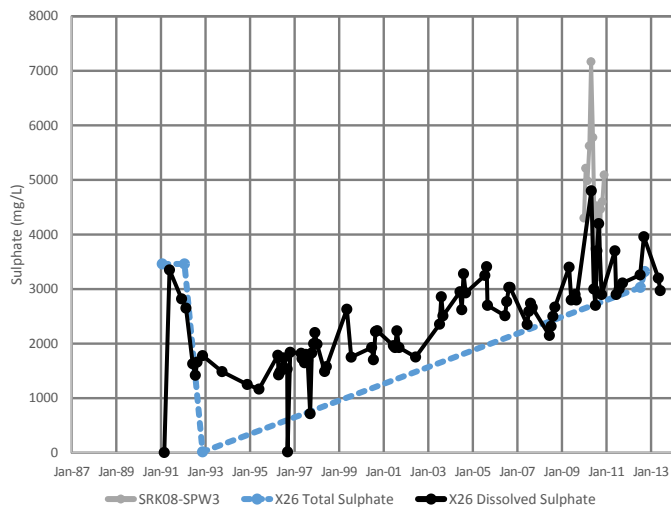
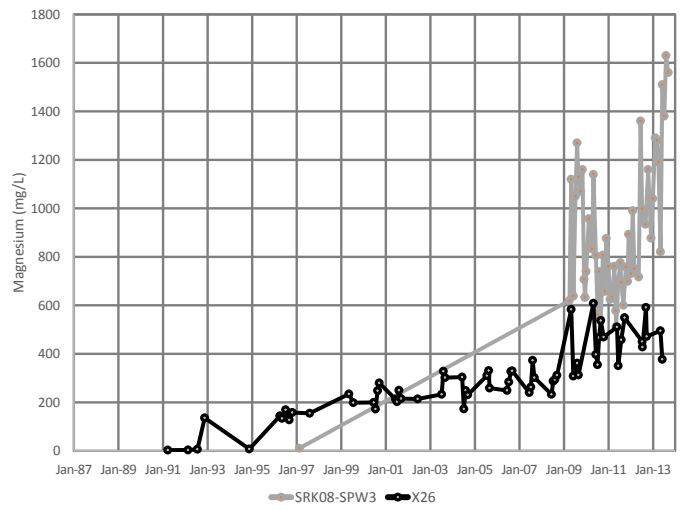
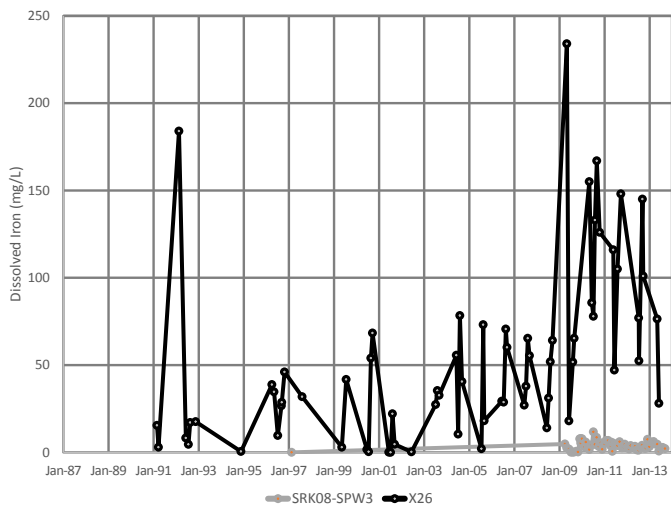
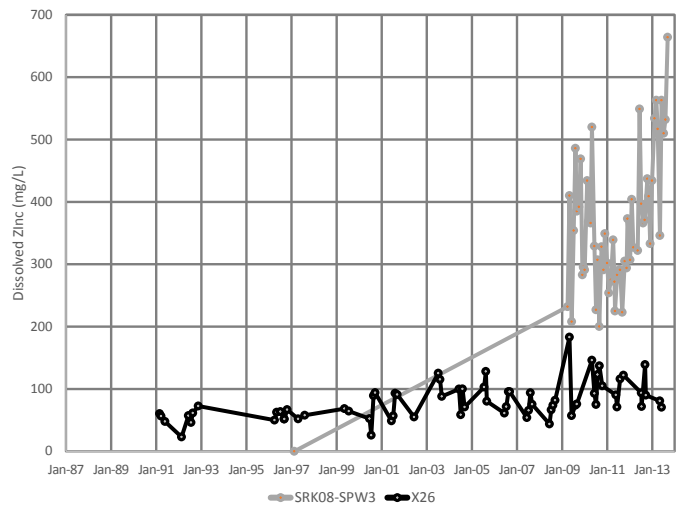
FIGURE 5-14
Trends in Selected Water Quality Parameters of
Intercepted Water from the Zone II and S-wells Area
Faro Mine Remediation Project

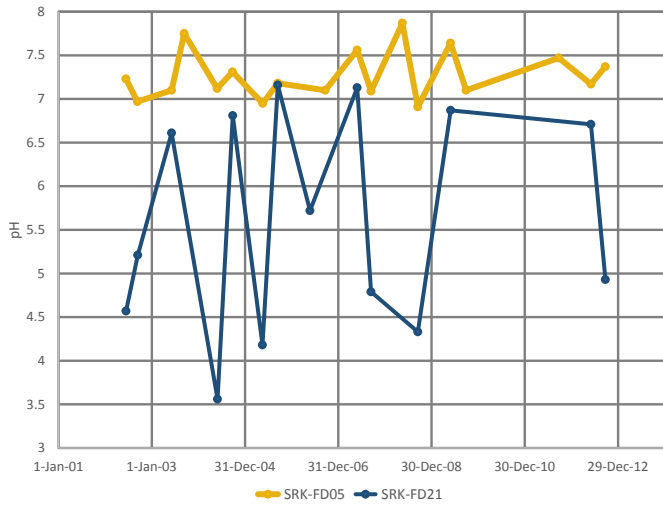
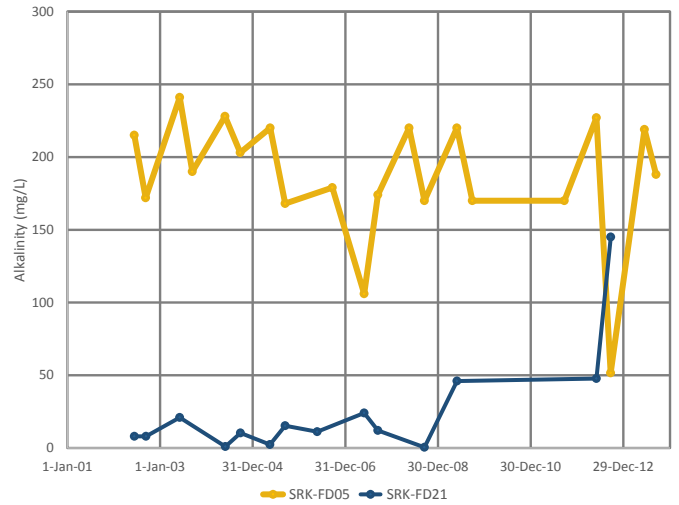
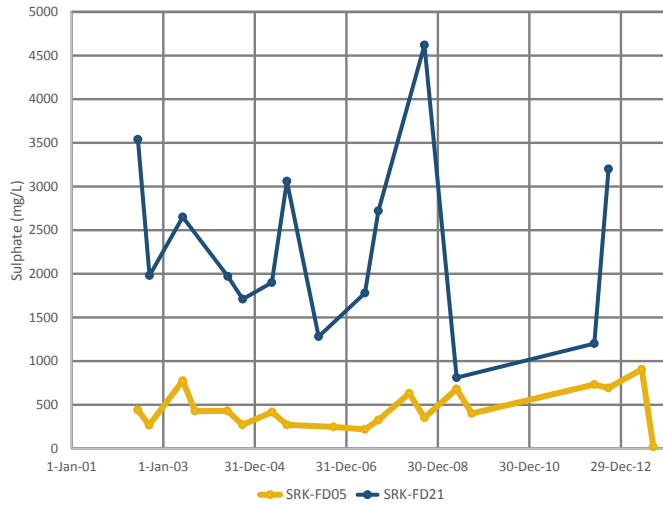
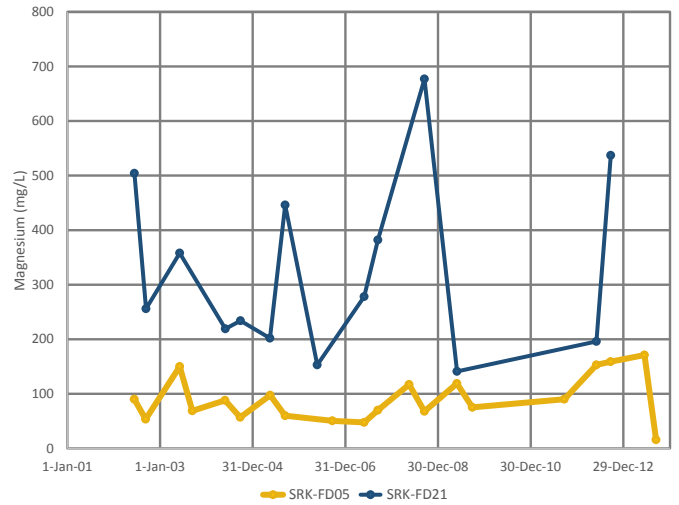
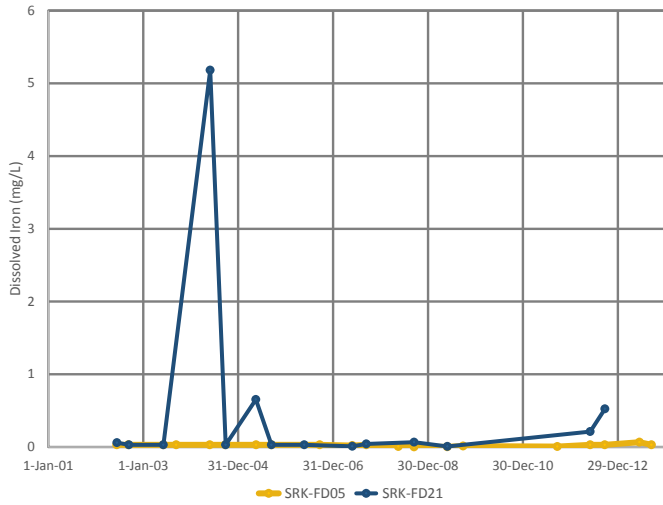
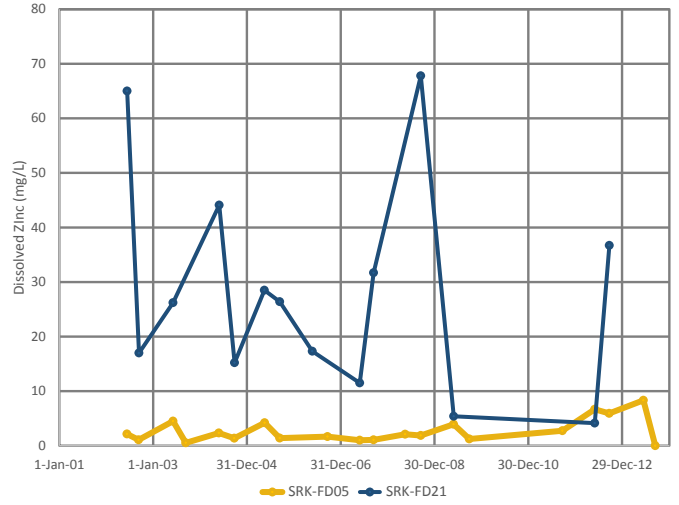
FIGURE 5-15
Trends in Selected Water Quality Parameters of
Seepage Draining toward North Fork Rose Creek
Faro Mine Remediation Project

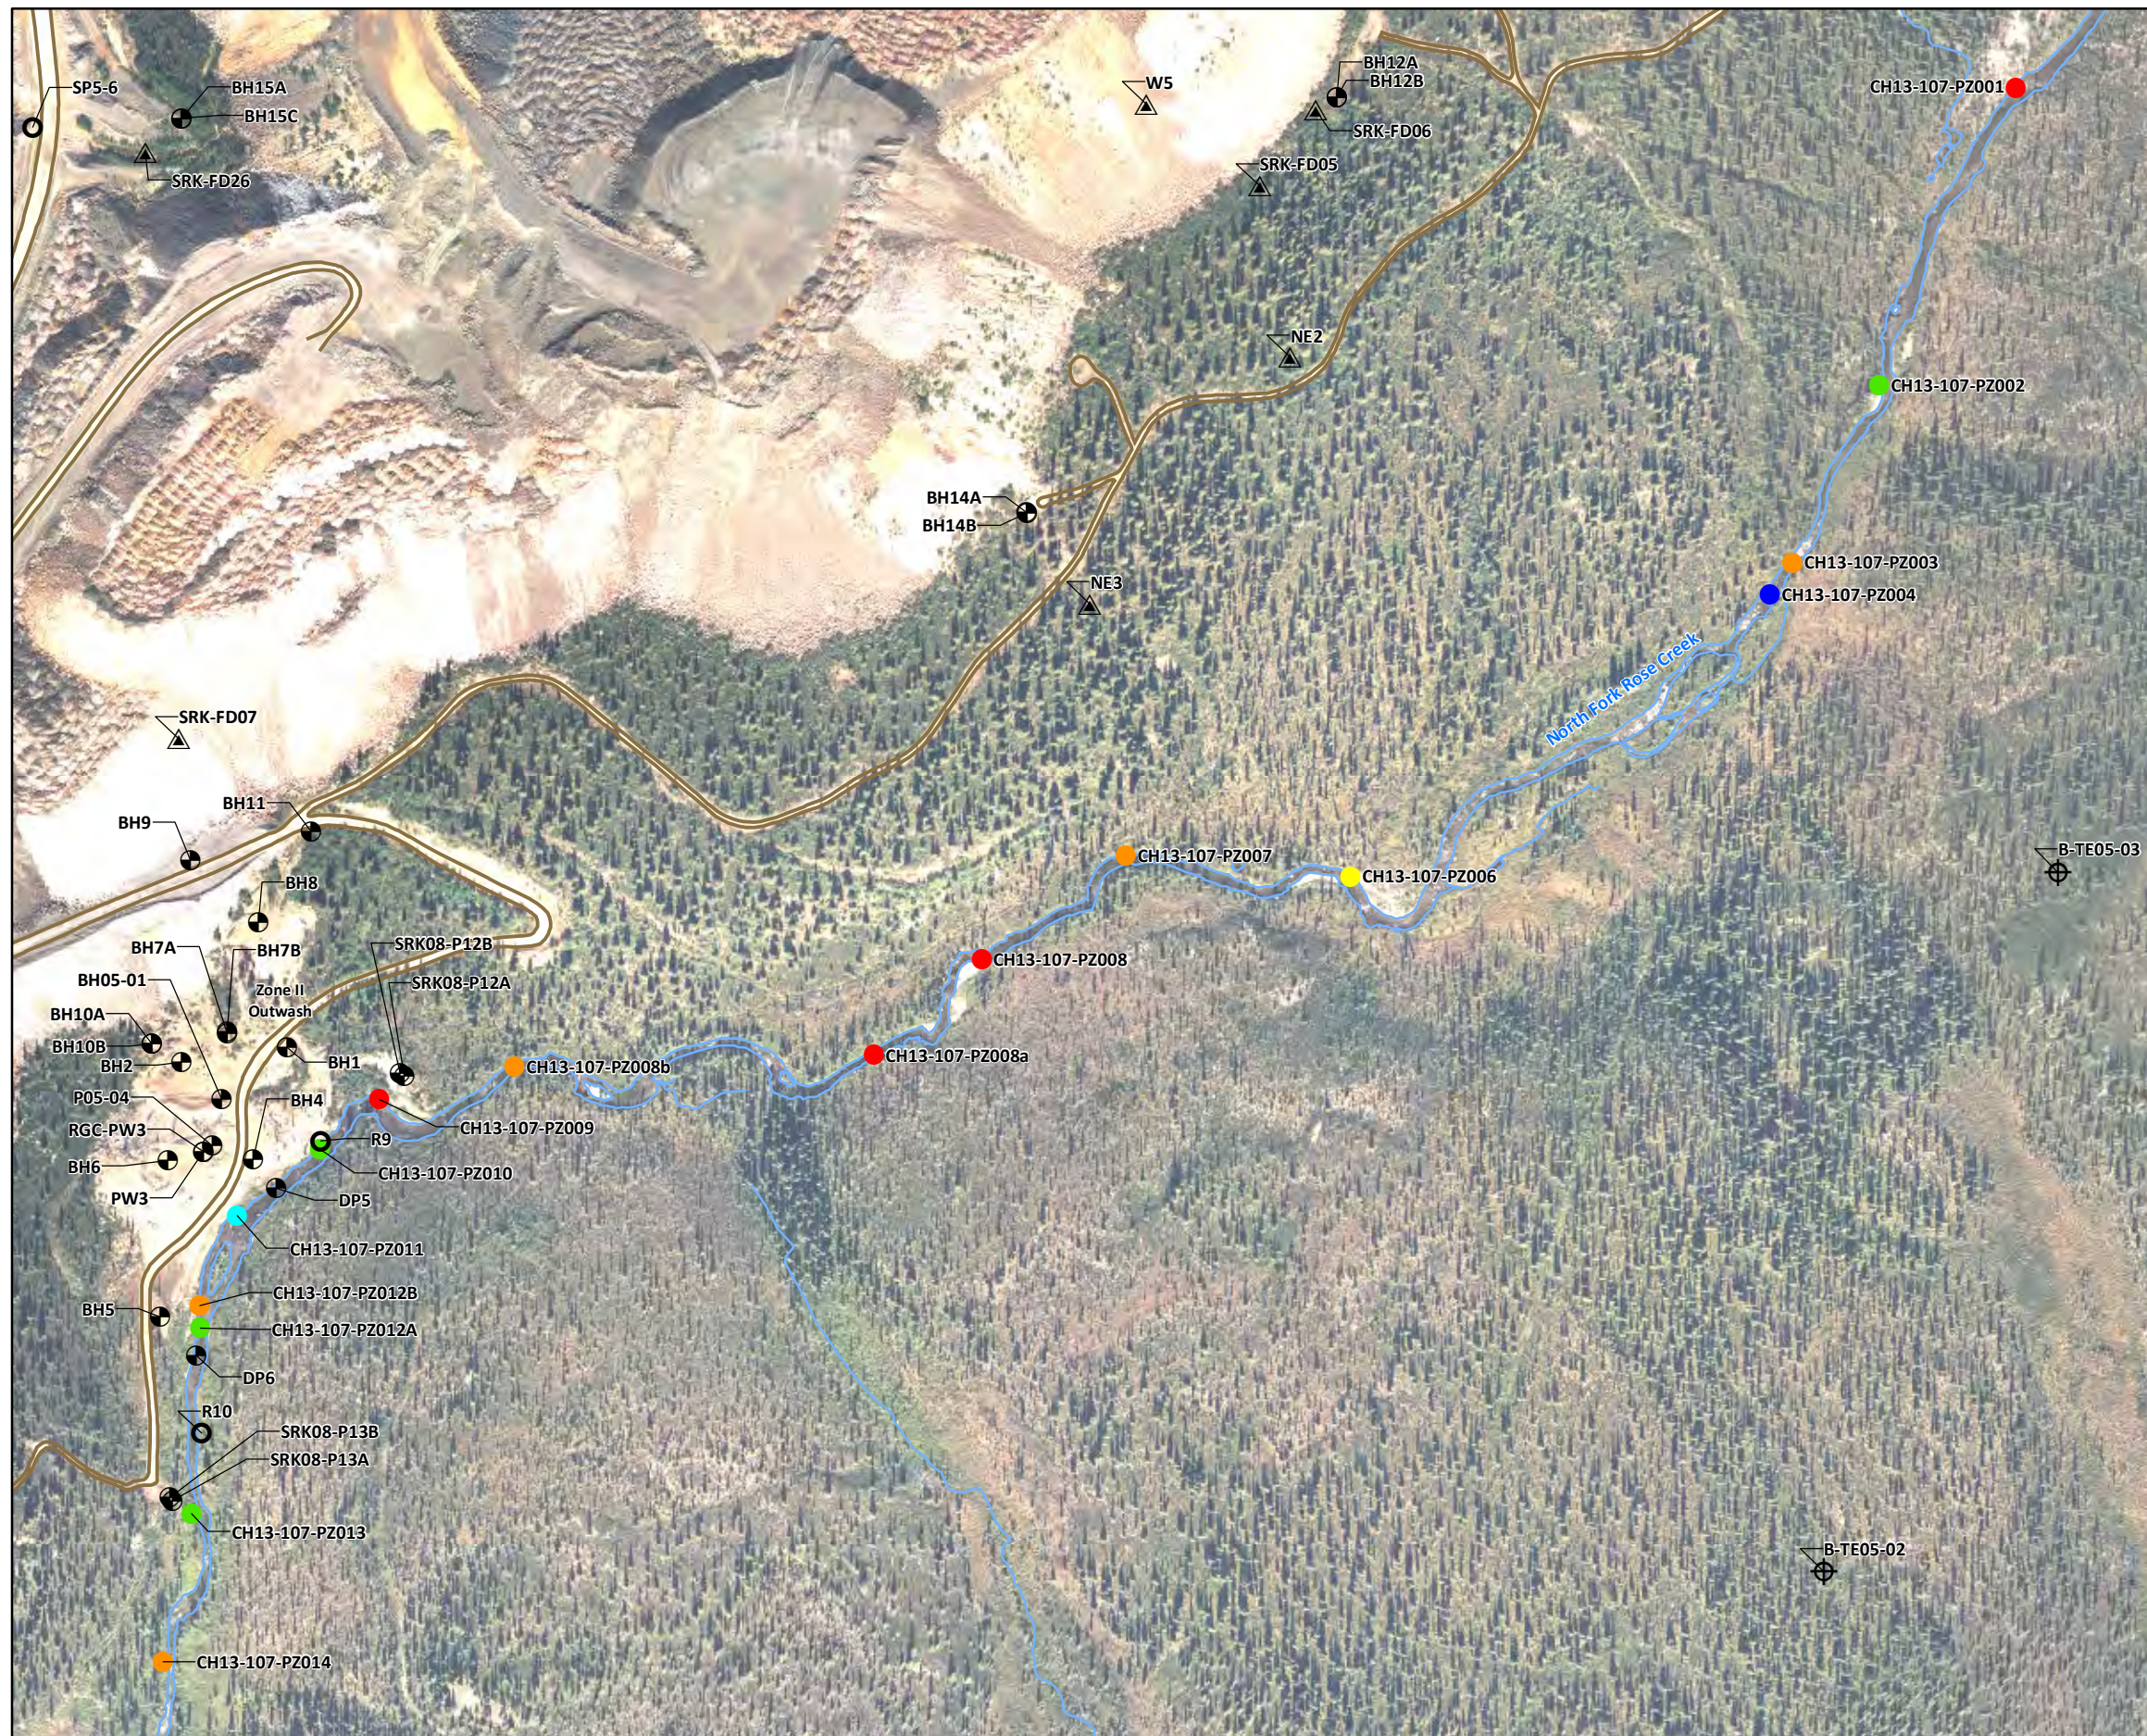
1. Vertical Hydraulic Gradient (VHG) were measured from 8/27/13 to 8/31/13.
2. Negative VHGs indicate the direction of flow is from the groundwater to the stream (gaining stream conditions).
3. Aerial photography acquired by Peregrine Aerial Surveyors Inc. and Eagle Mapping in August 2012.

FIGURE 5-16
Approximate Streambed Piezometer Locations and Vertical Hydraulic Gradient on NFRC, Summer 2013
 Faro Mine Remediation Project

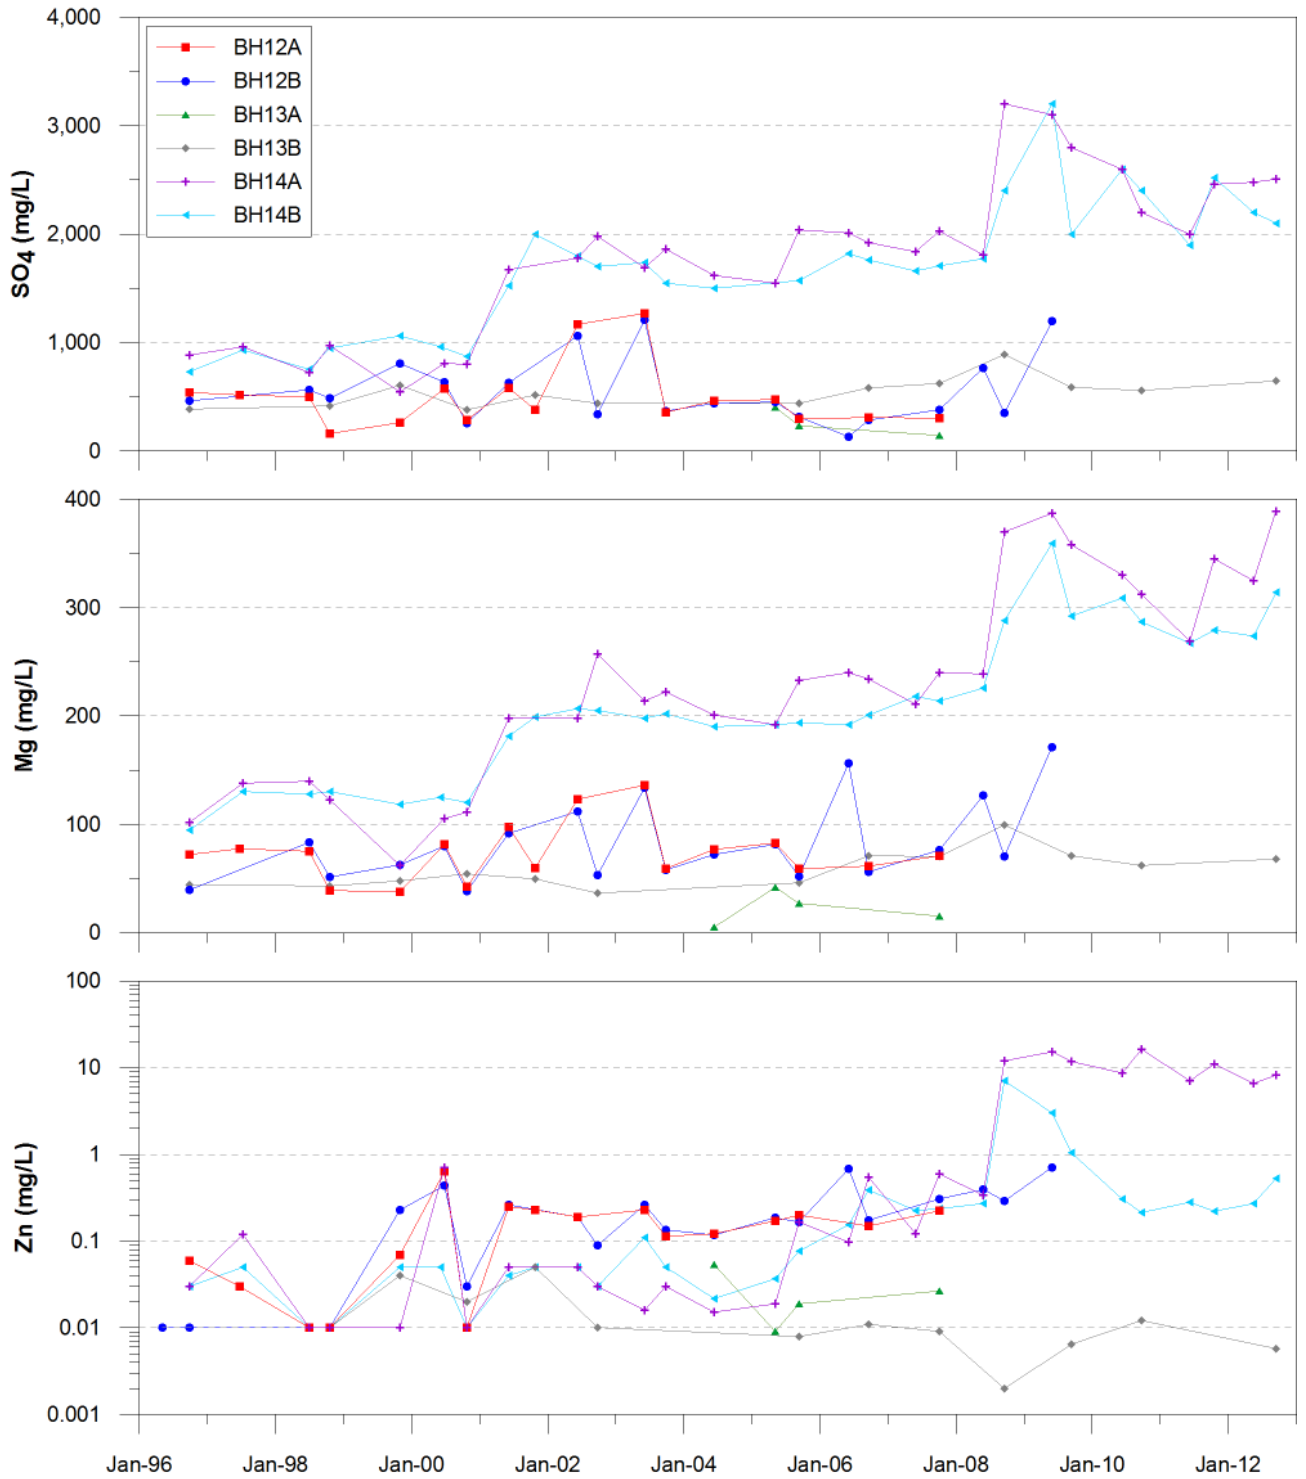
FIGURE 5-17
 Time Trends for SO₄, Mg, and Zn in Wells at the
 Toe of Northeast Waste Rock Dump
 Faro Mine Remediation Project
