Appendix A

Figures

FIGURE 1-1
Faro Mine Complex Location
 Faro Mine Remediation Project

FIGURE 1-2
Faro Mine Complex Overview
 Faro Mine Remediation Project

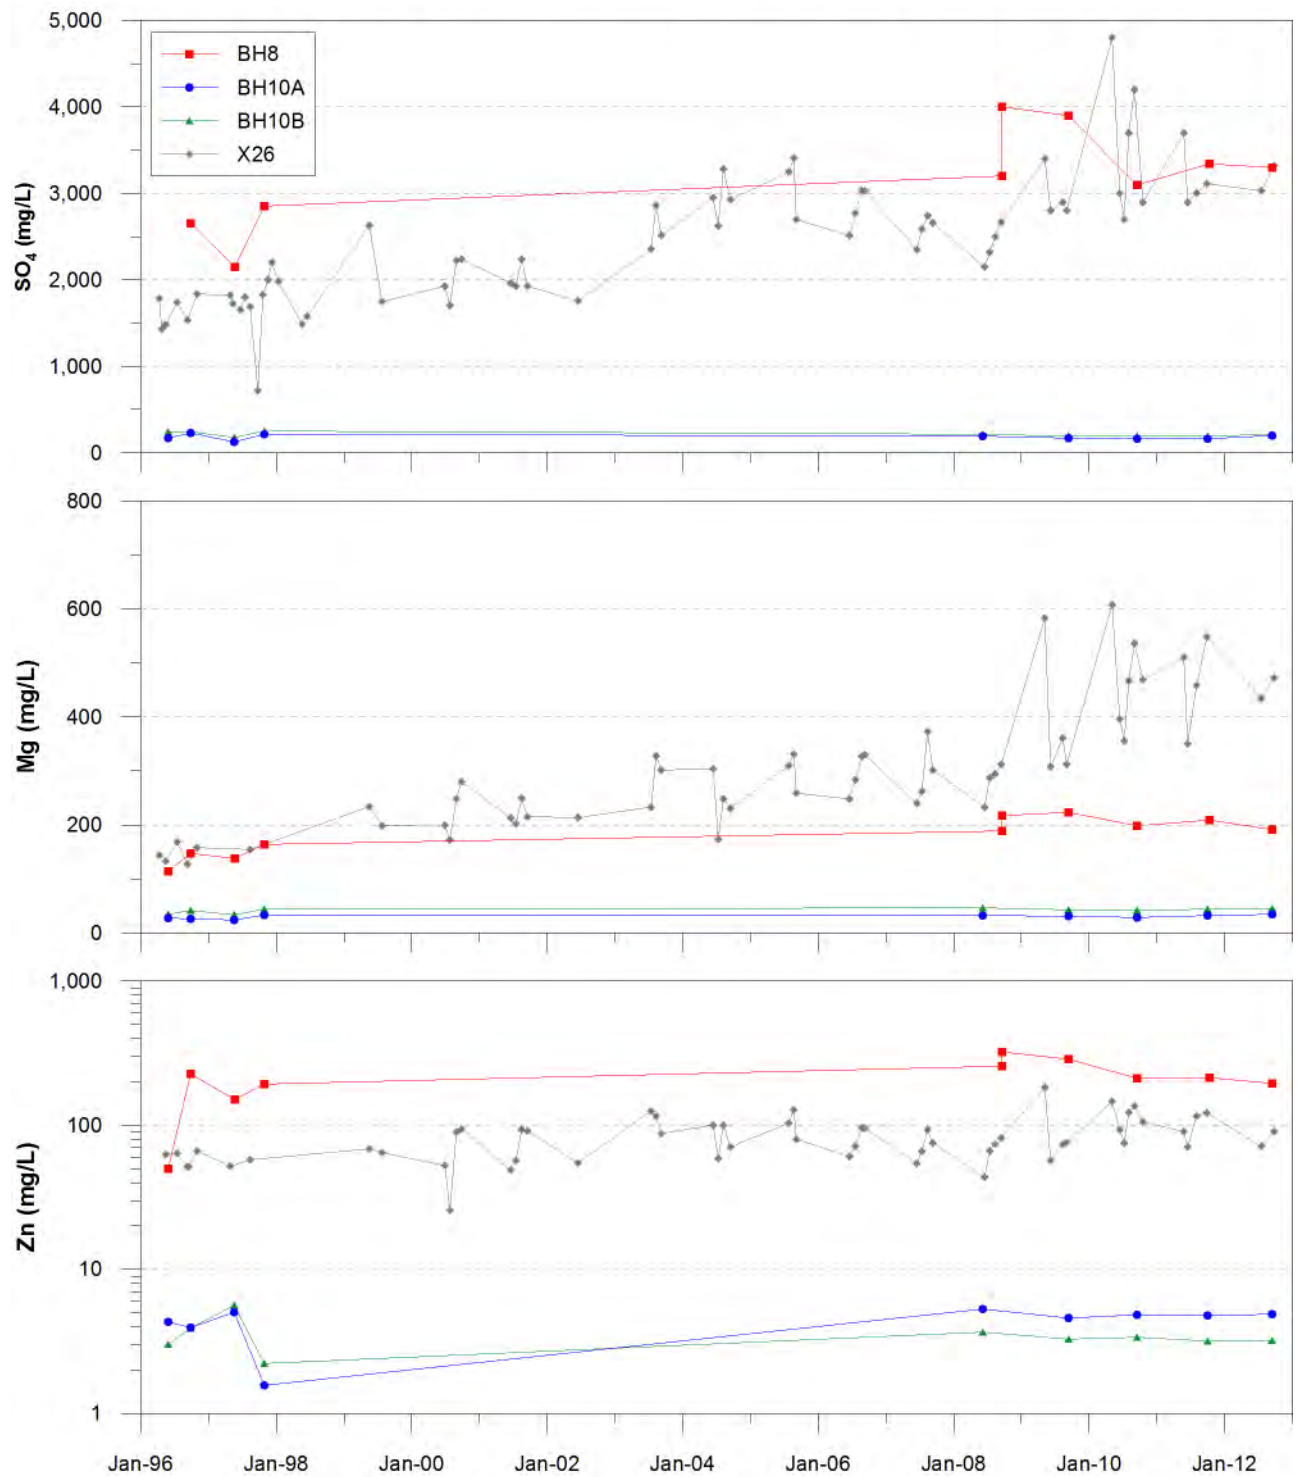
FIGURE 5-18
 Time Trends for SO₄, Mg, and Zn for Zone II Pit
 and Bedrock Wells
 Faro Mine Remediation Project

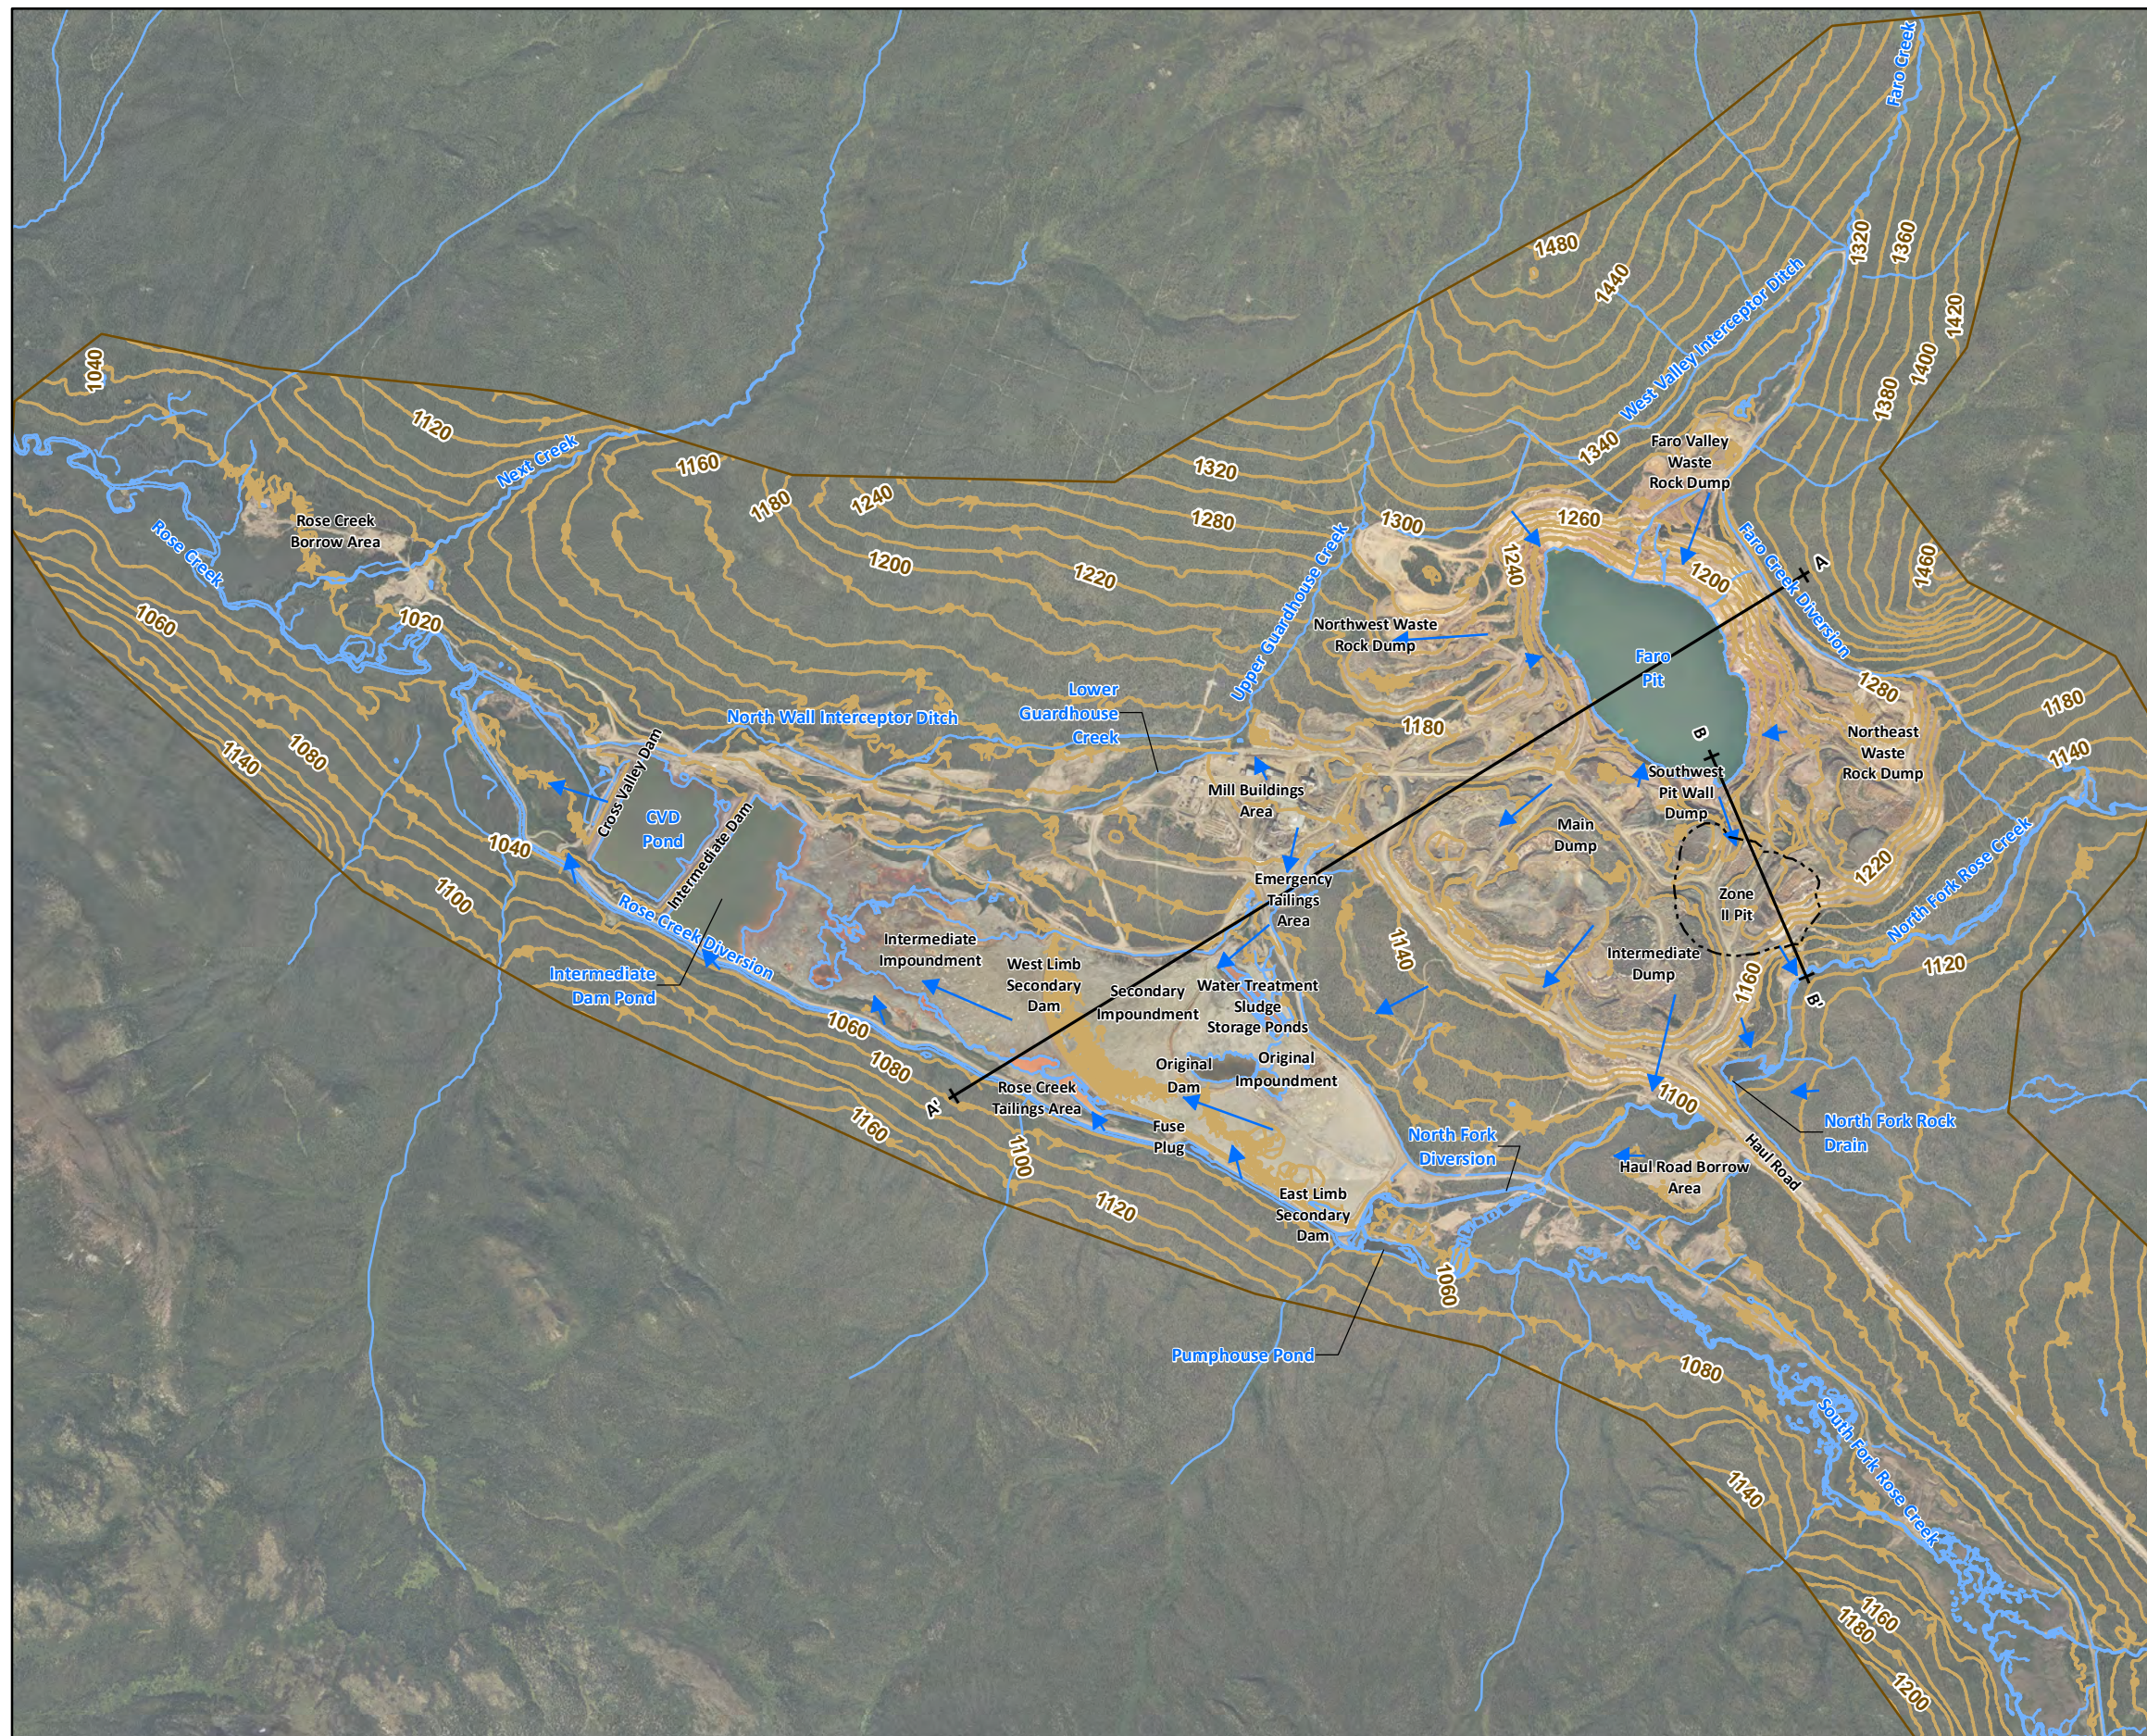
- LEGEND**
- +— Cross Section Location
 - Generalized Groundwater Flow Direction
- 2011 Topography**
- Index Contour (40m Interval)
 - Index Depression Contour (40m Interval)

FIGURE 5-20
Faro Mine Cross Section Locations and Generalized Groundwater Flow
Faro Mine Remediation Project

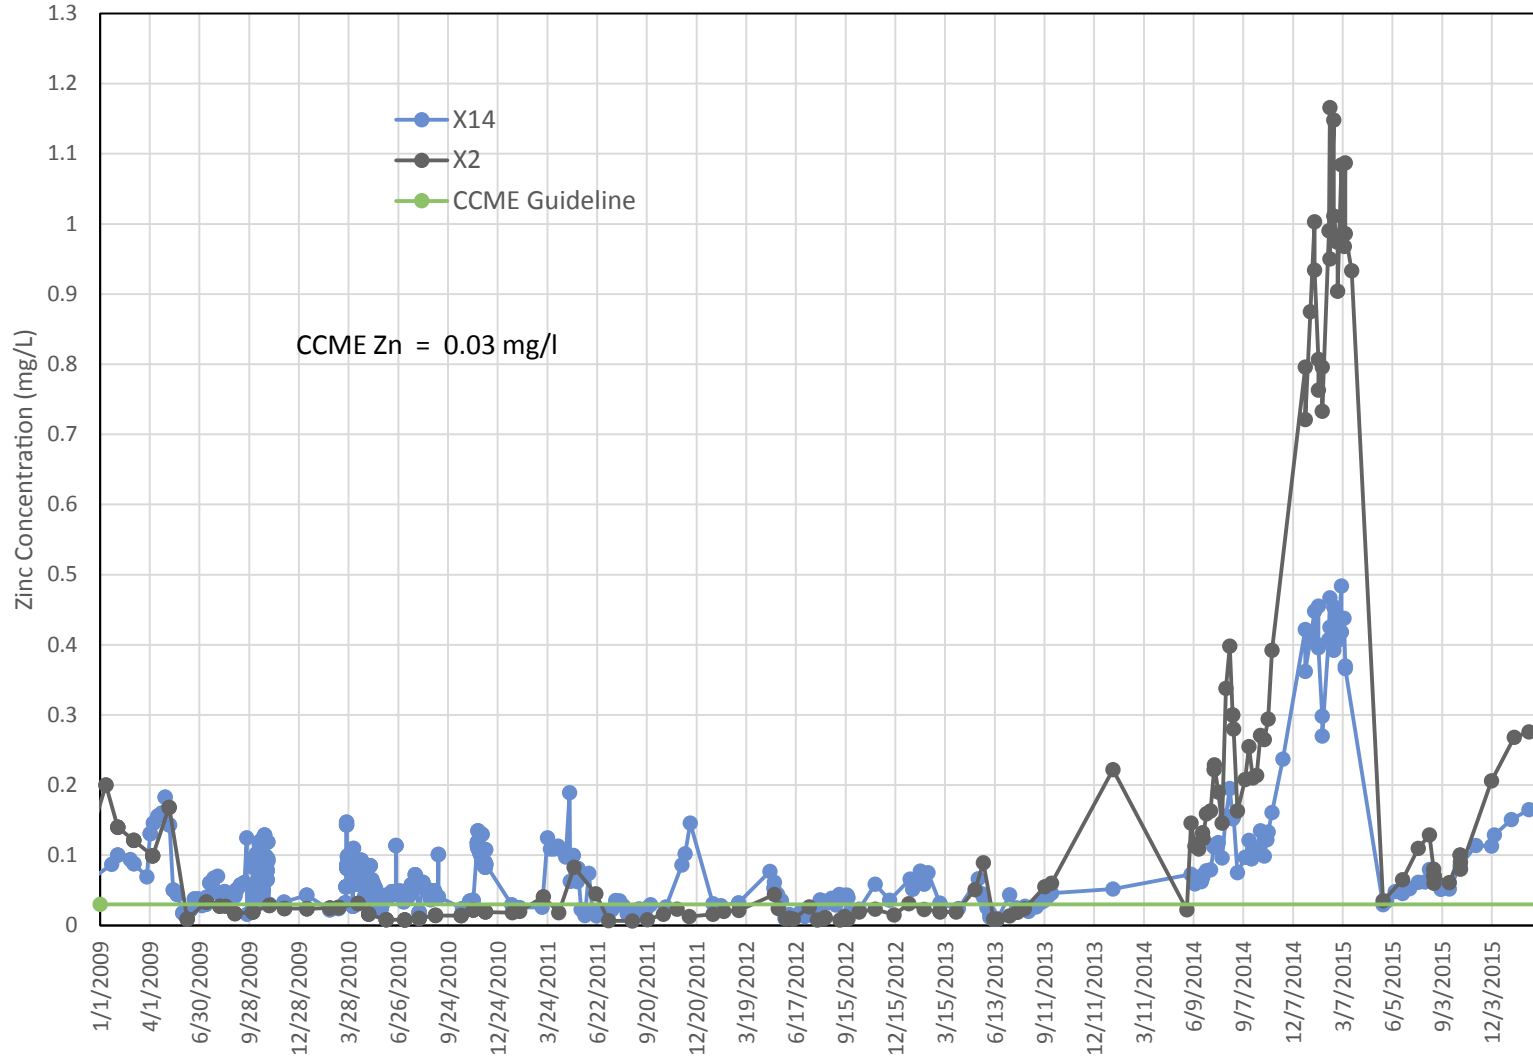
FIGURE 5-24
**Zinc Concentrations
 at Monitoring Stations
 X2 and X14**
Faro Mine Remediation Project

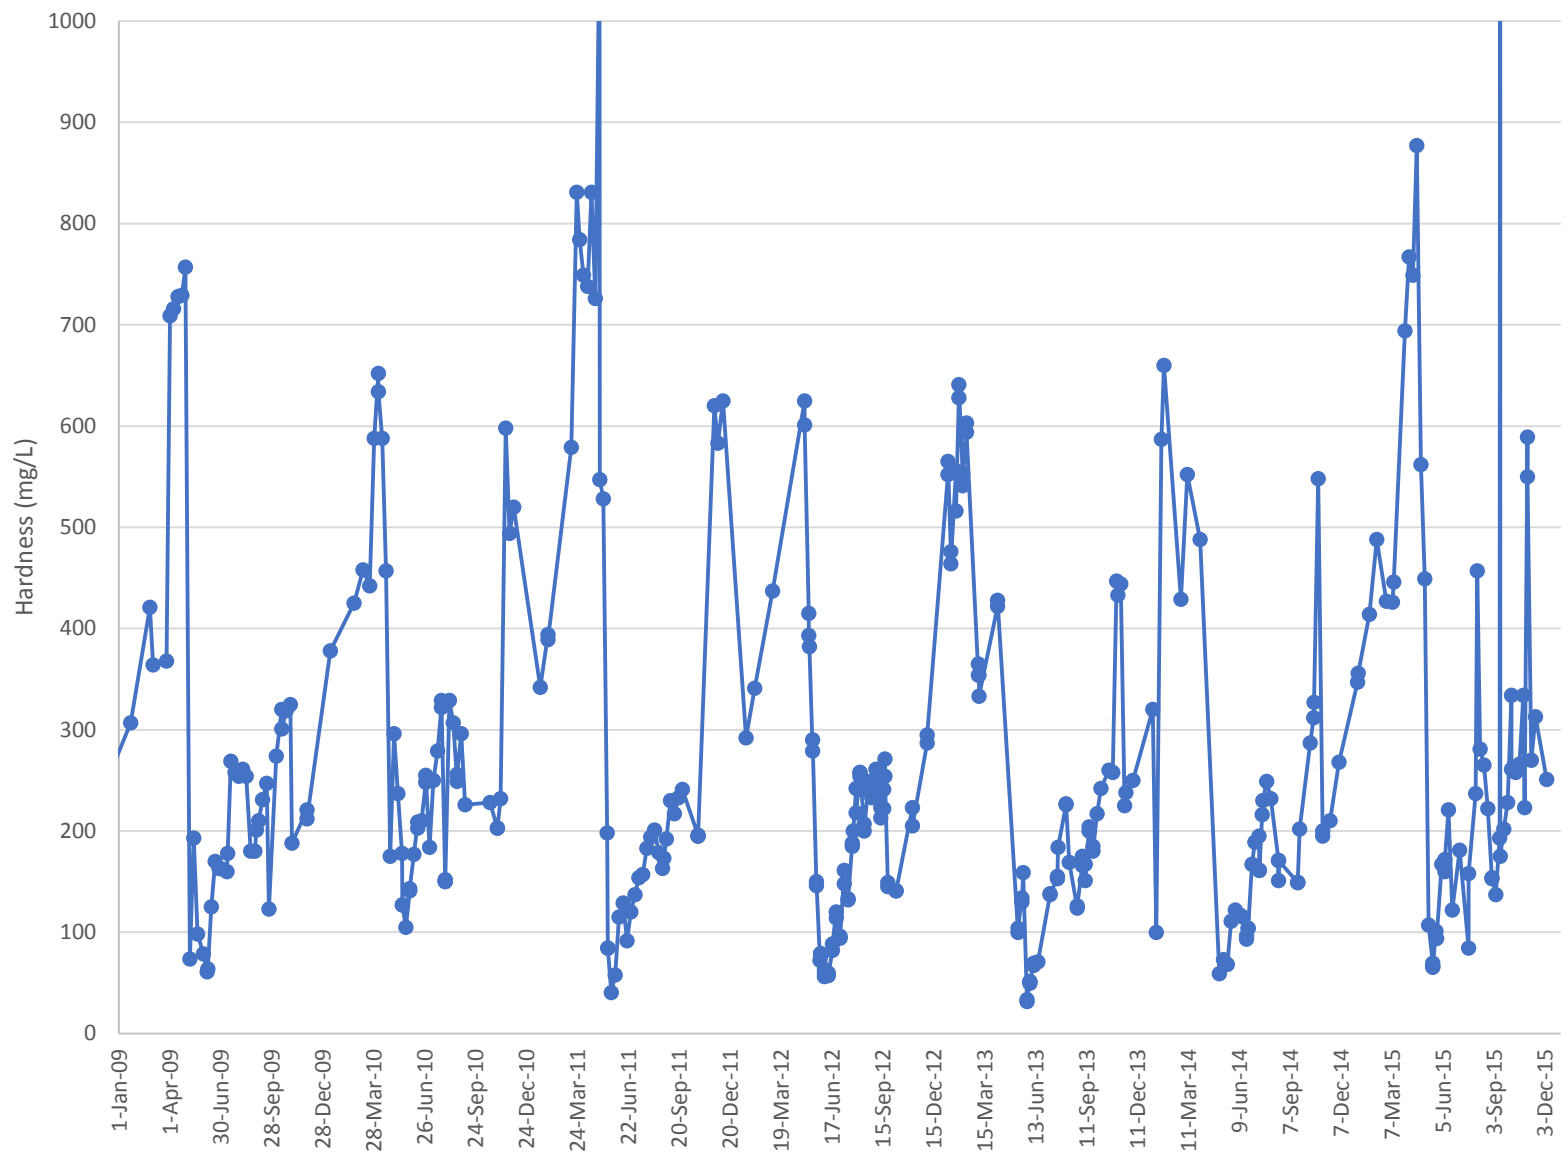
FIGURE 5-25
Hardness (As CaCO₃)
at Monitoring Station X14
Faro Mine Remediation Project

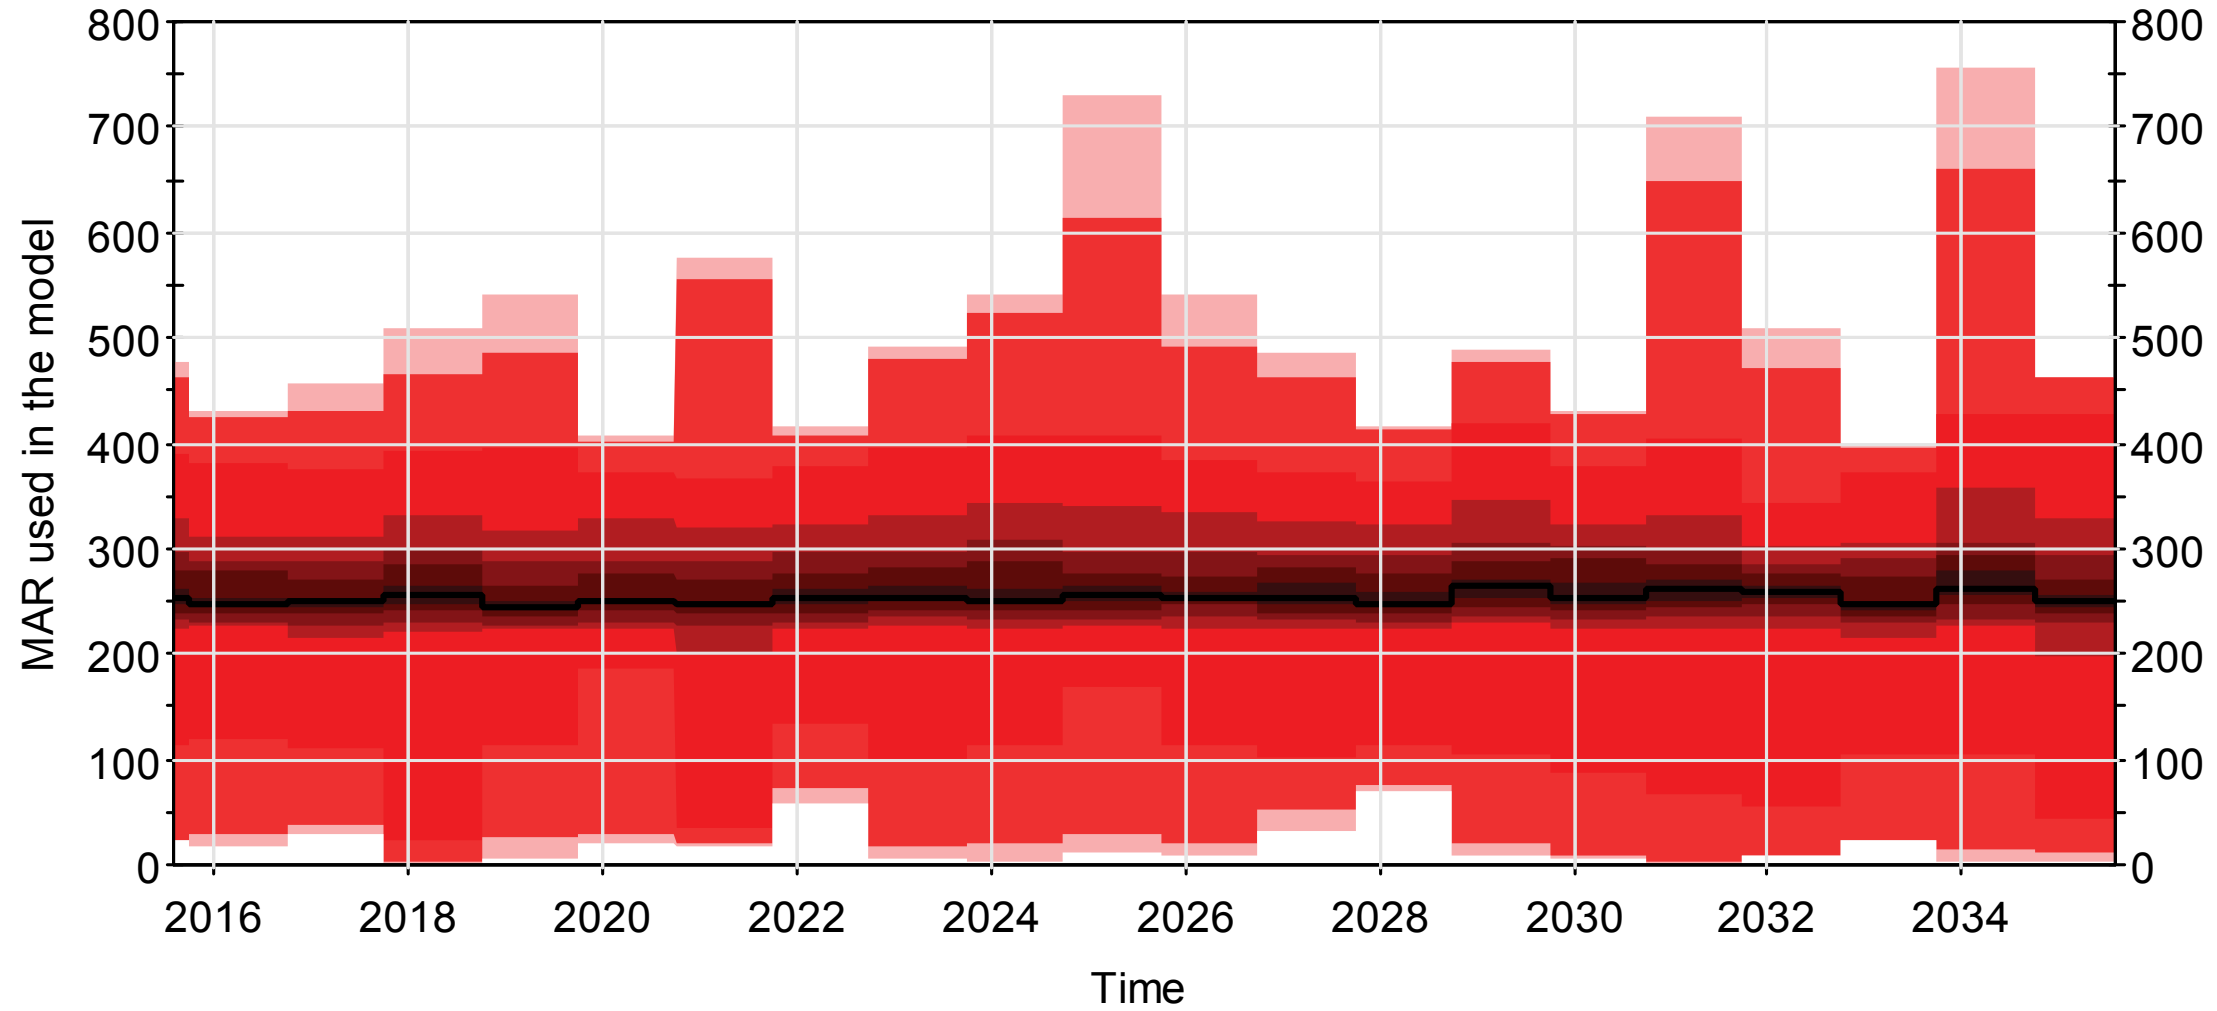
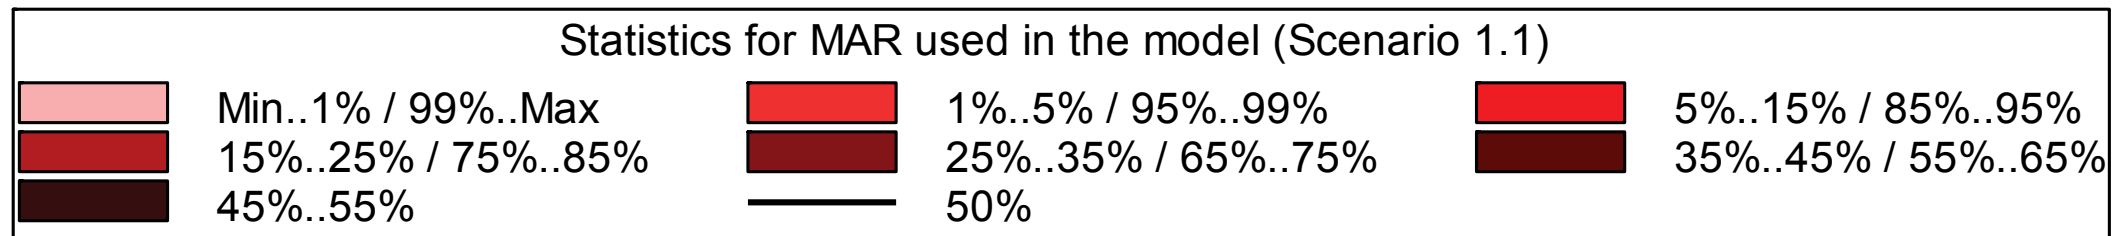
MAR used in the model
Values are resampled every year for stochastic and scaled for deterministic input

FIGURE 13-5
Mean Annual Run-off Used in Model
 Faro Creek Diversion
 Faro Mine Remediation Project

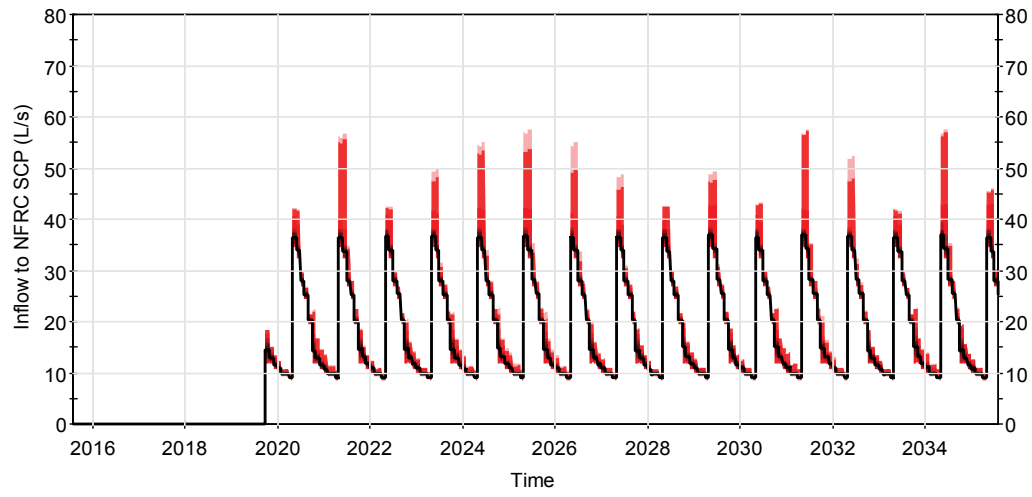
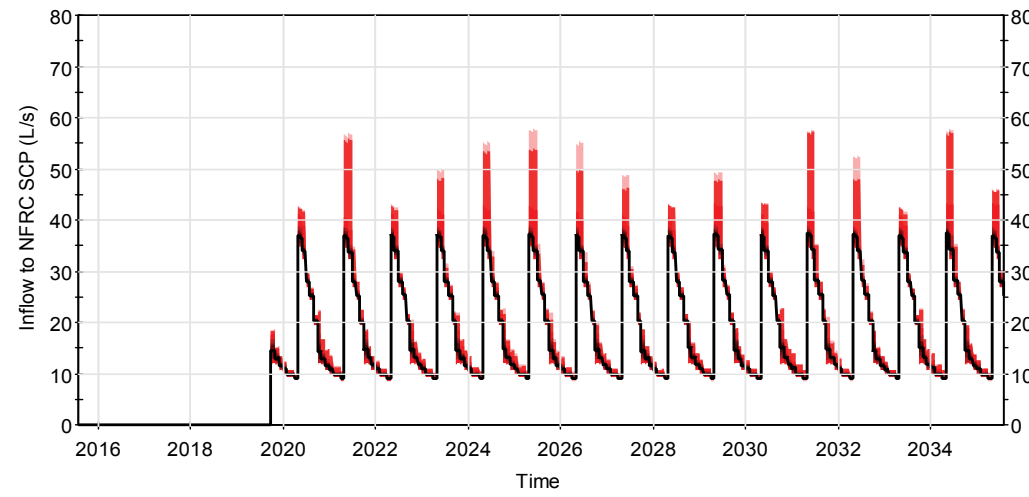
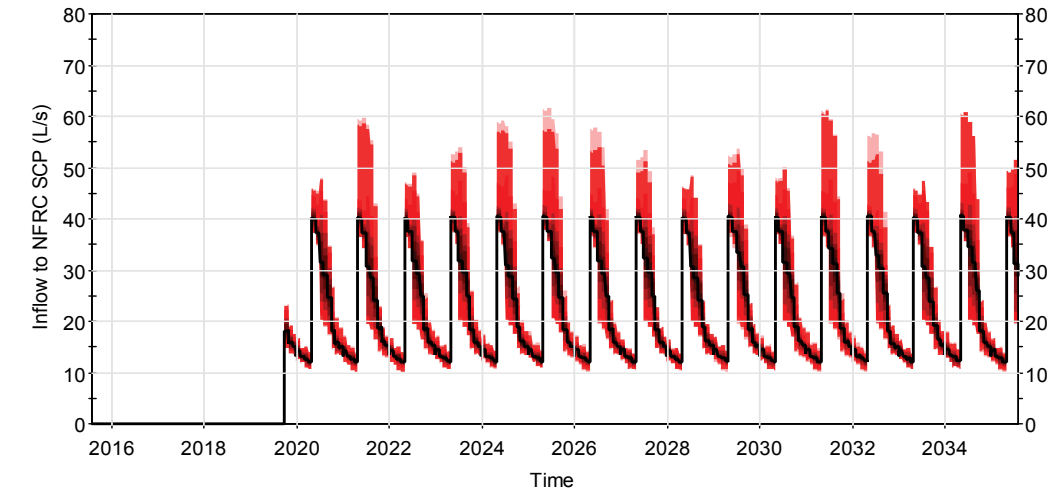
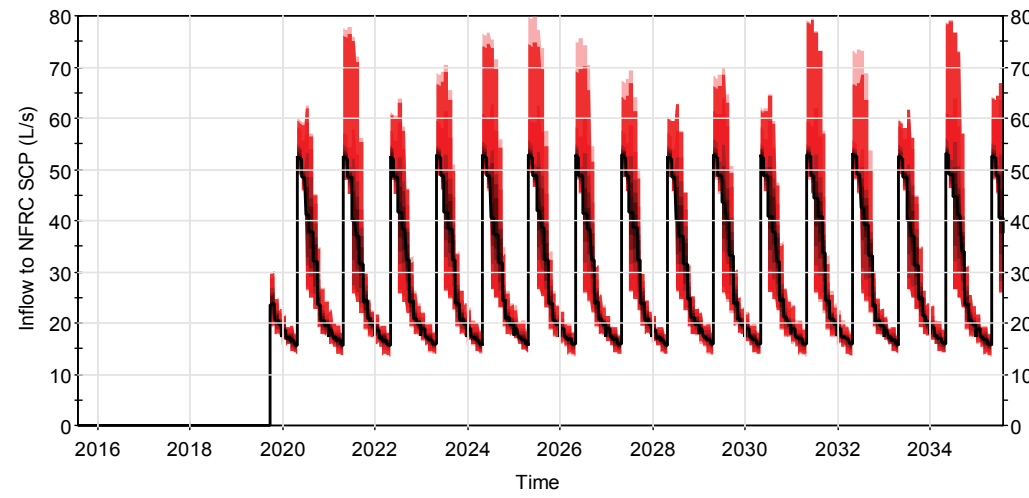
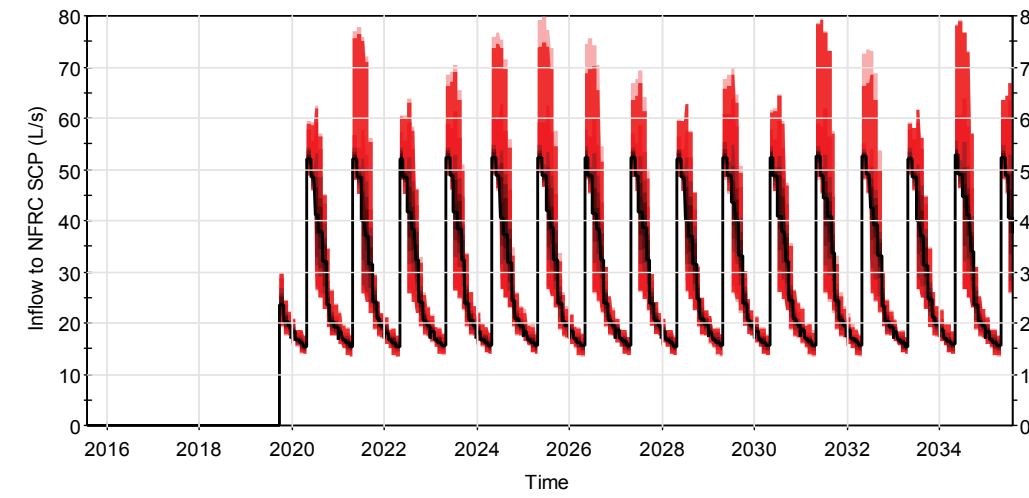
FIGURE 13-6a
Water Management Tool Results – Inflow to NFRC SCP
Faro Creek Diversion
Faro Mine Remediation Project

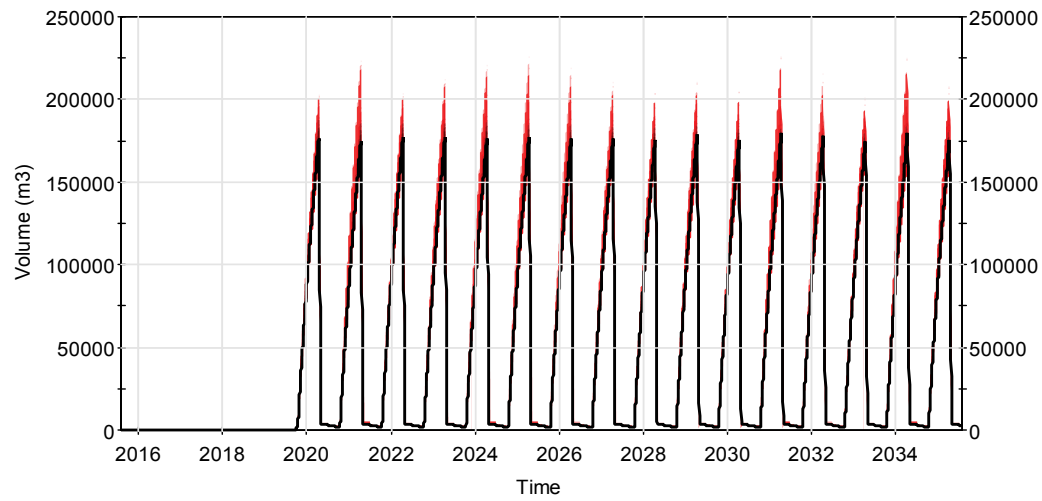
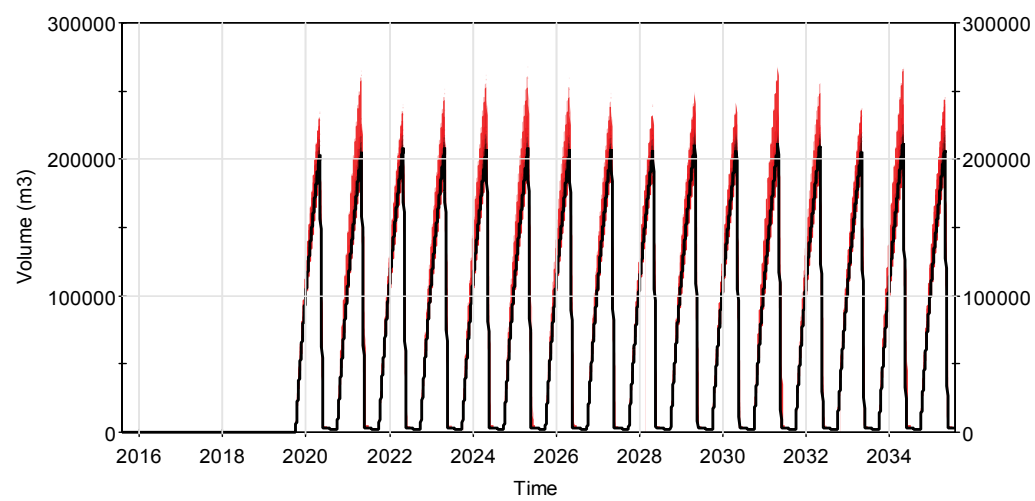
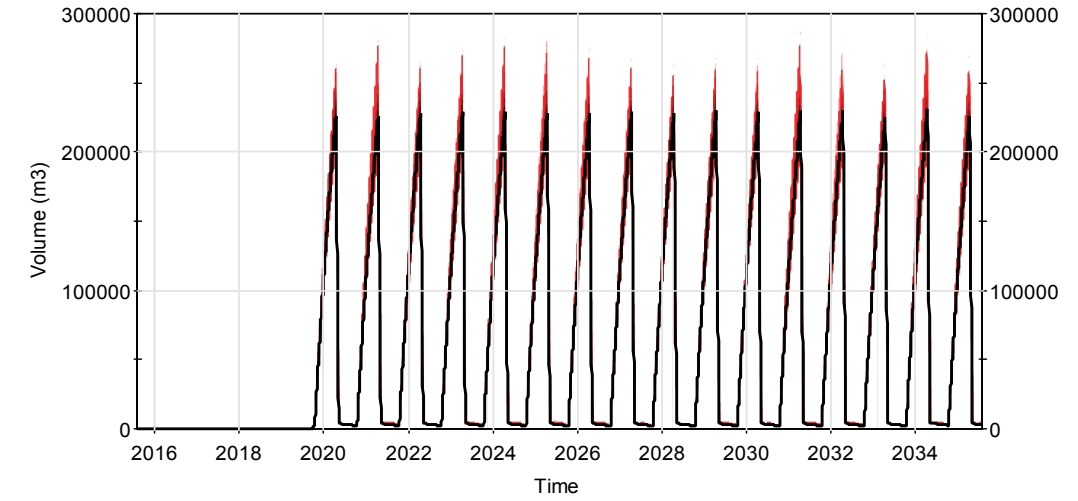
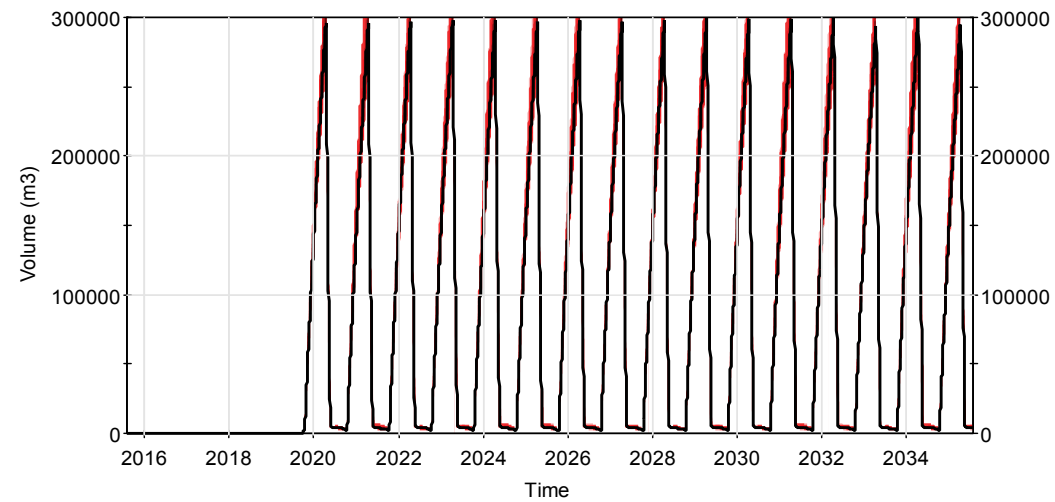
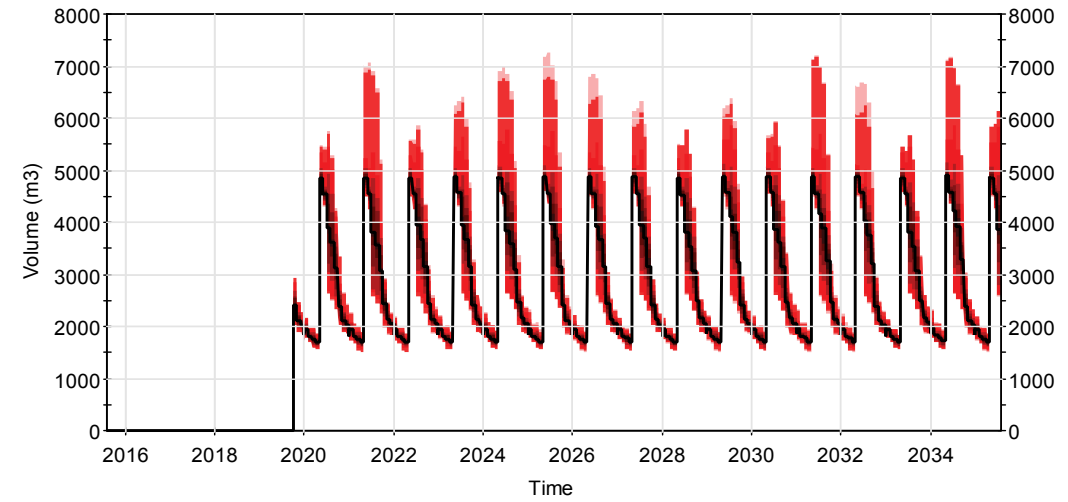
FIGURE 13-6b
Water Management Tool Results –NFRC SCP Stored Volume
Faro Creek Diversion
Faro Mine Remediation Project

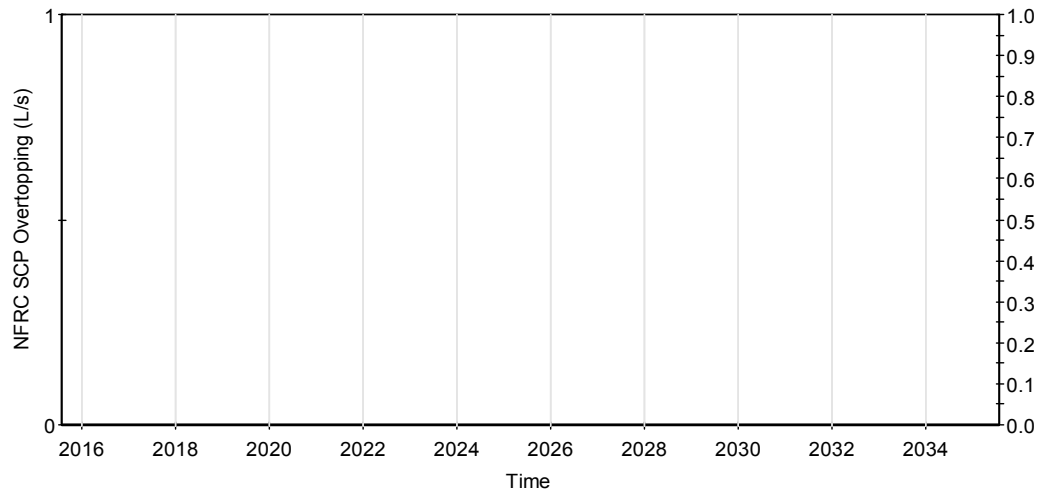
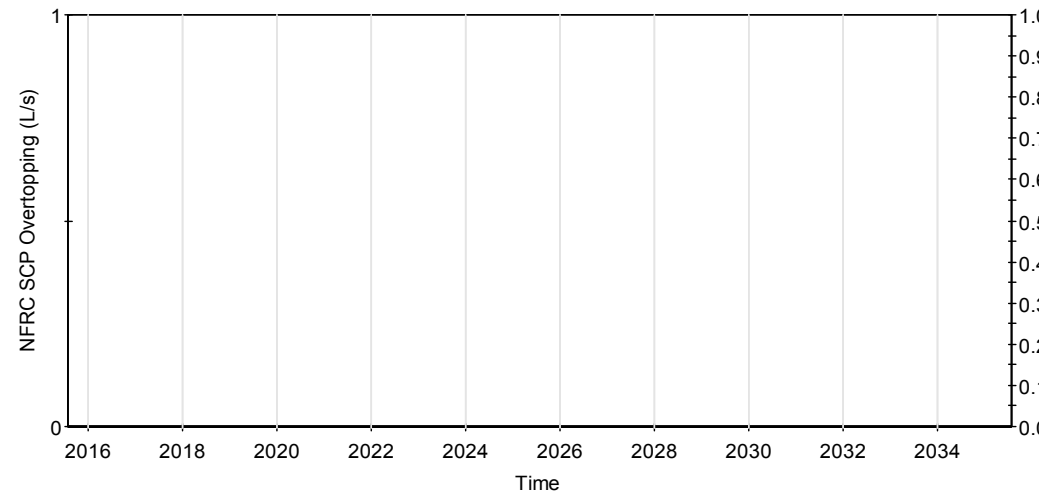
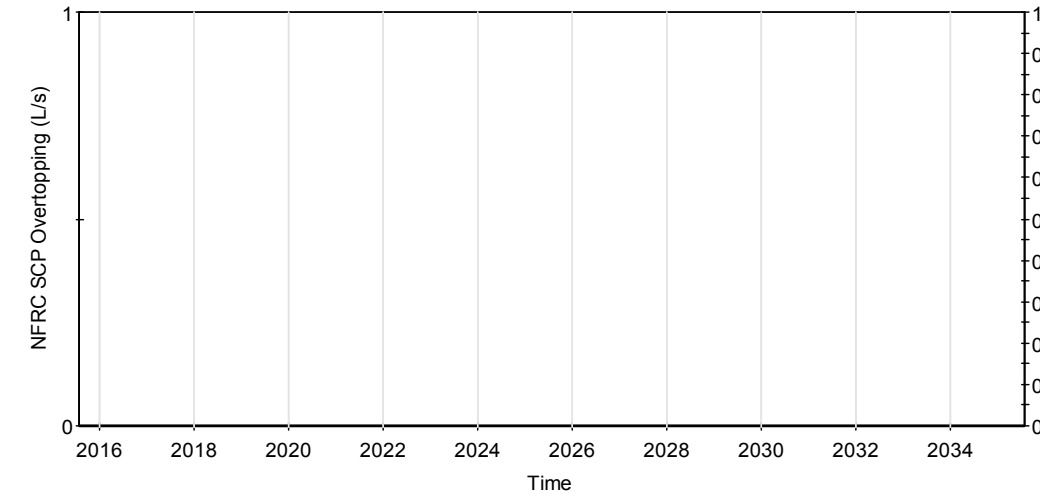
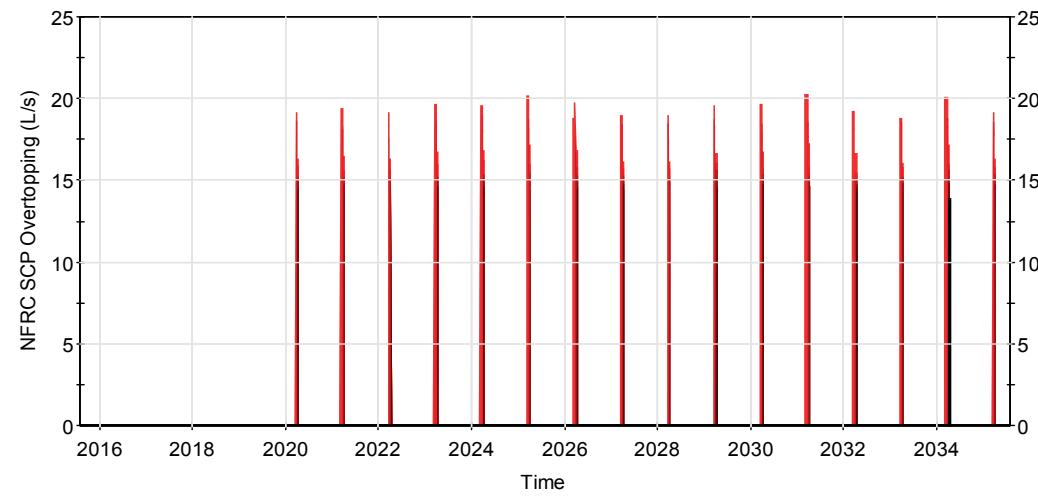
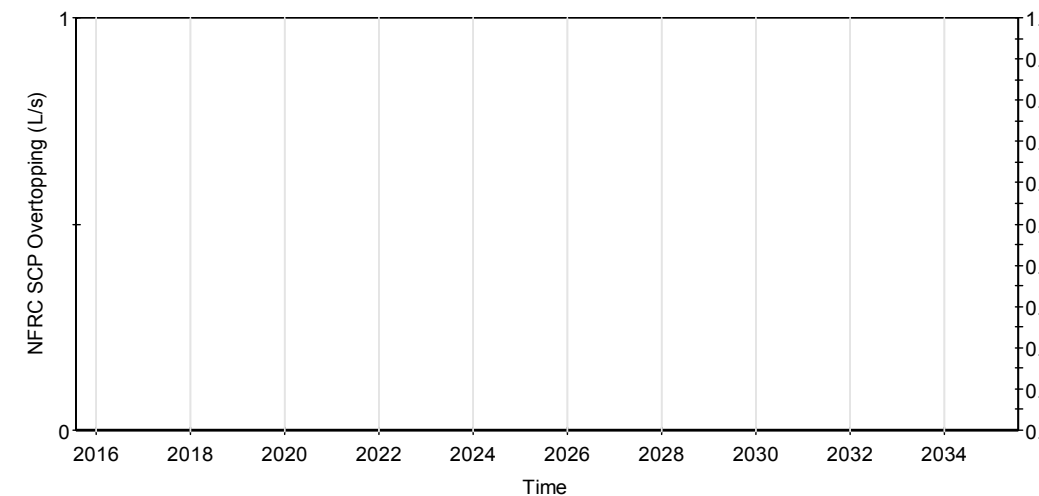
FIGURE 13-6c
Water Management Tool Results – Spills from NFRC SCP
 Faro Creek Diversion
 Faro Mine Remediation Project

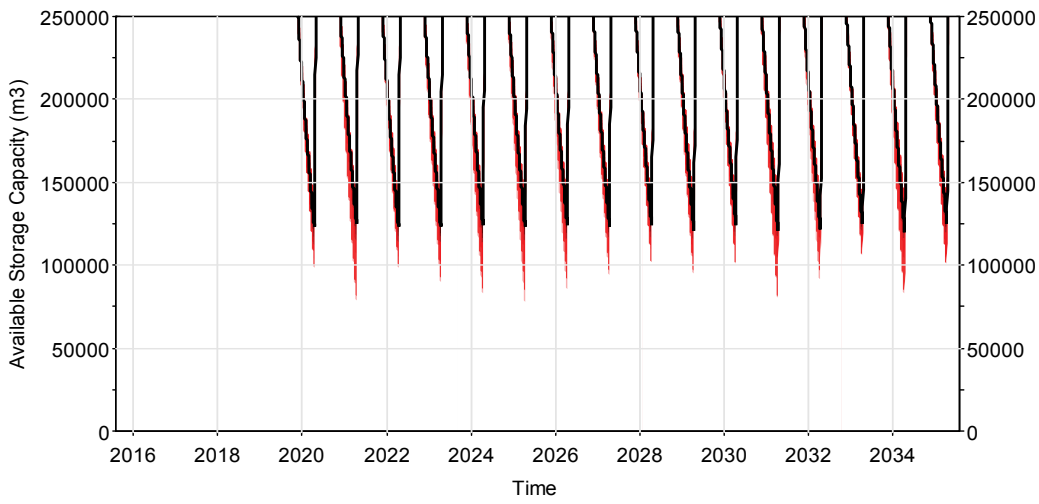
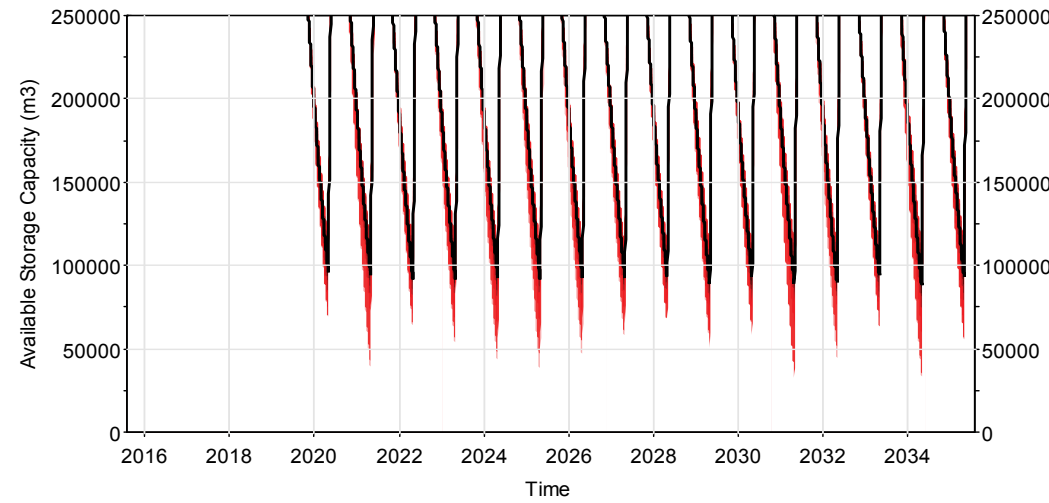
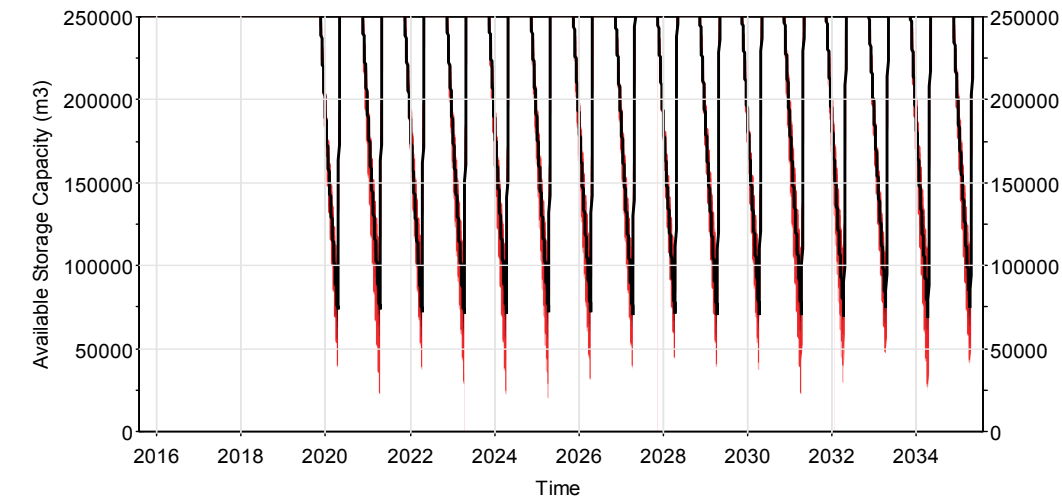
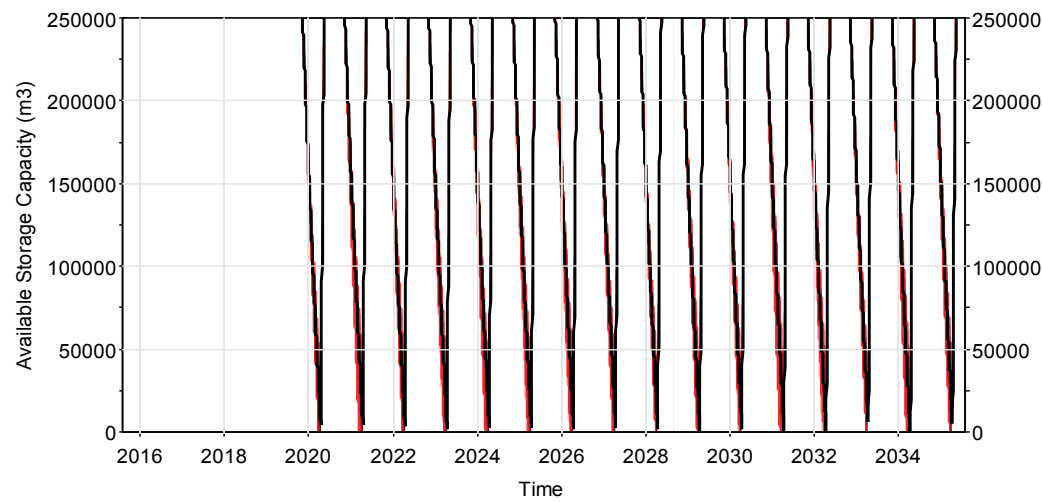
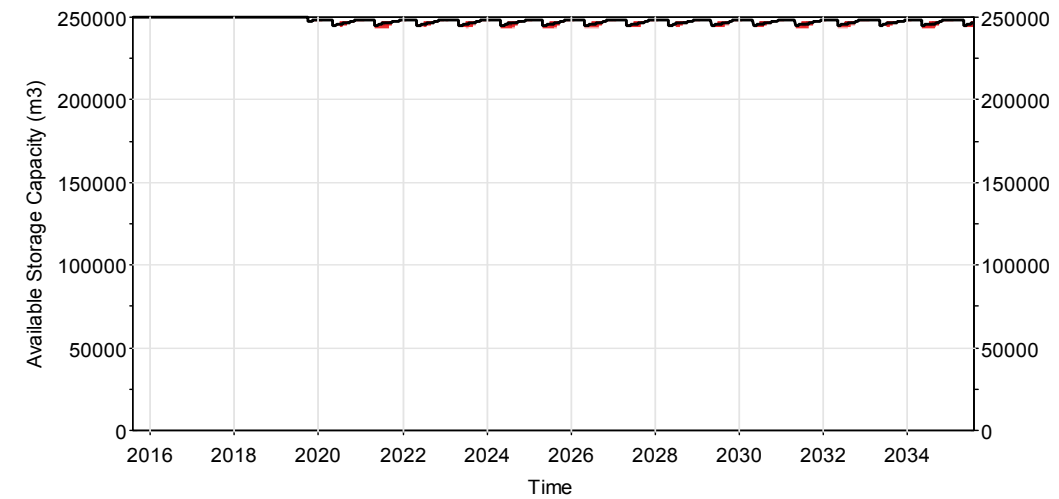
FIGURE 13-6d
Water Management Tool Results – Available Storage Capacity
 Faro Creek Diversion
 Faro Mine Remediation Project
