Appendix A

Figures

FIGURE 1-1
Faro Mine Complex Location
 Faro Mine Remediation Project

FIGURE 1-2
Faro Mine Complex Overview
 Faro Mine Remediation Project

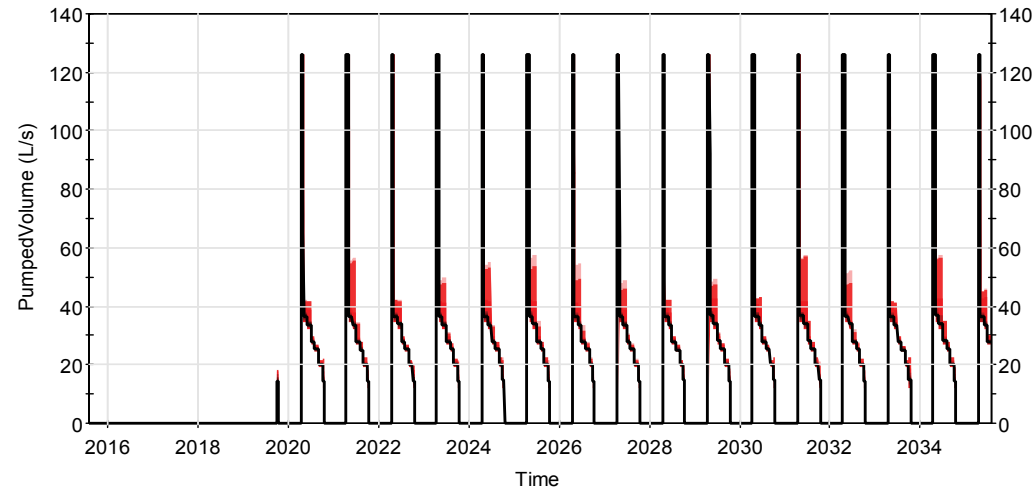
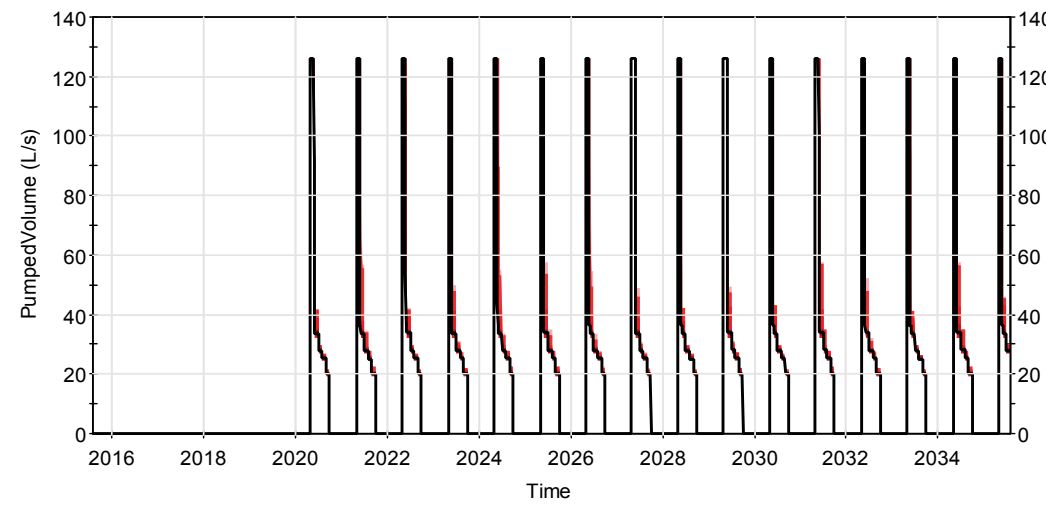
FIGURE 13-6e
Water Management Tool Results – Total Daily Volume Pumped
 Faro Creek Diversion
 Faro Mine Remediation Project

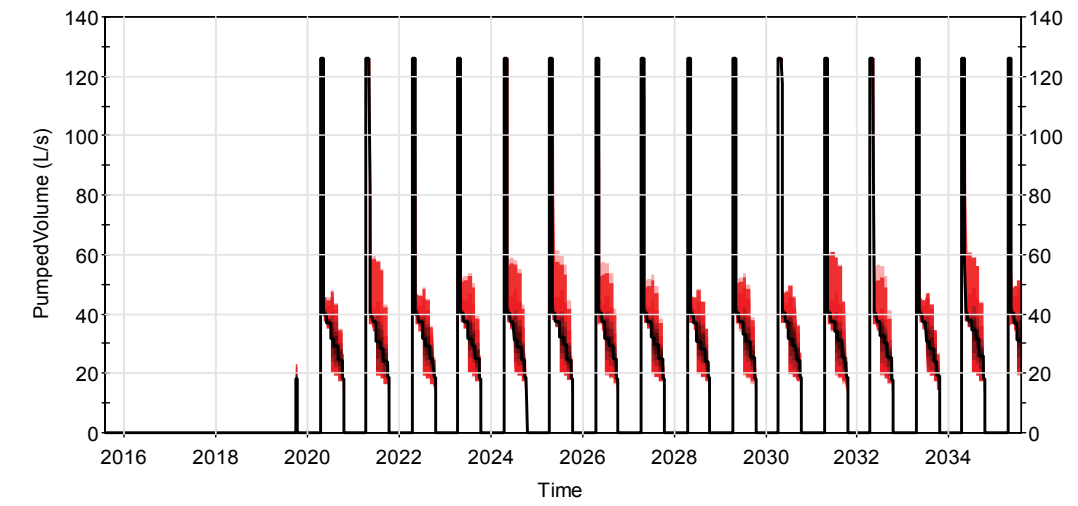
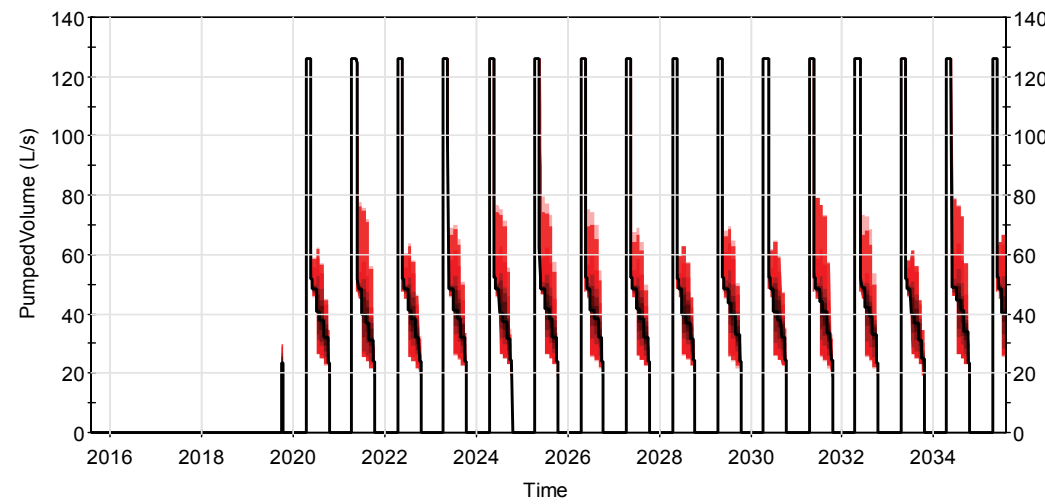
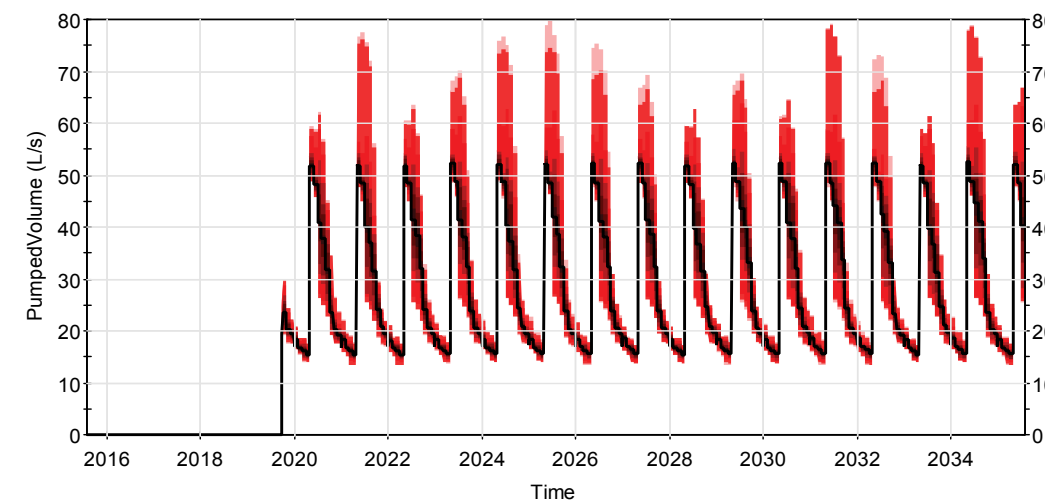
Total Daily Volume Pumped from NFRC SCP

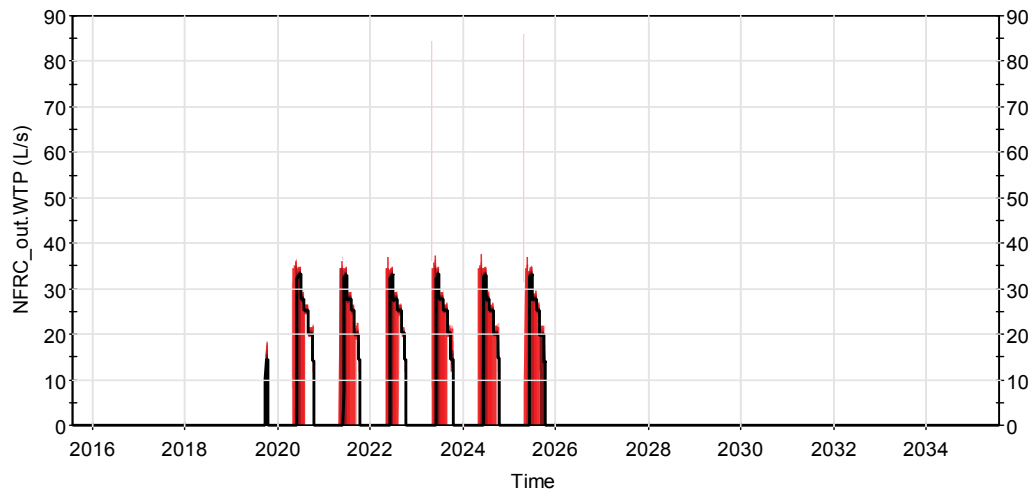
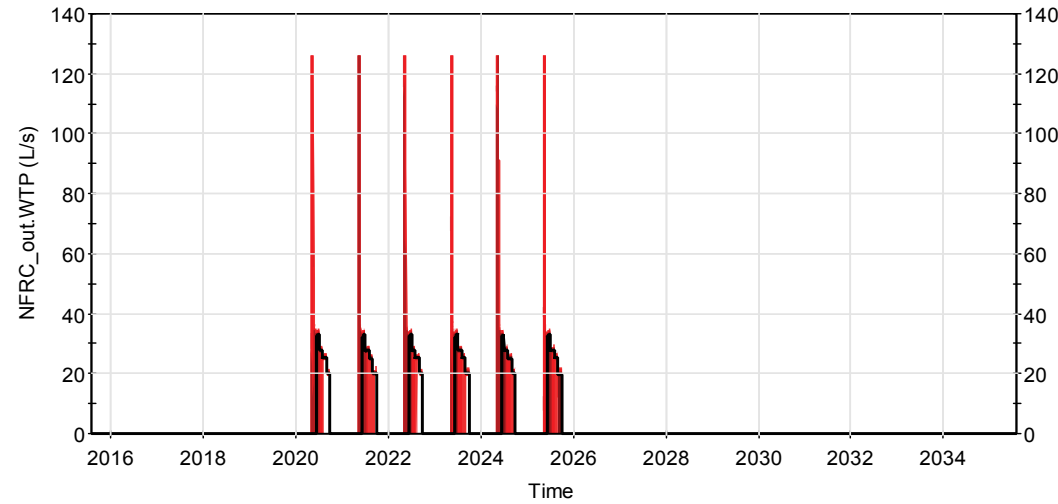
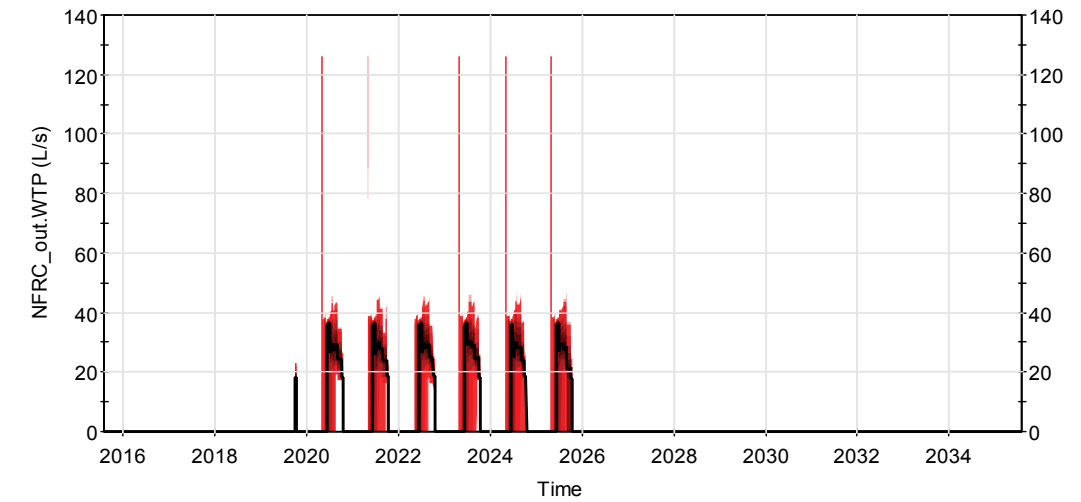
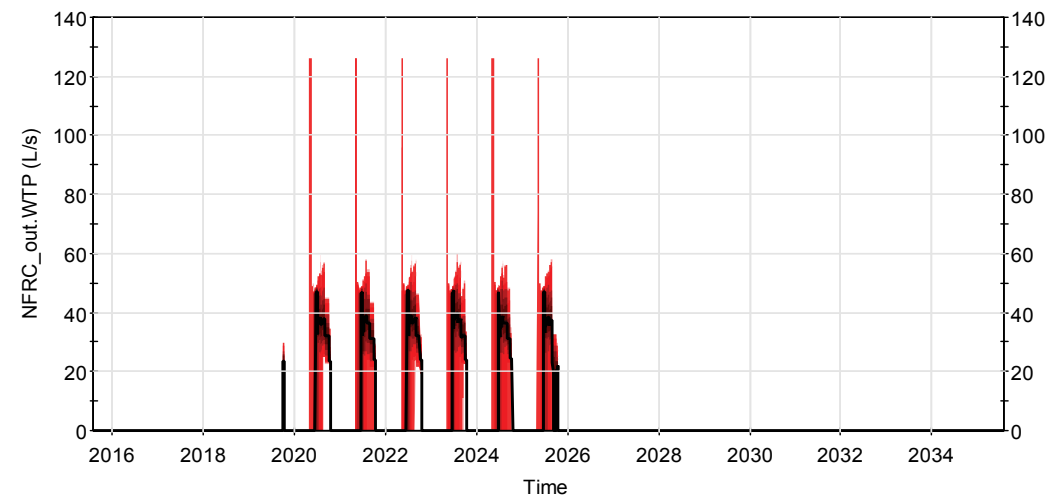
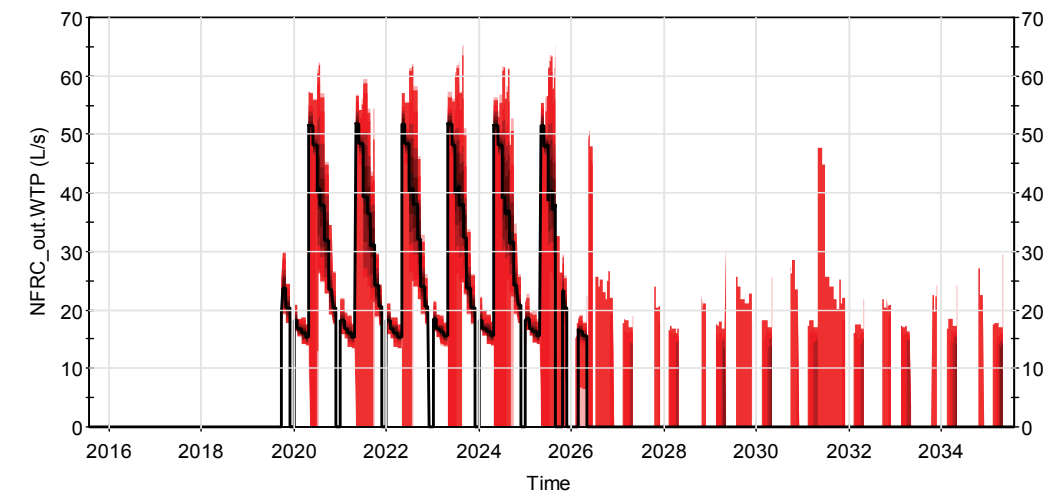
Total Daily Volume Pumped from NFRC SCP to IWTS

FIGURE 13-6f
Water Management Tool Results – Daily Pumping Rate to IWTS
Faro Creek Diversion
Faro Mine Remediation Project

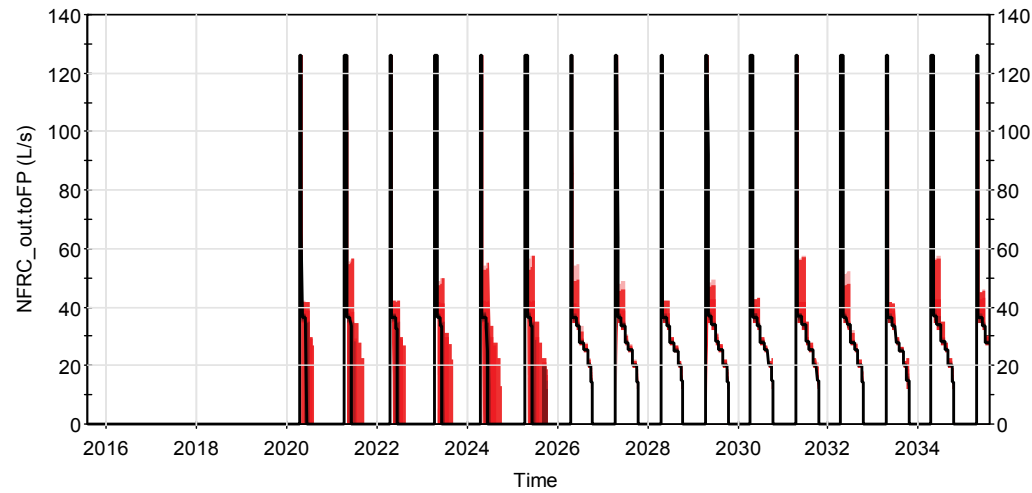
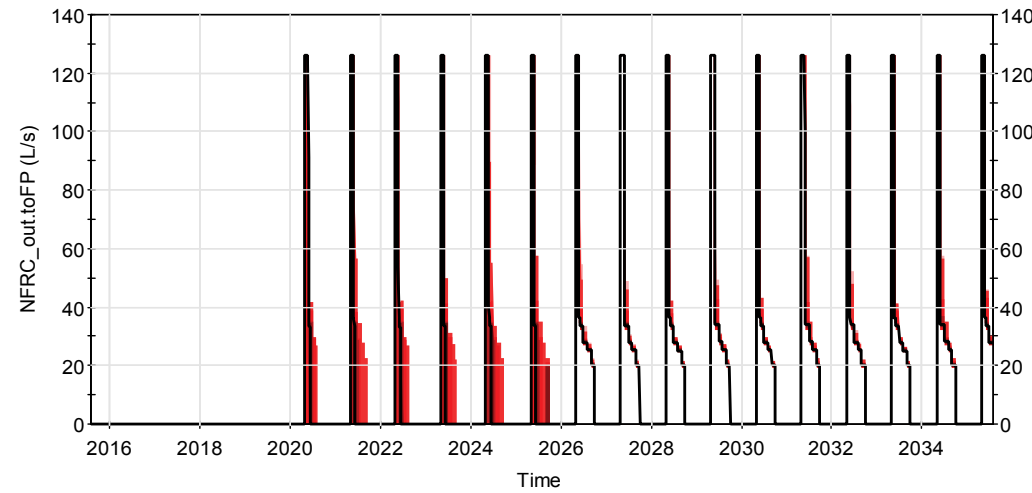
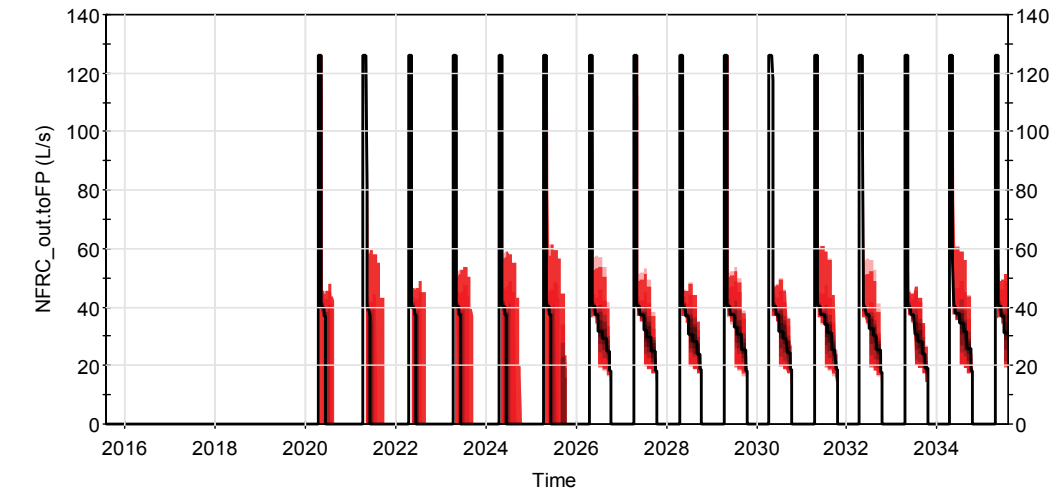
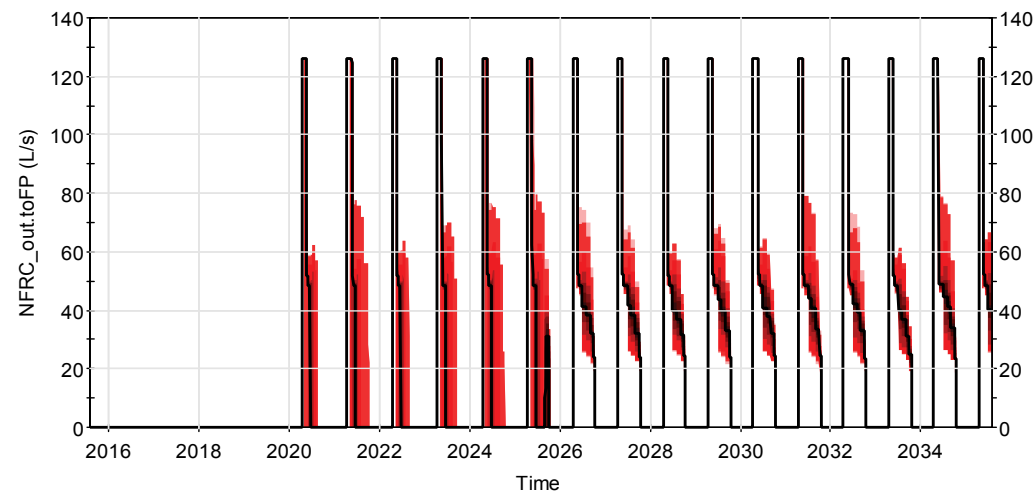
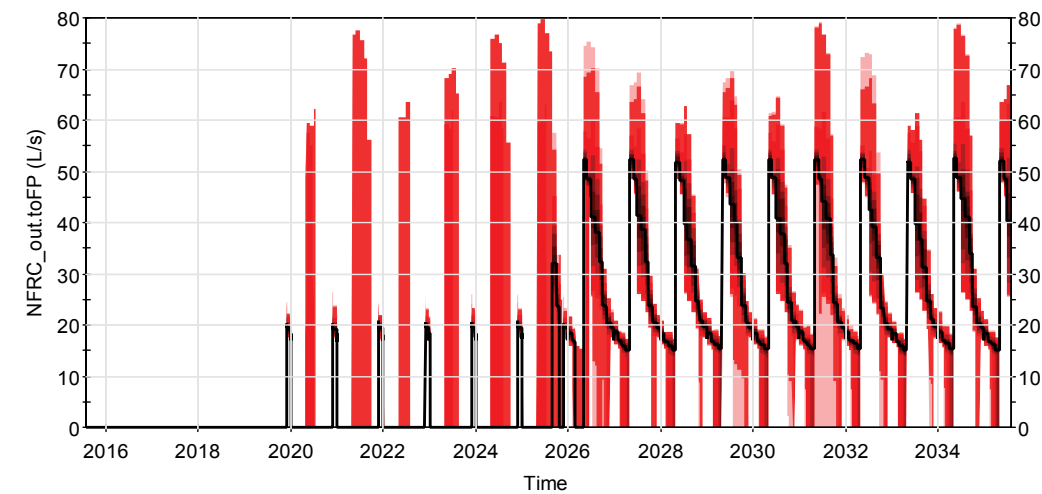
Total Daily Volume Pumped from NFRC SCP to Faro Pit

FIGURE 13-6g
Water Management Tool Results – Daily Pumping Rate to Faro Pit
Faro Creek Diversion
Faro Mine Remediation Project

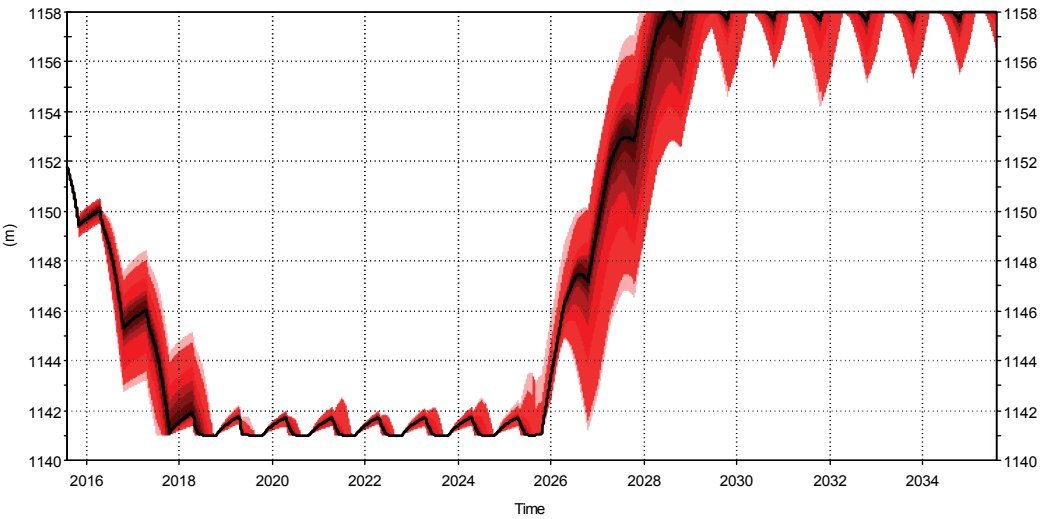
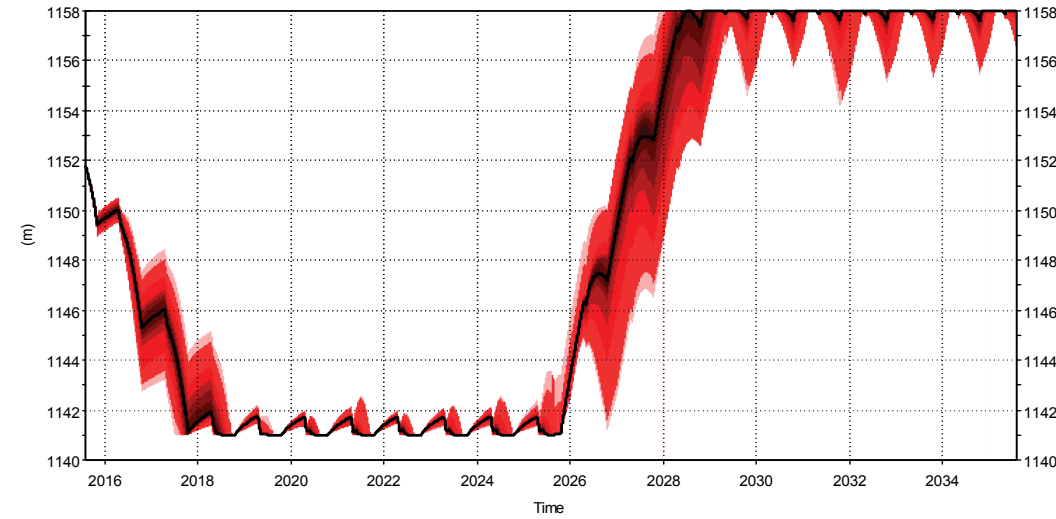
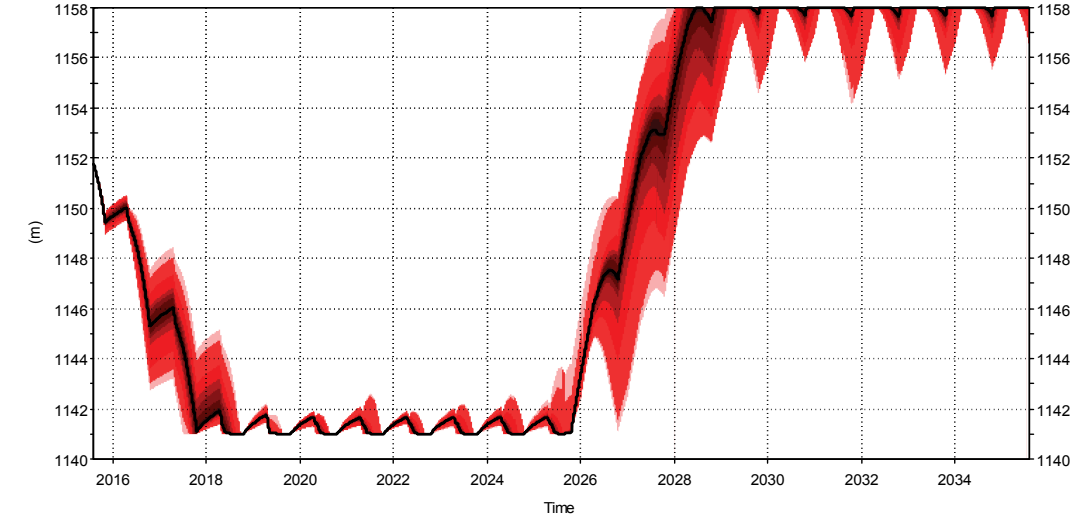
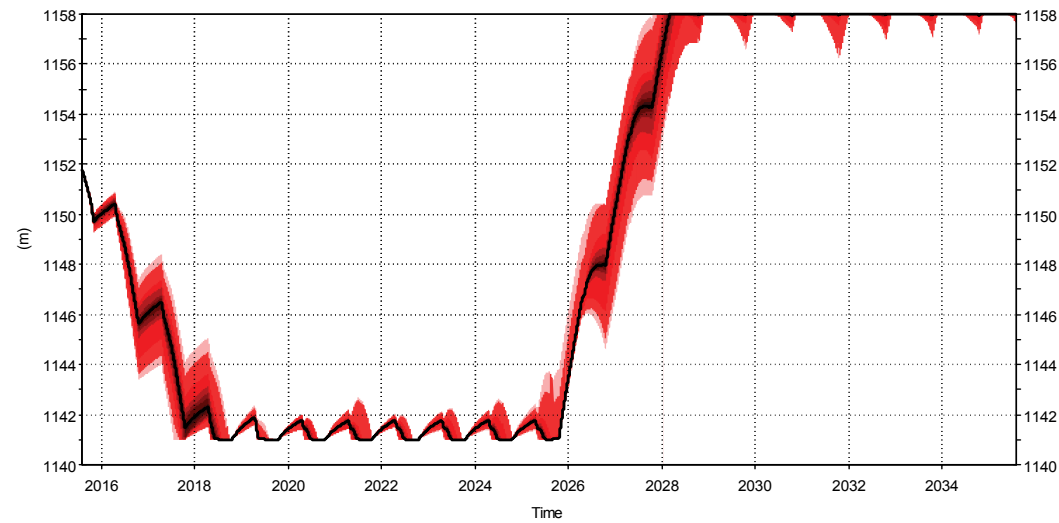
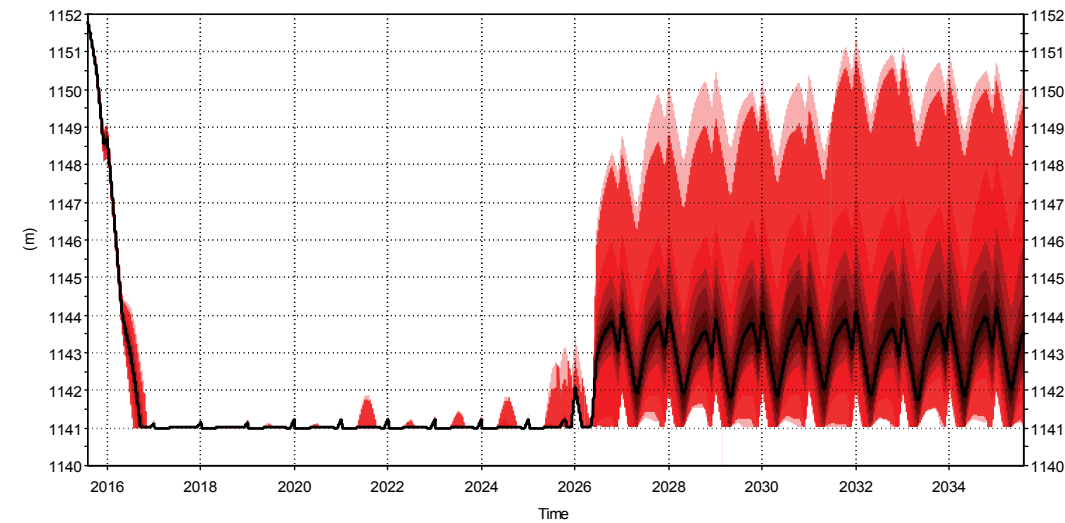
Faro Pit Elevation

FIGURE 13-6h
Water Management Tool Results – Water Elevation In Faro Pit
Faro Creek Diversion
Faro Mine Remediation Project

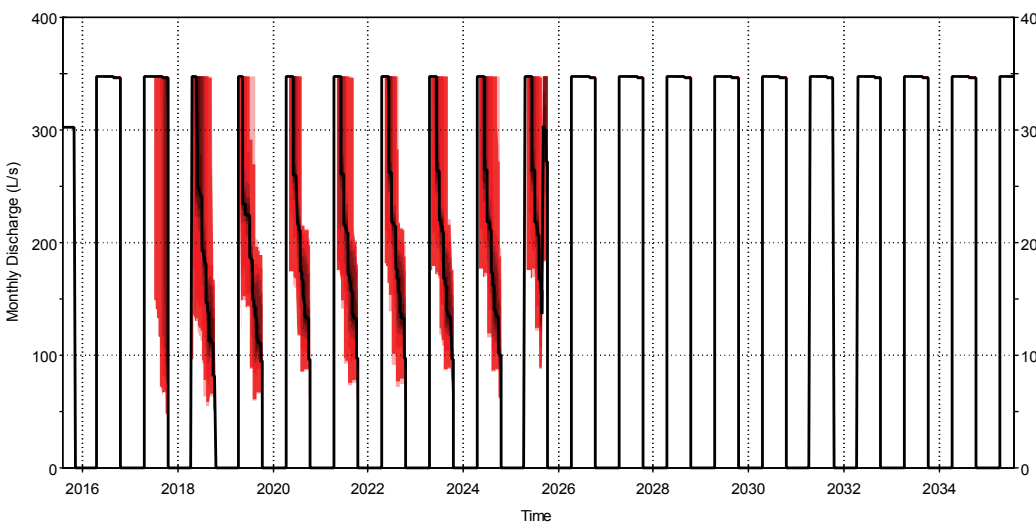
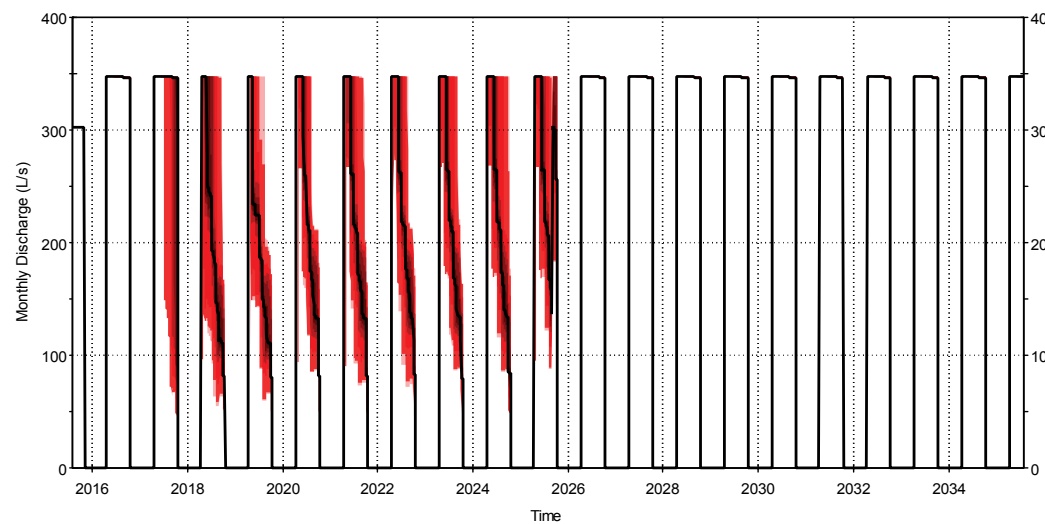
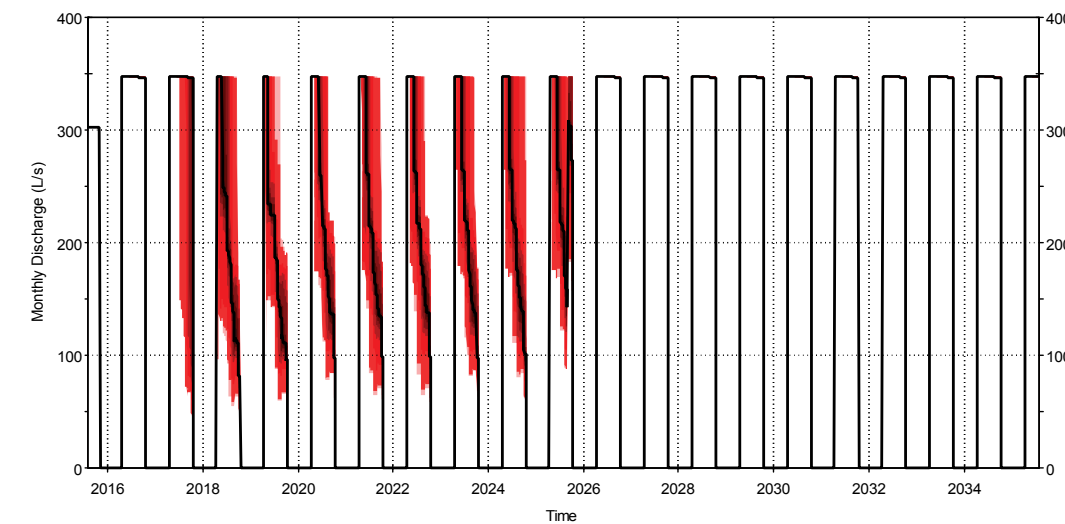
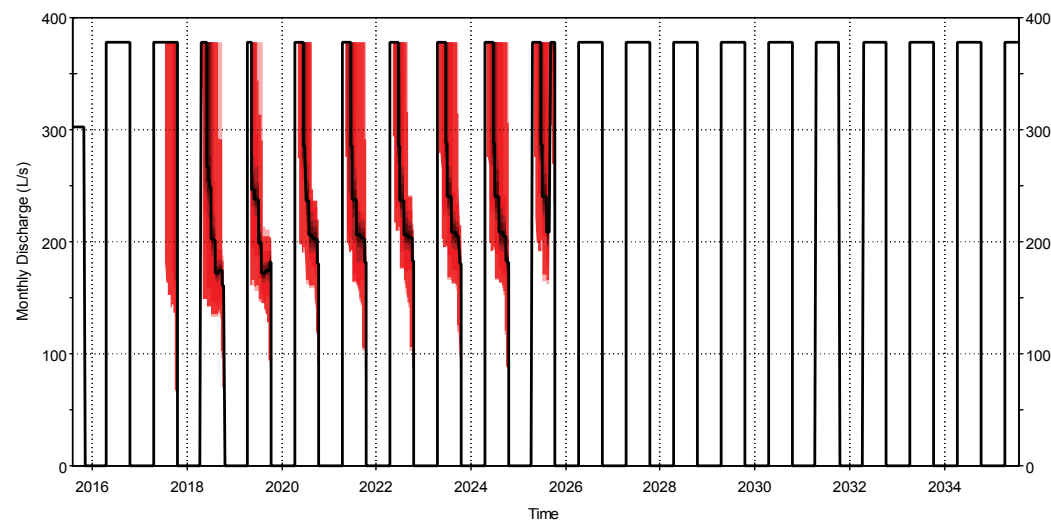
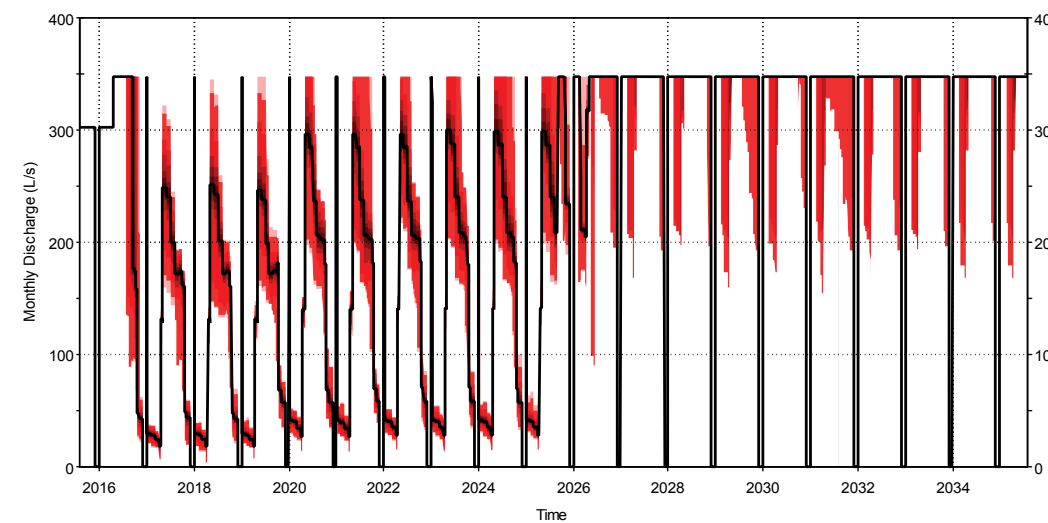
Daily IWTS Discharge

FIGURE 13-6i
Water Management Tool Results – Daily IWTS Discharge
 Faro Creek Diversion
 Faro Mine Remediation Project

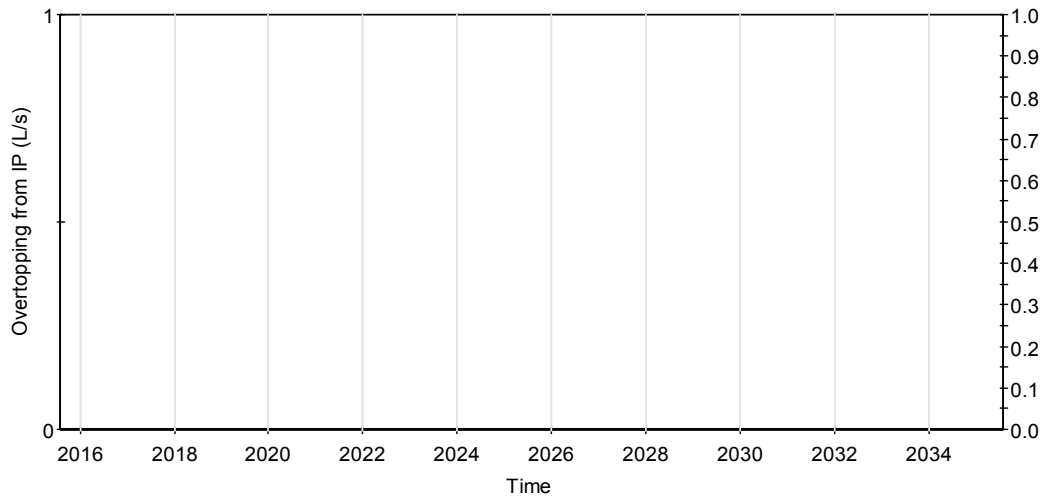
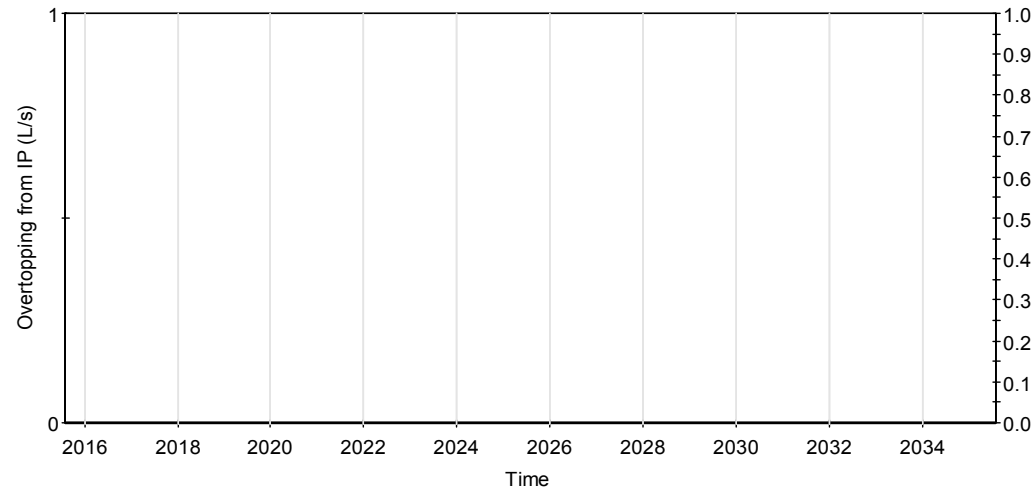
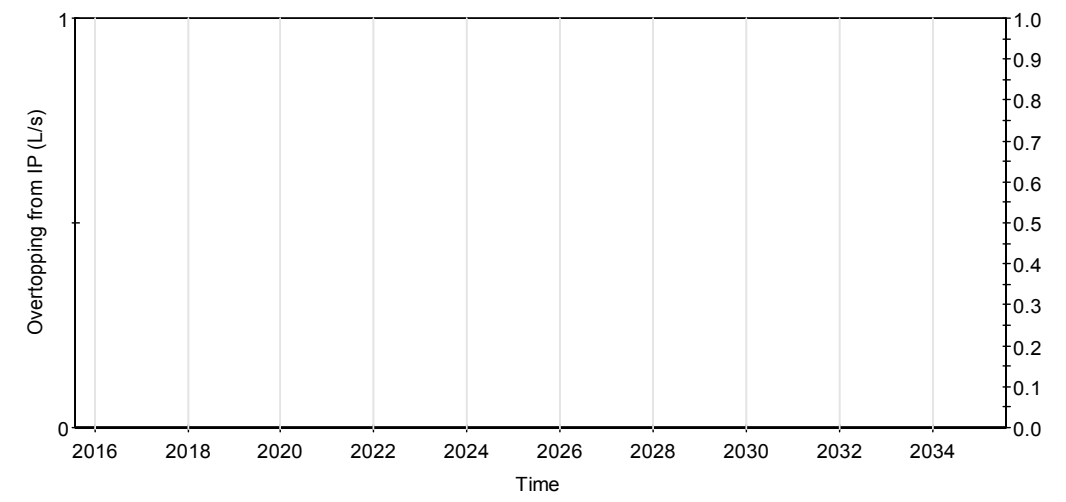
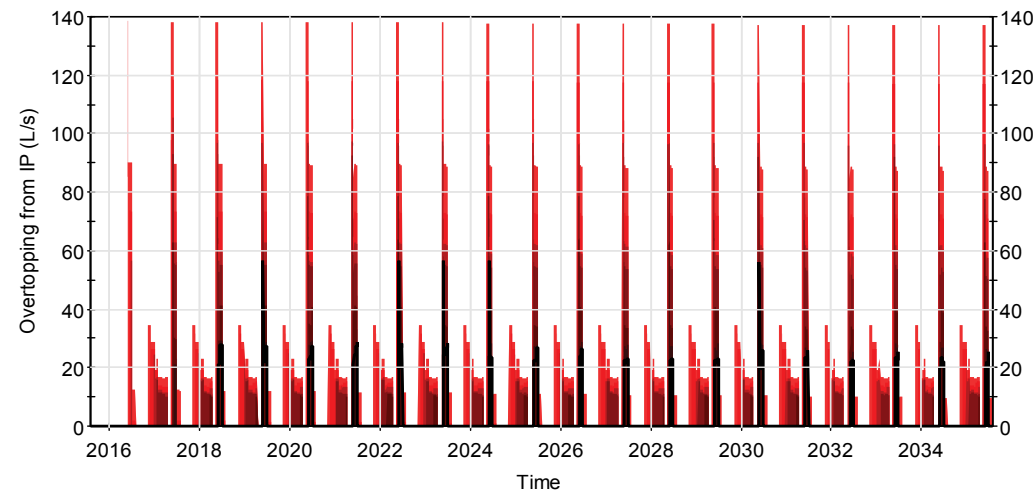
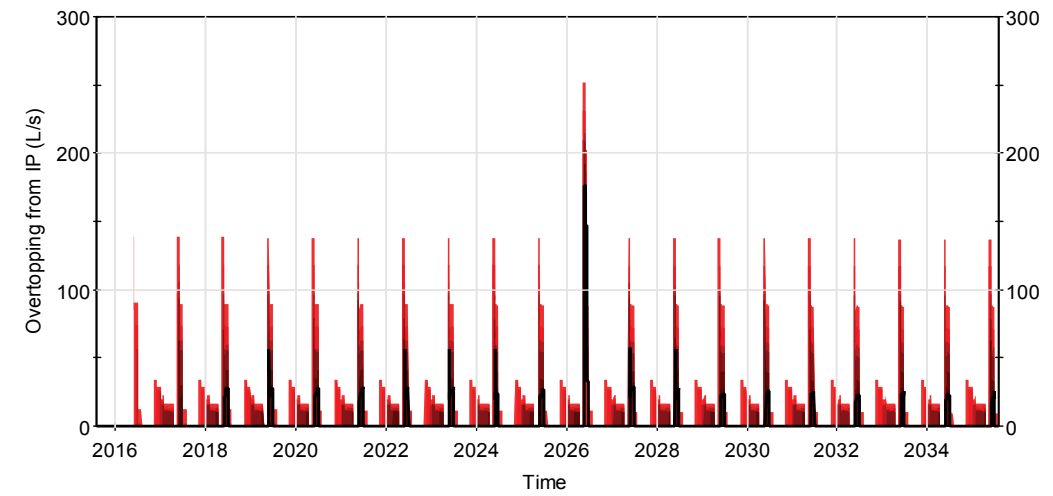
IP Overtopping

FIGURE 13-6j
Water Management Tool Results – Spills from Intermediate Dam Pond
 Faro Creek Diversion
 Faro Mine Remediation Project

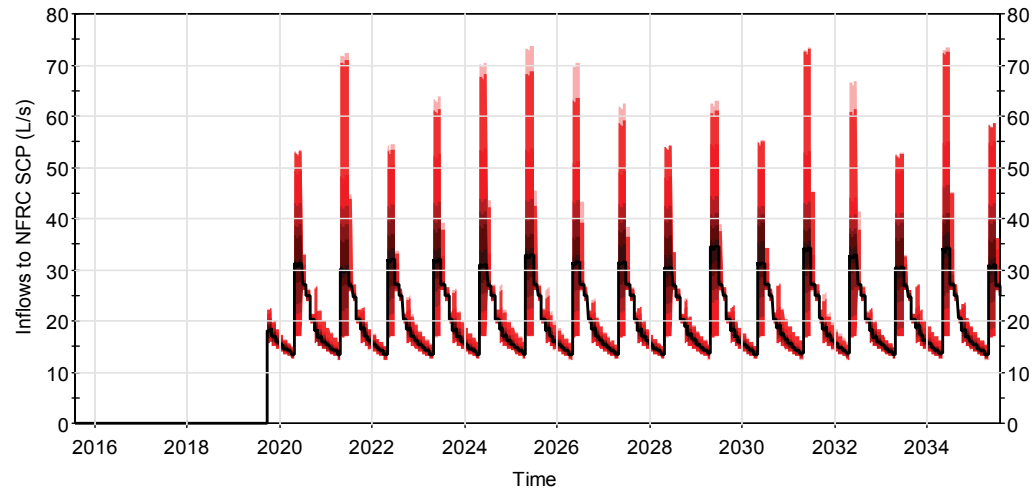
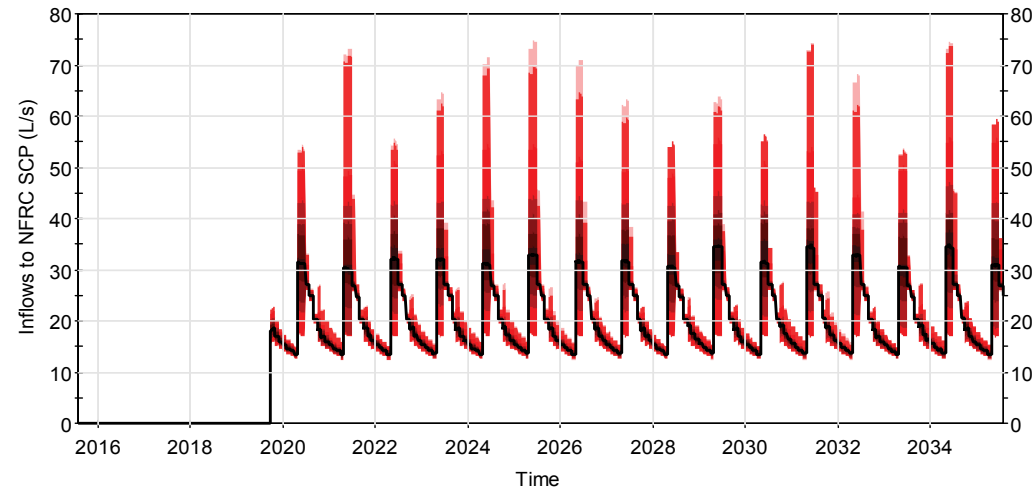
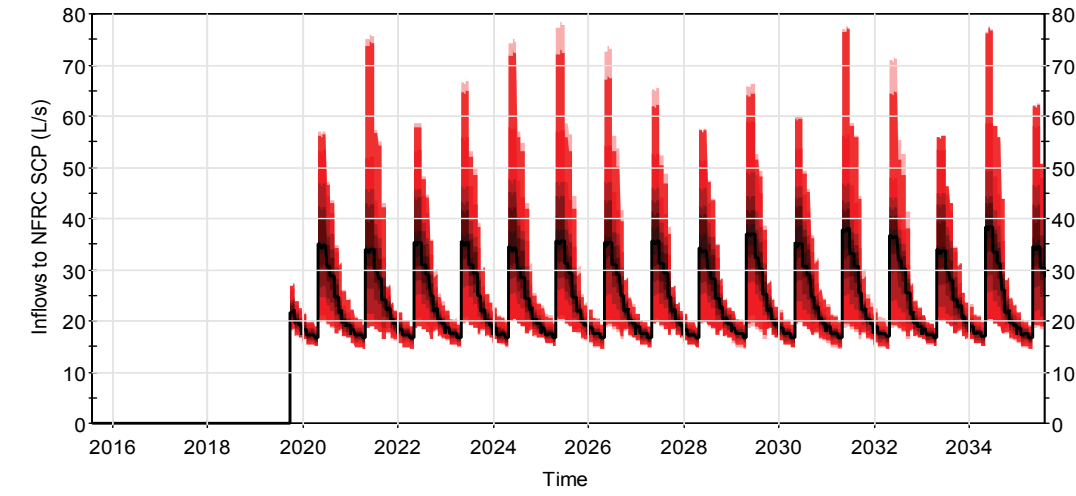
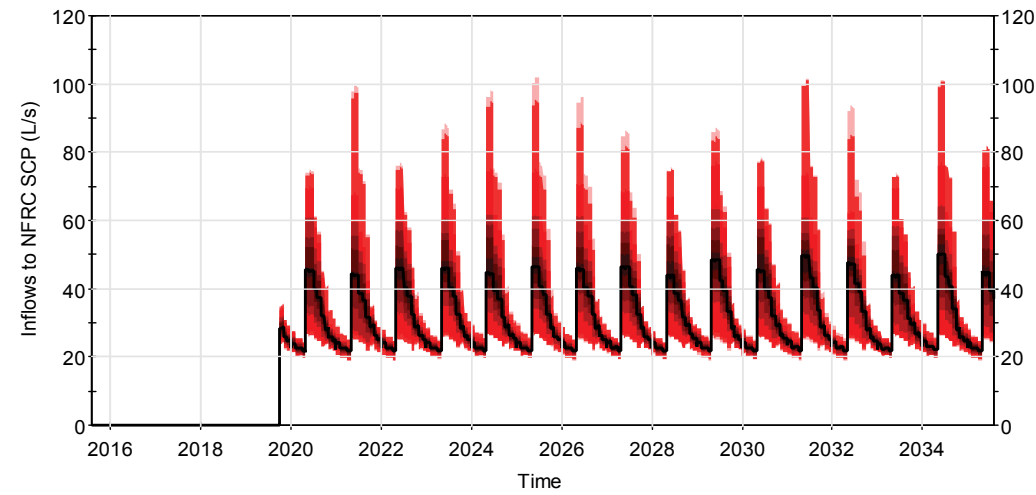
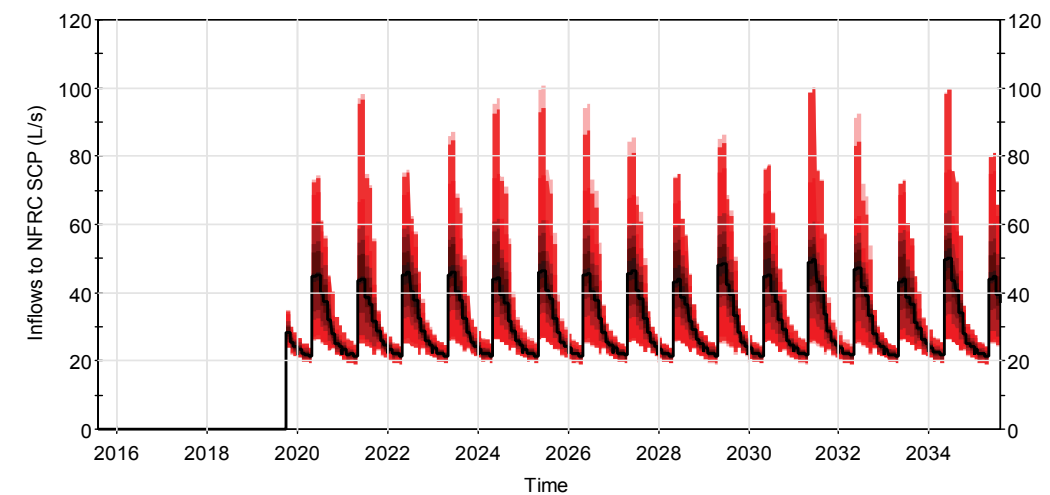
Inflows to NFRC SCP

FIGURE 13-7a
Water Management Tool Results – Inflow to NFRC SCP
Faro Creek Diversion
Faro Mine Remediation Project

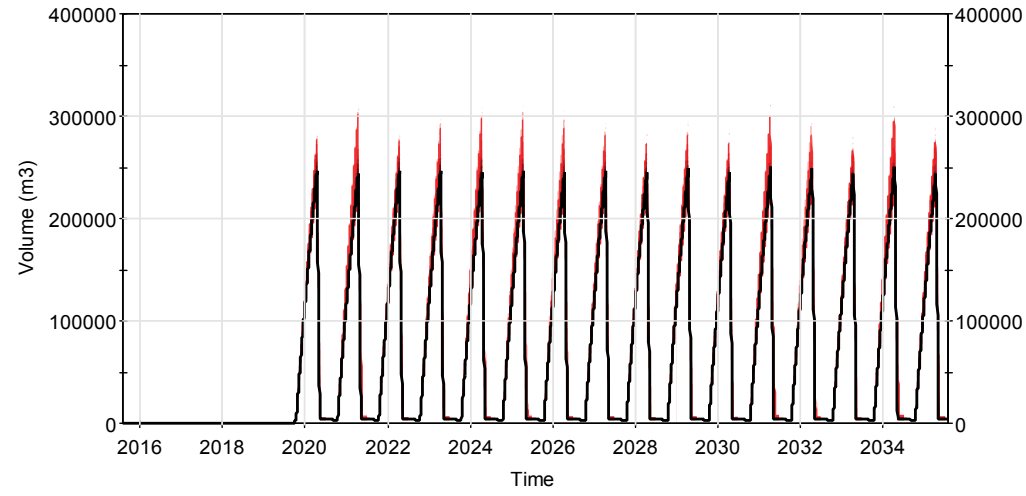
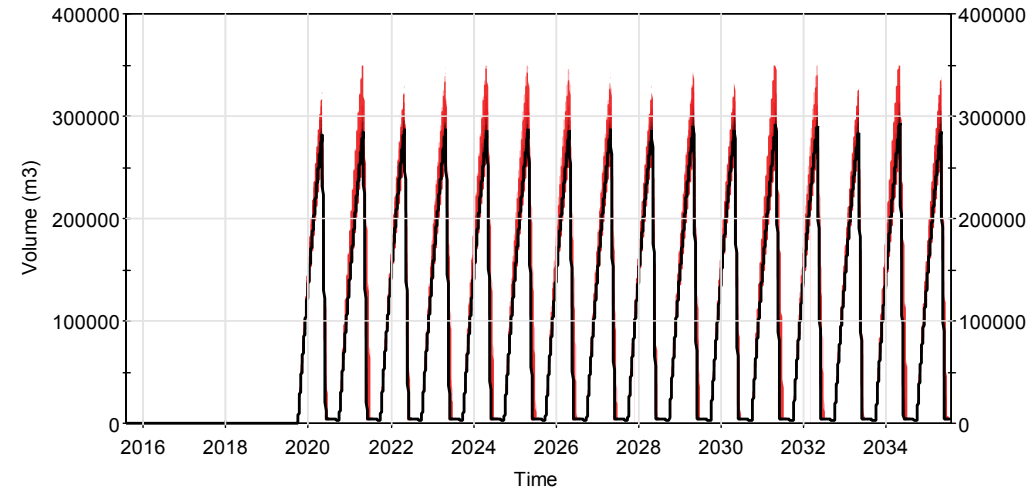
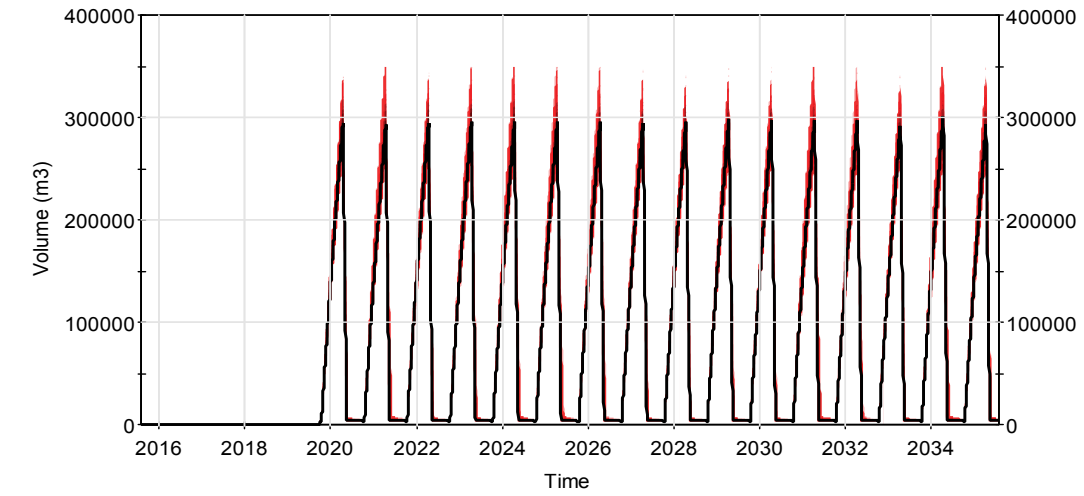
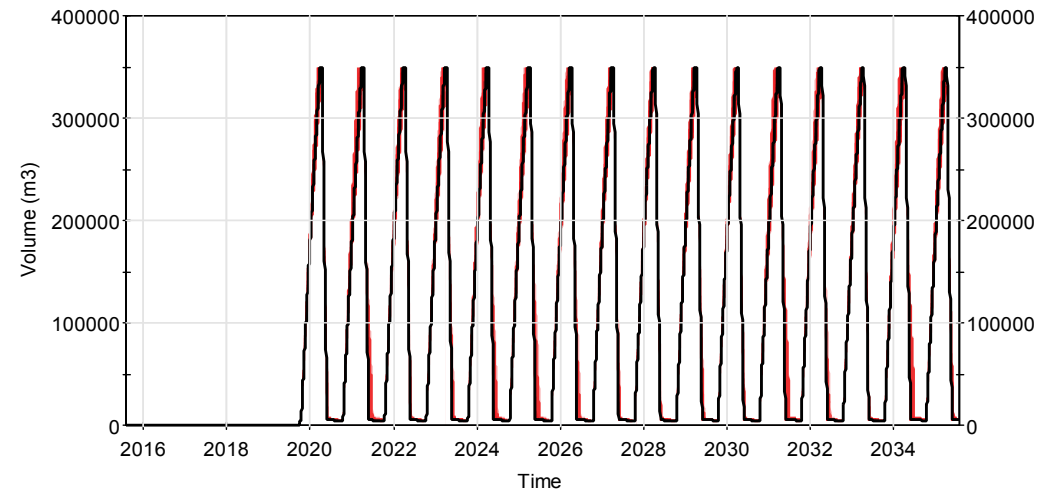
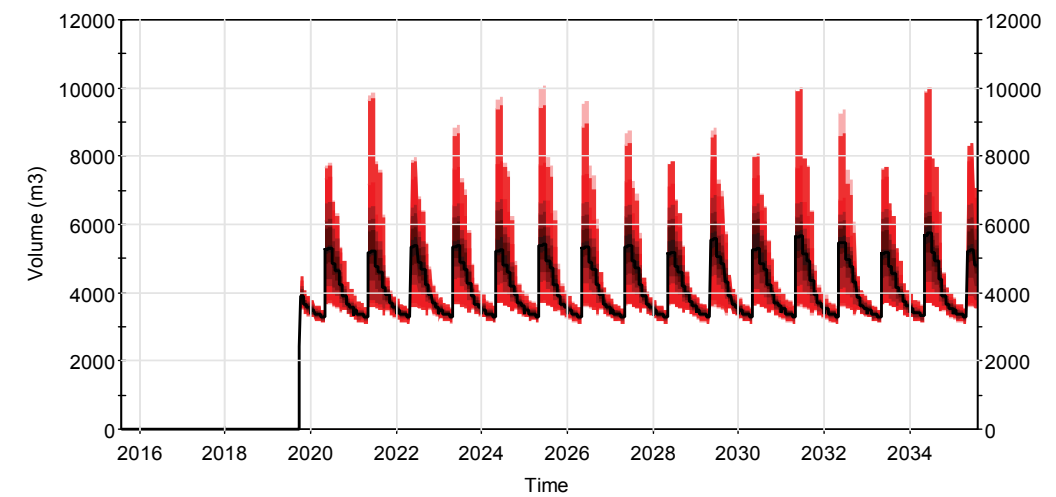
NFRC SCP Storage

FIGURE 13-7b
Water Management Tool Results –NFRC SCP Stored Volume
 Faro Creek Diversion
 Faro Mine Remediation Project

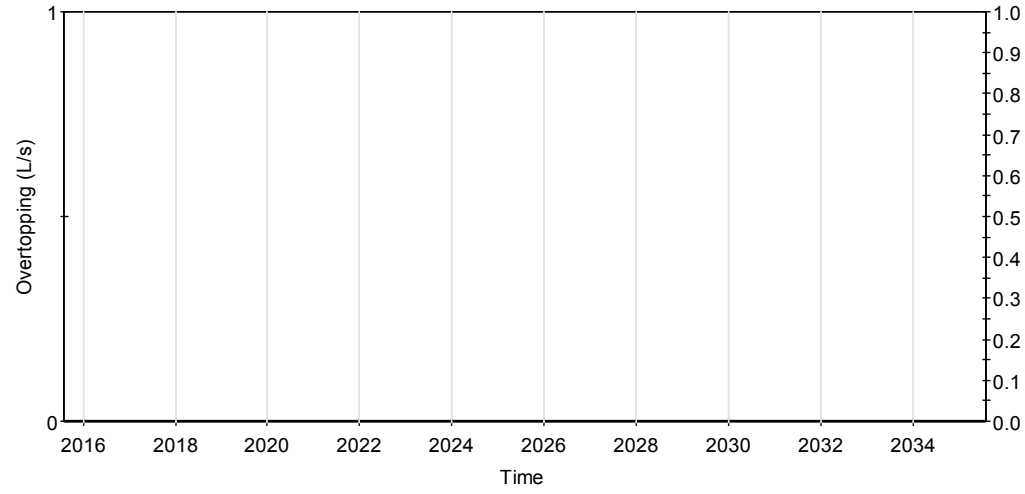
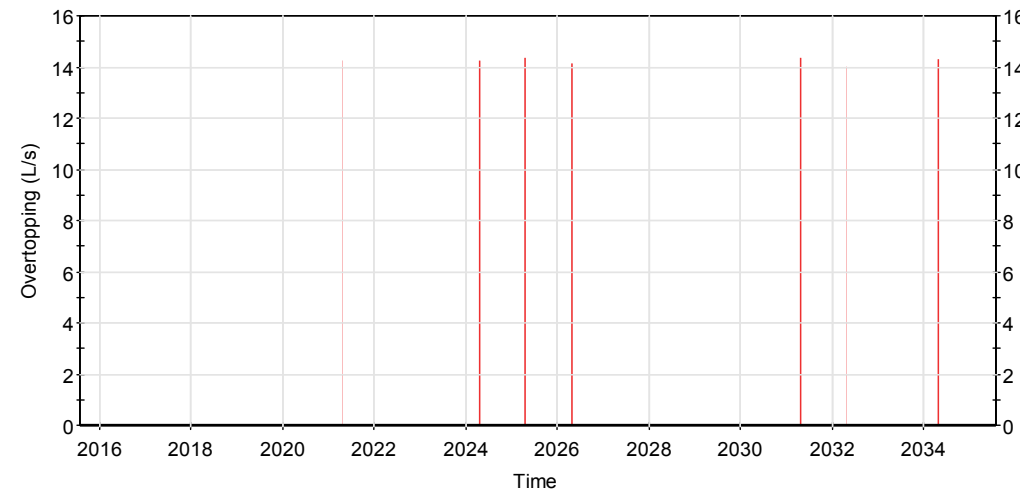
NFRC SCP Overtopping

FIGURE 13-7c
Water Management Tool Results – Spills from NFRC SCP
 Faro Creek Diversion
 Faro Mine Remediation Project

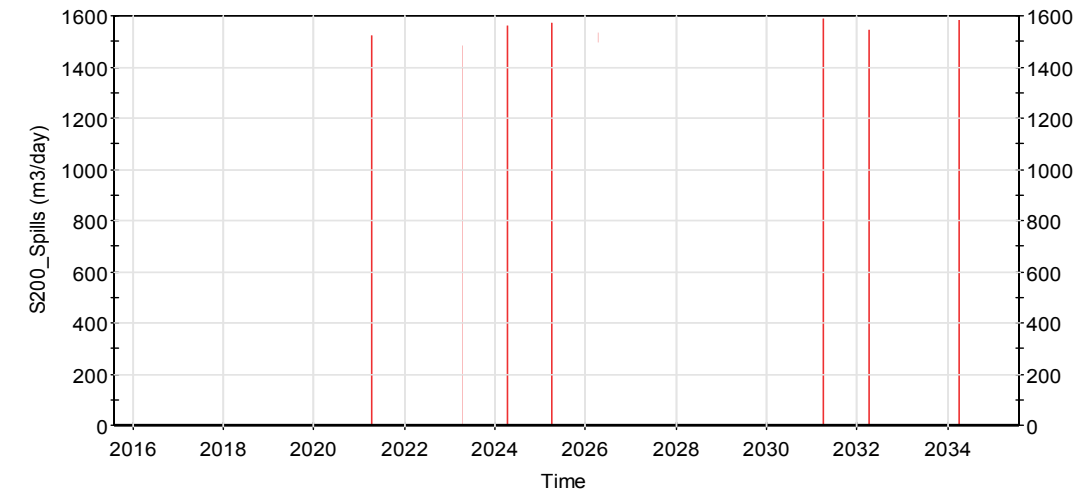
Scenario 2.3

NFRC SCP Overtopping
