Appendix A

Figures

FIGURE 1-1
Faro Mine Complex Location
 Faro Mine Remediation Project

FIGURE 1-2
Faro Mine Complex Overview
 Faro Mine Remediation Project

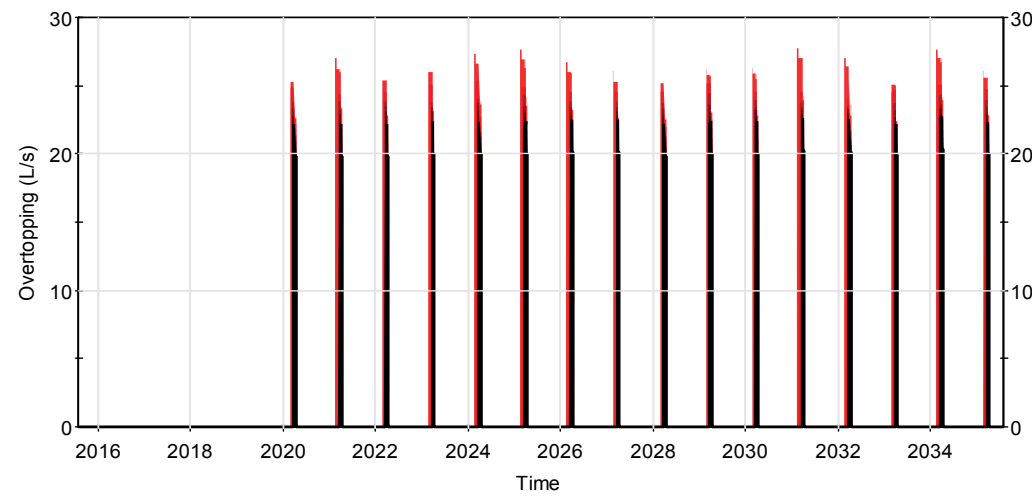
Scenario 2.4

NFRC SCP Overtopping

FIGURE 13-7c
Water Management Tool Results – Spills from NFRC SCP
 Faro Creek Diversion
 Faro Mine Remediation Project

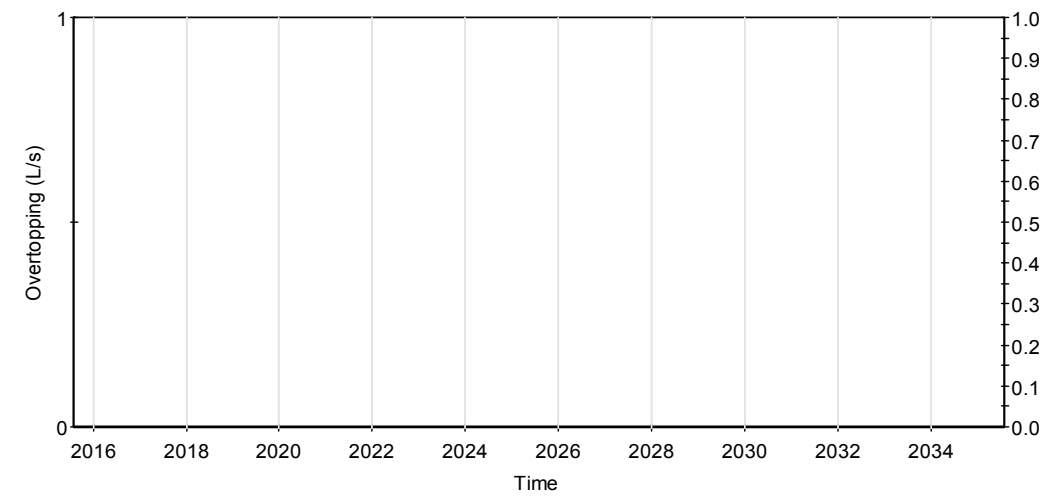
Scenario 2.5

NFRC SCP Overtopping

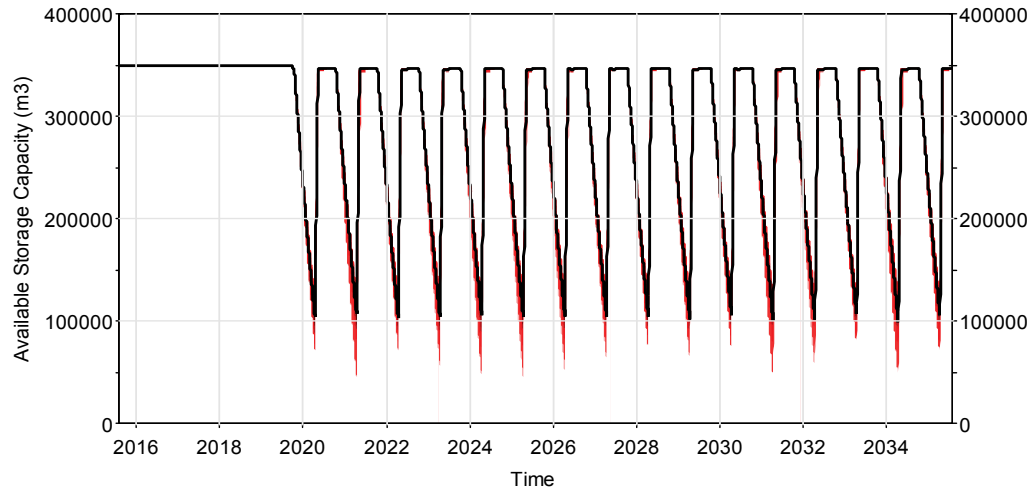
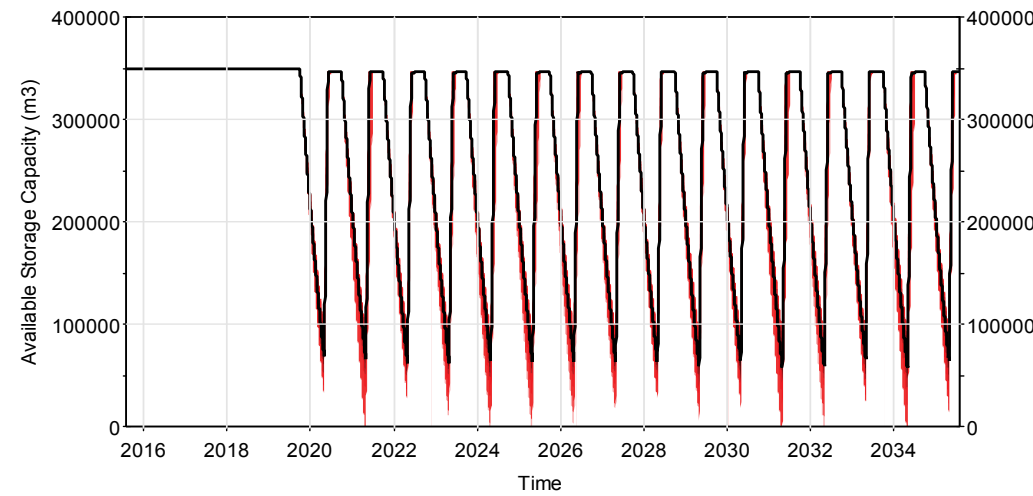
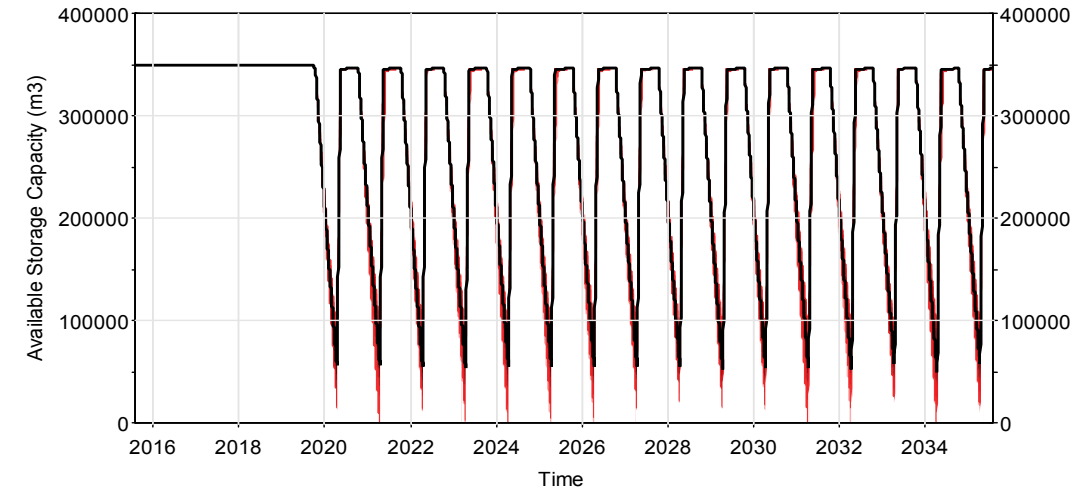
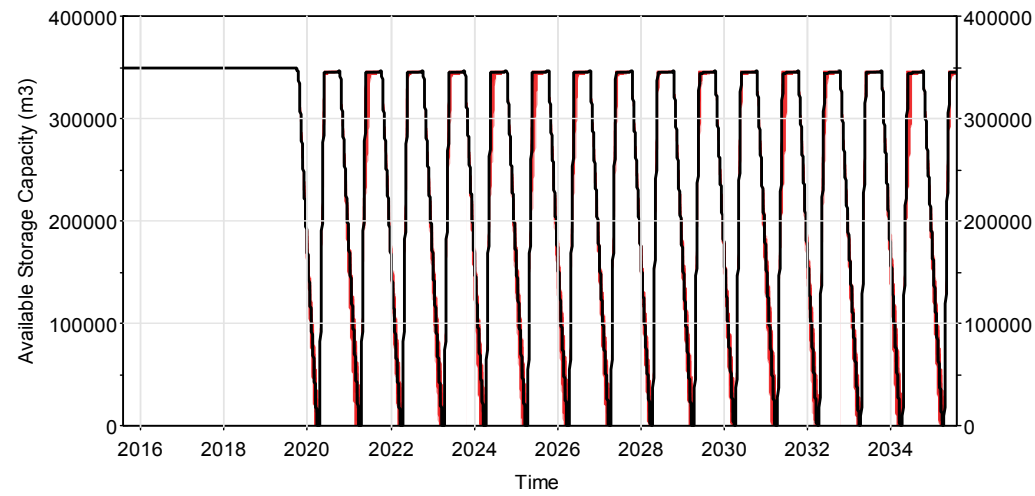
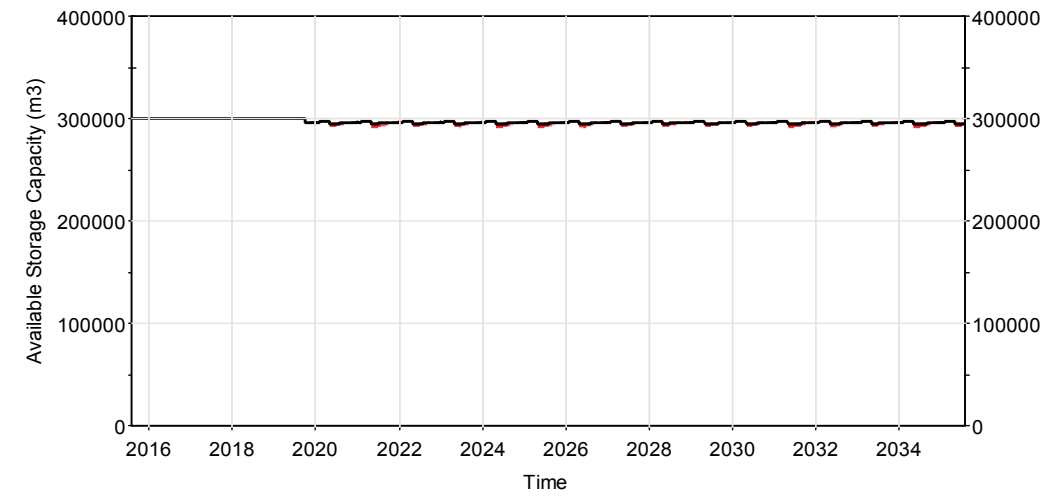
FIGURE 13-7d
Water Management Tool Results – Available Storage Capacity
 Faro Creek Diversion
 Faro Mine Remediation Project

Available Storage Capacity

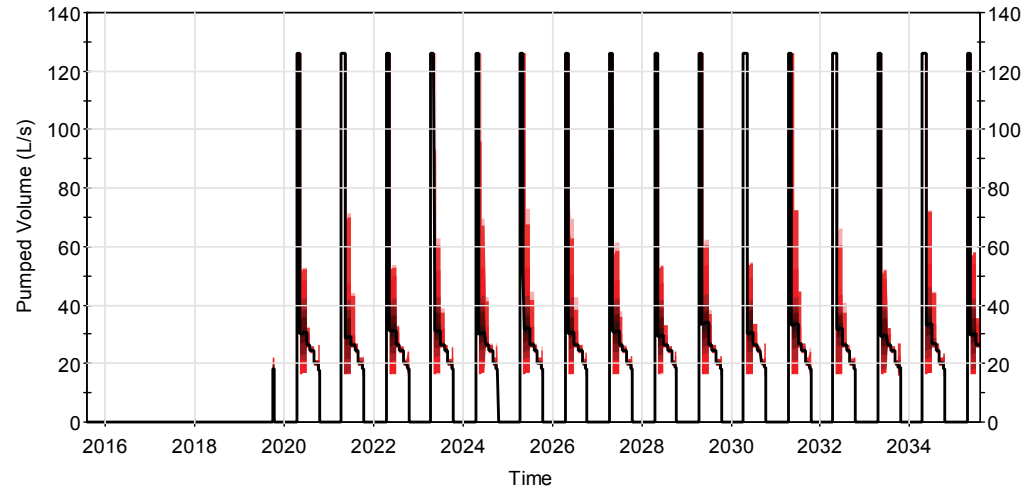
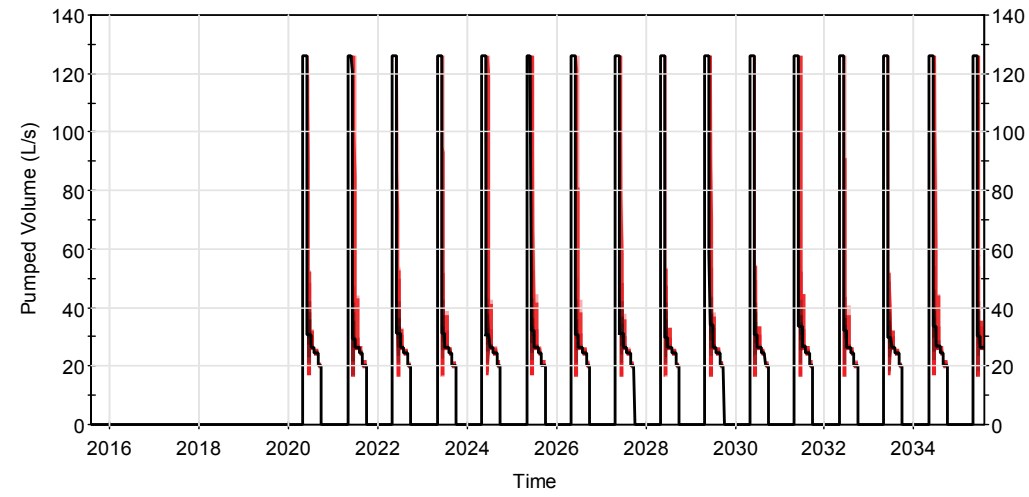
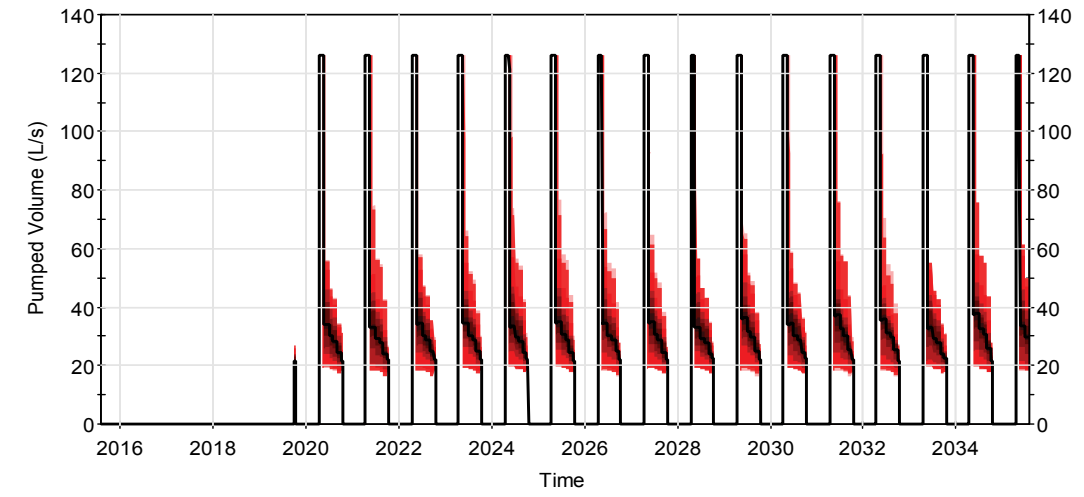
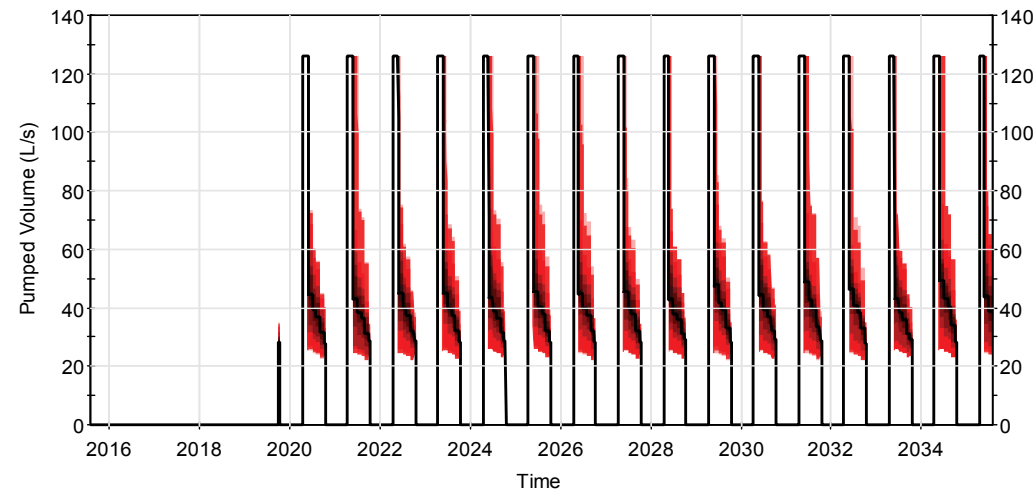
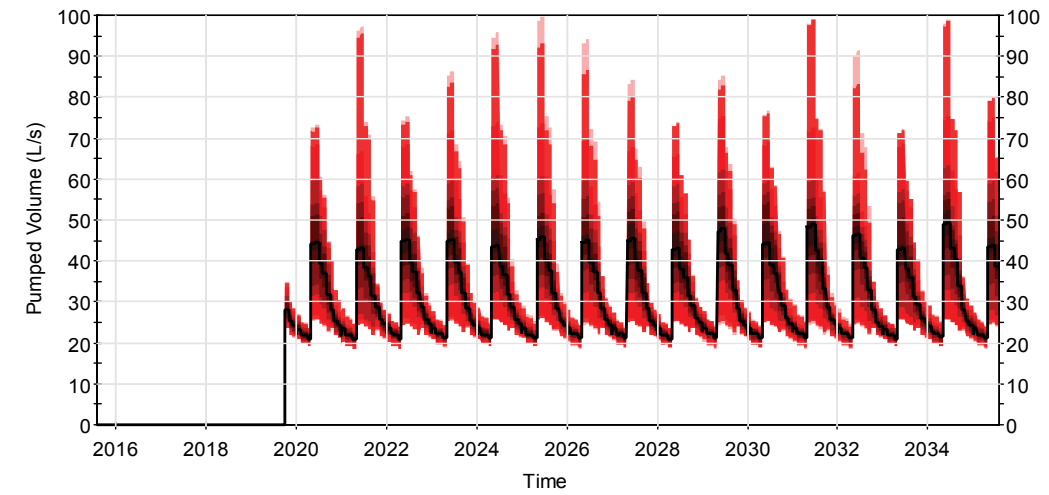
FIGURE 13-7e
Water Management Tool Results – Total Daily Volume Pumped
 Faro Creek Diversion
 Faro Mine Remediation Project

Total Daily Volume Pumped from NFRC SCP

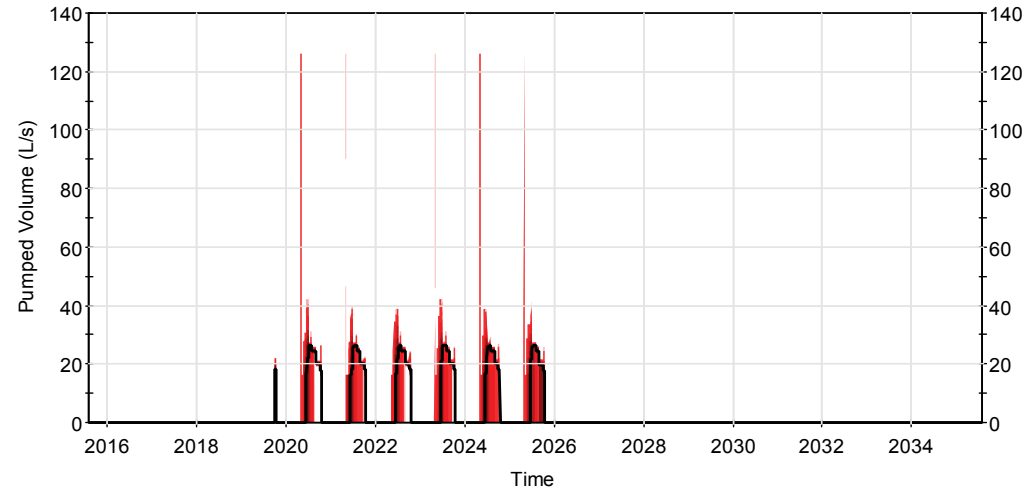
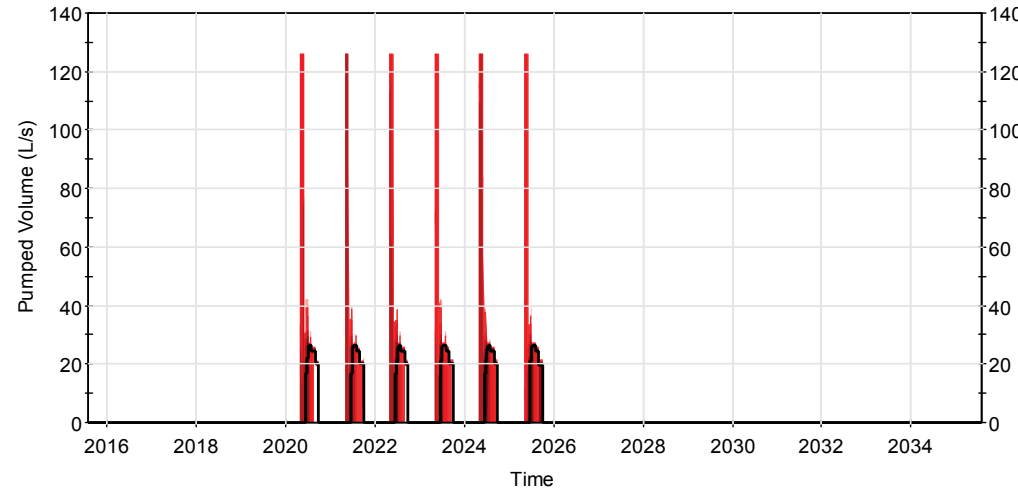
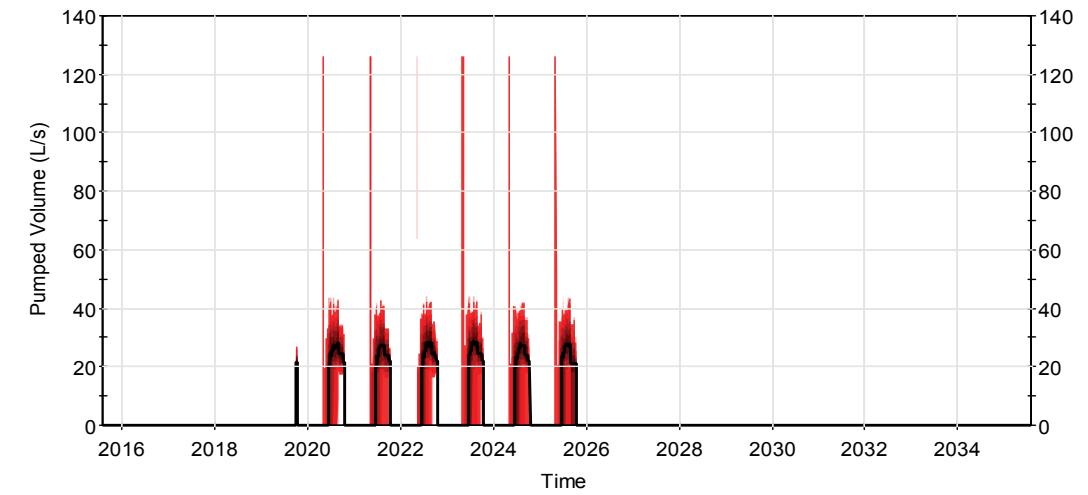
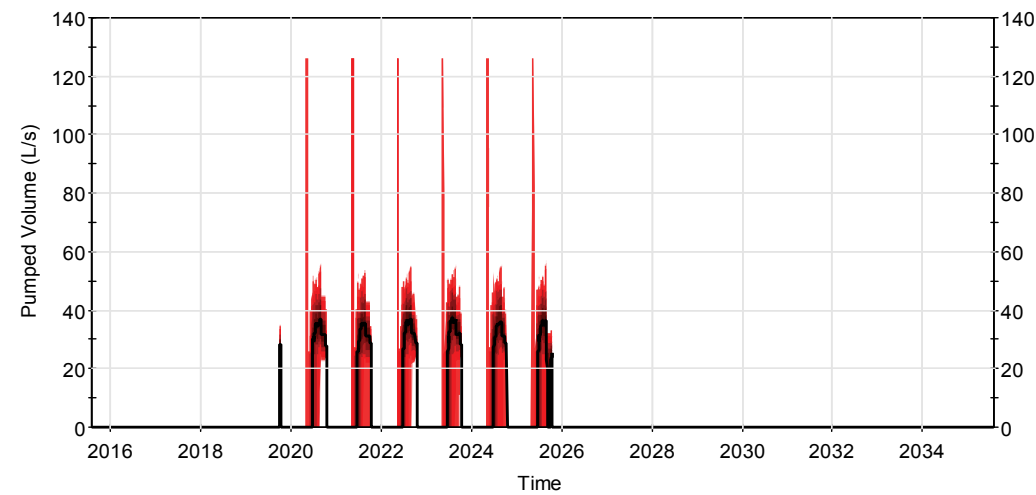
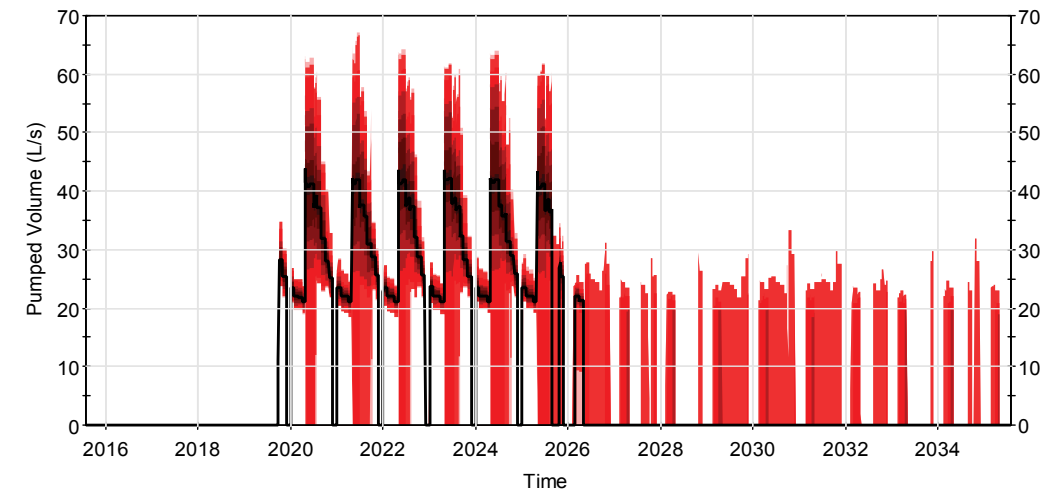
FIGURE 13-7f
Water Management Tool Results – Daily Pumping Rate to IWTS
 Faro Creek Diversion
 Faro Mine Remediation Project

Total Daily Volume Pumped from NFRC SCP to IWTS

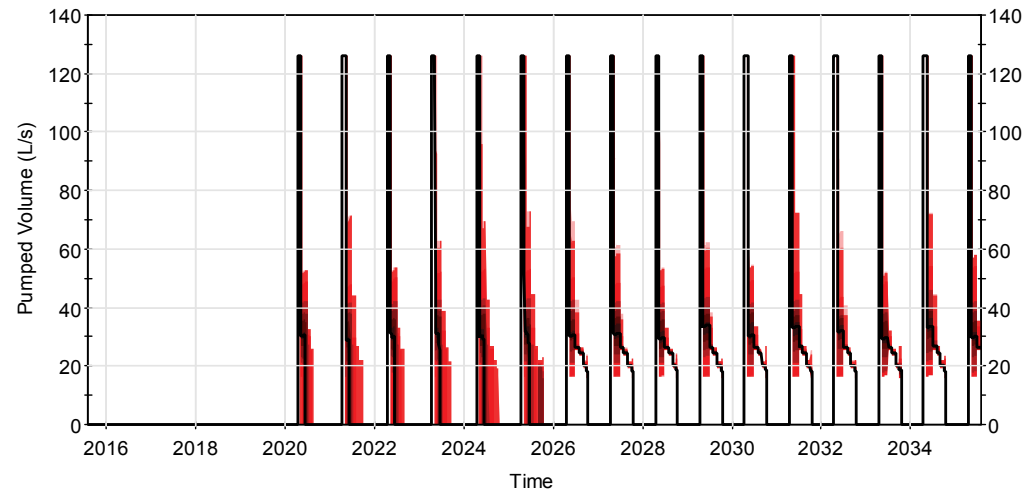
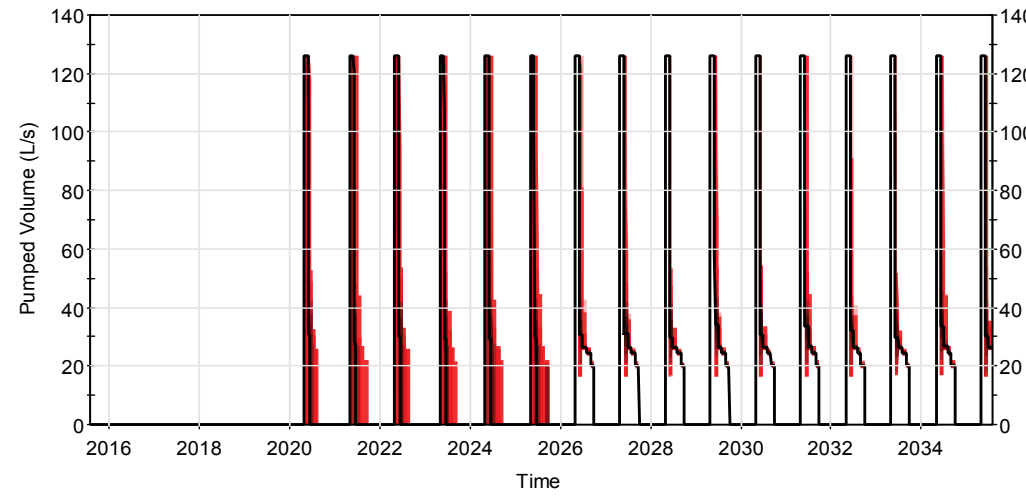
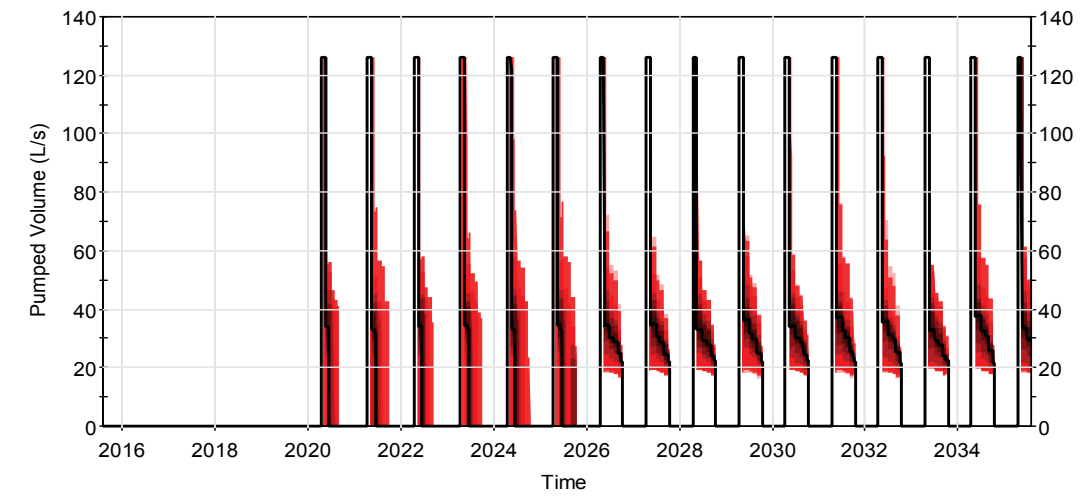
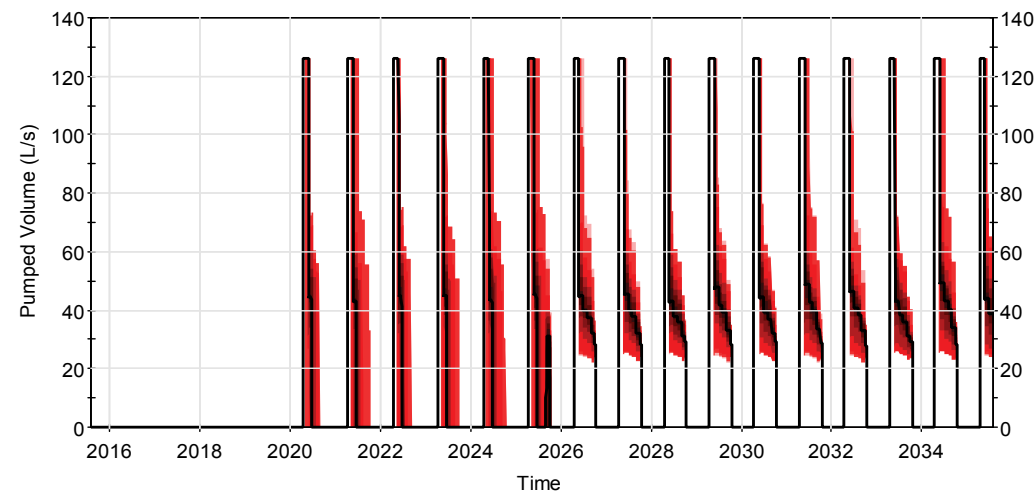
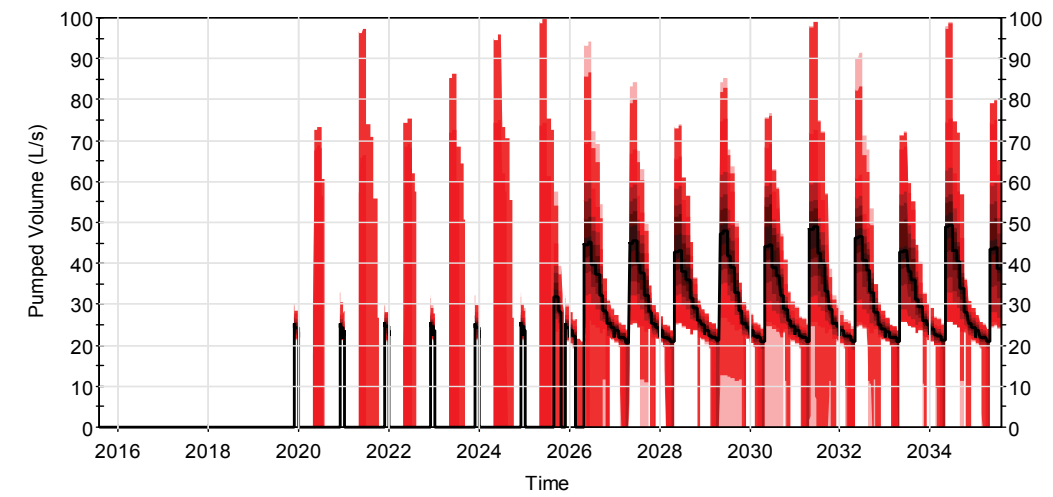
FIGURE 13-7g
Water Management Tool Results – Daily Pumping Rate to Faro Pit
Faro Creek Diversion
Faro Mine Remediation Project

Total Daily Volume Pumped from NFRC SCP to Faro Pit

Total Daily Volume Pumped from NFRC SCP to IWTS

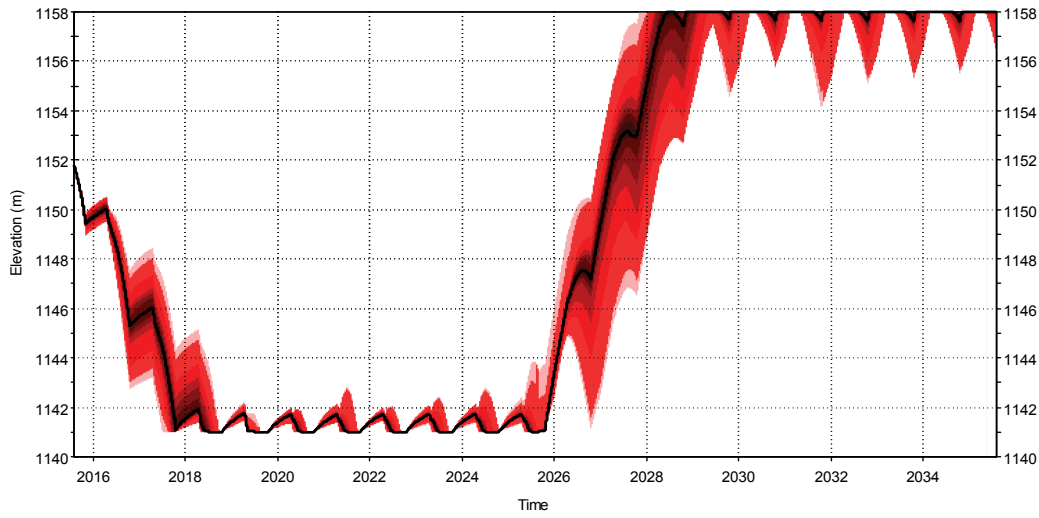
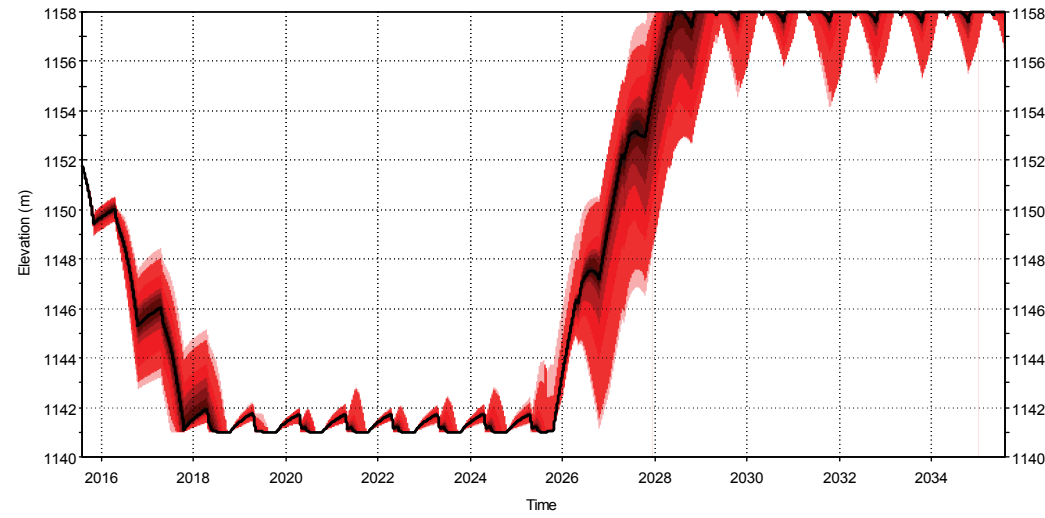
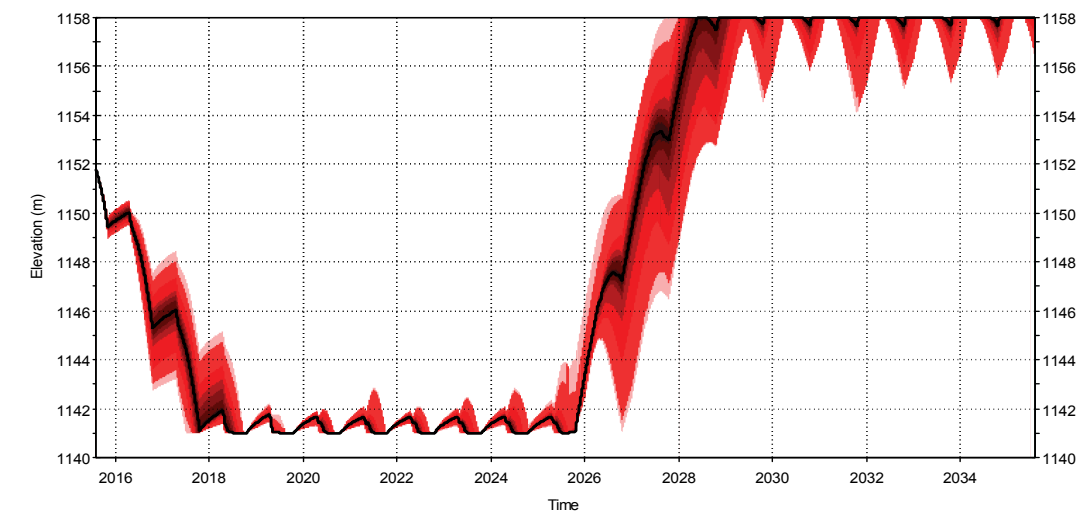
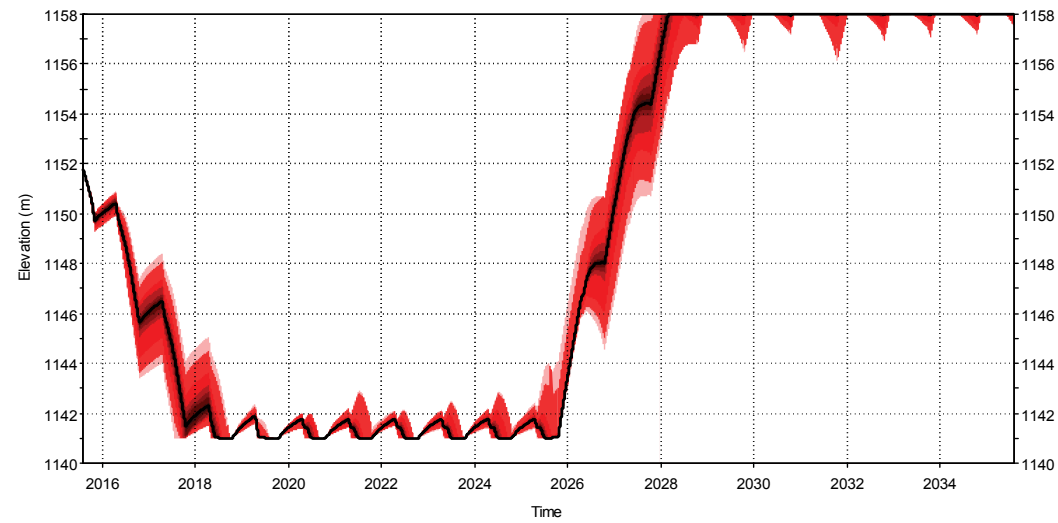
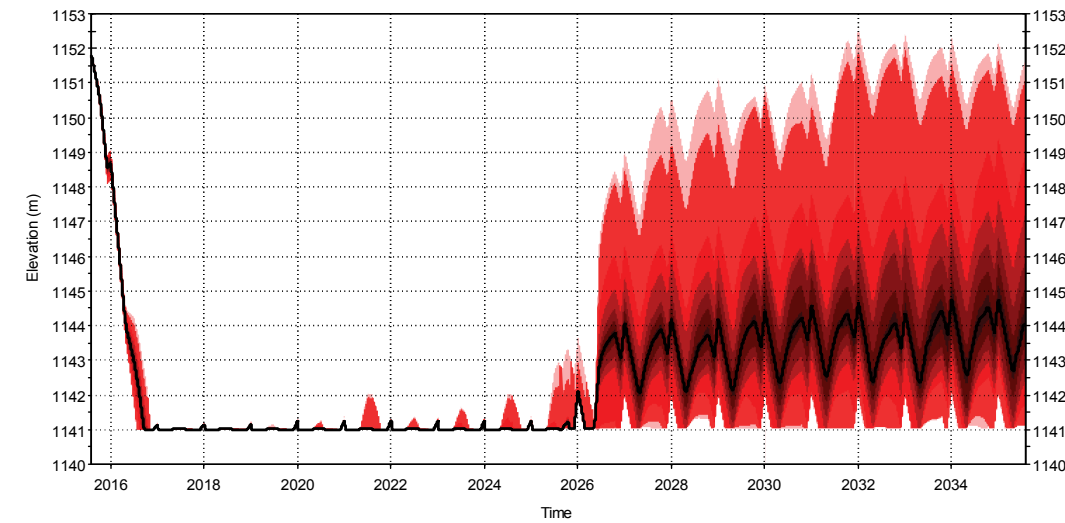
FIGURE 13-7h
Water Management Tool Results – Water Elevation In Faro Pit
 Faro Creek Diversion
 Faro Mine Remediation Project

Faro Pit Elevation

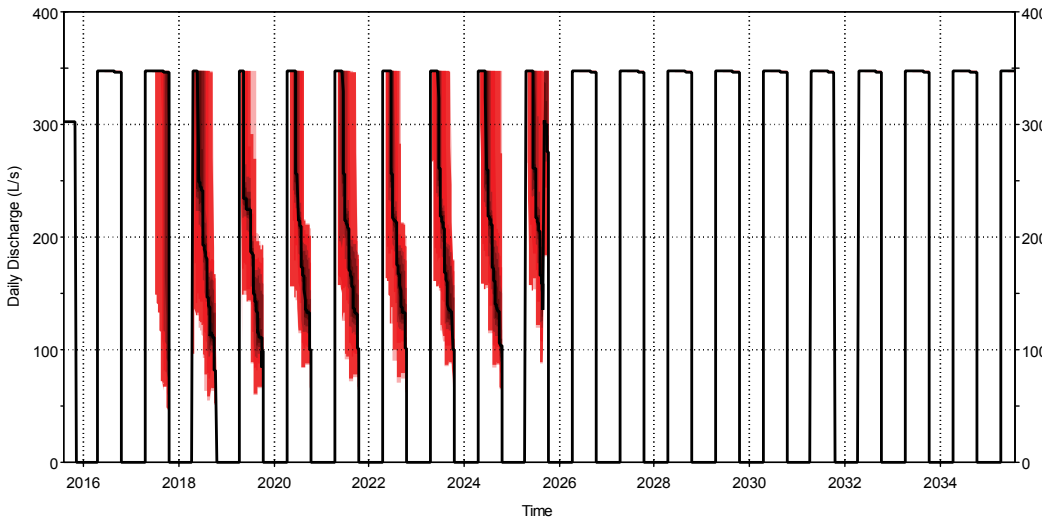
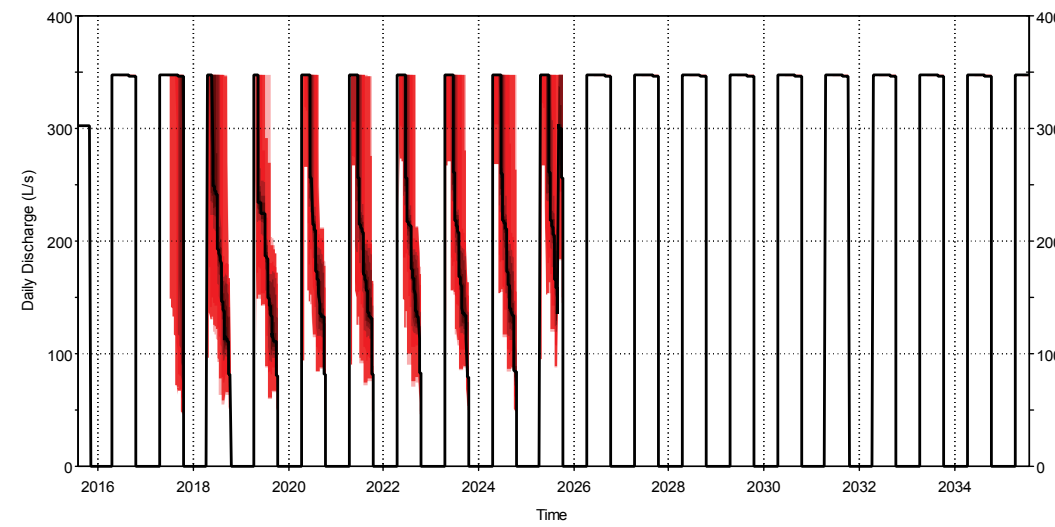
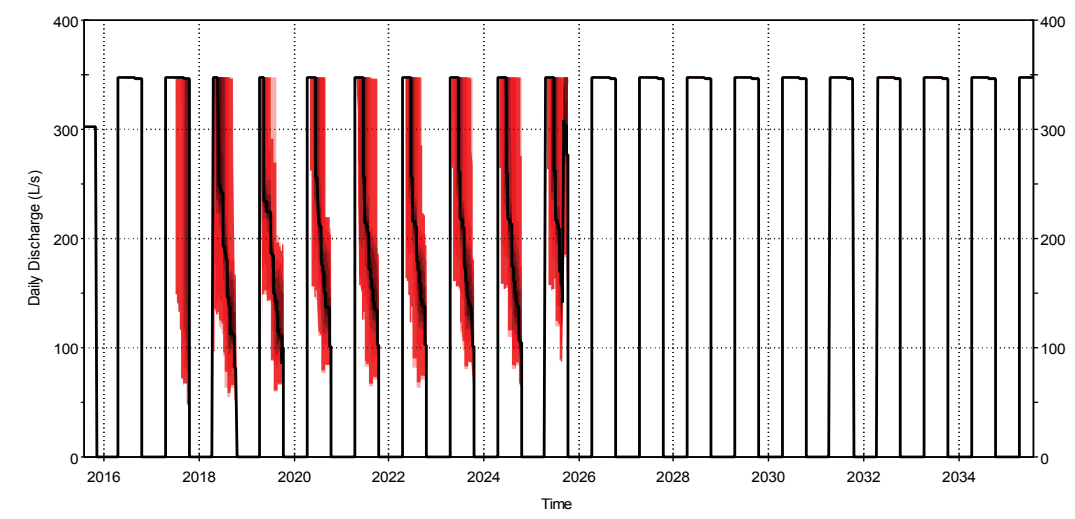
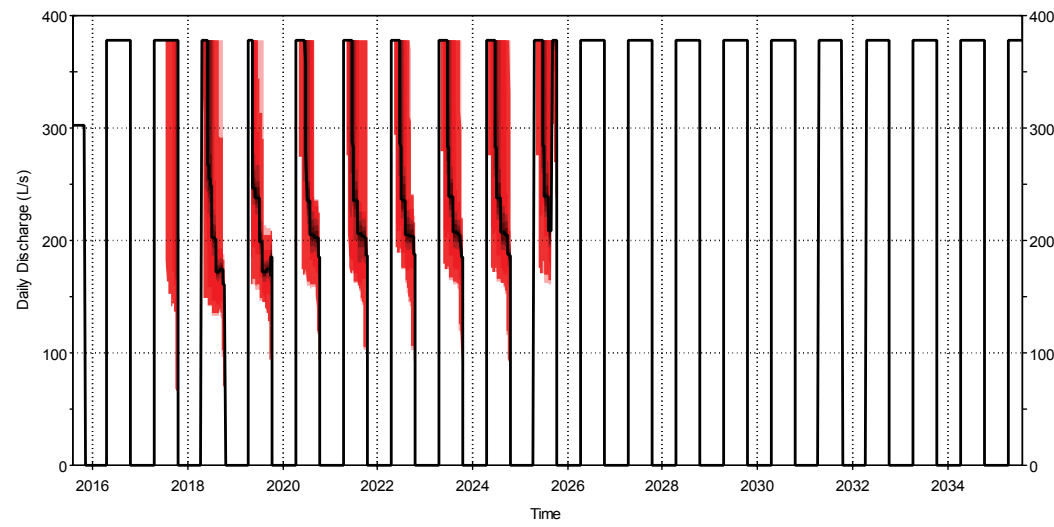
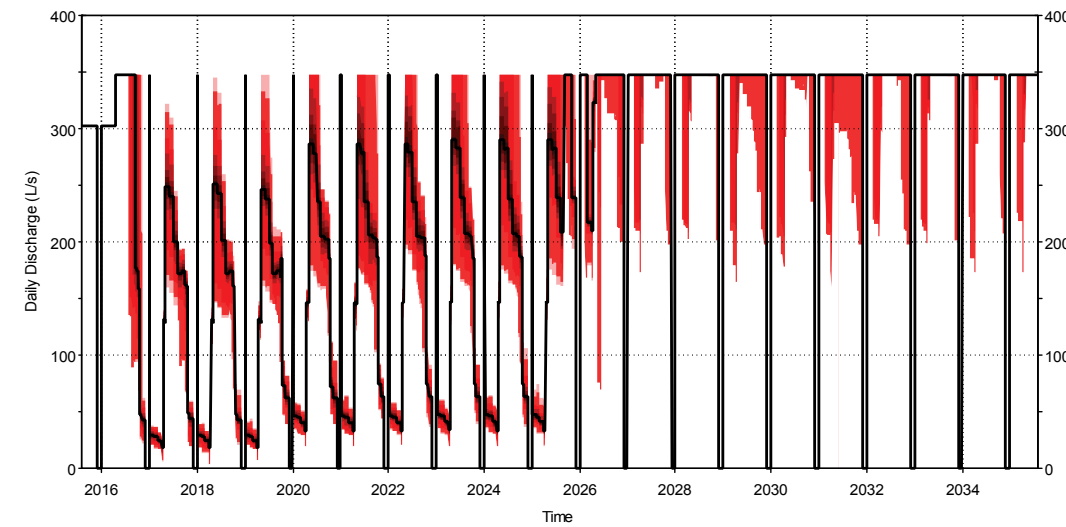
FIGURE 13-7i
Water Management Tool Results – Daily IWTS Discharge
 Faro Creek Diversion
 Faro Mine Remediation Project

Daily IWTS Discharge

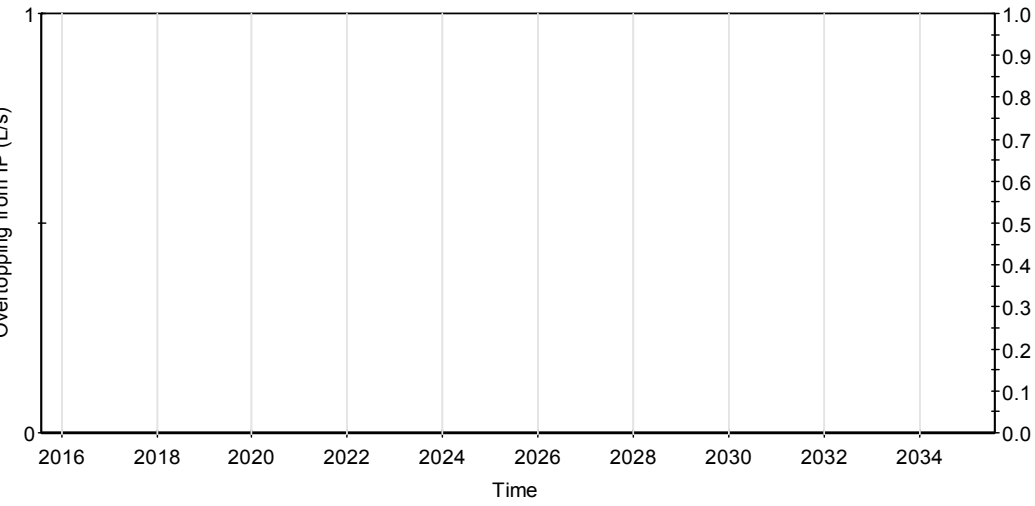
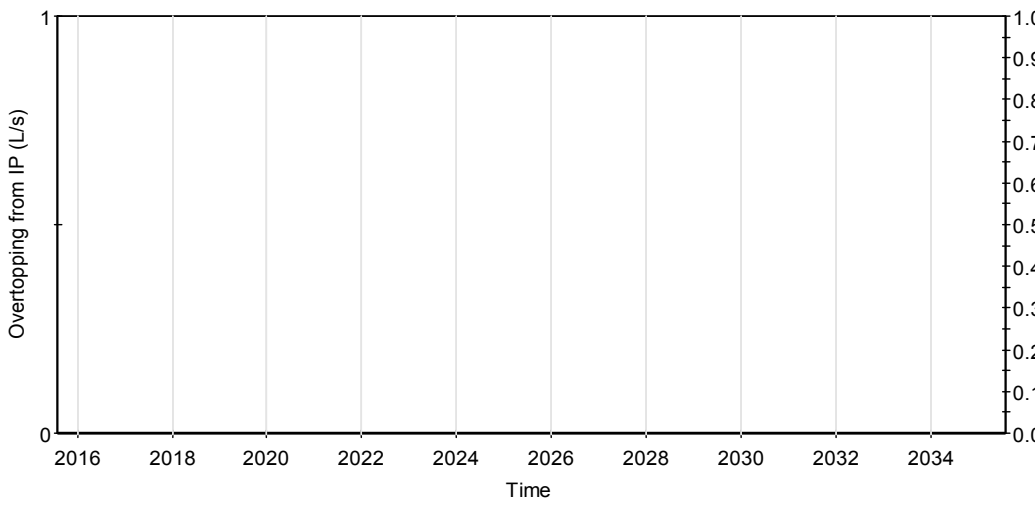
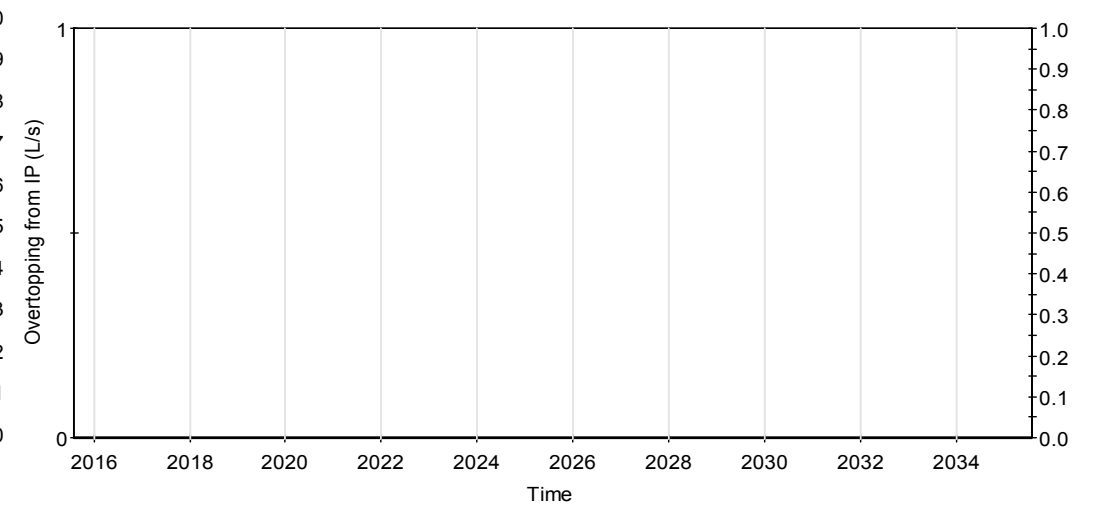
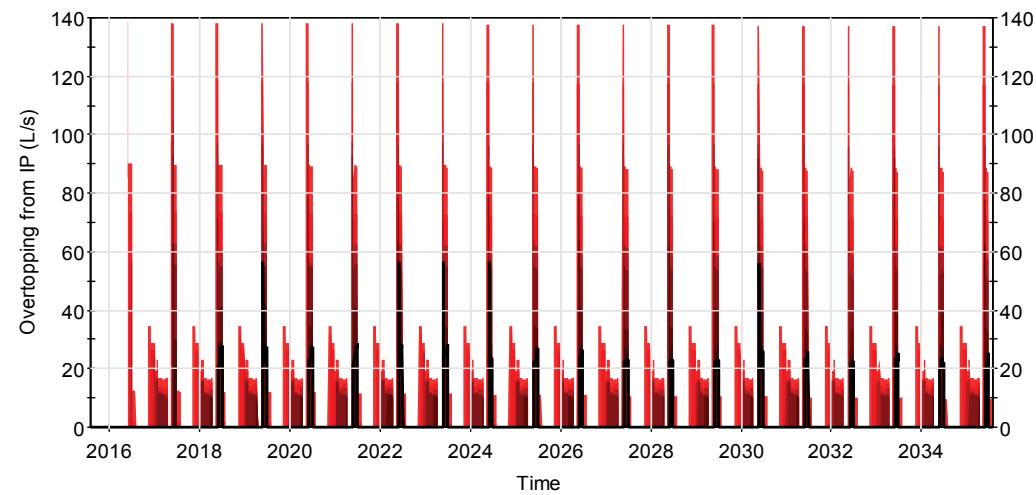
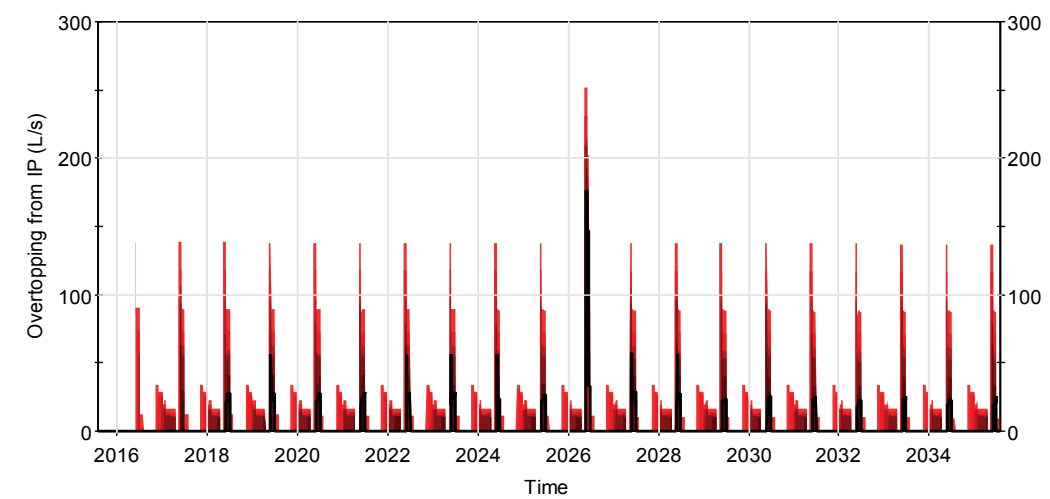
FIGURE 13-7j
Water Management Tool Results – Spills from Intermediate Dam Pond
 Faro Creek Diversion
 Faro Mine Remediation Project

IP Overtopping

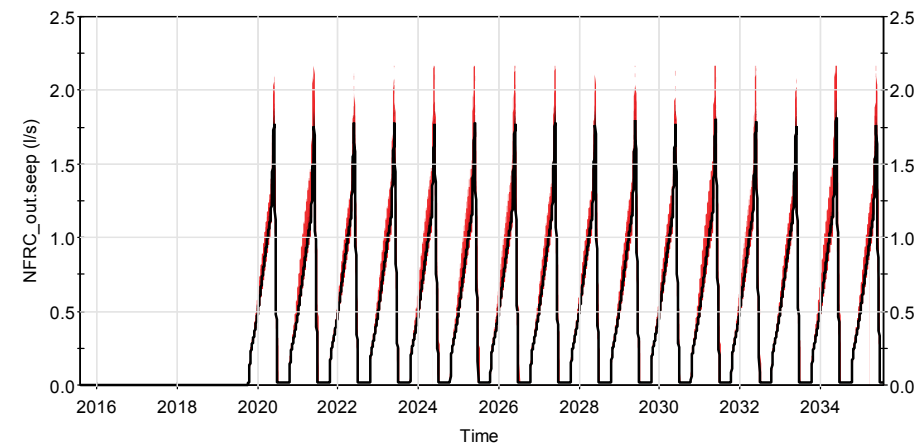
Scenario 3.1

Seepage Rate

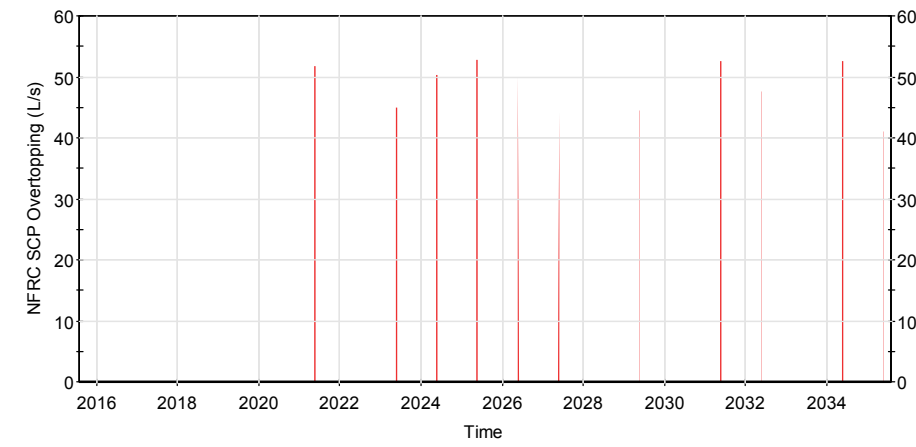
Scenario 3.1

Spills

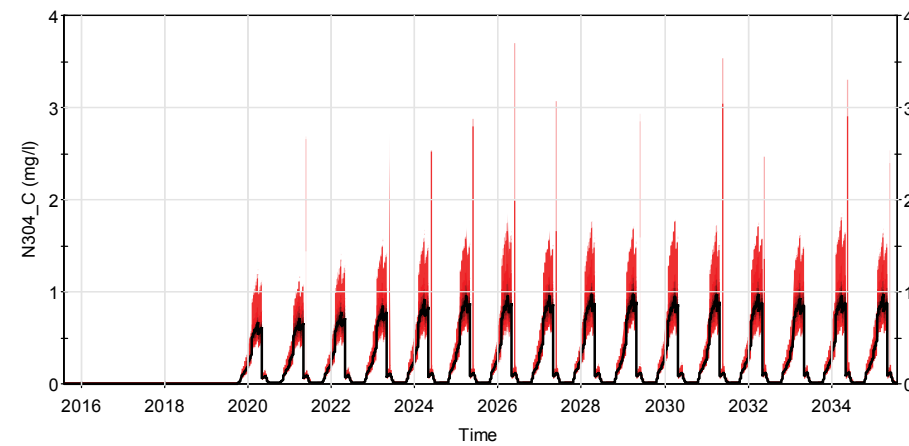
FIGURE 13-8
Water Management Tool Results – Water Quality
 Faro Creek Diversion
 Faro Mine Remediation Project

Scenario 3.1

Zinc Concentration

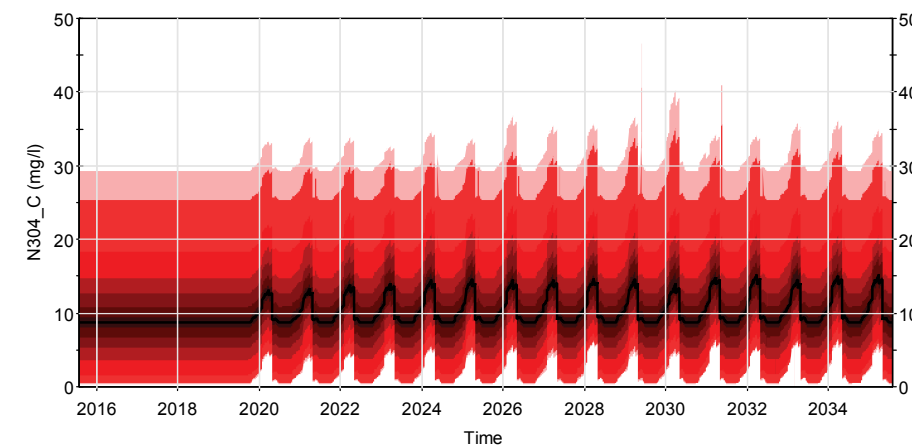
Scenario 3.1

Sulphate Concentration
