**QUALITATIVE RISK ASSESSMENT OF
DOWN VALLEY TAILINGS AREA
FARO MINE, YUKON**

Project No: 0257-004-01
Date: November 2001

**Final Report on Qualitative Risk Assessment of
Down Valley Tailings Area, Faro Mine, Yukon**

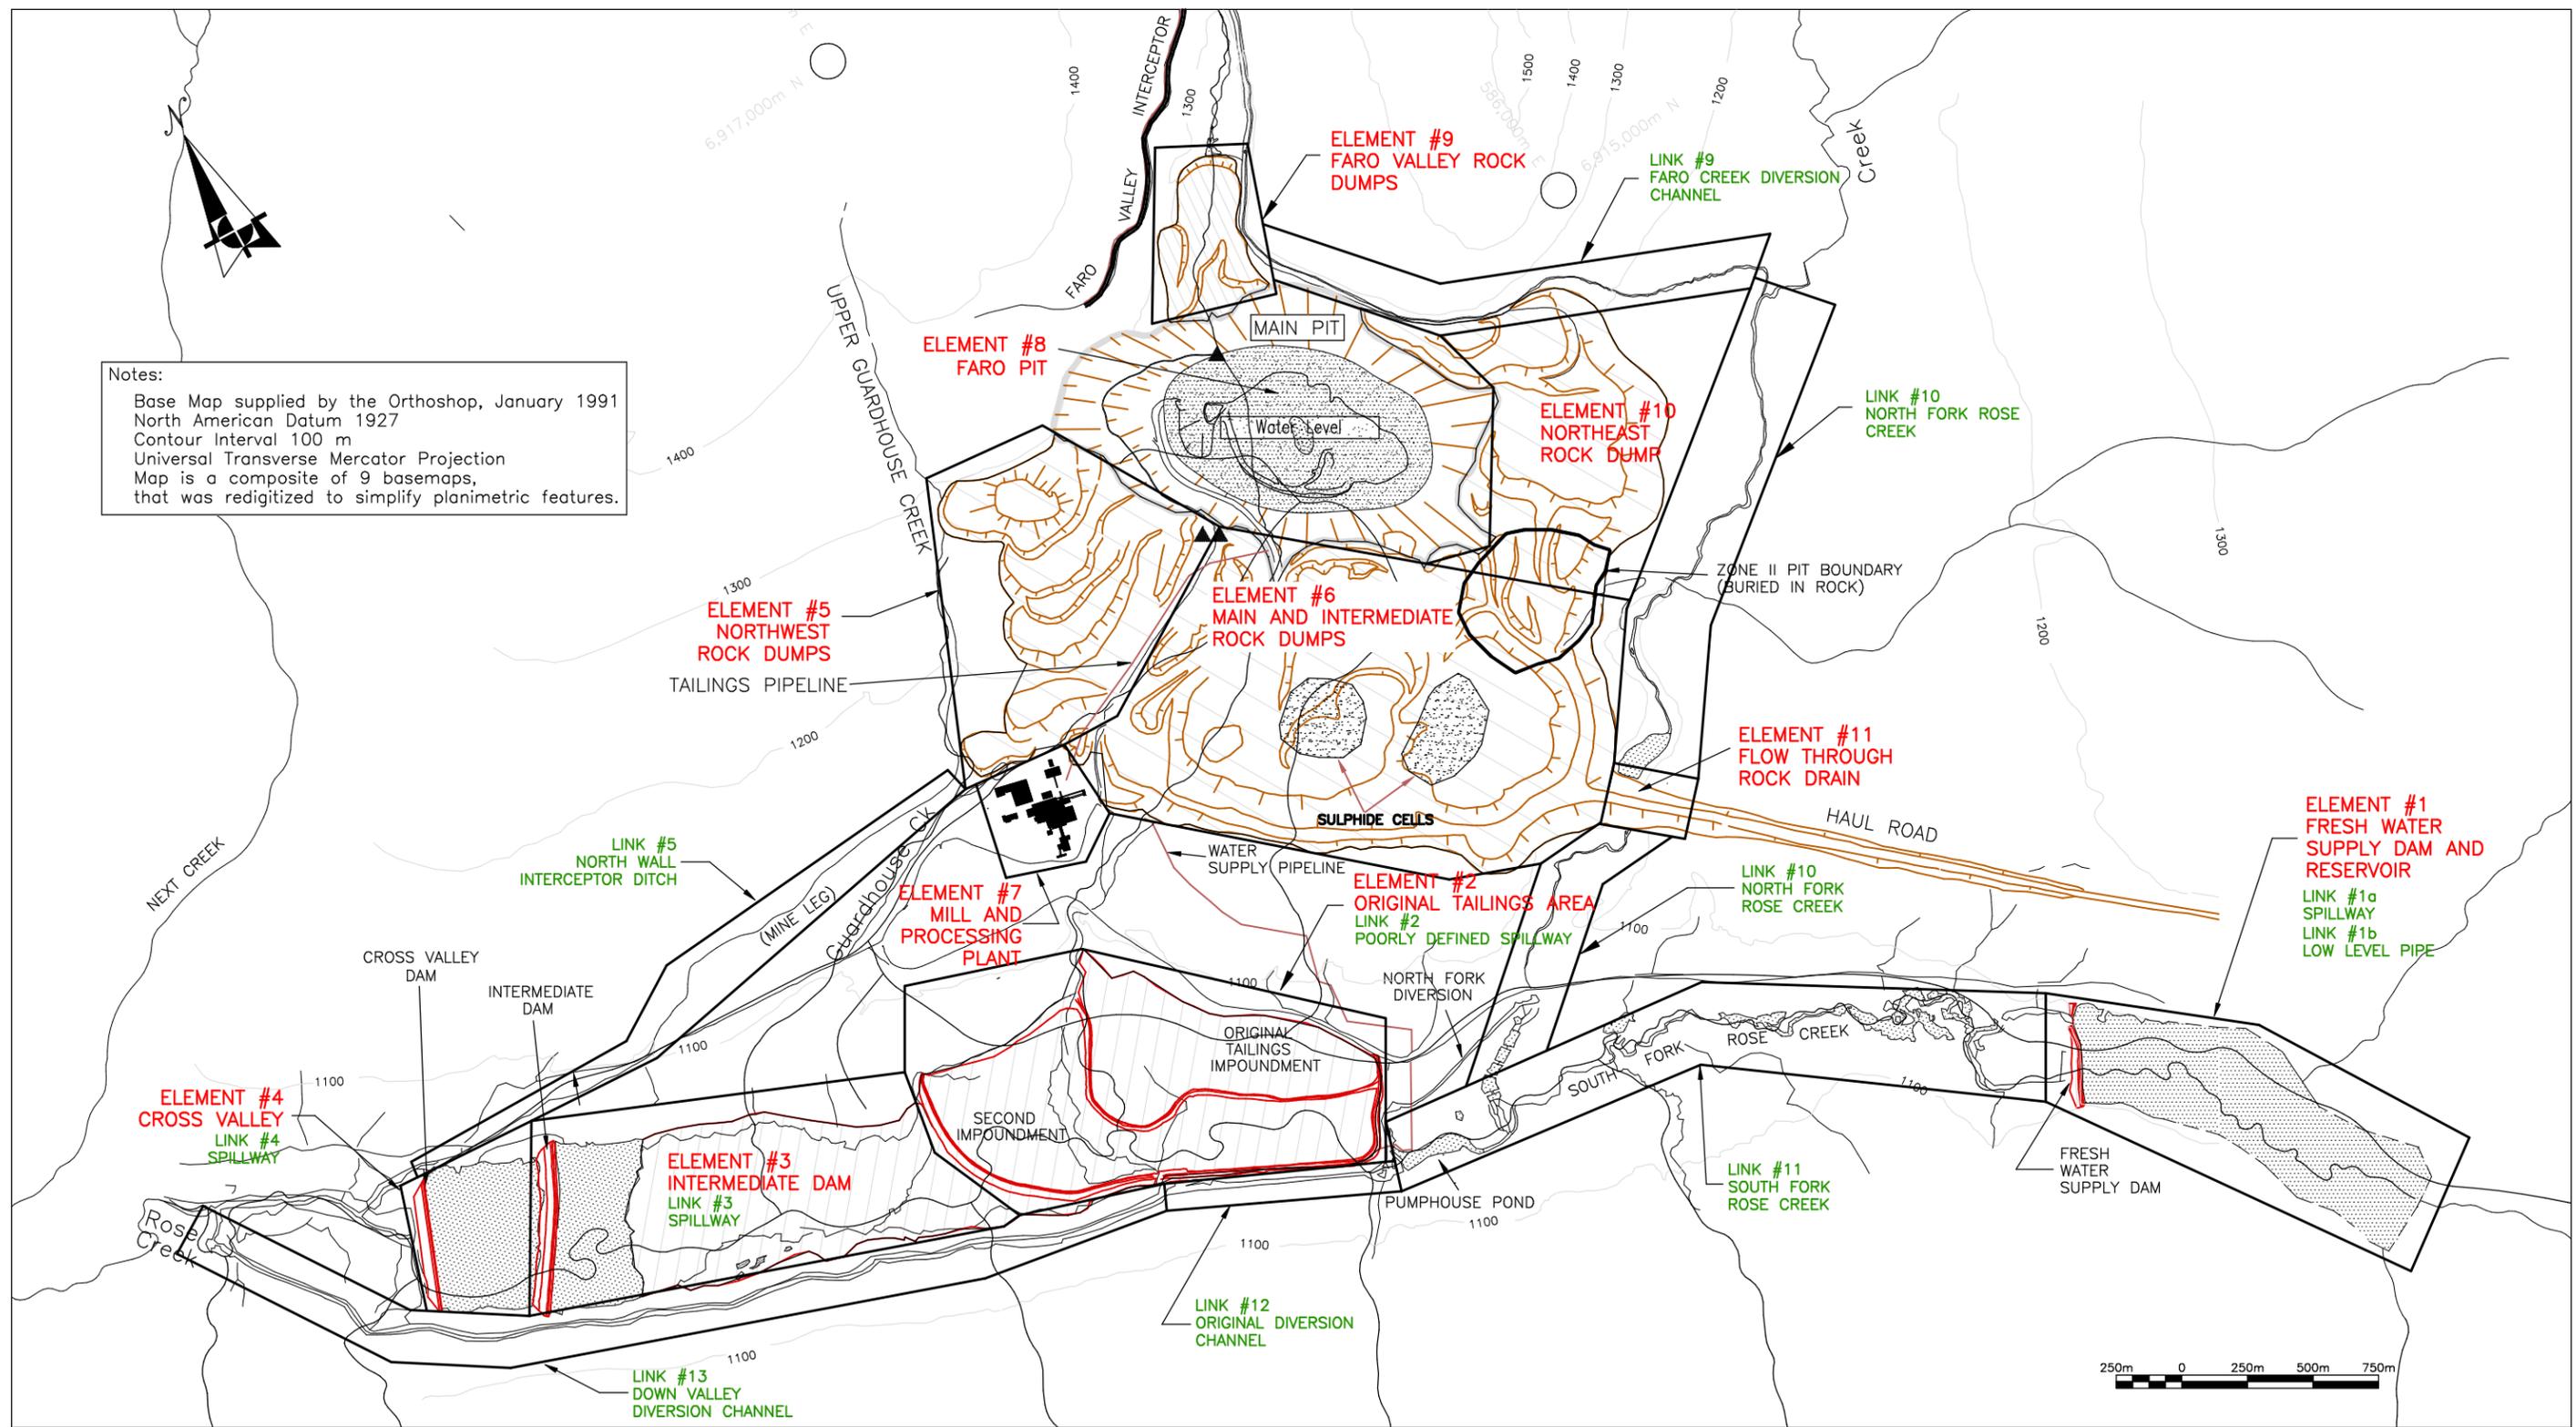
Figure 1 Faro Mine Site Plan Elements and Links for FMEA

In order to properly assess the risks of a tailing containment area failure, the containment “system” has to be bounded. In this case, the “system” assessed is limited to the elements and links shown on Figure 1. As illustrated, the system contains the Fresh Water Supply Dam, the other major dams and diversion canals situated within the Down Valley. The bounded system also considers the potential impact of further a field components such as the flow-through causeway and the waste dumps surrounding the Faro Pit. Hence, for example, the impact of a failure of the flow-through causeway on the physical integrity of the Down Valley tailings area is assessed.

1. The failure modes assessed for the Down Valley project are limited to the area as defined by the elements and links shown in Figure 1.
2. The assessment is limited to the current configuration of the structures and facilities within the Down Valley and on the current understanding of water conveying and procedural systems employed (as outlined in Section 4.4). As such, the analysis and results provided herein are considered appropriate for the period of the next several years, before any changes to the physical conditions are undertaken due to rehabilitation work and/or deterioration. Additional discussion on the relevance of the selected time period for the FMEA is provided in Section 4.5.1 as it pertains to the potential closure phase for this project.

Section 4.3.1 provides a summary of the major structures within the Down Valley and Section 4.3.2 provides a summary discussion of the surface water flow across the Faro site. This information provides the context for the selection of the important components to be considered, as shown in Figure 1.

As previously noted, a meeting was held on May 8 to 10, 2001 between Messrs. Eric Denholm, Glen Gilchrist, Jim Cassie, and Iain Bruce. At the meeting, a series of failure modes and effects were developed for each of the links and elements identified within the Down Valley tailings area, as shown on Figure 1.
