Mt. Nansen Draft Material

Review of the Resources and Economic Potential

of the Mt. Nansen Property

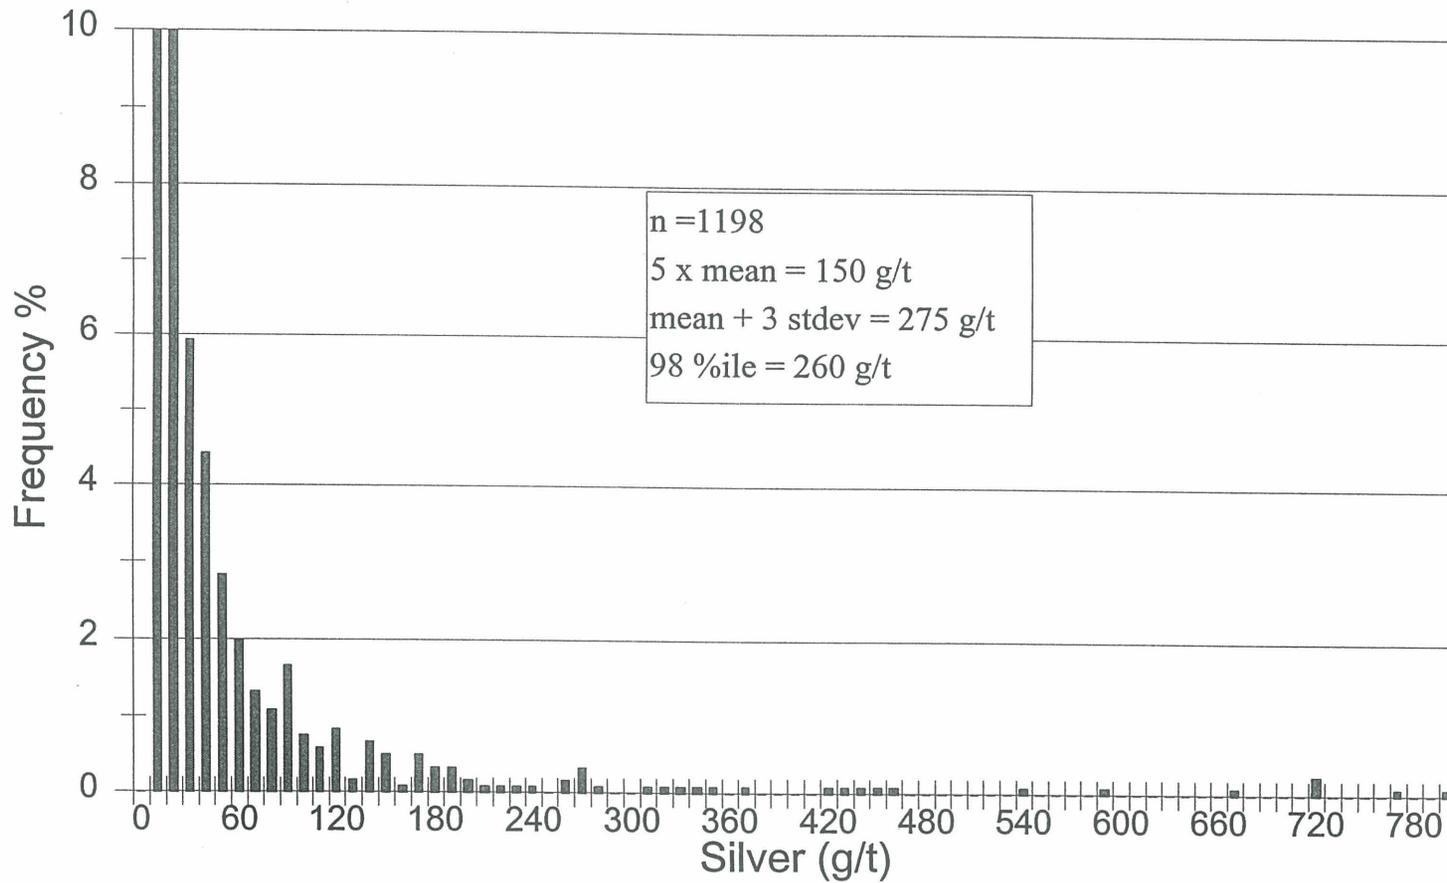
Fig 3

Mt. Nansen Property

BMD Zone - Ag Frequency Distribution

Individual high gold and silver assays were capped at 28 g/t and ²⁶⁰600 g/t respectively based on a statistical examination of the assay population for the Brown McDade structure (figures 3,4).

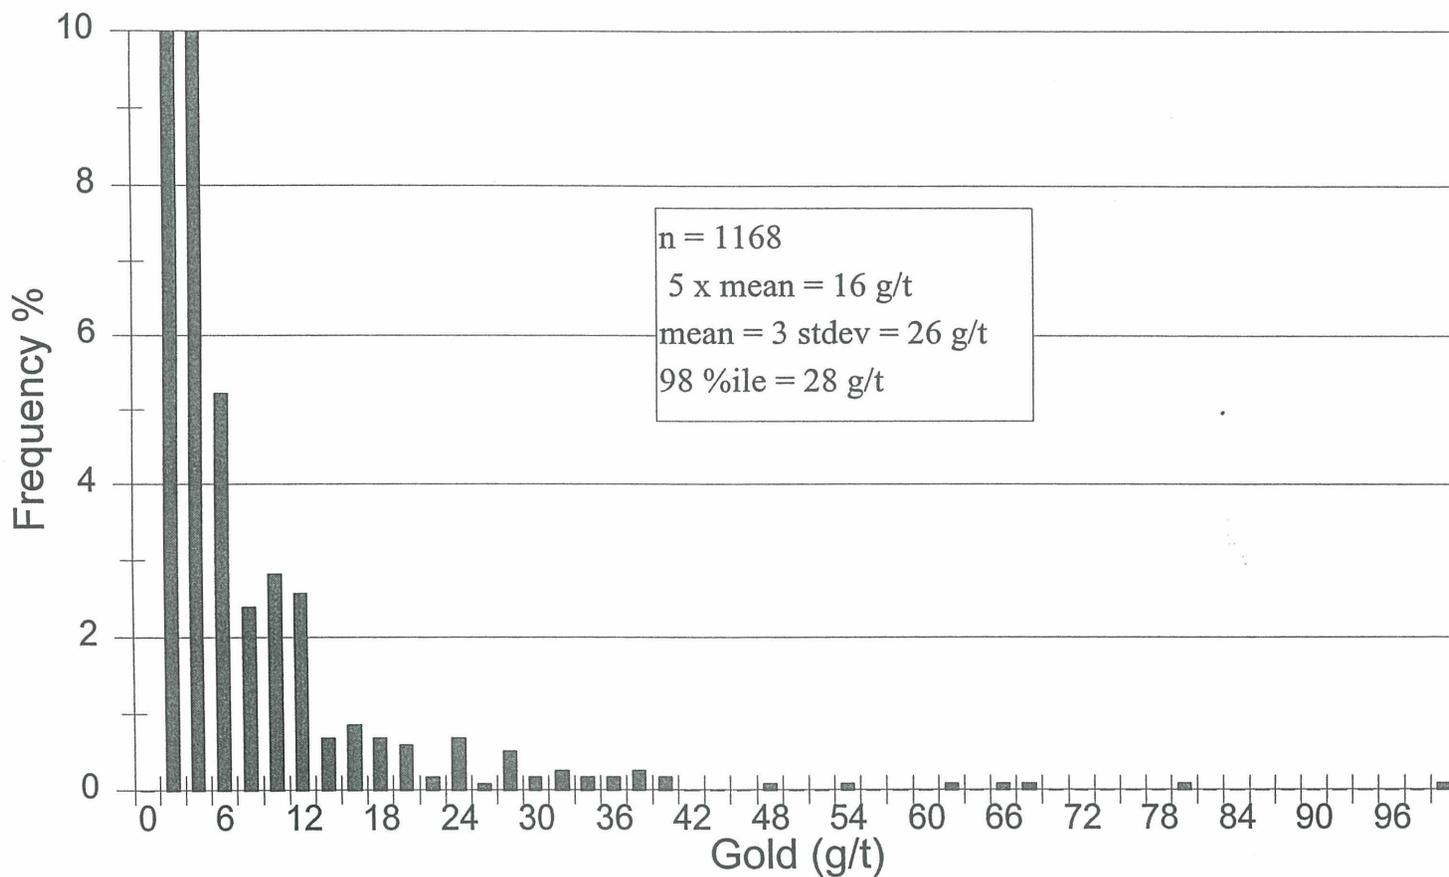
Fig 4

Mt. Nansen Property

BMD Zone - Gold Frequency Distribution

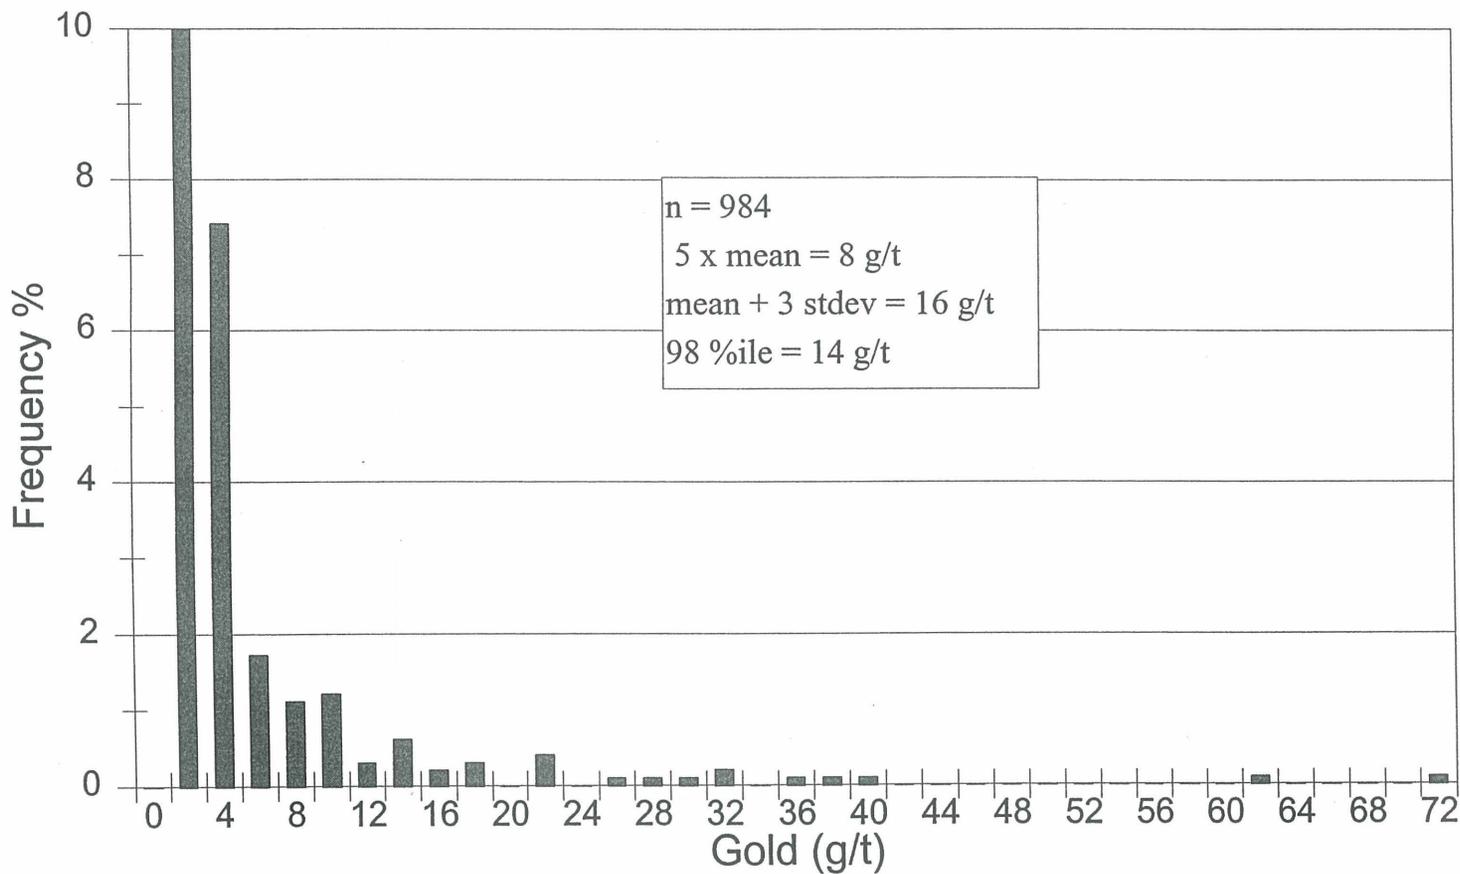
Fig 7

Mt. Nansen Gold Project

Flex Zone Gold Frequency Distribution

Individual high gold and silver assays were capped at 15 g/t and ³⁵⁰~~700~~ g/t respectively based on a statistical examination of the assay population for the Flex structure (figures 7,8).

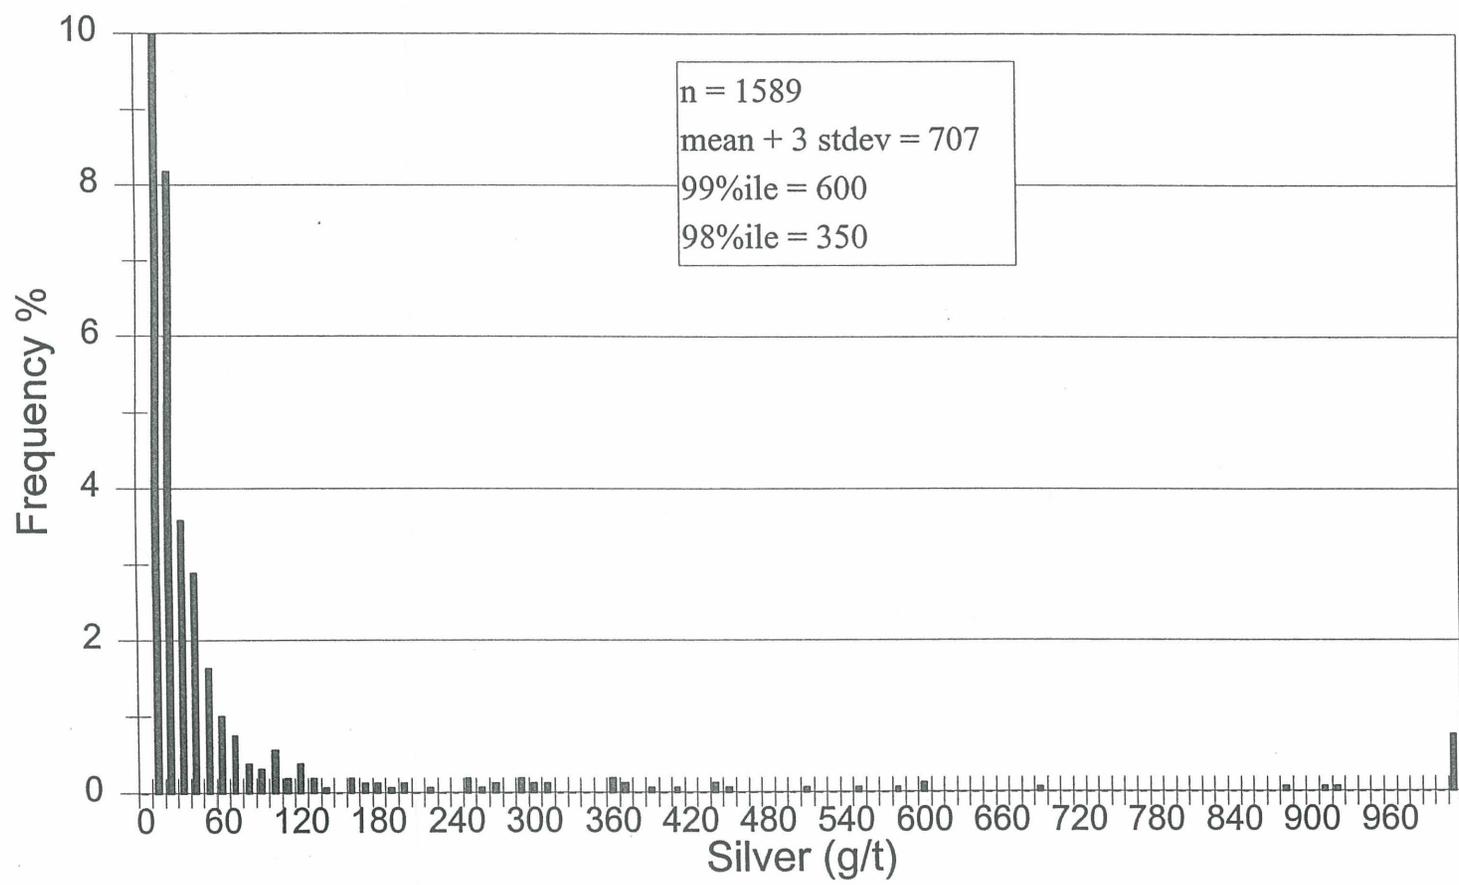
fig 8

Mt. Nansen Gold Project

Flex Silver Frequency Distribution

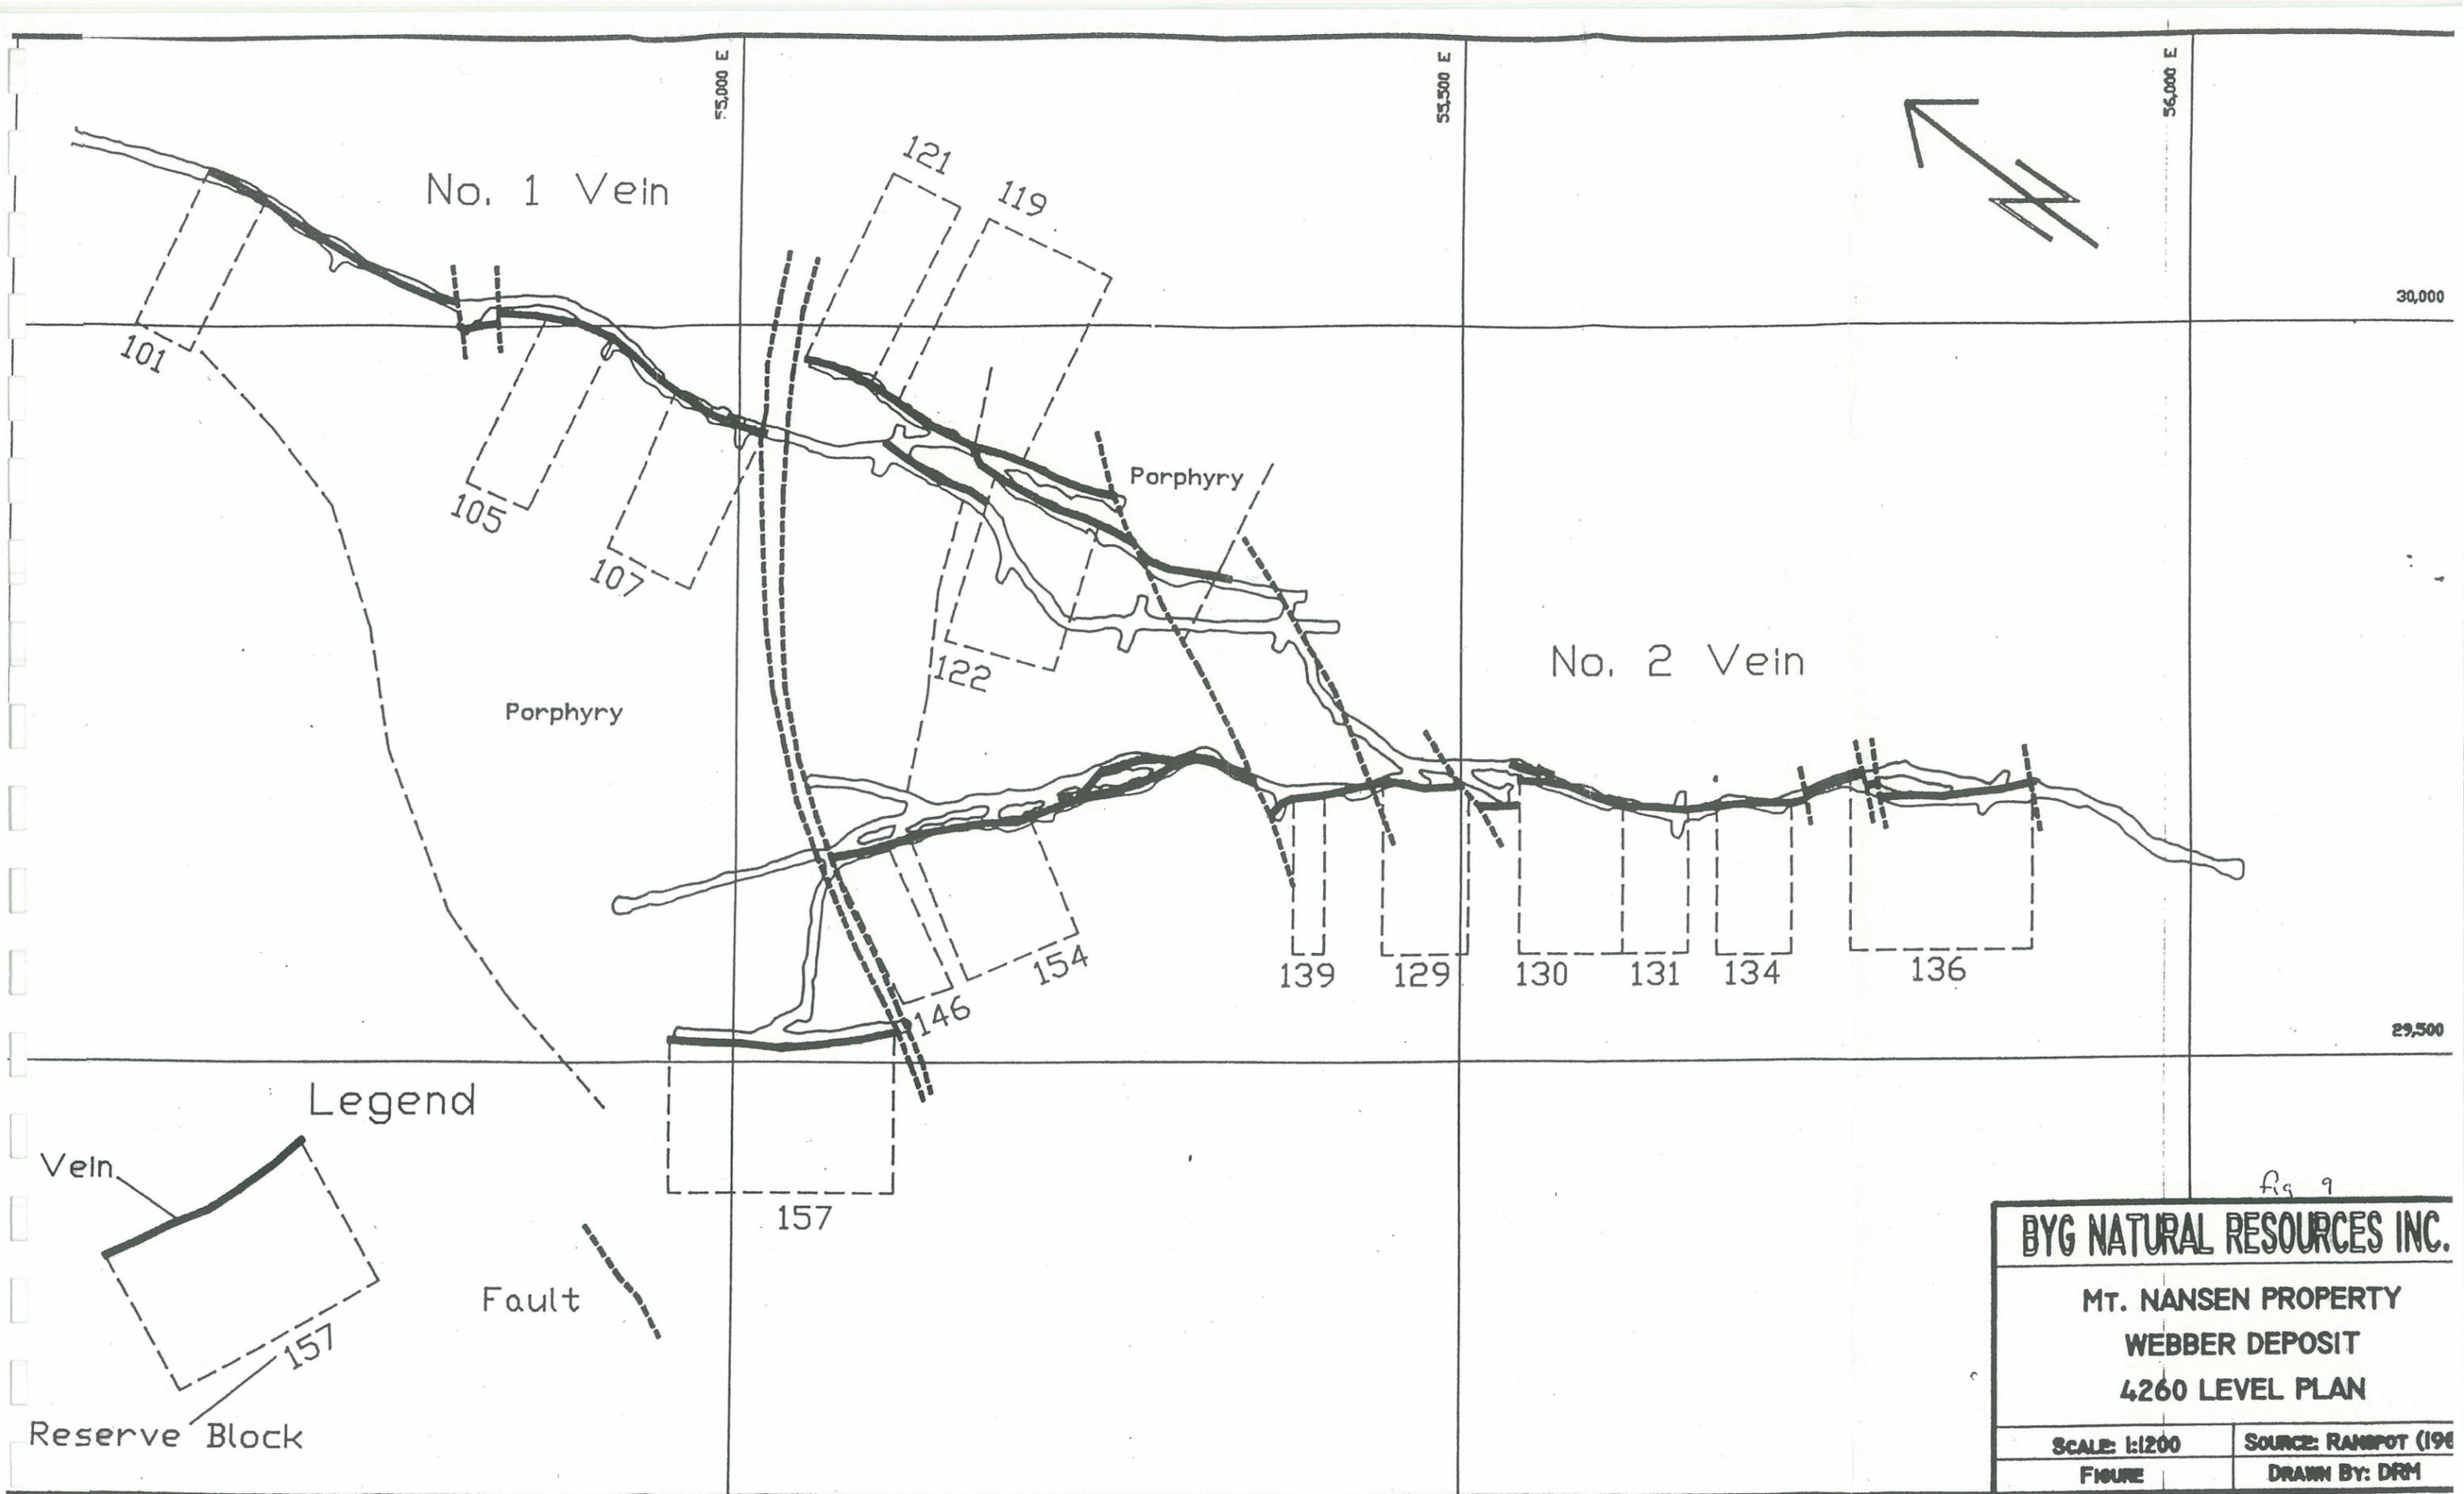
Fig. 9

BYG NATURAL RESOURCES INC.

SCALE: 1:1200	SOURCE: RANSPOT (196
FIGURE	DRAWN BY: DRM

The Webber deposit consists of a west northwest striking quartz vein network which dips steeply to the west. The veins, which individually vary from 0.3 to 2.0 metres in width, occupy shear controlled fractures in metamorphic rocks and have been traced over 500 metres along strike by both underground development and surface trenching. Two main vein structures have been recognized, the No. 1 (Footwall) and the No. 2 (Hangingwall), and they have been developed and extensively chip sampled on one level, the 4300, over distances of 200 and 250 metres respectively. Individual mineralized shoots within each vein are typically 50 metres in strike length and 100 metres along the steep plunge direction with the main shoots open to depth (figures 9,10).

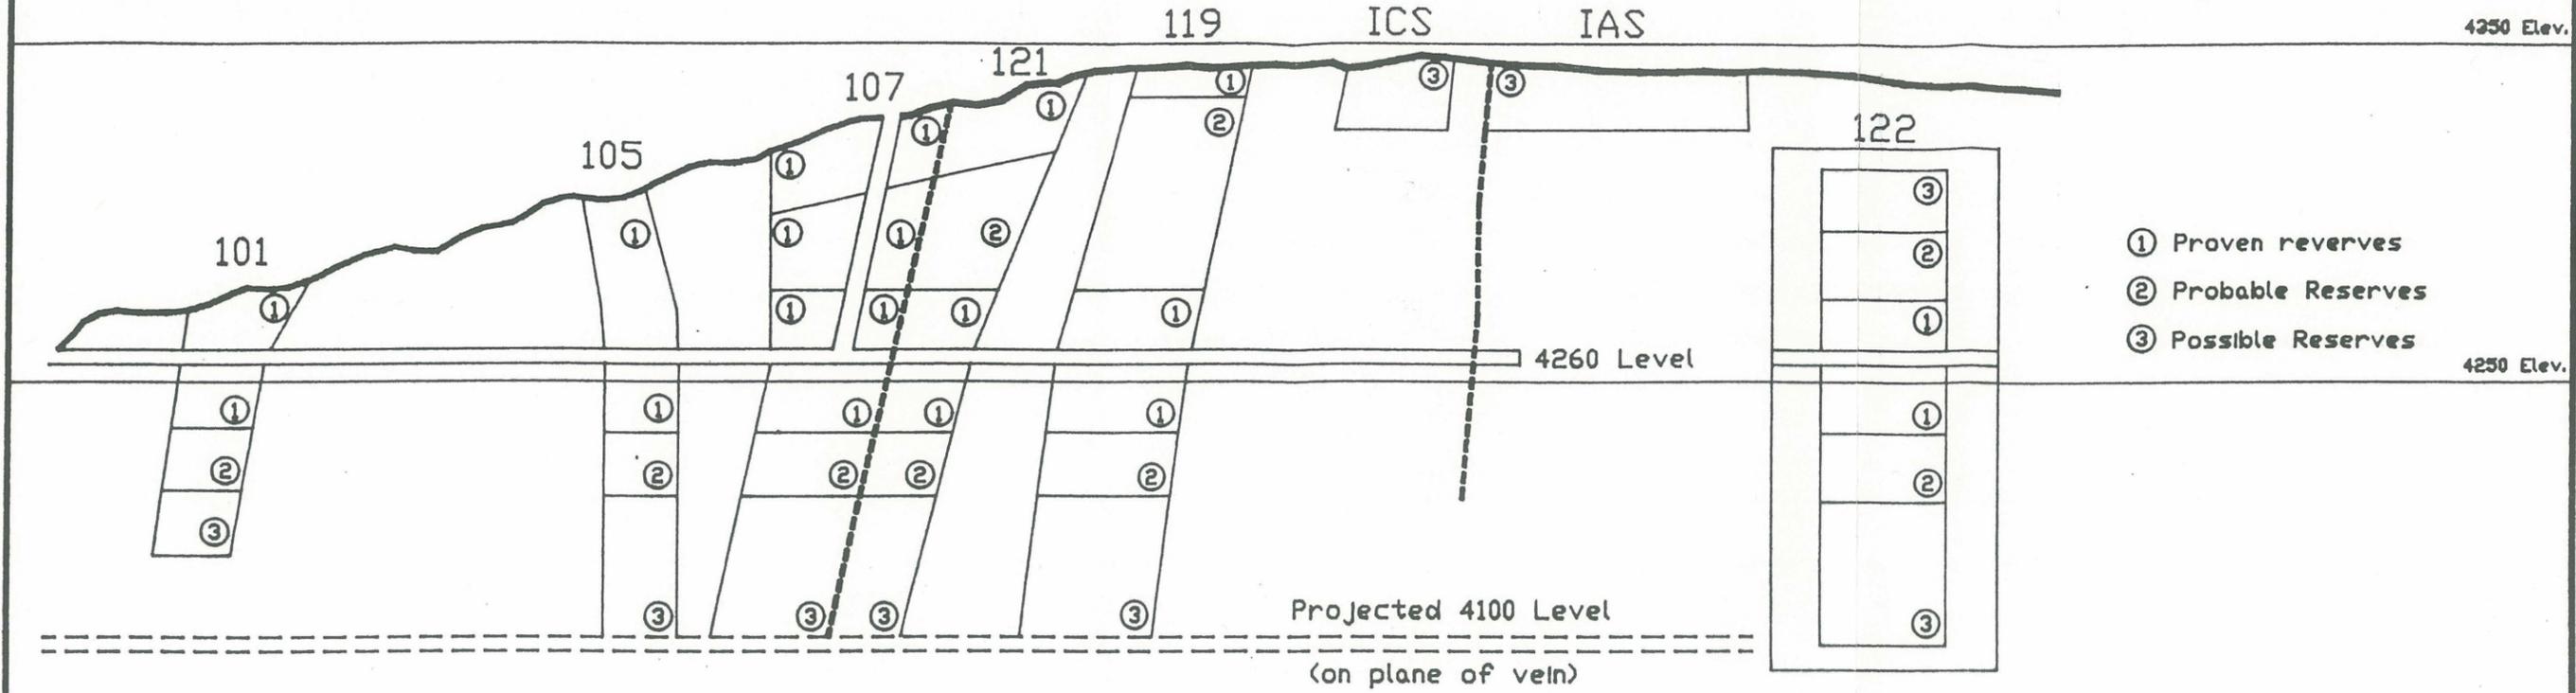
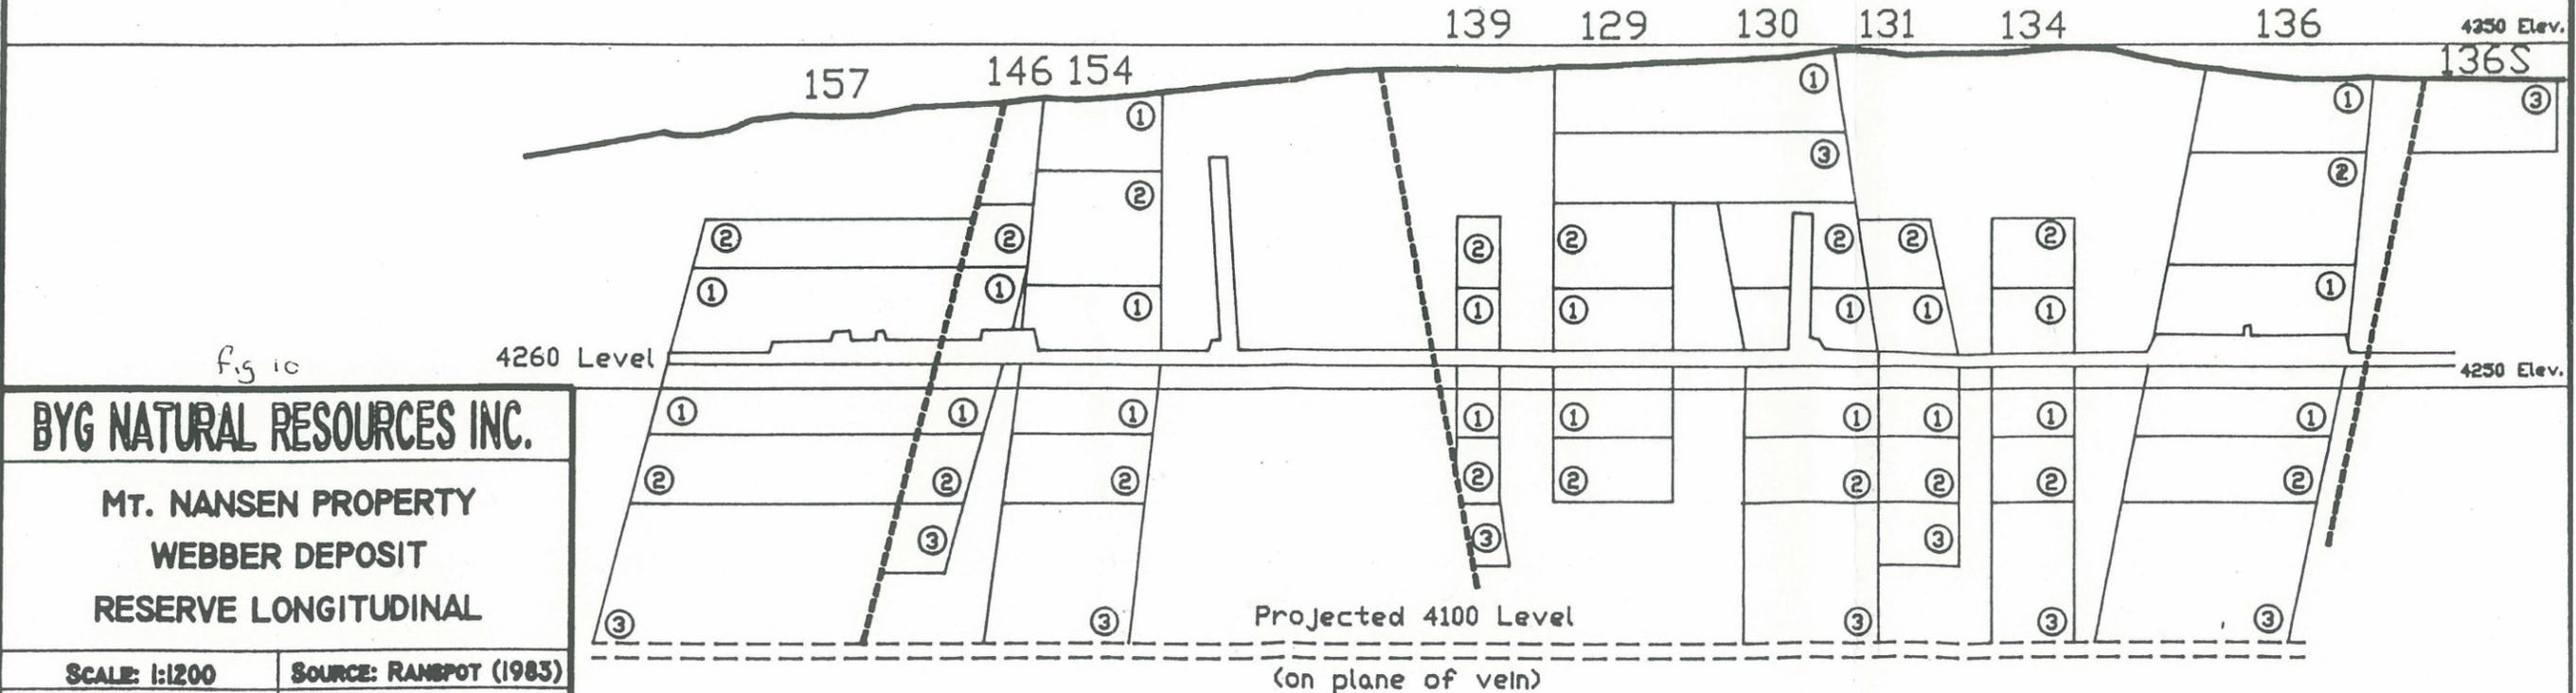
No. 1 Vein

No. 2 Vein

MT. NANSEN PROPERTY
 WEBBER DEPOSIT
 RESERVE LONGITUDINAL

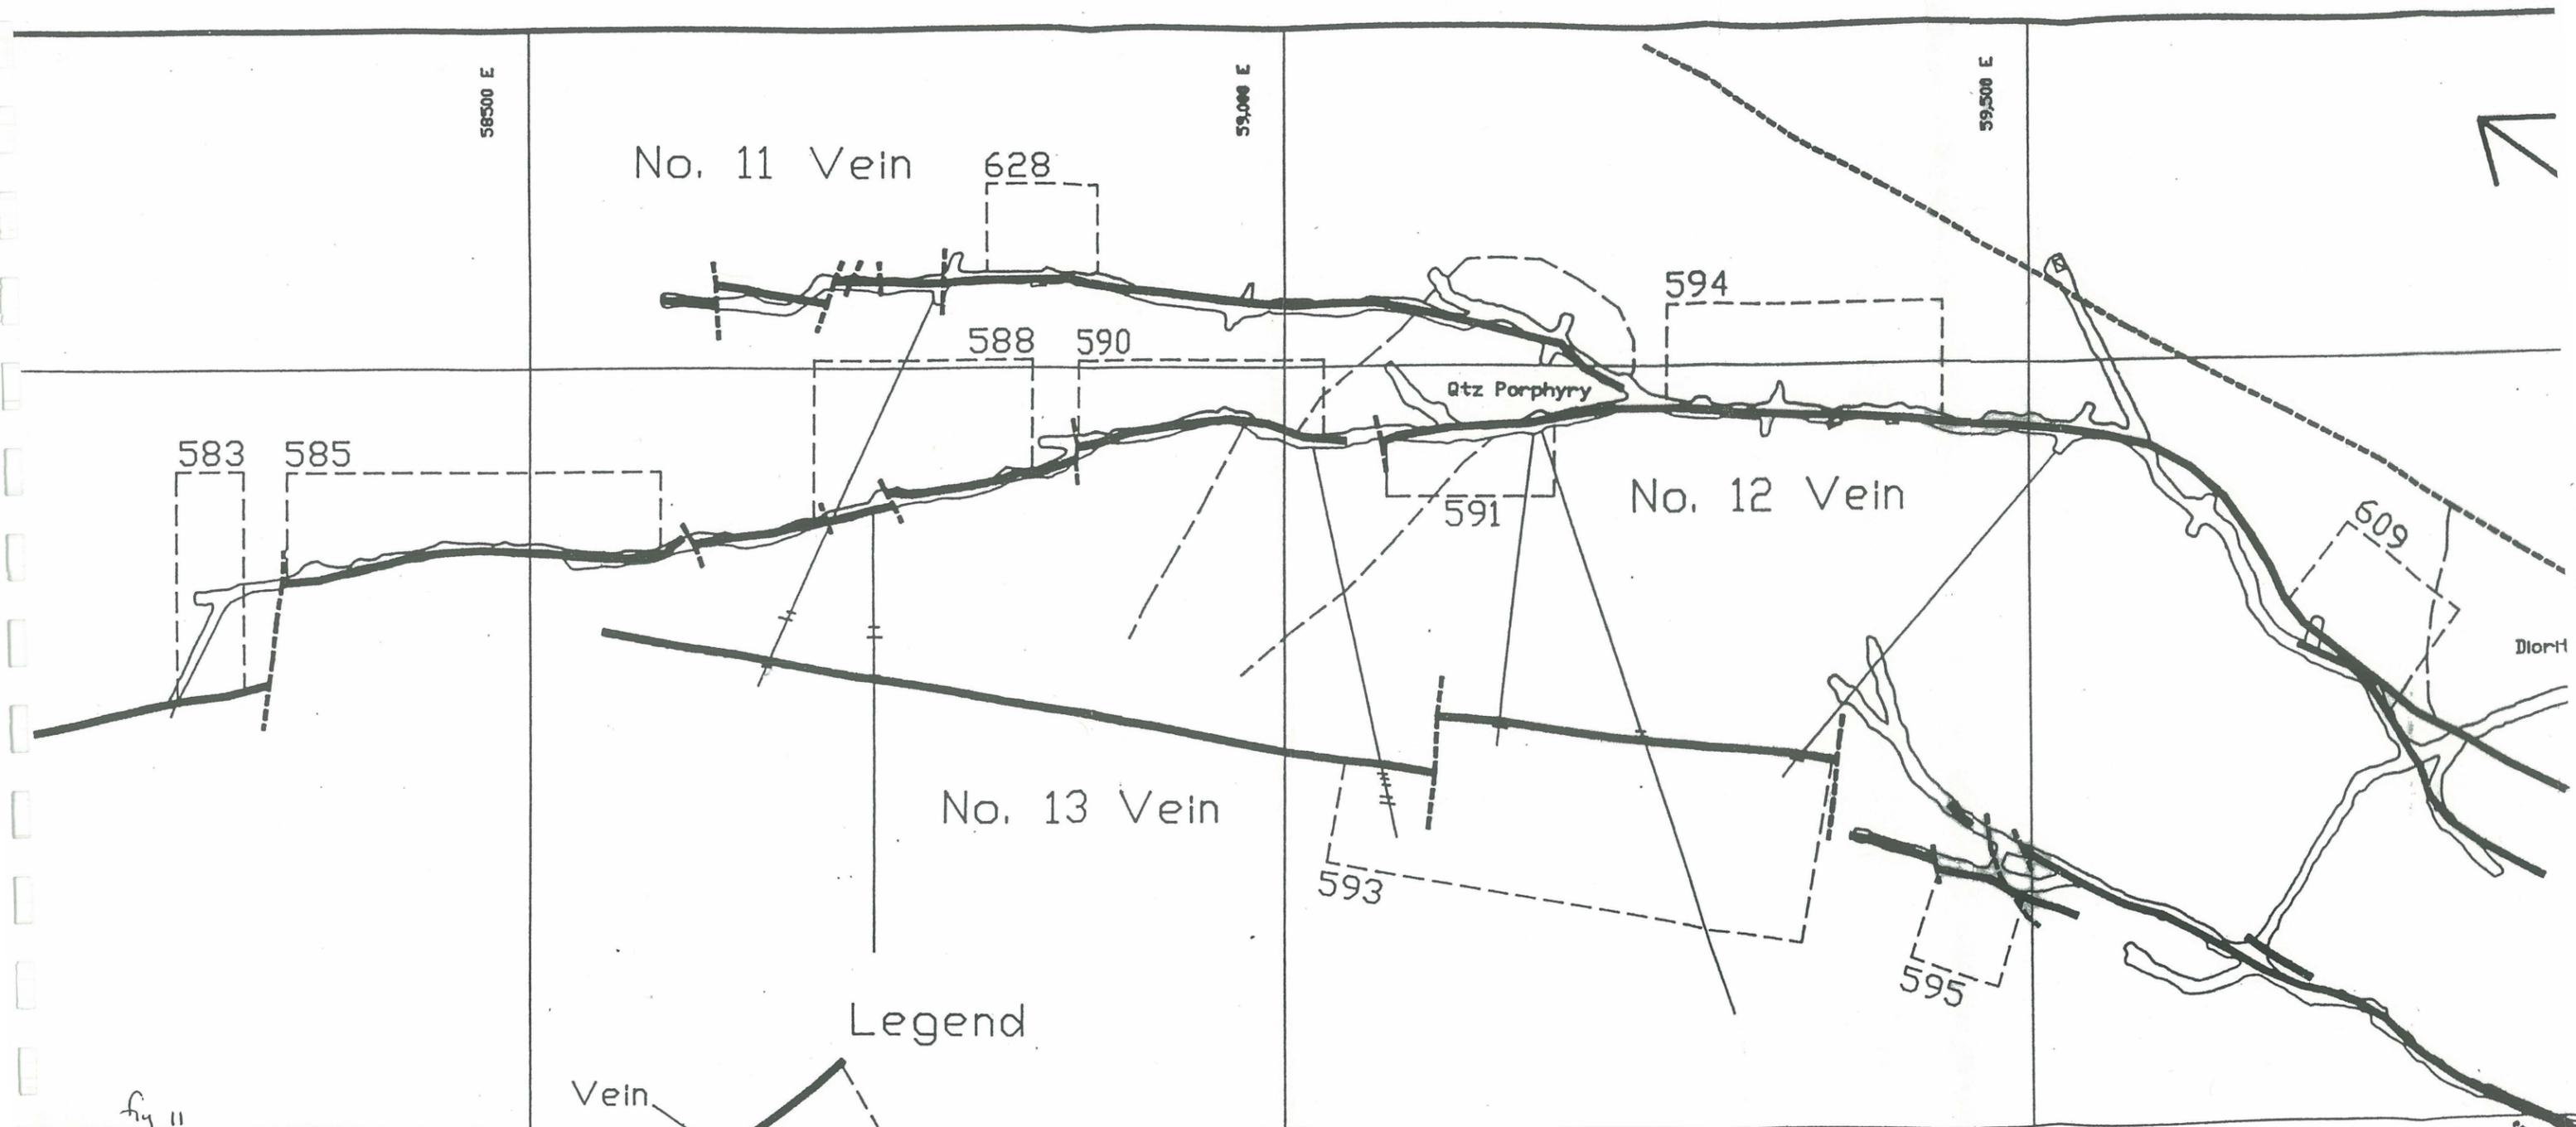
Fig 11

G NATURAL RESOURCES INC.

metamorphic rocks and have been traced over 500 metres along strike by both underground development and surface trenching. Three main vein structures have been recognized, the No. 11 (Hangingwall), the No. 12 (Intermediate) and the No. 13 (Footwall), and they have been developed and extensively chip sampled on two levels, the 4100 and 4300. Individual mineralized shoots within each vein are typically 100 metres in strike length and 170 metres along the steep plunge direction with the main shoots open to depth (figures 11,12).
