BACKGROUND PAPER ON
HAINES-FAIRBANKS (YUKON) FUEL-OIL PIPELINE

ROUTE
OF
HAINES-FAIRBANKS PIPE LINE

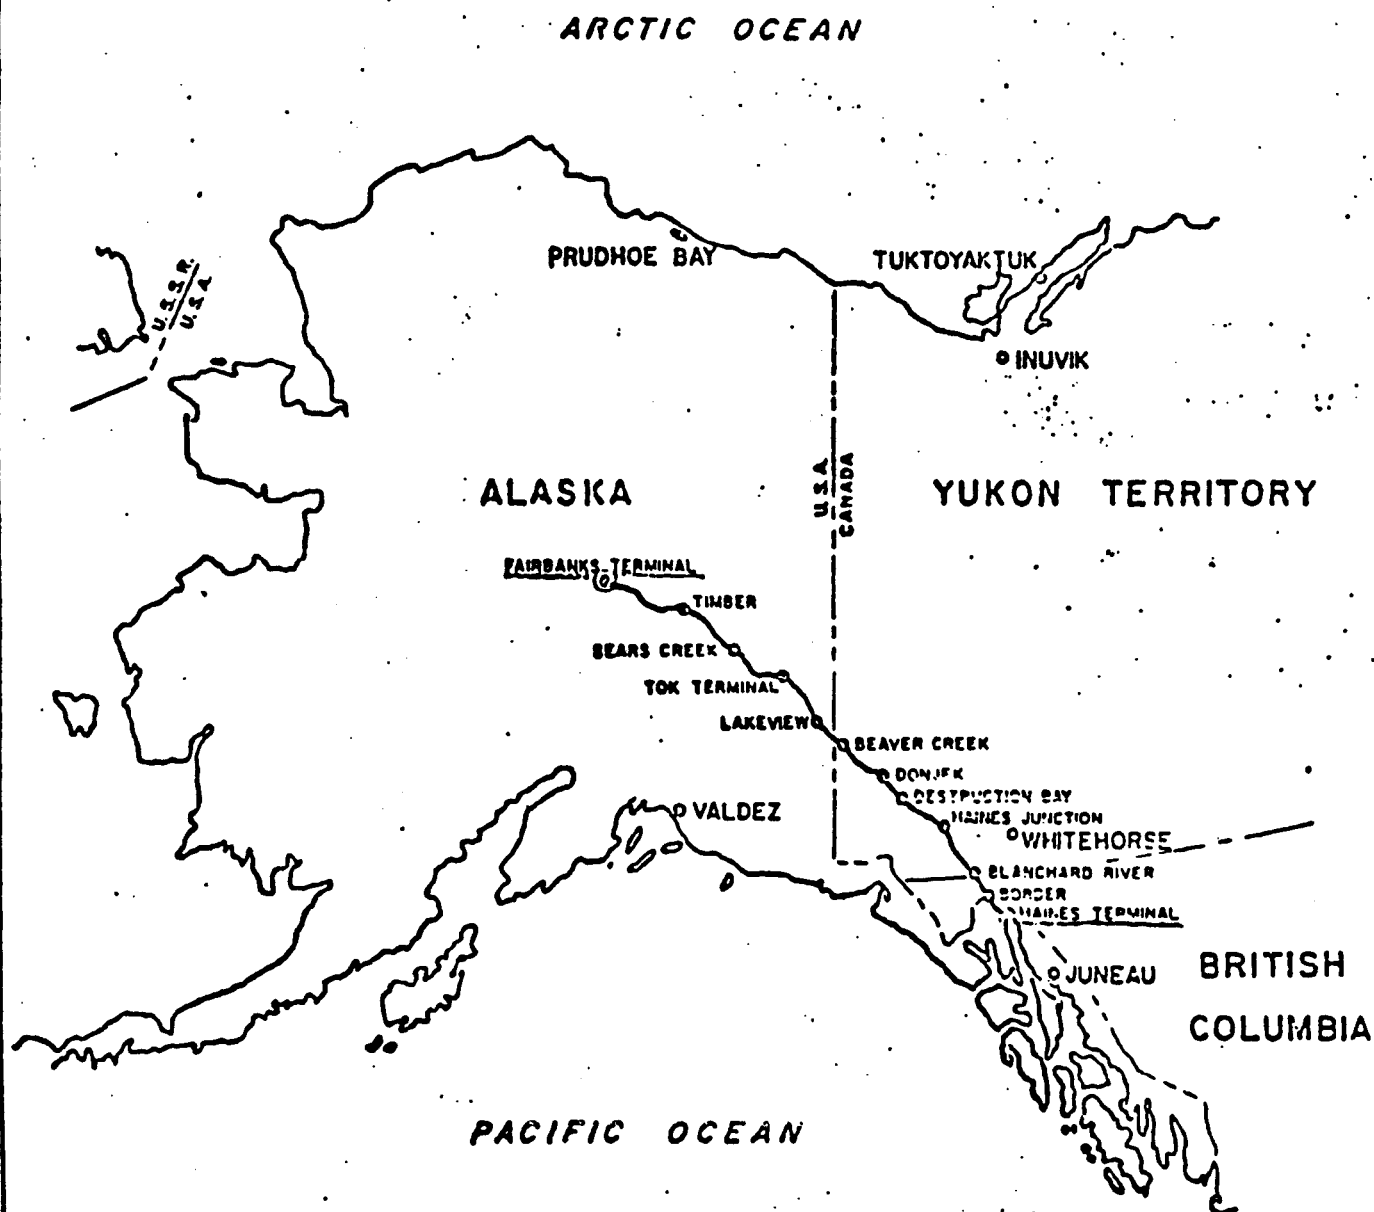
The Haines-Fairbanks Pipeline runs from Haines, Alaska, across a strip of British Columbia, crossing the Yukon Territory, including the Kluane National Park, and North to Fairbanks, Alaska. (Appendix A)

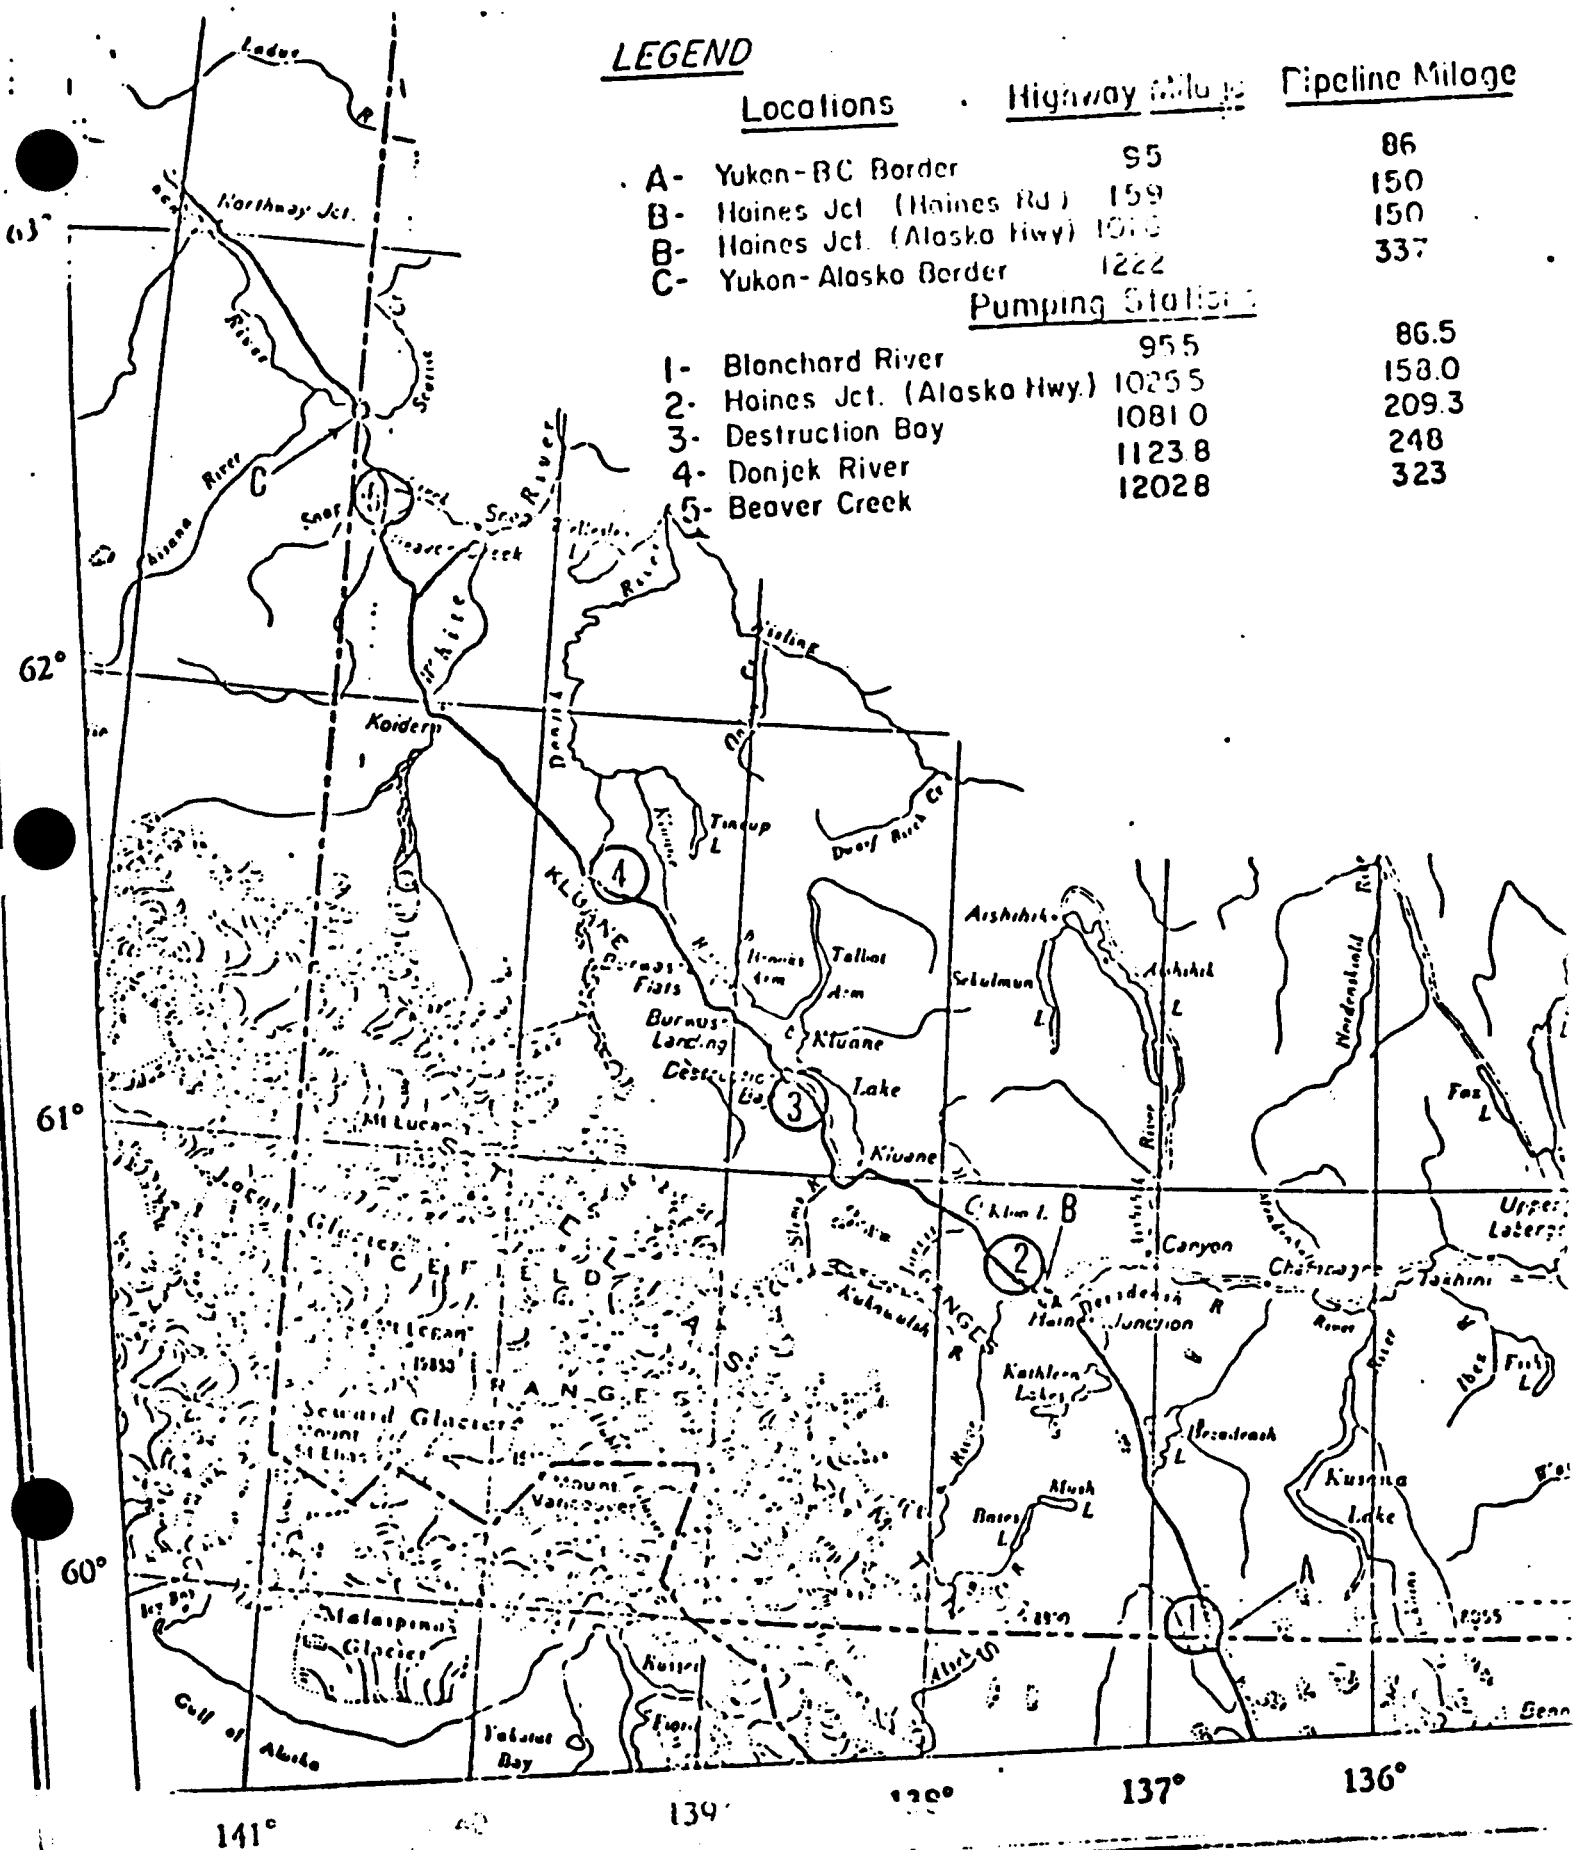
YUKON
TERRITORY

Pumping Stations

- 1- Blanchard River 95.5 86.5
- 2- Haines Jct. (Alaska Hwy) 1025.5 158.0
- 3- Destruction Bay 1081.0 209.3
- 4- Donjek River 1123.8 248
- 5- Beaver Creek 1202.8 323
