Faro Mine Complex, Yukon Territory

*Operations, Maintenance and Surveillance Manual for:
Intermediate Dam, Cross Valley Dam
and Little Creek Dam*

March 31, 2014

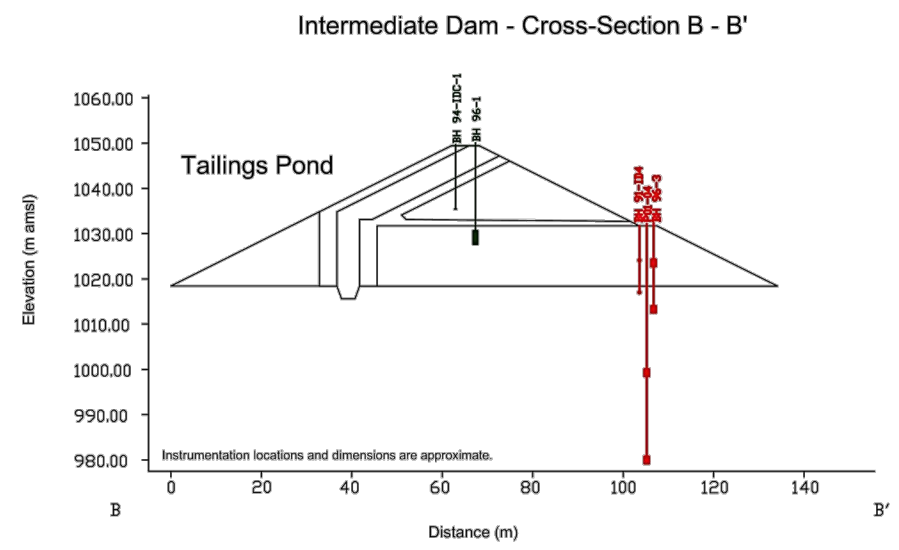
- Screened Intervals of Standpipe Piezometers
- Bottom of Standpipe Piezometers
- Pneumatic Piezometer Tips
- Crest Piezometers
- Downstream Toe Piezometers

Fig. 9 Original Source: Figure 18 - 2009 Annual Geotechnical Evaluation and Instrumentation Review, Volume 1

AS A MUTUAL PROTECTION TO OUR CLIENT, THE PUBLIC AND OURSELVES, ALL REPORTS AND DRAWINGS ARE SUBMITTED FOR THE CONFIDENTIAL INFORMATION OF OUR CLIENT FOR A SPECIFIC PROJECT AND AUTHORIZATION FOR USE AND/OR PUBLICATION OF DATA, STATEMENTS, CONCLUSIONS OR ABSTRACTS FROM OR REGARDING OUR REPORTS AND DRAWINGS IS RESERVED PENDING OUR WRITTEN APPROVAL.	Yukon Government	PROJECT FARO MINE COMPLEX OMS MANUAL FOR DAMS
		TITLE INTERMEDIATE DAM INSTRUMENTATION PLAN AND SECTIONS
	PROJECT No. M09770A03 02 01	FIG. No. B-017

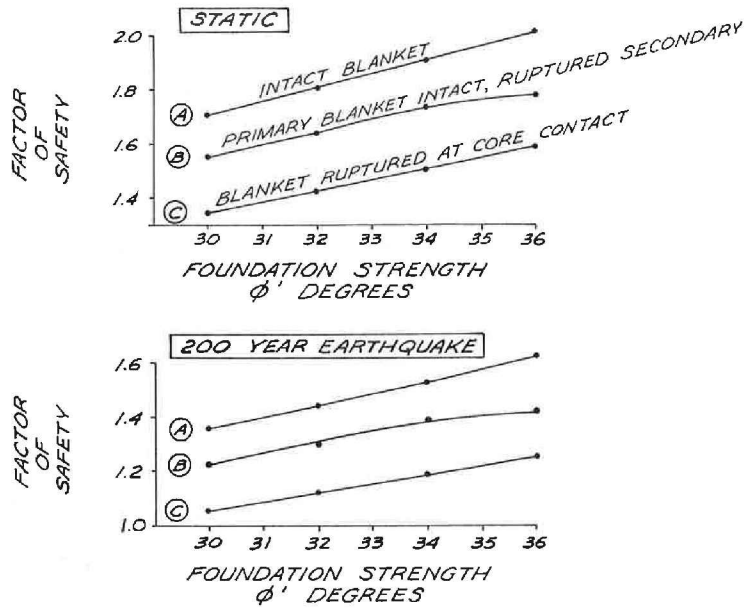
STABILITY ANALYSES - DOWNSTREAM SLOPE Figure VI- 5

- Notes:
- (1) Janbu analyses used to assess stability.
 - (2) Earthquake loading simulated by simple pseudodynamic method.
 - (3) Core strength chosen as $C' = 0$ $\phi = 35^\circ$
 - (4) Core considered to be leaking.
 - (5) Impervious blanket considered effective downstream of points A, B, or C, eg. B assumes secondary blanket ruptured.

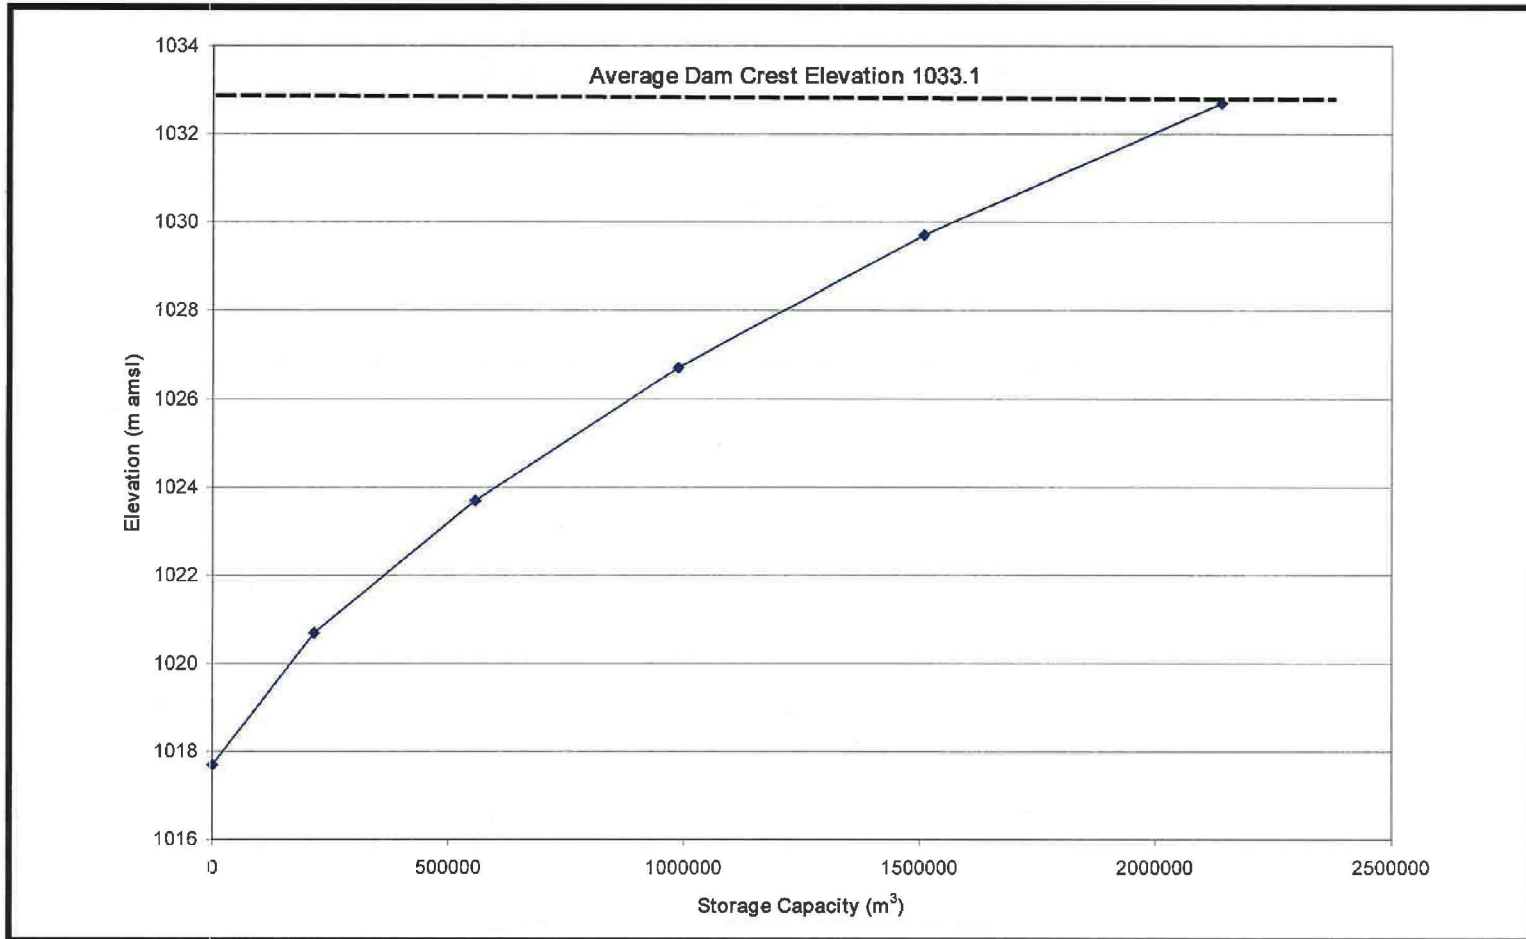
<small>AS A MUTUAL PROTECTION TO OUR CLIENT, THE PUBLIC AND OURSELVES, ALL REPORTS AND DRAWINGS ARE SUBMITTED FOR THE CONFIDENTIAL INFORMATION OF OUR CLIENT FOR A SPECIFIC PROJECT AND AUTHORIZATION FOR USE AND/OR PUBLICATION OF ANY STATEMENTS, ILLUSTRATIONS OR ABSTRACTS FROM OR REGARDING OUR REPORTS AND DRAWINGS IS RESERVED PENDING OUR WRITTEN APPROVAL.</small>		PROJECT FARO MINE COMPLEX OMS MANUAL FOR DAMS
		TITLE CROSS VALLEY DAM STORAGE CAPACITY CURVE
	PROJECT No. M09770A03 02 01	FIG. No. A-024
