**Attachment B**  
**Details of Example Alternatives**

**Attachment B1**  
**Example Alternatives for Faro Mine Area**

# 1 Example Alternatives for Faro Mine Area

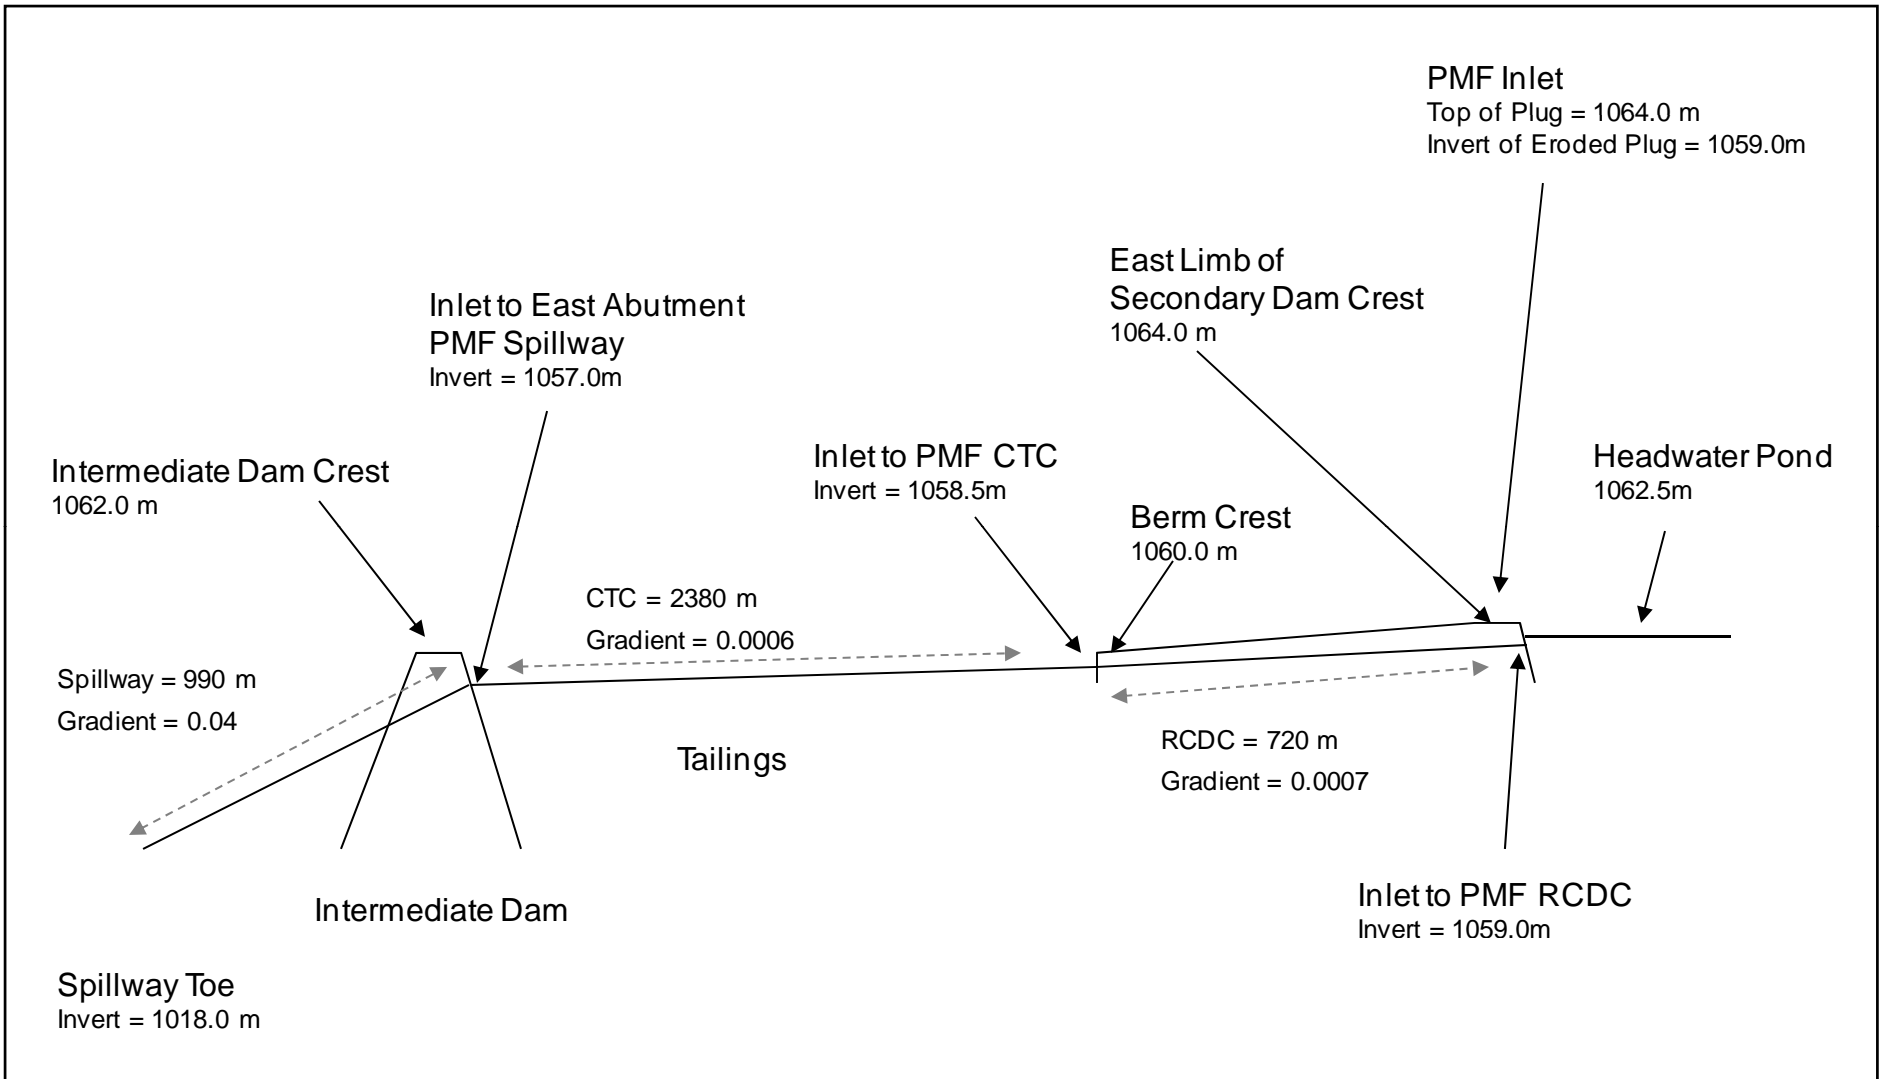
<p><b>Deloitte &amp; Touche</b></p>	PROJECT: 1CD001.065.100	DATE: April 2007	APPROVED:
			FIGURE: <b>2</b>

<p><b>SRK Consulting</b> Engineers and Scientists</p>	Anvil Range Mining Complex Yukon Territory		
	<p align="center"><b>Water Cover Alternative</b> <b>Flow Path Inverts and Gradients</b></p>
