**Report On The  
1992 Performance Monitoring  
On The  
DOWN VALLEY TAILINGS PROJECT  
FARO MINE  
VOLUME 1**

**RE: 1992 ANNUAL GEOTECHNICAL  
AND PERFORMANCE EVALUATION  
DOWN VALLEY TAILINGS PROJECT**

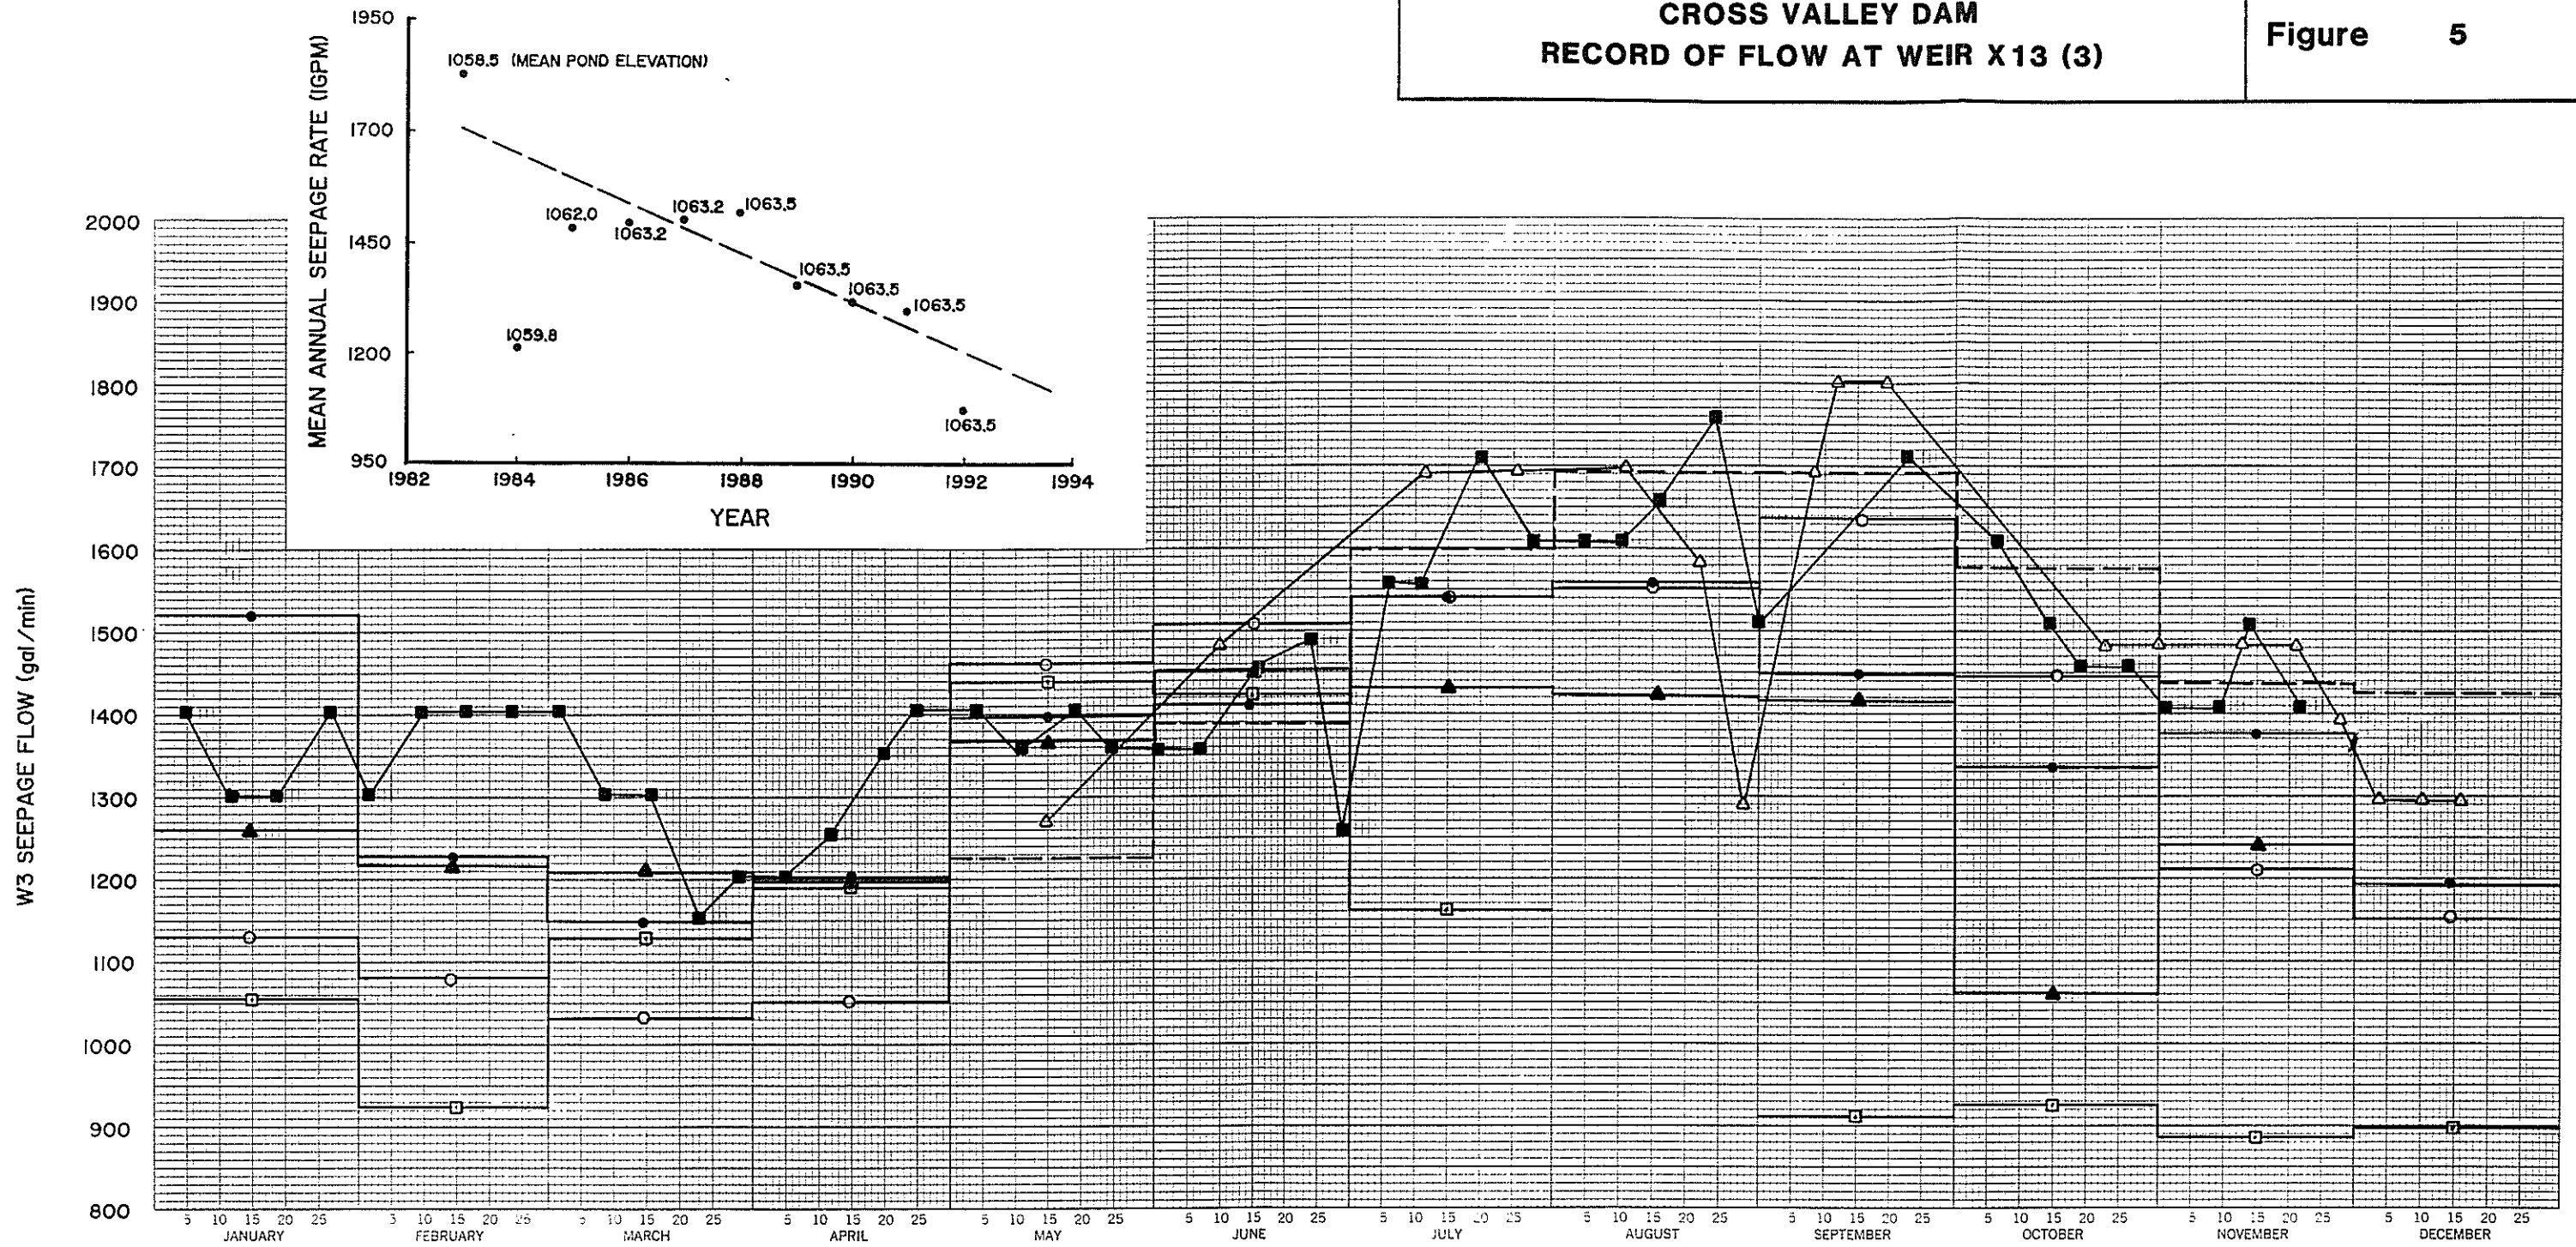
**Figure 5**

**CROSS VALLEY DAM  
RECORD OF FLOW AT WEIR X13 (3)**

During 1992 flows were measured at the north and south V-Notch weirs (X11 and X12, respectively) and the combined flow weir X13. The recorded monthly flows are presented on Table 5. Figure 5 presents the recorded seepage flows for Weir X13 and the old location of Weir 3 for the years 1986 to 1992, inclusive. Table 6 summarizes the minimum, maximum and average year flow at weir X13 (3) during the period 1983 to 1992. The summary graph presented in Figure 5 clearly demonstrates that there has been a steady decline in mean annual seepage rate. Table 5 indicates that the south abutment flow (x 12) is generally higher than the old Weir 6 flows taken in 1991, probably due to the collection of a larger tributary area of seepage.
