Stantec Consulting Ltd.

Date: July 24, 2023

**Reference: Desktop Geotechnical Overview – Ladue South, Town of Faro, Yukon.**

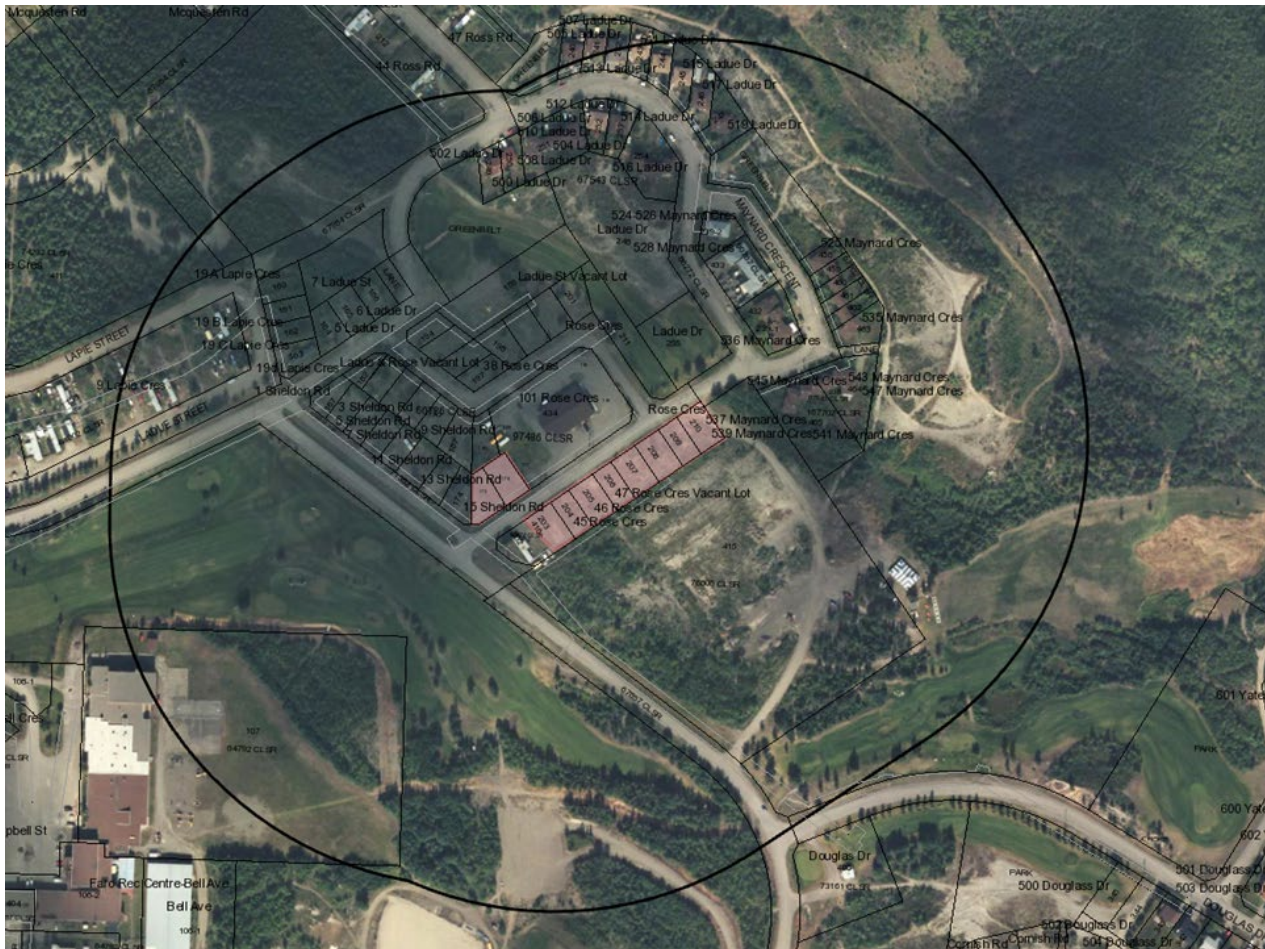
**Figure 1 - Overview of the Study Area within the Town of Faro, Yukon, facing due north. It is comprised of ten lots of mixed ownership (municipal vs. territorial government) on Ladue Drive and a 250 m buffer represented by the black polygon.**

For the purpose of this assessment, we have defined the Study Area as the Ladue South 'envelope' defined by the LDB (comprising the ten lots) and a 250 m buffer extending on all sides of the envelope. Although outlying hazards are considered beyond the buffer, we have focused data collection, including geotechnical borehole data review, on the Study Area. An overview of the Study Area is shown on Figure 1.

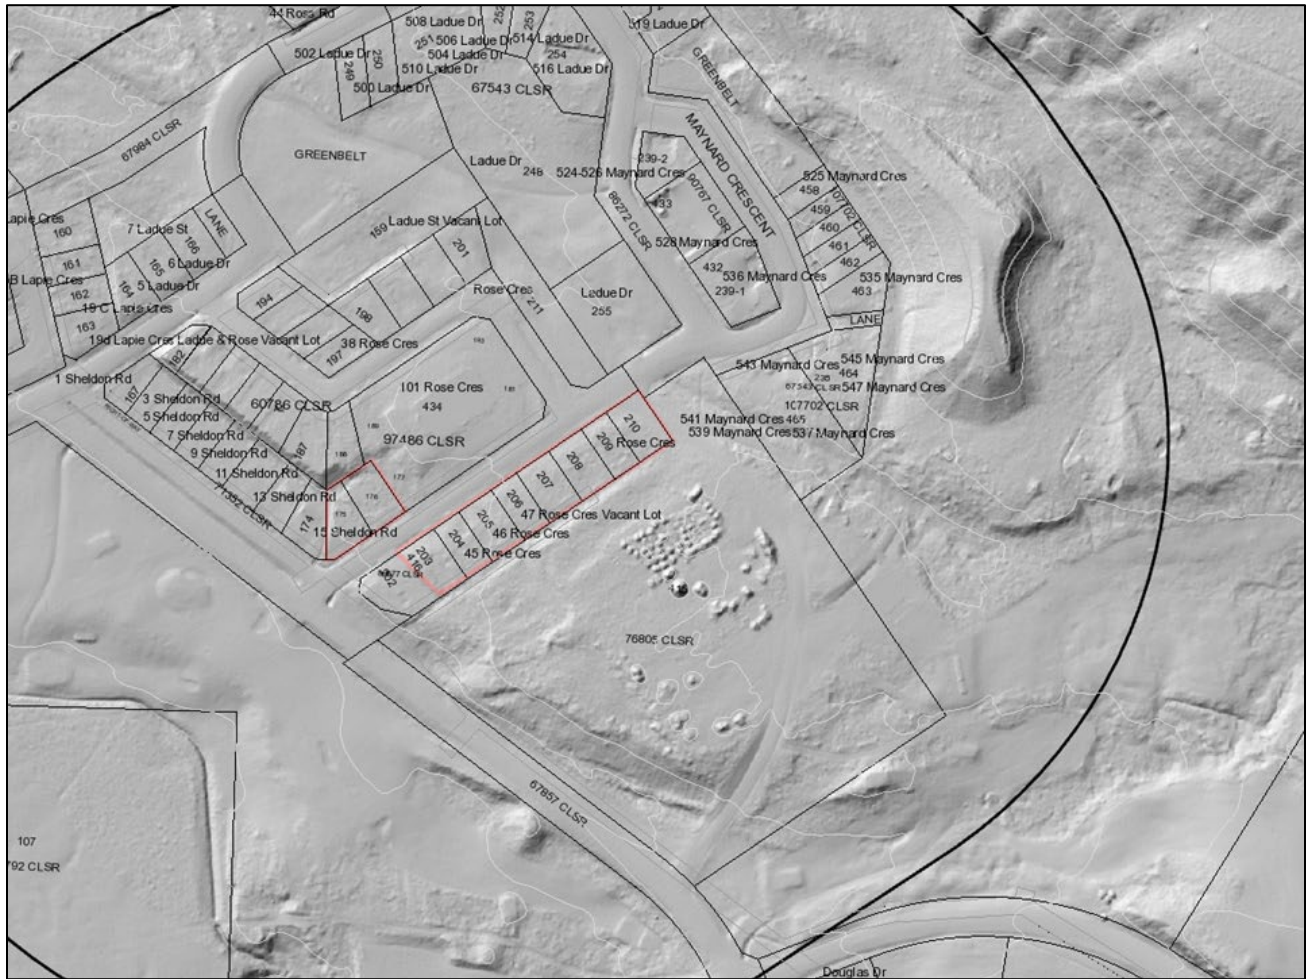
**Figure B.1 - Overview of the Study Area with hillshade and lot lines (from the Government of Yukon property parcels data) shown. Lot 203 is not officially surveyed as being separate from Lot 202 (the corner lot in the southwest corner) but is understood to have never been consolidated with Lot 202 and is not included in the feasibility study as per the Scope of Work.**

From the LiDAR data, the elevation profile through Lots 203 and 210 from southwest to northeast is approximately 727 to 732 m above sea level (asl); there is an overall slope downwards towards the southwest at Lot 203. Lots 175 and 176 on the north side of the street feature little elevation difference, at 726 m asl, but also slope southwesterly. These two lots are situated at slightly lower elevation than Lot 203 (~1.5 – 2 m). They feature short but steep scarps just outside the rear lot lines. A plain hillshade figure with the lot lines overlain is shown on Figure B.1 in Appendix B.

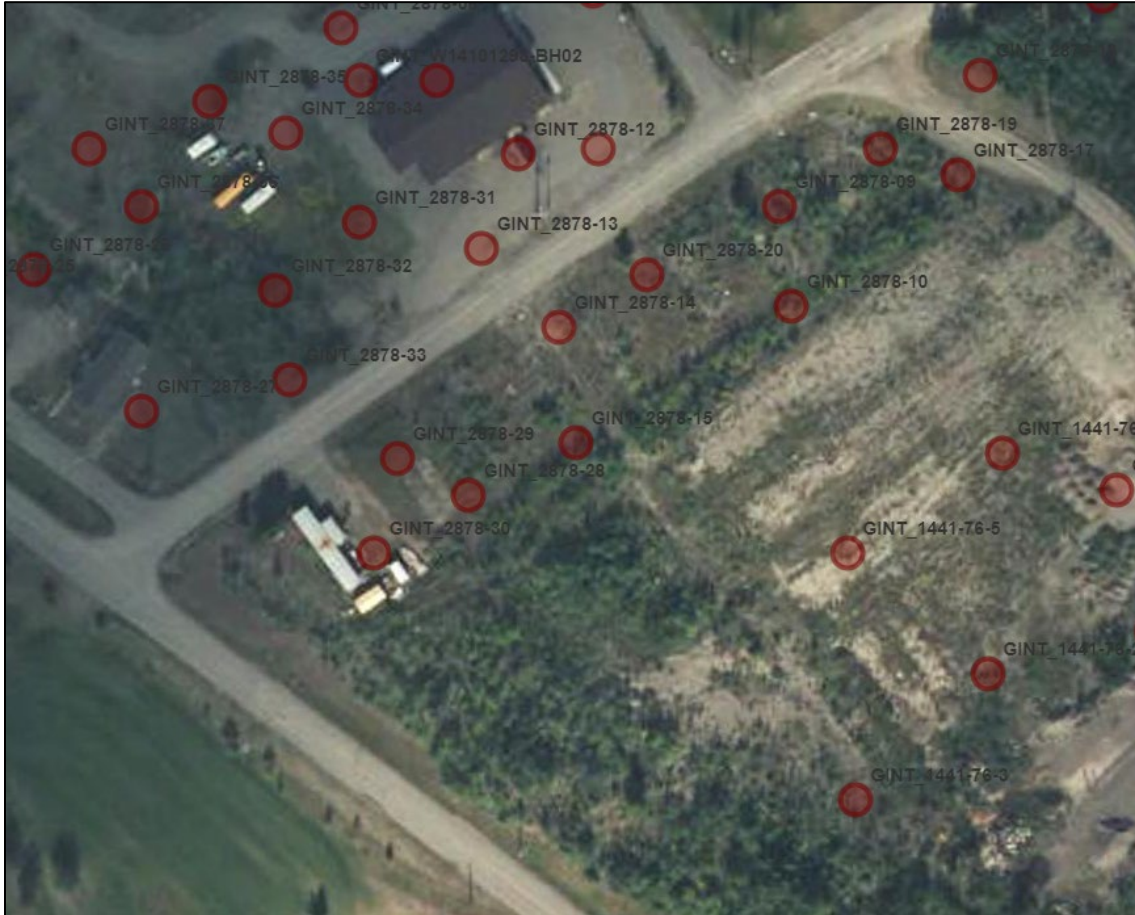
**Figure B.3 – Geotechnical boreholes with drill records within the Study Area along Ladue Drive. The labels are the drill record number. There are 12 records within the planned lots; 8 of these had permafrost information. From Yukon Geological Survey, 2023.**

The Yukon Permafrost Database has geotechnical borehole records for the Study Area (Yukon Geological Survey, 2023). Approximately 12 boreholes intersect what are now the ten lots that comprise Ladue South; these were drilled in 1980 for what was then the Cyprus Anvil Mining Corporation (‘Project Name: Proposed Basements for Mobile Home Park’). This project was presumably undertaken to develop housing for employees of the Faro Mine. In the southwest corner of the Study Area (towards Lot 203), drilling (GINT\_2878-30) recorded 4.6 m of gravel and sand (occasional cobbles and boulders) overlying silt (some sand and gravel, trace pebbles) to 12.2 m. The silt unit is identified as glacial till, which disagrees with the 2014 Yukon Geological Survey surficial materials mapping of glaciolacustrine.

The 1980 geotechnical borehole records available via the Yukon Permafrost Database for the Study Area show that bedrock is encountered at depths between 6 m and 12 m bgs. The shallowest bedrock was encountered in the northeast near Lot 210, at 6.4 m (GINT\_2878-19).

Frozen soils are present in 8 of the 12 geotechnical borehole records (drilled 1980) available via the Yukon Permafrost Database (note that no permafrost records are available for the remaining 4 drill records within the Study Area – it is unknown if this is because no permafrost was present, no permafrost was assessed in the samples, or the records are incomplete or missing).

The depths to frozen soil range from 2.1 to 7 m bgs and occur in both the glaciofluvial and glaciolacustrine deposits. Ice with interstitial soil (silt) and ice without soil inclusions was observed in four of the borehole records, all on the south side of Ladue Drive (GINT\_2878-14, -15, -19, and 20). Ice lenses were recorded up to 75 mm thick. Depths to ice range from 6.1 m to 9 m bgs, with visible ice (Vs) also present in two of the boreholes on this side of Ladue Drive. Ice is described when it meets the definition of being greater than 25 mm thick and without soil inclusions (Tart, 1996). On the northwest side of Ladue Drive around Lots 175 and 176, soils were found to be frozen at depths between 3.3 and 6.2 m bgs, with well-bonded to poorly-bonded soils with no visible ice to over 9 m bgs (GINT\_2878-27, and -33).
