MAYO AIRPORT
 TERMINAL
 BUILDING
 BLDG. #5653

SMALL PUBLIC WATER SYSTEMS ASSESSMENT
 NORTHERN REGION

GOVERNMENT OF YUKON
 HIGHWAYS & PUBLIC WORKS

MAYO TERMINAL BUILDING
 BUILDING # 5653
 SITE LOCATION DIAGRAM

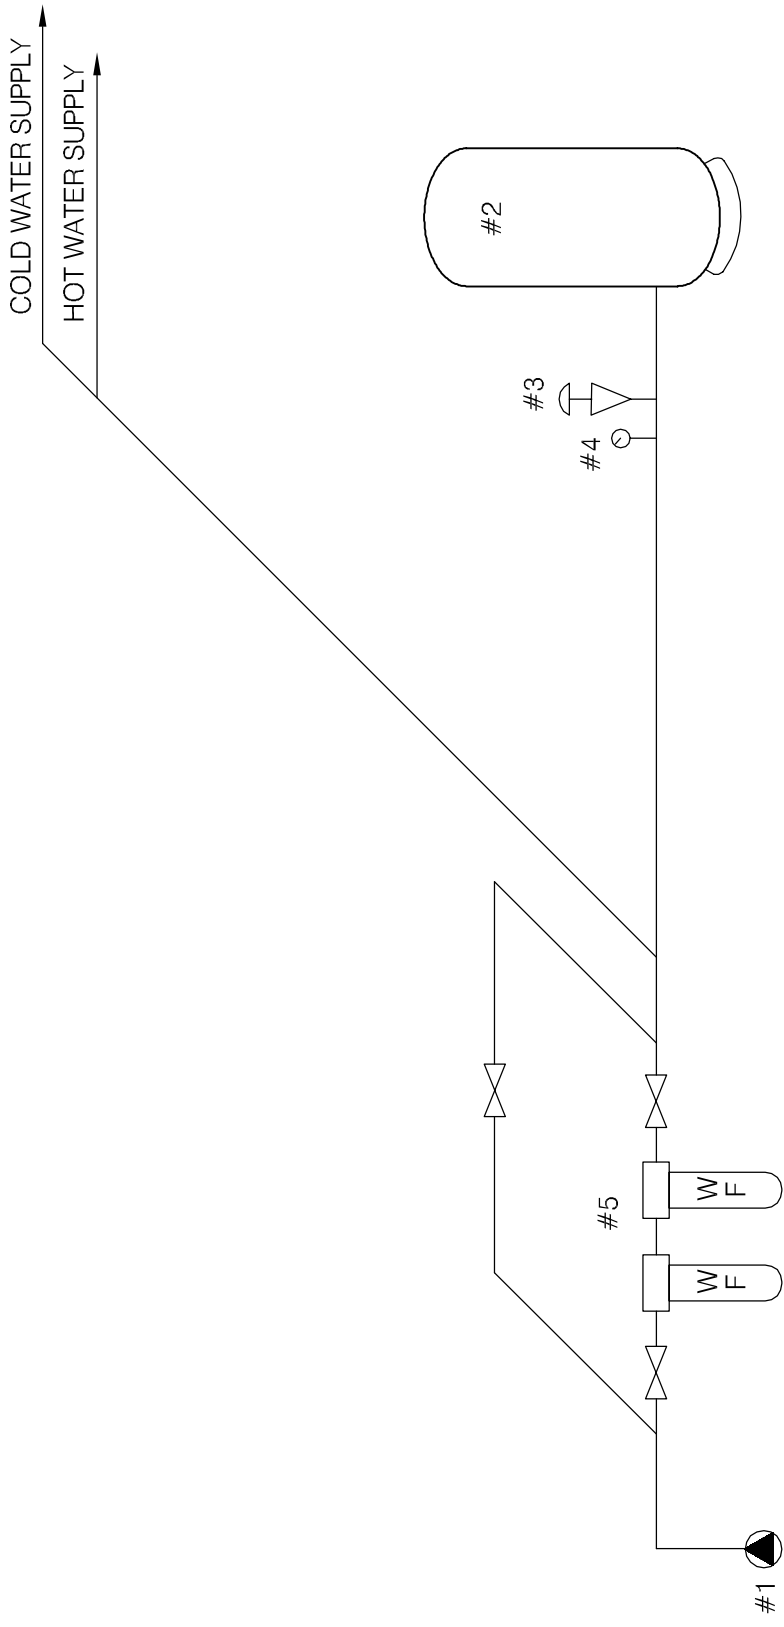
REVISION ISSUE
 0
 FIGURE No.
 WELL ID: 5653-A

DRAWING IS BASED UPON SCHEMATIC PROVIDED BY BERT ALBISSER OF AQUA TECH SUPPLIES AND SERVICES LTD.
