WOLVERINE MINE
RECLAMATION AND CLOSURE PLAN
2016-07 – REVISED V.2

Yukon Zinc Corporation

Shuksan Environmental Services Ltd.

September 29, 2017

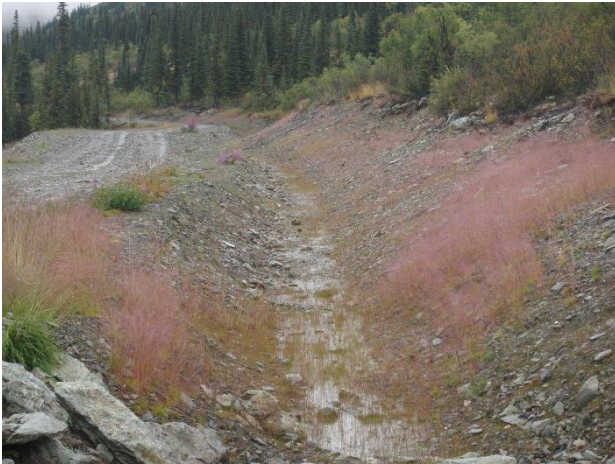
Photo 2-1: Looking North at Established Vegetation in Coarser Material Along Ditch B (August 2011)

Photo 2-1, taken in August 2011, shows vegetation establishment in Ditch B.

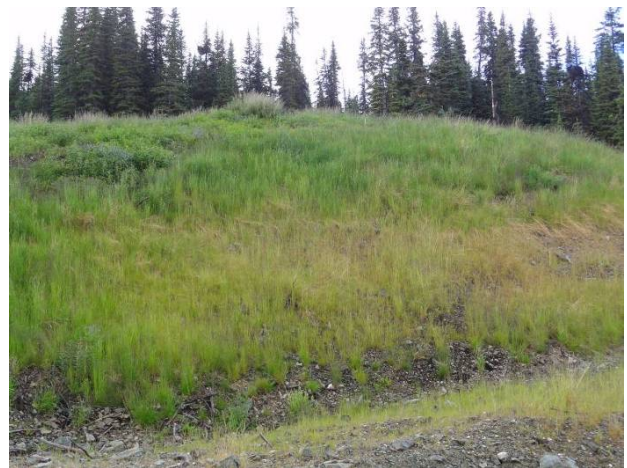
Photo 2-2: Revegetation Along the Site Access Road Corridor Near km 16 (July 2012)

Photo 2-2, taken in July 2012, demonstrate the success of re-vegetation efforts along the access road corridor, two years after seeding. Photo 2-2, taken in July 2012, shows grass cover establishment on the TSF dam face. Photo 2-4, taken in July 2013, show re-vegetation success around the TSF from seeding completed in 2012. Photo 2-5 to Photo 2-8, taken in September 2014, demonstrate the success of progressive reclamation and re-vegetation efforts around site. Given the success of this re-vegetation strategy, the same seed mix will be used during final closure.

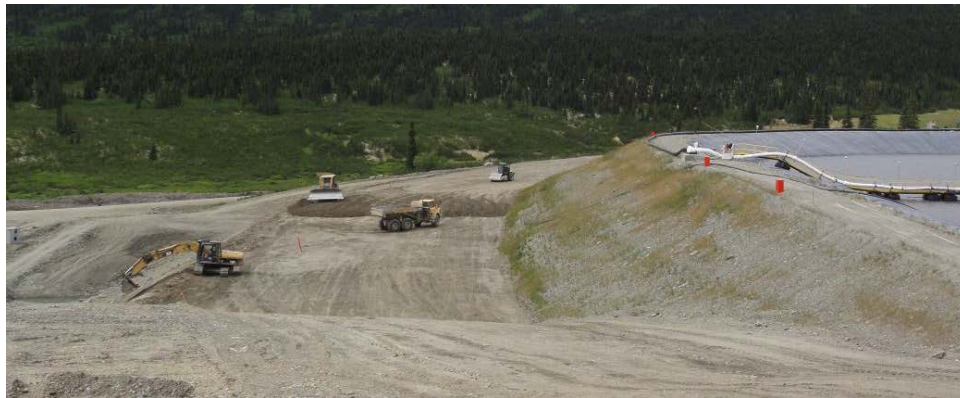
Photo 2-3: Construction of the Ultimate TSF dam; Note Seeding on the Starter Dam Face has Resulted in ~50% Grass Cover Between the Crest and Construction Zone (July 2012)

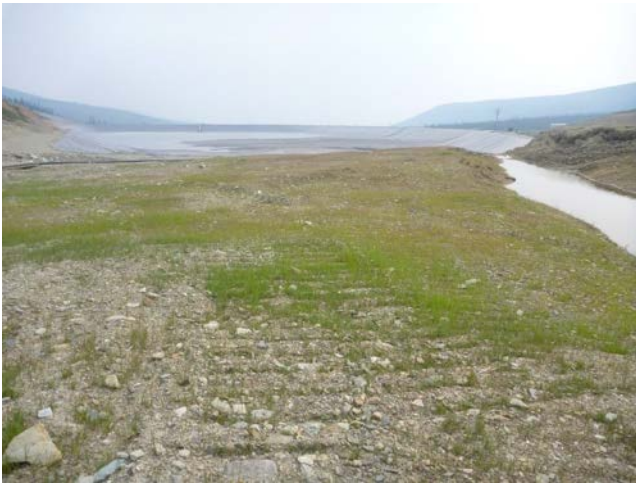
Photo 2-4: Looking South at Established Vegetation on Disturbed Ground Around the TSF Following Fall 2012 Seeding (July 2013)

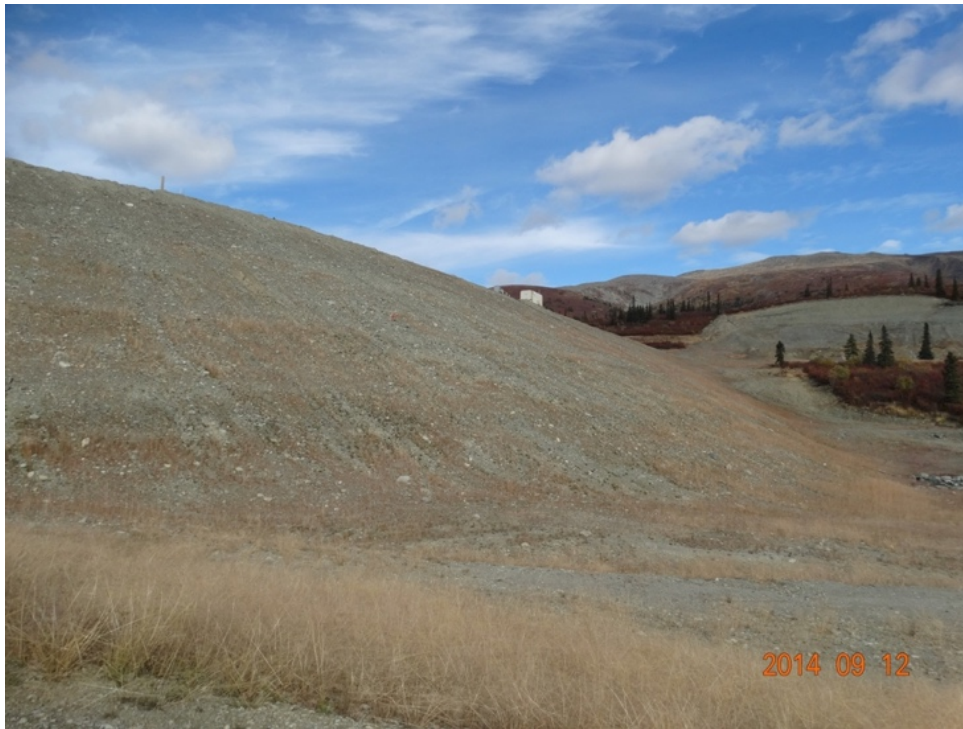
Photo 2-8: Revegetation Along the Downstream Face of the TSF Dam (September 2014)

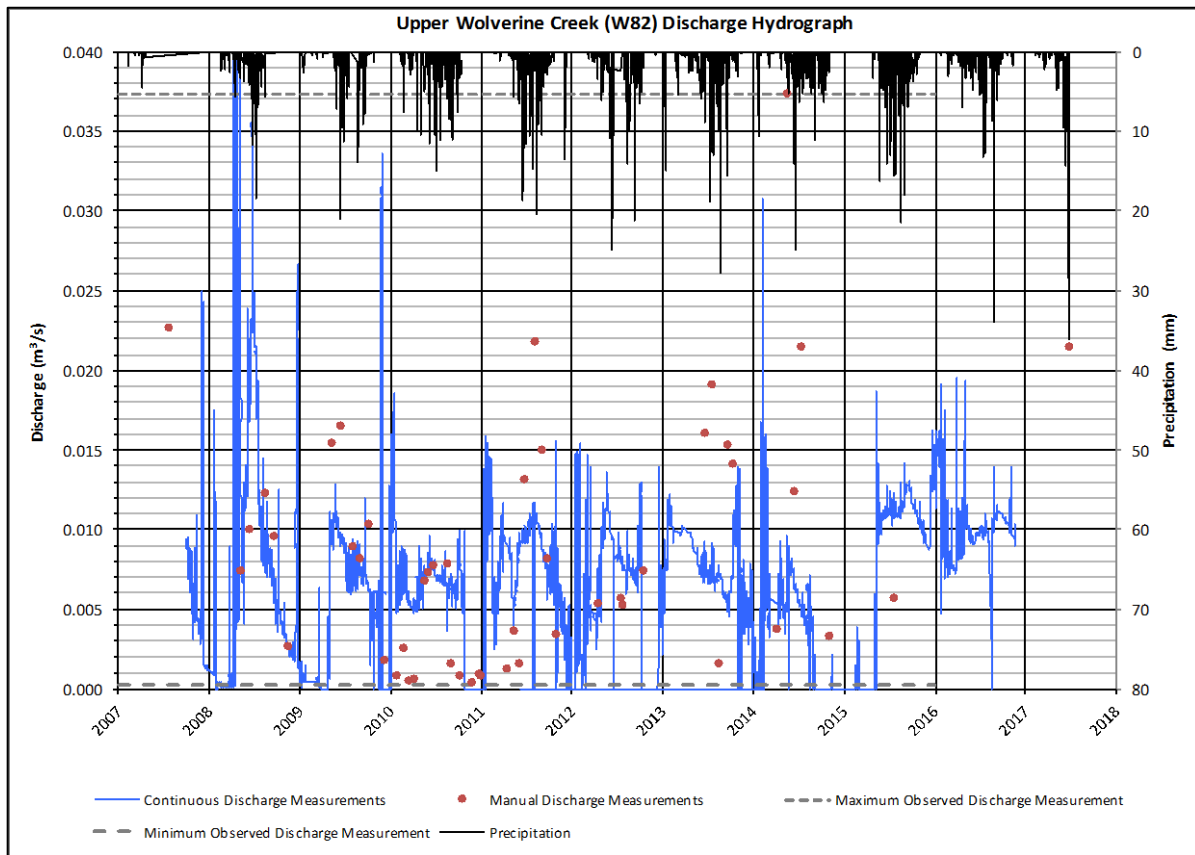
Figure 3-3: W82 Discharge Hydrograph

Stations W9 and W82, respectively, have been established on Wolverine Creek at the mouth and in the upper reaches immediately adjacent to the underground operations, respectively. These stations monitor the influence of underground dewatering on flow conditions in Wolverine Creek. Upper Wolverine Creek (station W82) is a narrow creek that freezes to ground in the winter. Flows at this station average $0.005 \text{ m}^3/\text{s}$, as shown in Figure 3-3. As Wolverine Creek descends towards Little Wolverine Lake, volumetric flows increase, with average flows just above the confluence of $0.01 \text{ m}^3/\text{s}$, on average, shown in Figure 3-5. Typically, the flows in Wolverine Creek are highest during spring freshet, level off during the late summer, and peak again in late fall during rain on snow events.

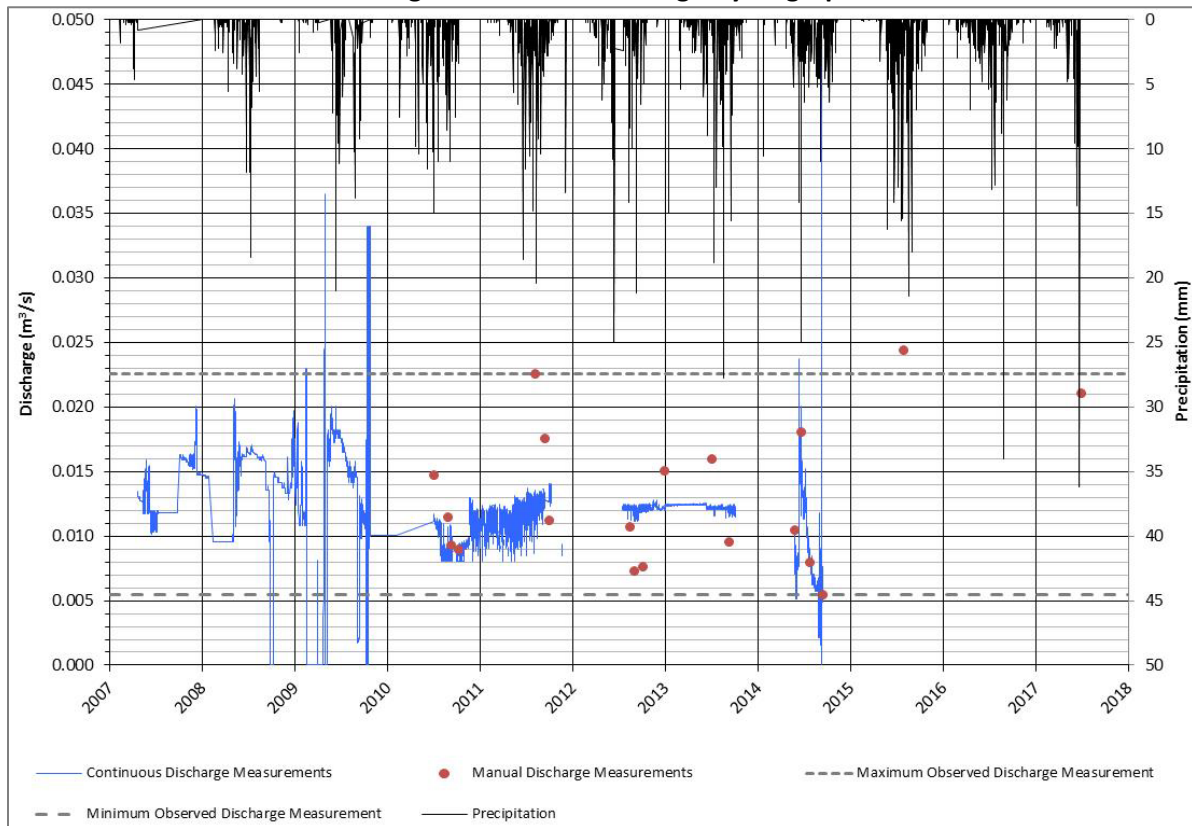
Figure 3-4: W9 Discharge Hydrograph

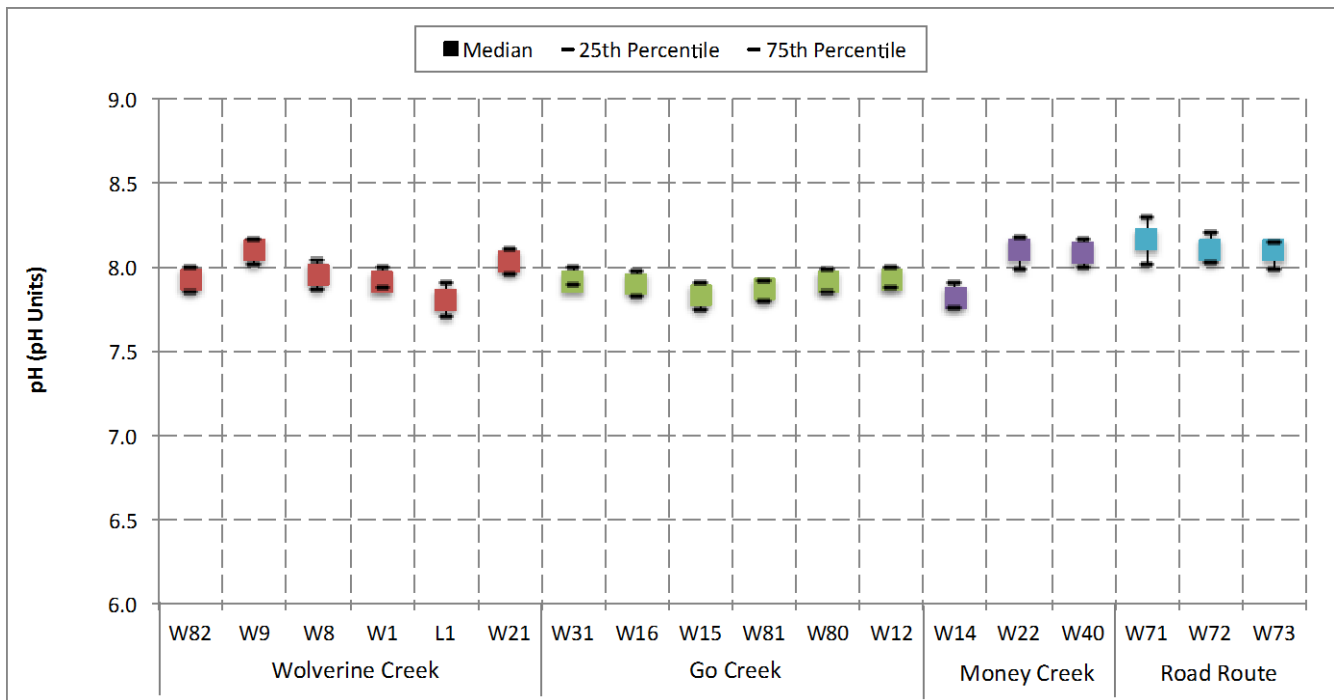
Figure 3-7: Surface Water Chemistry – pH (2009-2016 data)

Surface water quality in the area proximate to the Wolverine Mine is relatively pristine, with high metal concentrations directly adjacent to the ore body in Wolverine Creek. Water chemistry statistics for samples taken 2009-2016 inclusively are shown in Figure 3-7 through Figure 3-17, with water quality sites listed in order moving downstream from the mine. Values that were reported as being less than the reportable detection limit were taken to be half the detection limit when calculating the median, 25th and 75th percentile values. Parameter concentrations are compared to the Canadian Water Quality Guidelines for the Protection of Aquatic Life (CCME), or the ambient water quality guideline from the Ministry of Environment of British Columbia for sulphate, where applicable. Median hardness was used to calculate hardness dependent guideline concentrations (i.e., cadmium and sulphate).

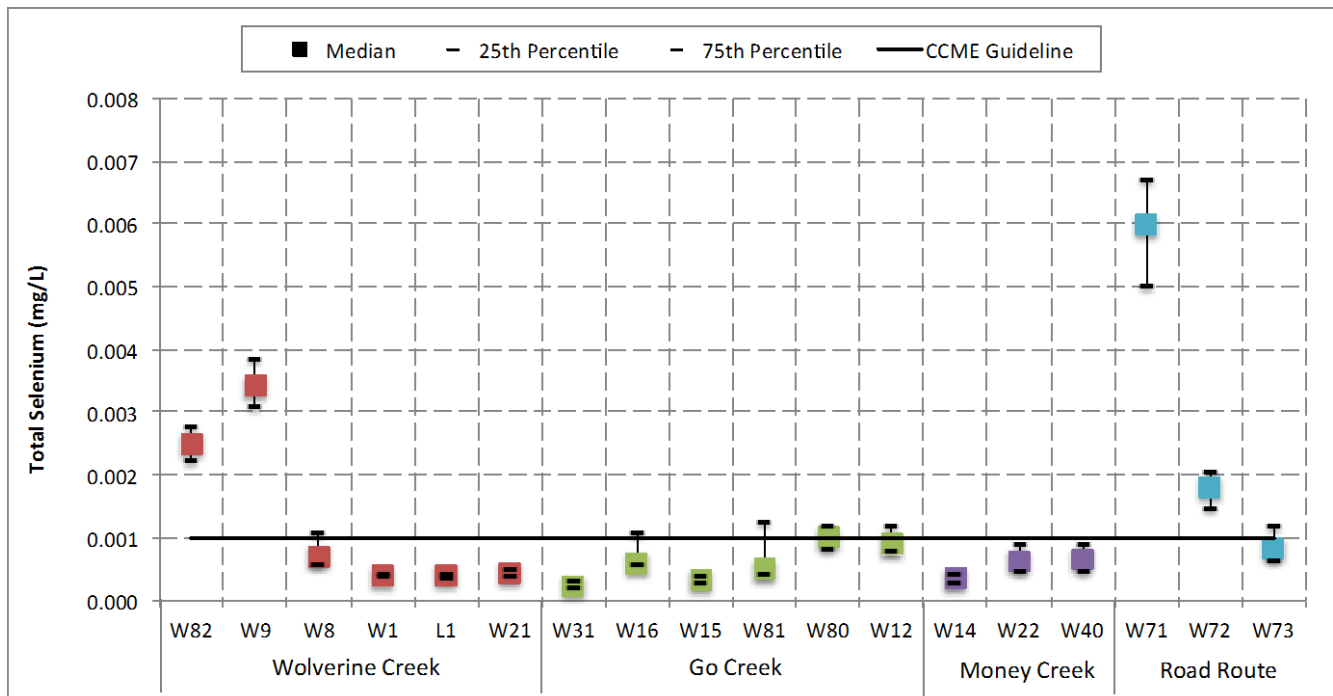
Figure 3-16: Surface Water Chemistry – Total Selenium (2009-2016 data)

Wolverine Creek naturally receives drainage from the mineralized area of the Wolverine deposit. As such, concentrations of cadmium, copper, selenium, and zinc in Upper Wolverine Creek (W82) are typically above the CCME guidelines and generally decrease with downstream distance (i.e., W82 is in upper Wolverine Creek and W9 is in lower Wolverine Creek). Metal concentrations above CCME guidelines were also evident at stations along the road route, which is likely tied to the high TSS values experienced in the spring (Figure 3-10). Metal concentrations in the Go Creek and Money Creek watersheds are statistically comparable and show very little fluctuations. These values and trends are consistent with baseline values (Lorax, 2010).

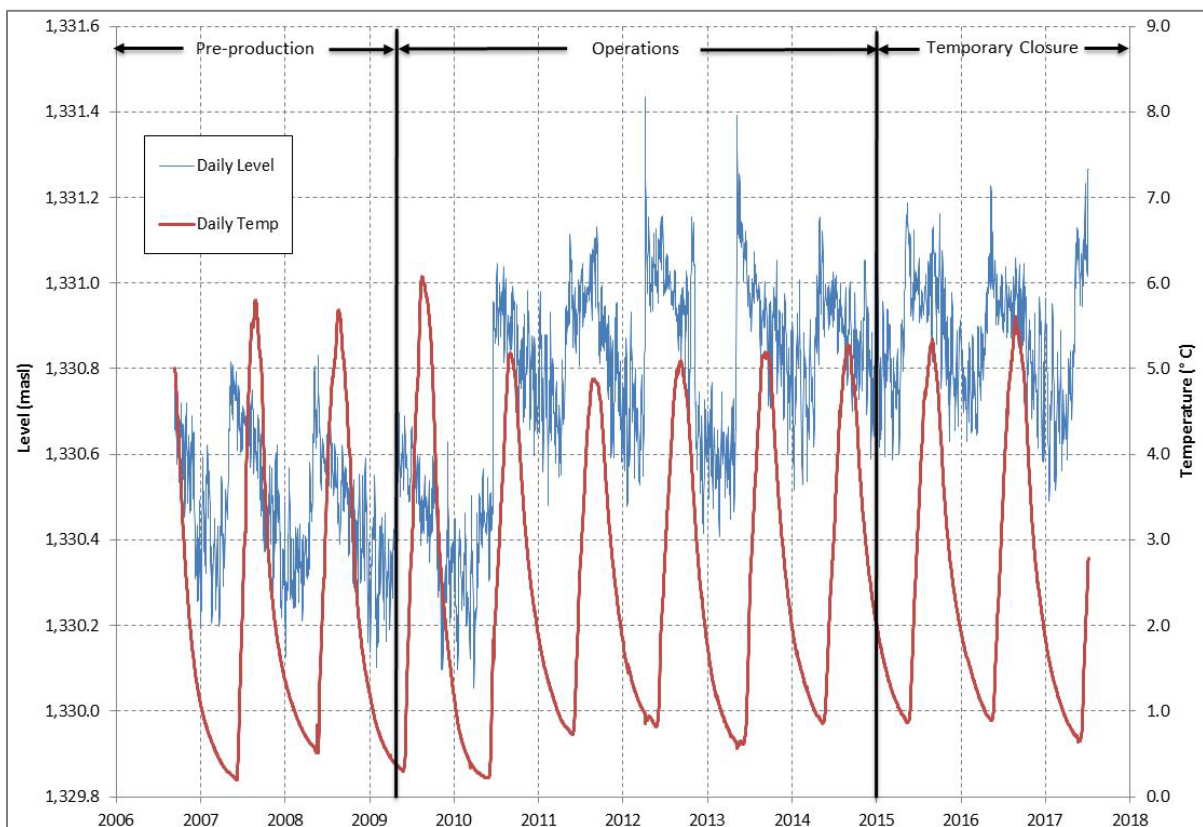
Figure 3-19: Groundwater Well MW05-5 Water Level and Temperature

In the vicinity of TSF area, the groundwater table is generally sloping southwest following the trend of the topography. Near the downstream end of the impoundment basin at MW05-7 (Figure 3-21), the piezometric pressure in the bedrock is slightly artesian (few meters above ground) and the water table rises, with the topography, towards the dam abutments. In general, the groundwater table in the overburden is slightly lower than that in the bedrock. Water levels in groundwater wells downstream of the mine (MW05-5 and MW06-11 - Figure 3-19 and Figure 3-20) have been relatively consistent, although water levels in MW06-11 dropped in mid-2011, and values have been relatively constant since. The increase in water level in mid 2007 and mid 2010 in MW05-5A and MW05-5B, respectively, are due to re-installation of the loggers, and not representative of actual water level shifts. The groundwater table exhibits seasonal variation, reaching highest elevation after spring runoff season (Figure 3-19 and Figure 3-20).

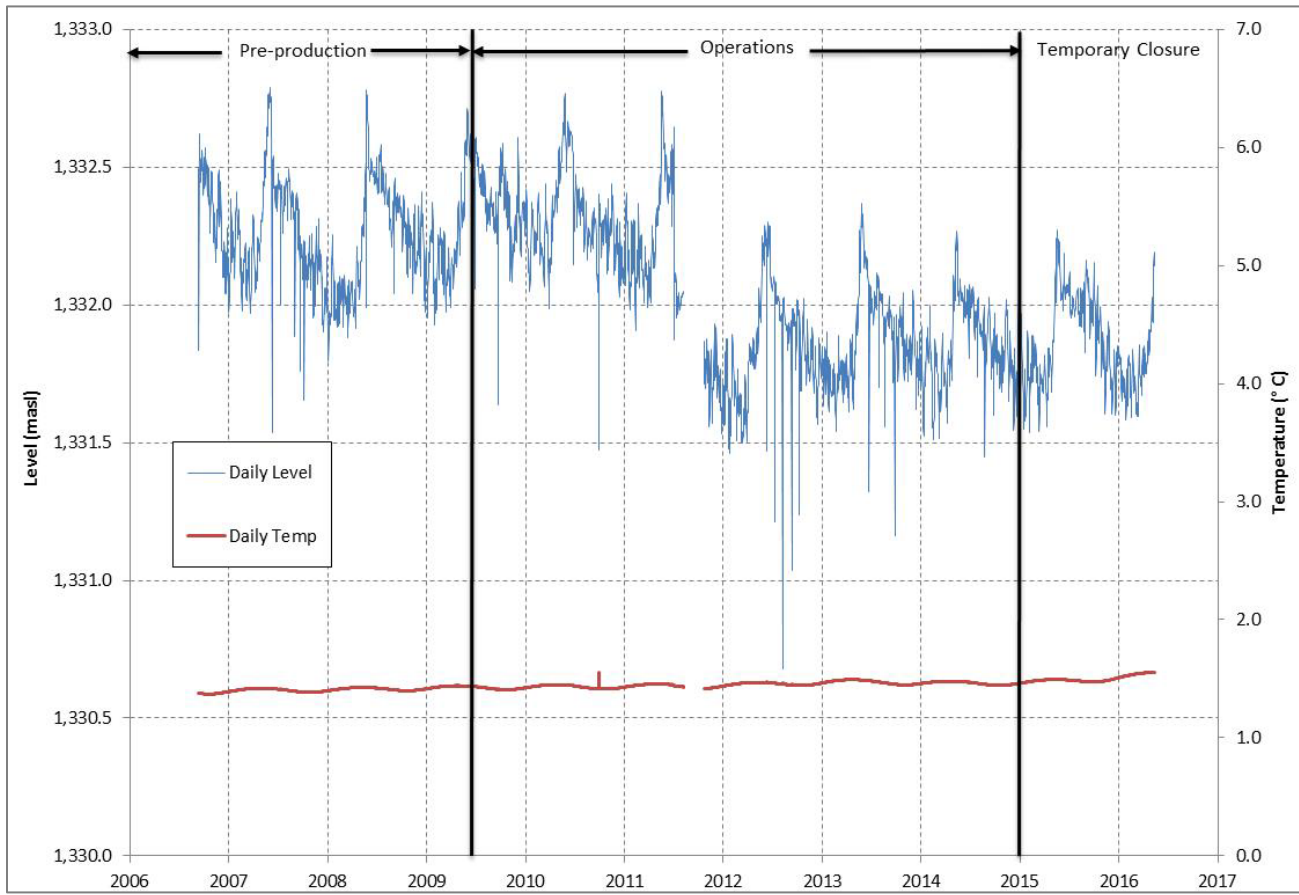
Figure 3-20: Groundwater Well MW06-11S Water Level and Temperature

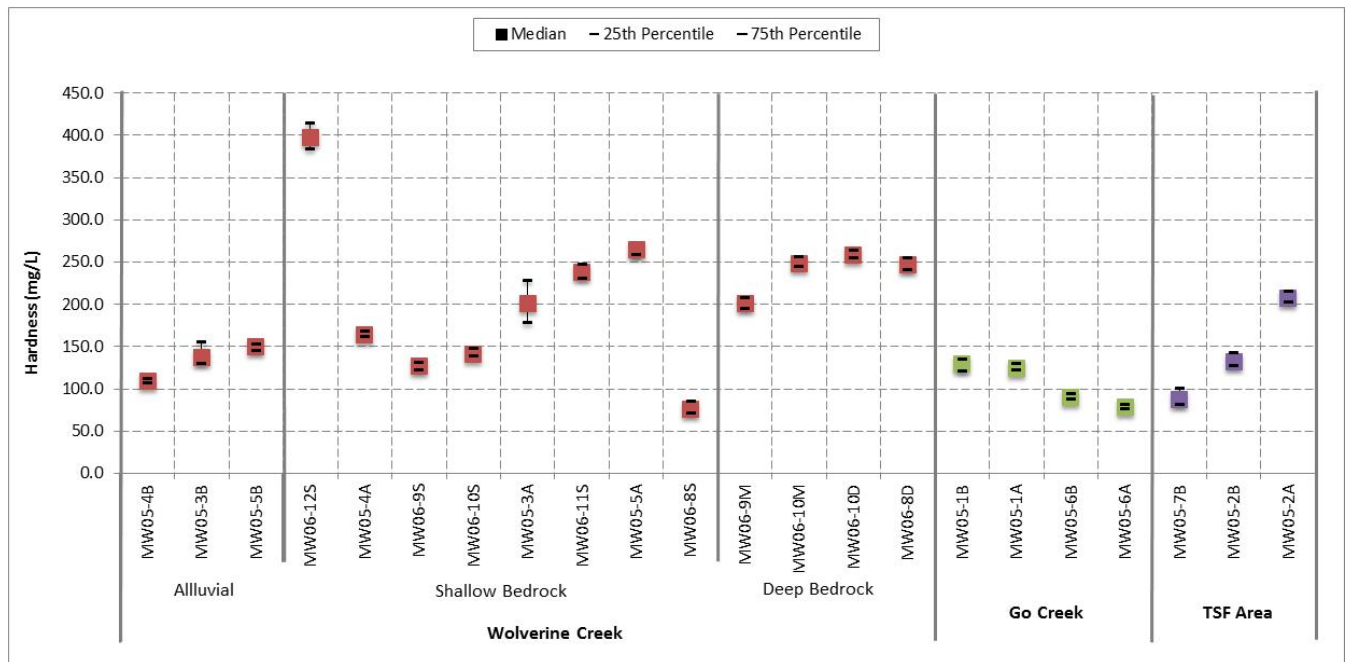
Figure 3-28: Groundwater Chemistry – Hardness (2009-2017)

Water chemistry statistics for samples taken 2009-2017 inclusively are shown in Figure 3-27 through Figure 3-36, with water quality sites listed in order moving downstream from the mine. Values that were reported as being less than the reportable detection limit were taken to be half the detection limit when calculating the median, 25th and 75th percentile values.

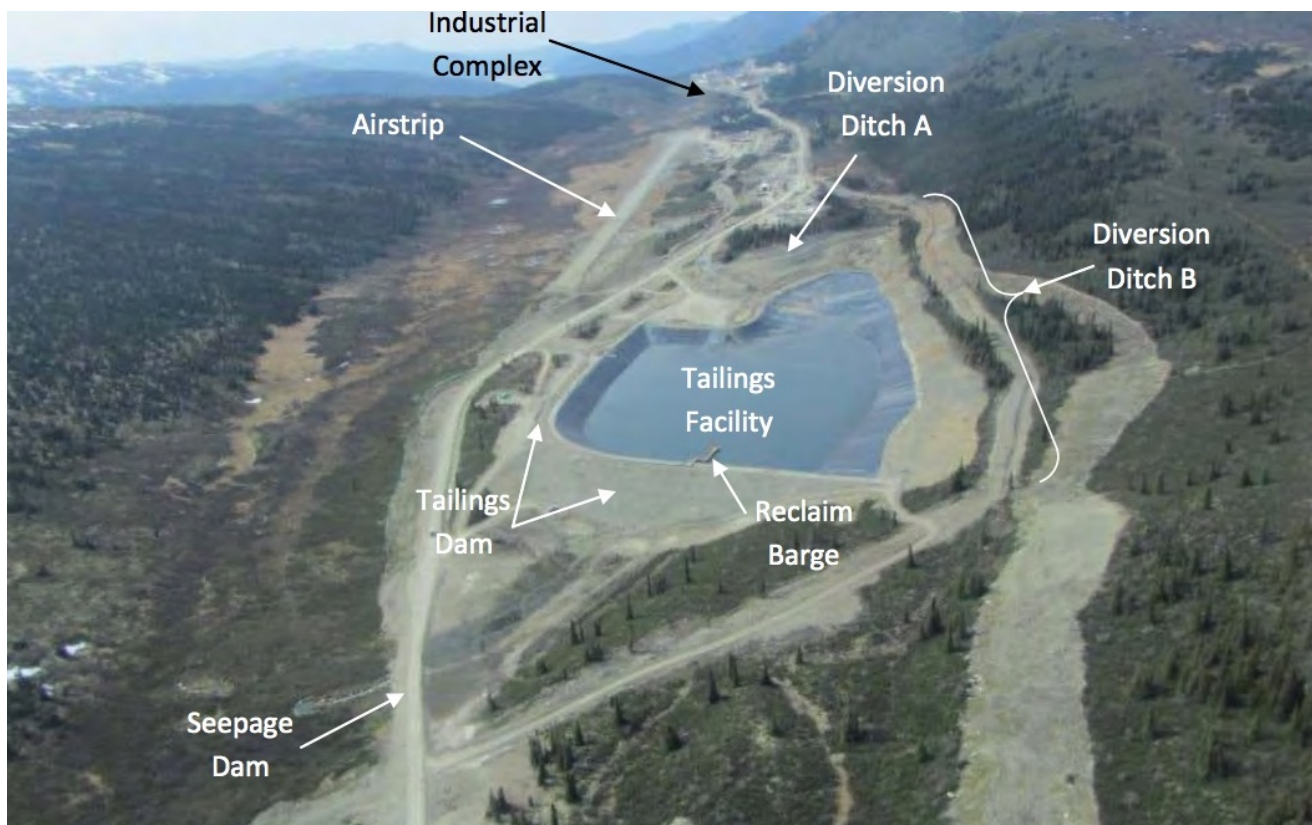
Figure 4-1: Tailings Storage Facility Layout

The location of the Wolverine Mine in Yukon is shown in Figure 1-1. Aerial views of the TSF area and industrial complex are shown in Figure 4-1 and Figure 4-2, respectively; while the general mine site layout of is illustrated in Figure 4-3. Figure 4-4 and Figure 4-5 provide the layouts for the industrial complex and TSF areas, respectively. Mine infrastructure remains in place during temporary closure and is described further below. Temporary closure conditions are described further in Section 5. The surface facilities and infrastructure at the Wolverine Mine include the following:

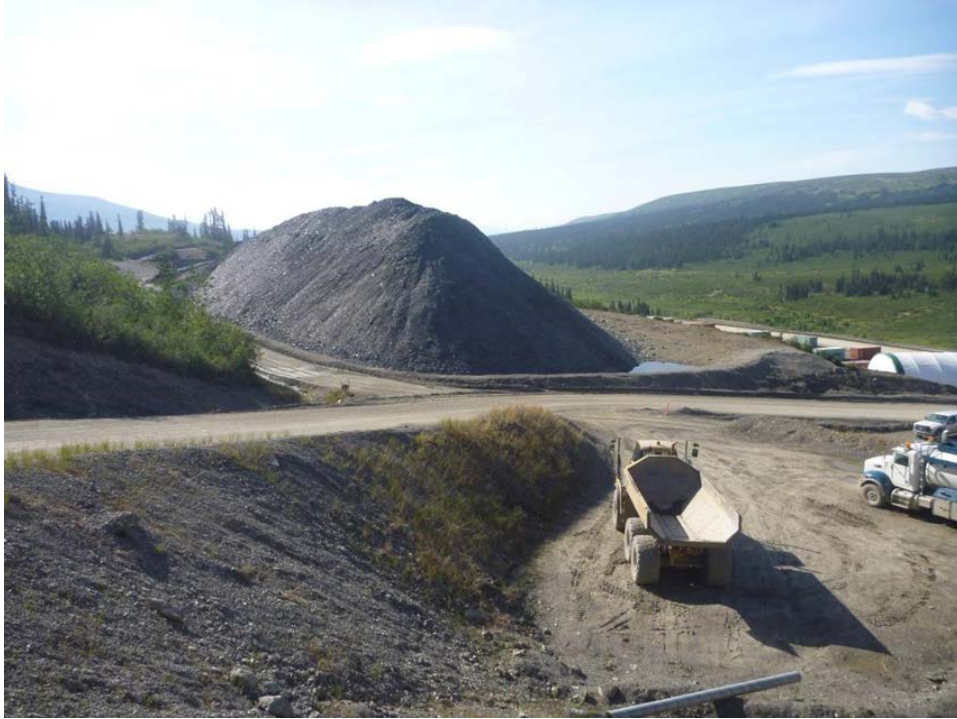
Photo 5-1: Waste Rock Pad #1, East of the Camp (July 2013)

Currently there are two waste rock pads at the Wolverine Mine site. Waste Rock Pad #1 (Photo 5-1) is located south of the camp and Waste Rock Pad #2 (Photo 5-2) is located north of the TSF. All temporary ore and waste stockpiles were moved to Waste Rock Pad #2 in July and August 2015. Waste Pad #2 was surveyed in August 2016, and the volume of waste and ore on the pad is 10,439 m³ and 29, 890 m³, respectively. Waste Pad #1 has not had material placed on it since 2012, and the volume at that time was 91,000 m³.

Waste Rock Pad #1 has a lined sump at the toe that is monitored for liner integrity. Crews check that there are no holes in the liner and that no material around the sump is slumping. Runoff from Waste Rock Pad #2 is currently routed through a bioreactor before entering the TSF, with the option to bypass the bioreactor and discharge directly to the TSF. Bioreactor maintenance is minimal; crews add material to the bioreactor

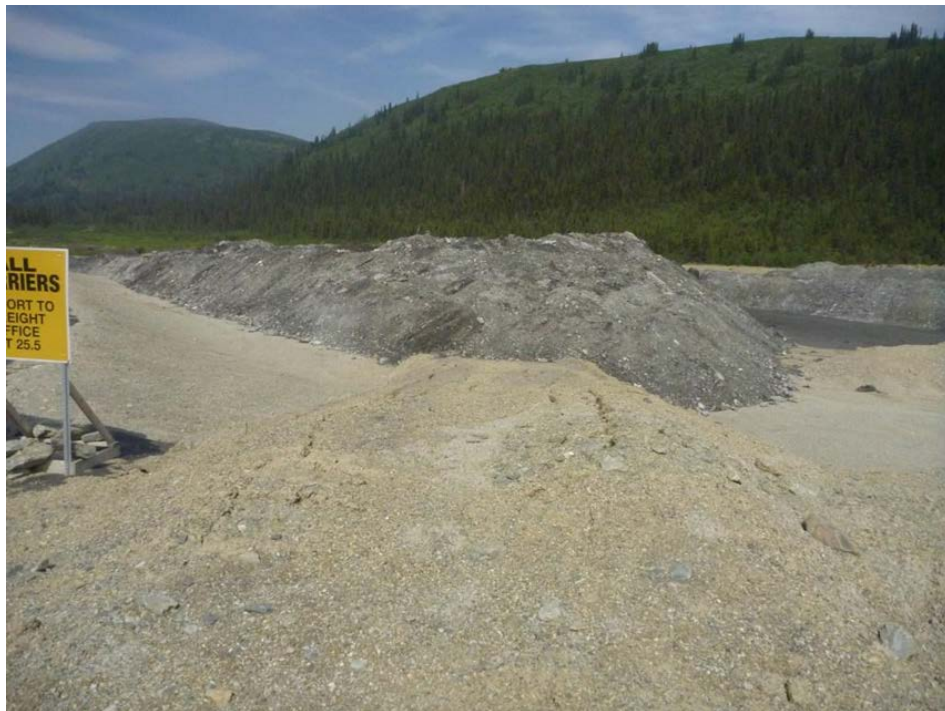
Photo 5-2: Waste Rock Pad #2, North of the TSF (July 2013)

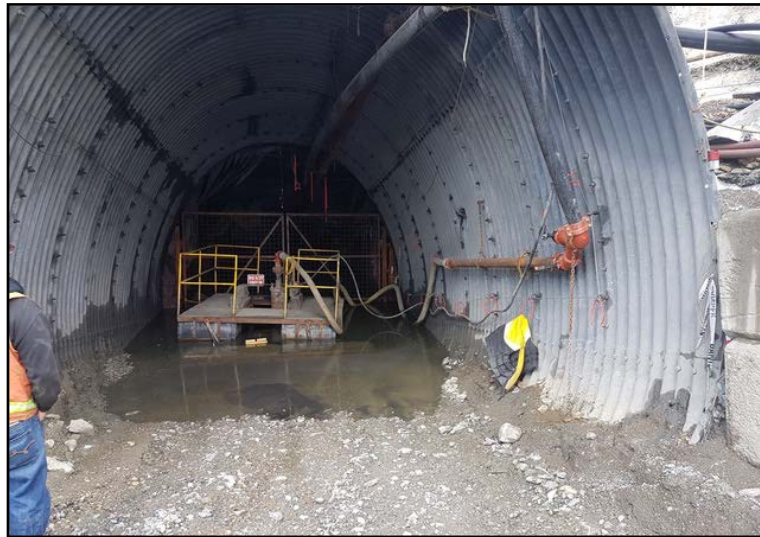
Photo 5-3: Wolverine Mine Adit Groundwater Pump System (July 13, 2017)

A pump and piping system has been installed at the adit of the underground mine (Photo 5-3) to pump excess groundwater recharge from the adit to the TSF. This system is installed above the gated entrance to the mine in the mine collar, as access below the collar is prohibited. The pump is run for a few hours per day as needed to maintain a consistent water level that prevents discharge to the mill pad. Water is pumped from the adit to the pumpbox in the mill, where it is then pumped to the TSF. Water quality has been monitored in the water pumped to the TSF since June, as summarized in Table 5-7, and compared to water quality measured during the 2006 – 2009 dewatering period.

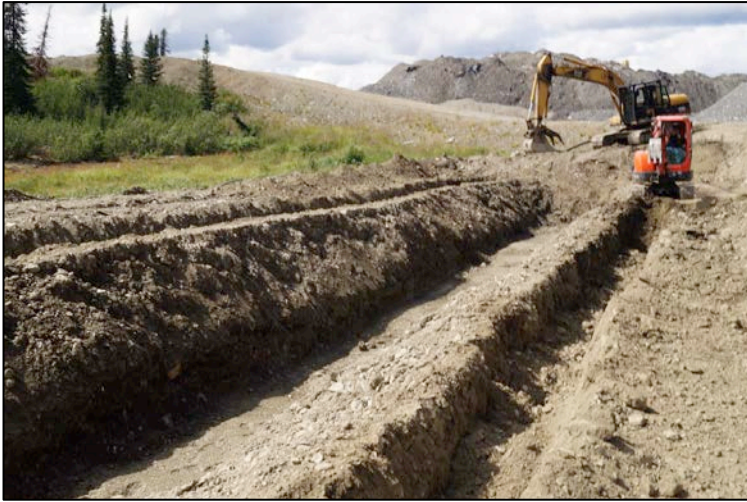
Photo 5-4: Bioreactor Trench (July 11, 2016)

Construction of the field scale bioreactor began in late May 2016. Construction activities consisted of cut and fill activities to create a stable 2% grade that the bioreactor could be excavated within. Once level, a trench for the bioreactor was dug (Photo 5-4), lined with geotextile fabric (Photo 5-5) and impermeable liner. The substrate material for the bioreactor was a mixture of locally sourced gravel, wood chips, and peat material excavated from the upper Go Creek area (Photo 5-6). It was mixed on surface with a back-hoe, then placed in the lined bioreactor trench (Photo 5-7). Influent to the bioreactor was from the original pipeline from Waste Pad #2, into a plastic tote, then distributed into the bioreactor at the upper end through a gravel pad (Photo 5-8). The final system also included two slotted pipe structures to enable sampling at two points within the bioreactor.

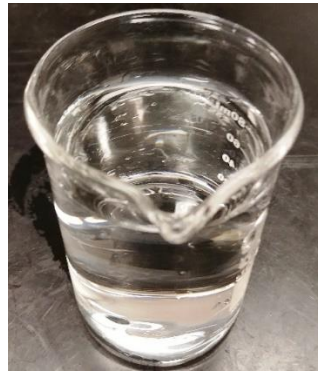
The water treated using ferric iron addition followed by sulphidation was used to test the removal of selenium and cyanide in the next unit process, Selen-IX™. Figure 6-2 shows an image of the water treated using ferric addition followed by sulphidization. As apparent from the image, the water was clear with no suspended solids indicating that all suspended solids were removed as part of the metals removal stage and will not be an issue for the downstream processes.

Figure 6-2 Effluent water from the metals removal stage. Solution is clear with no suspended solids.

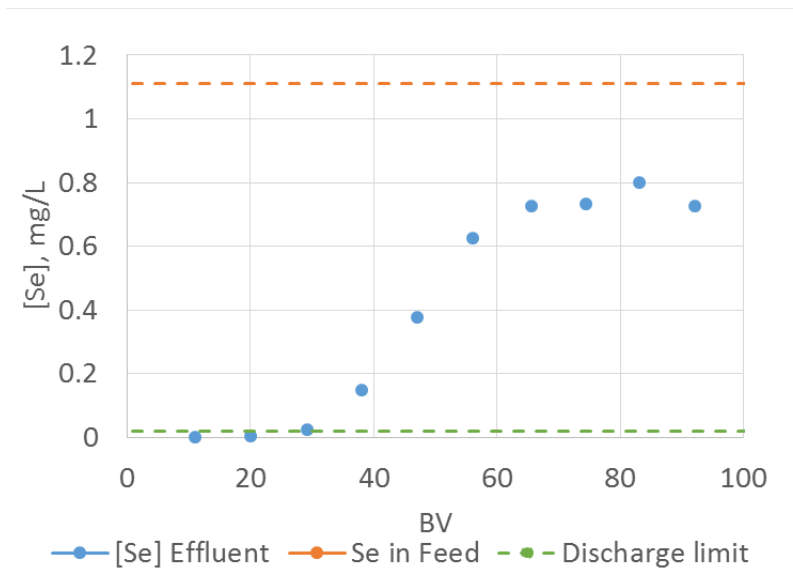
Water that had been treated by sulphidization with ferric addition for metals removal was subsequently fed into a packed bed IX column. Figure 6-3 shows the selenium concentration in the column effluent, i.e. the breakthrough curve. The horizontal axis of Figure 6-3 shows the number of Bed Volumes (BV) calculated by dividing the volume of water treated through the column by the volume of resin contained in the column. The units of BV are commonly used in IX testing to allow comparing results from columns of different sizes.

As can be seen from Figure 6-3, initially all selenium was removed from the feed before breakthrough which occurred at approximately the 35 to 40 BV mark followed by a plateau starting at 60 BV.

Figure 6-3 Selenium removal by IX in a packed bed column

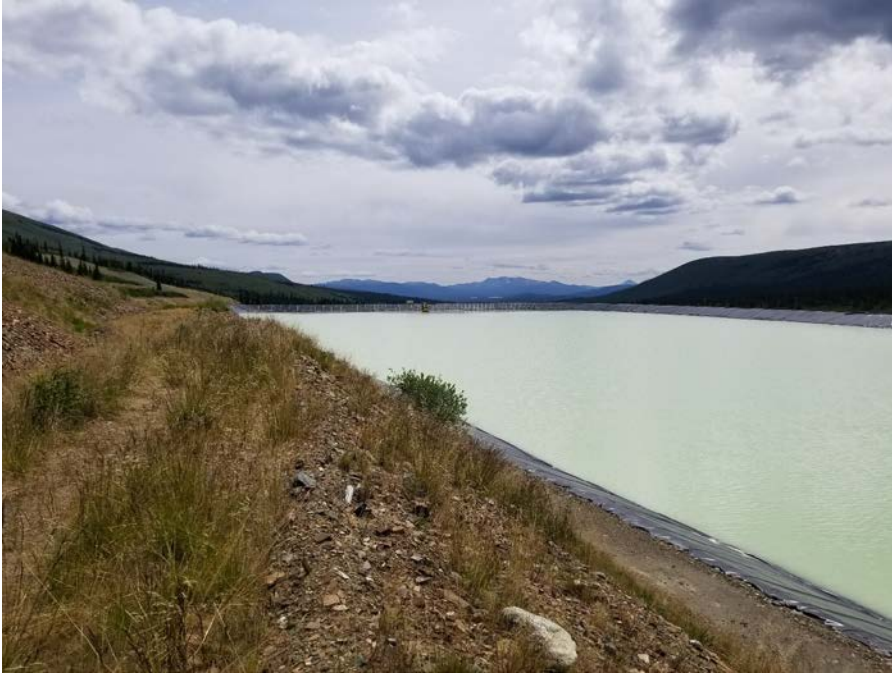
Photo 1 Overview of Pond Looking South

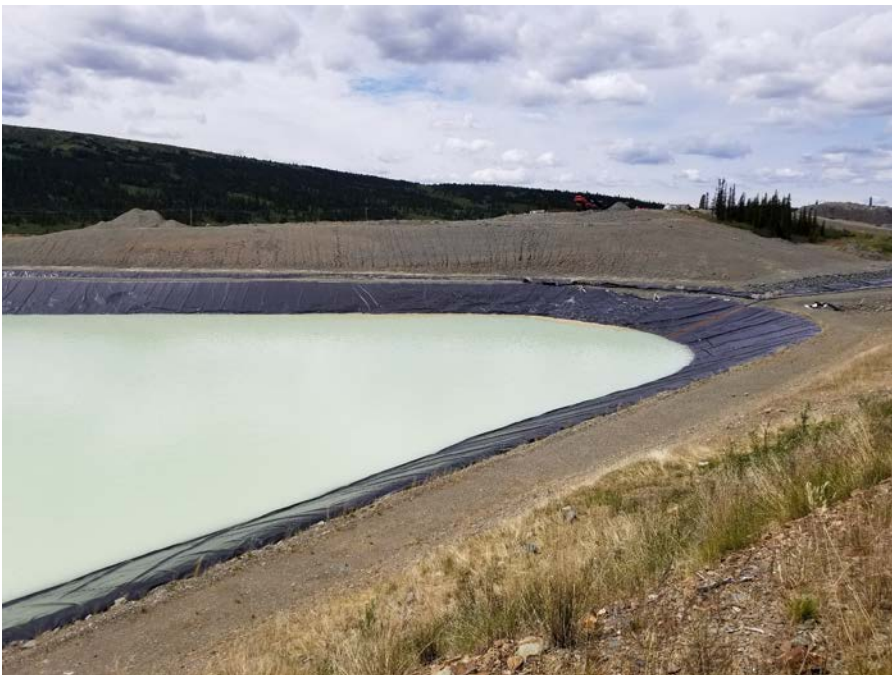
Photo 2 Overview of Pond looking north

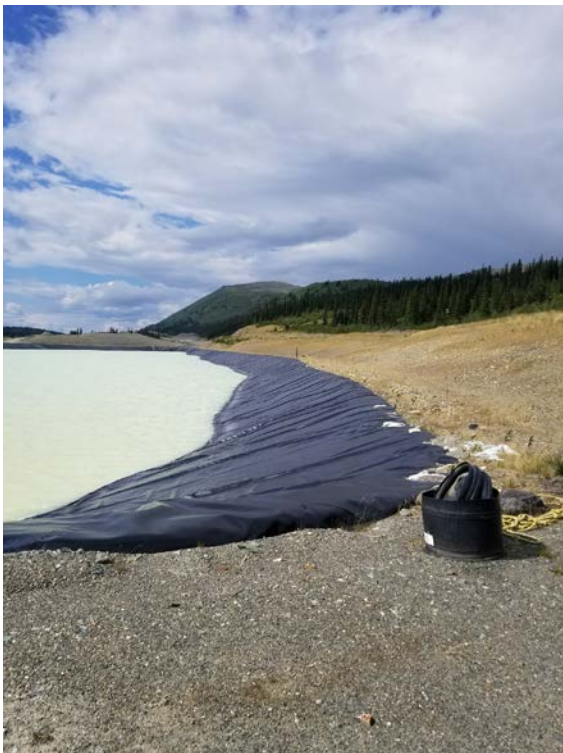
Photo 4 **Left abutment looking north**

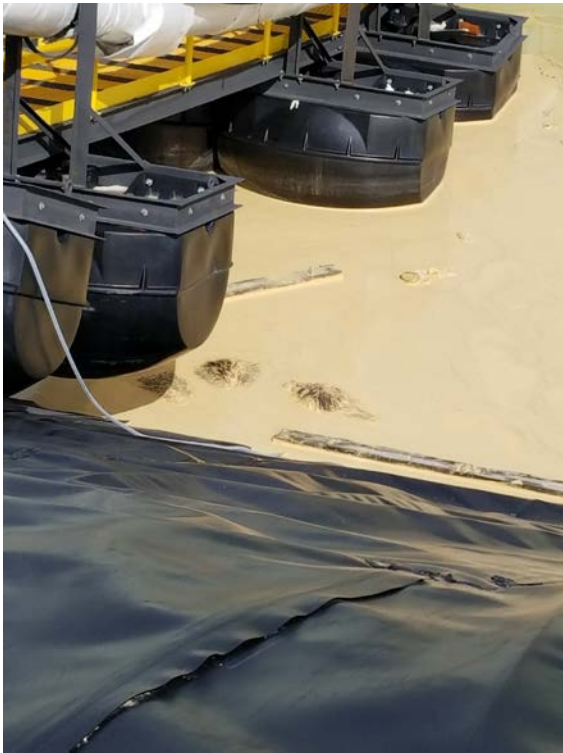
Photo 5 Debris and dead animals in pond

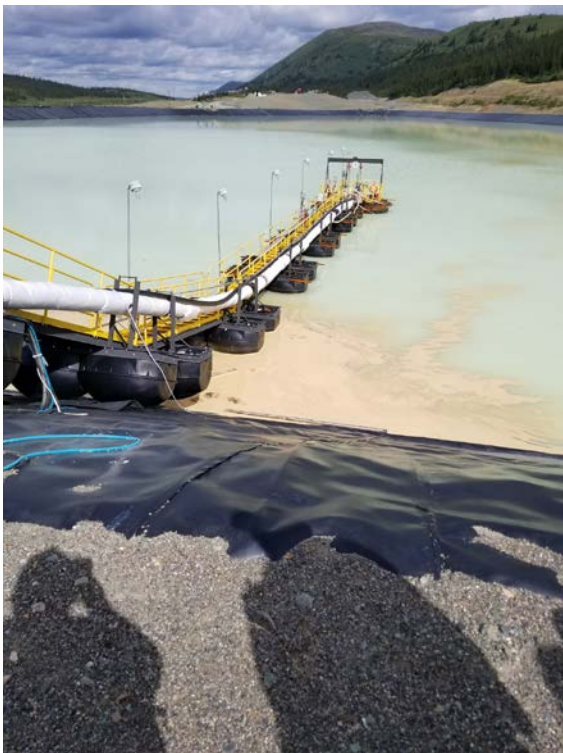
Photo 6 Reclaim barge

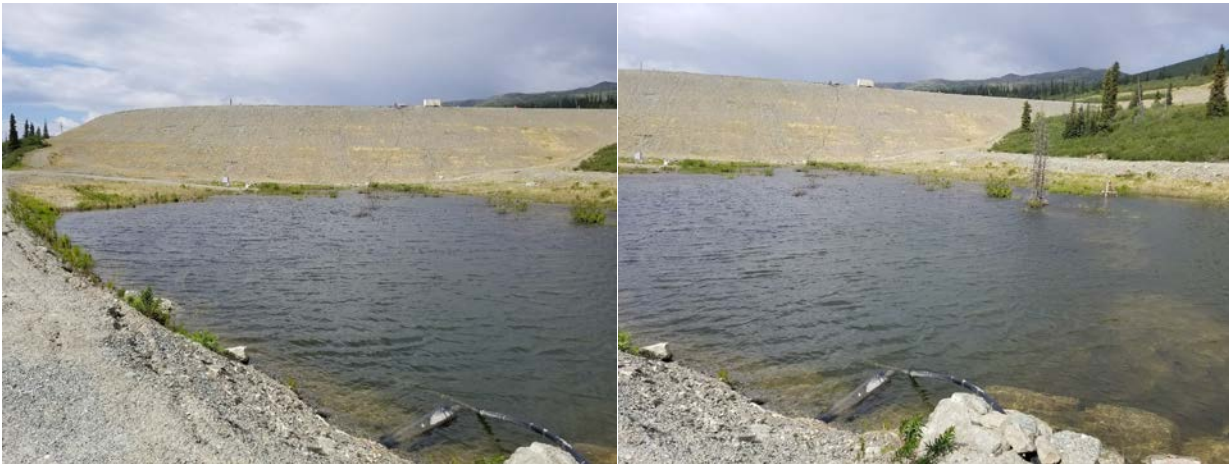
Photo 7 Overview of seepage pond looking back toward tailings dam

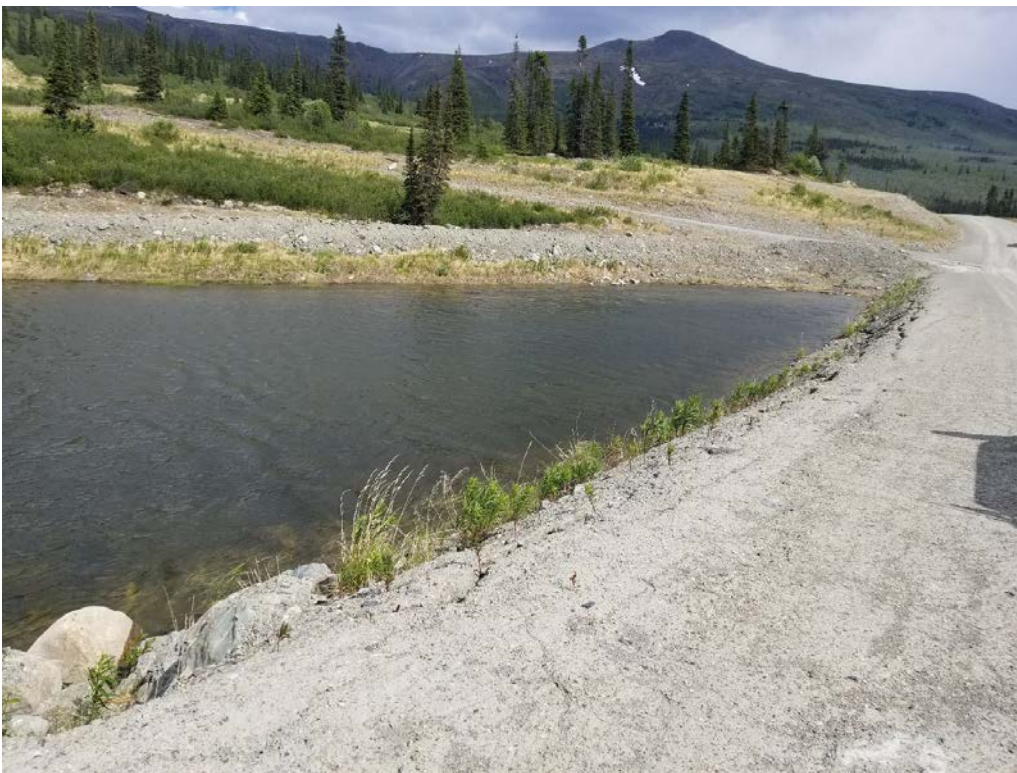
Photo 8 Seepage Pond Embankment Crest – Road

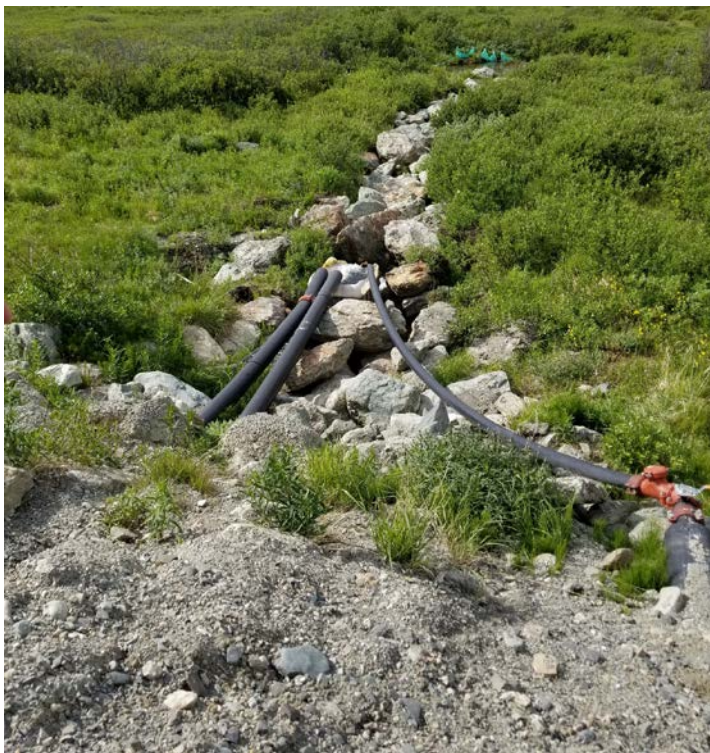
Photo 10 Discharge from under drain pipes downstream of seepage pond

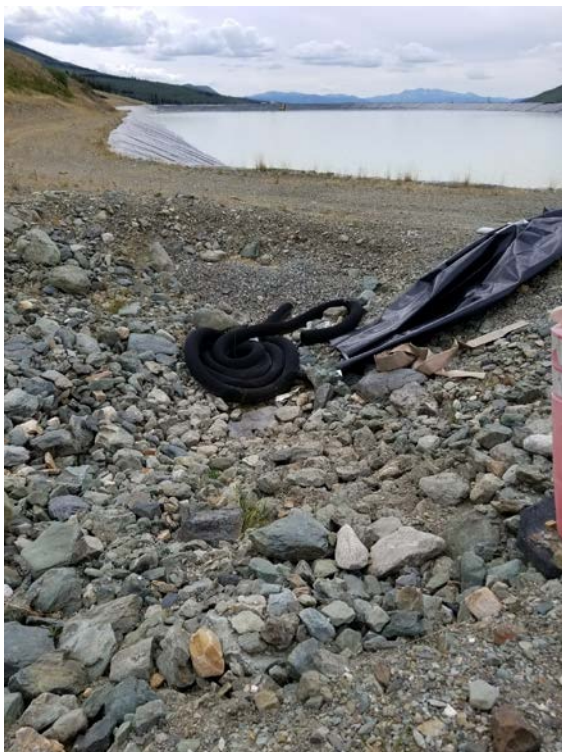
Photo 12 Upstream end of under drains

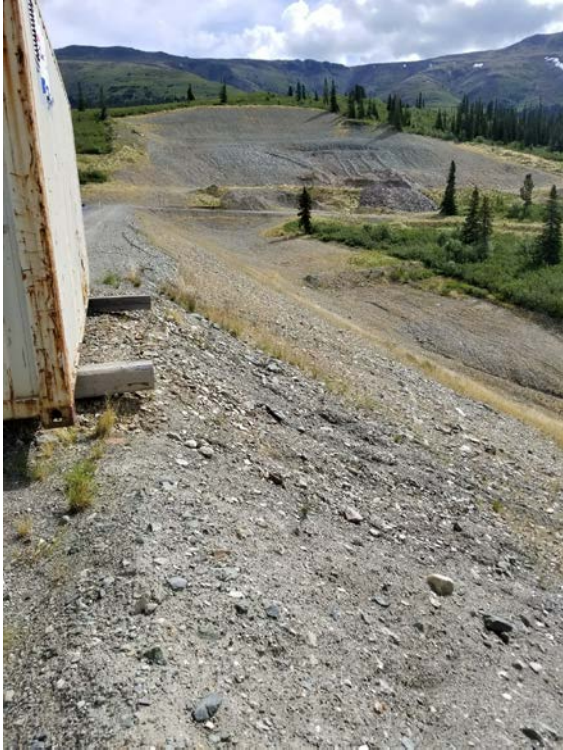
Photo 13 D/S Slope looking towards left abutment

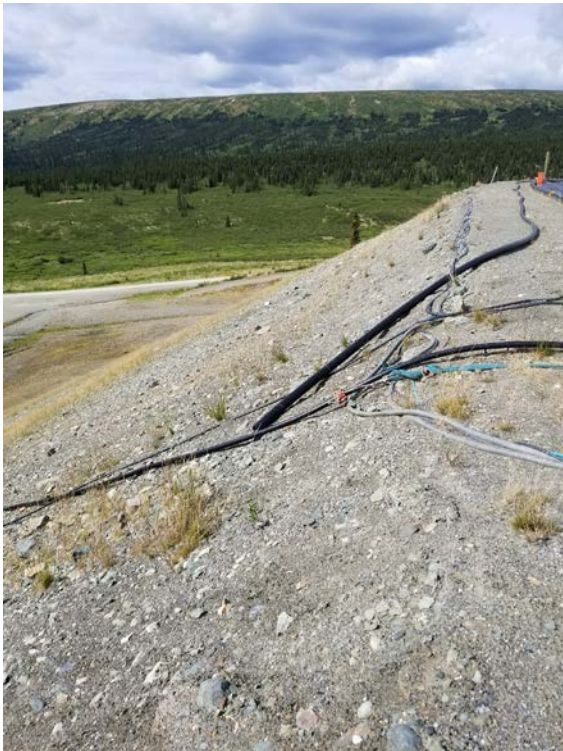
Photo 14 Downstream slope looking west

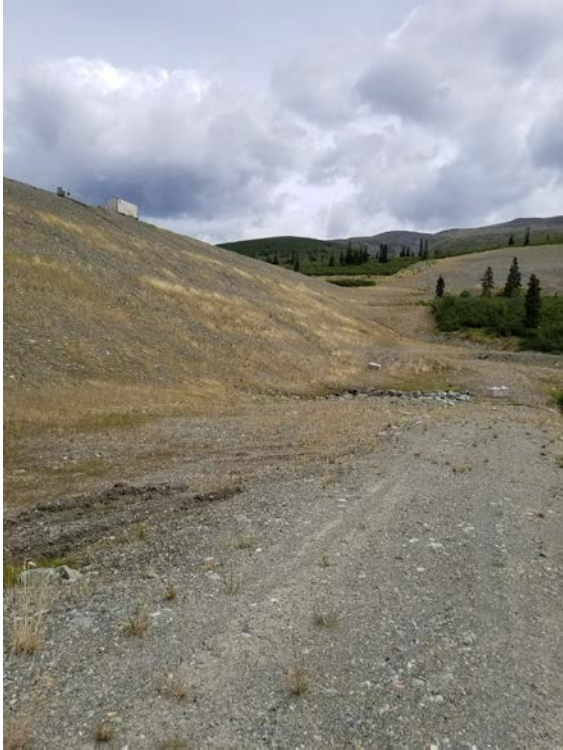
Photo 15 Downstream toe near seepage pond

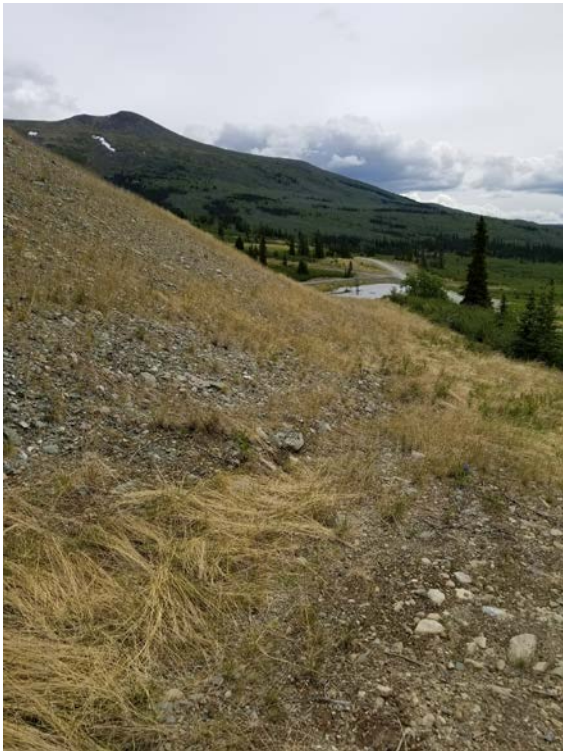
Photo 16 West Leg of Embankment Looking South

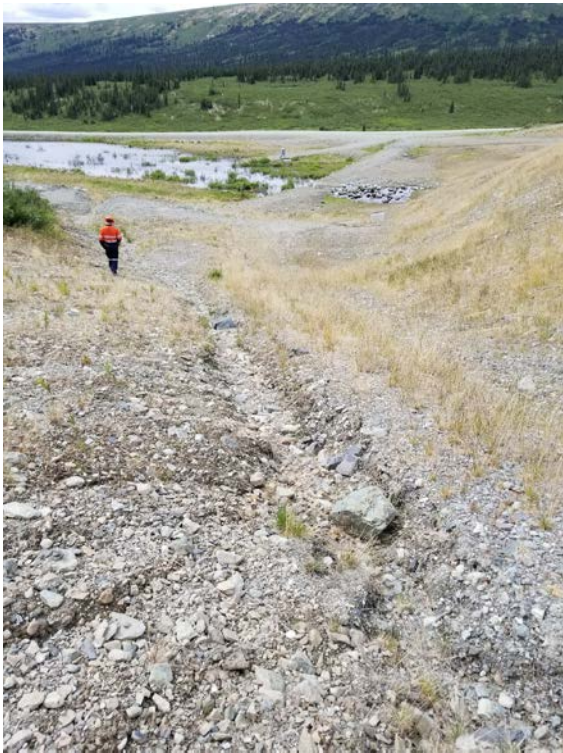
Photo 17 Erosion gully near d/s toe of dam

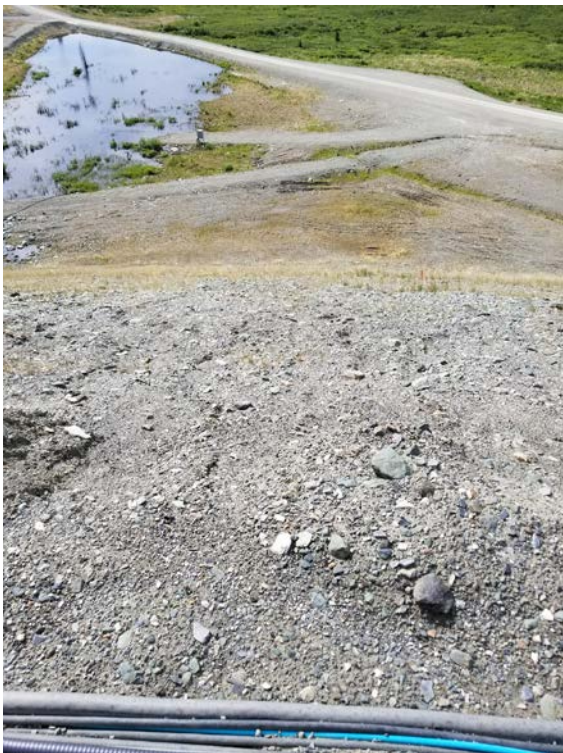
Photo 18 Minor erosion gullies on downstream slope
