WOLVERINE MINE
RECLAMATION AND CLOSURE PLAN
2016-07 – REVISED V.2

Yukon Zinc Corporation

Shuksan Environmental Services Ltd.

September 29, 2017

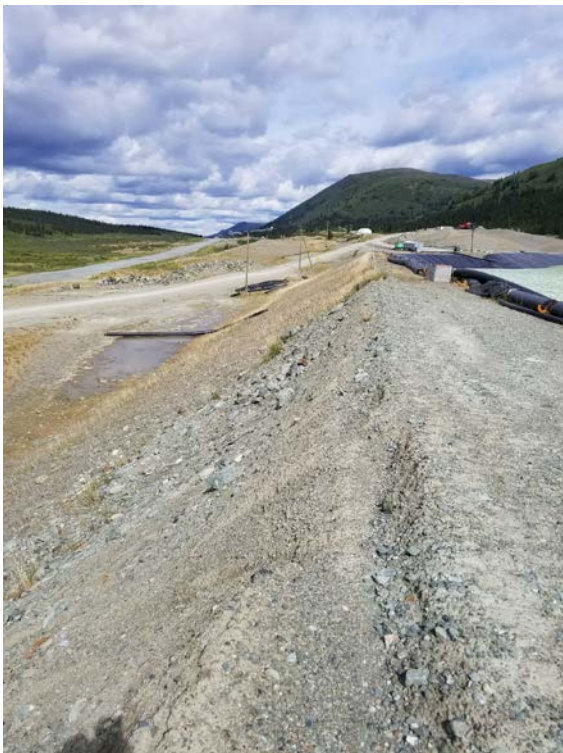
Photo 22 **Minor ponded water from recent rainfall**

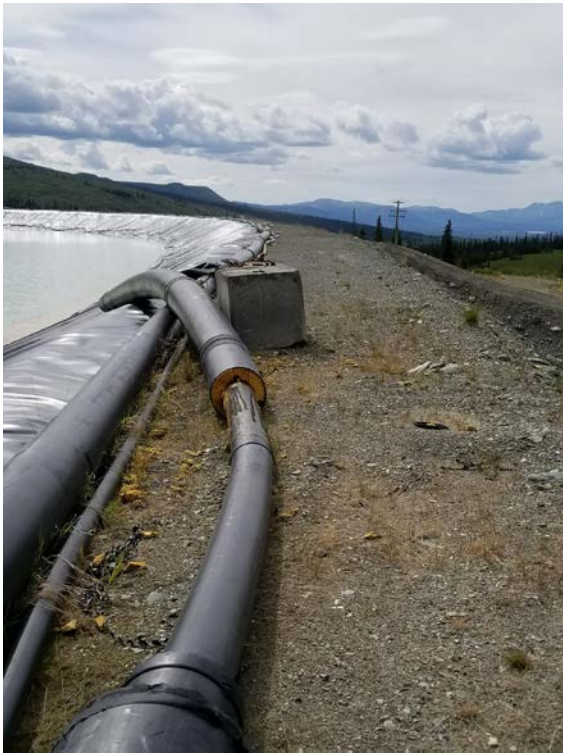
Photo 23 Pipe discharging water from other on site facilities

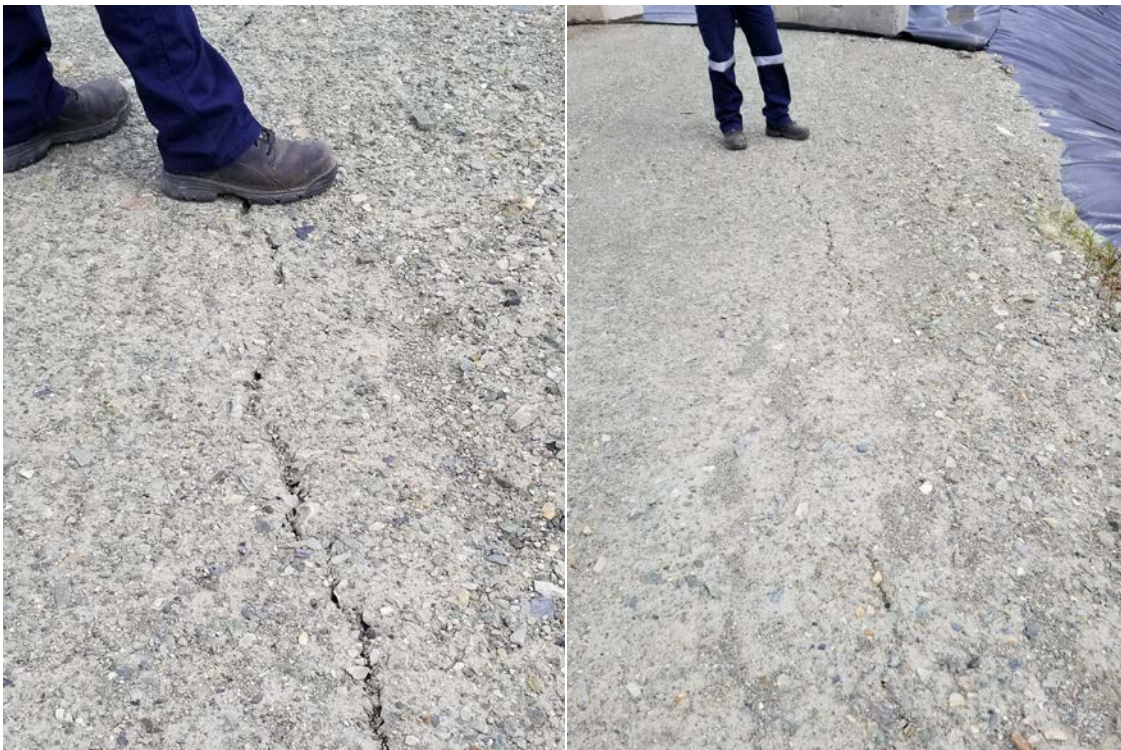
Photo 24 Cracking in dam crest near north end slump

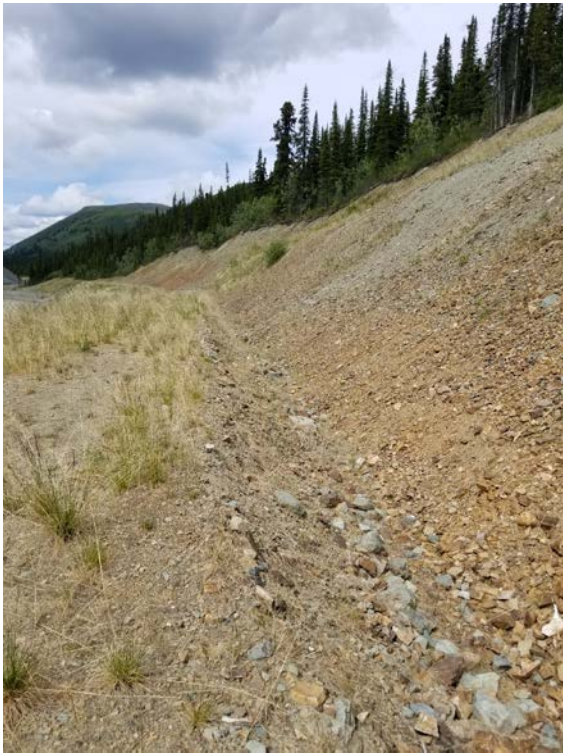
Photo 29 Ditch B

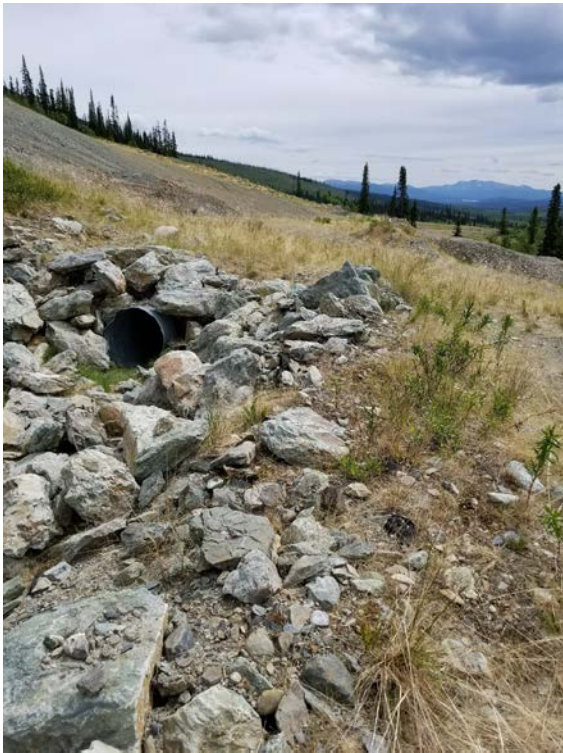
Photo 31 Ditch B Inlet to culvert section pipe to discharge pad

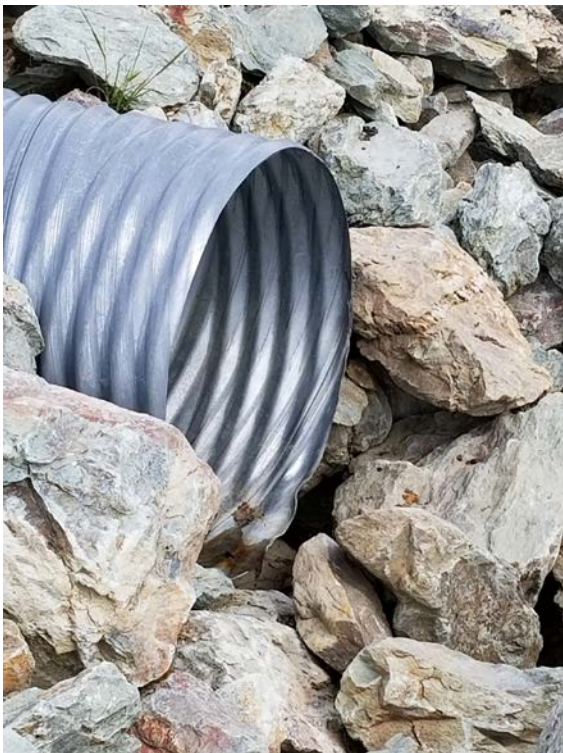
Photo 32 Outlet of Ditch B

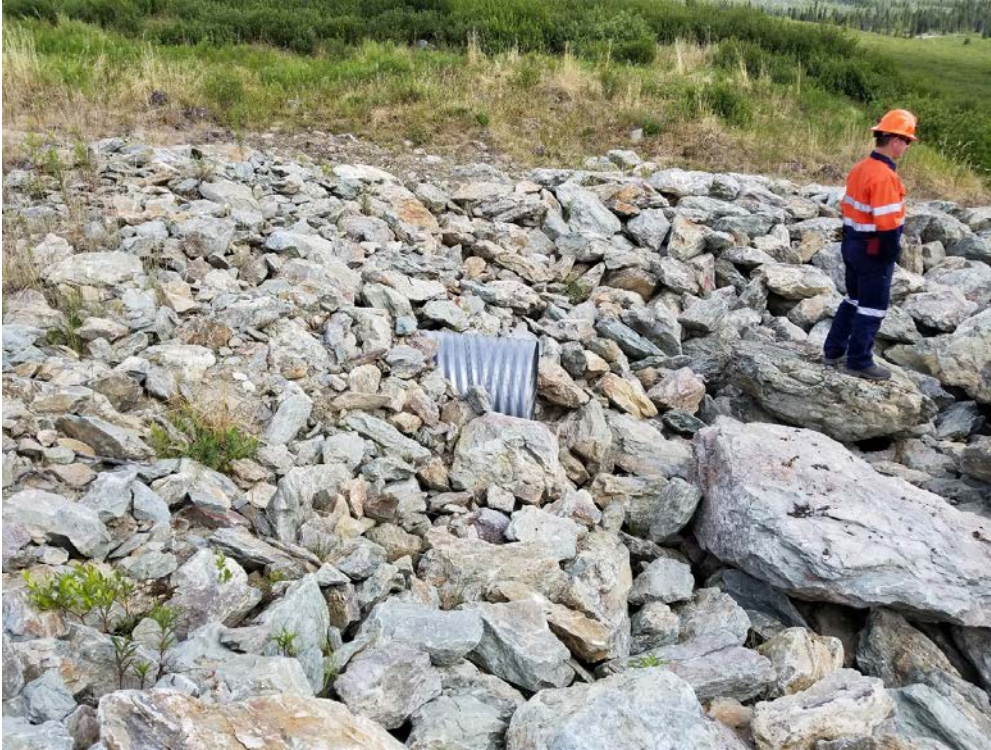
Photo 33 Discharge Pad at Bottom of Ditch B

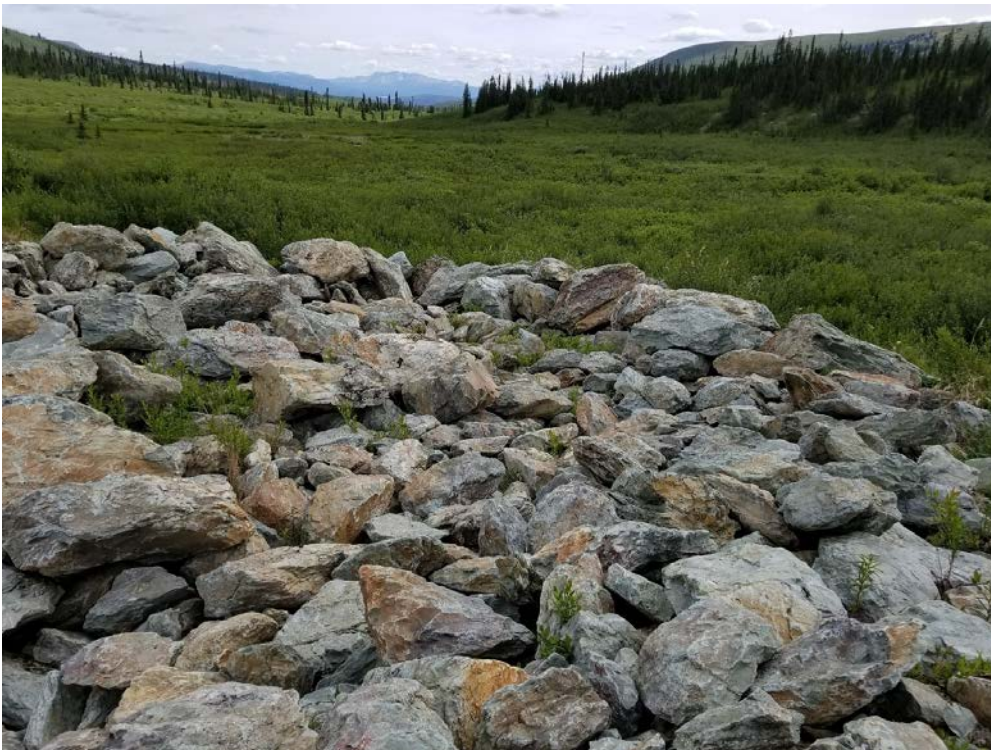
Photo 34 Ditch B Discharge Pad

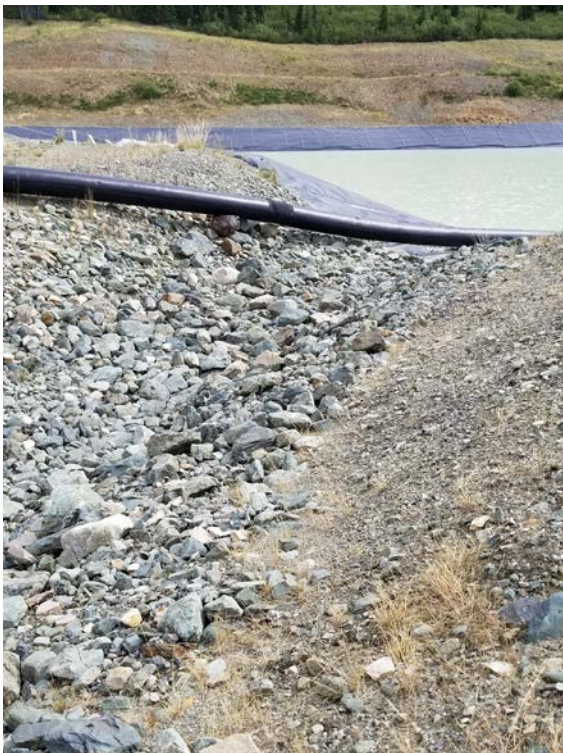
Photo 36 Spillway channel looking upstream towards pond

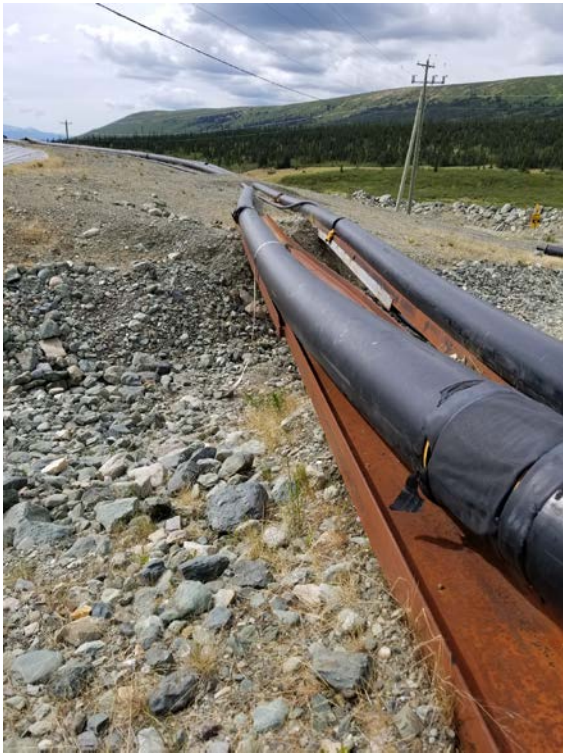
Photo 37 Pipe bridge over spillway channel

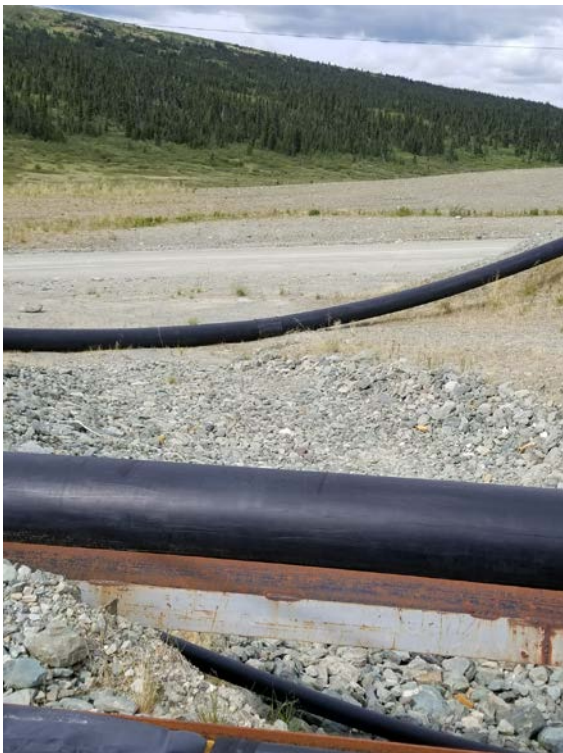
Photo 38 Spillway channel looking downstream

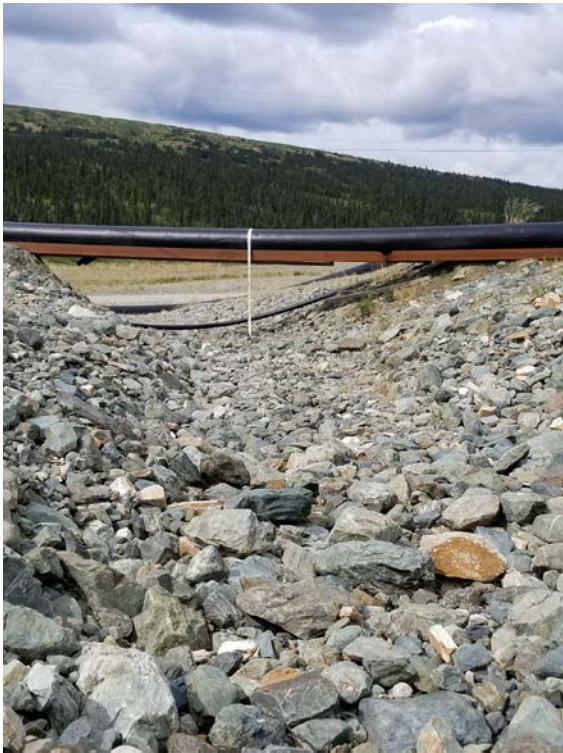
Photo 39 Pipe bridge over spillway channel looking downstream

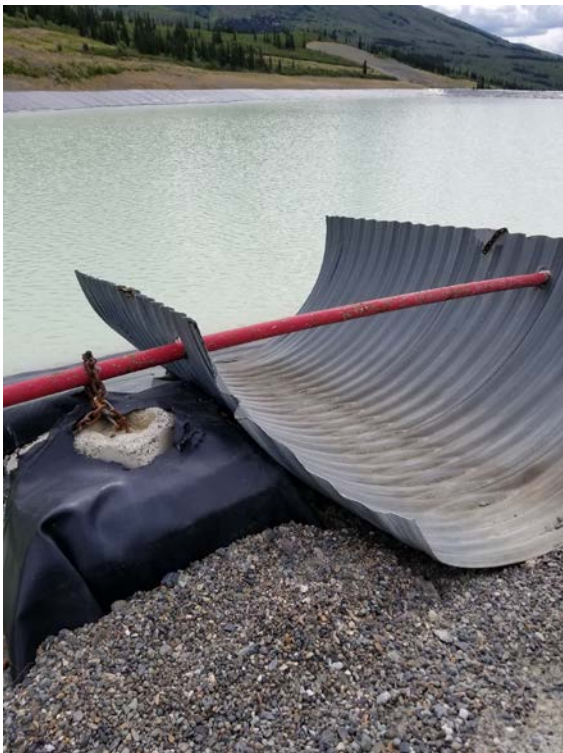
Photo 40 Discharge pad for vacuum trucks

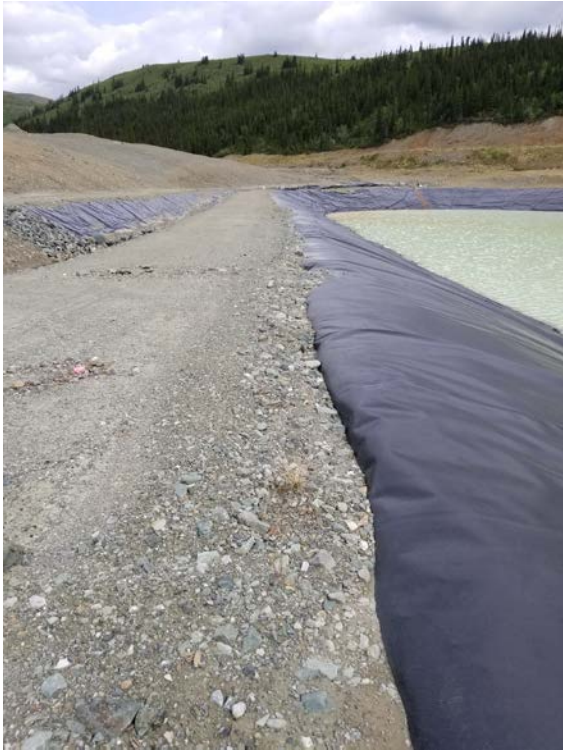
Photo 41 Upstream face and lined section of Ditch A

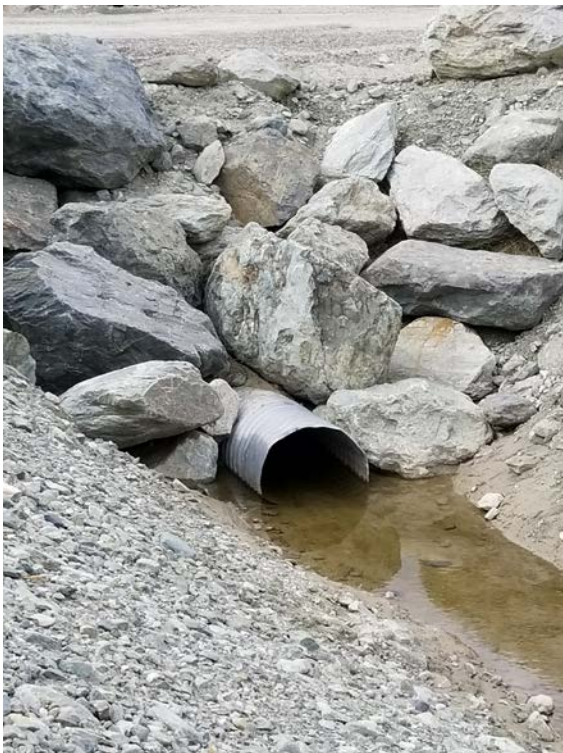
Photo 42 Ditch A Culvert leading to discharge point

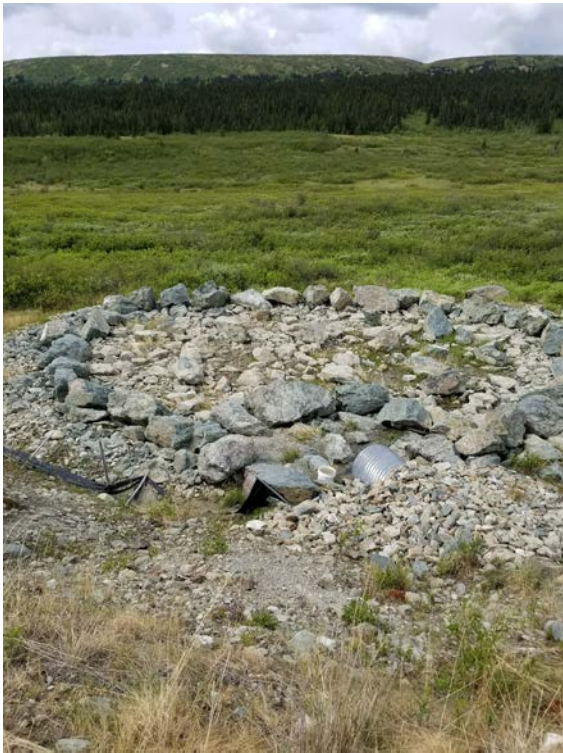
Photo 43 Discharge pad from Ditch A

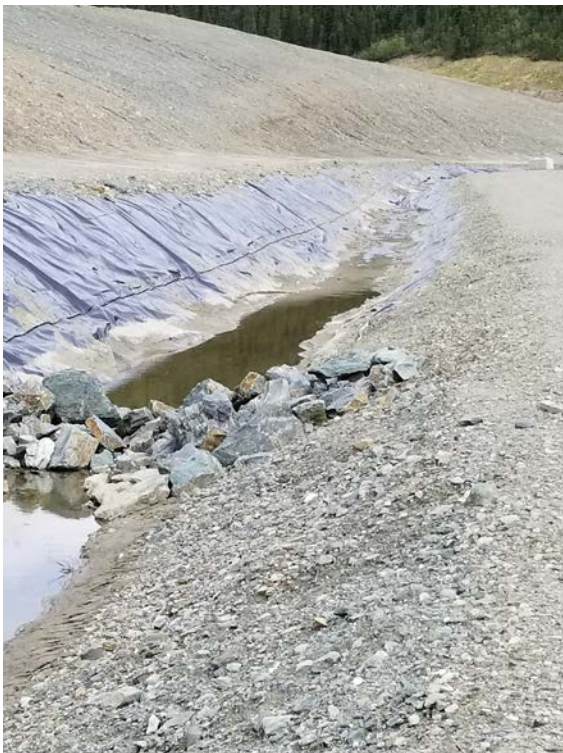
Photo 44 Lined section of Ditch A

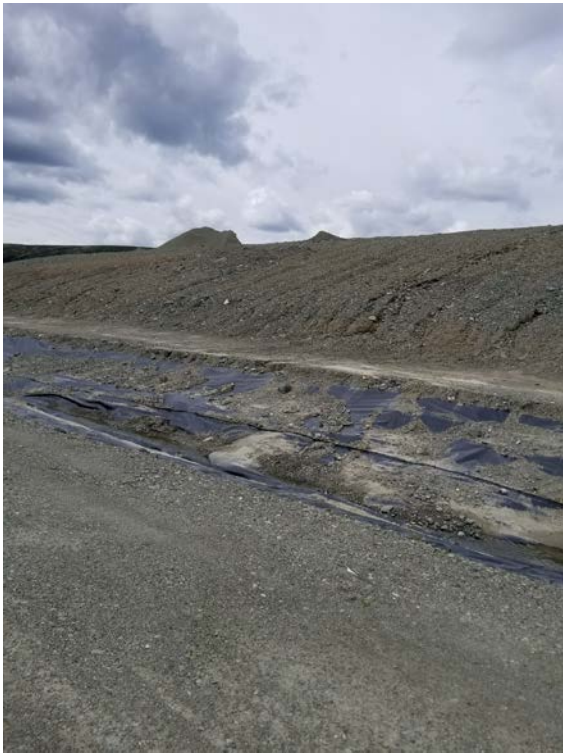
Photo 45 Debris collecting in ditch from surface erosion

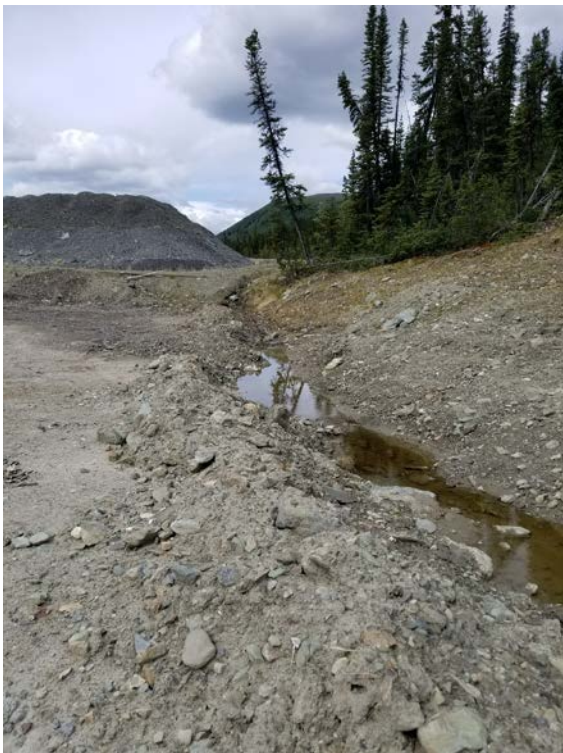
Photo 46 North End of Ditch A

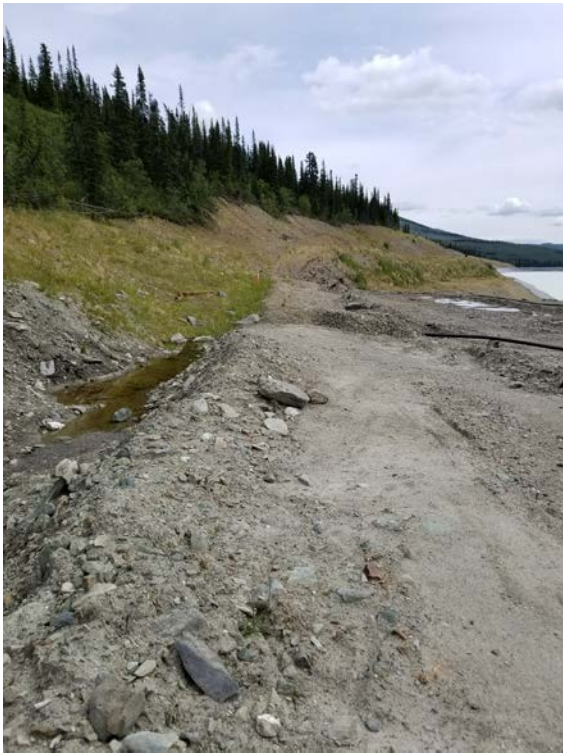
Photo 47 **Ditch A Adjacent to Biopass**

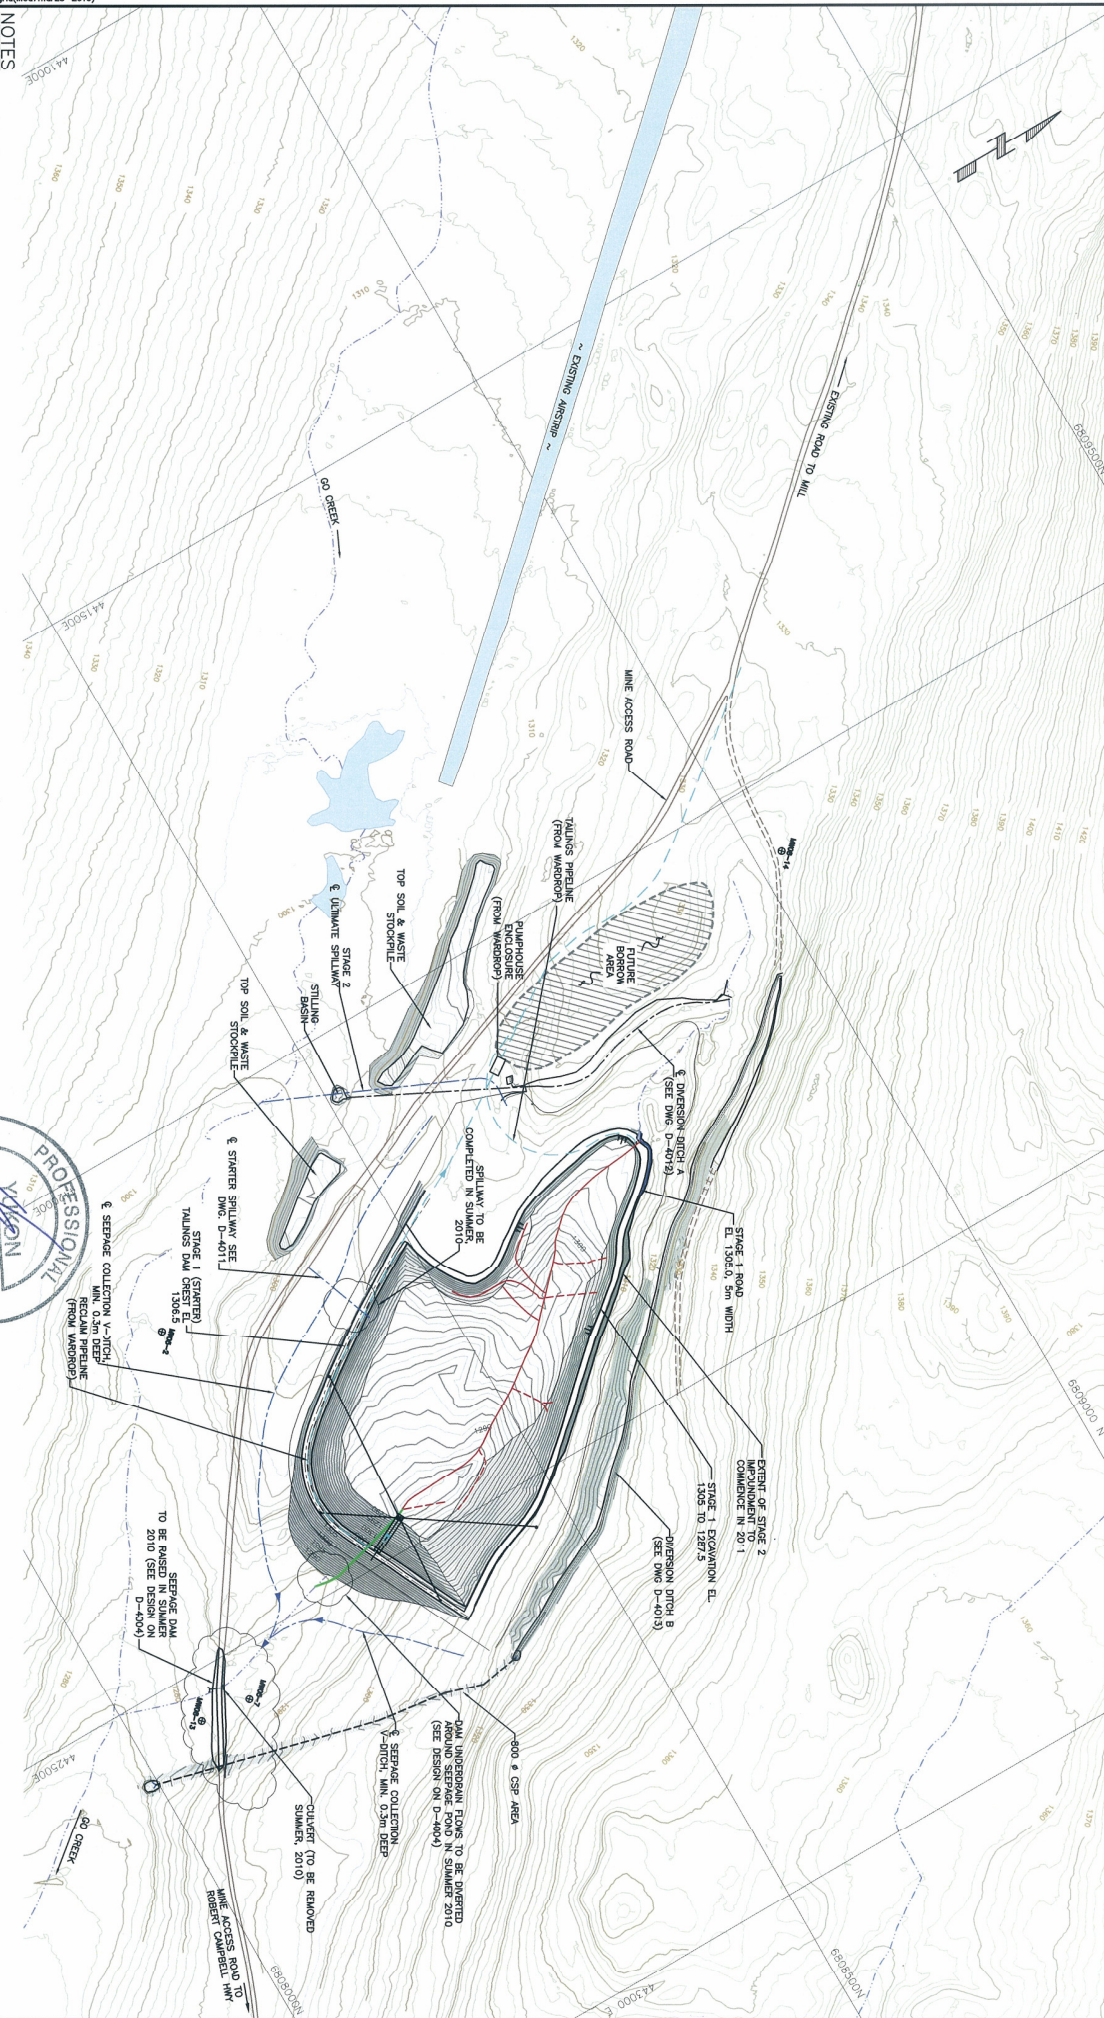
DATE	SCALE	PROJECT NUMBER	DRAWING NUMBER	REV.
MAY 12/10	0	09234405	D-4001	3

Yukon Zinc
 GOVERNMENT PROJECT
 TAILINGS STORAGE FACILITY
 GENERAL SITE ARRANGEMENT

- FOR GENERAL SITE ARRANGEMENT SEE DWG. D-4001.
- VERT ELEVATIONS SHOWN ARE TO FINISHED CHANNEL BOTTOM.
- CULVERT BEDDING/BACKFILL WELL GRADED 100 MM MINUS MATERIAL WITH LESS THAN 20% PASSING THE #200 SIEVE.
- FOR REPAIR AND GRANULAR FILTER GRADATION AND LAYER THICKNESS SEE DWG. C-4013 SHEET 2 OF 2.
- RECORD ISSUE DRAWING IS BASED ON LIMITED "AS BUILT" DATA PROVIDED BY T2C. THE DRAWING MAY NOT REFLECT ALL FIELD CHANGES.
