WOLVERINE MINE

TAILINGS STORAGE FACILITY

OPERATION, MAINTENANCE AND SURVEILLANCE MANUAL

Yukon Zinc Corporation and Klohn Crippen Berger

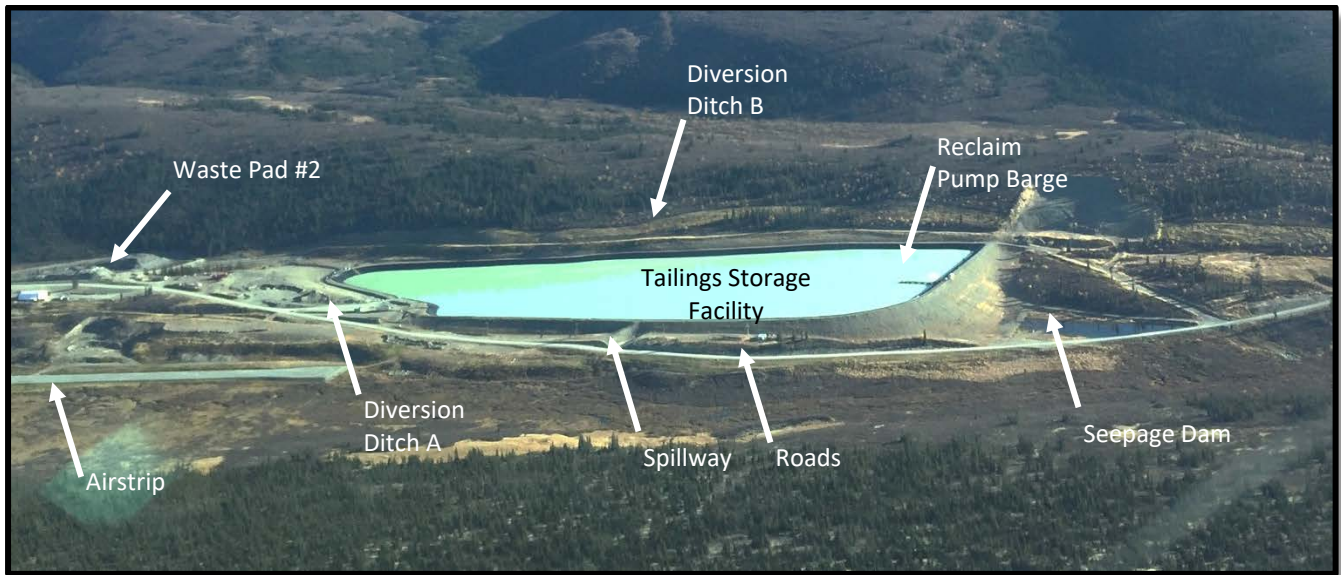
Arial views of the TSF area and industrial complex are shown in Figure 3-2 and Figure 3-3, respectively. Mine infrastructure remains in place during temporary closure.

**Figure 3-2 Tailings Storage Facility Layout**

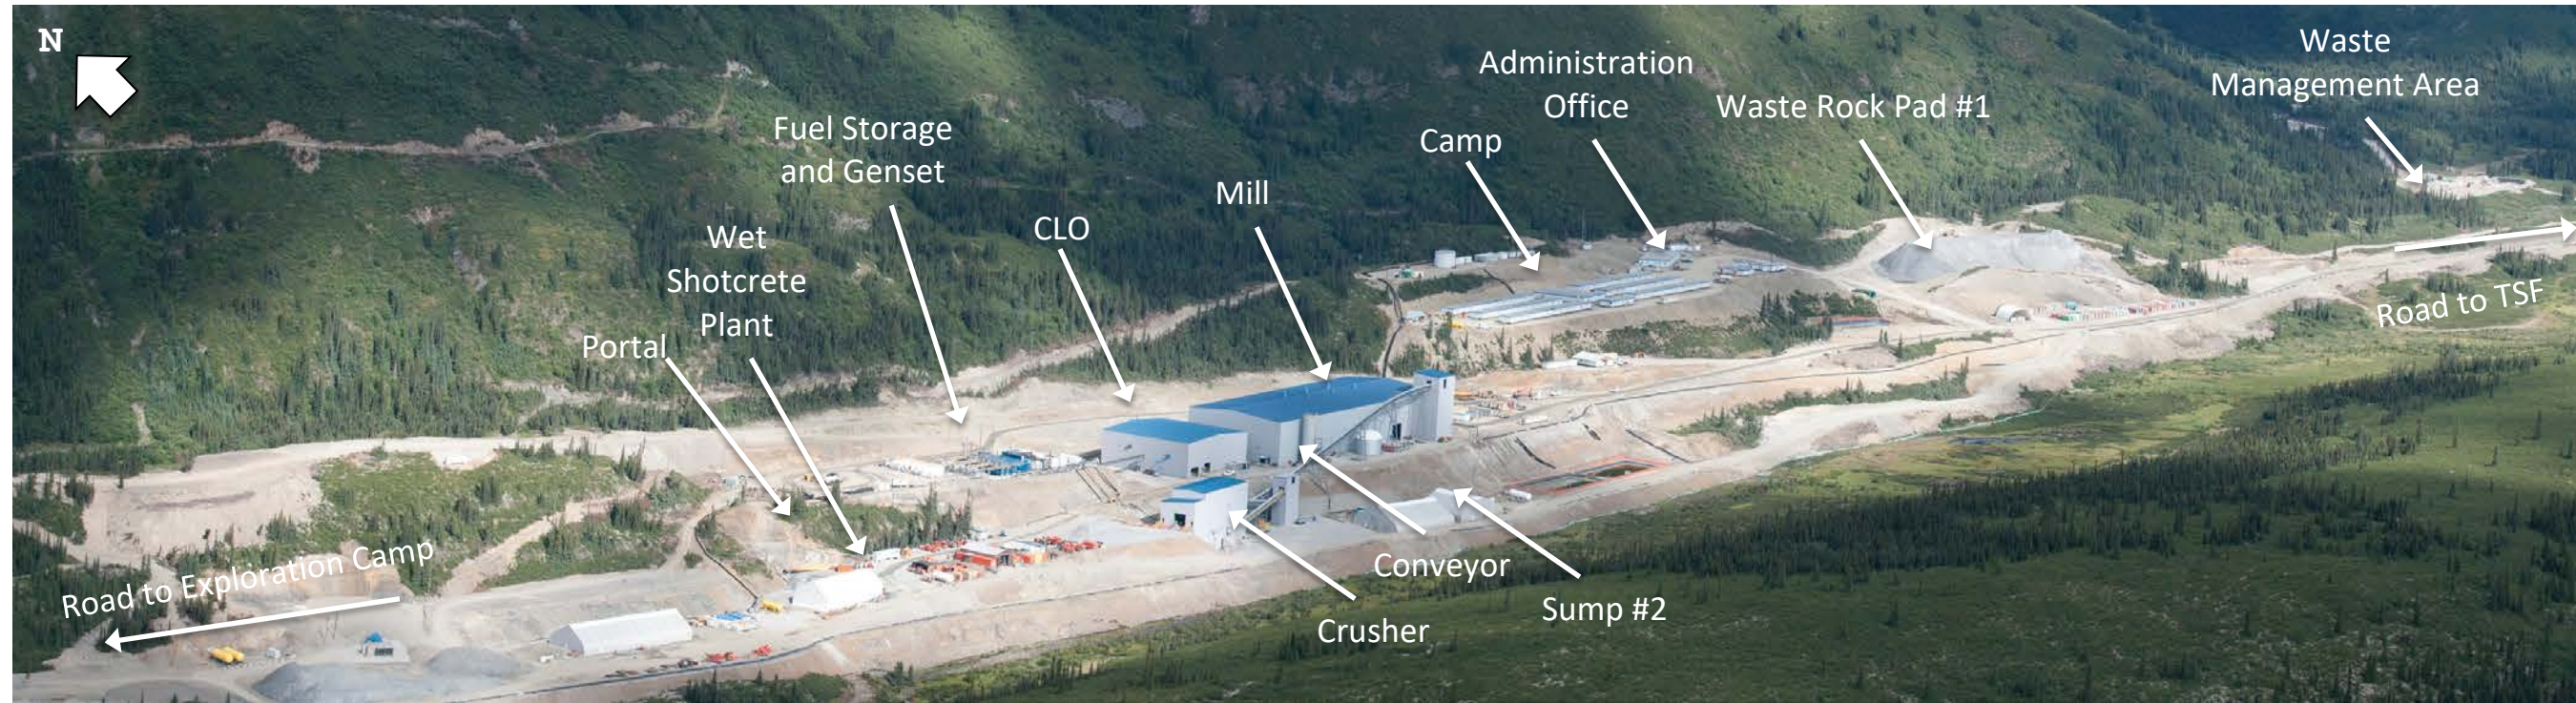
Figure 3-3 Industrial Complex Layout

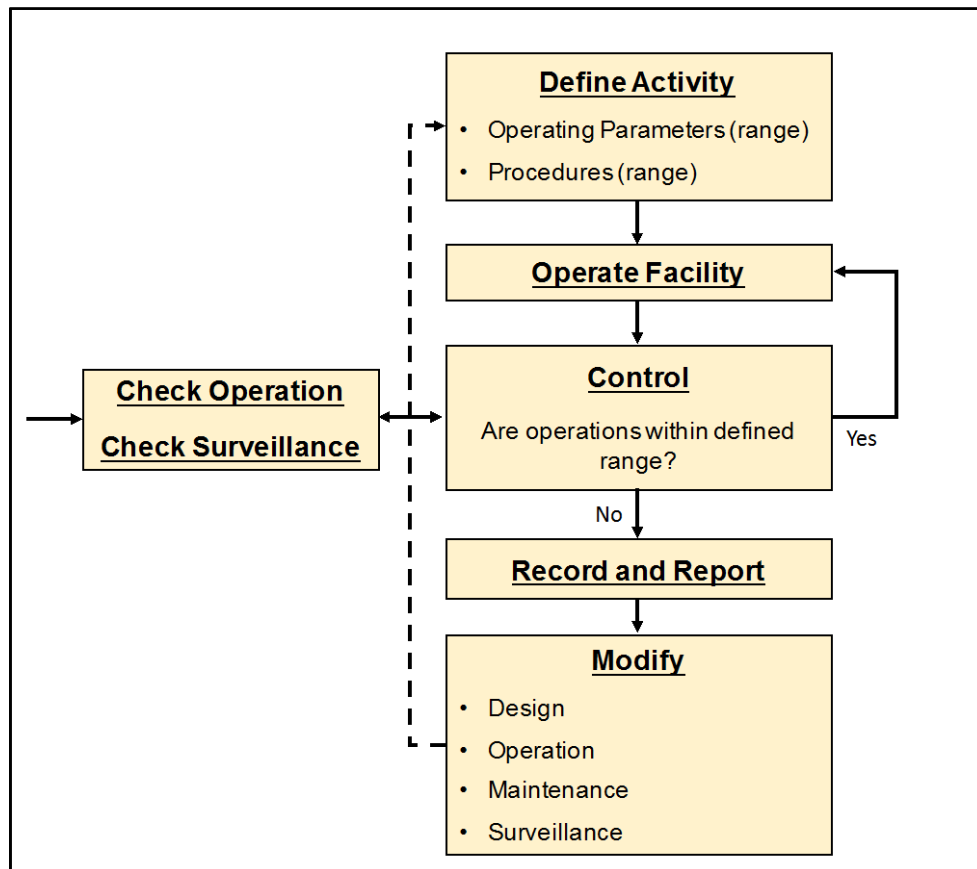
A typical operation flowchart is shown in Figure 5-1. The flowchart describes the performance review procedure that will be applied to each component of the facility to help ensure safe operation. The main operational aspects of the tailings facility include: water management and seepage collection system operation. As the planned water treatment is still in the design stage and construction has been completed, operation of the water treatment plant is not included herein.

Figure 5-1 Typical Operation Flowchart

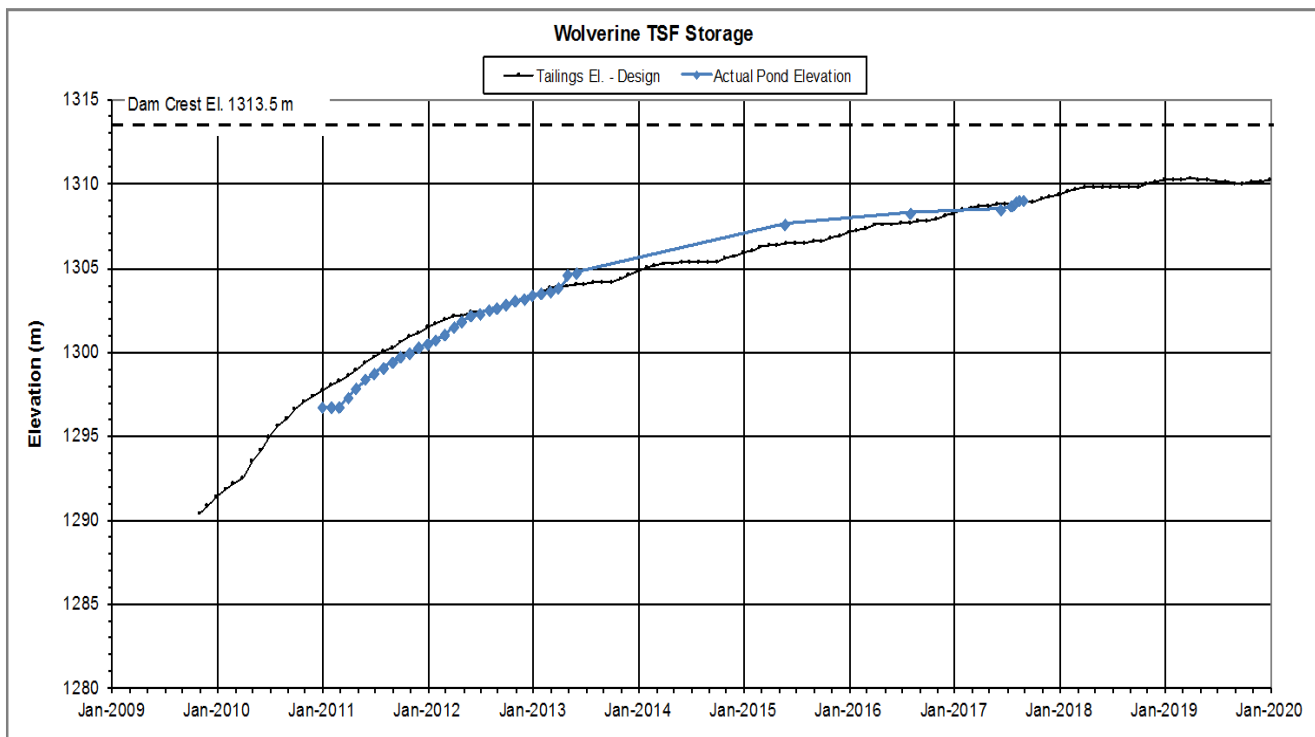
The results of the actual and predicted accumulation of water and solids storage are presented in Figure 5-2, along with the stage storage elevation curve for the impoundment.

**Figure 5-2 Stage Storage Curve for the Starter and Ultimate Tailings Impoundments**

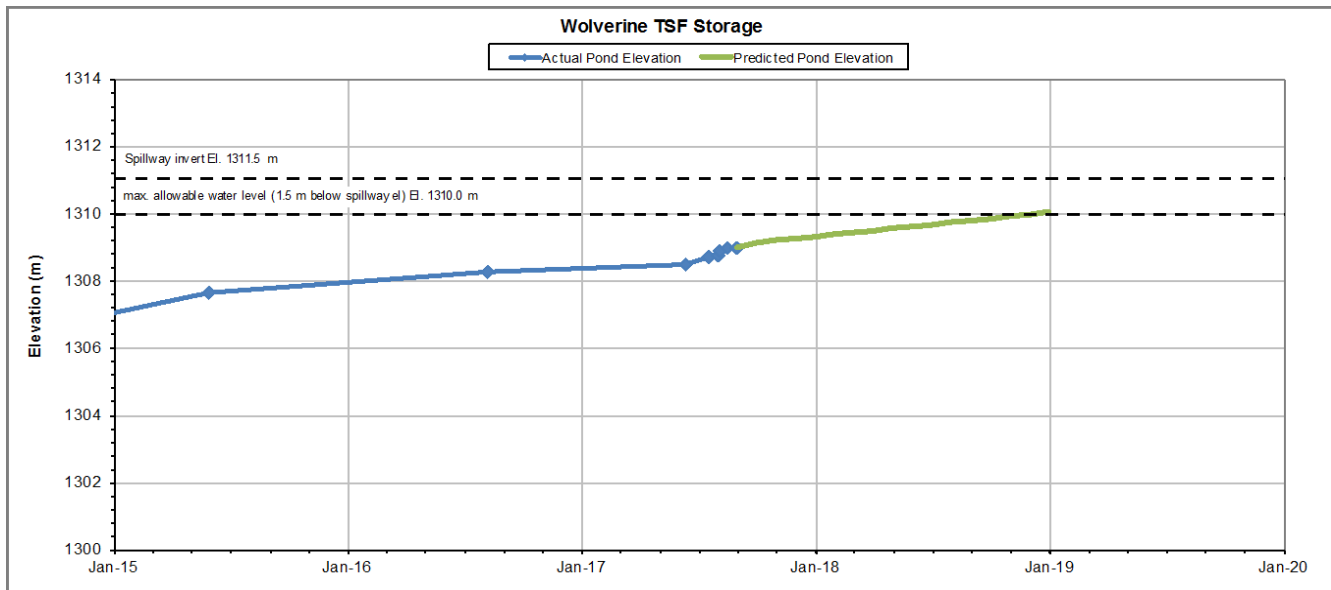
As water is accumulating in the TSF, monitoring of the water level in the TSF is conducted weekly to add to the water level monitoring conducted when the mine was in operation. Since December 2014, the pond elevation in the TSF has increased from 1307.1 m to 1309.0 m. Pumping from the underground adit started in June 2017 at an average 250 m<sup>3</sup>/day, which is consistent with historic inflow rates, which averaged 300 m<sup>3</sup>/day in 2012 through 2014. Figure 5-3 shows the historic and predicted pond levels based on site inflows.

**Figure 5-3 Historic and Forecasted Pond Level**

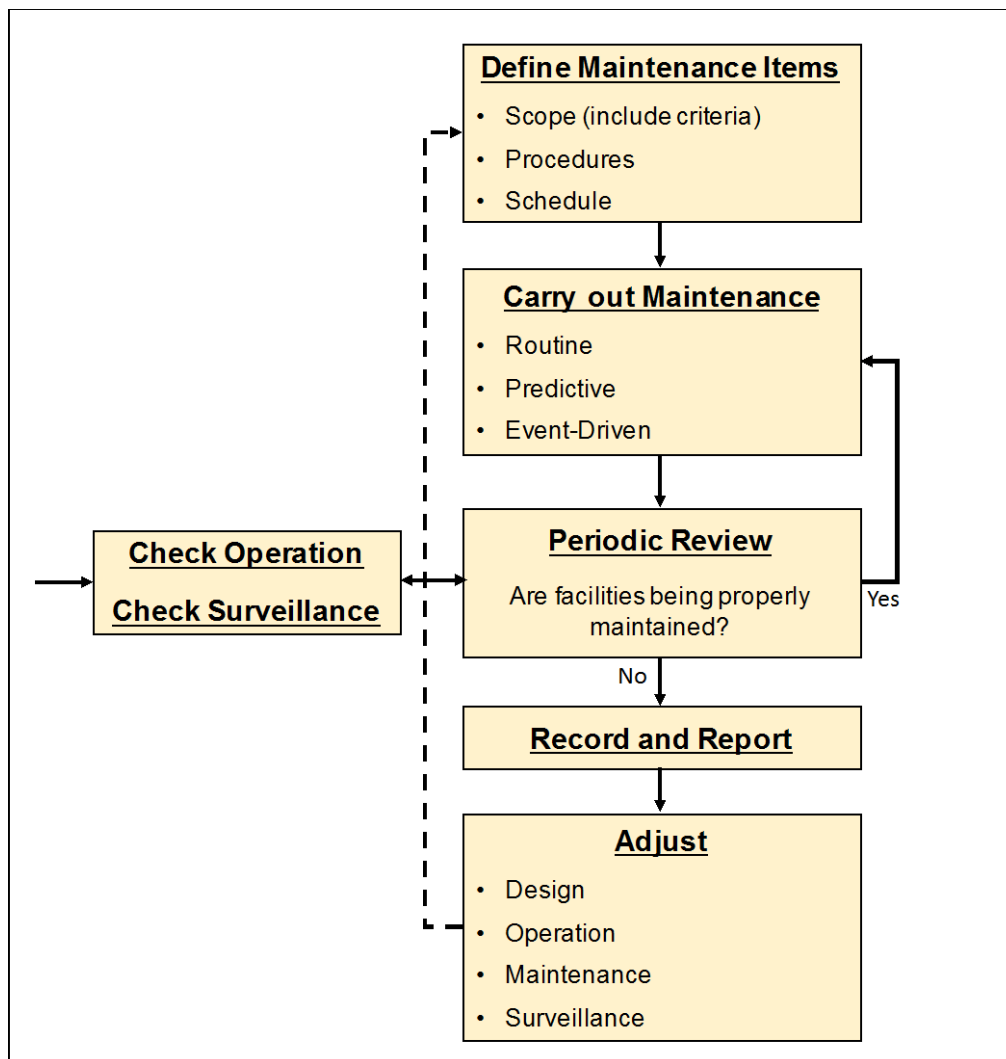
A general Maintenance Flowchart is shown in Figure 6-1. The flowchart describes a maintenance review procedure that should be applied to each component of the facility to help ensure safe operation. Components requiring maintenance include:

Figure 6-1 Maintenance Flowchart

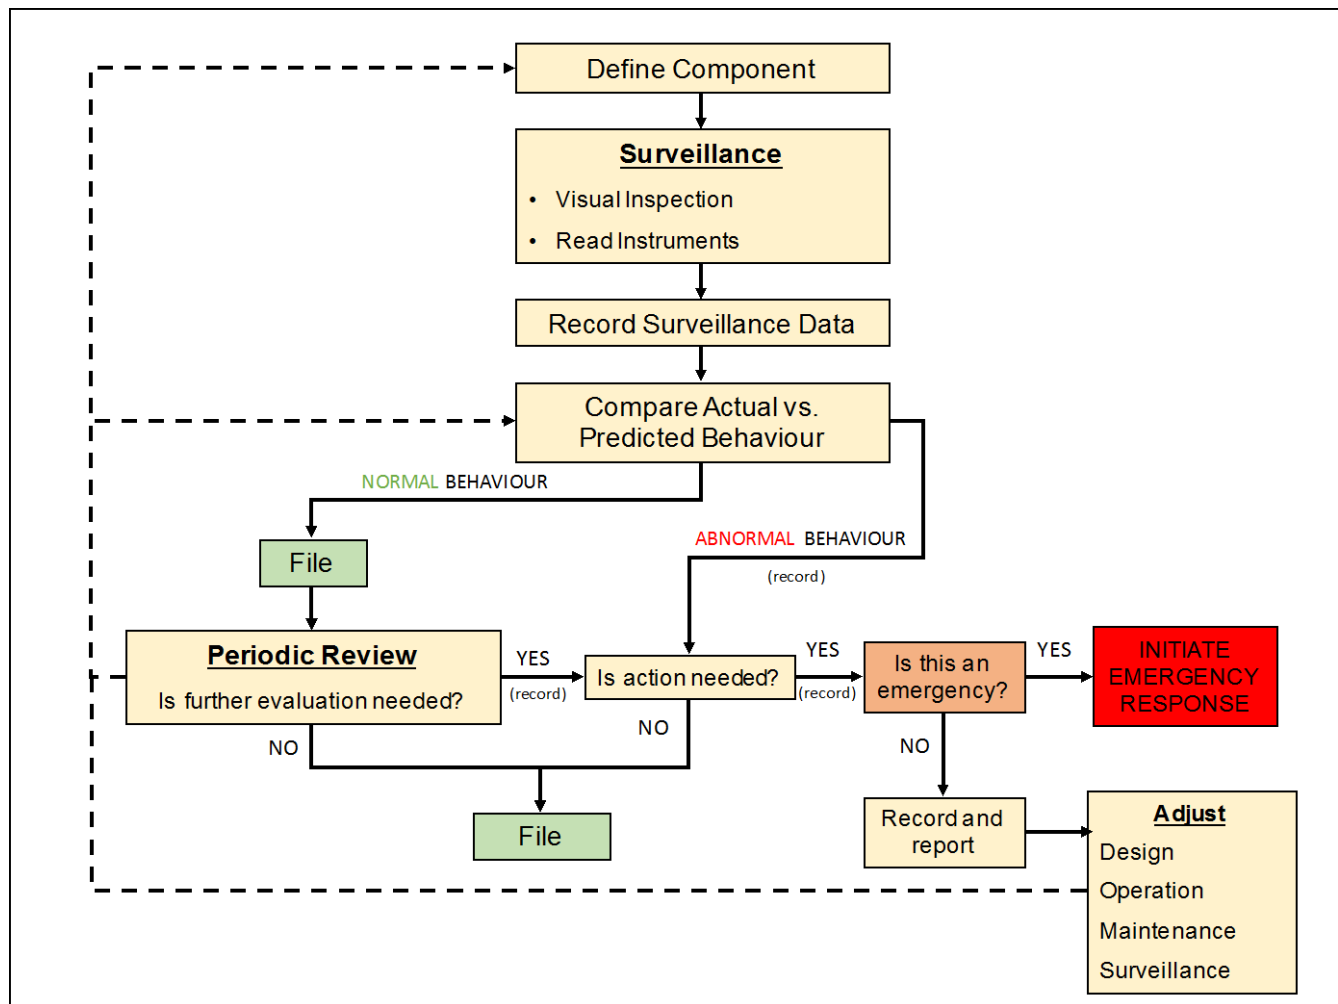
A flowchart of the Surveillance process is shown in Figure 7-1. The flowchart describes a surveillance review procedure that will be applied to each component of the facility to help ensure safe and continued operation.

Figure 7-1 Surveillance Flowchart

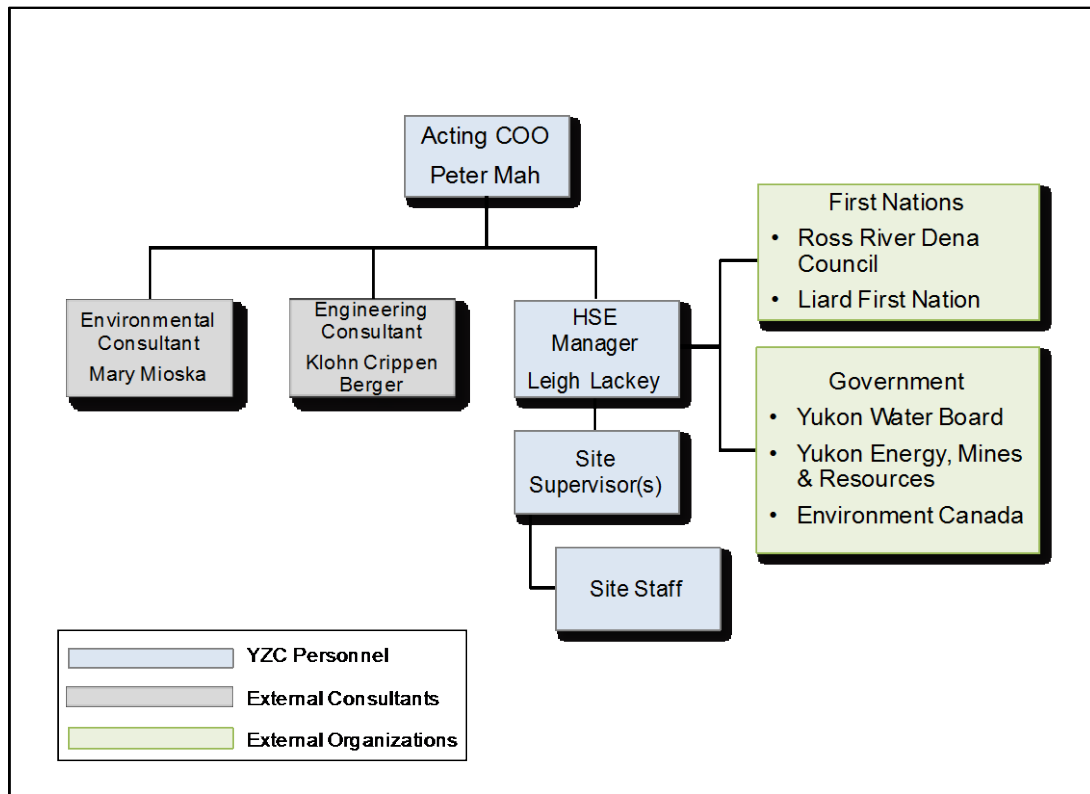
Lines of communication with the site and the responsibility to notify affected external stakeholders, including government agencies, local organizations, First Nations, and other individuals are illustrated in Figure 8-1.

**Figure 8-1 Internal and External Reporting Personnel**

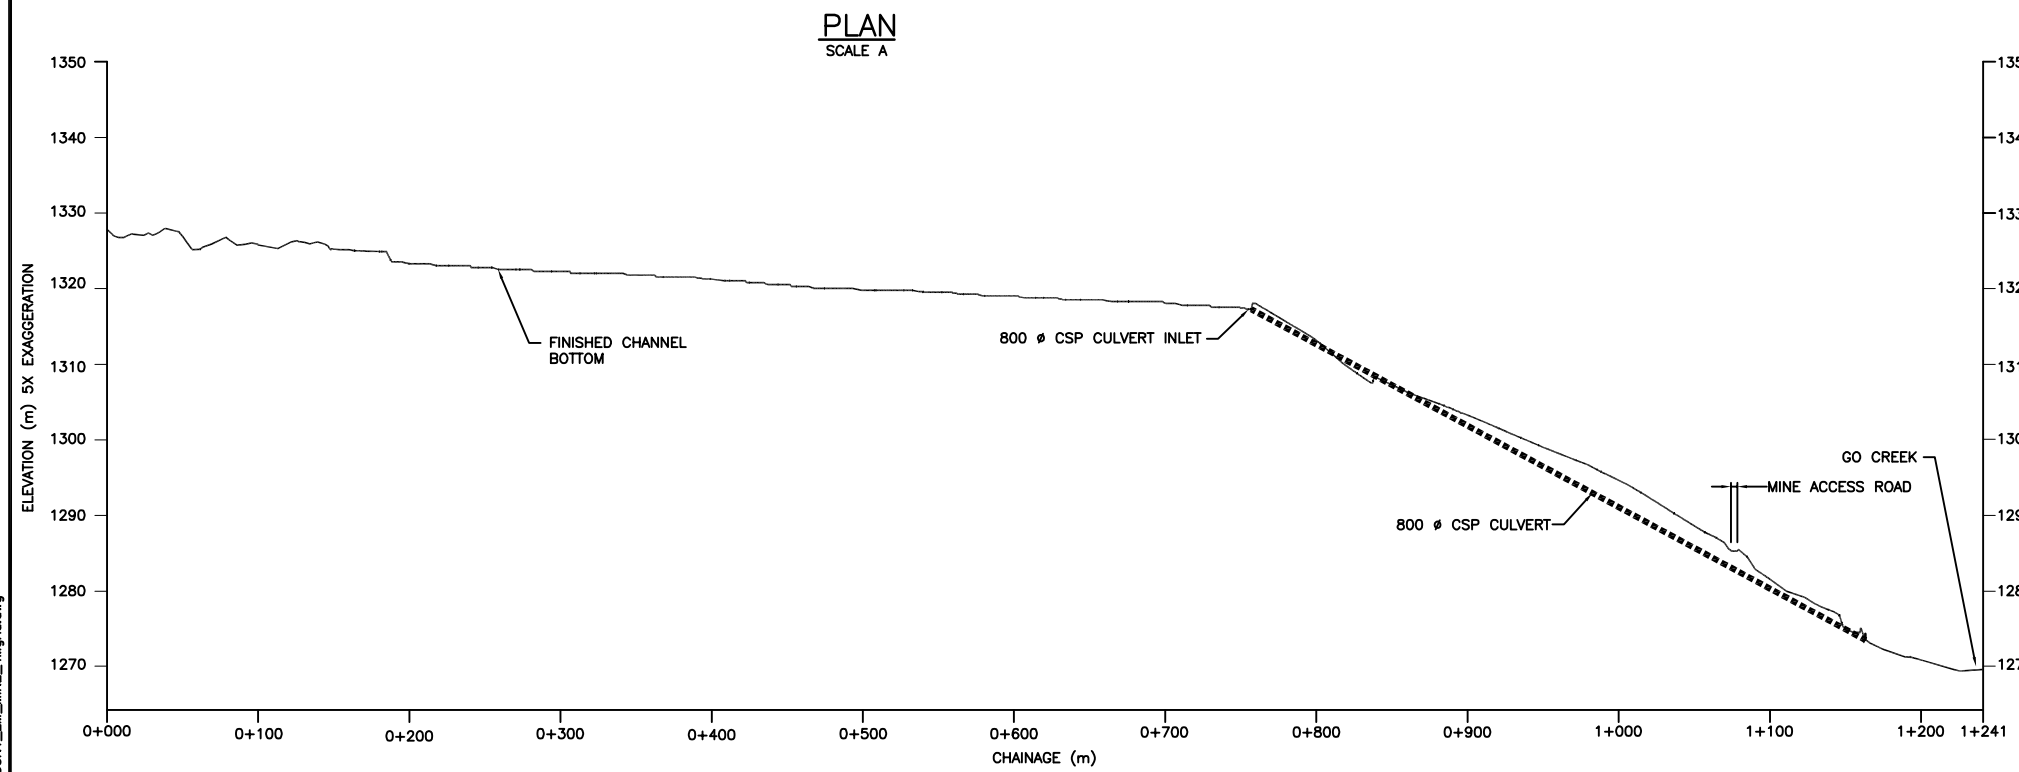
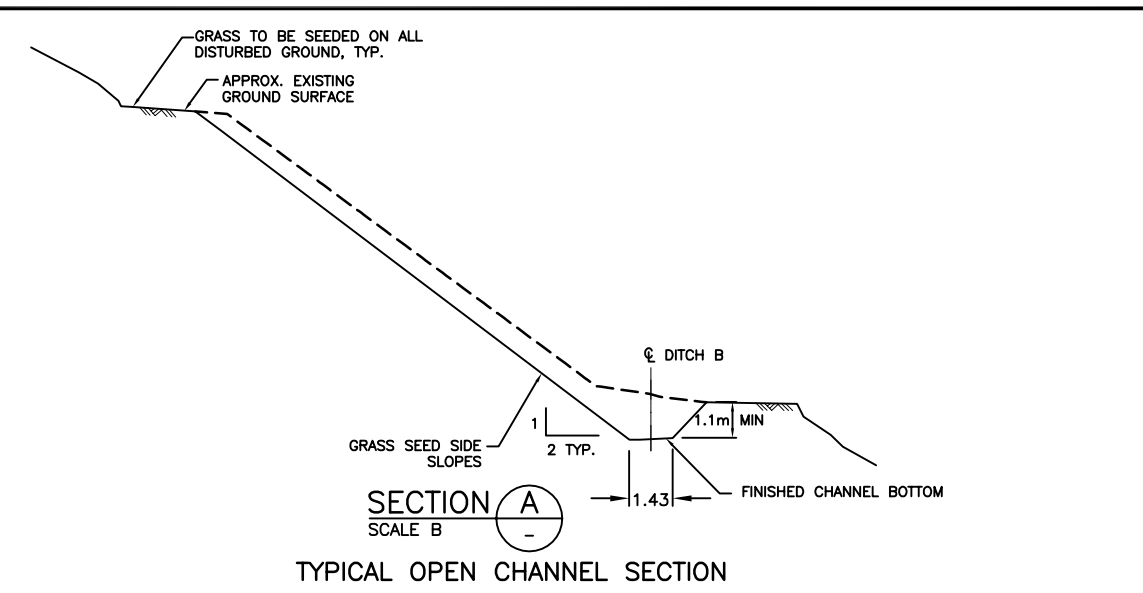
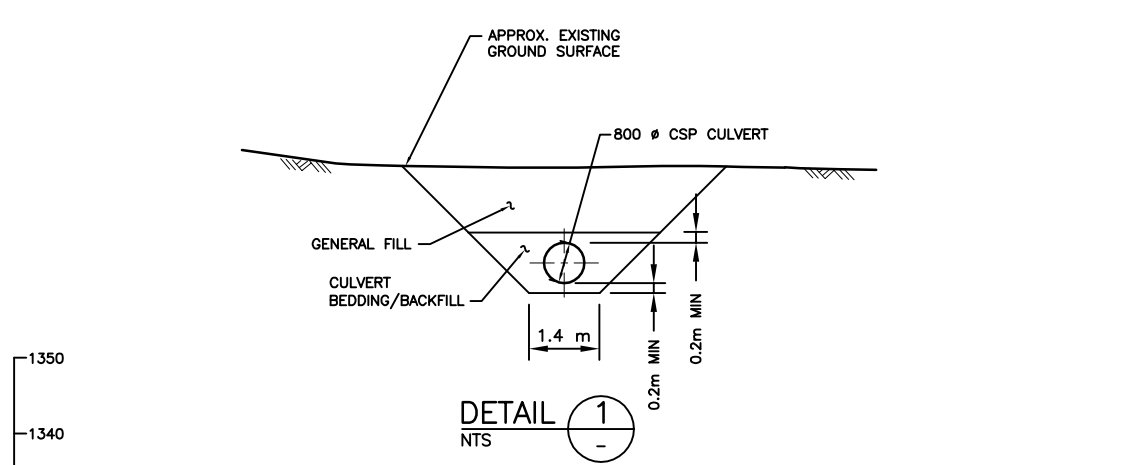
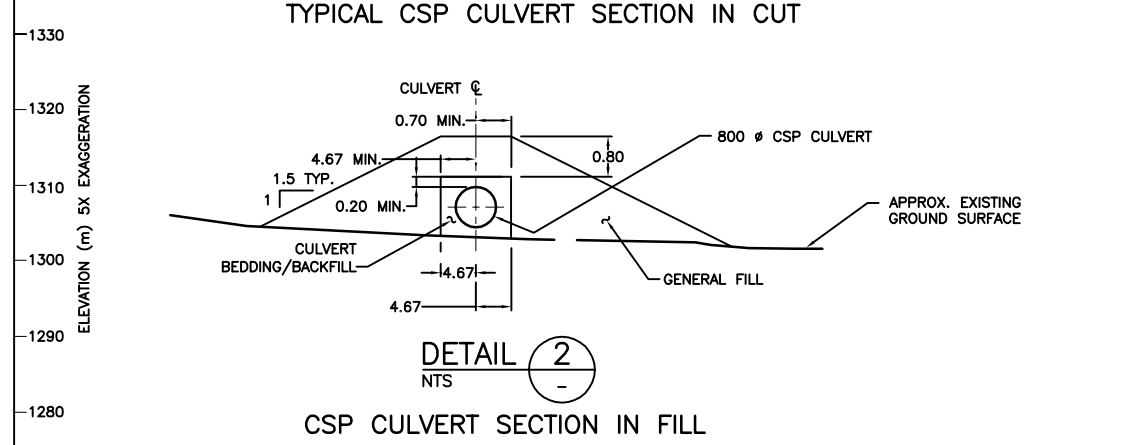
- NOTES:**
- FOR GENERAL SITE ARRANGEMENT SEE DWG. D-5001.
  - INVERT ELEVATIONS SHOWN ARE TO FINISHED CHANNEL BOTTOM.

**WOLVERINE PROJECT**  
**TAILINGS STORAGE FACILITY**  
**DIVERSION DITCH B**  
**PLAN, PROFILE AND SECTIONS**

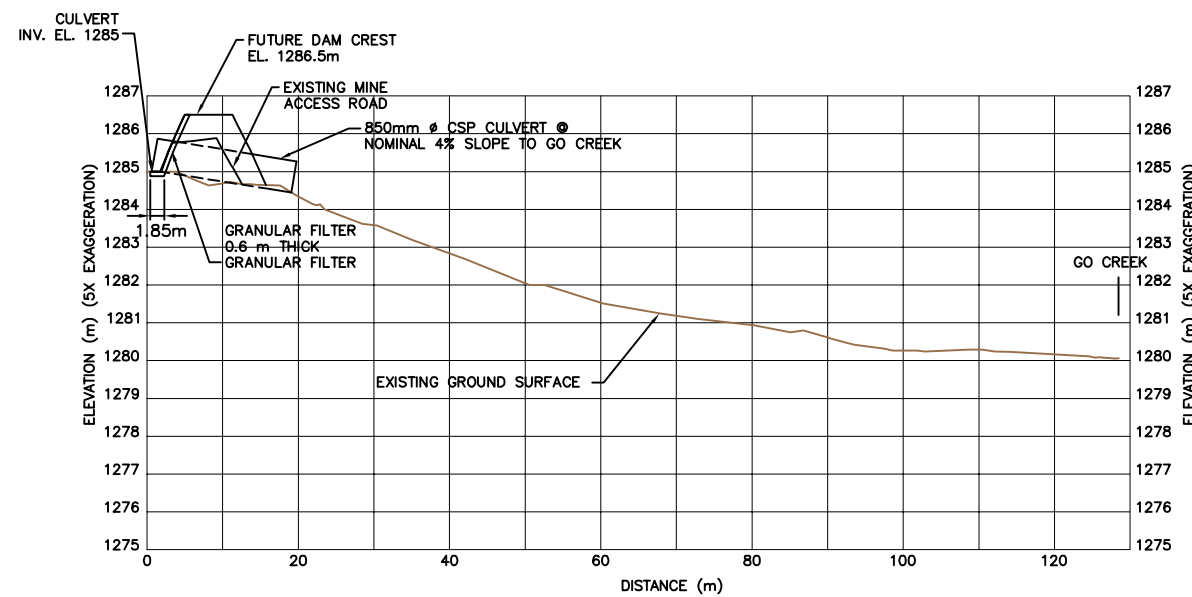
PROFILE OF SEEPAGE SPILLWAY  
SCALE: C

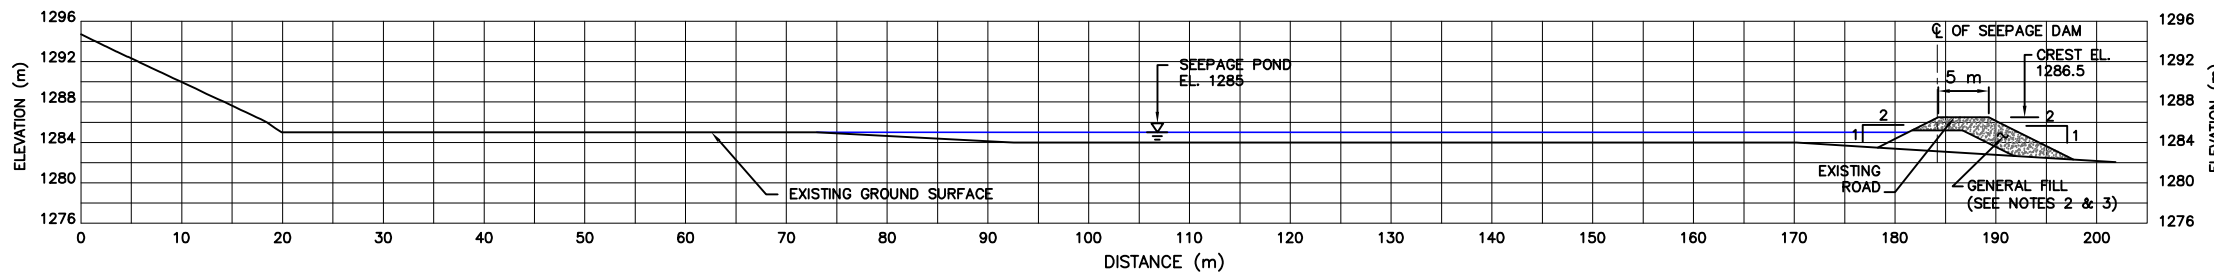
SECTION A  
SCALE B

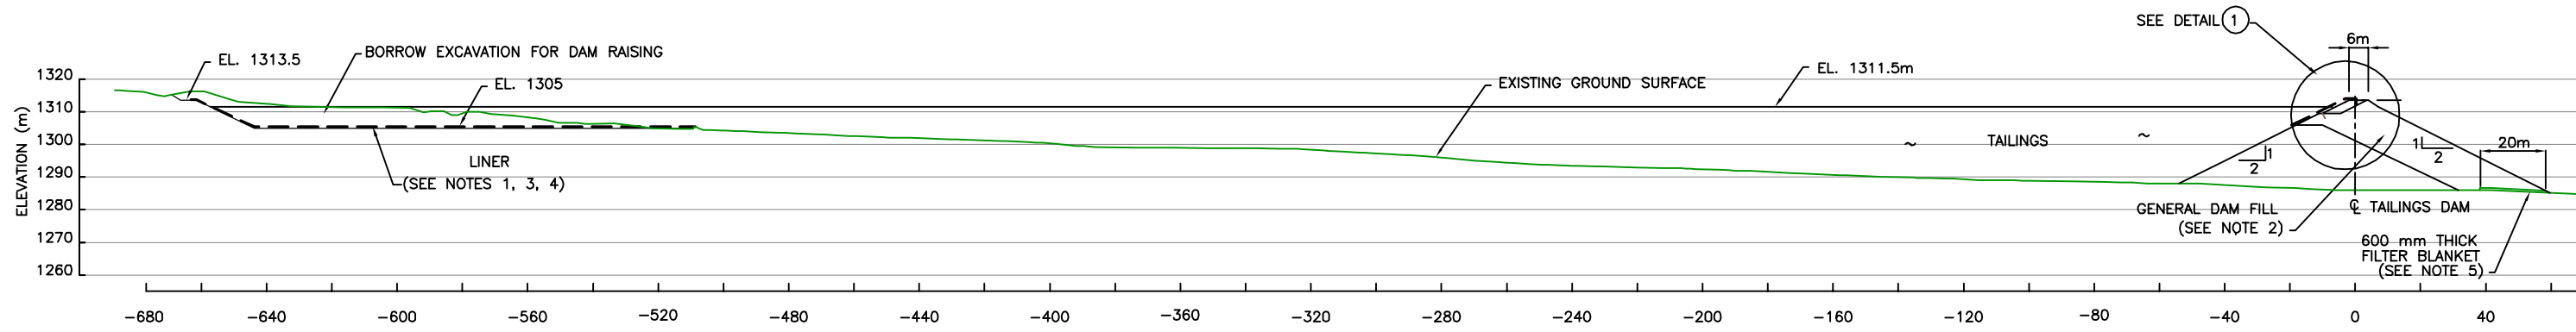
SECTION A  
SCALE A 2

**Yukon Zinc Corporation**  
**Wolverine Project**  
 TAILINGS STORAGE FACILITY  
 STAGE 2 IMPOUNDMENT EXCAVATION AND FILL  
 SECTIONS AND DETAILS

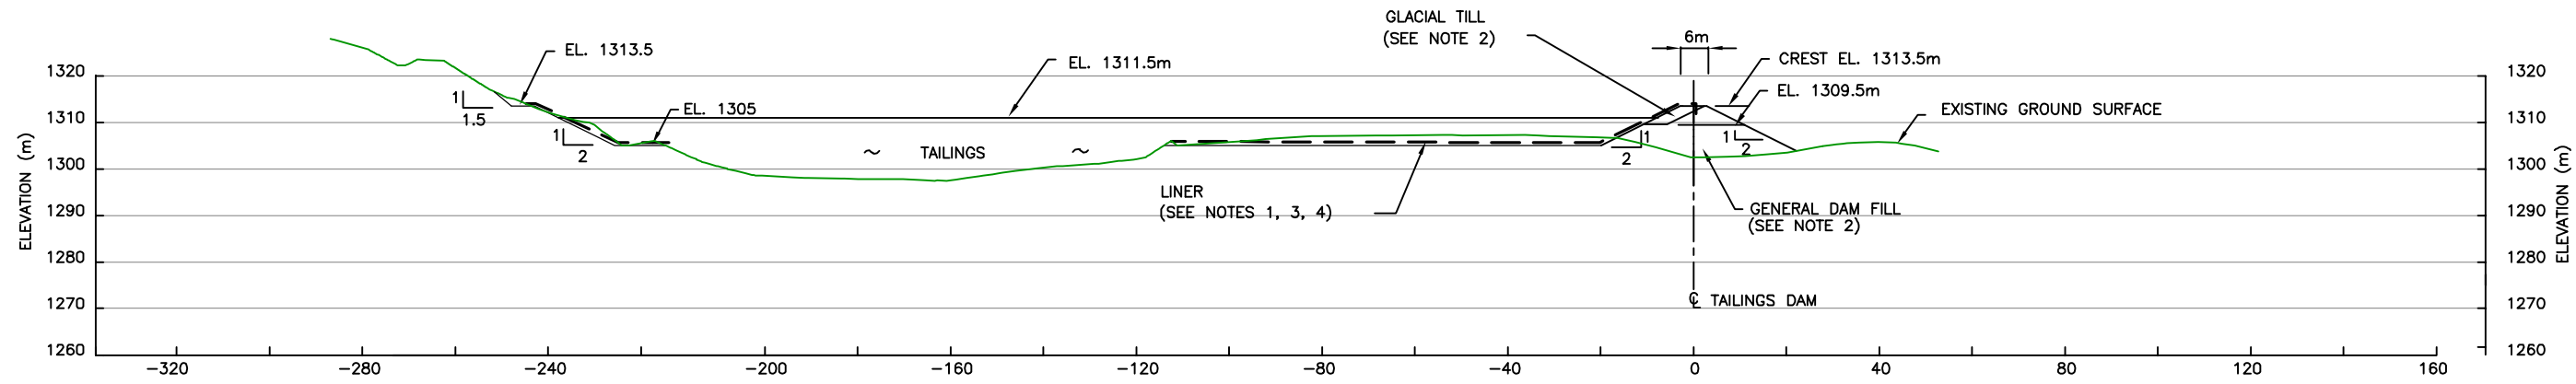
SECTION B  
SCALE B 2

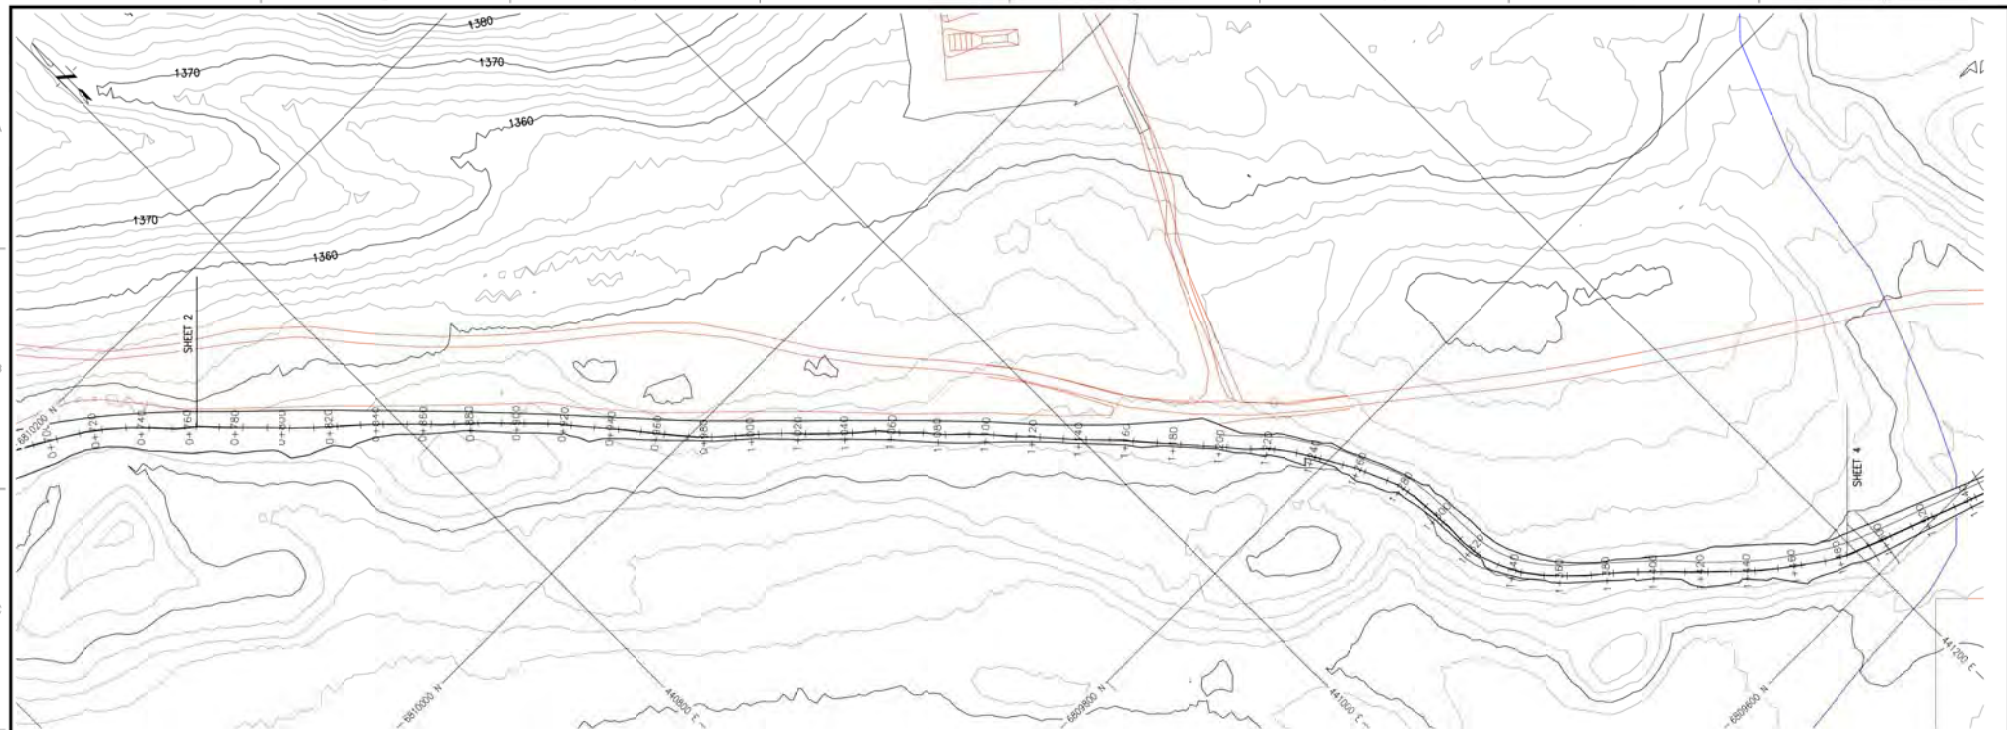
PLAN  
SCALE 1:1000

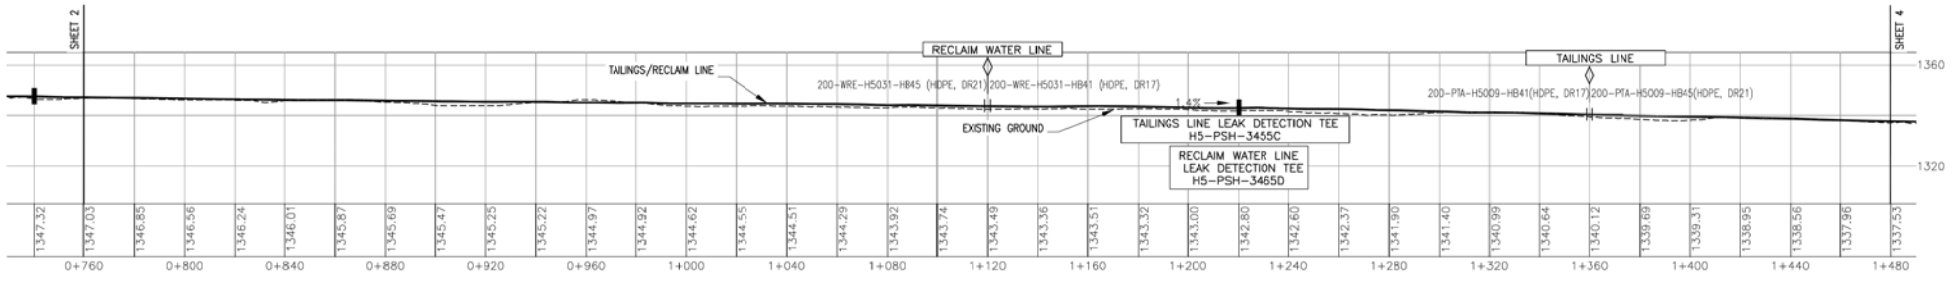
PROFILE  
SCALE 1:1000 V  
1:1000 H

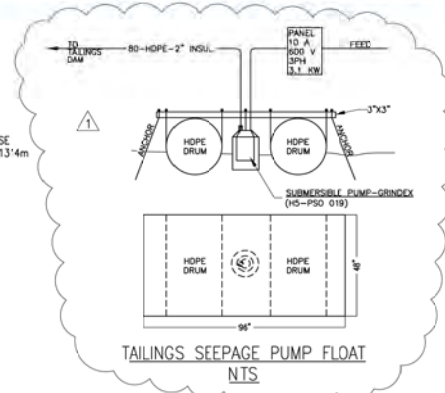
TAILINGS SEEPAGE PUMP FLOAT  
NTS

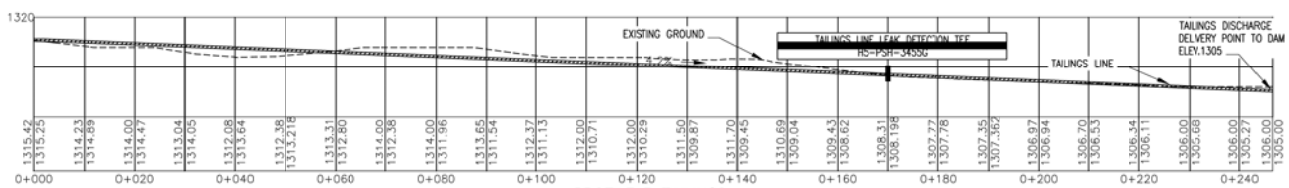
PROFILE 3 TAILINGS  
SCALE 1:500 V  
1:500 H

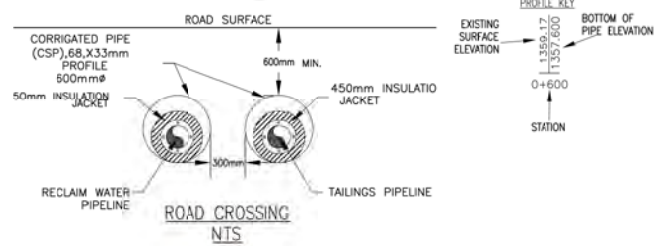
ROAD CROSSING  
NTS

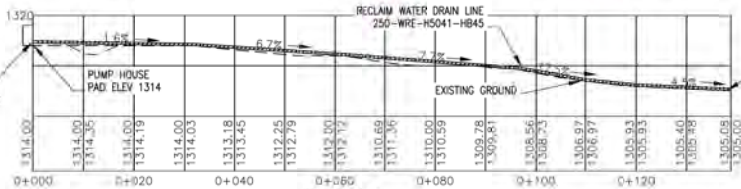
PROFILE 1  
RECLAIM DRAIN PIPELINE  
SCALE 1:500 V  
1:500 H

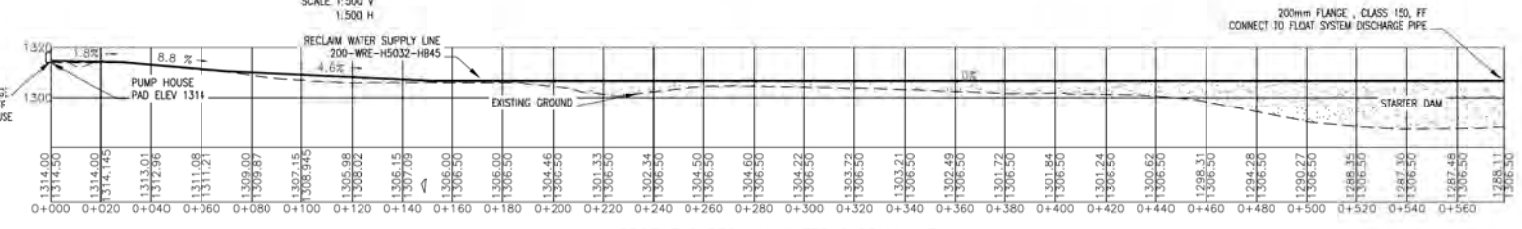
PROFILE 2 RECLAIM WATER SUPPLY LINE  
SCALE 1:1000 V  
1:1000 H
