## **Wolverine Project**

# **TAILINGS AND INFRASTRUCTURE DESIGN AND CONSTRUCTION PLAN**

***VERSION 2009-02***

**Klohn Crippen Berger Ltd**

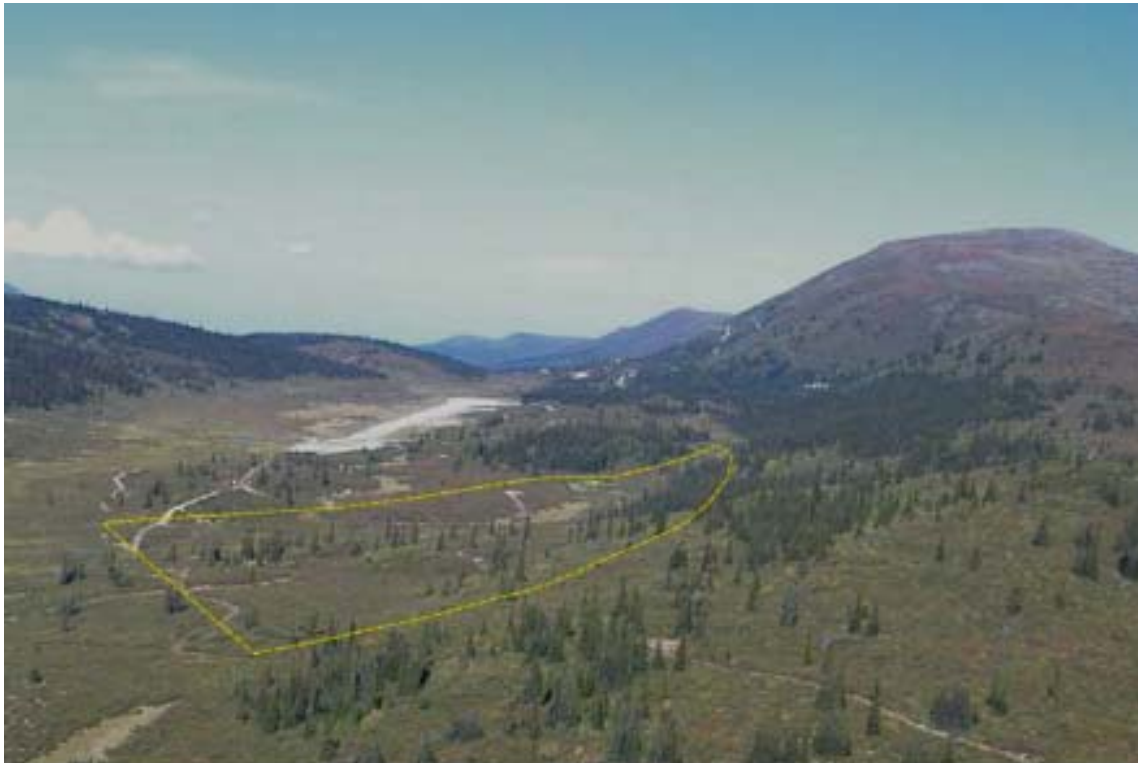
**Photo 2.1 Tailings Facility General Area, looking northwest.**

Photo 2.1 presents a photograph of the tailings facility area looking northwest, with the tailings impoundment outlined in yellow and the main dam located at the left end of the yellow outline.
