## WOLVERINE PROJECT

### TAILINGS FACILITY

# OPERATION, MAINTENANCE AND SURVEILLANCE MANUAL

Prepared by  
Yukon Zinc Corporation

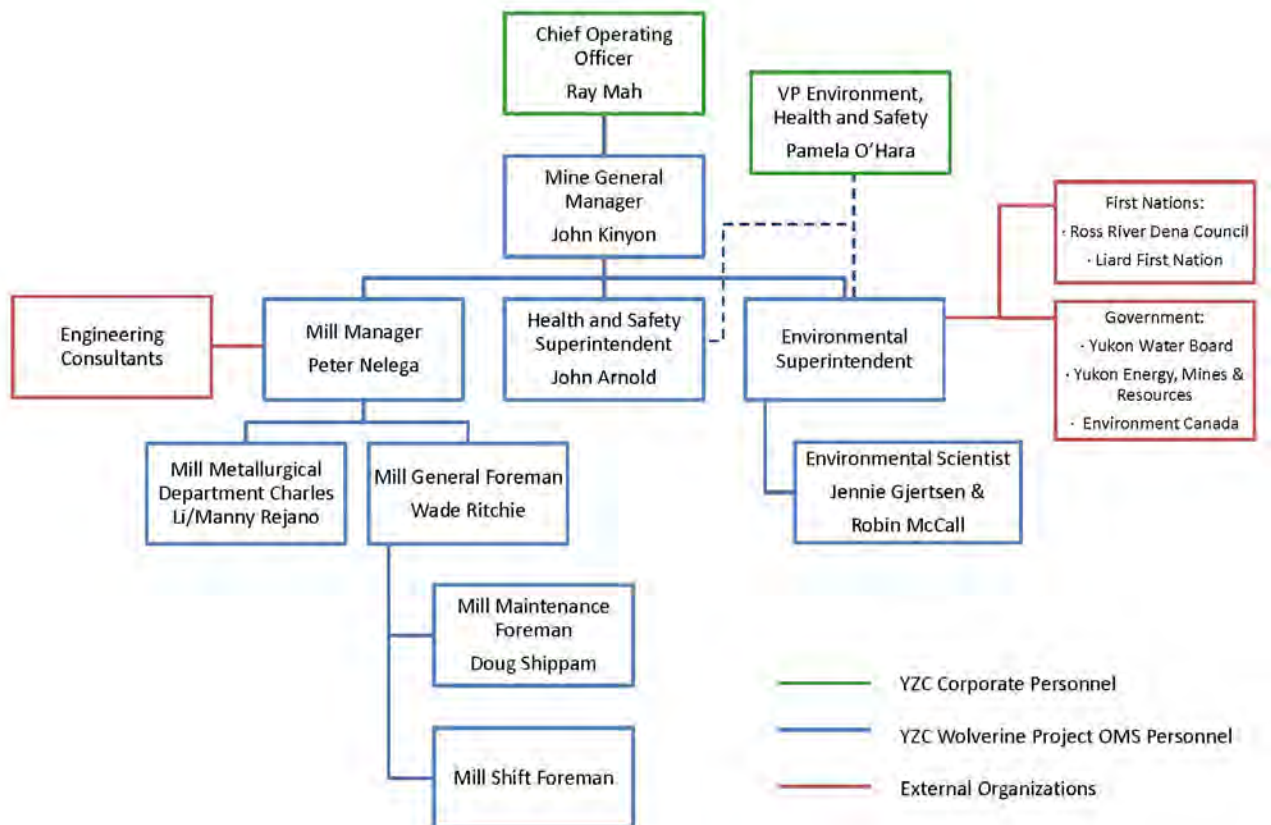
**Figure 2-1: OMS Organization Chart**

The main individuals associated with the tailings facility OMS are the Mill Manager and Environmental Superintendent. Other supporting personnel include the Mine General Manager, Health and Safety Superintendent, Mill General Foreman, and employees trained in the operating of the tailings facility. Certain YZC corporate personnel also support the onsite operations. Support external to YZC will be provided by KCBL (Engineering Consultants), and external reporting will occur to First Nations and Government. Figure 2-1 provides an organization chart that shows reporting links within the organization and communication links to external organizations.

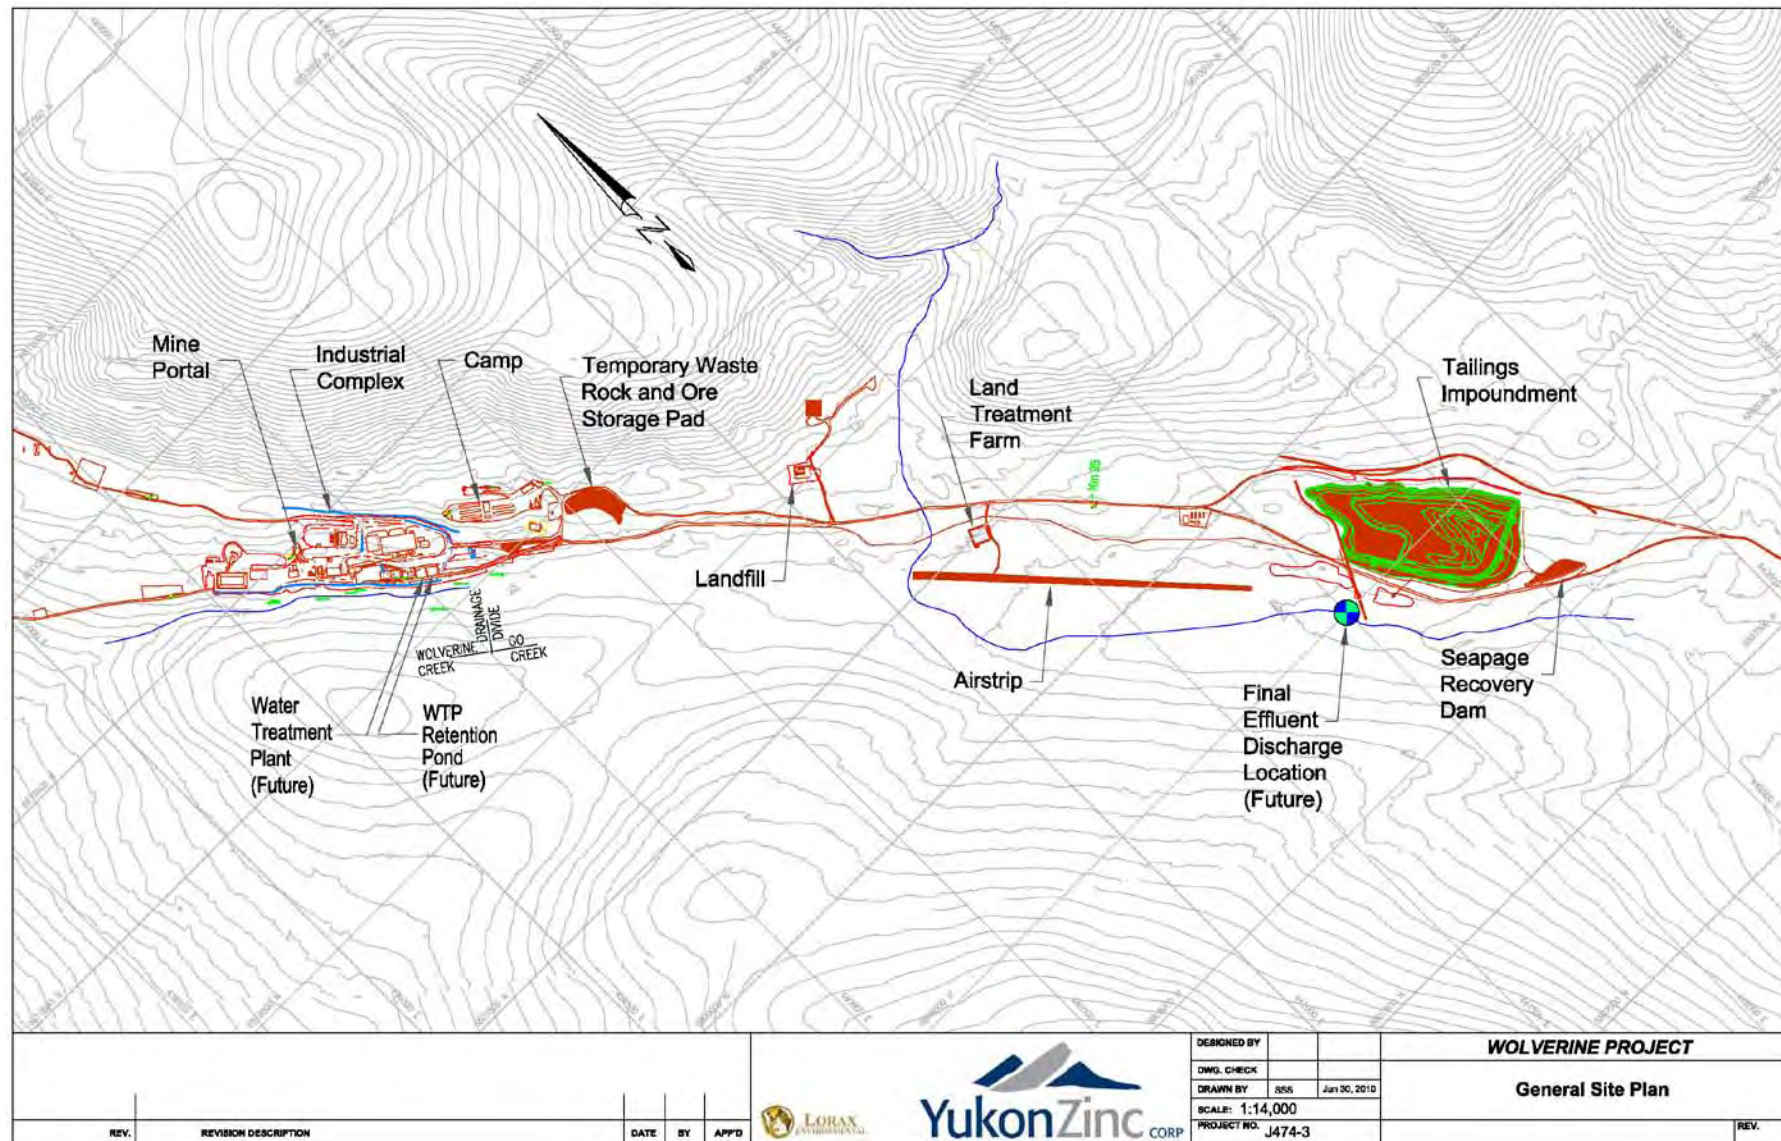
Figure 3-2: Wolverine Mine Project General Site Plan

The main industrial complex includes a process plant, crusher building, concentrate load-out building, maintenance and fuelling facilities, water diversion and collection infrastructure, sewage treatment plant, 230 man camp, laboratory, and office buildings. The camp consists of a kitchen and mess hall building, a recreation facility, and six bunk houses with laundry facilities. Power is supplied by diesel gensets and water is supplied from a local well. In 2012, a water treatment plant and retention pond will be constructed. Figure 3-2 provides a general site plan for the Wolverine Project mine area operations.

As mentioned above, the tailings facility will operate with a positive water balance. A water treatment plant to treat excess water accumulating in the tailings impoundment is currently being designed and will be built within the industrial complex area (see Figure 3-2 for proposed plant and retention pond location) in 2012. The tailings impoundment has sufficient capacity to store approximately three years of water discharged to the impoundment. Accordingly, water treatment operations, and effluent discharge, will not be required until May-June 2013. The annual tailings production rates are summarized in Table 3-3.

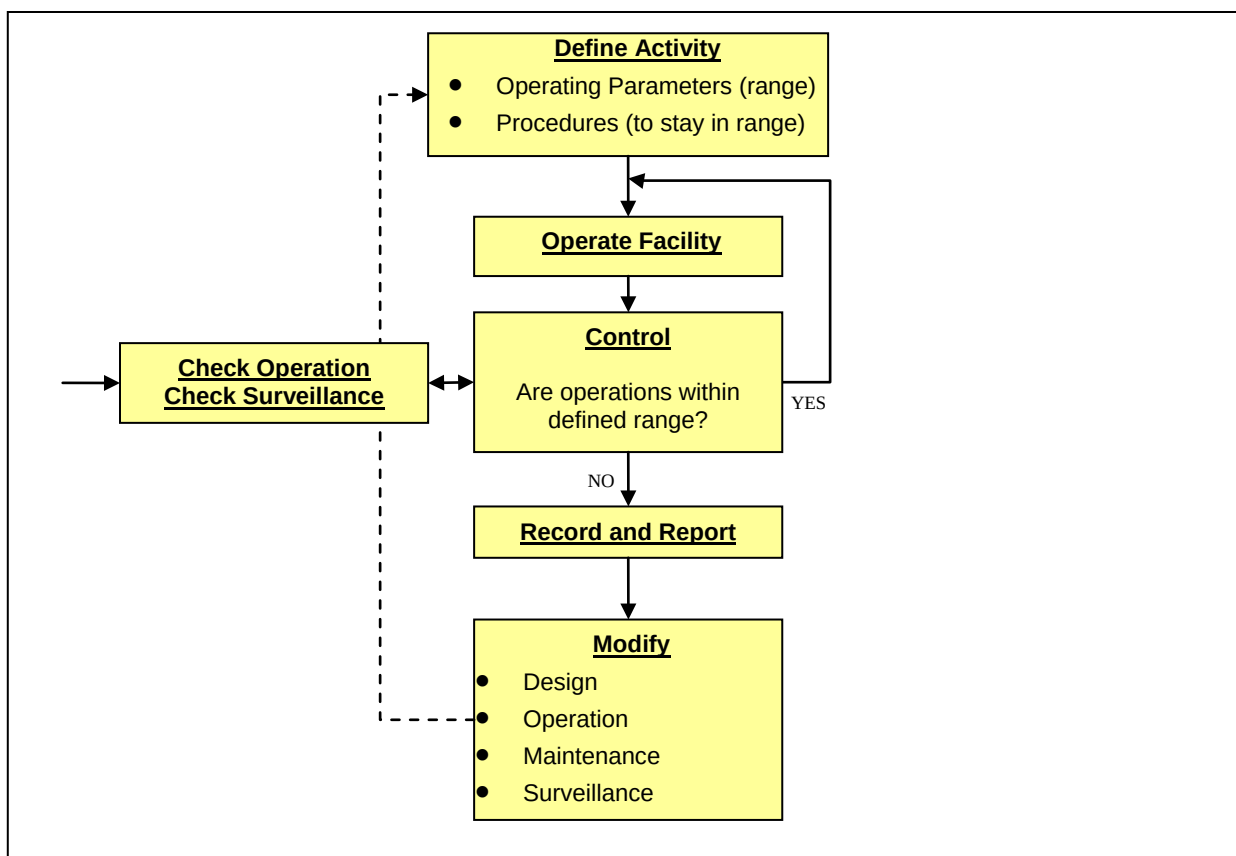
Figure 5-1: Typical Operation Flowchart

A typical operation flowchart is shown in Figure 5-1. The flowchart describes the performance review procedure that will be applied to each component of the facility to help ensure safe operation. The main operational aspects of the tailings facility include: deposition of tailings, water management, water reclaim barge operation, and seepage collection system operation. As water treatment will not be conducted until the ultimate dam has been completed, operation of the water treatment plant is not included herein.

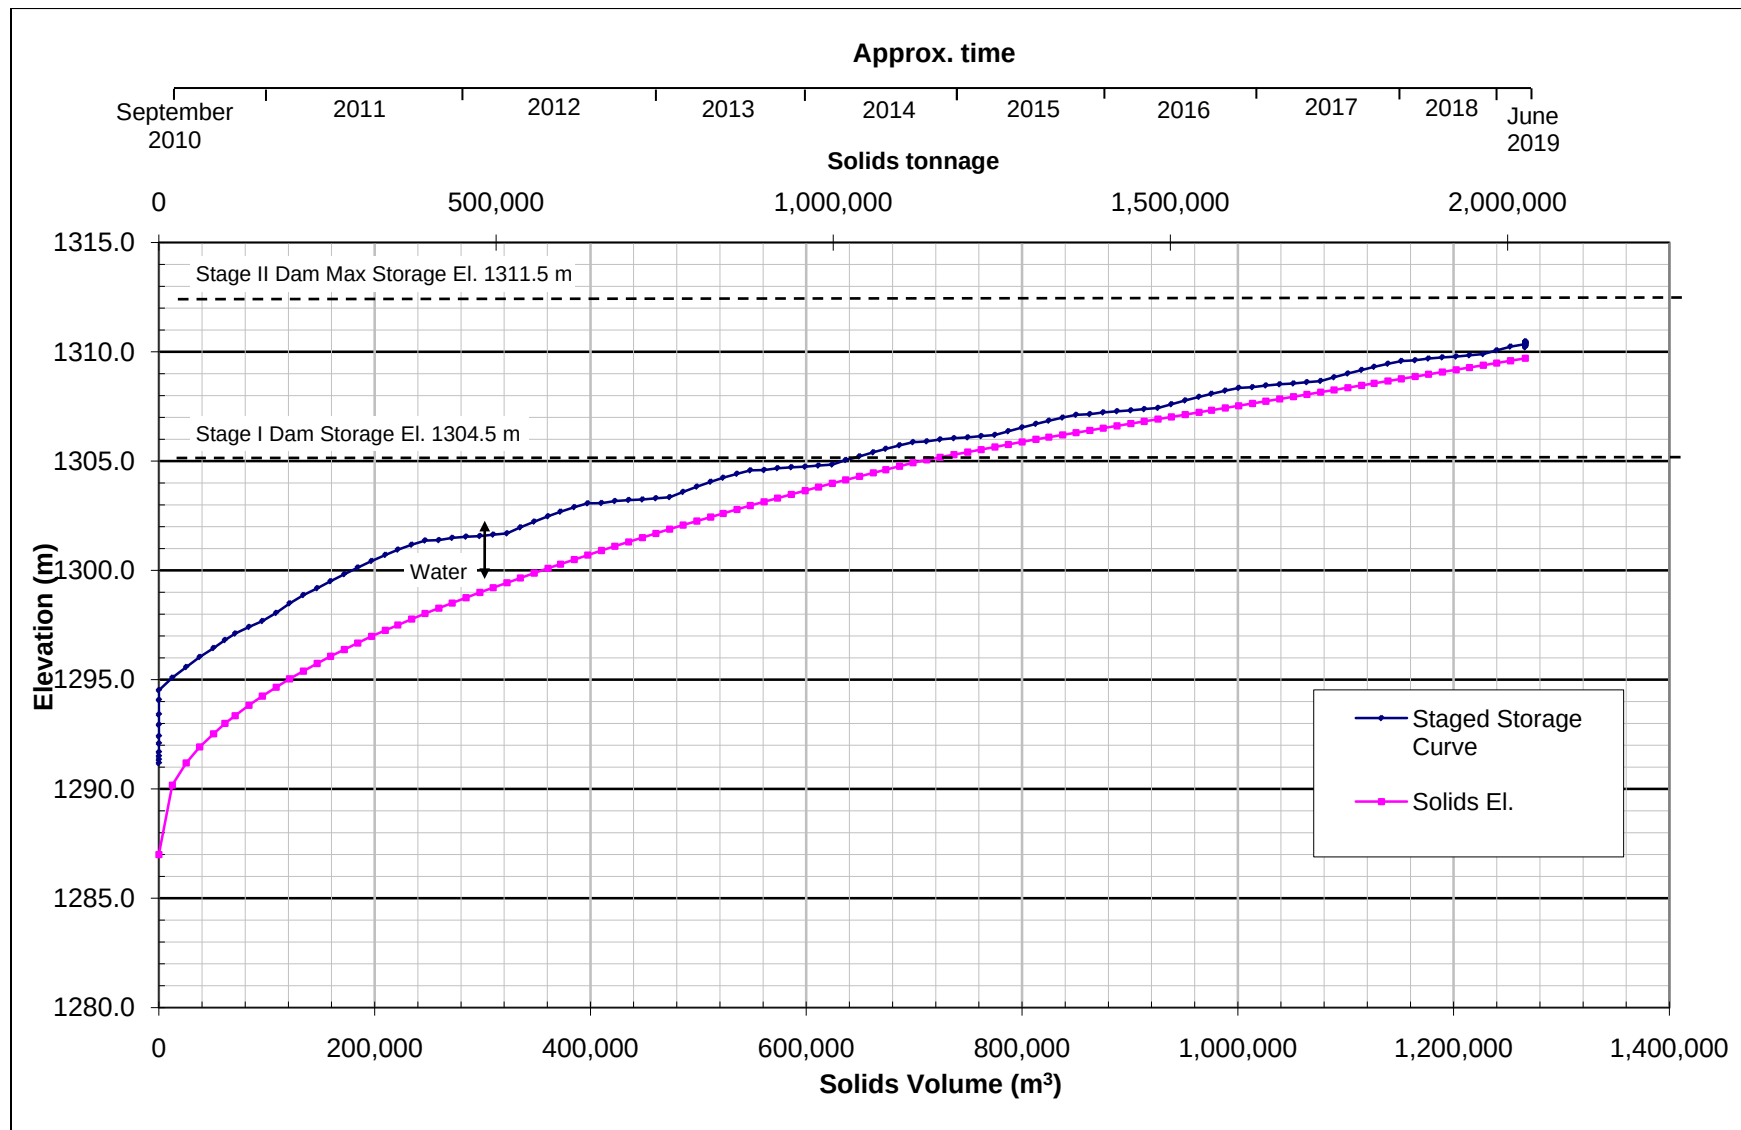
Figure 5-2: Stage Storage Curve for the Starter and Ultimate Tailings Impoundments

The results of the annual accumulation of water and solids storage are presented in Figure 5-2, along with the stage storage elevation curve for the impoundment.

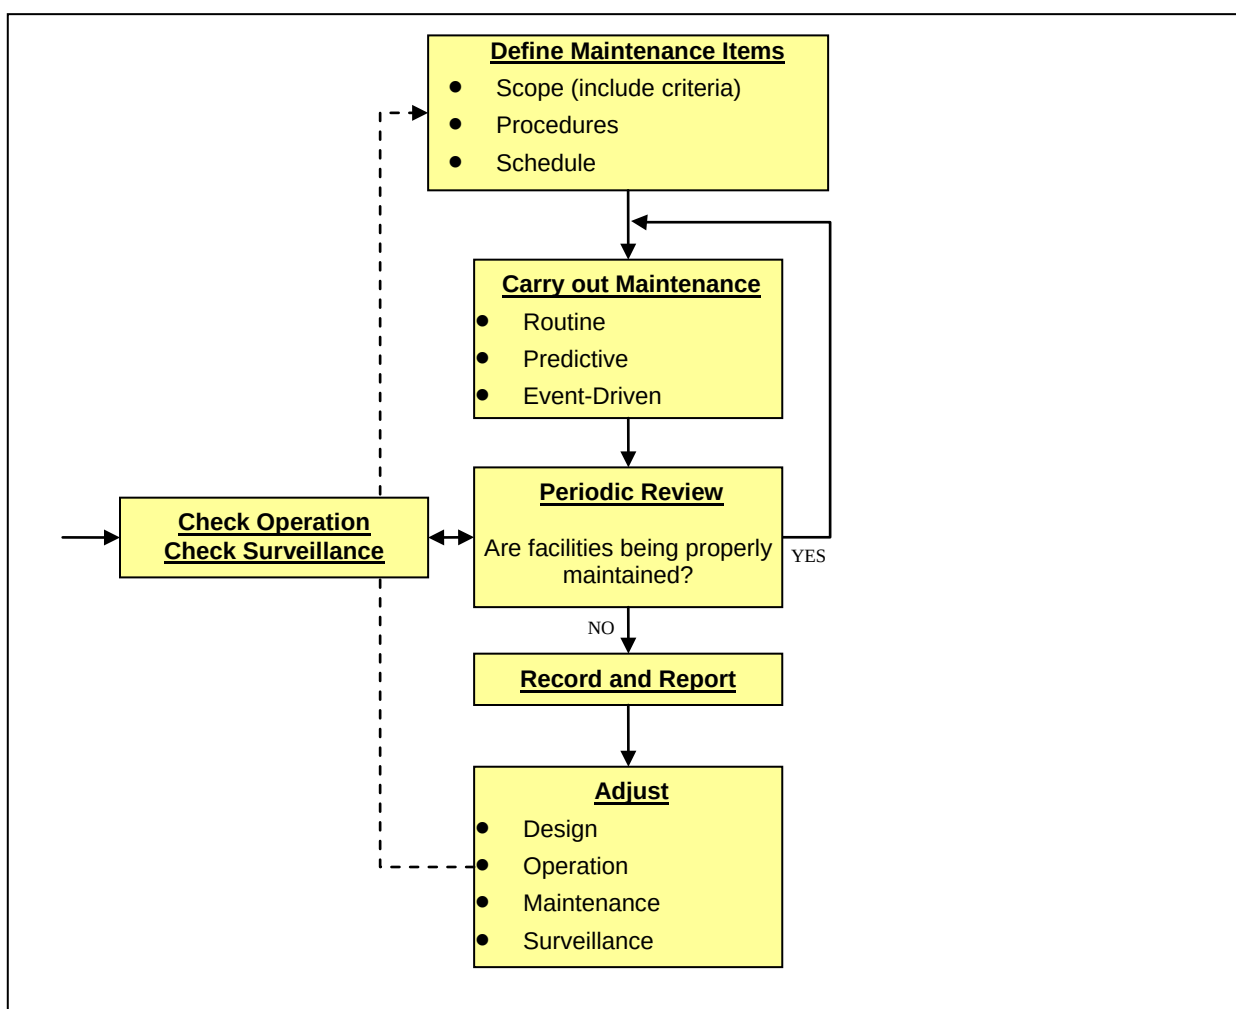
Figure 6-1: Maintenance Flowchart

A general Maintenance Flowchart is shown in Figure 6-1. The flowchart describes a maintenance review procedure that should be applied to each component of the facility to help ensure safe operation. Components requiring maintenance include:

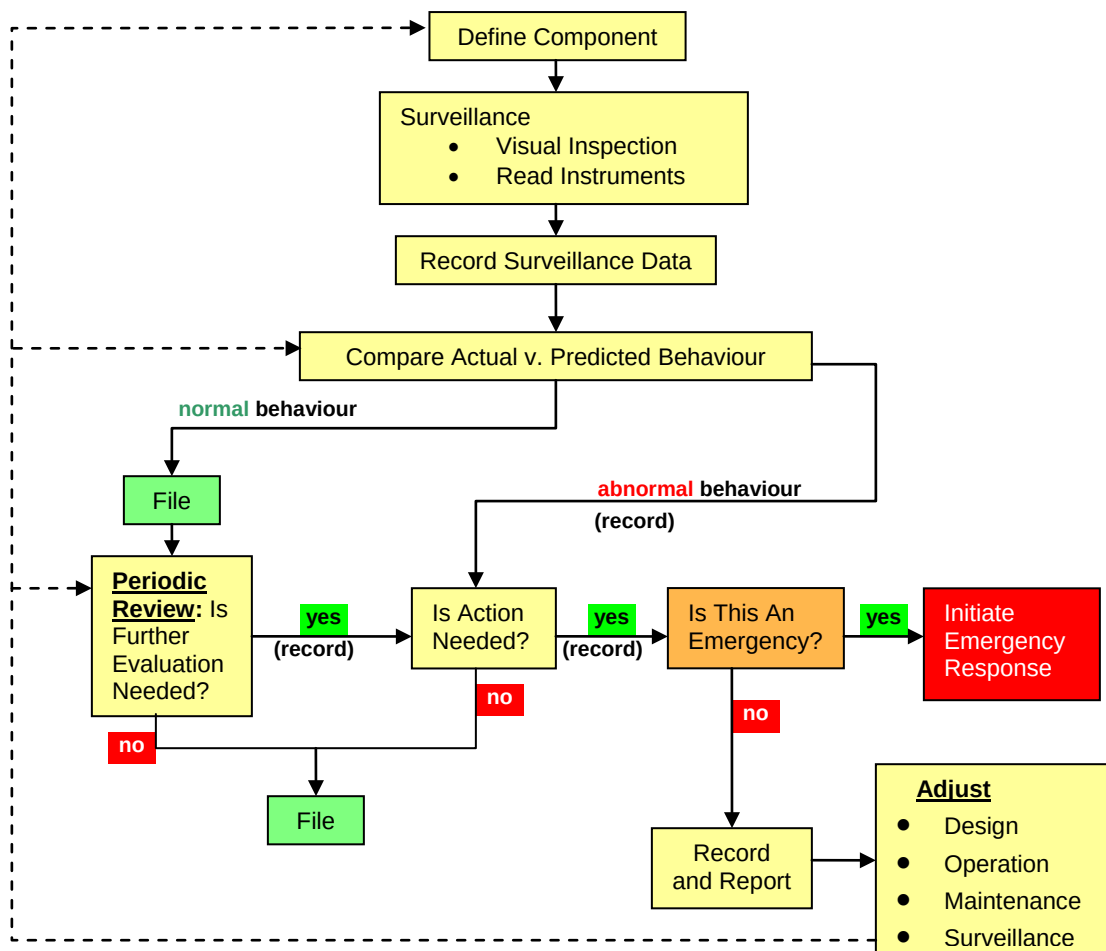
Figure 7-1: Surveillance Flowchart

A flowchart of the Surveillance process is shown in Figure 7-1. The flowchart describes a surveillance review procedure that will be applied to each component of the facility to help ensure safe and continued operation.

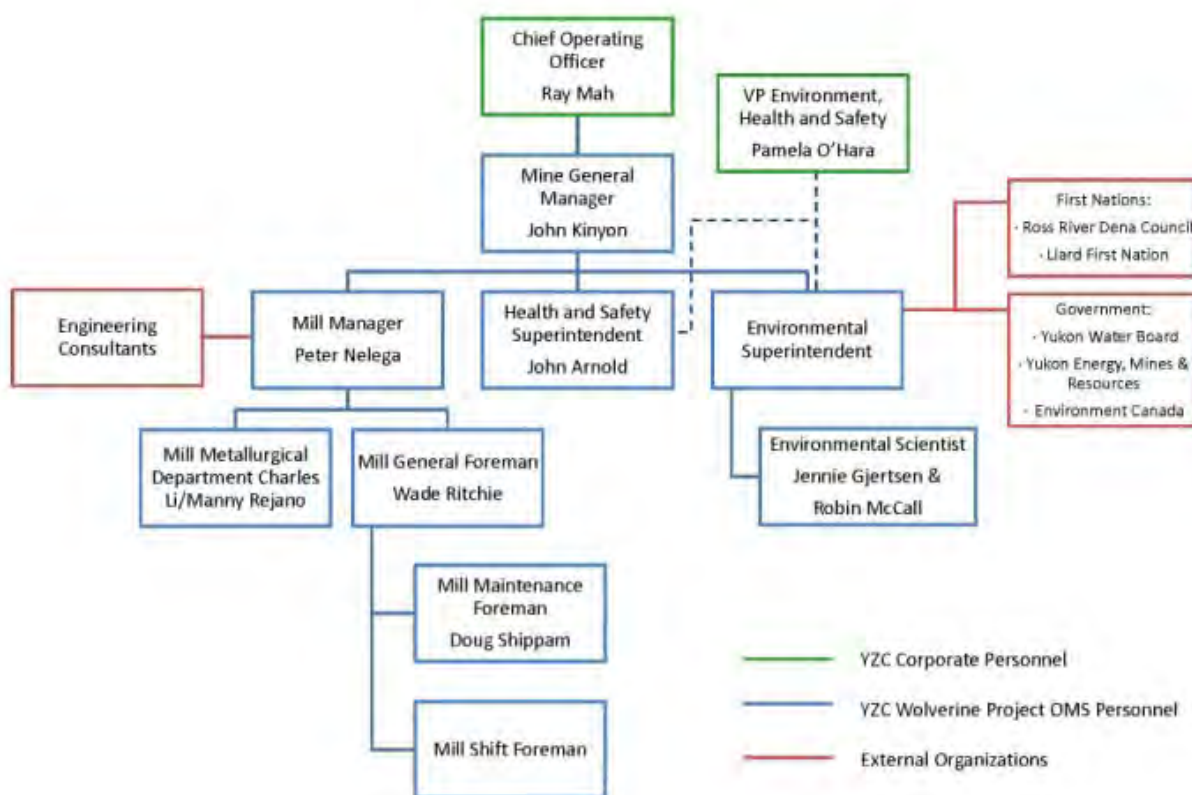
**Figure 8-1: Internal and External Reporting Personnel**

Lines of communication with the site and the responsibility to notify affected external stakeholders, including government agencies, local organizations, First Nations, and other individuals are illustrated in Figure 8-1.

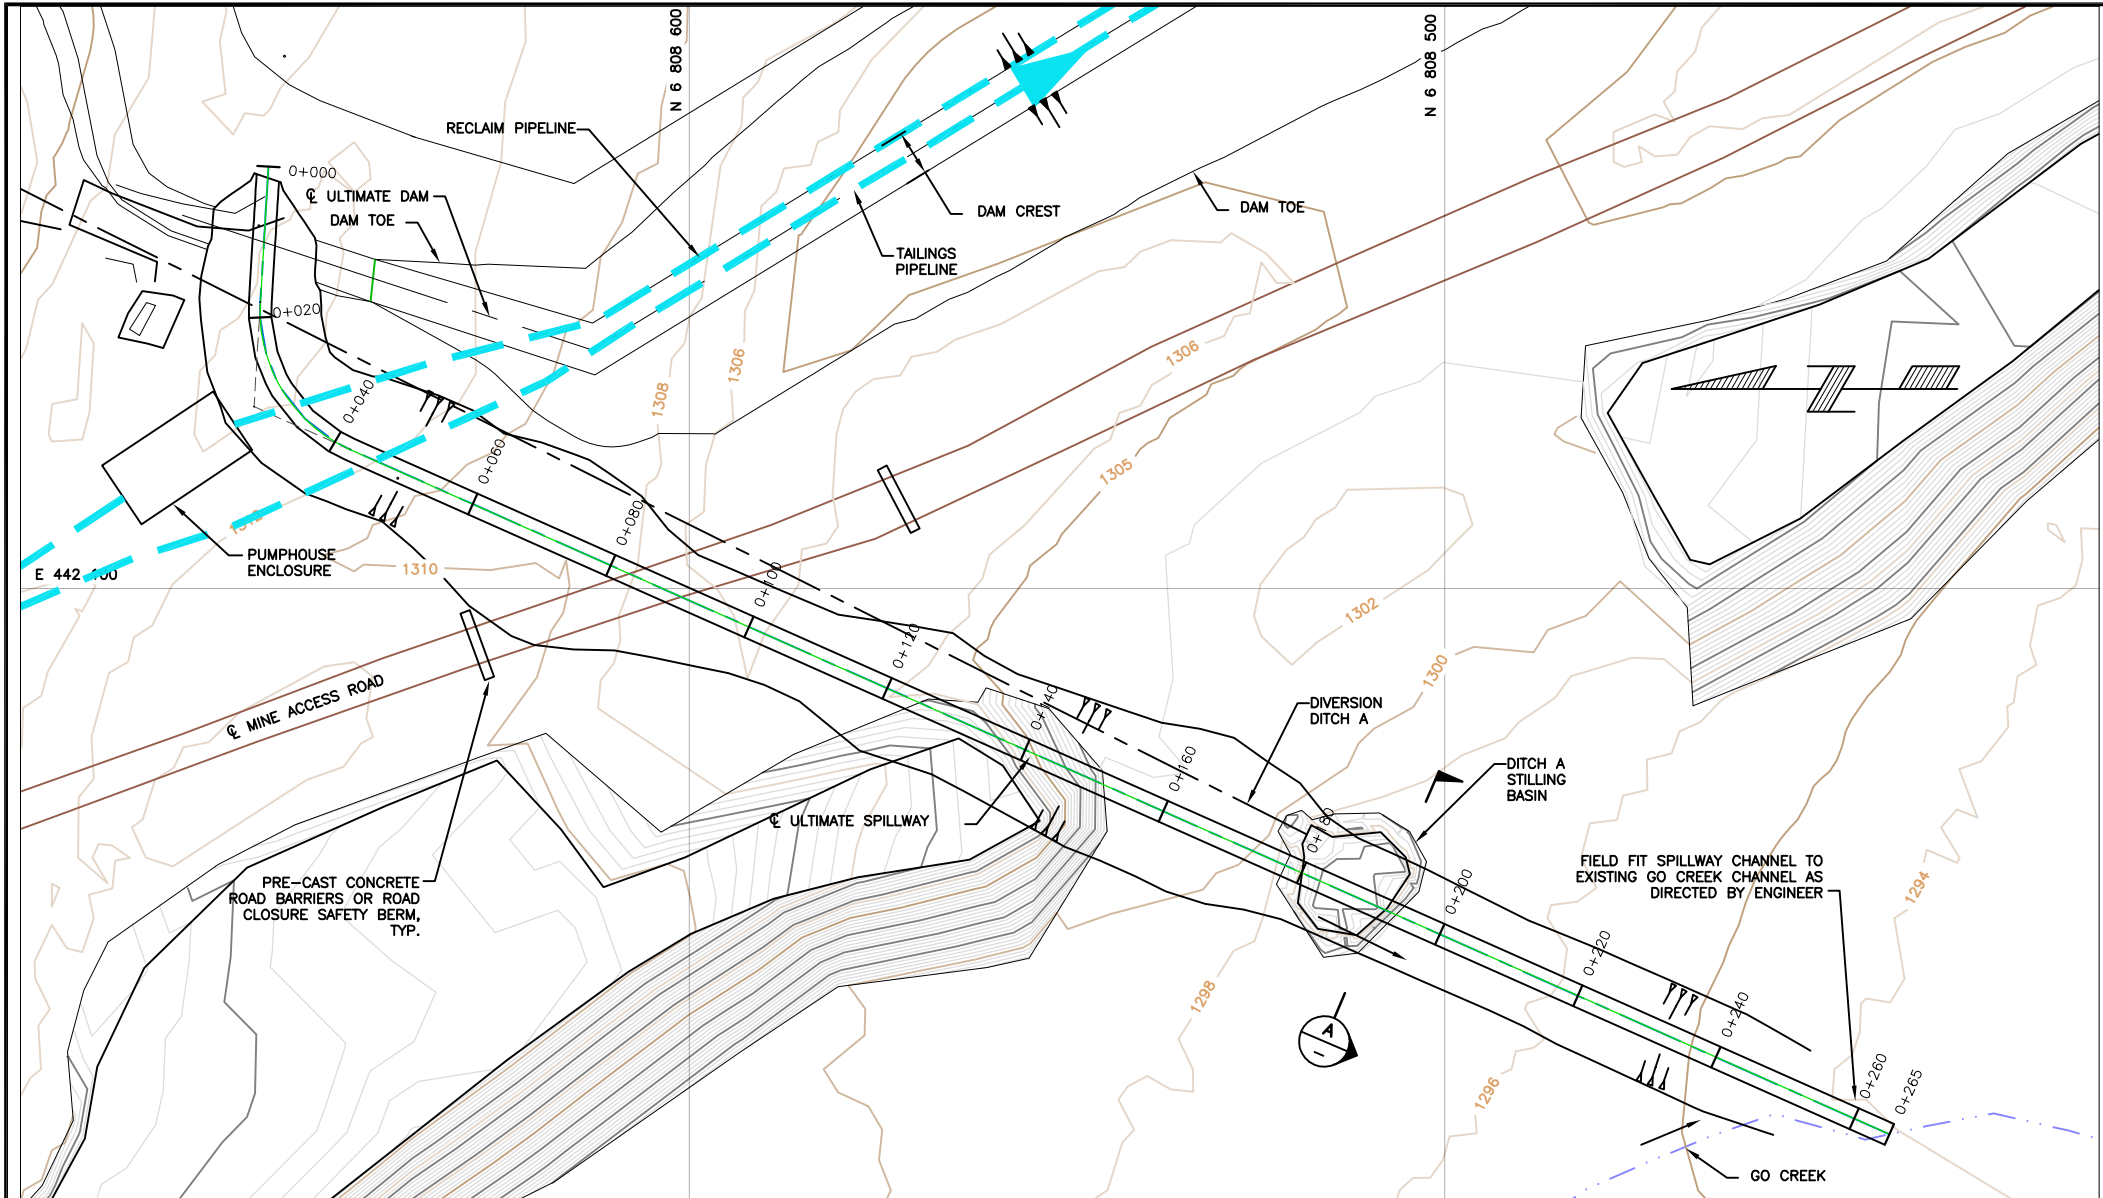
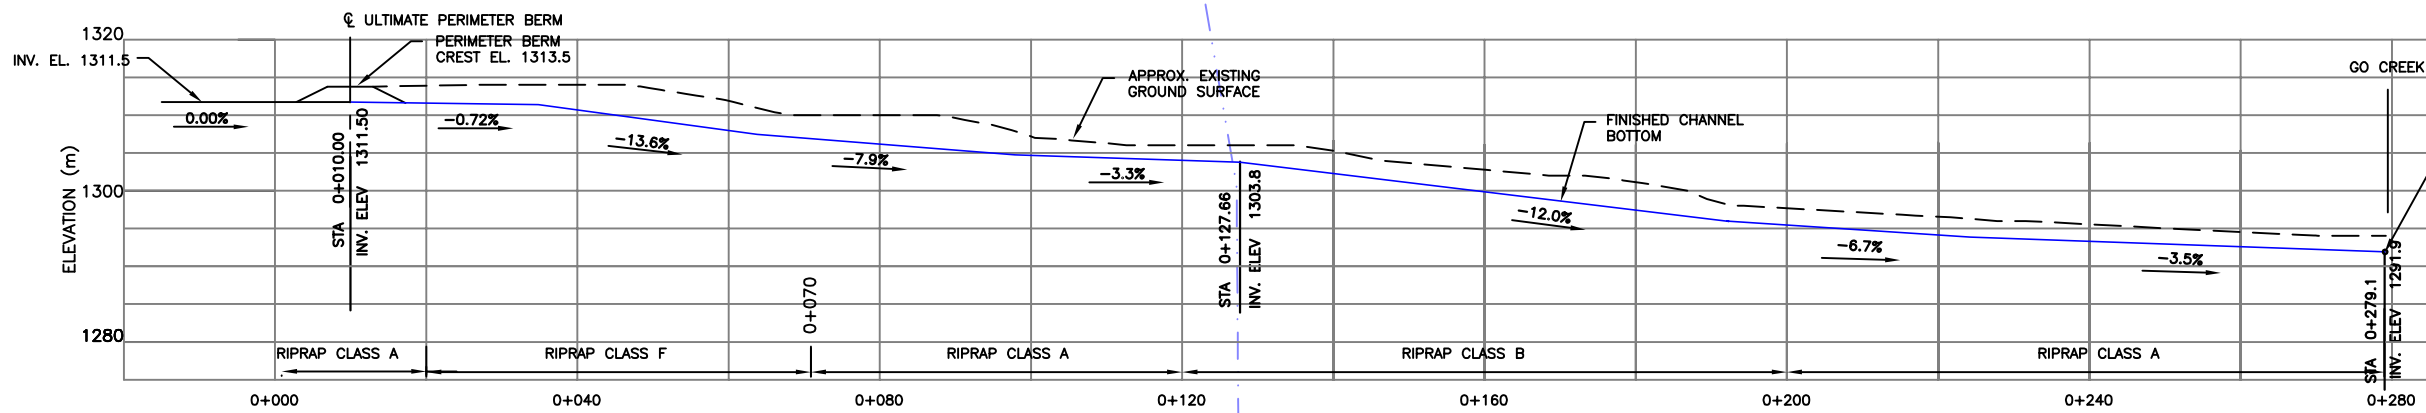
PLAN  
SCALE A

PROFILE - ULTIMATE SPILLWAY  
SCALE A

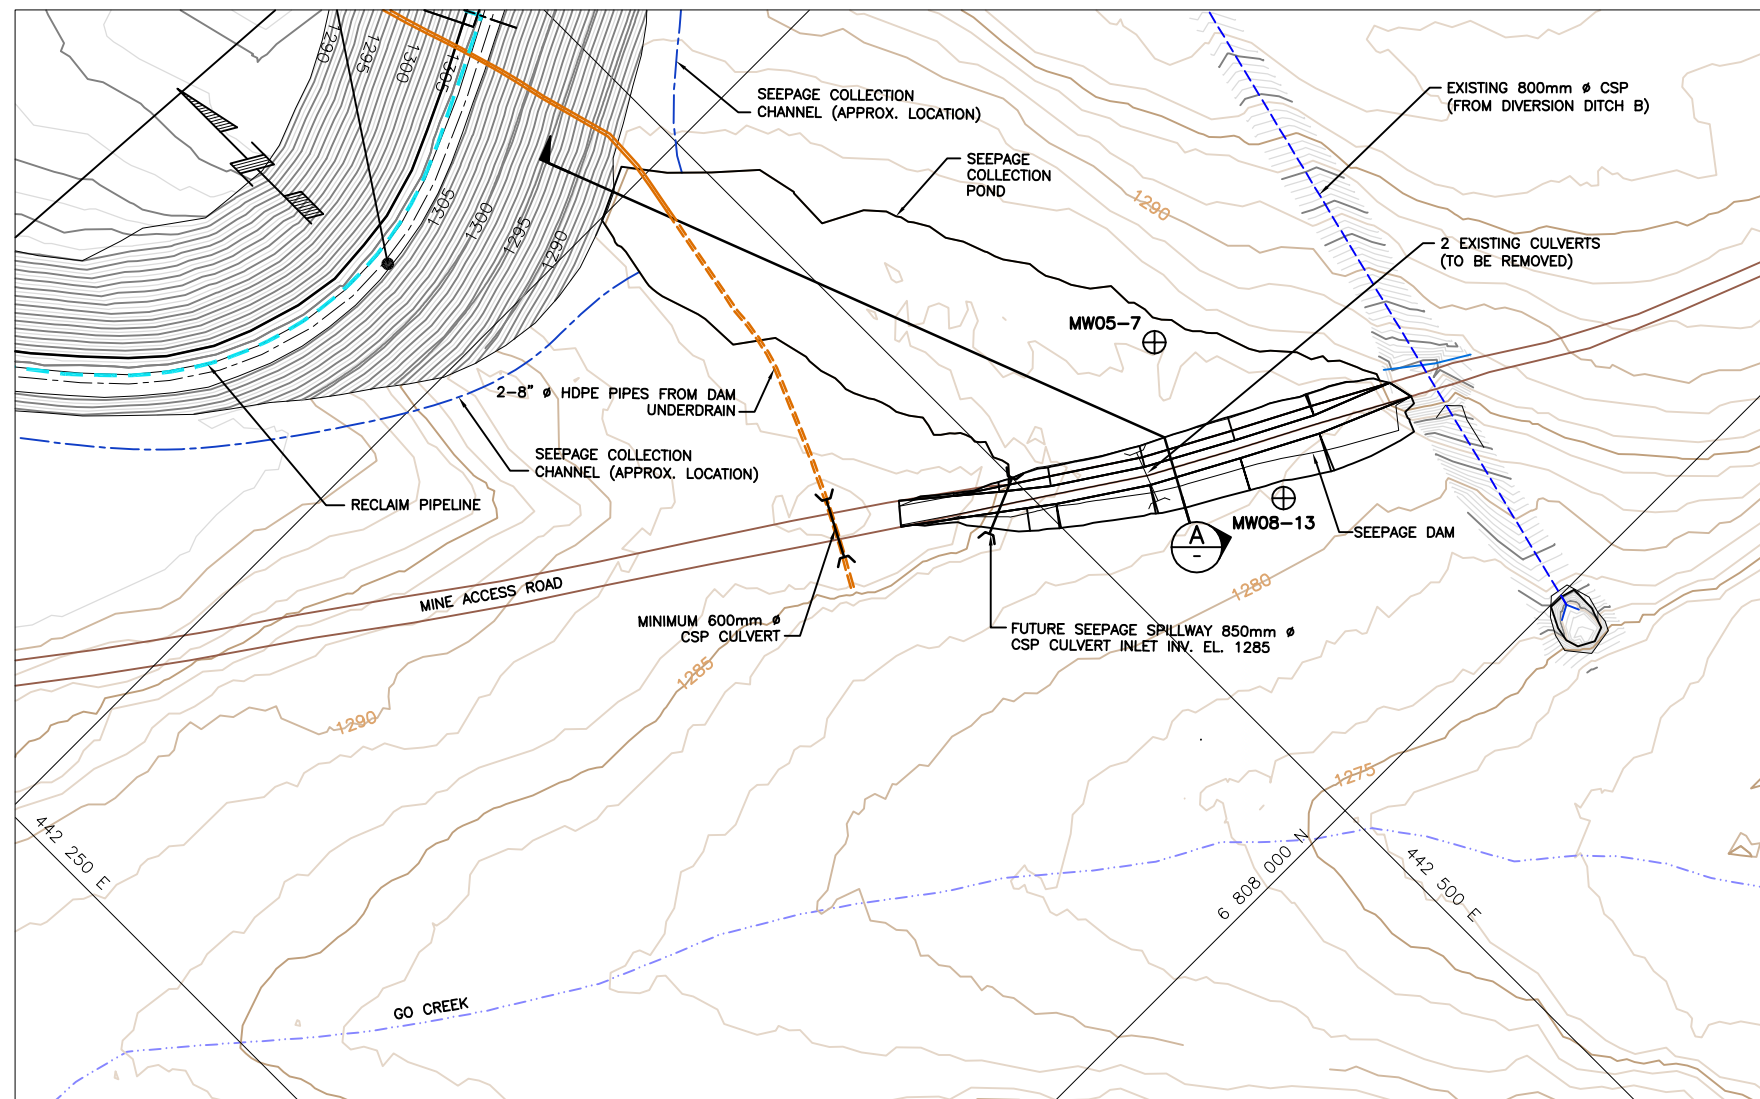
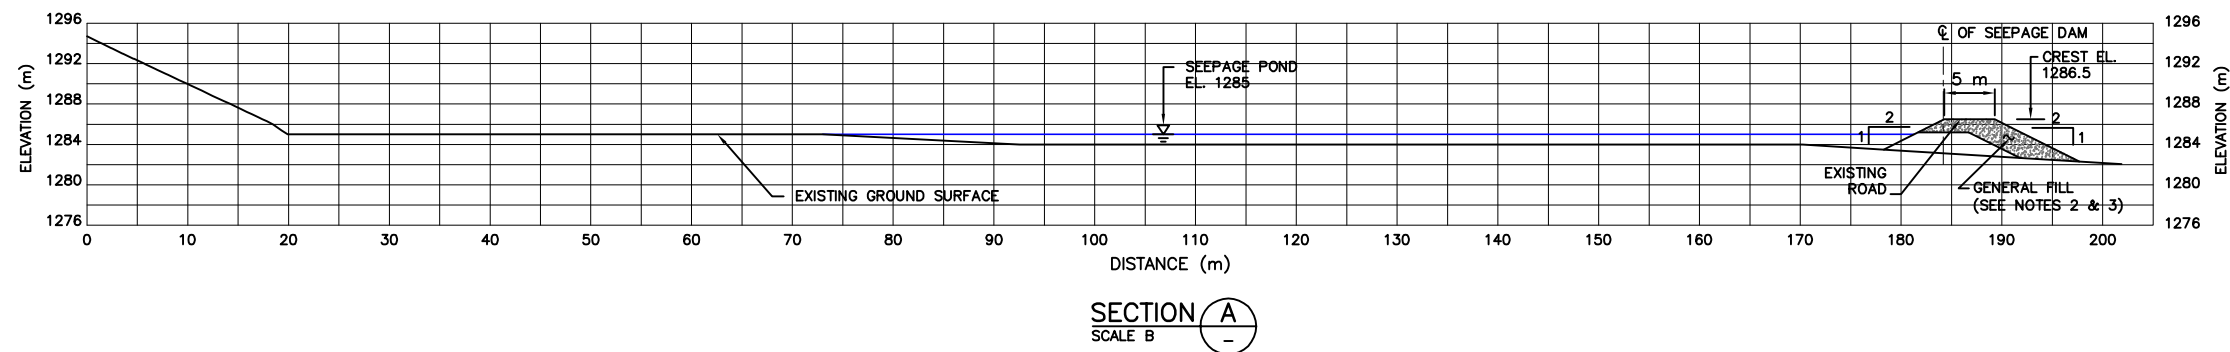
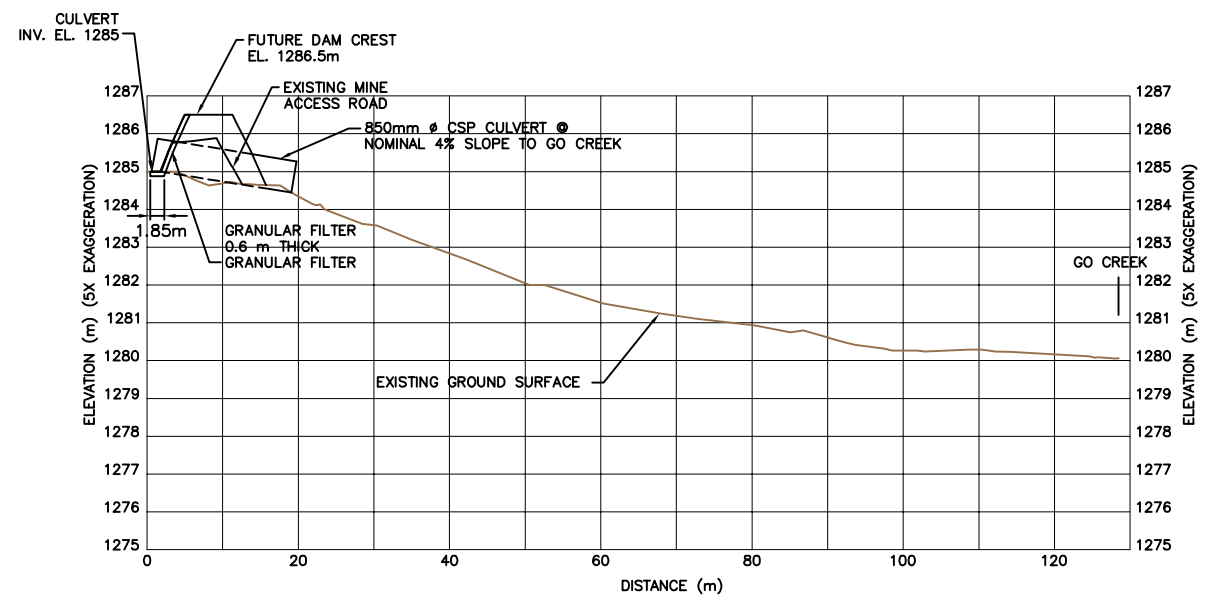
PLAN  
SCALE A

### PROFILE OF SEEPAGE SPILLWAY

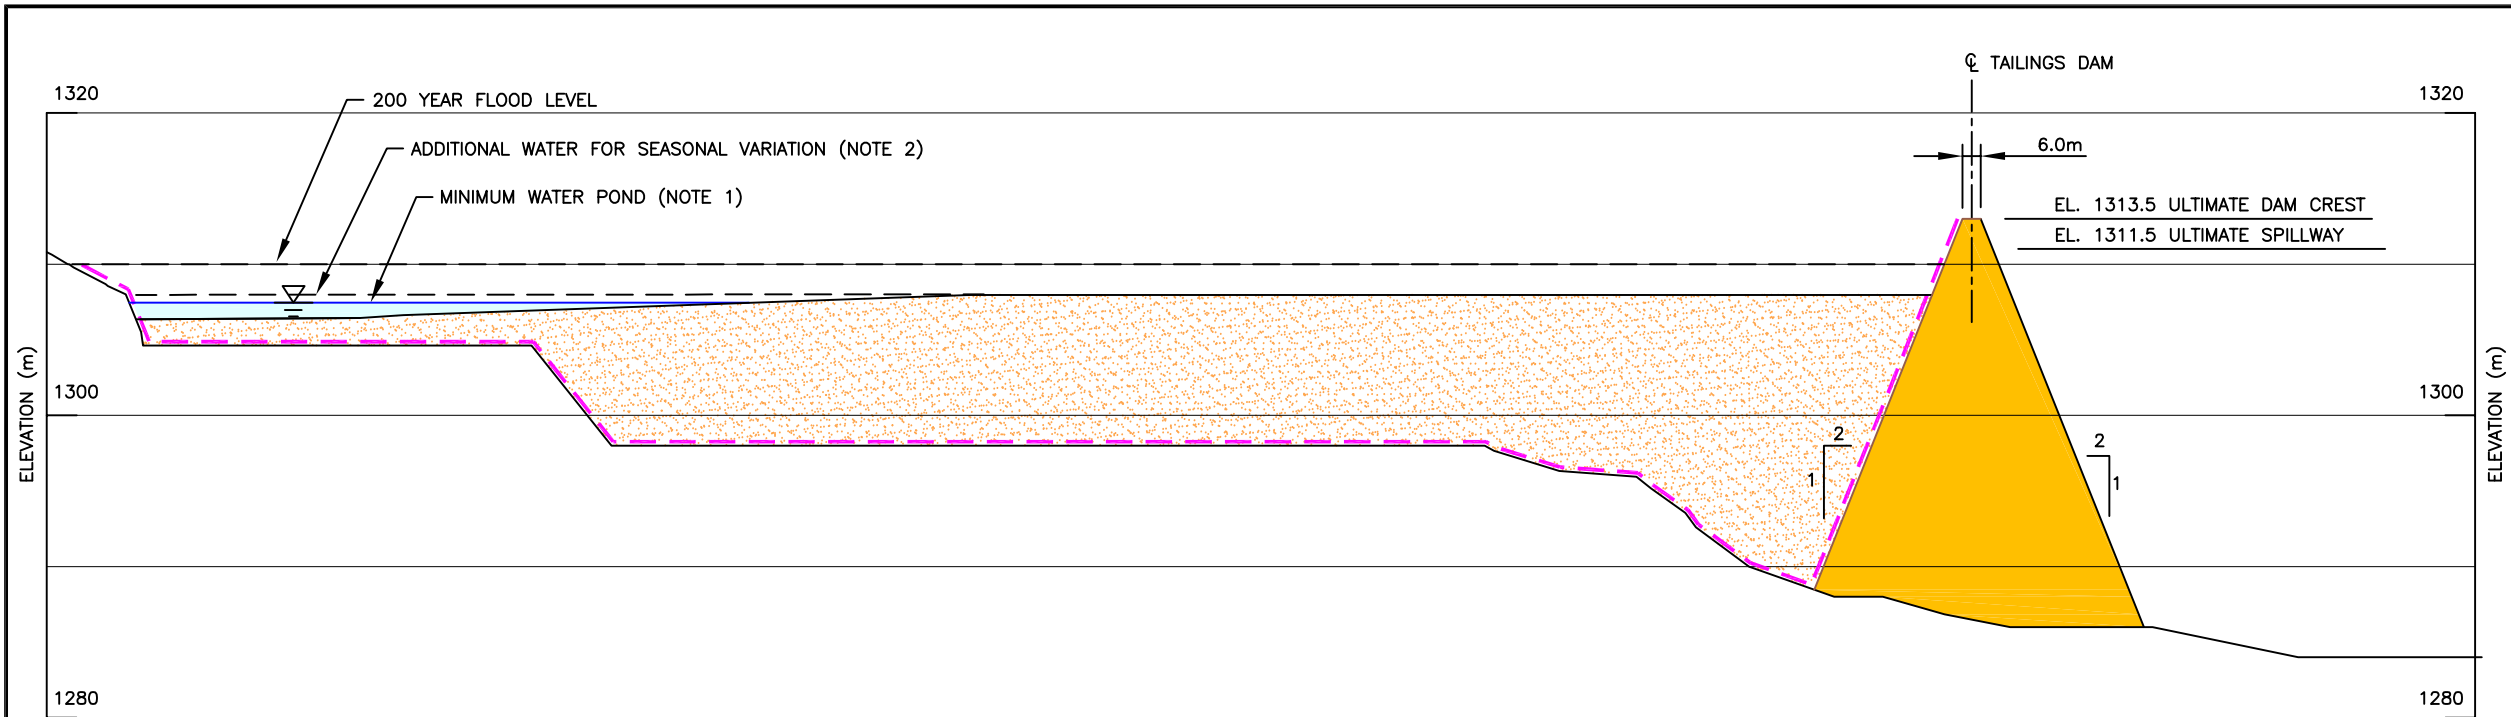
TYPICAL SECTION YEAR 6

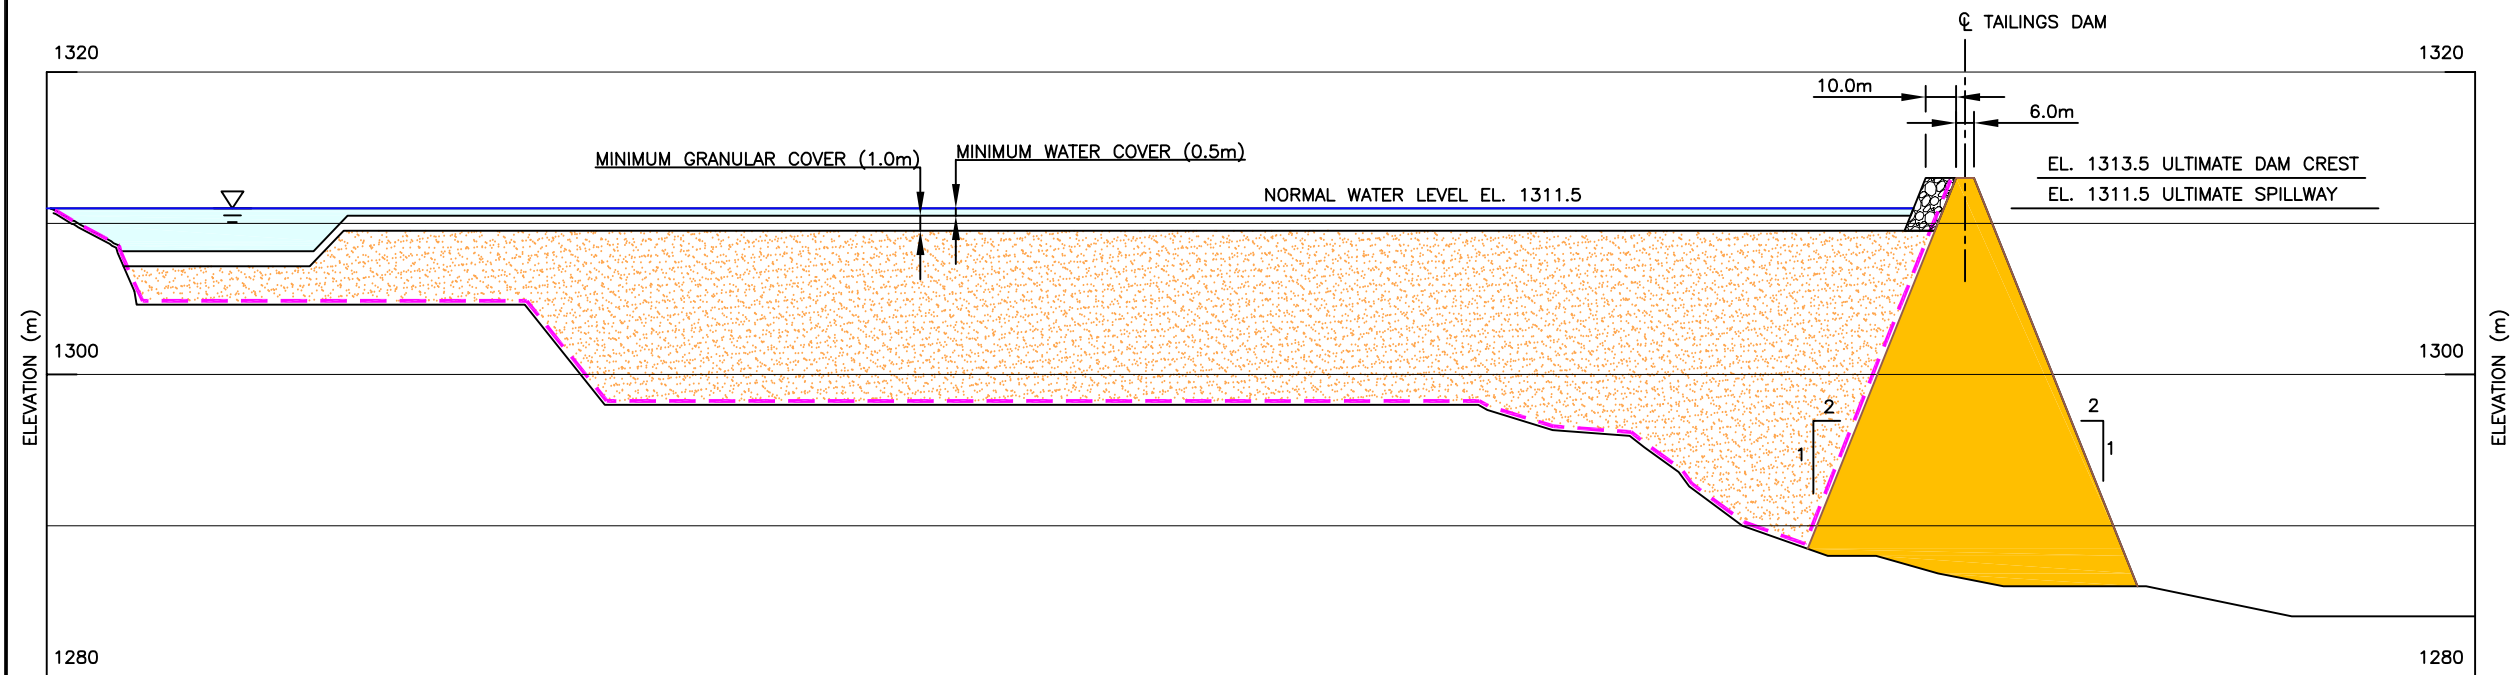
TYPICAL SECTION - CLOSURE
