## WOLVERINE PROJECT

### TAILINGS FACILITY

# OPERATION, MAINTENANCE AND SURVEILLANCE MANUAL

Prepared by  
Yukon Zinc Corporation

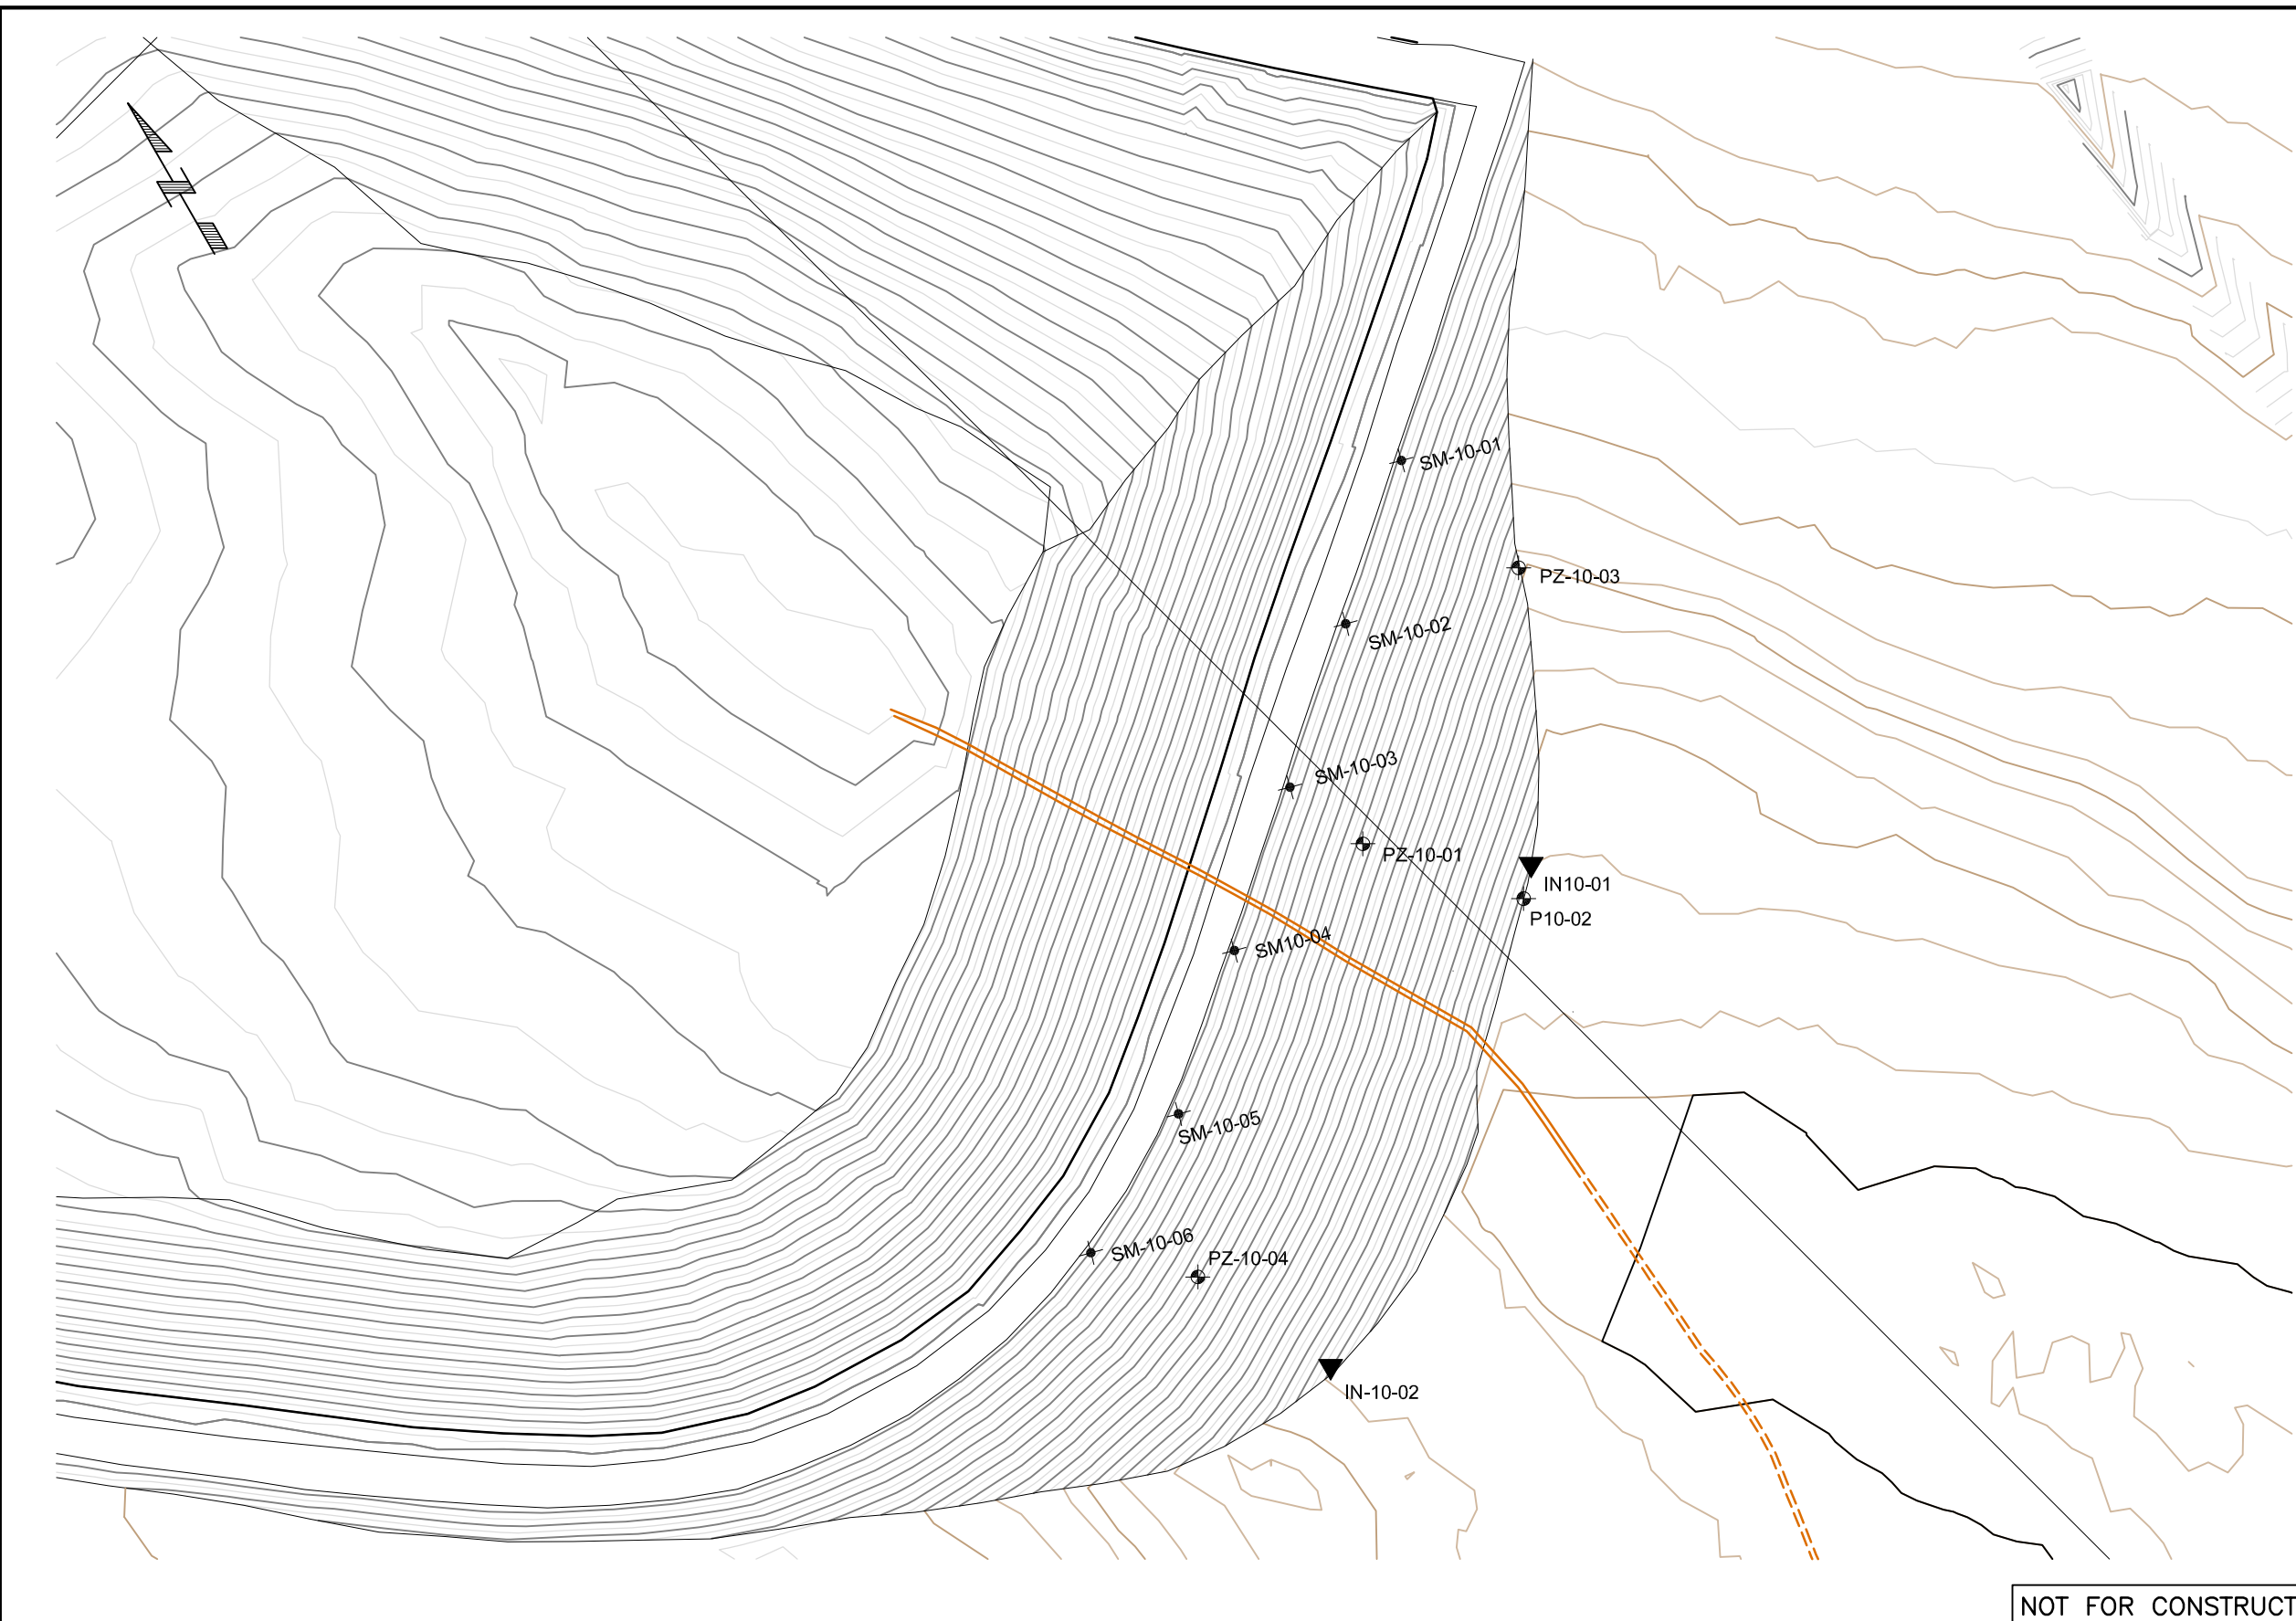
TAILINGS STORAGE FACILITY  
INSTRUMENTATION PLAN

| <b>Drawing D5013</b> | <b>Tailings Storage Facility Instrumentation Plan</b> |

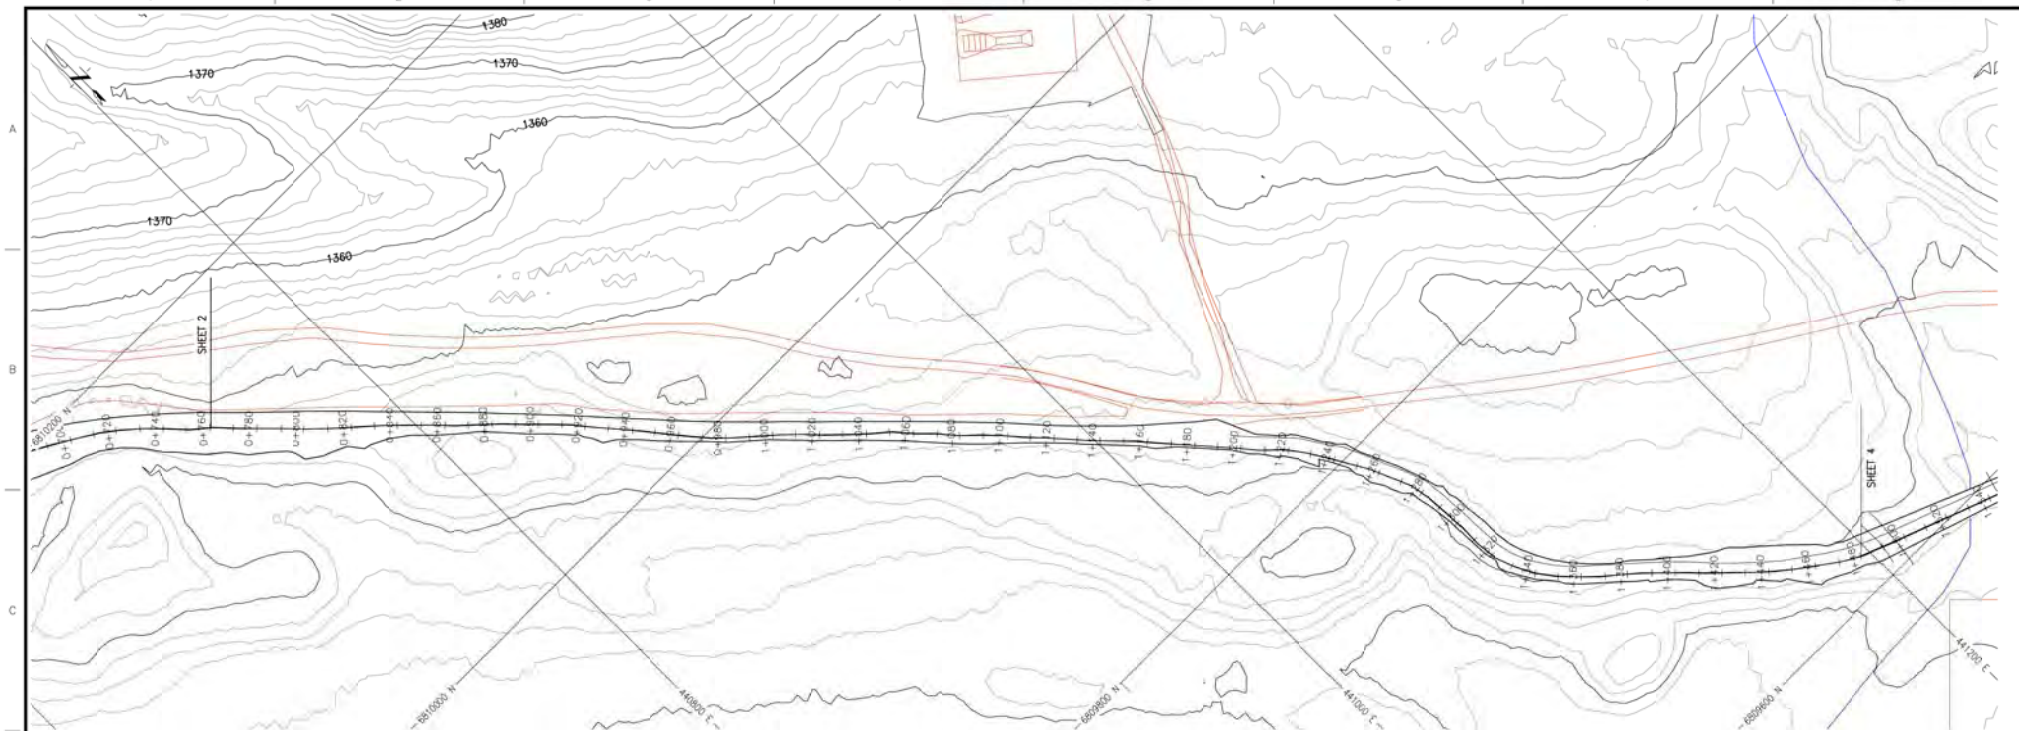
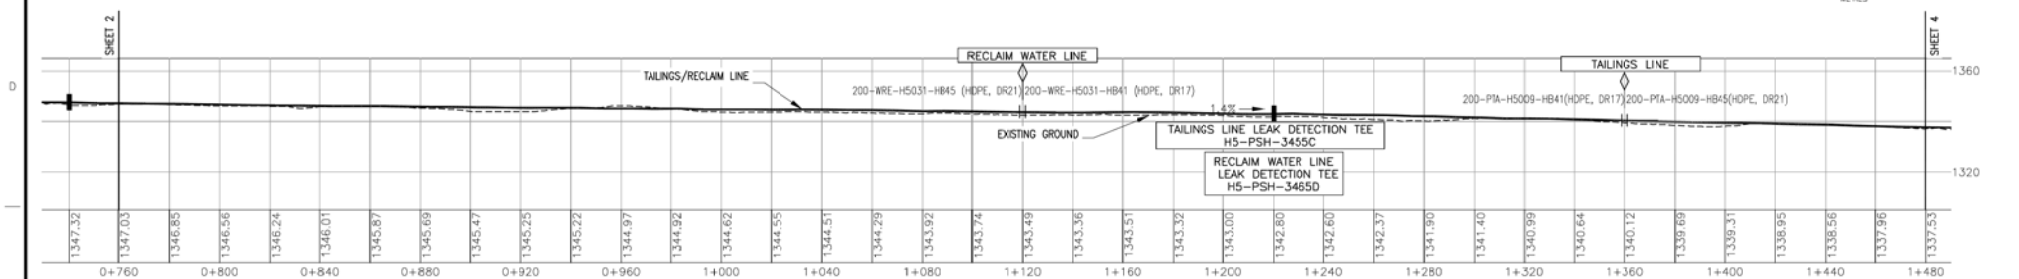
PLAN  
SCALE 1:1000

PROFILE  
SCALE 1:1000 V  
1:1000 H

| <b>Drawing H5-13-101 to H5-13-107</b> | <b>Tailings and Reclaim Pipeline Routing – Sheets 1 – 7</b> |
