Whitehorse

Vehicle Emissions Testing Clinic

June 4th and 5th 2009

Final Report

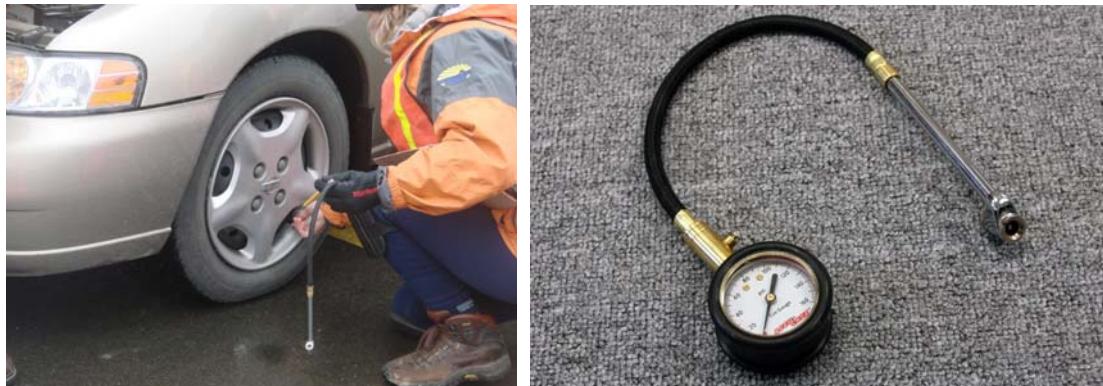
- **Tire Pressures** were checked using mechanical gauges. All four pressures were recorded; then, in consultation with the vehicle owner and after checking any information on the vehicle decals, the tires that needed it were adjusted upward or downward to the correct pressure as needed.

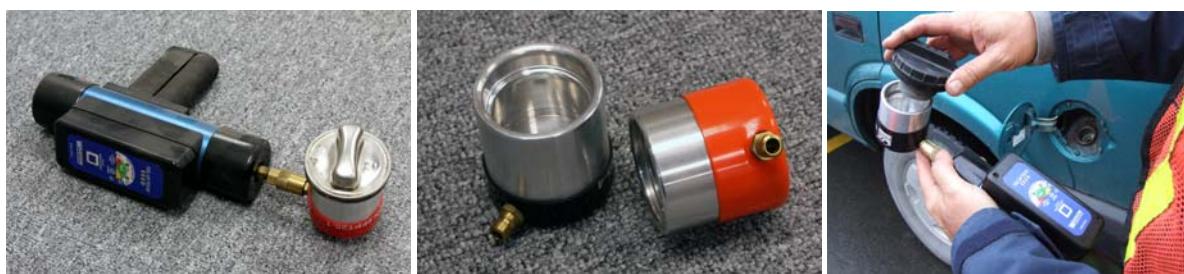
- **Gas Caps** on all 1997 and older vehicles were removed and pressure-tested using Waekon hand-held testers. Diesel caps were not tested because diesel vehicles do not have evaporative emission controls. Most gas caps from 1998 and newer vehicles were not tested, because their sealing ability is regularly checked by the vehicle's OBD system.

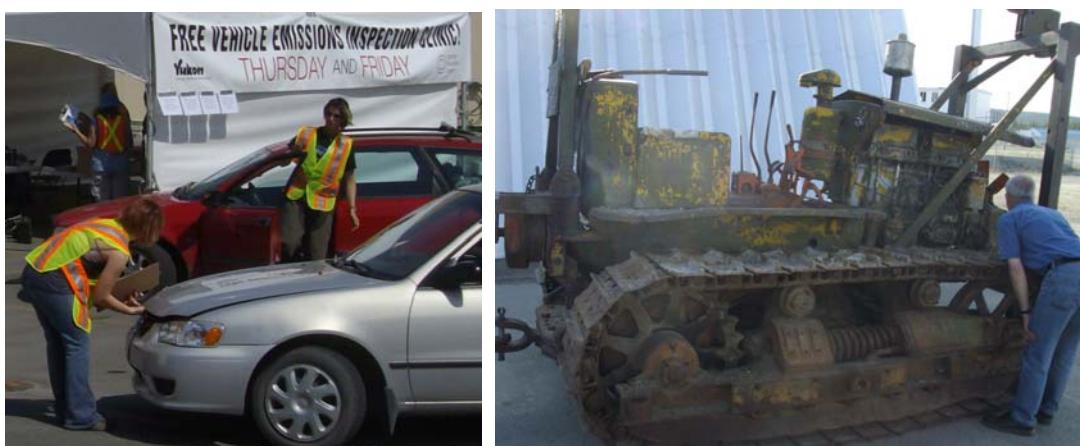
- **Emission Control System** components were checked on all 1997-and-older model year vehicles for evidence of tampering or removal. In most cases, the components to be checked were as indicated on the underhood emissions decal. Typical ECS components checked were: Catalytic Converter; Positive Crankcase Ventilation (PCV) valve; Exhaust gas Recirculation (EGR) valve; Air Injection System (AIS); and Evaporative Canister.

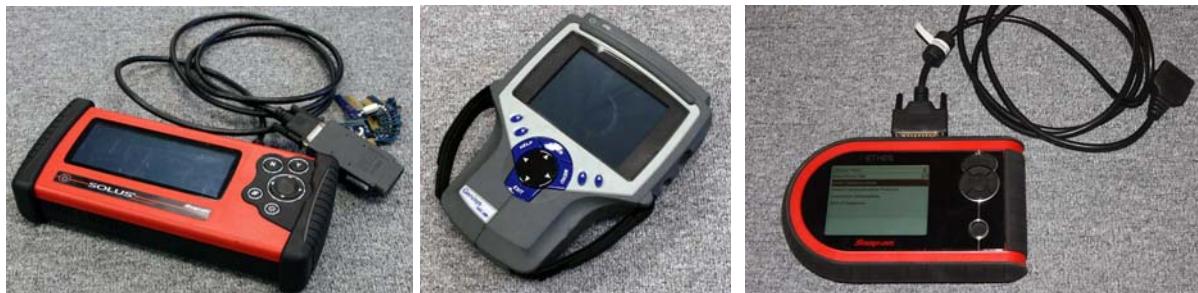
- **OBD Inspection** was performed using an OTC Genisys scanner, Snap-On Solus scanner, or Snap-on Ethos scanner connected to the Diagnostic Link Connector (DLC). It also included visual Key-On Engine-Off (KOEO) and Key-On Engine-Running (KOER) Malfunction Indicator Lamp (MIL) checks. All monitors were recorded as 'ready', 'not ready', or 'not supported'. The MIL command status was checked, and any Diagnostic Trouble Codes (DTCs) were noted.

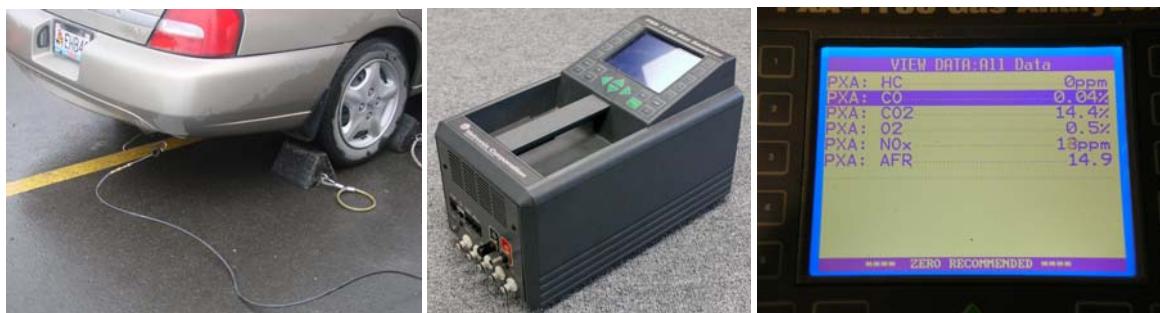
- **The Tailpipe Test** for non-diesel vehicles consisted of a Two-Speed Idle test: a high-idle at 2500 rpm, followed by a curb idle (foot off the accelerator). Concentration measurements of Oxygen (O₂), Carbon Dioxide (CO₂), Hydrocarbons (HC) and Carbon Monoxide (CO) were taken using Vetronix portable 5-gas analysers. [The fifth gas measured is Oxides of Nitrogen (NO_x), but NO_x is only emitted in meaningful quantities when an engine is under load, so the values were not recorded.] The cutpoints used to determine PASS or FAIL for the curb idle test were the same as those used for idle tests in the AirCare program. For the 2500 rpm, high-idle test, the pass/fail limits were set at 220 ppm for HC and 1.2% for CO, consistent with U.S. EPA guidelines for such a test.

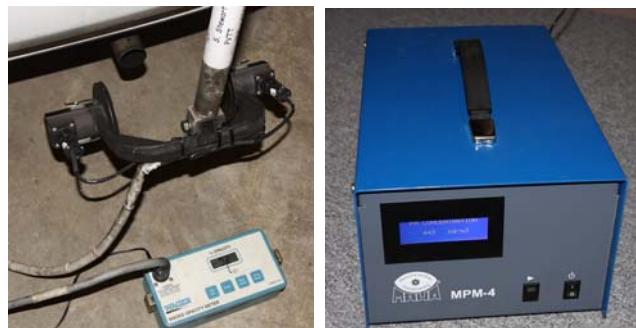
- **Smoke Opacity** of diesel exhaust was measured using a Wager full-flow Opacimeter using the SAE J1667 Snap Acceleration Test procedure. **PM10 Concentration** measurements were also taken using a MAHA MPM4 analyser. This analyser had only just been acquired, and appropriate test protocols were still being developed. It was set up in one of the inspection lanes. On the first day, it was used to measure PM10 concentrations in gasoline vehicle exhaust during the steady-state two-speed idle tests. On the second day we measured only peak PM10 concentrations during snap-acceleration tests of diesel vehicles.

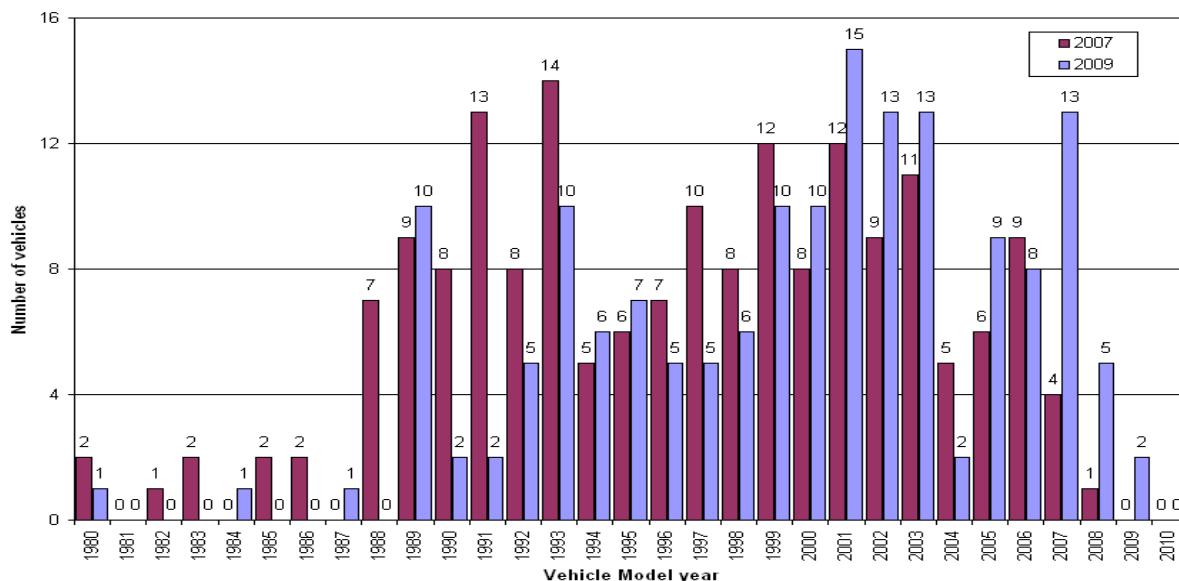
Number of Vehicles Tested in 2007 and 2009 by Model Year

Passenger vehicle	median model year = 2001, (range from 1984 to 2009)
Light truck	median model year = 2000, (range from 1987 to 2007)
Heavy truck	median model year = 2000, (range from 1989 to 2000)

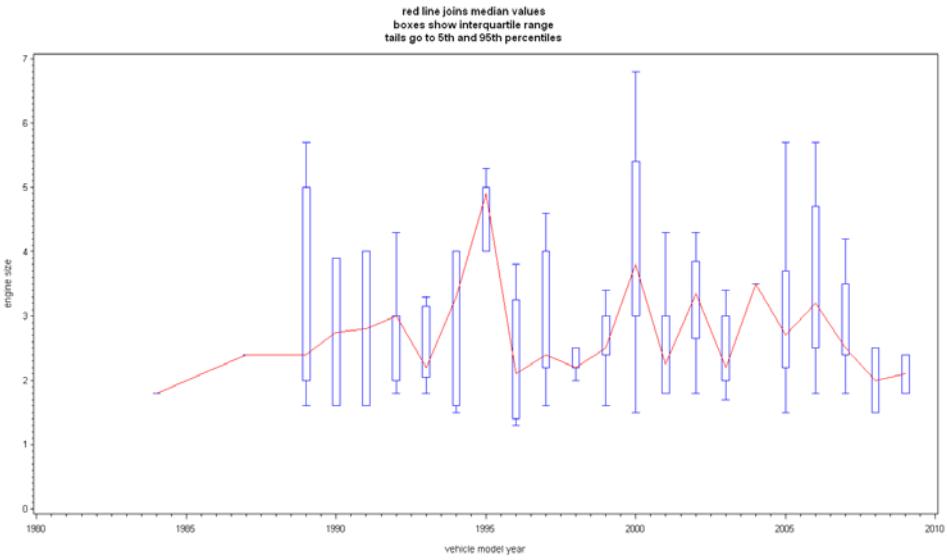
Engine Size - Distribution by Model Year

The chart suggests a general trend to larger displacement engines over time, but the variation within each model year is much greater than the trend in the average.

Passenger	mean=2.0L, (range from 1.3 to 3.8)
Light truck	mean=3.6L, (range from 2.0 to 5.8)
Heavy truck	mean=5.7L, (range from 5.4 to 6.8)

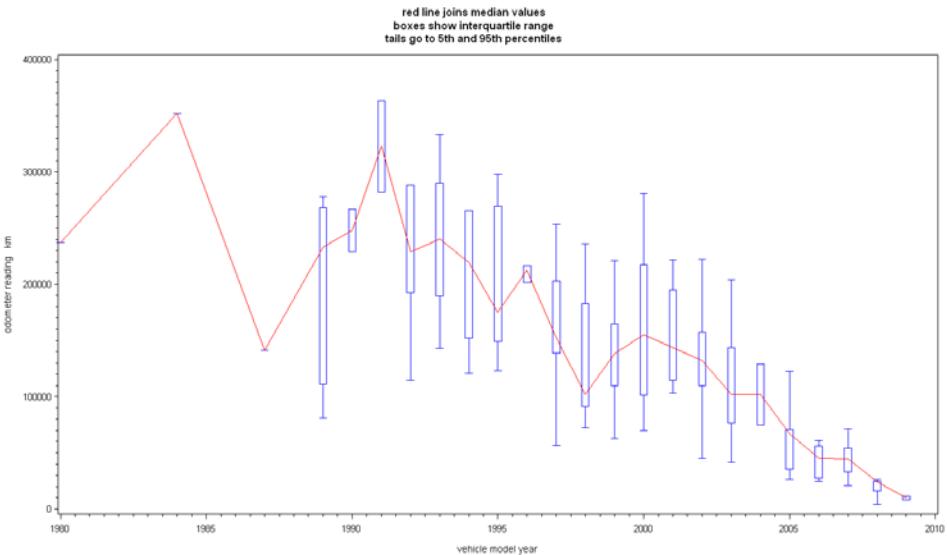
Odometer Reading - Distribution by Model Year

The slope of the following chart suggests that annual mileage (odometer reading divided by age) averages around 19,000 km/year over the first 6 years of life and then drops off a little. This is a bit higher than the observed trend in the Vancouver region.

Passenger	mean= 123,151 km, (range from 4,041 to 352,364)
Light truck	mean= 157,355 km, (range from 24,432 to 363,772)
Heavy truck	mean= 212,511 km, (range from 70,196 to 463,336)

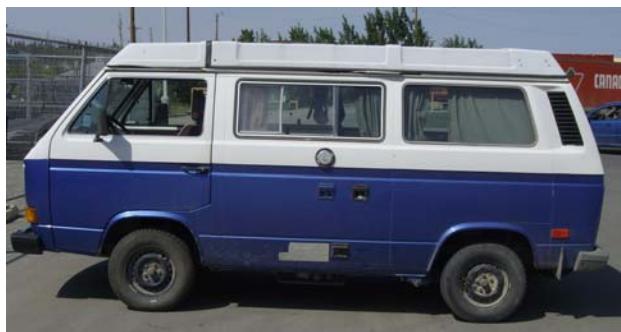
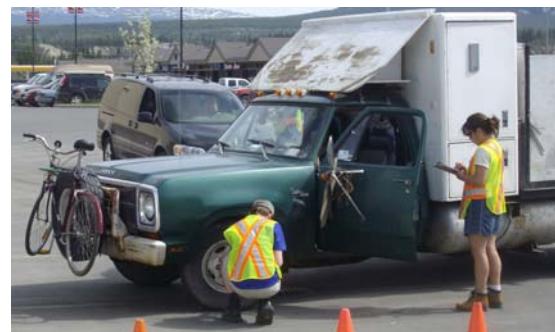
The other two vehicles that stood out as particularly high emitters were a 1984 Volkswagen Vanagon and a 1980 Dodge truck running on propane. The VW Vanagon had very high CO and HC readings at the tailpipe. It also had a gross exhaust leak just upstream of the catalytic converter that caused the readings to be greatly diluted (as indicated by very high O₂ concentrations), so the actual HC and CO concentrations from the engine would have been 2 or 3 times what was measured at the tailpipe. Fortunately this vehicle is not usually driven. Even so, considering that its emissions are likely 100 times the level expected from a new car or truck, even driving it 200 km a year will produce the same HC and CO emissions as 20,000km in a 2009 model year vehicle.

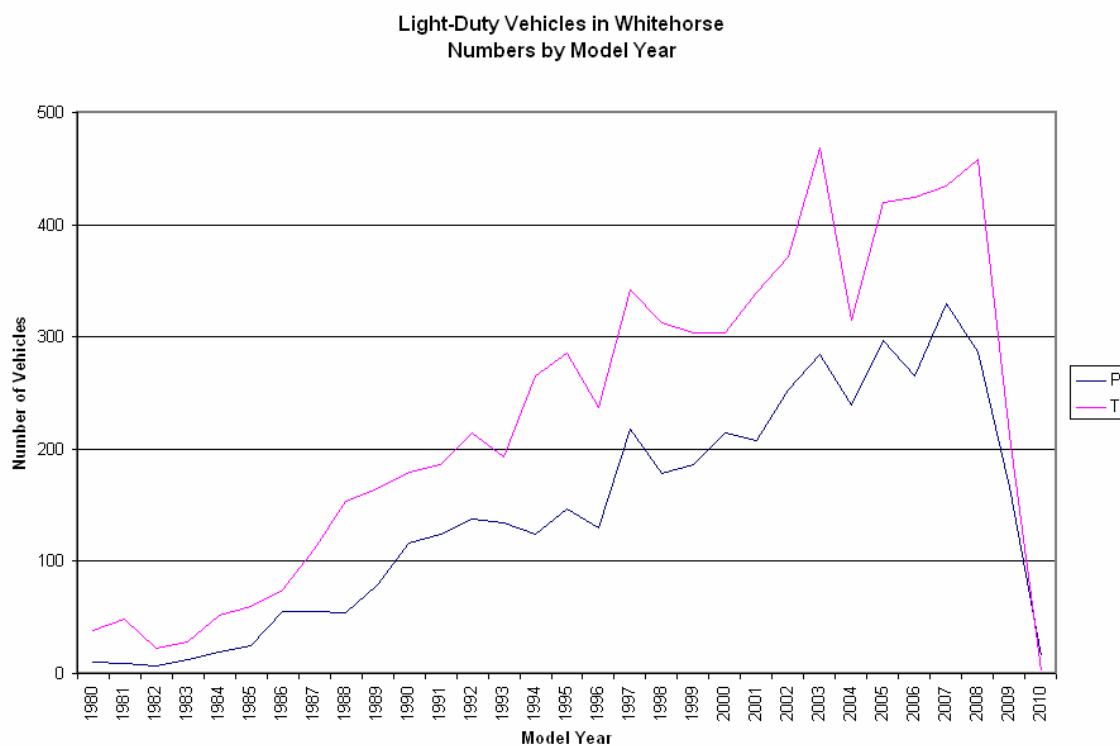
The following chart plots the numbers of passenger vehicles and light-trucks in Whitehorse against their model years. In general the proportions of cars and trucks seems to be about the same each model year, and if we assume that the original sales were in the same proportions, we can conclude that the rate of loss of old trucks and old cars is also about the same. Or, in other words, cars and trucks both deteriorate and are retired from use at about the same rate. This observation is also true for the rest of the territory.

One important conclusion is that the age profile of the fleet is not likely to have changed between 2007 and 2009, or in fact for the past decade or two. This is indicated by the fairly consistent slope of the lines. Although some year-to-year variation is natural, there are no indications of any major changes in the numbers of vehicles registered by model year, other than the expected reduction as vehicles age and are retired. This was not apparent from the clinic test results, because a clinic can only test those vehicles that show up.

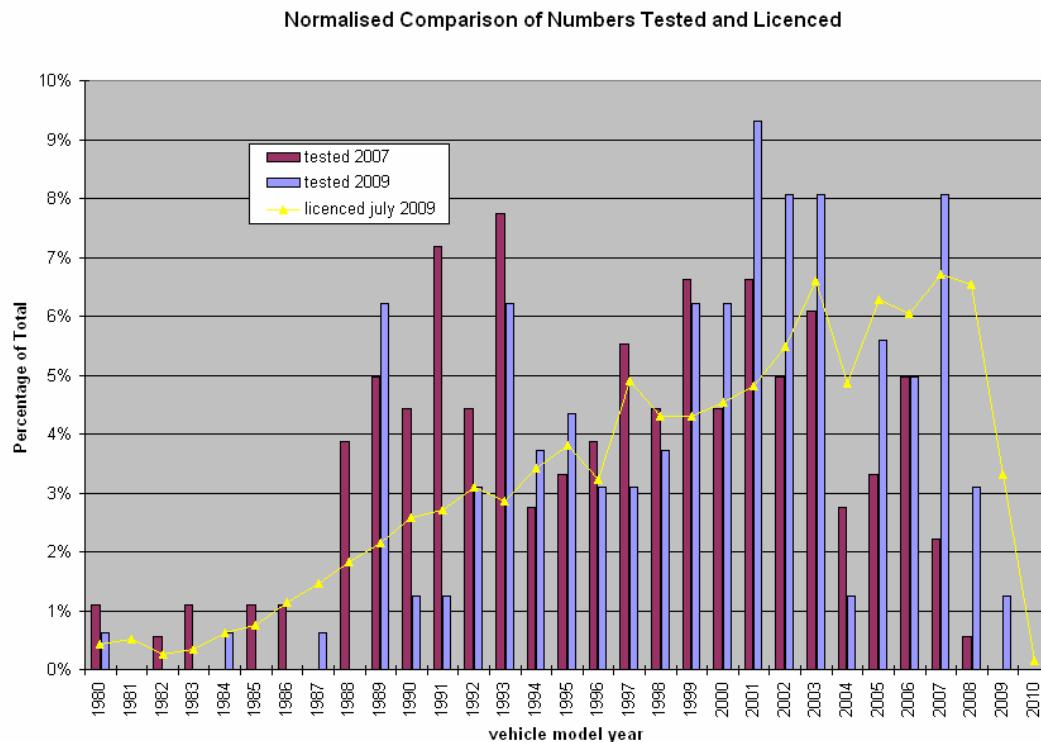
The next chart combines the numbers tested in 2007 and in 2009 with the numbers licensed in Whitehorse in July 2009. To allow comparison the numbers for each model year are normalized and presented as percentages of the totals. The tested profiles are clearly different from the licensed profile.

from 2004 and newer; these years account for a large part of the fleet, but a relatively small part of those vehicles tested.

We do not actually know why a greater number of older vehicles were brought for testing in 2007 than in 2009. One could only speculate as to why this was, but the reason is more probably associated with behavioural responses to the opportunity for testing than being in any way related to the vehicle fleet make up.

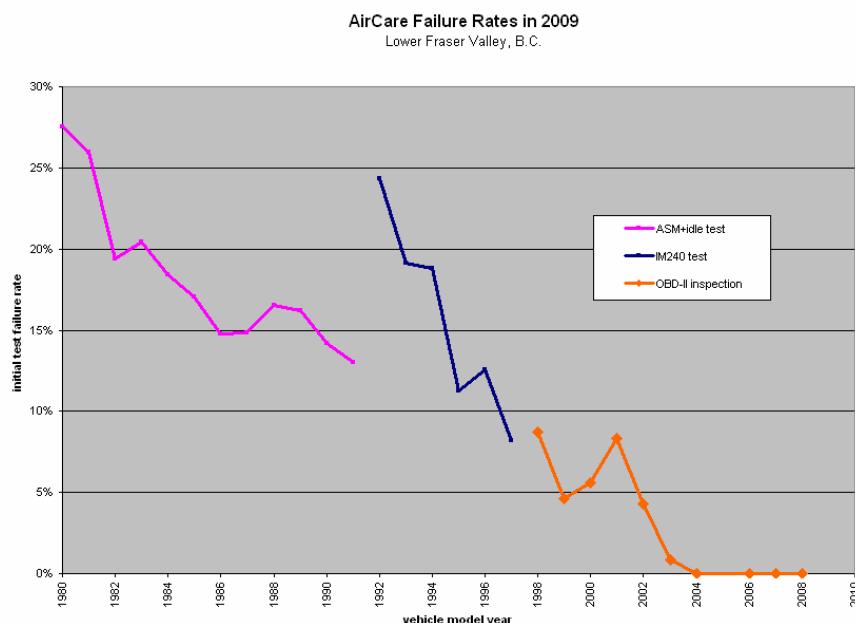
What the failure rates do indicate is the probable range of failure rates that might be expected in a clinic of this type and of this size. The rates from the table can be compared to the AirCare failure rates for vehicles in the Vancouver region in 2009, which are plotted below.

dynamometer. The tests actually used by AirCare are usually loaded tests, during which the vehicle is driven on a dynamometer. For vehicles up to and including model year 1991, this is a steady-speed loaded test at 40 km/h known as ASM2525, during which the tailpipe concentrations of HC, CO, NO_x and CO₂ are measured. It is followed by a curb idle during which HC, CO and CO₂ concentrations are measured. For model years 1992 to 1997 the test is an IM240 test, which requires a transient driving cycle lasting up to 240 seconds, and which gives a result expressed in units of gram/km for HC, CO, NO_x and CO₂. Until fairly recently this IM240 test was also used for newer vehicles, but it has now been replaced for 1998 and newer vehicles by an inspection that relies entirely on downloading information from the On Board Diagnostics system. However, the failure rates for IM240 and OBD-II inspections are quite similar, as can be deduced from the reasonable continuity of the blue and orange lines in the chart.

All the AirCare inspection test methods are more demanding, and therefore more difficult to pass, than the two-speed idle test used in the clinic. (It is also clear from the discontinuity between 1991 and 1992 model years that the ASM+idle test is not as demanding as the IM240 test.) If the Lower Fraser Valley vehicles were tested using just a two-speed idle their failure rates would be much lower than those shown in the chart.

For the pre-1996 vehicle the clinic TSI failure rates were 38% in 2007 and 18% in 2009. This range is almost entirely above the range of ASM+idle and IM240 failure rates observed by AirCare in the LFV in 2009 for the same age of vehicles, even though the two-speed idle test is much less demanding.

For the 1996 to 2003 vehicles the clinic TSI failure rates averaged about 6%, which is similar to the AirCare IM240 and OBD rates. But, again, the TSI is much easier to pass.

The comparison of Whitehorse TSI failure rates with AirCare ASM+idle and IM240 failure rates suggests that the incidence of high-emitting vehicles in Whitehorse is likely to be at least double their incidence in the Lower Fraser Valley. This is to be expected, because the vehicles in the LFV have been subject to regular AirCare inspection requirements ever since 1992, but, to date, there has been little or no effort to correct in-use vehicle emission problems in the Yukon. In the LFV the average AirCare failure rates at present mean that about 6.1% of the entire light-duty fleet vehicles are high-emitters. In other words one in every 16 or 17 vehicles has a problem that causes its emissions to be higher than they should be. In Whitehorse, by extension, it is likely that at least one out of every 8 vehicles is a high-emitter. For a total Whitehorse fleet size of 11,699 light-duty vehicles this means there are 1,419 high emitters. And in the entire territory light-duty fleet of 15,503 vehicles there are probably 1,881 or more high-emitters.
