GEOLOGICAL SURVEY OF CANADA
 DEPARTMENT OF ENERGY, MINES AND RESOURCES

YUKON RIVER DRAINAGE BASIN
 SITE NO. 38
**LOWER LAPIE CANYON
 DAM SITE**
 TO ACCOMPANY TOPICAL REPORT NO. 115
 GEOLOGY BY E. B. OWEN, 1964

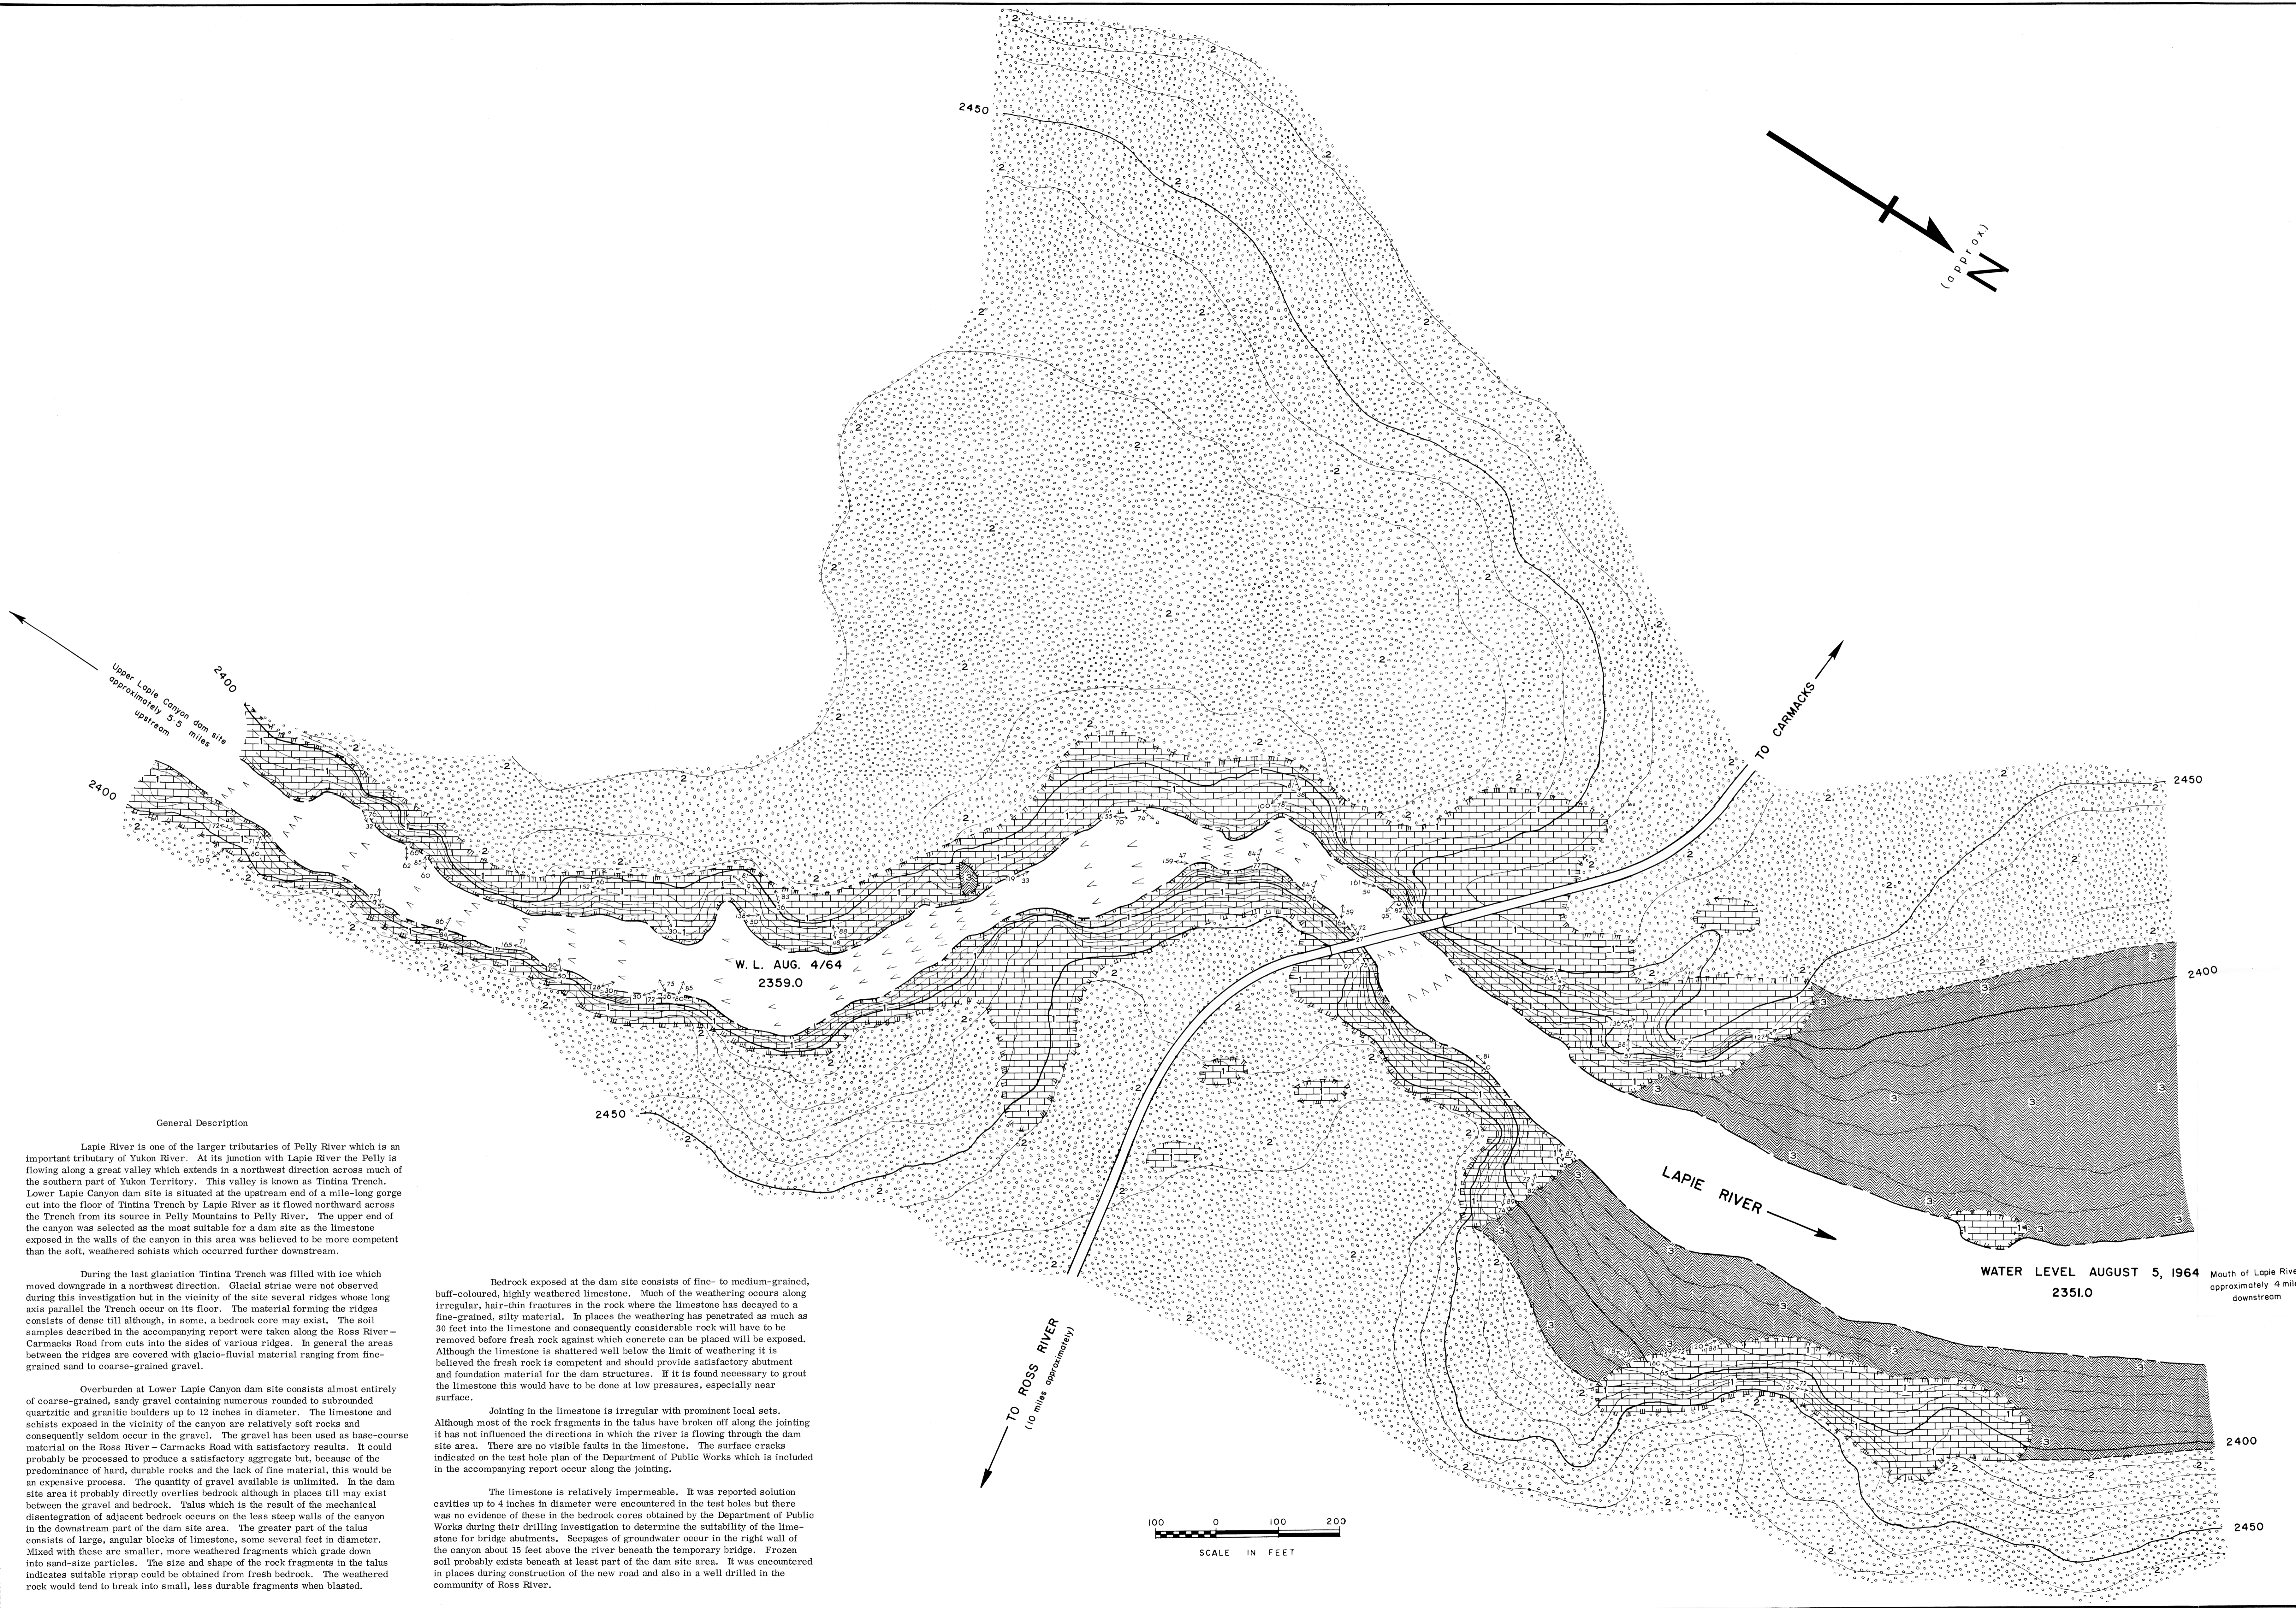
CENOZOIC	3	QUATERNARY TALUS: in places a mixture of rock fragments and gravel
	2	GLACIO-FLUVIAL: sand, gravel
PRECAMBRIAN (?)	1	LIMESTONE: fine-to medium-grained, light grey, buff-weathering
	Jointing

Overburden at Lower Lapie Canyon dam site consists almost entirely of coarse-grained, sandy gravel containing numerous rounded to subrounded quartzite and granitic boulders up to 12 inches in diameter. The limestone and schists exposed in the vicinity of the canyon are relatively soft rocks and consequently seldom occur in the gravel. The gravel has been used as base-course material on the Ross River - Carmacks Road with satisfactory results. It could probably be processed to produce a satisfactory aggregate but, because of the predominance of hard, durable rocks and the lack of fine material, this would be an expensive process. The quantity of gravel available is unlimited. In the dam site area it probably directly overlies bedrock although in places till may exist between the gravel and bedrock. Talus which is the result of the mechanical disintegration of adjacent bedrock occurs on the less steep walls of the canyon in the downstream part of the dam site area. The greater part of the talus consists of large, angular blocks of limestone, some several feet in diameter. Mixed with these are smaller, more weathered fragments which grade down into sand-size particles. The size and shape of the rock fragments in the talus indicates suitable riprap could be obtained from fresh bedrock. The weathered rock would tend to break into small, less durable fragments when blasted.

Bedrock exposed at the dam site consists of fine- to medium-grained, buff-coloured, highly weathered limestone. Much of the weathering occurs along irregular, hair-thin fractures in the rock where the limestone has decayed to a fine-grained, silty material. In places the weathering has penetrated as much as 30 feet into the limestone and consequently considerable rock will have to be removed before fresh rock against which concrete can be placed will be exposed. Although the limestone is shattered well below the limit of weathering it is believed the fresh rock is competent and should provide satisfactory abutment and foundation material for the dam structures. If it is found necessary to grout the limestone this would have to be done at low pressures, especially near surface.

Jointing in the limestone is irregular with prominent local sets. Although most of the rock fragments in the talus have broken off along the jointing it has not influenced the directions in which the river is flowing through the dam site area. There are no visible faults in the limestone. The surface cracks indicated on the test hole plan of the Department of Public Works which is included in the accompanying report occur along the jointing.
