GEOLOGICAL SURVEY OF CANADA
DEPARTMENT OF ENERGY, MINES AND RESOURCES

MACKENZIE RIVER DRAINAGE BASIN
SITE NO. 19
UPPER SEAPLANE DAM SITE
TO ACCOMPANY TOPICAL REPORT NO. 118
GEOLOGY BY E. B. OWEN, 1964

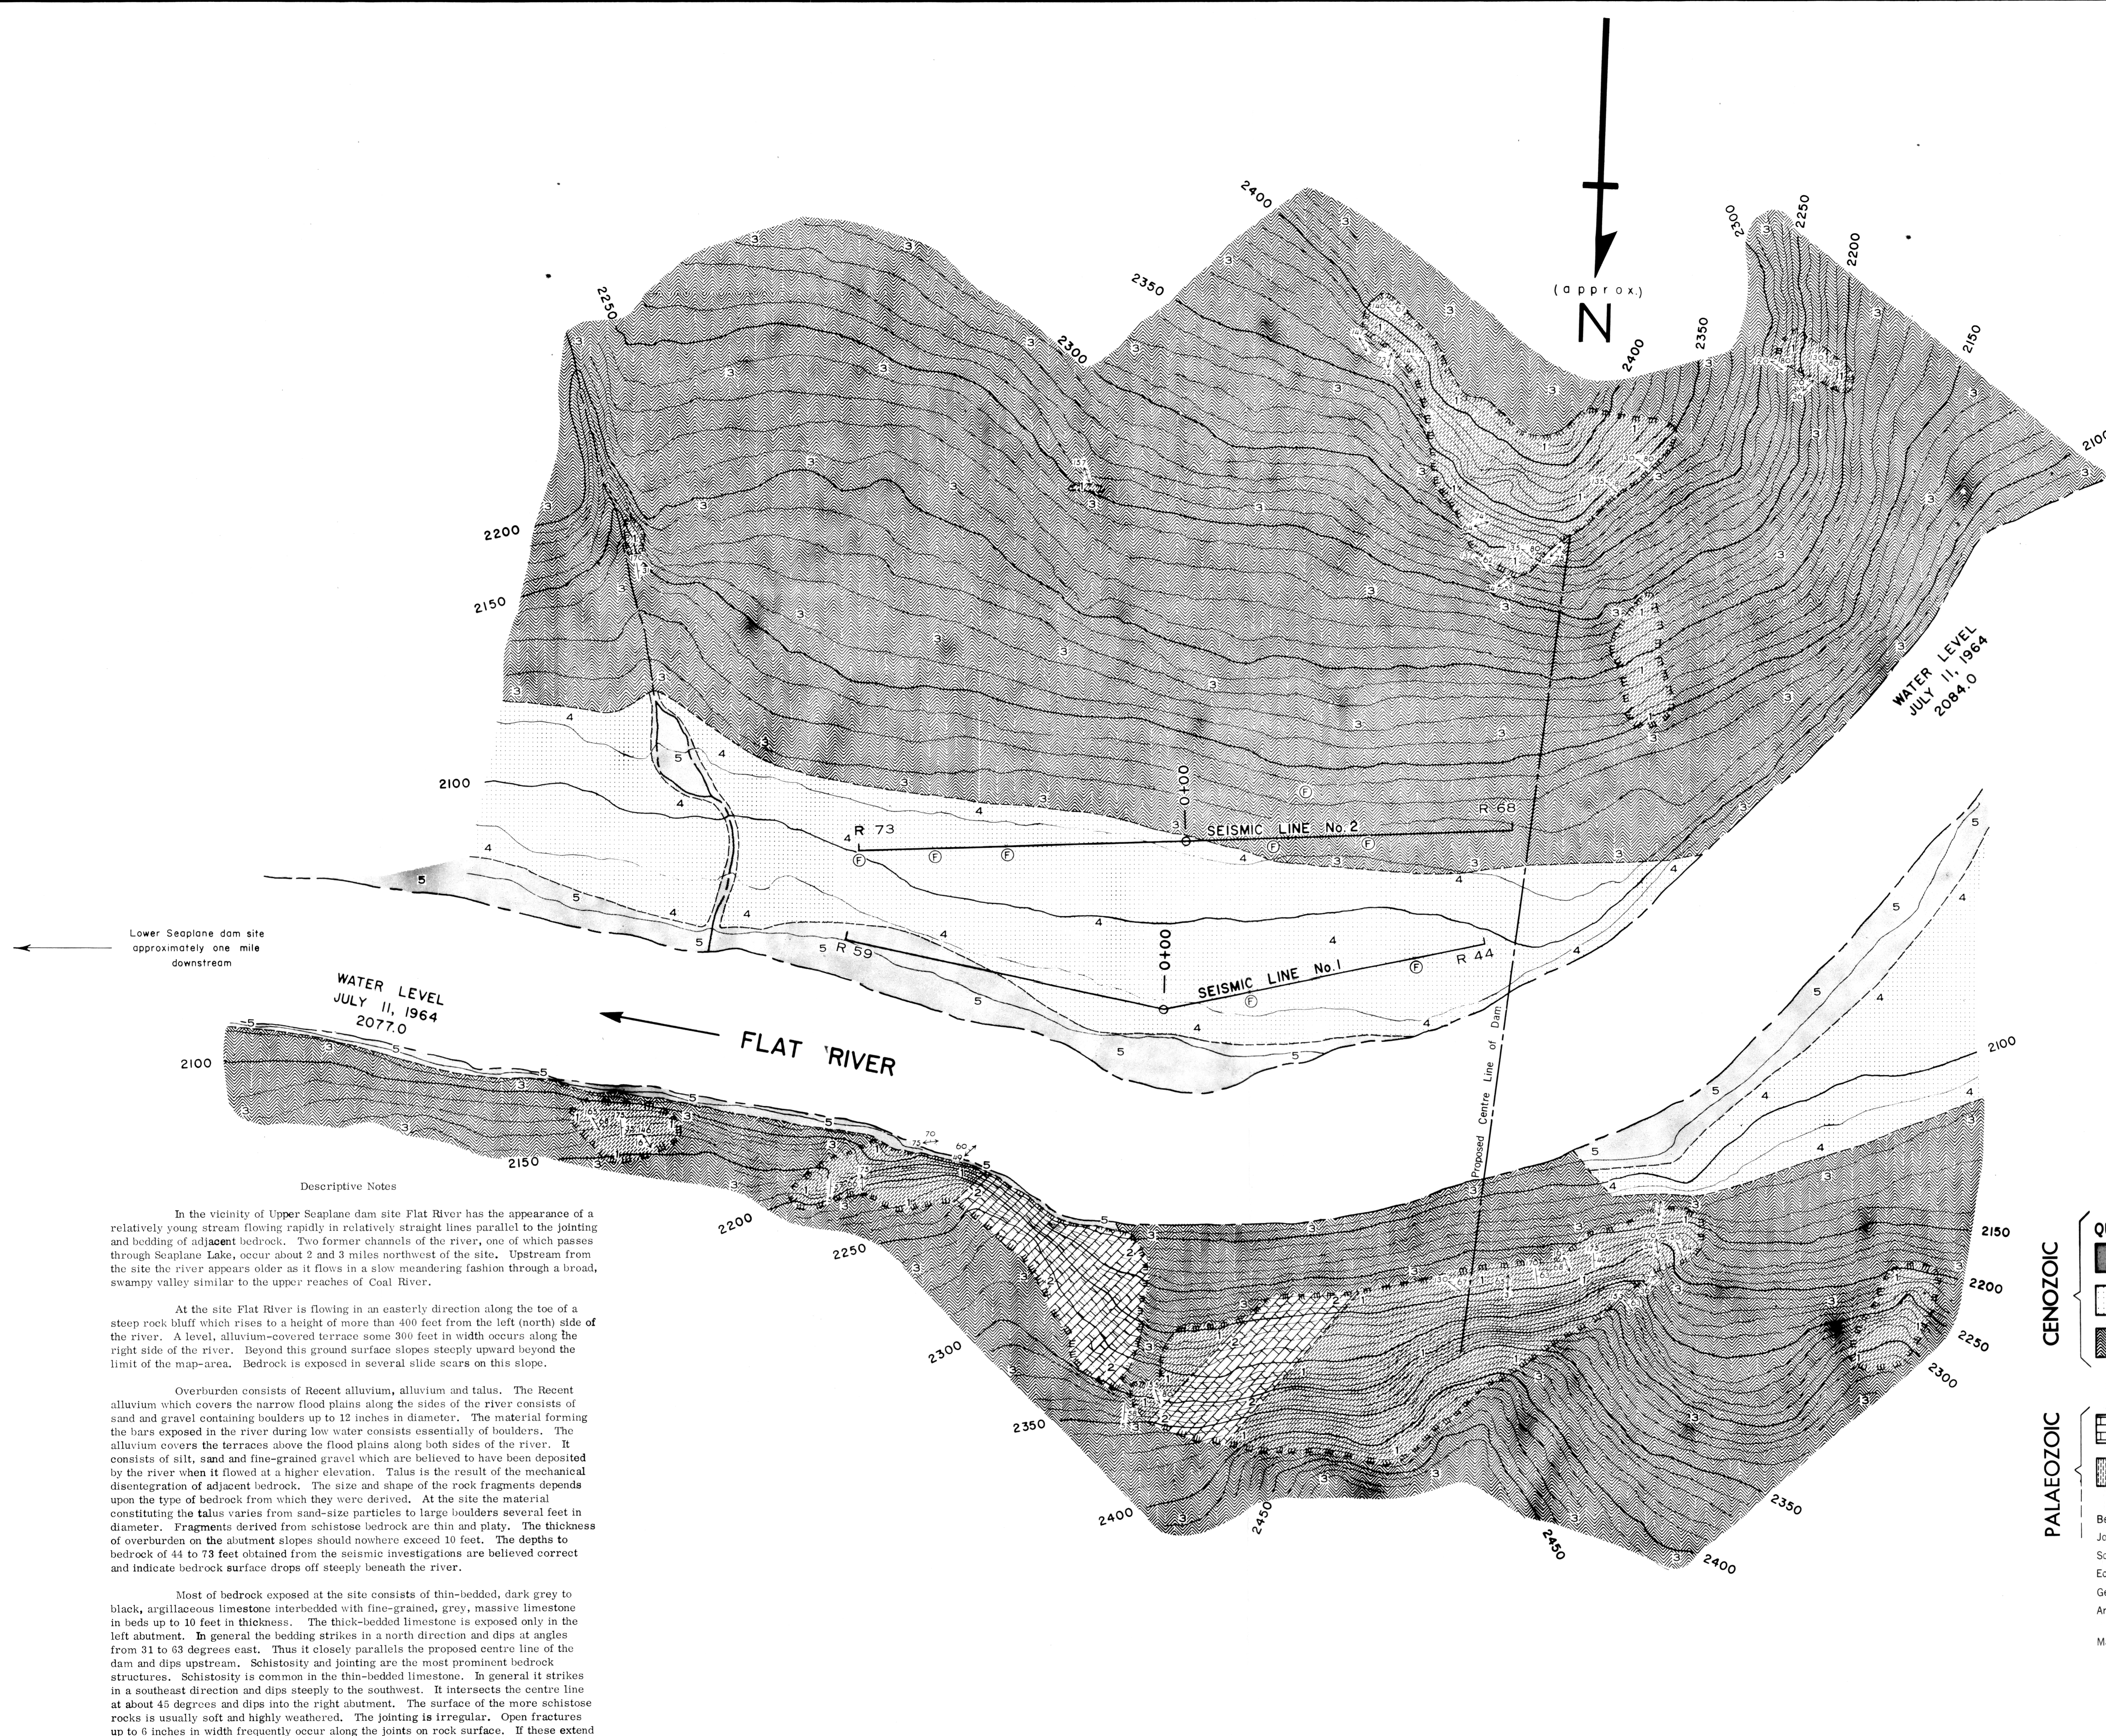
In the vicinity of Upper Seaplane dam site Flat River has the appearance of a relatively young stream flowing rapidly in relatively straight lines parallel to the jointing and bedding of adjacent bedrock. Two former channels of the river, one of which passes through Seaplane Lake, occur about 2 and 3 miles northwest of the site. Upstream from the site the river appears older as it flows in a slow meandering fashion through a broad, swampy valley similar to the upper reaches of Coal River.

At the site Flat River is flowing in an easterly direction along the toe of a steep rock bluff which rises to a height of more than 400 feet from the left (north) side of the river. A level, alluvium-covered terrace some 300 feet in width occurs along the right side of the river. Beyond this ground surface slopes steeply upward beyond the limit of the map-area. Bedrock is exposed in several slide scars on this slope.

Overburden consists of Recent alluvium, alluvium and talus. The Recent alluvium which covers the narrow flood plains along the sides of the river consists of sand and gravel containing boulders up to 12 inches in diameter. The material forming the bars exposed in the river during low water consists essentially of boulders. The alluvium covers the terraces above the flood plains along both sides of the river. It consists of silt, sand and fine-grained gravel which are believed to have been deposited by the river when it flowed at a higher elevation. Talus is the result of the mechanical disintegration of adjacent bedrock. The size and shape of the rock fragments depends upon the type of bedrock from which they were derived. At the site the material constituting the talus varies from sand-size particles to large boulders several feet in diameter. Fragments derived from schistose bedrock are thin and platy. The thickness of overburden on the abutment slopes should nowhere exceed 10 feet. The depths to bedrock of 44 to 73 feet obtained from the seismic investigations are believed correct and indicate bedrock surface drops off steeply beneath the river.

Most of bedrock exposed at the site consists of thin-bedded, dark grey to black, argillaceous limestone interbedded with fine-grained, grey, massive limestone in beds up to 10 feet in thickness. The thick-bedded limestone is exposed only in the left abutment. In general the bedding strikes in a north direction and dips at angles from 31 to 63 degrees east. Thus it closely parallels the proposed centre line of the dam and dips upstream. Schistosity and jointing are the most prominent bedrock structures. Schistosity is common in the thin-bedded limestone. In general it strikes in a southeast direction and dips steeply to the southwest. It intersects the centre line at about 45 degrees and dips into the right abutment. The surface of the more schistose rocks is usually soft and highly weathered. The jointing is irregular. Open fractures up to 6 inches in width frequently occur along the joints on rock surface. If these extend to any depth they would increase the permeability of the rock mass. The most competent rock at the site is the thick-bedded limestone exposed in the left abutment. The proposed centre line has been located so that these rocks could form part of the foundation and abutments of the dam and at the same time advantage would be taken of the shortest distance between the abutments.
