YUKON RIVER DRAINAGE BASIN
SITE NO. 33
**UPPER LAPIE CANYON
DAM SITE**

TO ACCOMPANY TOPICAL REPORT NO. I22
GEOLOGY BY E. B. OWEN, 1966

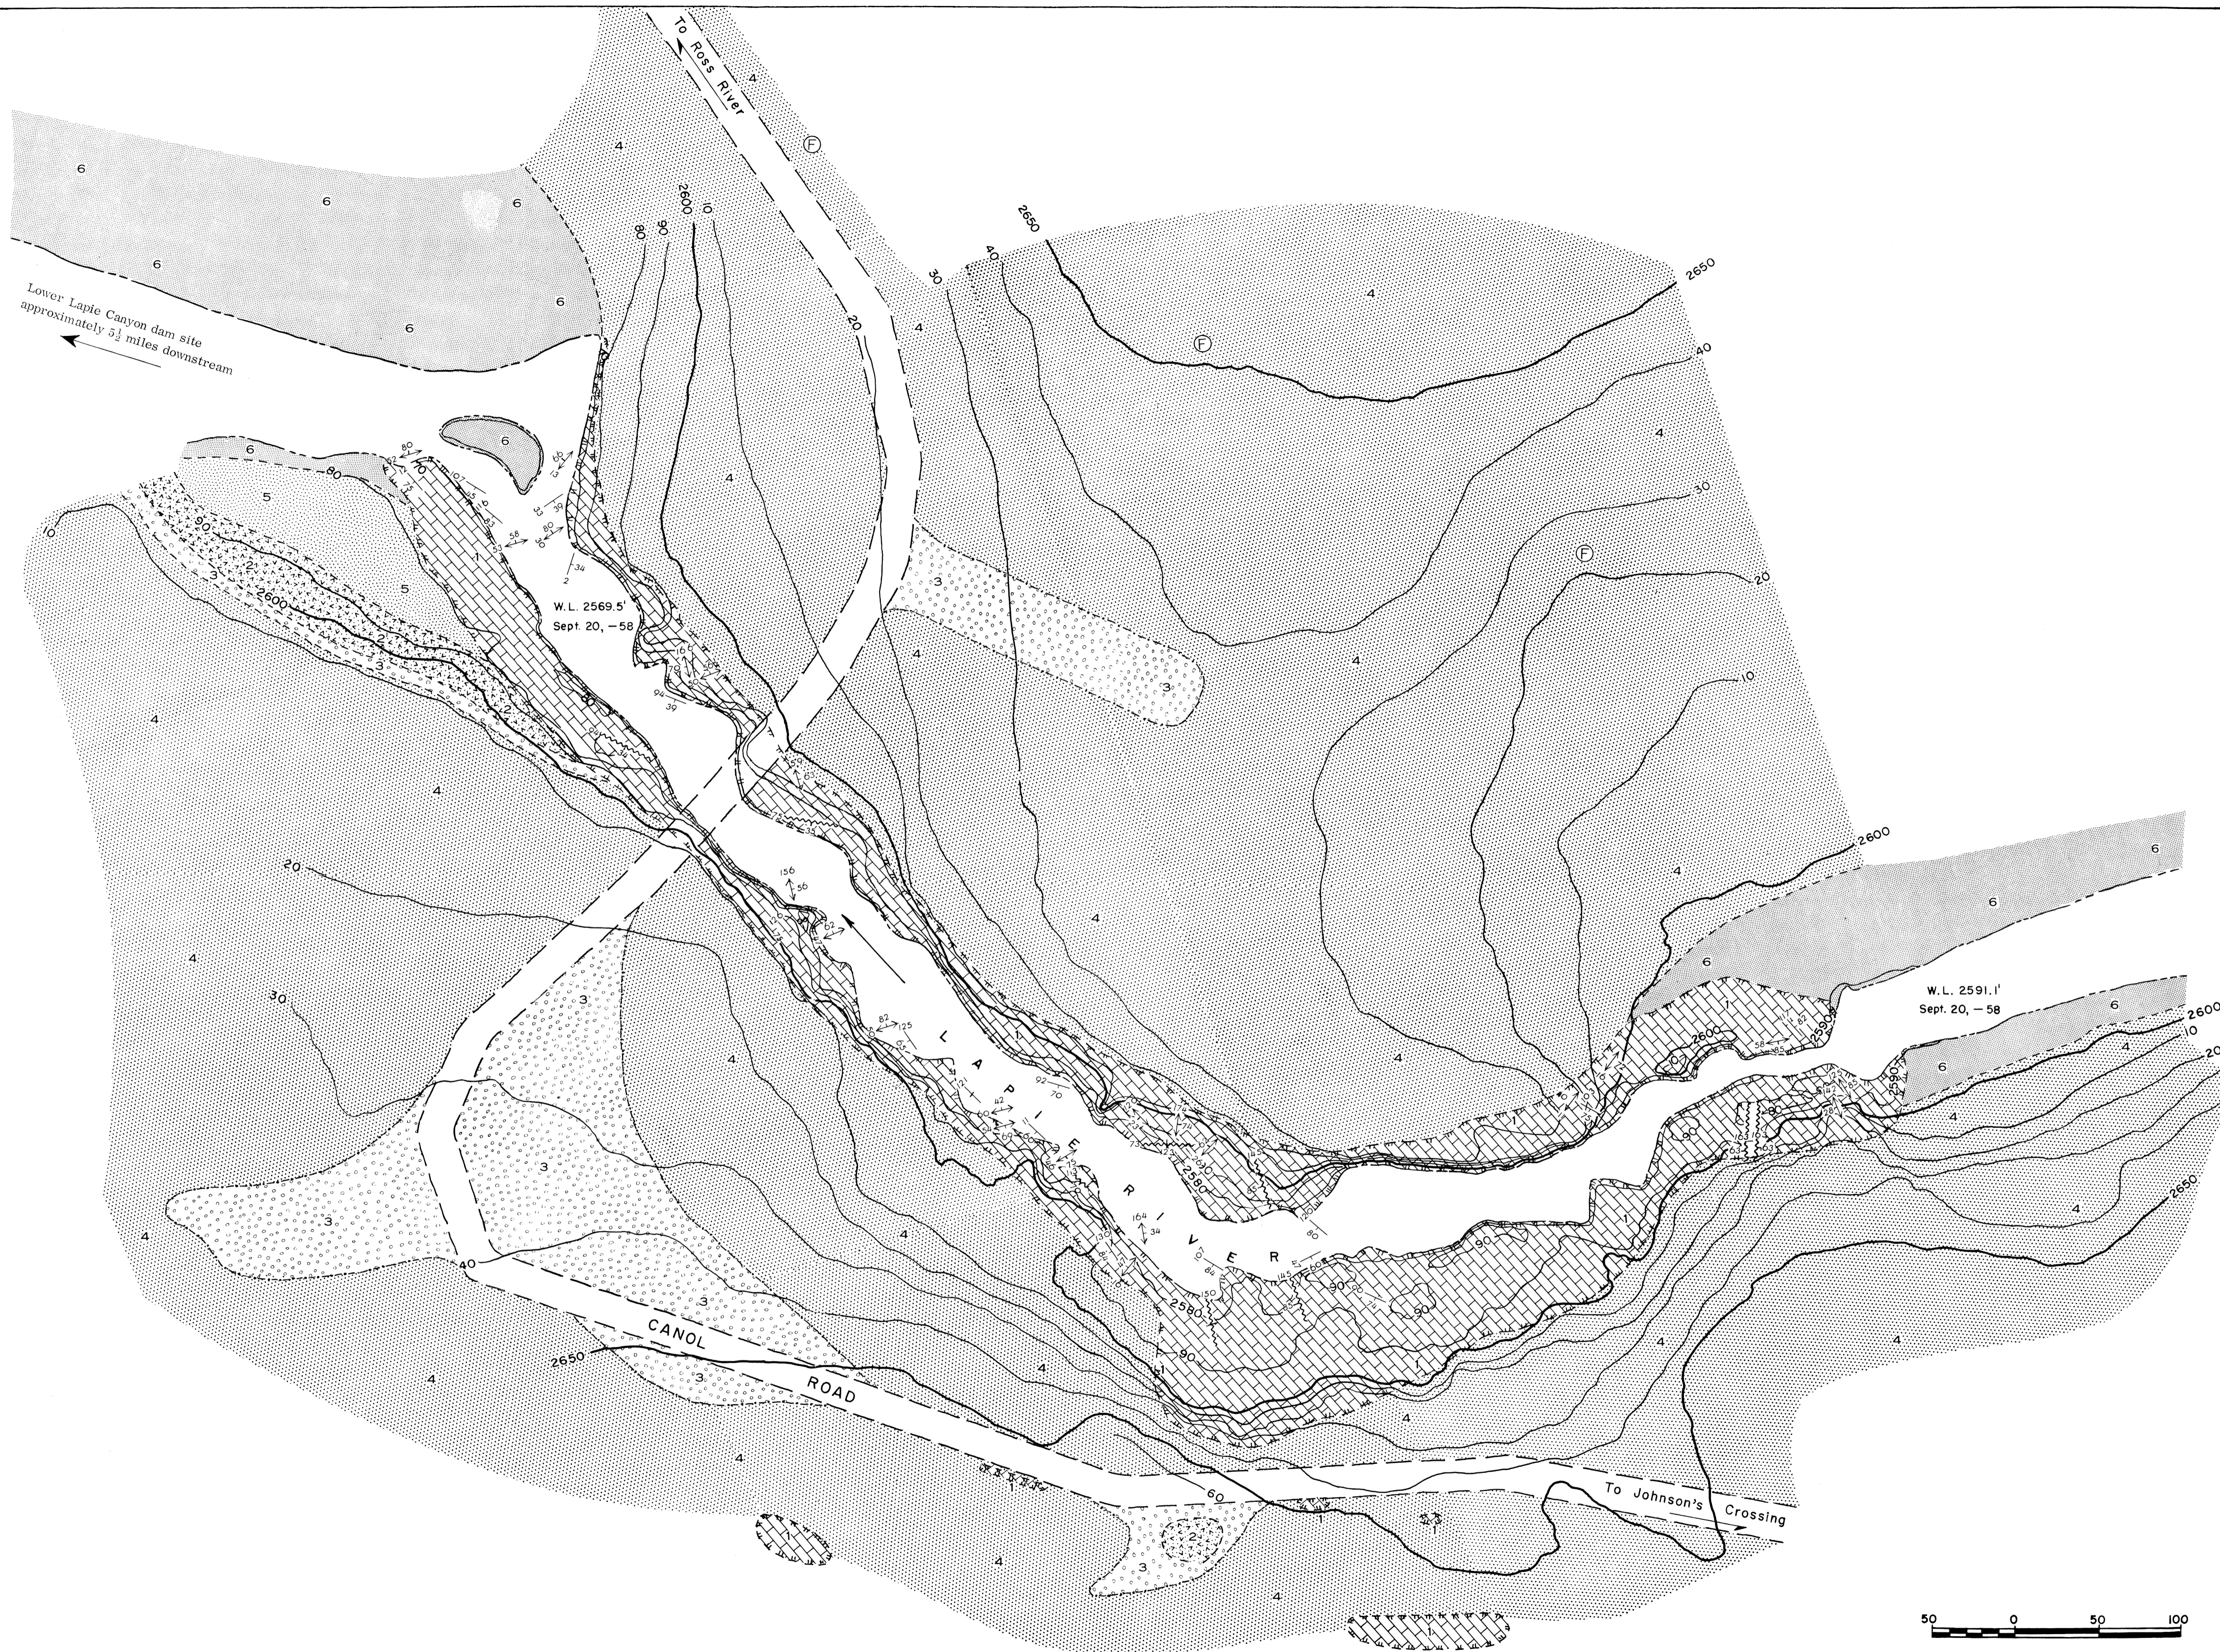
The greater part of overburden covering ground surface at the proposed dam site is silty sand. This material is described on the accompanying geological map as glacio-lacustrine in origin. However, there is a strong possibility it may be aeolian. It is more coarse-grained than the silts occurring along Yukon River. The thickness of the deposit varies from a few inches to 4 feet. There is no visible stratification. Coarse-grained, glacio-fluvial, sandy gravel containing granitic and quartzitic boulders up to 24 inches in diameter underlies the silty sand. In the dam site area this material is exposed chiefly in excavations made during construction and maintenance of the Canol Road. Here the thickness of the deposits vary from 3 to 8 feet. However, exposures of similar material up to 40 feet in thickness occur along the Canol Road between the site and the community of Ross River some 5 miles distant. The gravel would be useful chiefly as fill. It is too dirty and bouldery to be used as aggregate. The gravel usually overlies bedrock; however, in two places in the dam site area till is visible beneath it. The till (sample No. 1) is a dense, greyish-brown, sandy, silty material which contains few rock fragments greater than 3 inches in diameter. Many of the pebbles in the 1 to 2-inch range consist of black chert. The till is exposed in a steep bank, 25 feet in height, along the left side of the river in the downstream part of the site area and in the bottom of a small excavation along Canol Road. It is a potential impervious material. Unlimited quantities are available within 5 miles of the dam site chiefly from deposits exposed along the Canol and Watson Lake - Ross River - Carmacks Roads.

Bedrock exposed at Upper Lapie Canyon dam site consists of interbedded grey to black phyllite and grey quartzite. The phyllite strata are seldom more than 1 inch in thickness whereas the quartzite beds range up to 4 feet. Local folding has produced considerable distortion in the bedding and this along with zones of shattered rock associated with the numerous faults present suggests considerable remedial work will be necessary before the rock will provide satisfactory abutment and foundation material. The poor condition of bedrock may be due to the proximity of Tintina Fault, a major structure which is believed to follow along the southwest side of Tintina Trench close to Pelly Mountains. To prevent leakage of reservoir water grouting will be necessary especially along the faults. In general the bedding strikes between west and north 45 degrees west and dips steeply to the north. Many faults are visible in the walls of the canyon but only the larger are indicated on the accompanying map. Few of these are parallel to the northwest trend of Tintina Fault. Numerous intersecting joints in bedrock have decreased the stability of the canyon walls and increased the permeability of the rock mass. There are 2 prominent joint sets which intersect at angles close to 90 degrees. One set is parallel to the upstream part of the canyon above the sharp bend and dips steeply into the right wall. The other set closely parallels the downstream section of the canyon where it has a strike and dip similar to the bedding.

The most competent rock is exposed along a 250-foot section in the northwest-trending, upstream section of the canyon. Numerous bedrock exposures indicate overburden is thin in the left abutment area. There is no indication, however, as to the thickness of overburden on the right abutment. It is estimated there is about 25 feet of alluvium beneath the river in the canyon. There is little information regarding groundwater in the area. Springs or seeps do not occur in the walls of the canyon although there is some evidence of previous percolation of groundwater along the fault zones. On August 16, 1966 the frost line occurred about 21 inches below ground surface in the silty sand covering the gently sloping terrace south of the canyon.
