GEOLOGICAL SURVEY OF CANADA
DEPARTMENT OF ENERGY, MINES AND RESOURCES

PACIFIC COAST DRAINAGE
SITE NO. 37
OTTER FALLS DAM SITE
TO ACCOMPANY TOPICAL REPORT NO. 127
GEOLOGY BY E.B. OWEN, 1964

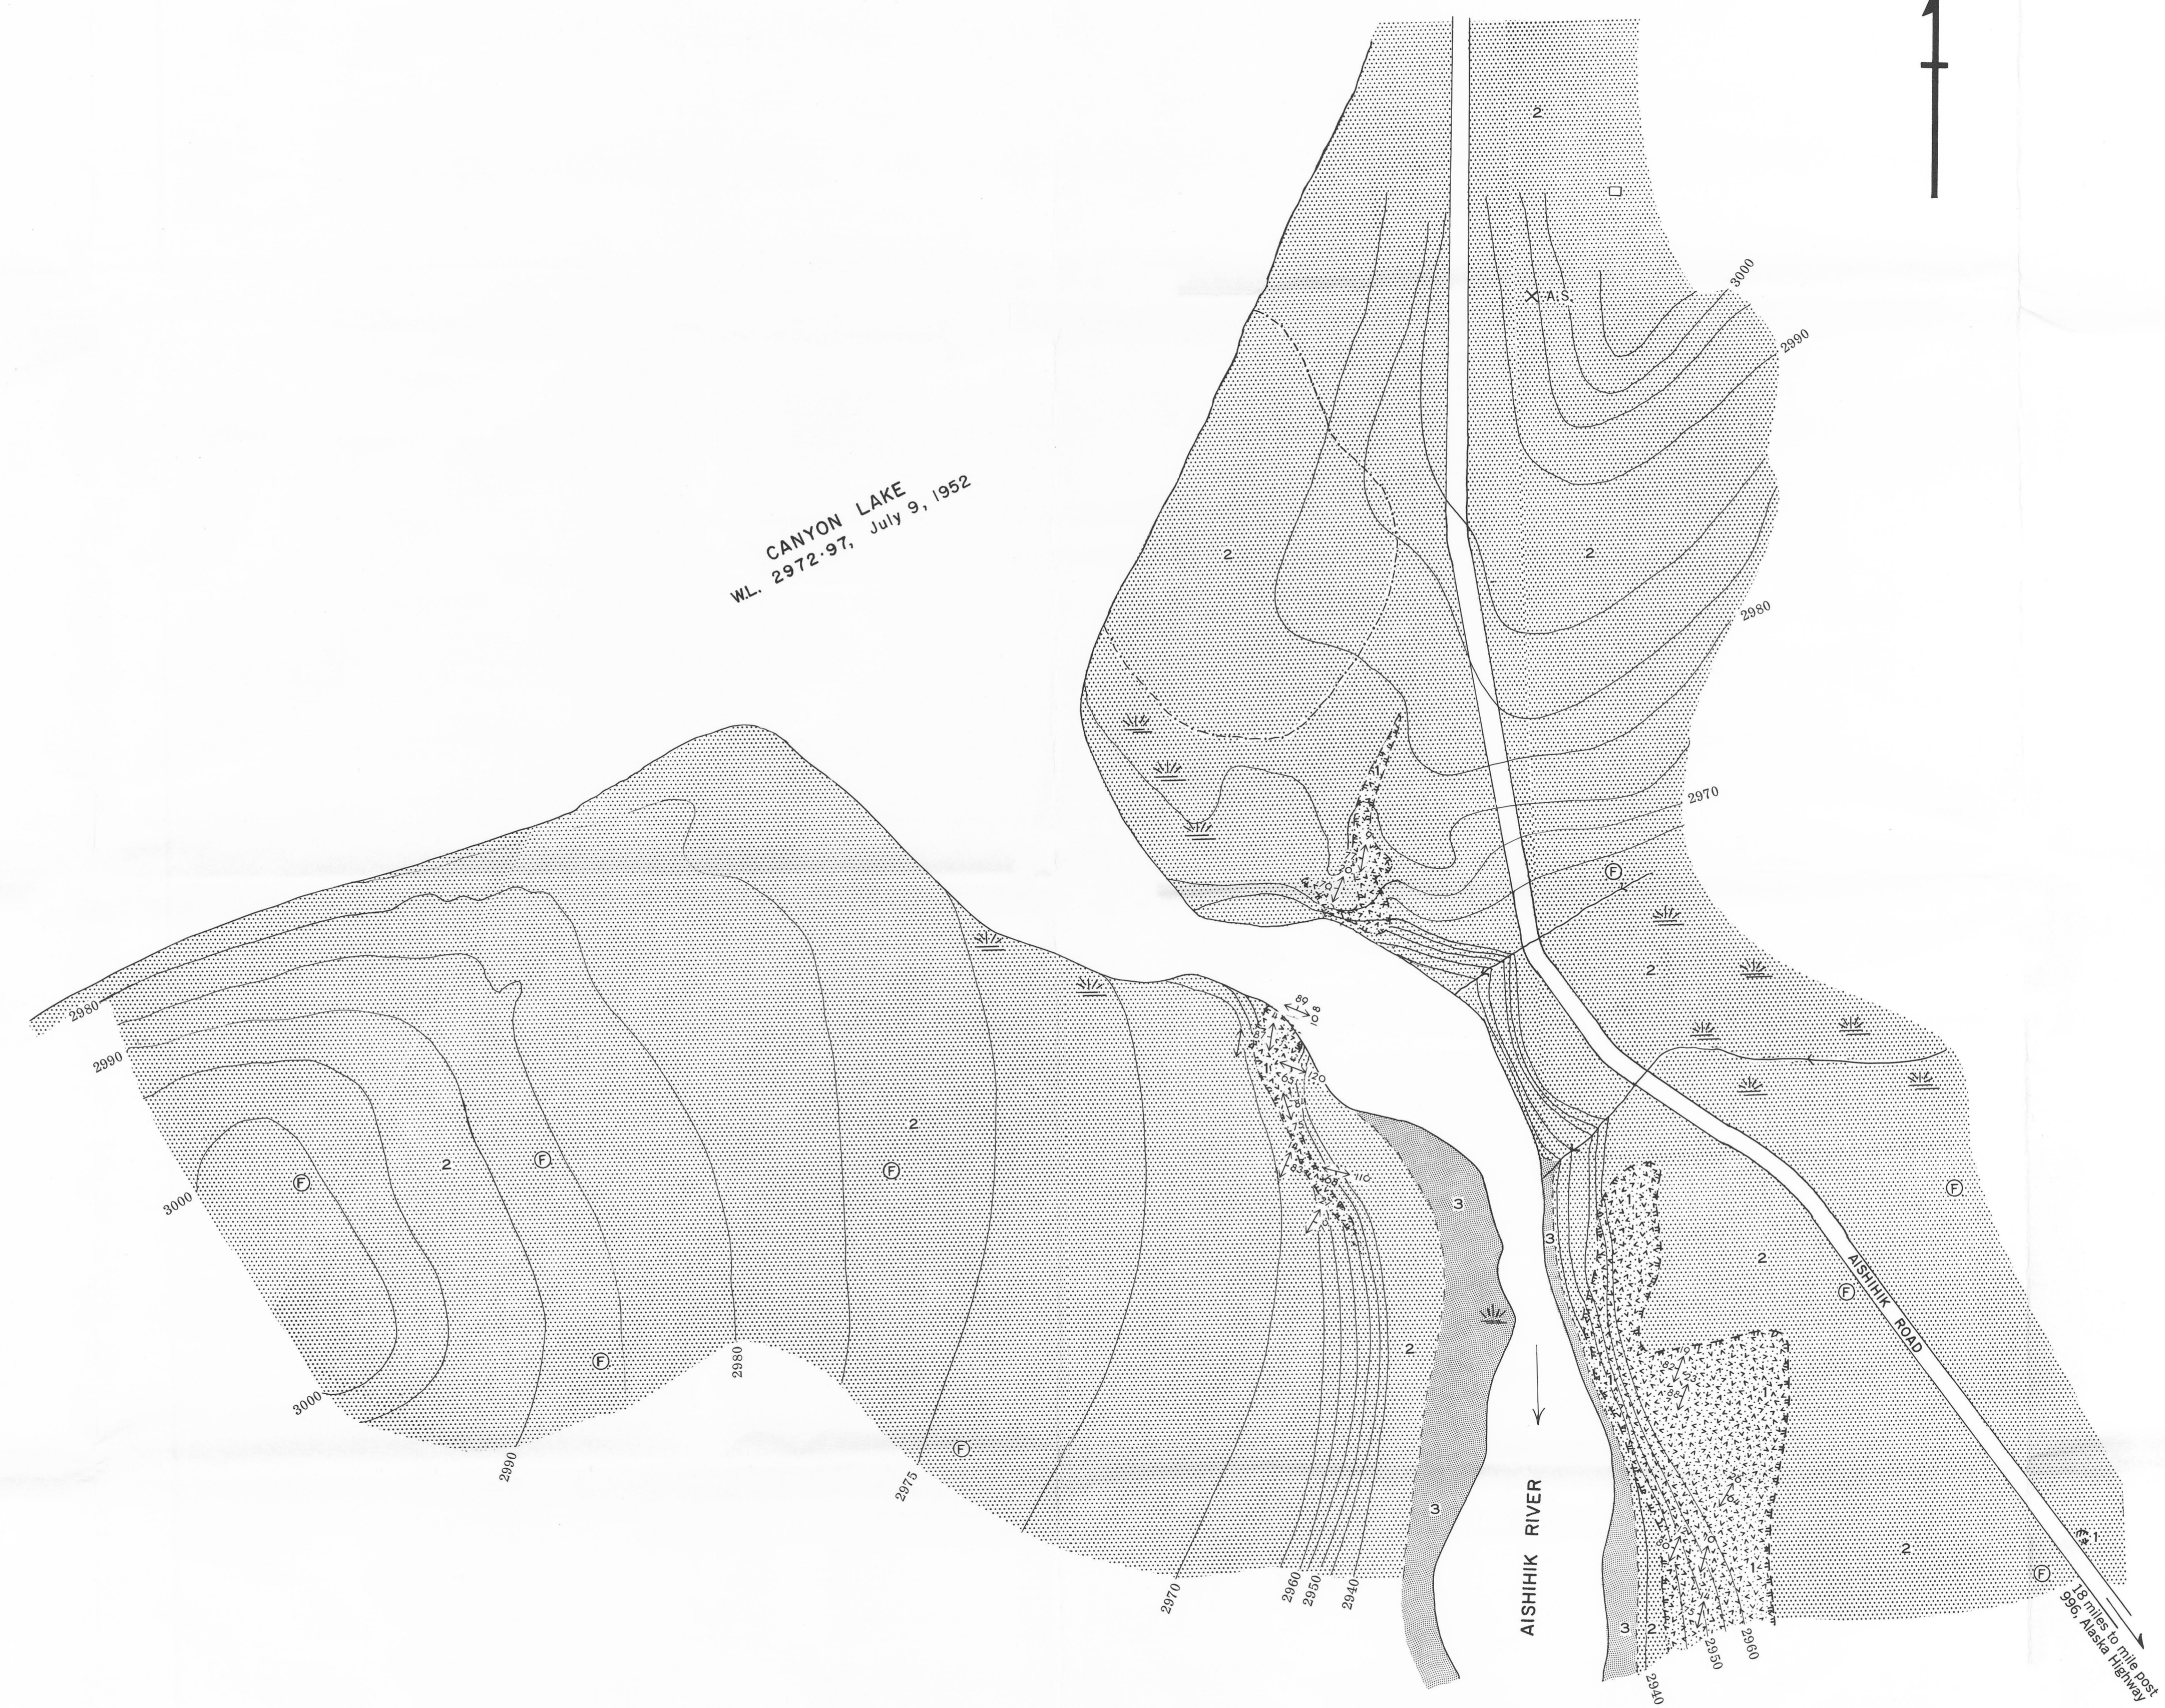
Aishihik and Canyon Lakes occupy a broad, north-trending valley which drains south through Aishihik River. During Pleistocene time the area was glaciated by ice moving north from the St. Elias Mountains. Large quantities of glacial materials chiefly impervious, clayey, silty till (sample No. 1) were deposited on the floor and sides of the valley. Morainic ridges of till extending across the valley floor have acted as natural dams which have partially blocked the drainage and created Canyon and Aishihik Lakes. The till is not exposed at Otter Falls dam site but is visible in cuts along Aishihik Road and bluffs along Aishihik River. It was encountered in several shallow test pits put down in the dam site area. Following glaciation a glacial lake covered a large area to the south and east including much of the valleys of Dezadeash and Takhini Rivers. One arm of this lake extended north into the lower part of Aishihik River valley and as a result the area in the vicinity of Otter Falls dam site is covered with a thin layer of stratified silt and silty clay (samples Nos. 2 and 4). The thickness of these glacio-lacustrine materials in the dam site area as determined by several test pits varies between 6 and 36 inches. Invariably they overlie till or bedrock.

The till should be satisfactory as core material for a rolled earth dam. It contains few boulders sufficiently large that they would have to be removed in order that the soil could be satisfactorily compacted. Large quantities will probably be excavated during construction of the canal from Canyon Lake to Rainbow Falls. The till exposed along the sides of the canal will be relatively stable if it is not frozen. However the frost line was encountered within 18 inches of ground surface in several test pits put down in the dam site area. Considerable ice was observed in the overlying silt and clay and these materials became fluid when allowed to thaw. Test borings will be required along the centre line of the proposed canal to determine the extent of the frozen soil as well as the types of materials which would be excavated.

Bedrock exposed at Otter Falls consists of fine- to medium-grained, grey, biotite, granodiorite. It is a competent rock and should provide excellent foundation and abutment material. Many of the angular rock fragments in the till and boulders in the alluvium along Aishihik River are of this rock type. In places especially on north-facing exposures bedrock surface is highly weathered and covered with up to 24 inches of soft, sandy residual soil. However, in no place should it be necessary to remove more than 4 feet of rock to expose fresh material against which concrete could be placed. There are two sets of joints both of which are common in bedrock throughout the dam site area. The presence of these could lower the competency of the rock mass and increase its permeability. One joint set strikes in a general north-northwest direction and has a relatively steep dip. As indicated on the accompanying joint rosette this set intersects the river at a fairly acute angle and dips steeply both upstream and downstream. The spacing varies from a few inches to several feet. Open fractures up to 6 inches frequently occur along these joints. The other set is a form of sheet jointing with curved surfaces essentially parallel to the surface of the outcrop. The visible spacing varies from 8 to 24 inches with the smallest closest to surface. Openings along these fractures are seldom more than one inch in width and usually less. The presence of these fractures at depth could cause overbreak when excavating and would constitute planes of weakness causing instability in the rock abutment.

Suitable riprap and aggregate could be obtained from bedrock at the site. However cheaper aggregate could probably be obtained from beach deposits around the edge of the former glacial lake. The most likely place to prospect for these materials would be downstream from the dam site along the sides of Aishihik River valley between elevations 2,300 and 2,800.
